BMP Inspection Form

Type of Inspection: **1st REINSPECT** FacilityID: **3839205** BMP Identifier: **POND A- EXTENDED DRY**  
Type of Violation: ☒ Notice to Comply ☐ Notice of Violation **DETENTION**  
BMP Score:

# FPL2000-00107 Hamiltons Crossing Fac ID #3839205

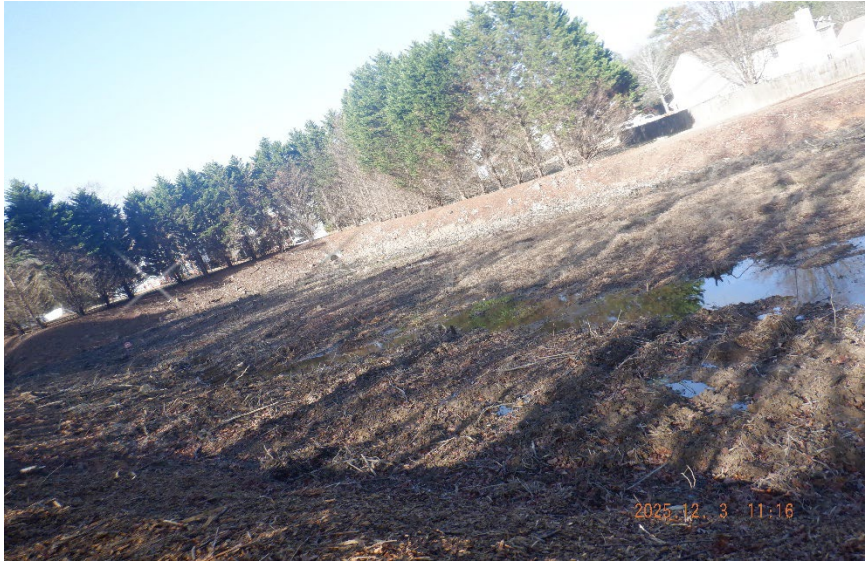
| Woody vegetative overgrowth has been cut/removed throughout pond, embankments, top, back face of dam & outfall area. | Corrected | Corrected on 12/3/25. QA |

**Woody vegetative overgrowth has been cut/removed throughout pond, embankments, top, back face of dam & outfall area.**

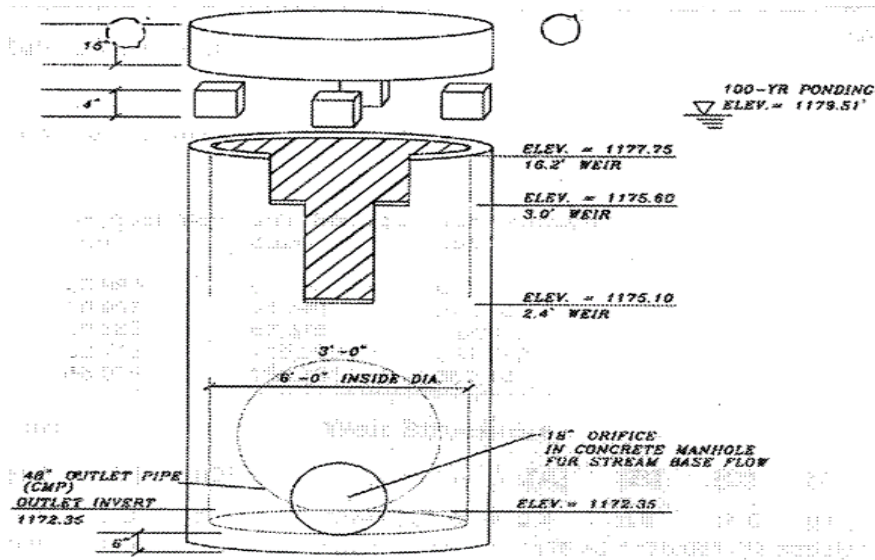
OCS Specs.

Water quality orifice should measure 18".

Provide tape measured pics of correct orifice sizes.
