# Your survey report

EXAMPLE\_GLOUCESTER

11/11/2024

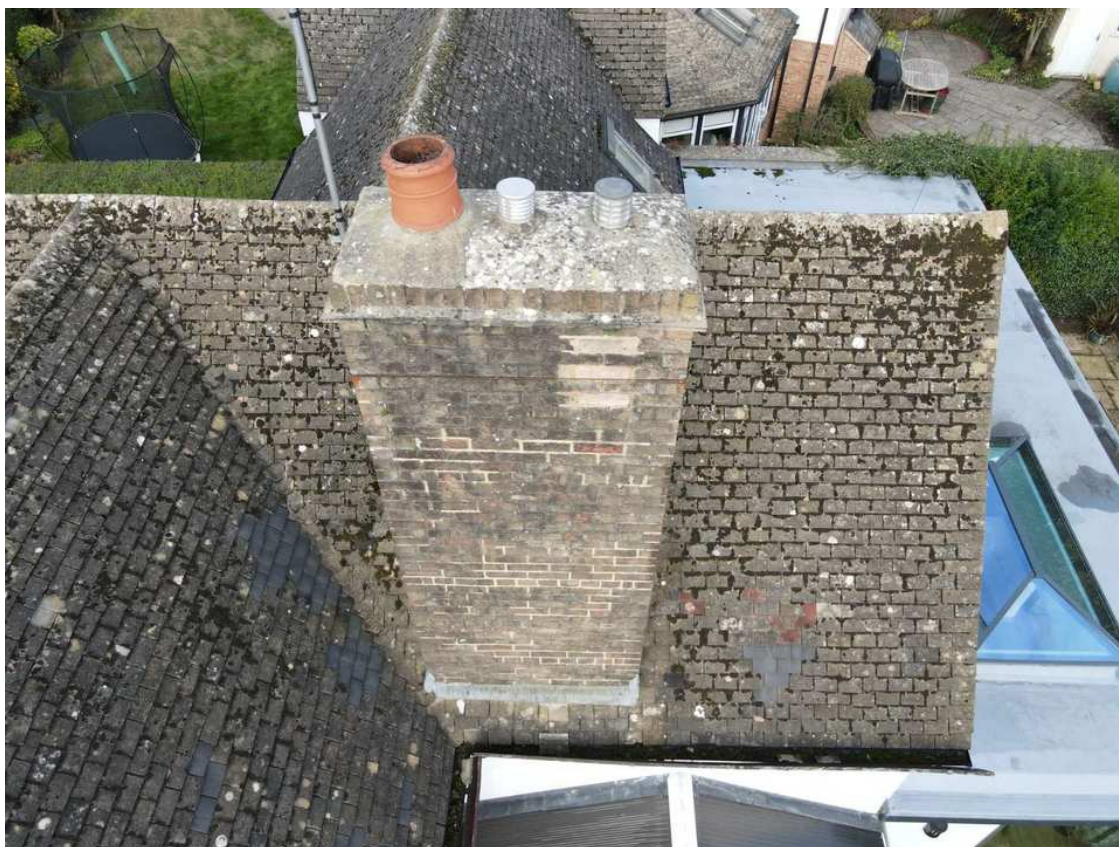
The property has a single chimney stack that now only serves the living room fireplace. The stack is built from solid brickwork with a central flue. The fireplace vents through a clay pot that is bedded in cement flashing. The flashing appears to be in good condition and enables water to run off the top of the stack. It would appear as though historic repairs have been undertaken to the stack that have included brick replacements and repointing to ensure the stack, flue and internal building fabric remains dry.

***General view chimney stack.***

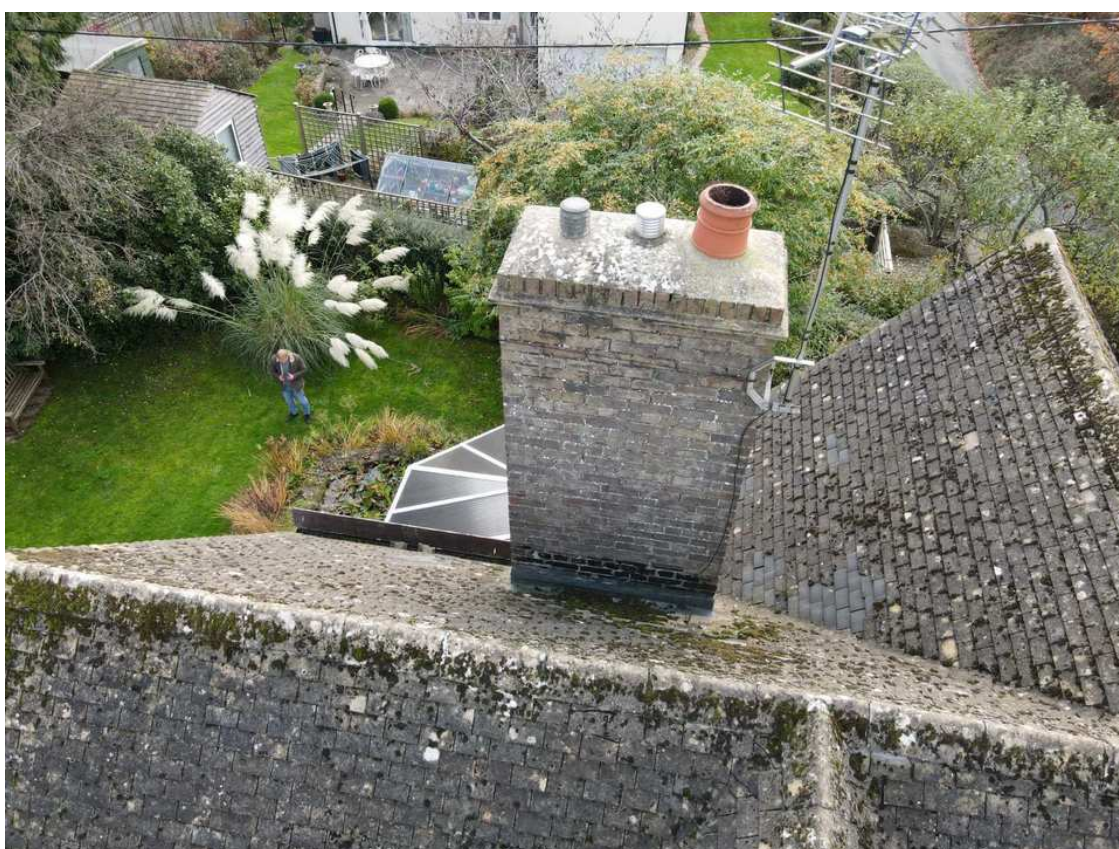
Additionally substantial moss growth to the rear of the stack at roof level can often draw moisture into the property via capillary action - it is advisable to clear the moss growth.

***General view rear of stack.***

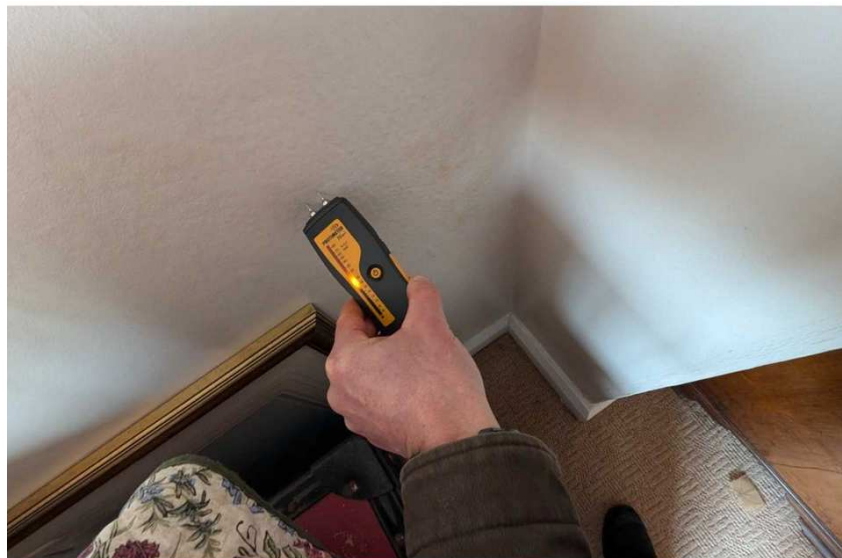
However, it is clear that rainwater is penetrating through the stack and is permeating in bedroom number 2, plaster finishes and chimney breast reveals were recorded as having raised/ damp moisture readings using an electronic damp meter.

***High moisture.***

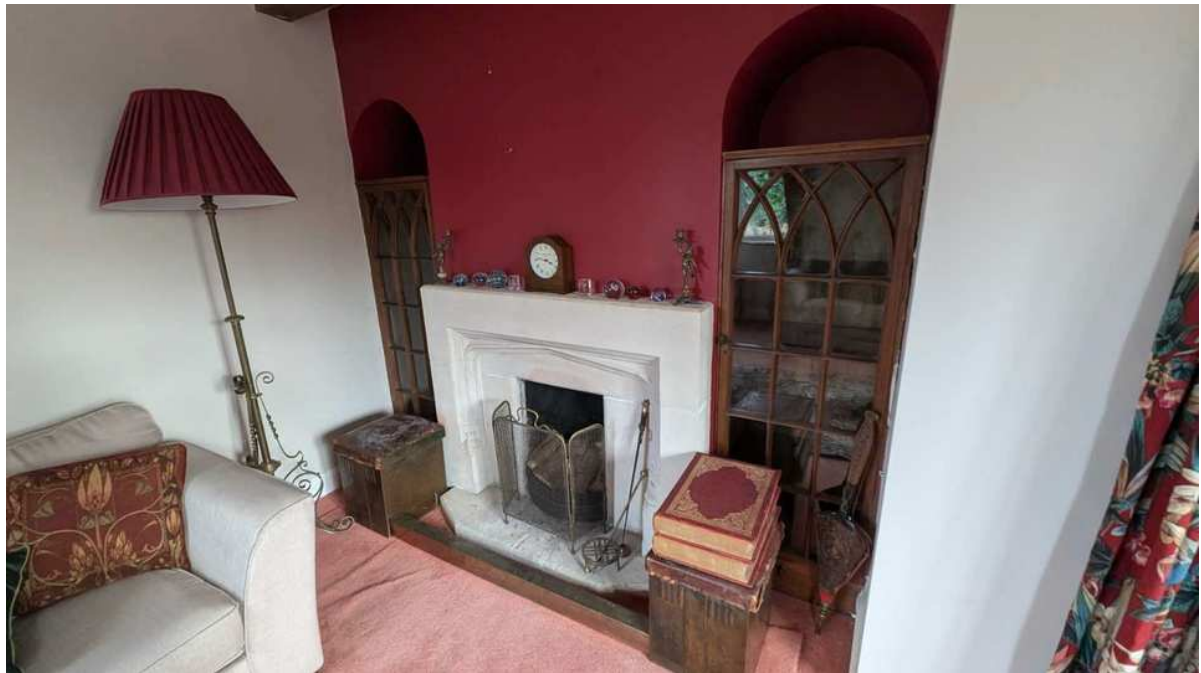
On the balance of probability, gravity is drawing moisture down to the living room fireplace chimney breast reveals also, we could not inspect or test for damp because of furniture obscuring the wall. It is likely that the open chimney pot is allowing water to run inside the flue and to migrate back into the property, a simple cowl will prevent rainwater ingress.

***Potential for damp at the base of the fireplace.***

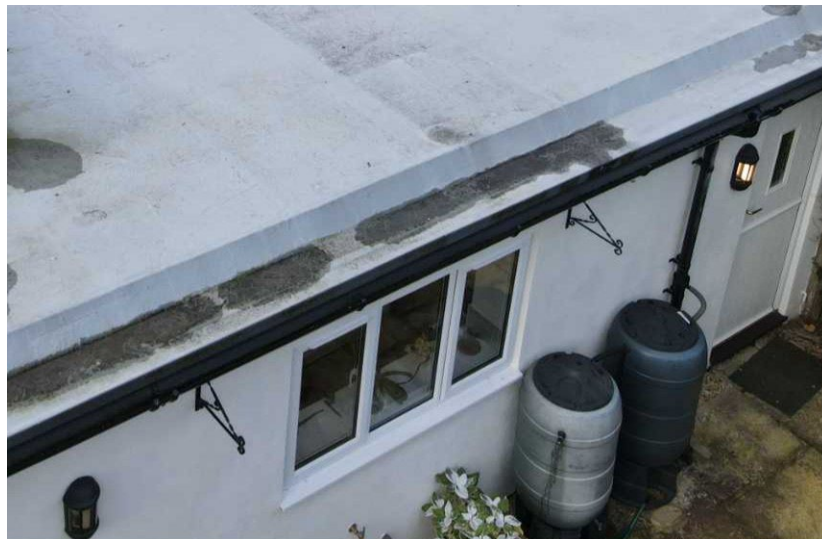
***Falls and gutters to flat roof.***

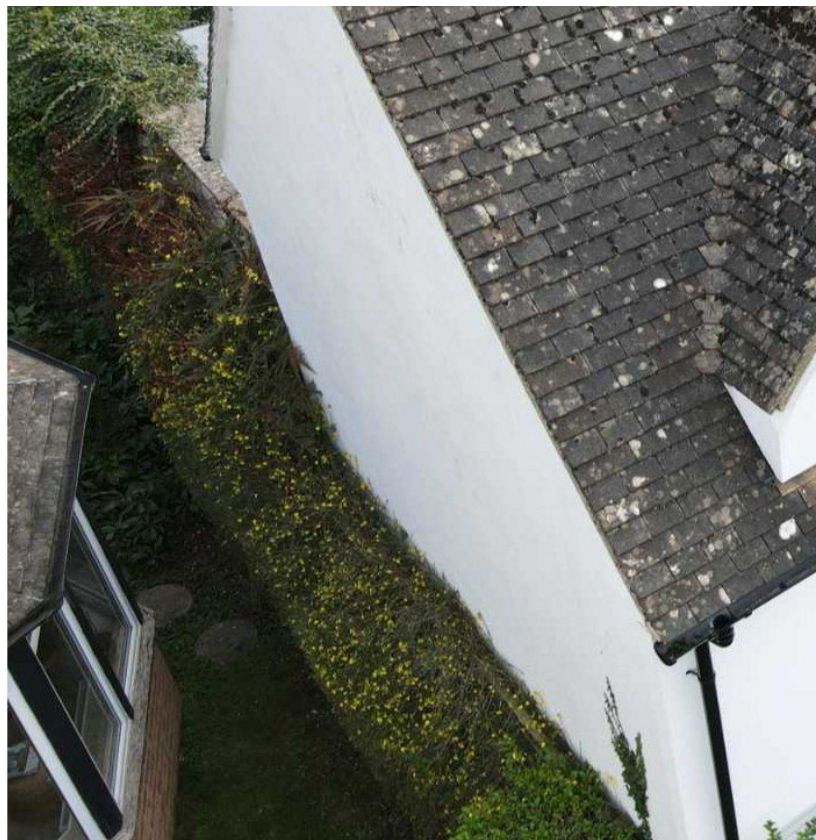
***No access to wall left hand side.***

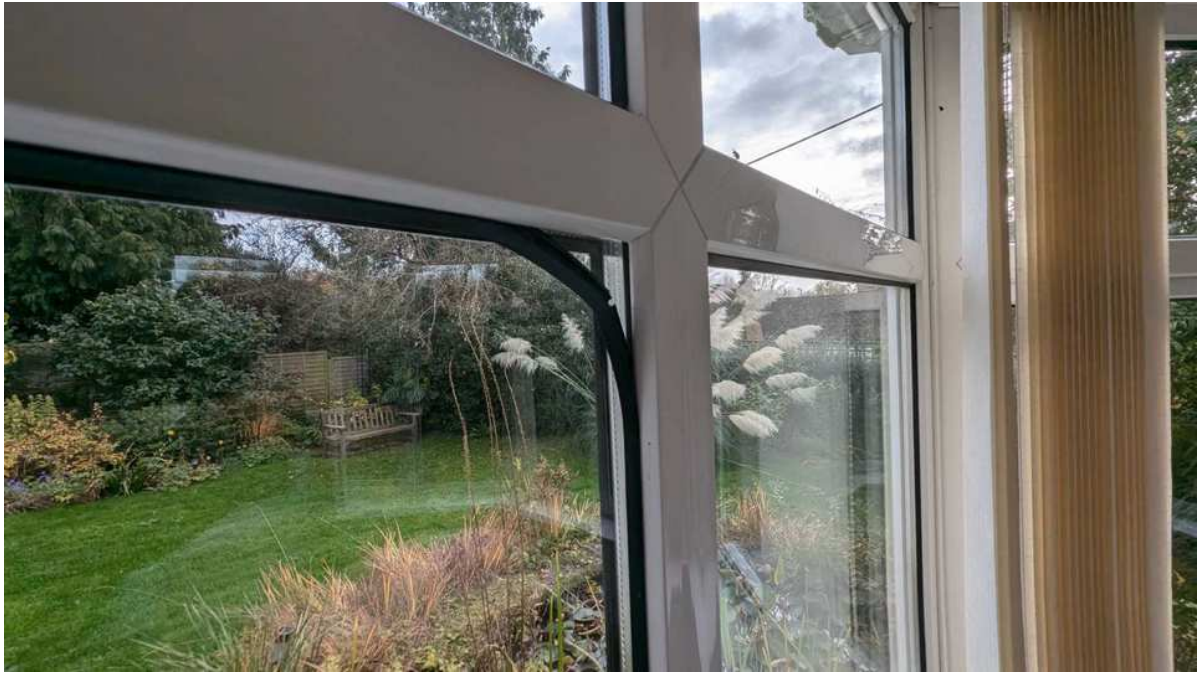
However, it is important to note that the conservatory windows exhibited evidence of gasket seals that have shrunk, which may compromise their thermal efficiency. This shrinkage can lead to potential drafts and reduced insulation performance, making it advisable to consider replacing or repairing these seals to enhance energy efficiency. Overall, while the main windows are performing well, addressing the issues with the conservatory windows will help maintain the comfort and energy efficiency of the property.

***Conservatory Windows: Shrunk seals.***

| Element no. | Element name | Comments (if applicable) |
|---|---|---|
| D5 | Windows | Replace conservatory window seals. |

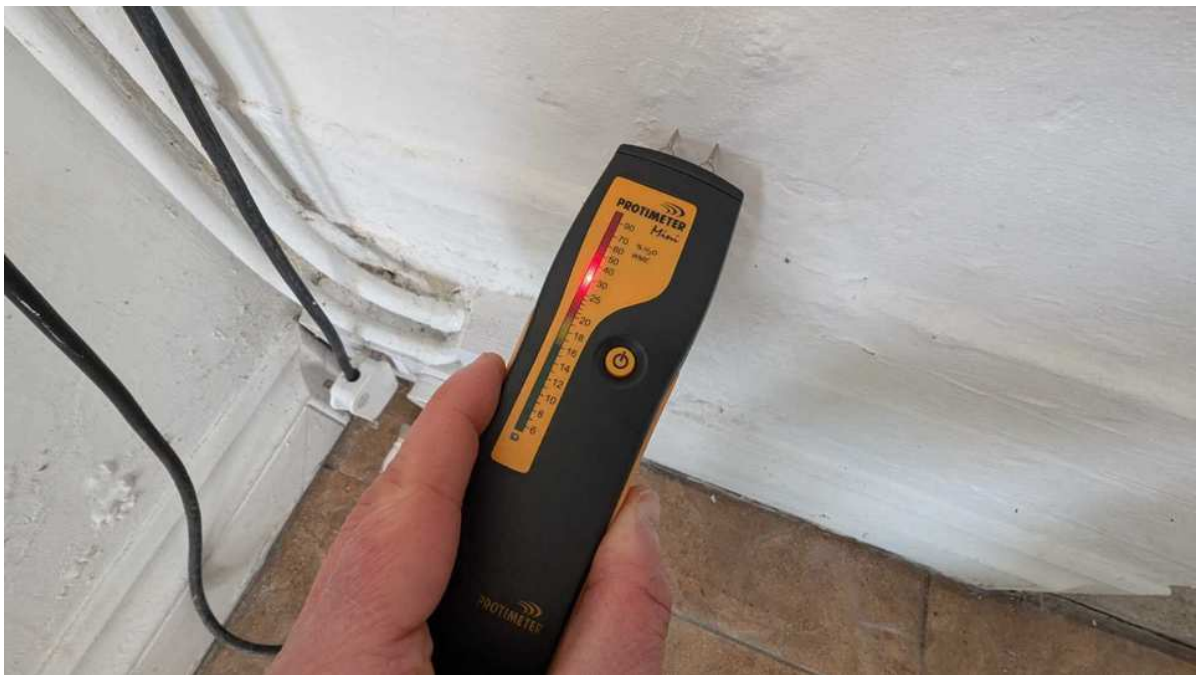
However, there are significant concerns regarding dampness to the internal plaster finishes of the low-level brickwork facing wall. While the damp has not migrated elsewhere into the house, the damp is likely caused by several factors:

***High moisture reading.***

To address these issues, it is crucial to either remove or make watertight the rainwater harvesting water butt. Additionally, it is important to break out and completely repoint all low-level brickwork in the conservatory using medium-strength cement mortar. Allow the walls to dry out, ideally utilising an industrial dehumidifier to expedite the process. If dampness persists, consider emptying the pond and ensuring that there are no cuts or leaks in its lining, preventing further moisture from permeating back into the conservatory - or worst case, infill the pond.

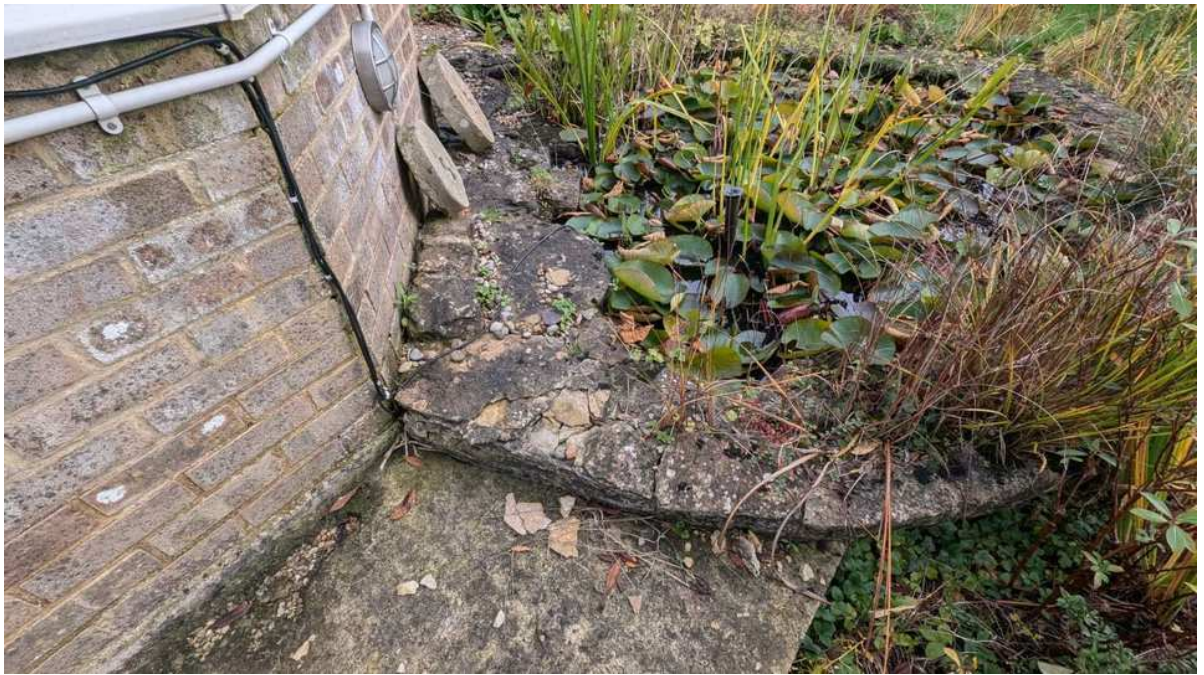
- the proximity of a pond, which may allow for capillary action drawing moisture into the conservatory;
- a leaky rainwater harvesting water butt that enables water penetration;
- and most likely failed lime mortar jointing to the external face of the low level perimeter brick wall.

***Proximity of pond.***

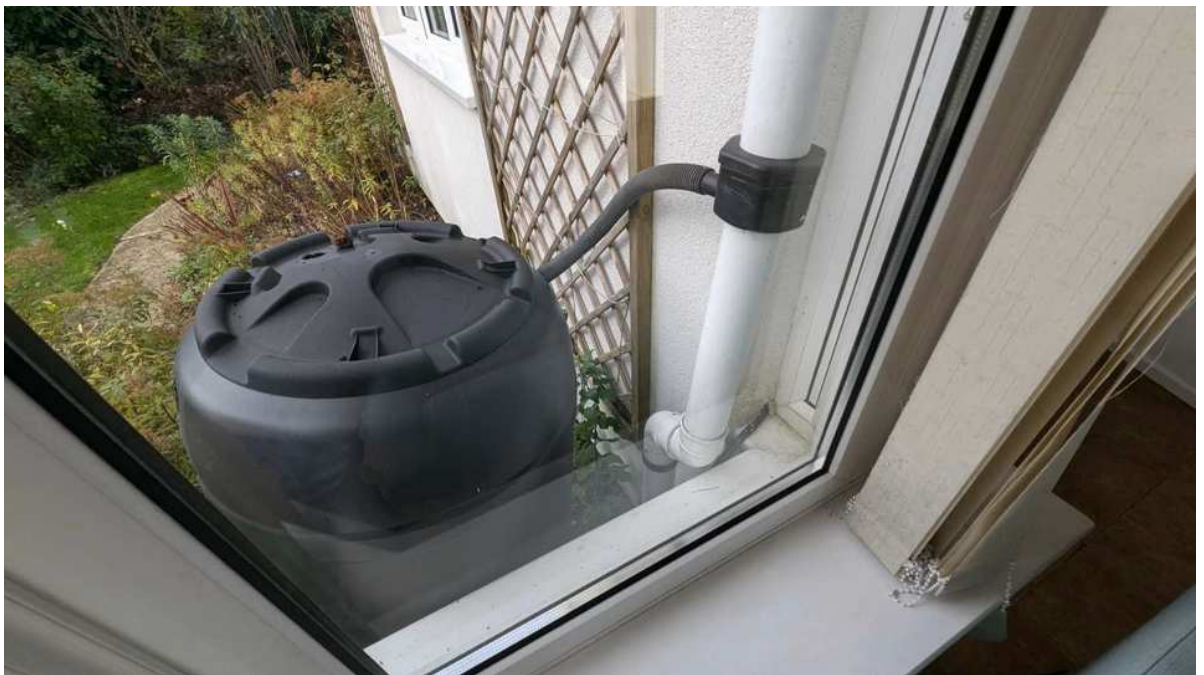
***Proximity of leaky rainwater harvester.***

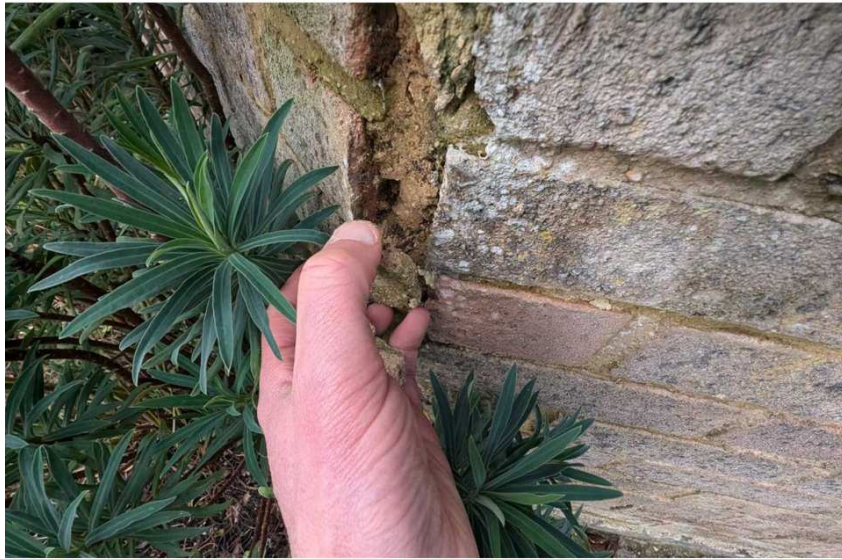
***Failed cement jointing.***

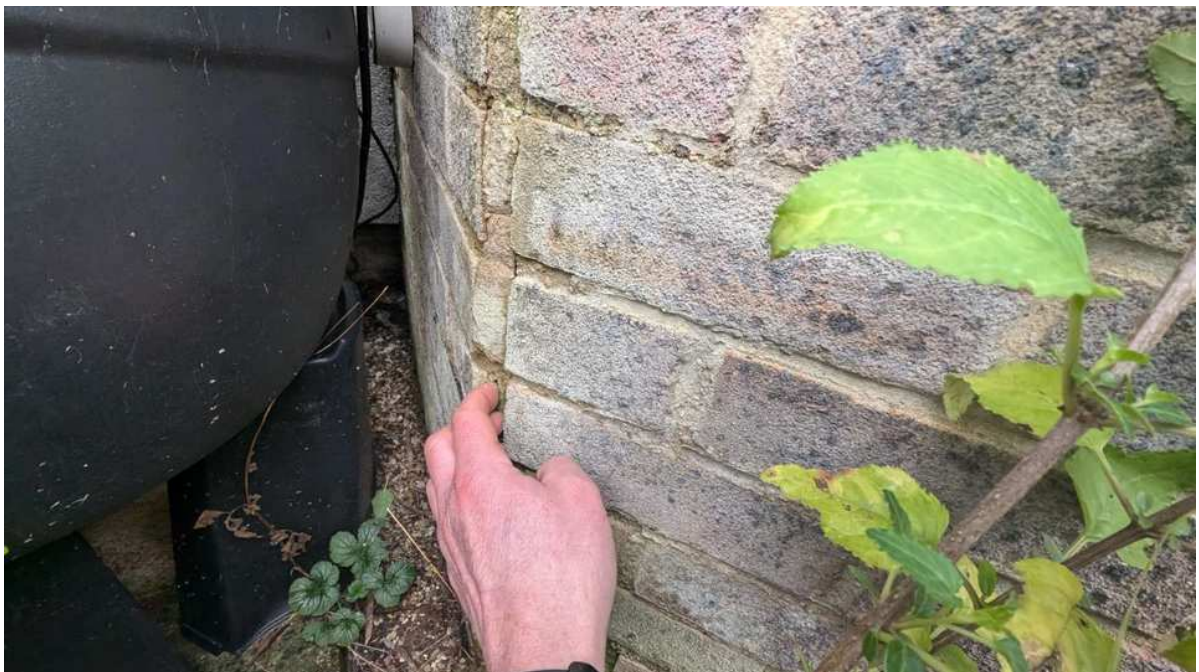
***Failed cement jointing.***

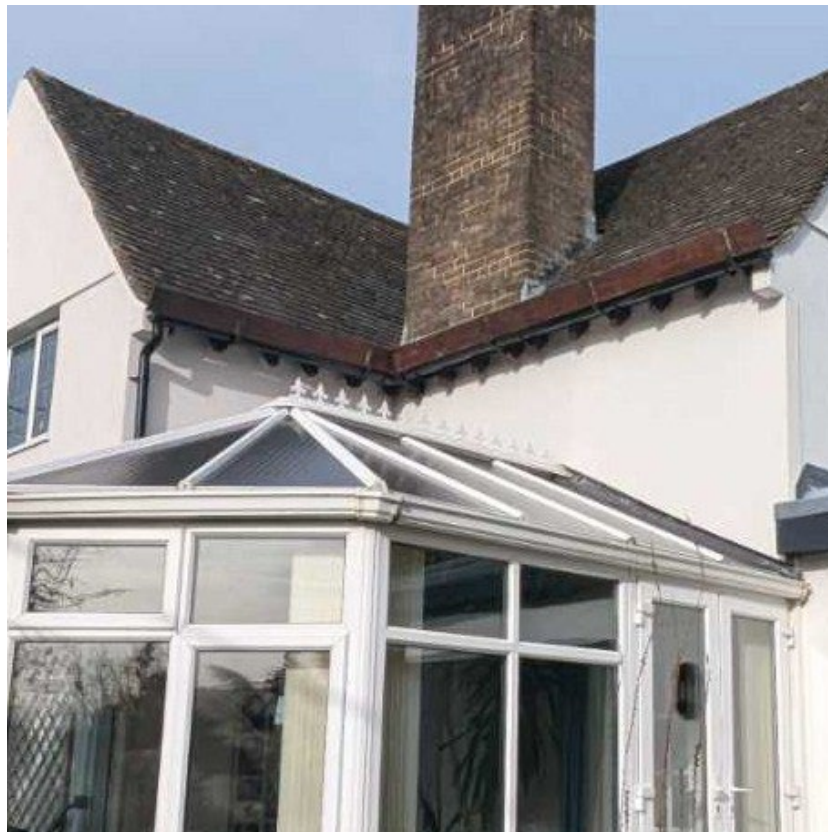
The exposed rafter shoes at the eaves levels are in satisfactory condition, kept in good decorative condition they show no signs of decay or rot. Their well-maintained appearance indicates that they have been properly cared for, contributing to the overall aesthetic of the structure while ensuring structural integrity.

Above the conservatory roof, a corner snow guard is installed, serving a crucial function in preventing ice and snow from sliding off onto the conservatory below. This feature is often overlooked, but it plays an essential role in protecting the conservatory from potential damage caused by falling snow and ice. By retaining snow on the roof, the guard helps to manage the load and reduces the risk of sudden, heavy falls that could compromise the conservatory's structure. Its presence is a practical solution that enhances safety and longevity, making it an important aspect of the roofing system.

***Exposed rafter shoes and snow guard.***

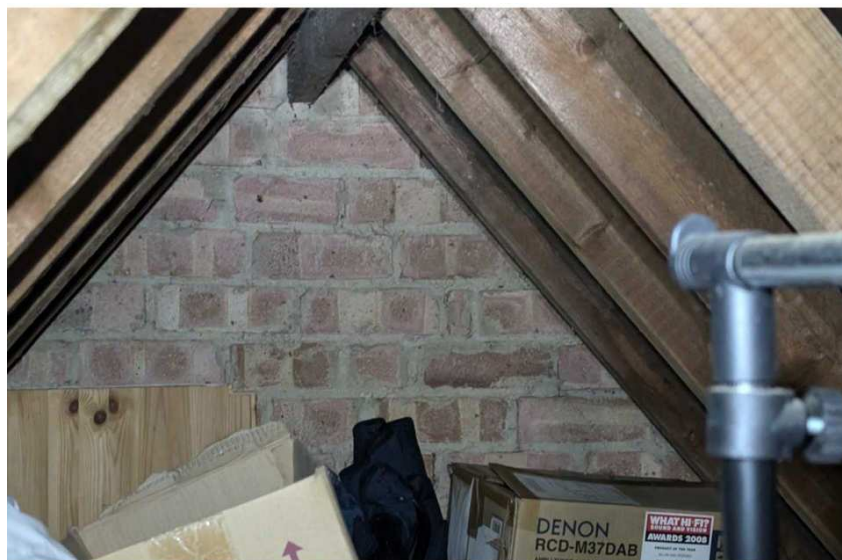
The exposed brick and blockwork within the loft were free from cracking, further evidencing the unlikely effects of ground heave on the property.

***Solid brickwork free from cracking.***

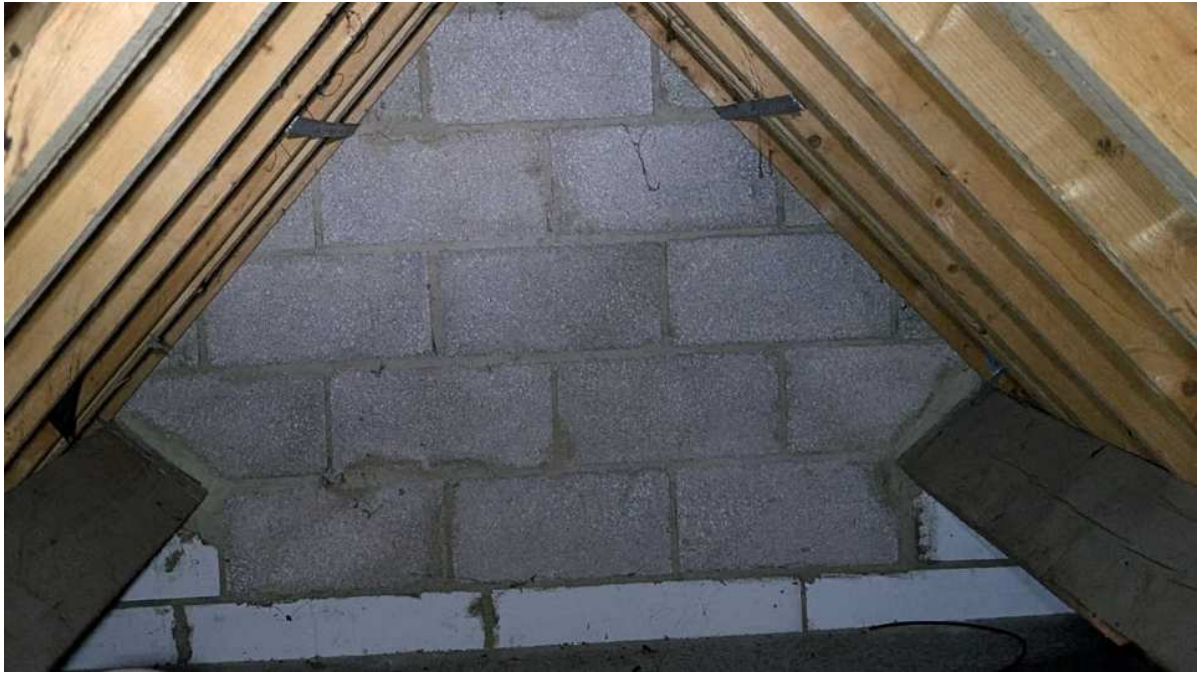
***Blockwork free from cracking.***

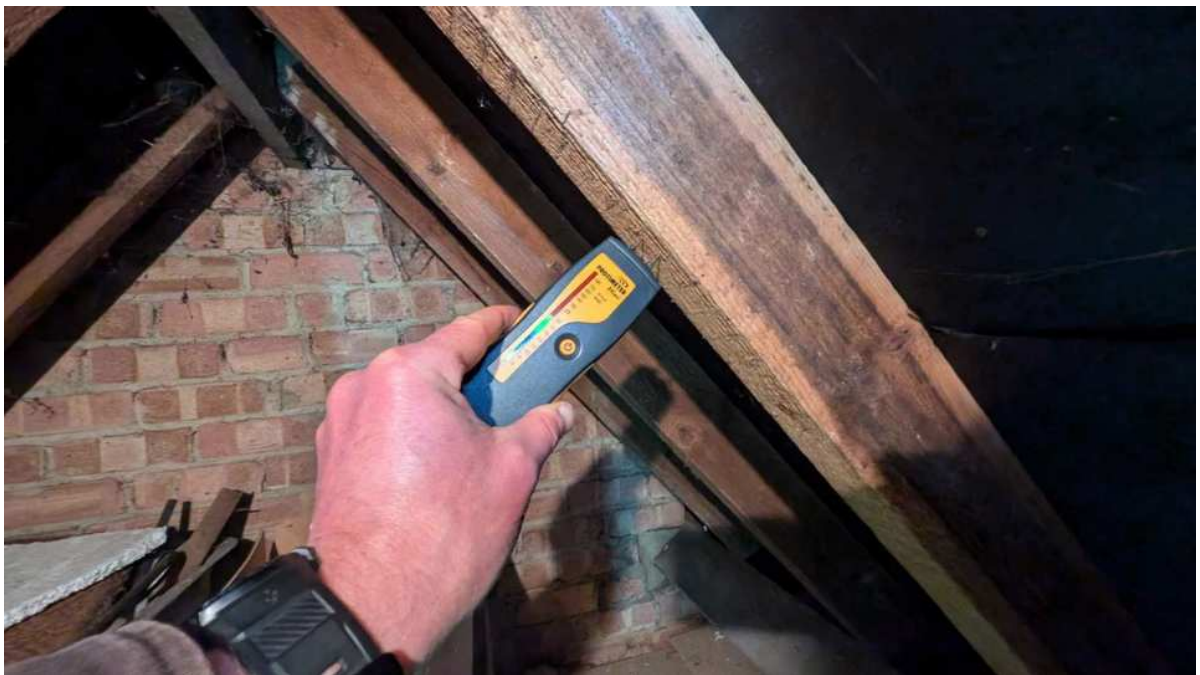
***Roofing Timbers : acceptable moisture level.***

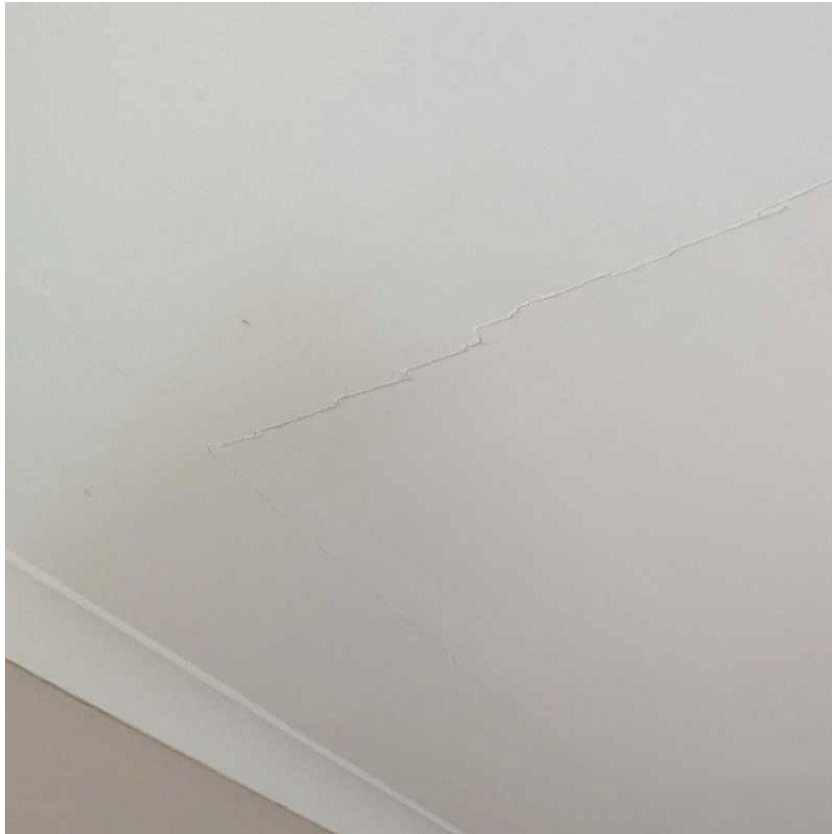
Cracking through the plaster finishes was evident on the ceilings that constitute the majority of the original build of the property. However, we do not believe this cracking is structural in nature; rather, it is likely due to the ceilings being formed using lath and plaster, which are prone to drying out and cracking over time.

***Hairline cracking to ceiling.***

For remediation, it is feasible to directly fix plasterboard over the existing lath and plaster ceilings, followed by plaster skim and decorating. Additionally, filler and paint can be applied to conceal any cosmetic cracking. Nonetheless, it is advisable to continue monitoring these cracks to ensure they do not develop further.

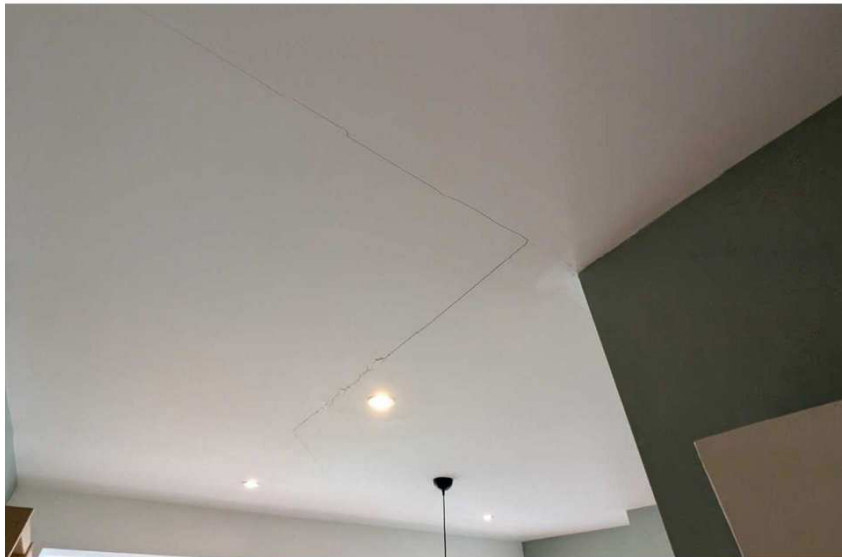
Some evidence of shrinkage in the gypsum plaster finishes was observed in the dining room area, where hairline cracks were present. Again, these cracks appear to be more related to shrinkage rather than structural issues. It's important to note that if ground heave or progressive movement were a concern, we would expect to see corresponding cracking in the external render, which is not the case here.

***Ceiling plaster shrinkage dining room.***

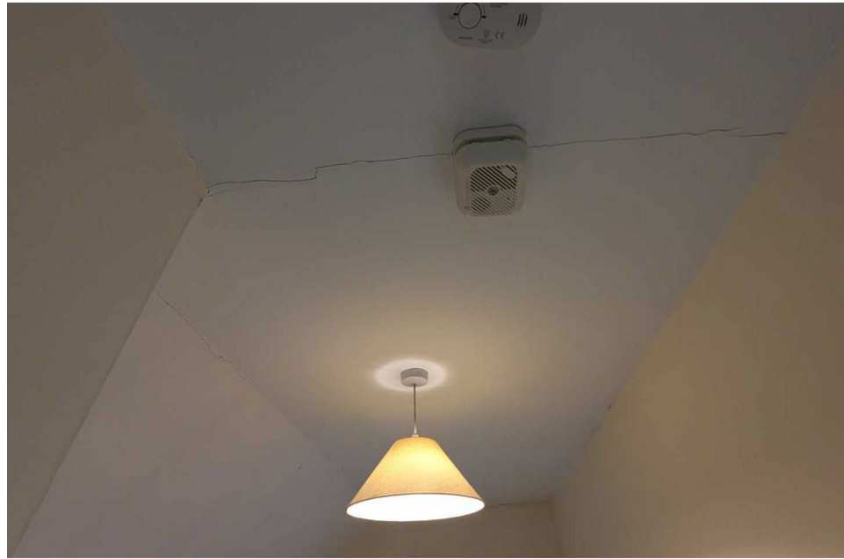
***Hallway ceiling crack.***

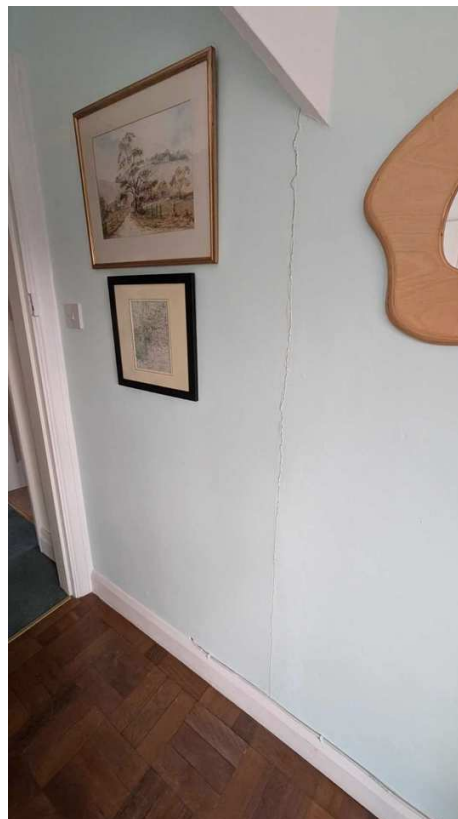
Cracking is predominantly observed between the solid brick walls and the stud walls, where differential movement has led to a rate of expansion between the differing building materials, resulting in cosmetic cracking. Importantly, these cracks are not structural in nature. They arise from the way the ridge rafters are seated onto the solid brick walls, combined with the use of stud walling during the construction phase, likely implemented to economise on costs.

***Cracking between solid wall and stud wall.***

1. **Break Open Stud Work:** Carefully remove the stud work between the brickwork, ensuring to empty any boarding and Rockwool insulation from the loft space.
2. **Retain or Trim Joists:** Assess the existing joists; retain them where necessary, or trim them back as needed to accommodate the new layout.
3. **Create New Stud Wall:** Construct a new stud wall to define the space, including a door opening and frame if required. Alternatively, consider creating an open space that seamlessly integrates into the new room.
4. **Modify Existing Door:** If applicable, remove the existing door to bedroom four and close the opening using stud work and plaster finishes to maintain a cohesive look.

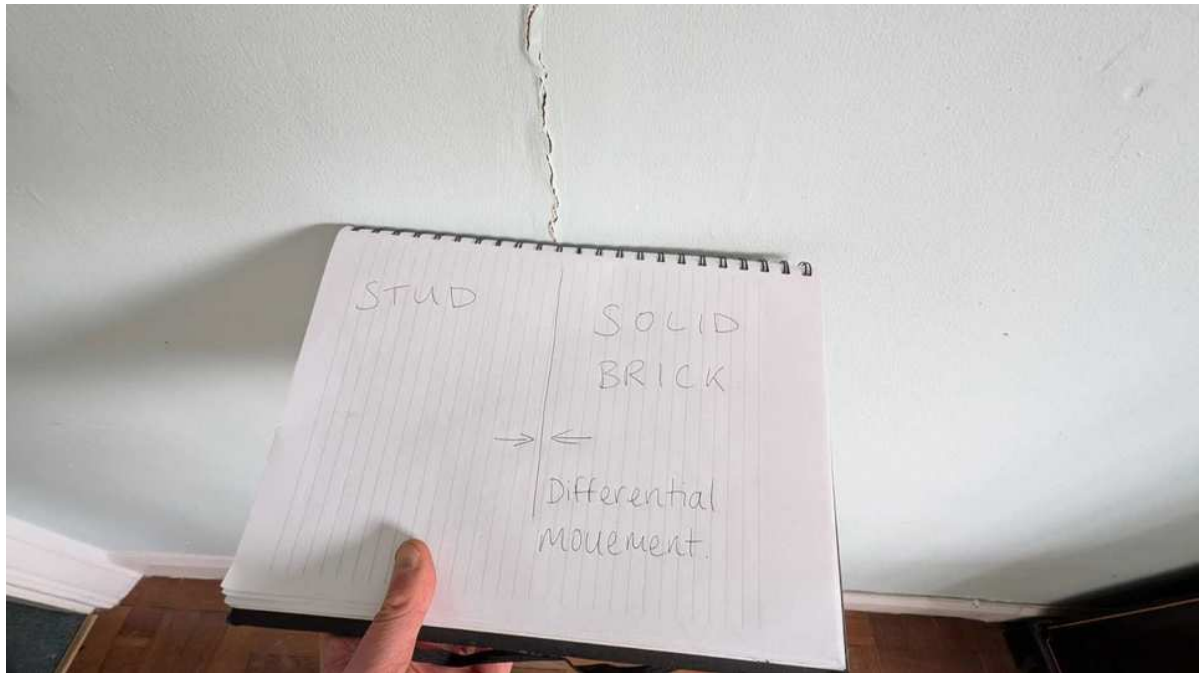
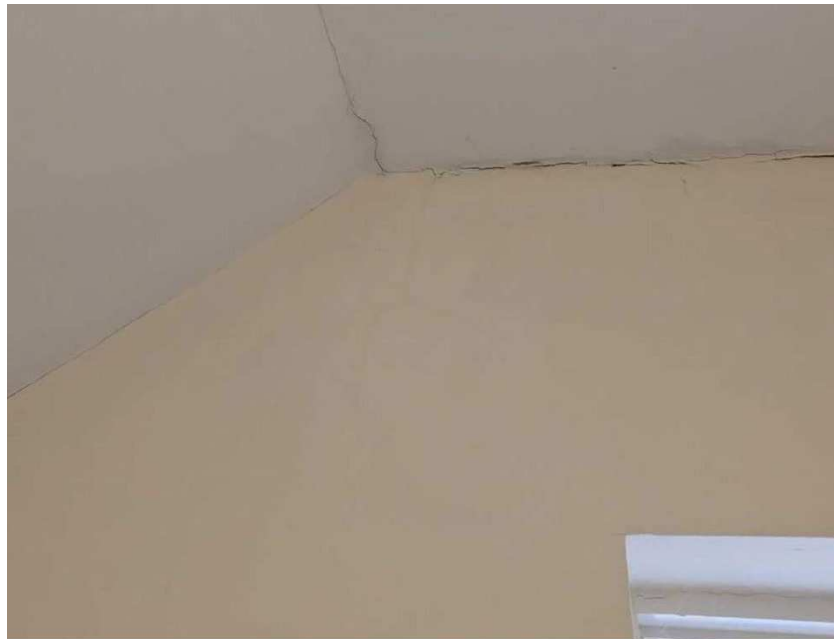
***Cracking between original build and extension.***

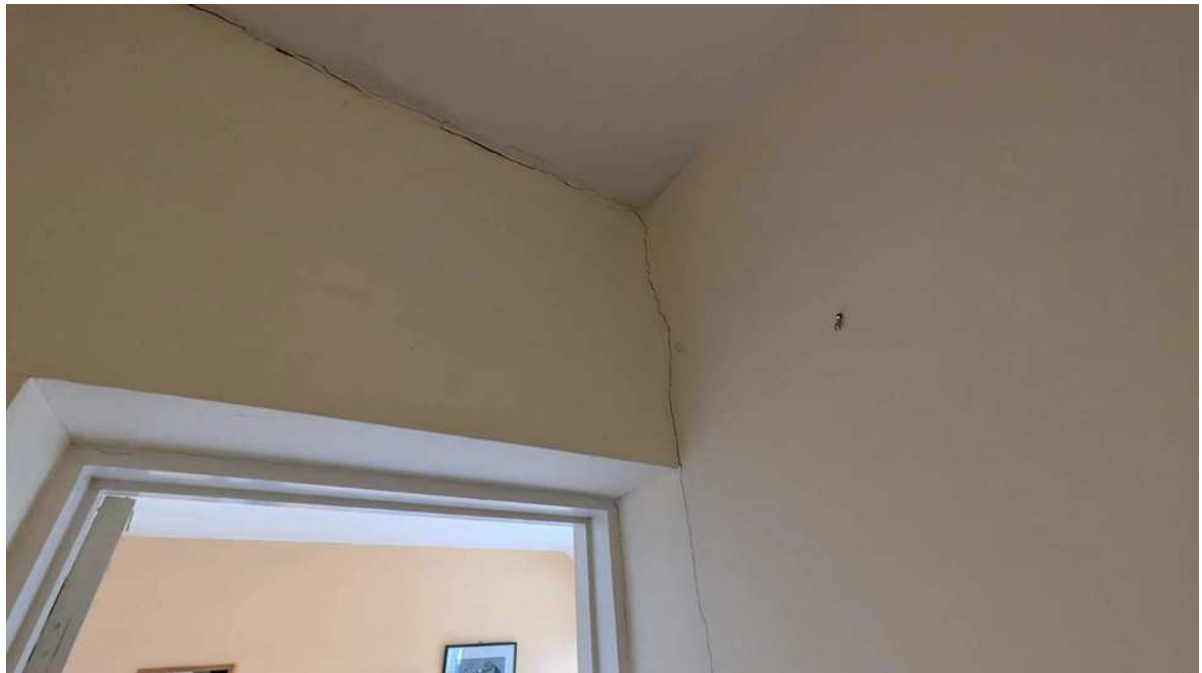
***Cracking between original build and extension.***

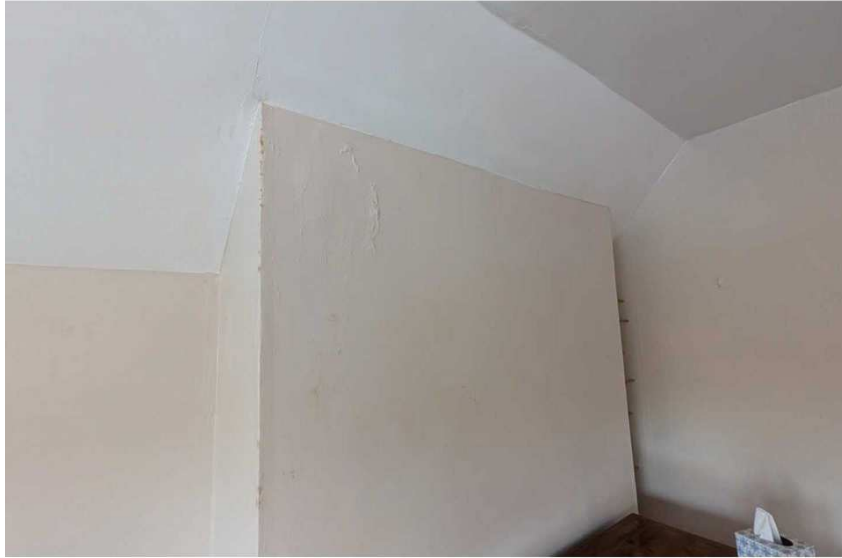
Plaster finishes to bedroom number 2 and the sitting room appear to be in reasonable condition despite damp staining and bubbled decorations. Use of a dehumidifier to dry the room out once the chimney pot has been capped it should be sufficient. Nonetheless redecoration will be required.

***Bedroom 2. damp chimney breast.***

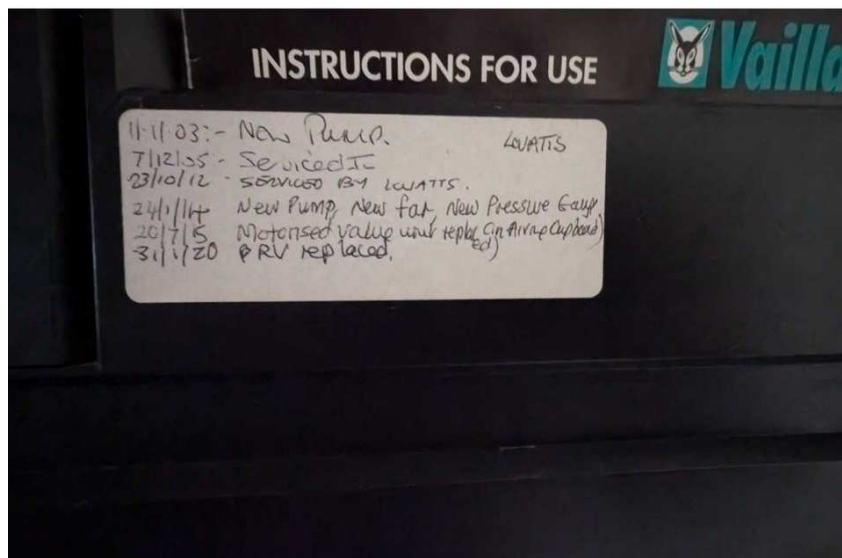
The property utilises a system boiler that provides hot water to wall hung radiators and to an underfloor heating system, all of which utilise heated hot water. The system boiler appears to be old and has had repairs undertaken to it that date back to 2003. To the first floor there is an electric immersion heater, these types of heating systems are dated and less energy efficient than modern condensing combination boilers. The energy performance certificate declares that hot water (showers, running water etc.) is heated from the main system. The energy performance certificate can be located here:

***Numerous repairs completed over the last 20 years.***

| Repairs | Cost Guidance (optional) |
|---|---|
| Replace old system boiler and immersion water heater. | £5,000 |

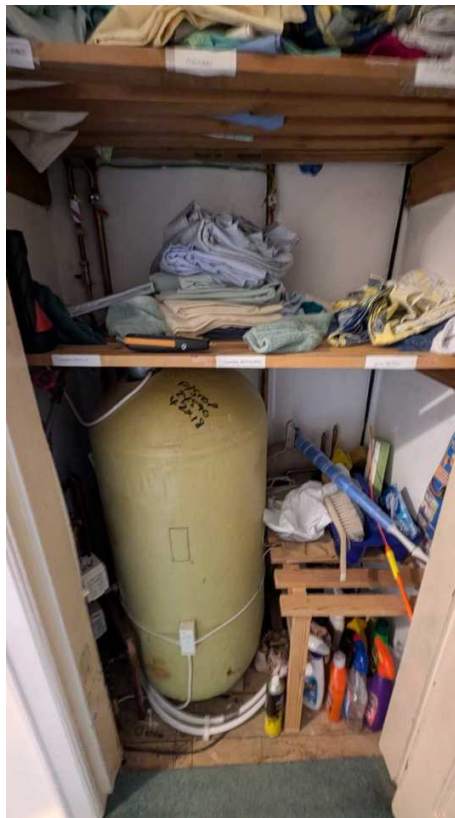
At the time of inspection, the immersion heater was turned off, and no hot water output was observed when the taps were run. This likely contributed to the hydraulic hammer heard from the shower, possibly due to the immersion being drained. We recommend hiring a competent plumber to assess and potentially overhaul the water heating system in the short term, with attention paid to the potential presence of legionella disease often associated with still water (loft water tank).

***Immersion - upstairs storage room.***

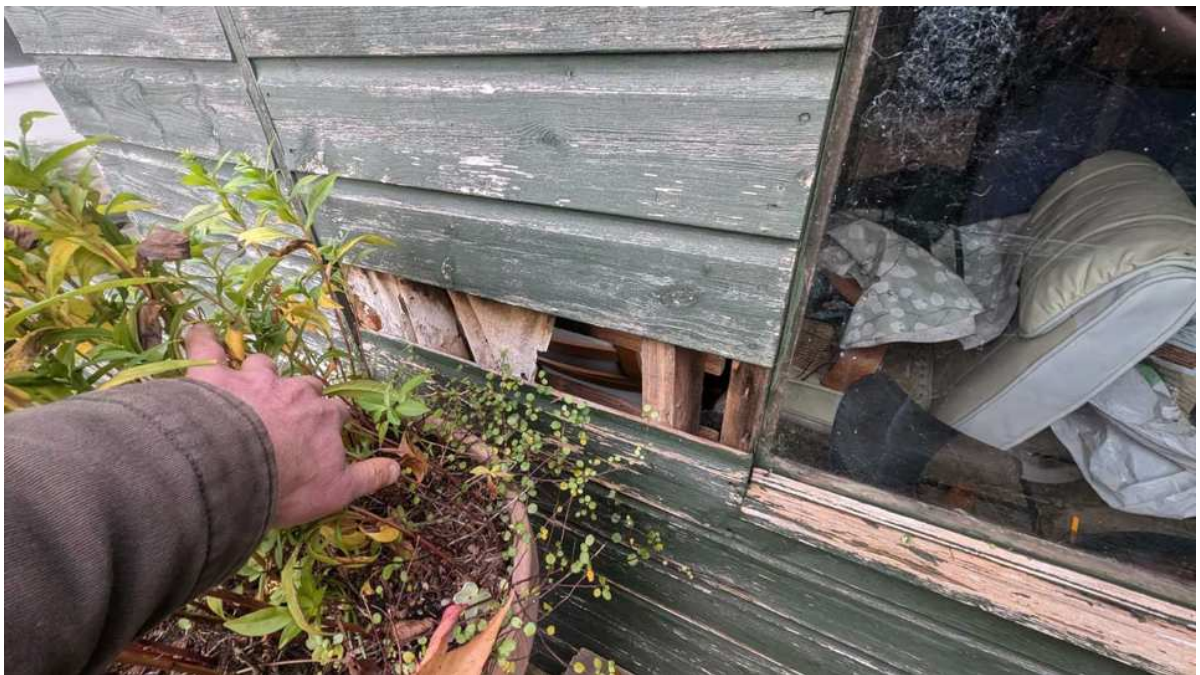
The garden includes a timber storage shed with a flat roof covered with roofing felt. The shed currently provides storage for various household items. We found that some of the panelling to the side of the shed is missing possibly a result of impact damage.

***Missing wood panels.***

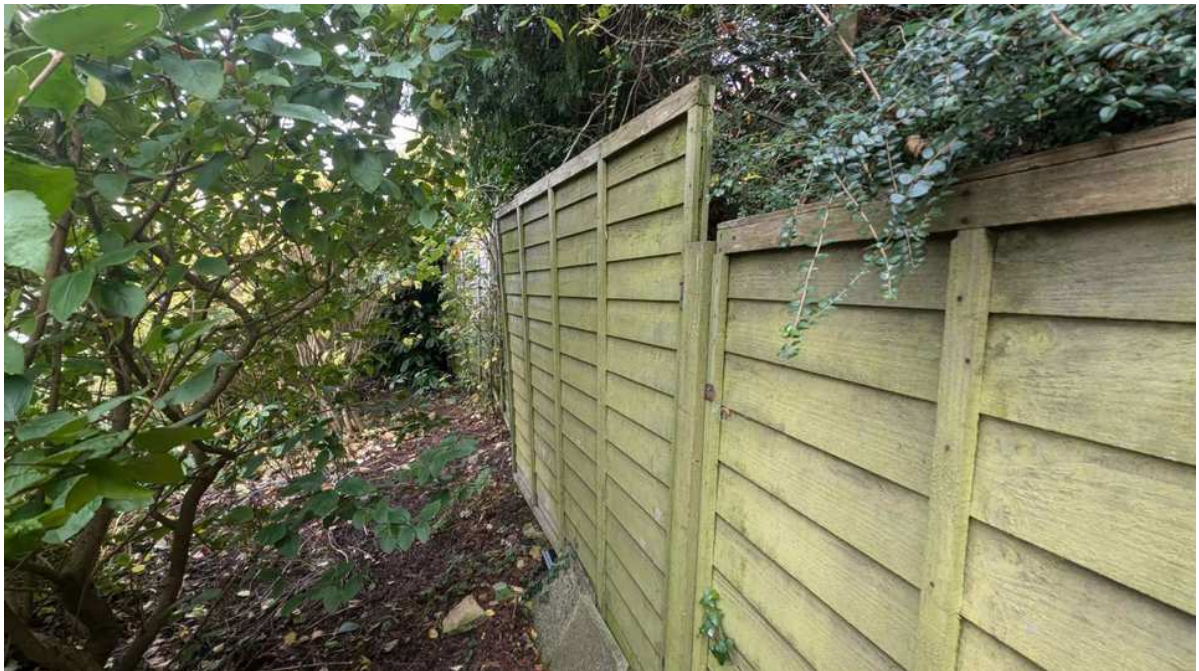
***Wobbly fence.***

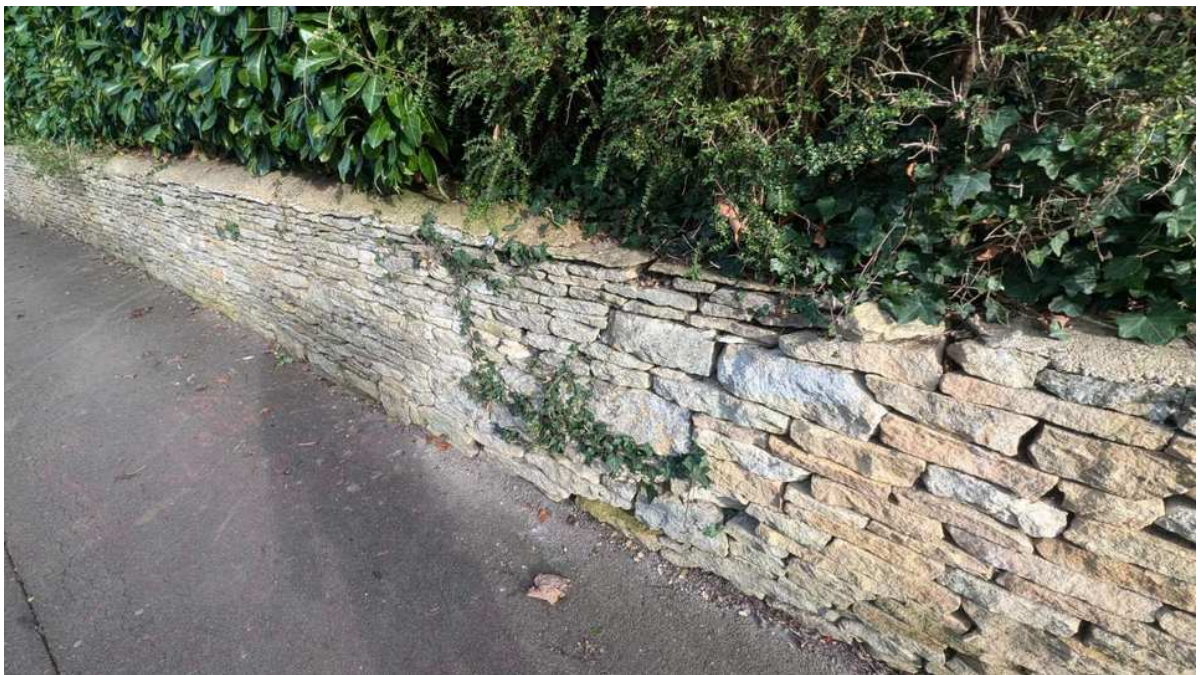
***Area in need of repair.***

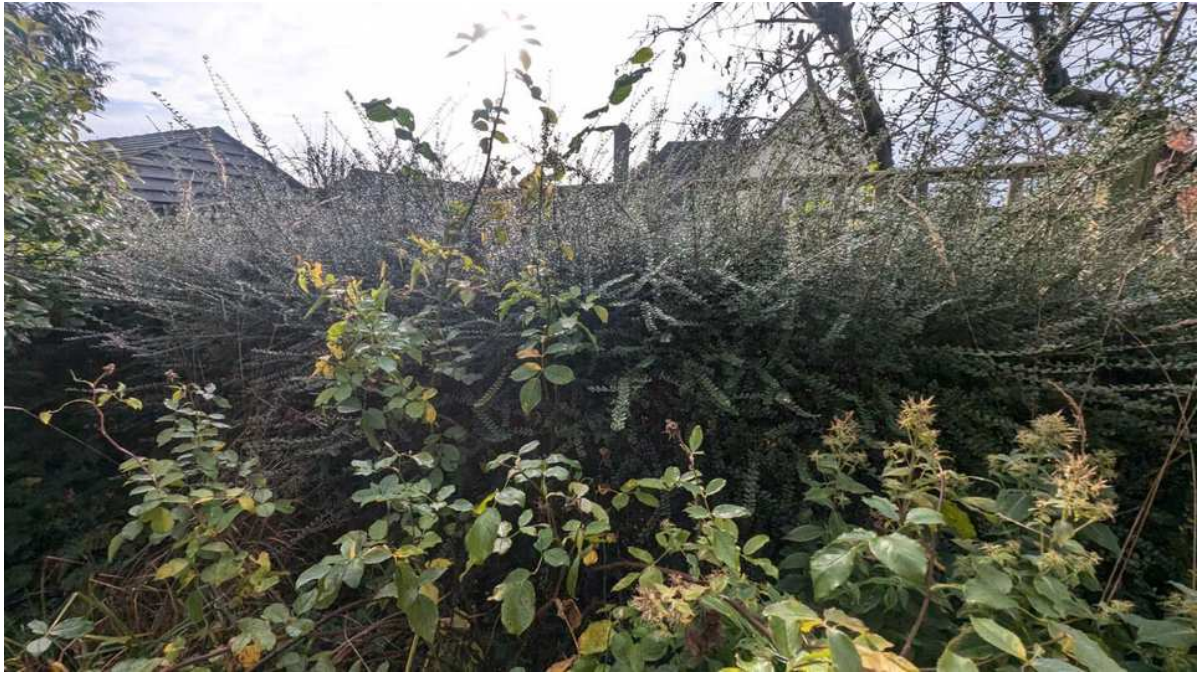
***Boundary responsibility.***

| G3 | Other grounds | Ensure repair responsibility for boundaries is confirmed via solicitors. Consider infilling the pond. |
