Home Inspection Report
Property address: 123 Main St. Columbia, SC 29071
Prepared for: Joe Homebuyer
Inspection date: 01/01/2017
Jay Wojack- Inspector
South Carolina License # RBI.49073
Inspector e-mail- jay@alphaonehomeinspections.com
Website- www.alphaonehomeinspections.com

Inspection Overview

Address: 123 Main St.

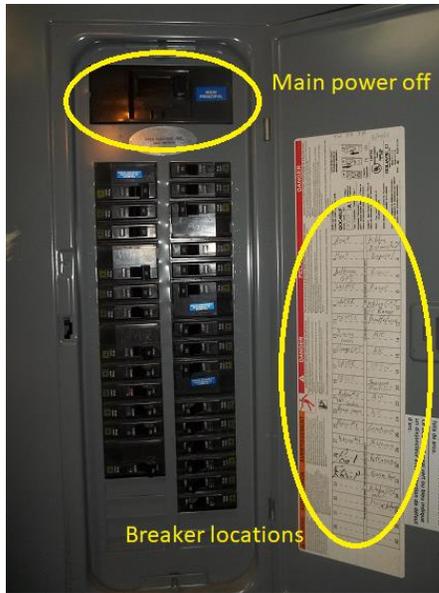
Main electrical panel size/location: 200 amp service panel in garage

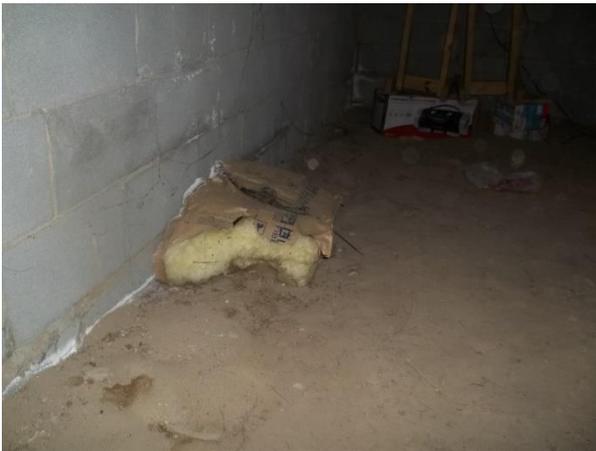
Repair: Insulation in crawl space has fallen in a few areas and should be re-attached/strapped or replaced.

Insulation in crawl space has fallen in a few areas and needs to be reinstalled, re-strapped or removed and replaced.

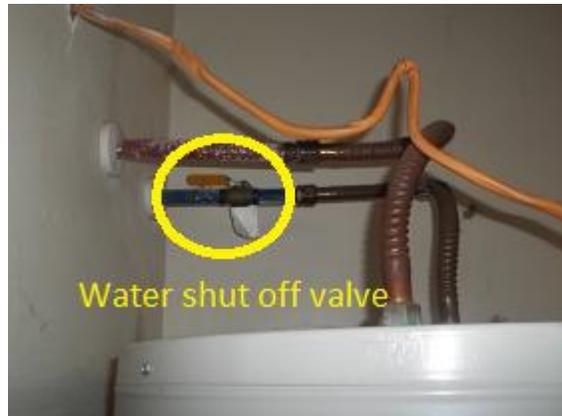
Water shut off location: In box near street and top of unit (photo below)

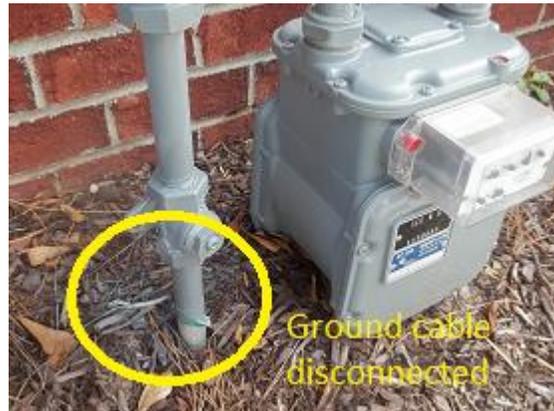
Repair: The ground cable on the gas meter is not connected. Reattaching by approved means is recommended.
