**777 Wilderness Way  
Mount Pleasant, TX 75455**

## PROPERTY INSPECTION REPORT

**Concerning:** 777 Wilderness Way, Mount Pleasant, TX 75455  
(Address or Other Identification of Inspected Property)

**By:** Charles John Peitsmeyer Jr, Lic #7092 08/03/2020  
(Name and License Number of Inspector) (Date)

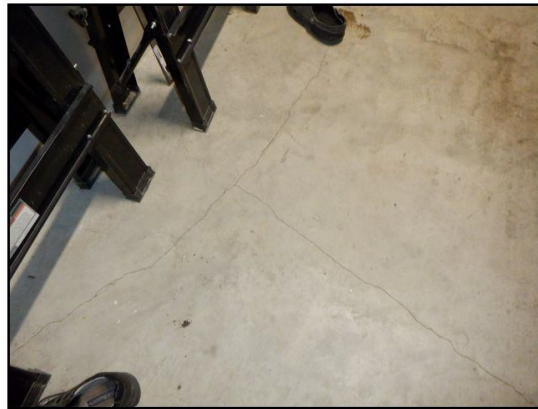
**Note:** Typical cracks observed in the garage flatwork.

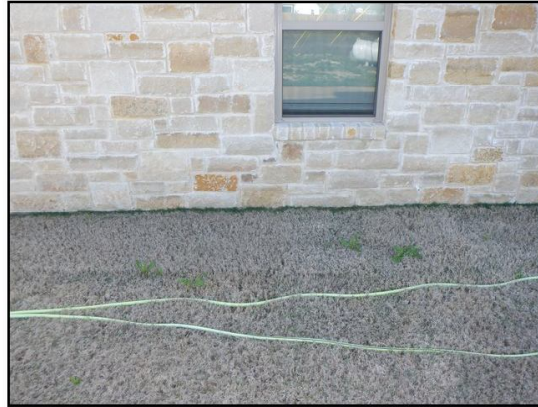
Insufficient clearance from the ground to the exterior cladding was observed. Grading in contact with the exterior cladding is conducive to problematic water related issues and wood destroying insect activity. Ideally four (4) to six (6) inches of clearance should be maintained between the grading and the exterior cladding. The grading should then slope away from the structure at a rate of six (6) inches in the first ten (10) feet. (Various locations)

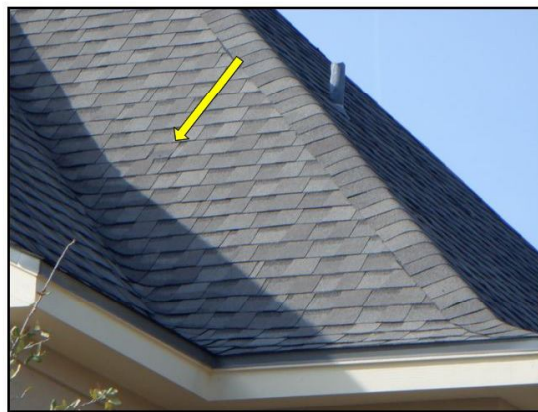
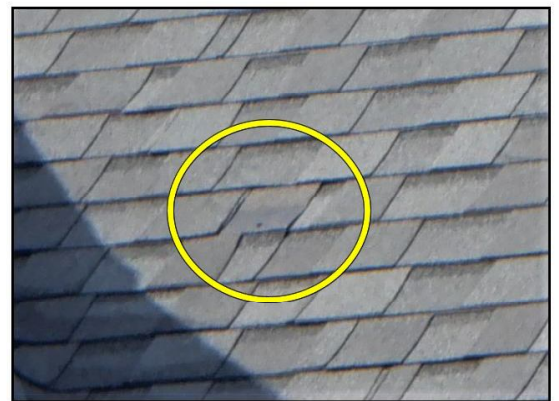
A shingle at the front right slope appeared to have a hole in it and missing aggregate. This may be a manufacturing defect. Further evaluation is recommended.

Prior repairs to the roofing were evident. This would suggest that nail holes have been covered in the past. Areas where prior repairs have been performed should be monitored for proper performance.

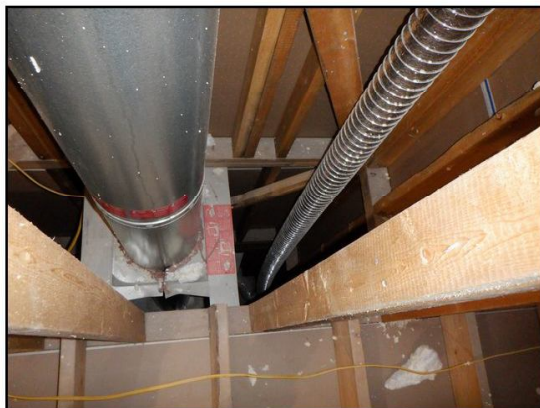
The fire wall was missing at the fireplace within the attic.

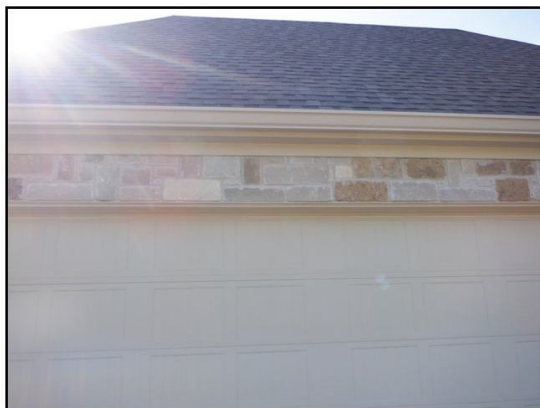
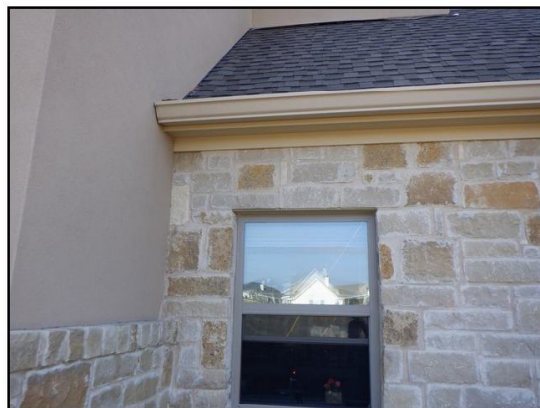
No weep holes over window and or door lintels observed. Weep holes are used to remove moisture that accumulates behind the masonry wall.

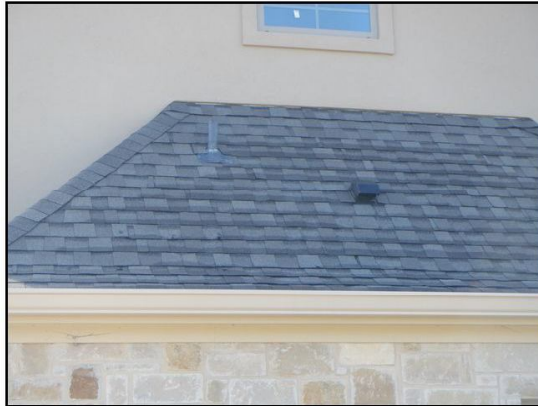
The exterior insulated finished system (EIFS siding) did not appear to terminate at the bottom with a weep screed. There is a greater potential for water related issues because of this.

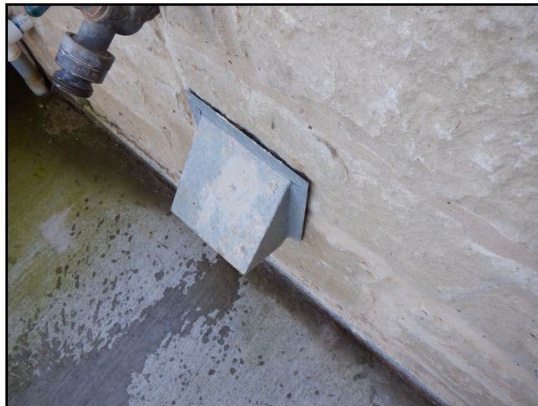
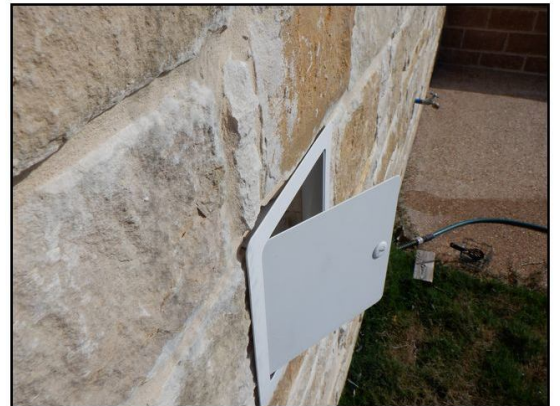
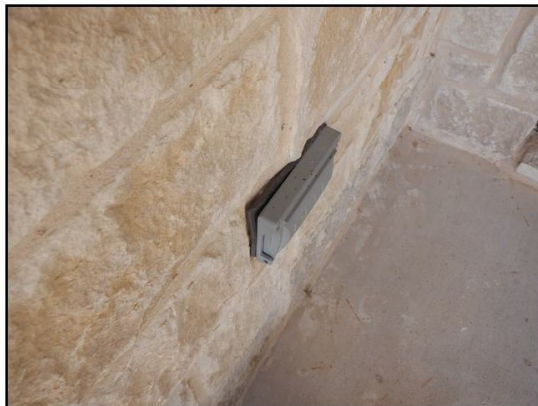
Penetrations in the exterior wall should be sealed. (Plumbing, electrical, vents, conduit etc.)

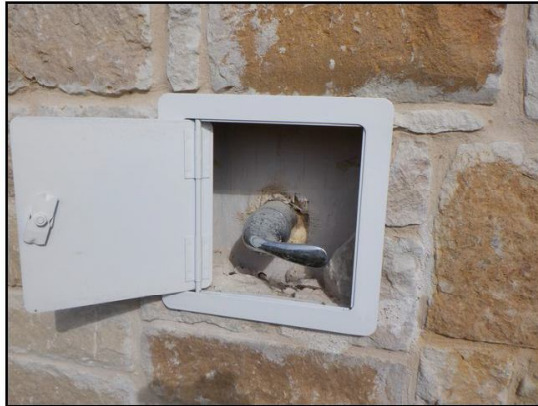
Poor workman ship at the interior of the outside shower faucet housing.

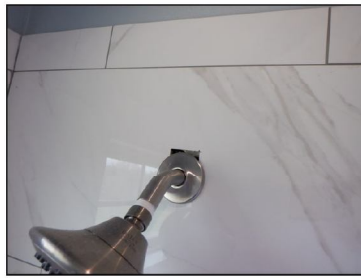
Wall tile not finished properly at shower head. (Upstairs bedroom one bathroom)

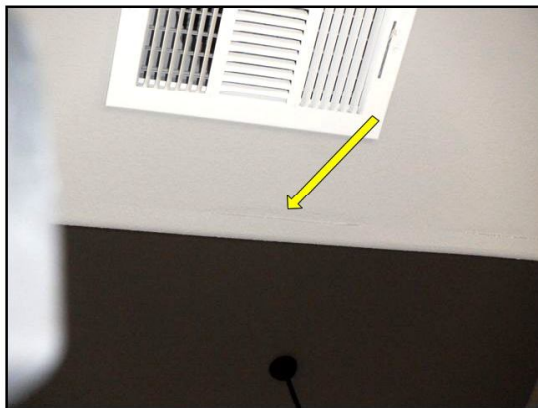
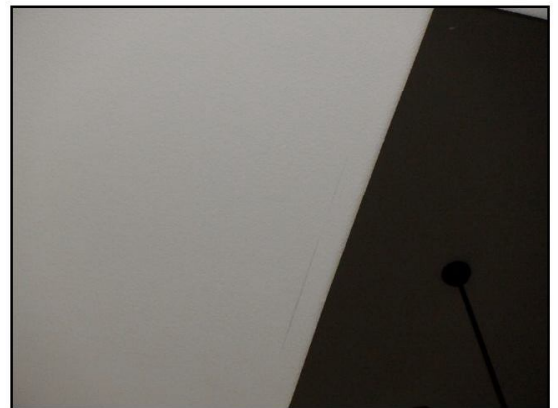
Loose and or weakened ceiling finishes observed in the living room at the corner bead.

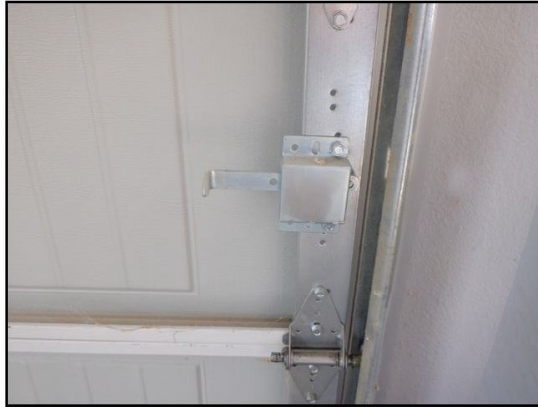
Manual locking devices for the overhead doors had not been disabled. Recommended on doors with operators to prevent accidental damage.

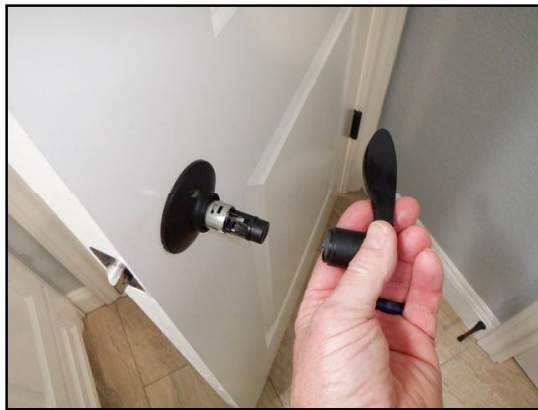
Hardware repairs and or adjustments were needed at doors in various locations. (North downstairs bathroom) (Master bathroom toilet room) (Upstairs bedroom one bathroom) (Upstairs hallway bathroom)

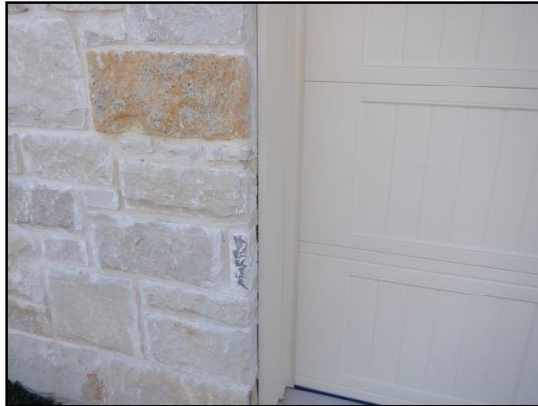
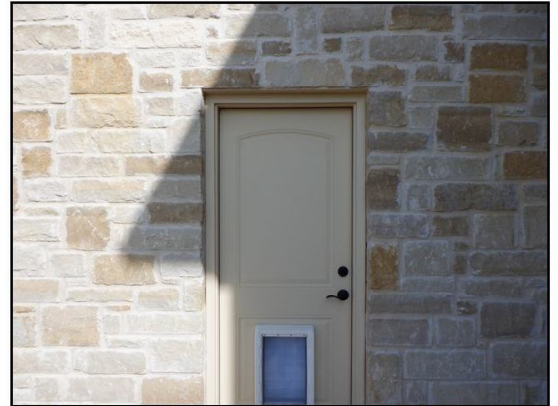
Exterior doors need caulking to brick and or caulking improvements.

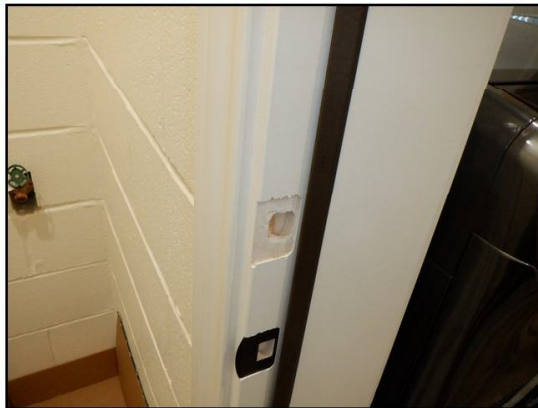
The dead bolt did not extend completely when operated. The dead bolt does not lock into place if it is not extended fully. Also missing a latch keeper. (Safe room)

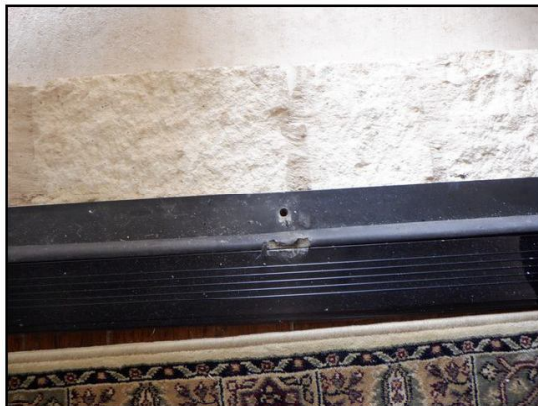
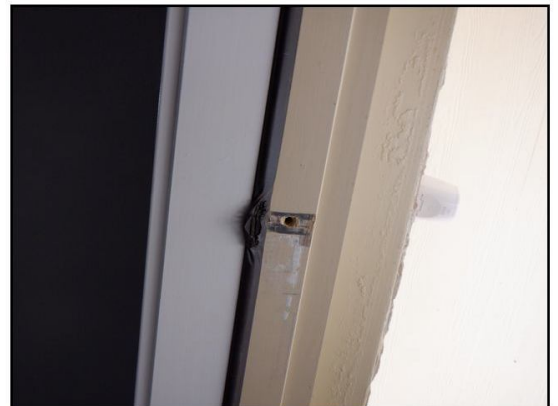
Weather stripping damaged and stationary door lock pin keeper was not installed. (Rear exterior of the house)

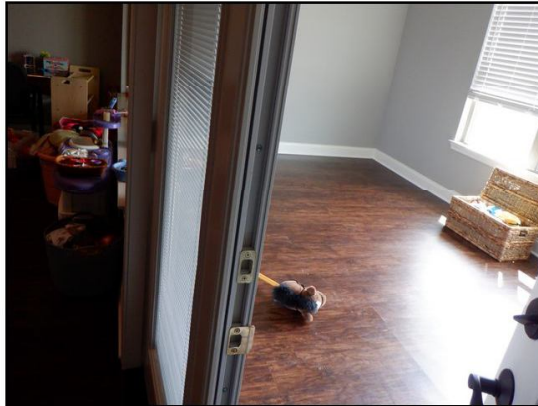
The typically stationary doors appeared to be missing trim at the pin latch sides. (Upstairs exercise room) (Downstairs exterior doors)

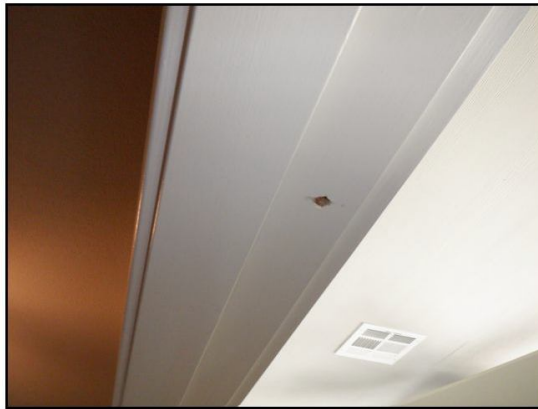
Latch keeper missing on typically stationary door upper pin latch at the upstairs exercise door.

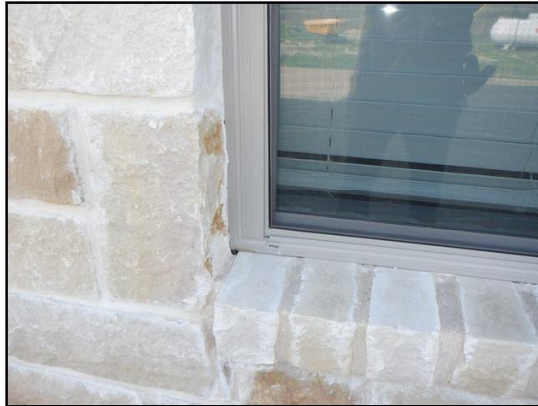
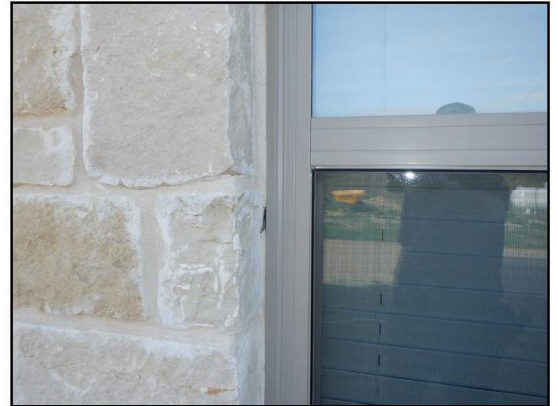
Windows were not caulked at exteriors where window frames meet exterior cladding.

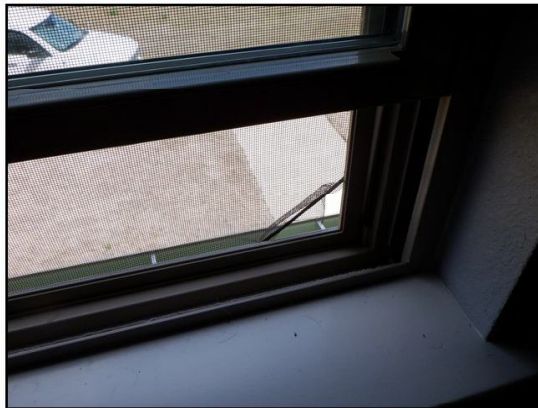
Loose screen mesh observed at window exterior. (Bedroom two upstairs)

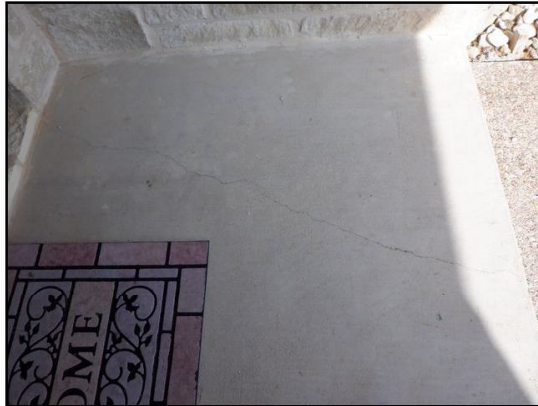
**Note:** Typical shrinkage cracks were observed in exterior flatwork in various locations.

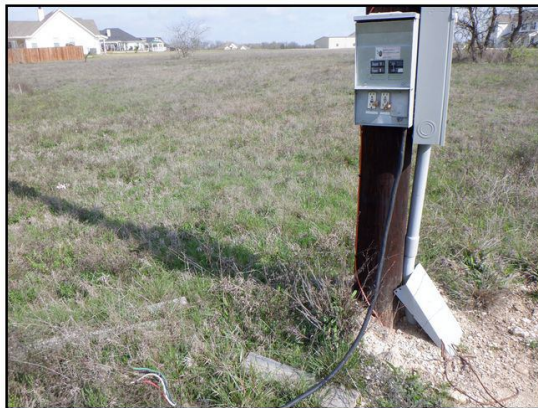
An abandoned electrical box and wiring at the service pole had not been removed or properly terminated.

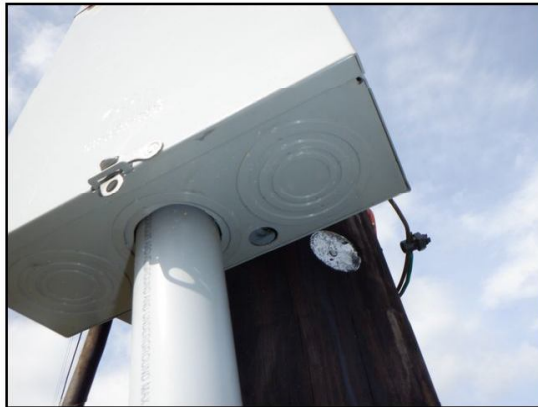
The unused opening (knockout) in the main panel should be covered/filled.

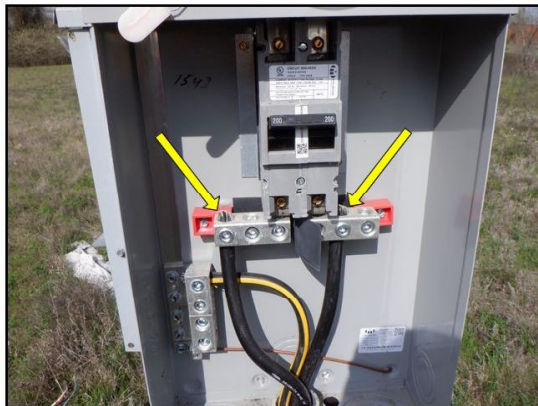
Aluminum service wire connectors had no antioxidant.

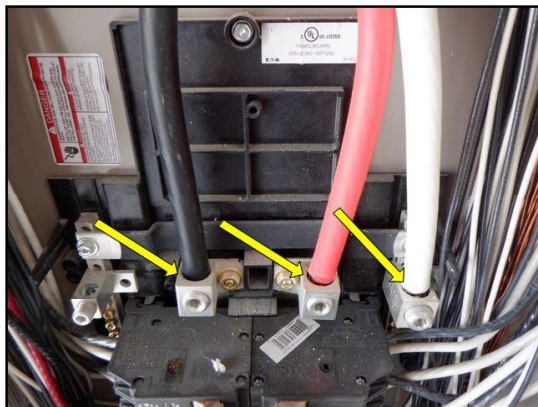
Aluminum service wire connectors had no antioxidant.

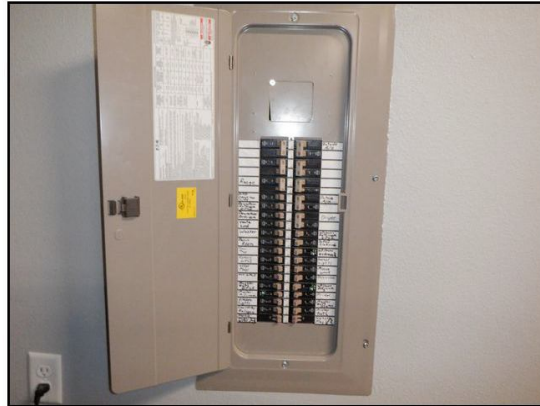
Service panel breaker labeling was incomplete.

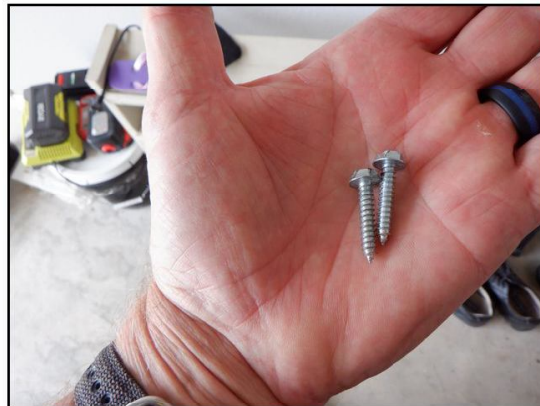
Improper screws holding main distribution panel cover in place. Pointed screws can penetrate wiring which is a potential shock hazard.

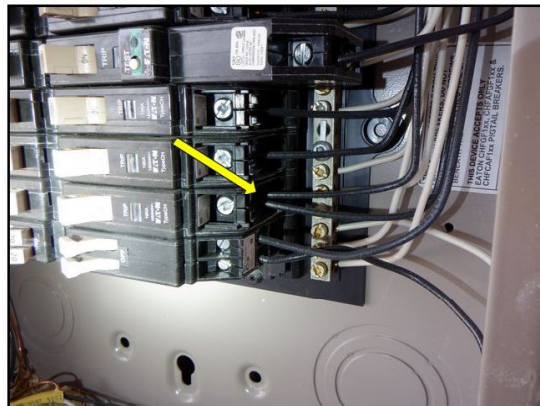
One circuit breaker had multiple wires connected to it. Not rated for multiple wire connections (Double taps)

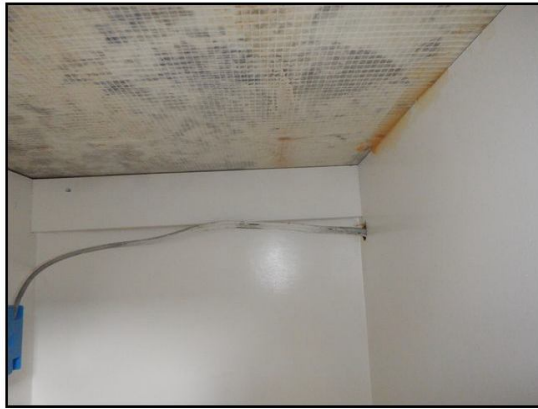
Exposed wiring not protected within conduit. (Within the kitchen island cabinet)

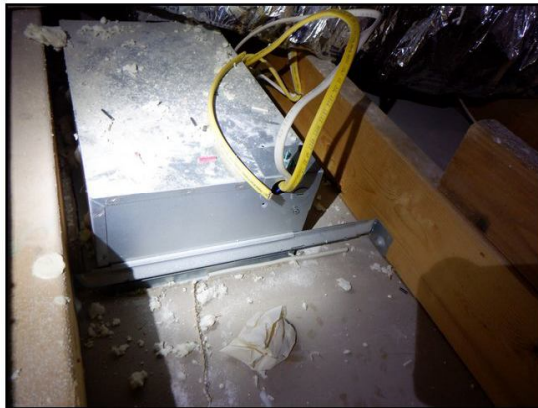
No cable clamp observed in the attic at a mechanical exhaust vent in the south attic.

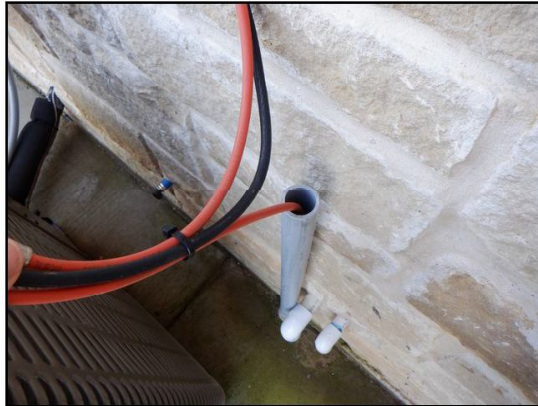
**Note:** A conduit which was not used for branch circuits was not sealed at the top.

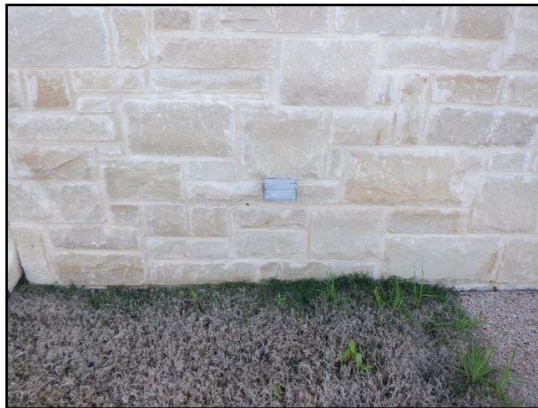
The installation of wet location covers is recommended over receptacles with exposure to rain fall, irrigation systems or splashing water from any other source. This will give added protection if something is plugged into these receptacles.

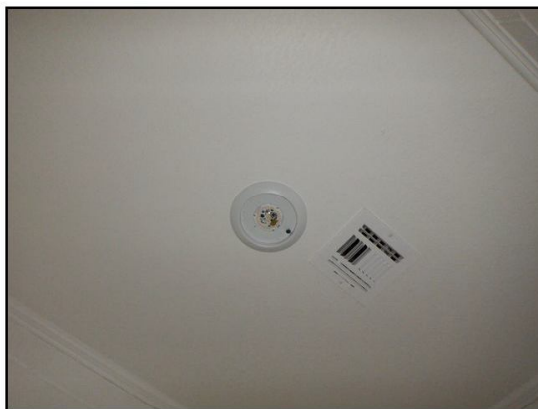
The light shade/cover was missing in the safe room. Recommend adding a light switch at the interior of the safe room and an emergency source of light.

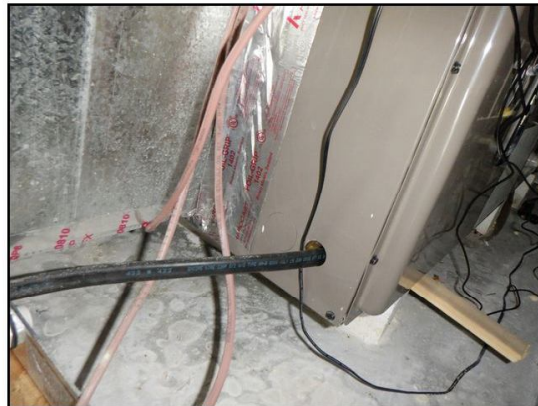
A cable clamp or bushing was missing where the electrical wiring passes into the furnace housing. (Unit in the attic above the second floor)

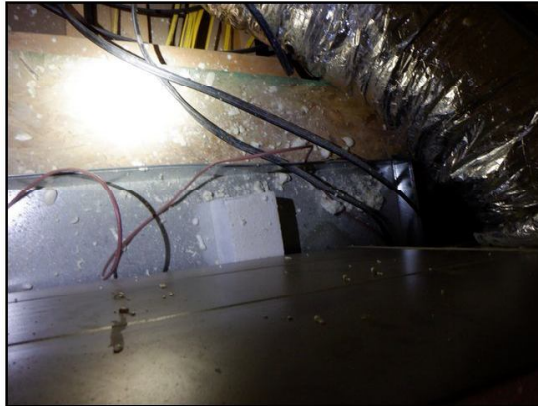
**Note:** The auxiliary drain pan was not free of insulation and or debris. (North attic)

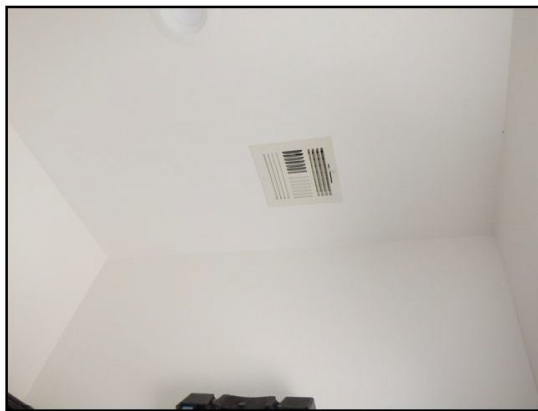
A ceiling register for the HVAC system was observed in a garage closet. This is an increased safety hazard.

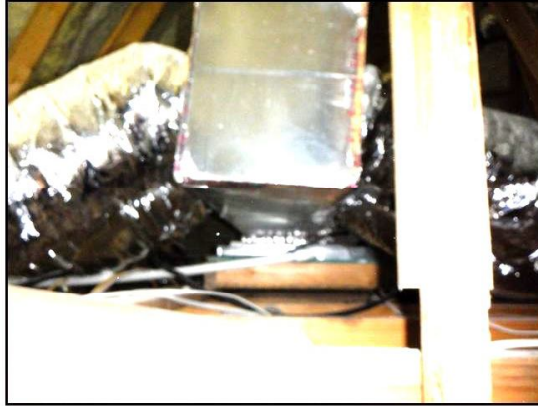
Plenums attached to the attic mounted units were not properly supported. (North attic and attic above the second floor)

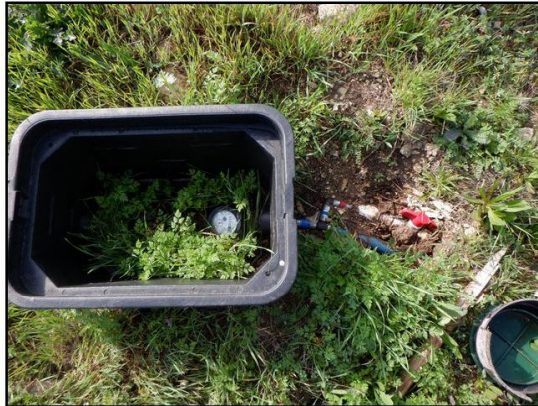
Exposed water supply lines were observed adjacent to the water meter. These are subject to physical damage and freezing.

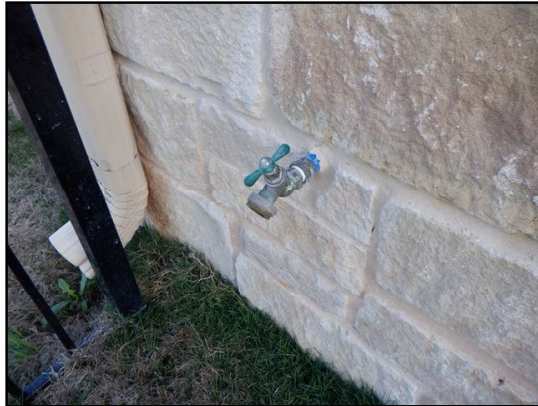
Part of the anti siphon device was missing on the left rear hose bib.

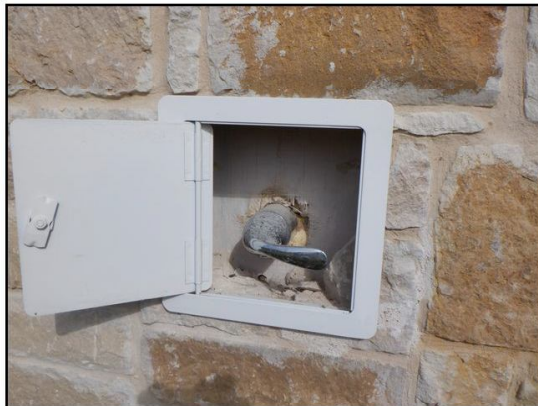
Hot and cold water reversed at the outdoor shower faucet.

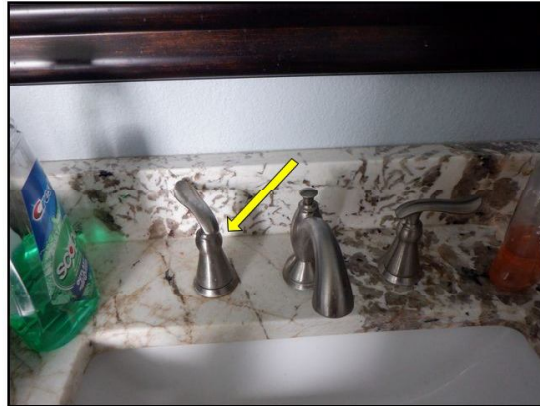
The hot water handle on the right hand sink in the master bathroom was loose at the base.

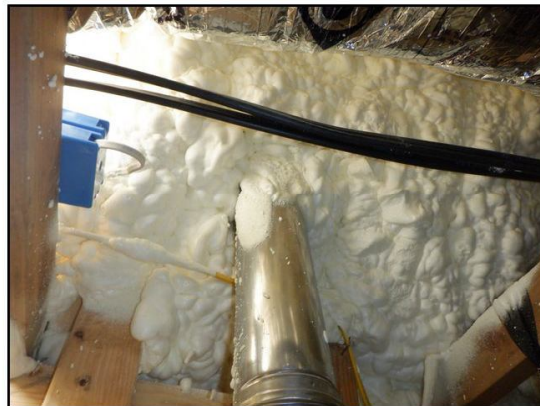
The flues on both water heaters were in contact with spray foam that was not fire rated.

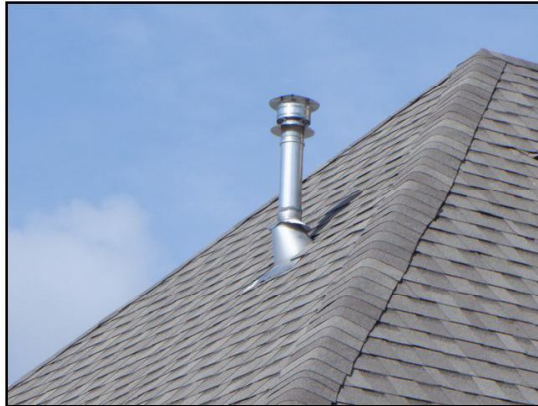
The south water heater flue shroud at the bottom did not fit well. (Cosmetic)

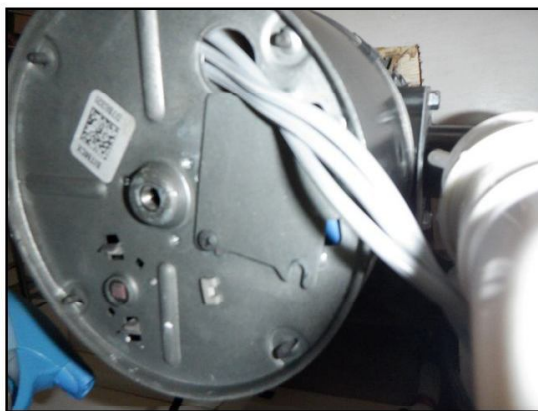
Cable clamp or bushing was missing where power cord entered the food waste disposer unit.  
(Potential damage to electrical wiring)

Wiring insulation was also stripped excessively.

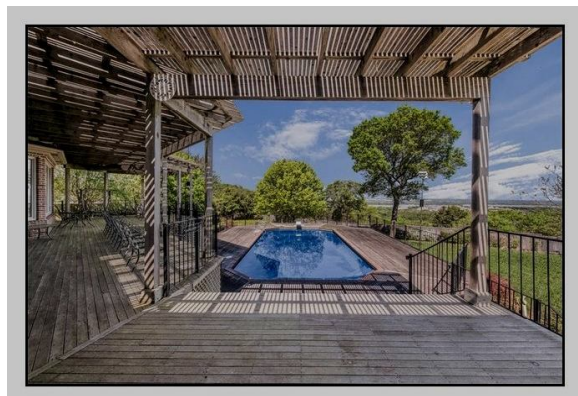
For improved safety fences for pools should be at least 4 feet tall, not easily climbed (railing on the inside for wood fences) with self closing self latching gates and a locking device at a minimum of 3 inches below the top of the gate. The gate should have no opening with 18 inches of the locking device larger than ½ inch. Windows and doors opening up directly to the pool area and not protected behind a fence should be equipped with an alarm so as to sound when a window or

door has been opened. The pool did not meet these current standards for safety.

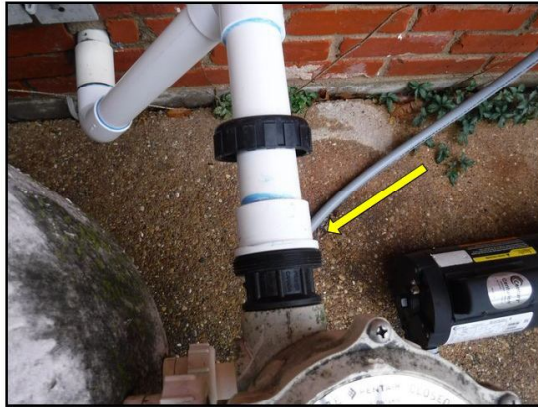
Connection nut not fastened at the pool equipment.

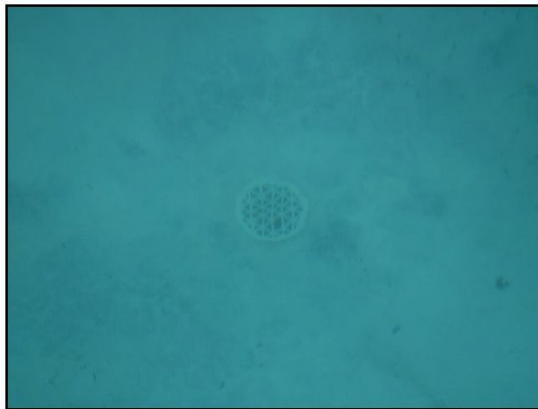
The existing drain cover should be replaced with an anti vortex drain cover for improved safety. An anti vortex drain cover can aid in preventing hair entanglement. (Pool)

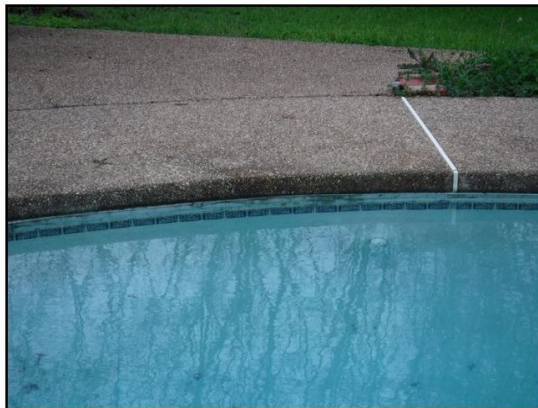
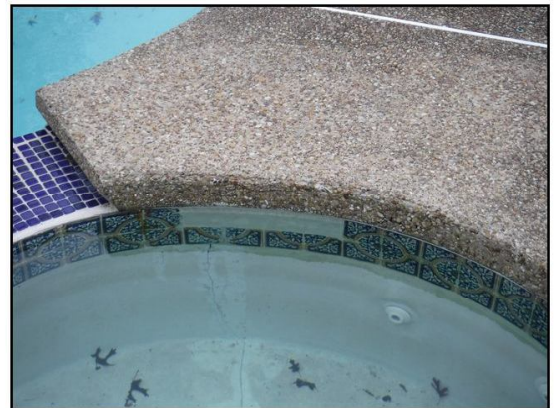
Water level tile was missing in a few locations at the pool and spa.

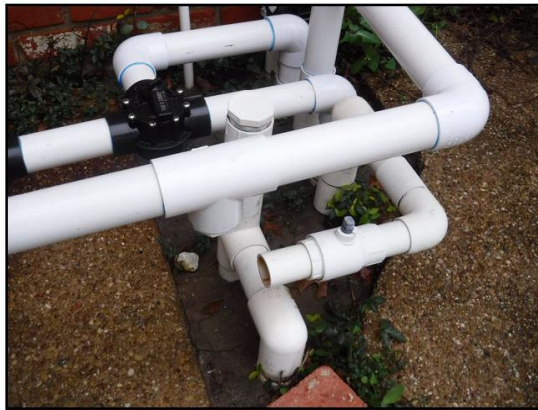
Abandoned pool lines observed. Abandoned electrical disconnects and or timers observed for equipment that was missing or not installed including the spa blower and heater.

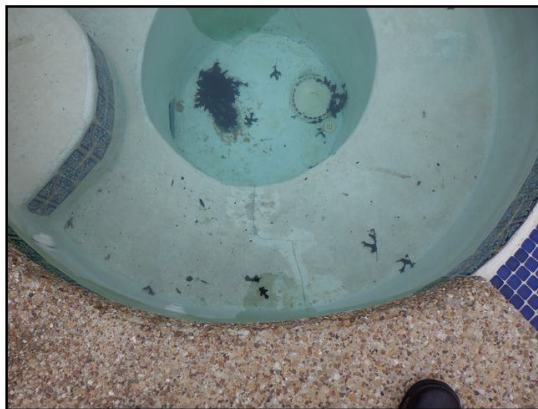
Cracks and previous repairs were observed in the spa and pool.

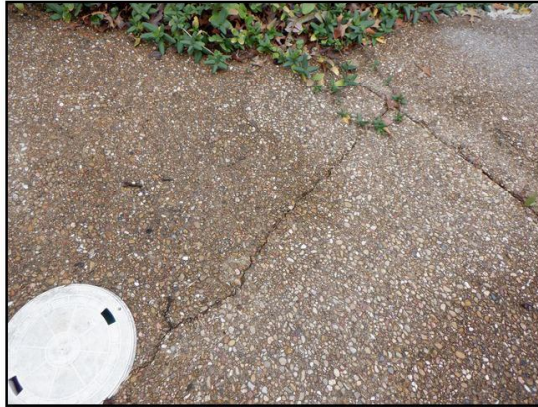
Typical cracks at exterior pool decking in various locations.

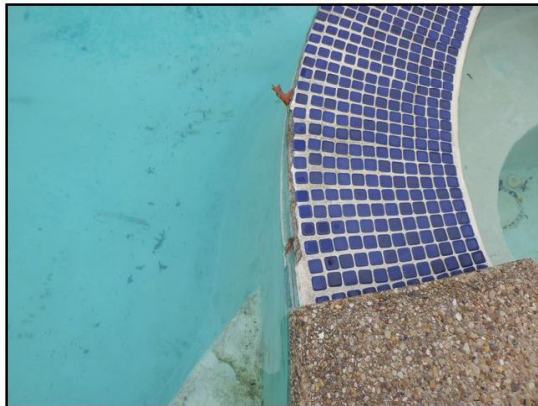
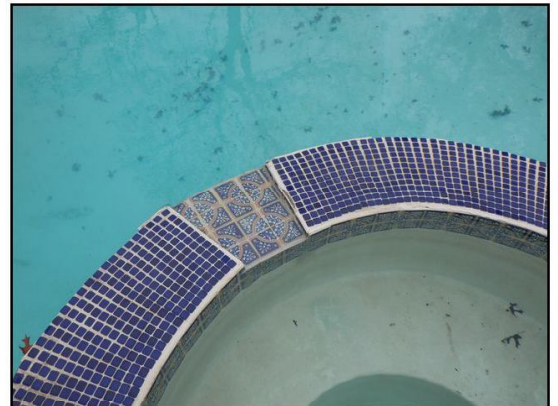
Damaged and or missing tile at spa.
