FULL HOUSE INSPECTIONS

RESIDENTIAL HOME INSPECTION

1234 Main Street Waco TX 76708

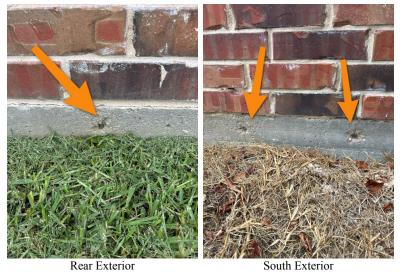
2: Exposed Rebar

Exposed reinforcement bar was observed. Exposed re-bar should be sealed to prevent rusting and potential weakening of the structure.

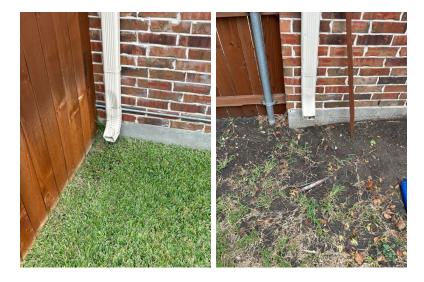
1: Downspout Extension Needed

Downspouts terminate near the foundation. Splash blocks or extensions are needed to move storm water at least 5 feet from foundation.

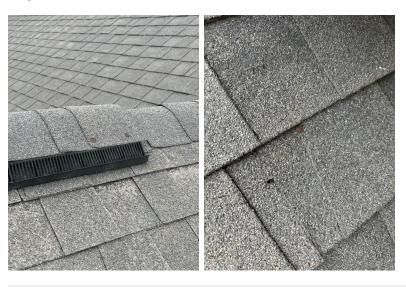
1: Exposed Nail Heads

Exposed nail heads were observed. Any exposed nail heads at flashings or shingles should be sealed to reduce the potential for leaks into the structure.

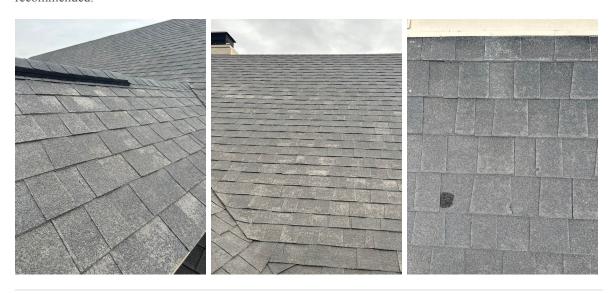
4: Significant Aggregate Loss

Significant aggregate/granule loss observed on shingles in various locations. This is a sign of severe shingle wear that can be caused by various factors, such as hail damage, age, installation issues, heavy foot traffic, etc.. This leads to an exposed underlying asphalt layer and makes the shingle more vulnerable to cracking, curling, or tearing. It can also lead to roof leaks and water damage. Further evaluation by a qualified roofer is recommended.

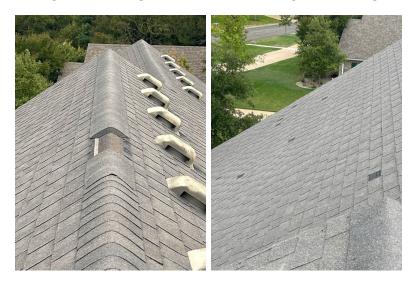
5: Shingles Missing

Missing or broken shingles observed. Recommend qualified roofing contractor evaluate & repair.

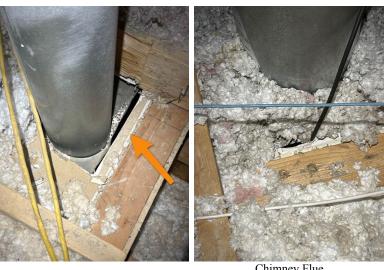
Chimney Flue

Ceiling was not sealed or insulated at the range hood duct and chimney flue in the attic.

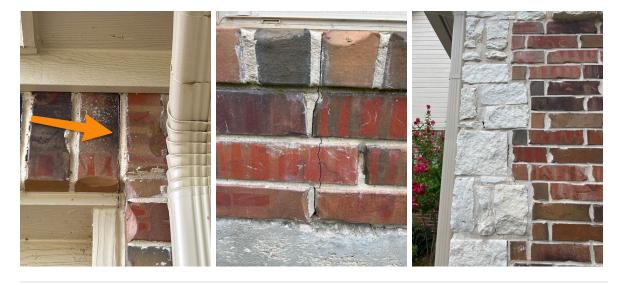
2: Typical Exterior Wall Cracks Deficiency

Exterior wall and or mortar cracks observed. This is evidence of typical differential foundation movement.

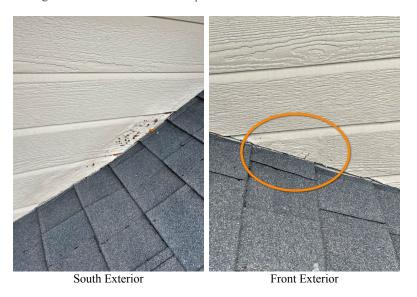
7: Siding Damage/Deterioration

Damaged/deteriorated exterior siding and or trim observed. Further evaluation to determine extent of damages and estimated costs of repairs is recommended.

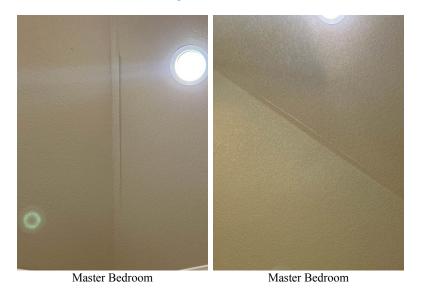
2: Loose Ceiling Finish

Loose and or weakened ceiling finishes observed.

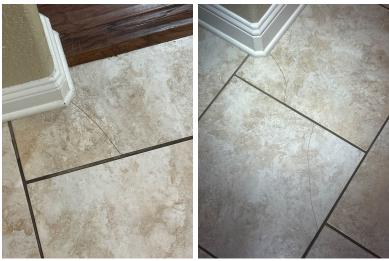
4: Cracked Floor Tile

Cracked floor tile observed. This may be related to structural movement.

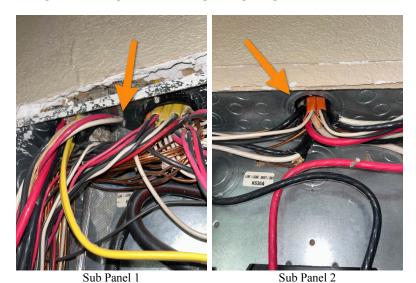
1: Cable Clamps Missing

Cable clamps or bushings were missing where wires pass through the panel. These are used to protect the wiring from the edges of the metal panel openings.

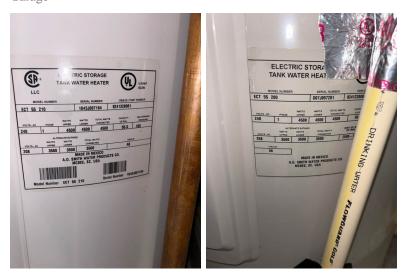
1: Water Heater Cable Clamp Missing

Cable clamp or bushing missing where the wiring enters the housing. There is a higher potential for damage to occur to the wiring.
