FULL HOUSE INSPECTIONS

RESIDENTIAL HOME INSPECTION

1234 Main Street
Waco TX 76708

10/10/2023 9:00AM

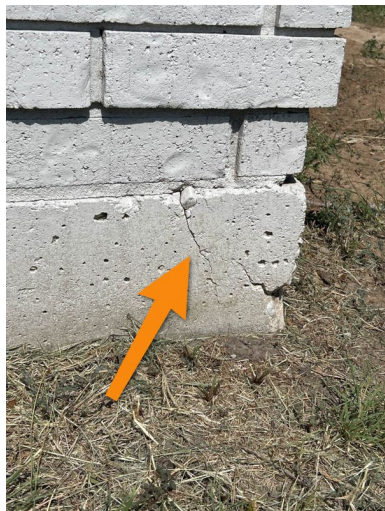
1: Cracked Corners

Note: Cracks or "corner pops" observed at the exterior foundation corners are typical and do not usually represent a structural concern.

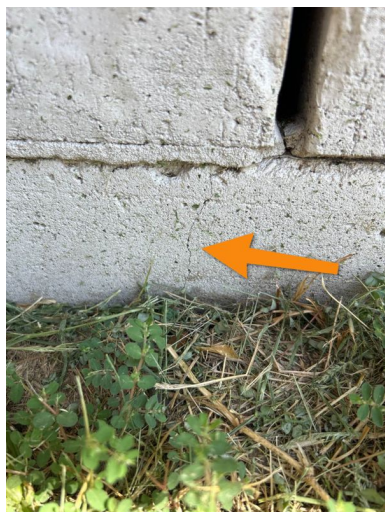
2: Hairline Foundation Cracks

Typical hairline cracks were observed in the foundation walls of the house. This implies that some structural movement of the building has occurred.

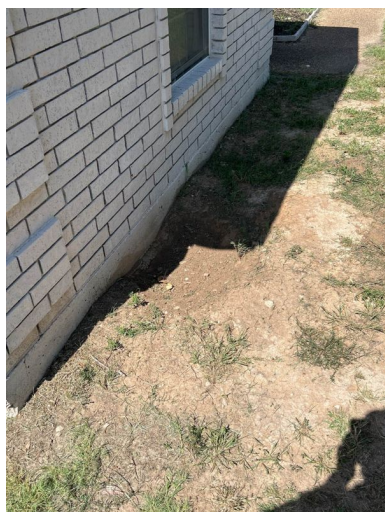
Improper grading was observed. The grading should be improved to promote the flow of storm water away from the house. This can usually be accomplished by the addition or removal of topsoil. (Standing or ponding water at the foundation can affect the performance of the foundation) The ground should slope away from the house at a rate of 6 inches for the first ten feet.

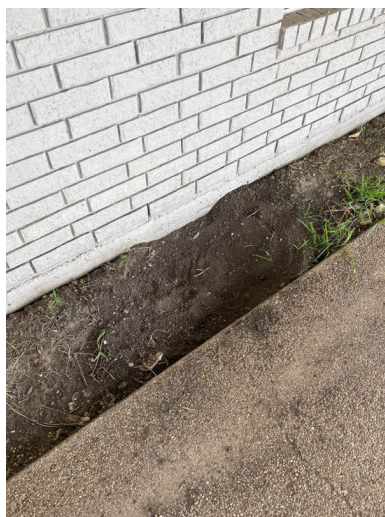
2: Sidewalks High

Sidewalks or flatwork surrounding or connected to parts of the foundation are higher than the adjacent grade at the foundation. This can lead to standing water at the foundation which can contribute to foundation movement or moisture issues.

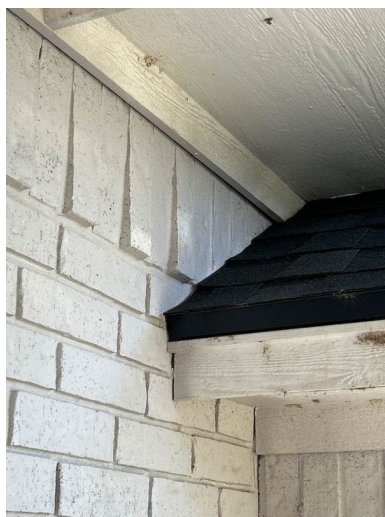
1: Flashings Missing

No flashings installed where shingles meet the vertical walls in one or more locations. This is conducive to moisture infiltration.

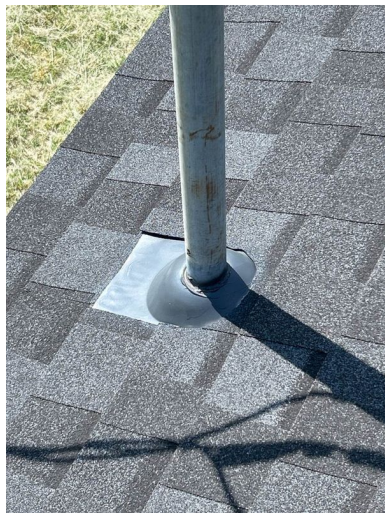
2: Rubber Rain Collar Missing

Rubber rain collar was missing. Repairs should be performed to prevent storm water from entering the structure.

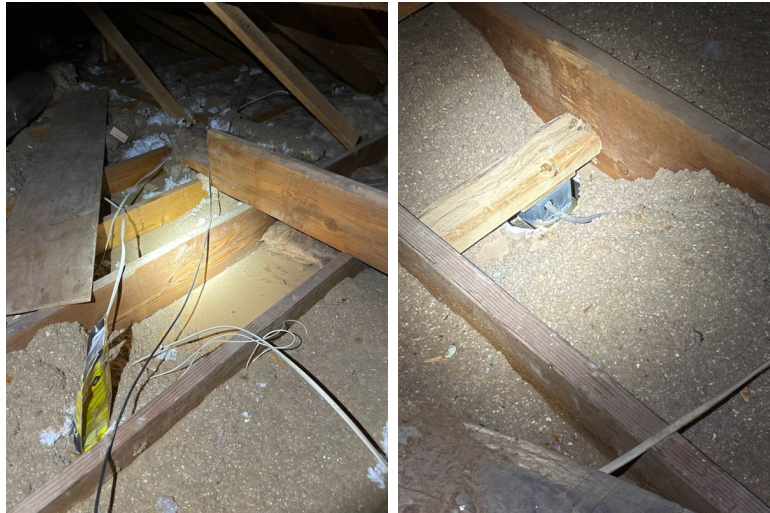
1: Missing Insulation

Missing insulation observed in the attic. This results in reduced insulating efficiency and typically higher utility bills.

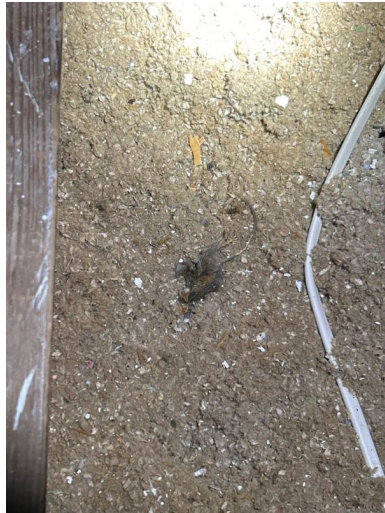
Evidence of previous vermin activity observed in attic. Further evaluation is recommended.

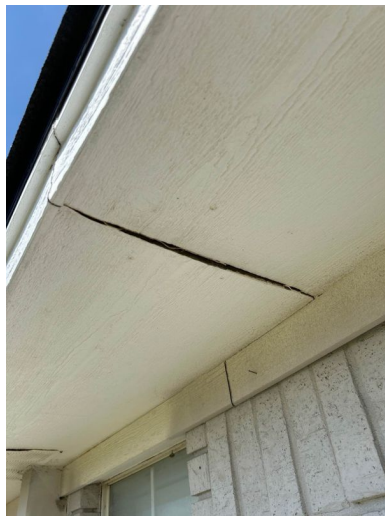
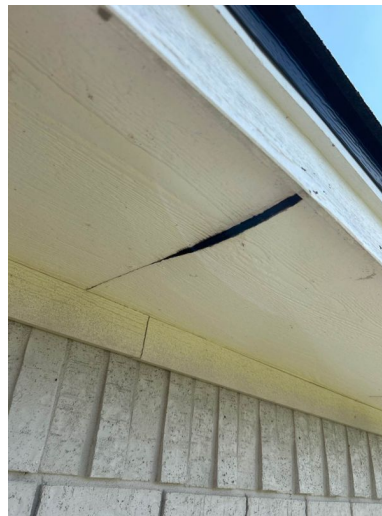
4: Sagging Soffit

Sagging or loose soffit observed.

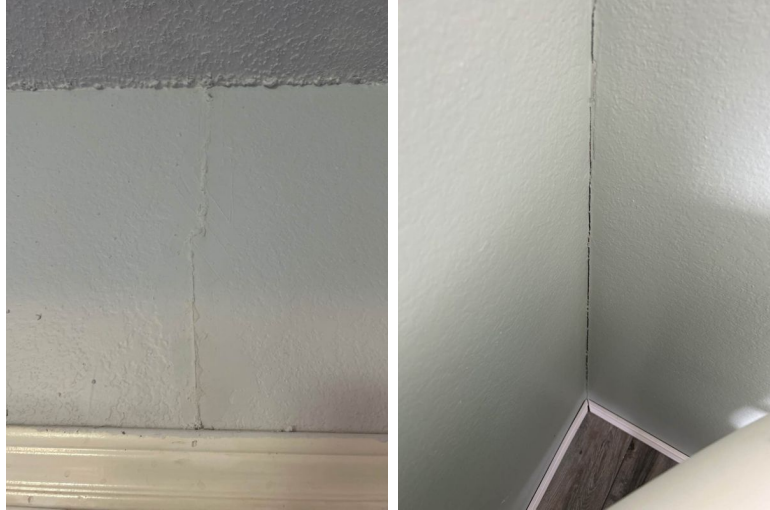
1: Interior Wall Cracks

Interior wall cracks and or movement at tape joints observed. This appears to be the result of previous structural movement.

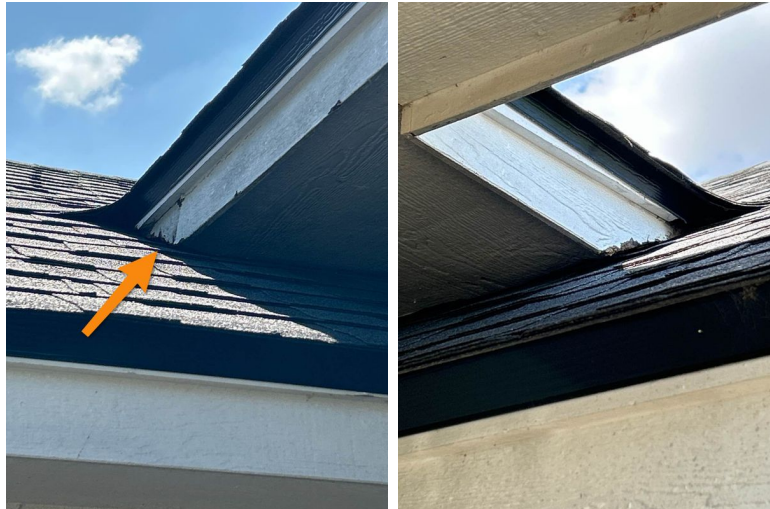
2: Damaged and/or deteriorated Fascia

Damage and/or deterioration observed at exterior fascia and trim.

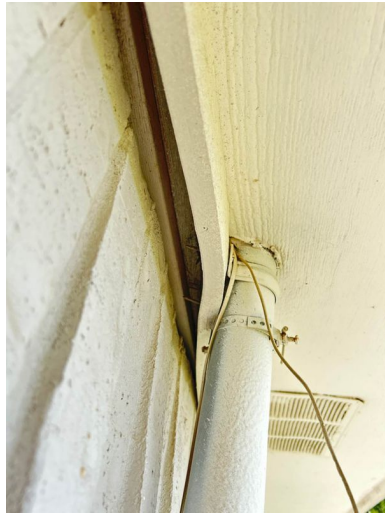
3: Loose siding and/or trim

Loose siding and/or trim observed.

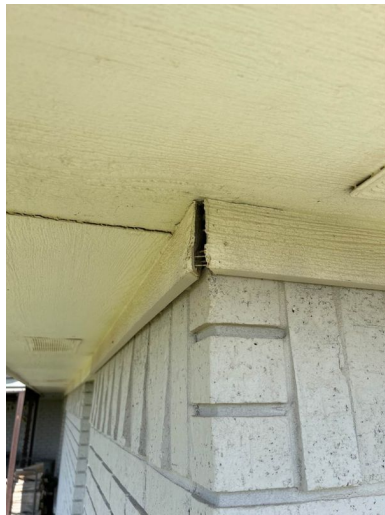
4: Brick Frieze Separations

Separation at the brick frieze observed. This is an indicator of previous foundation movement.

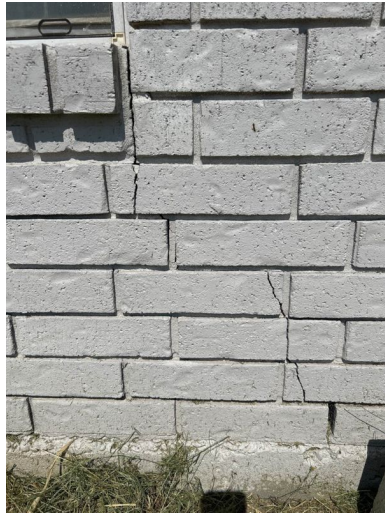
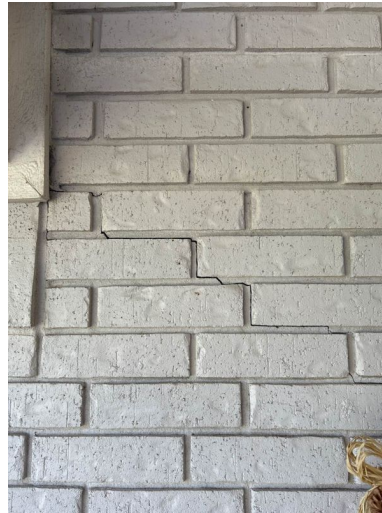
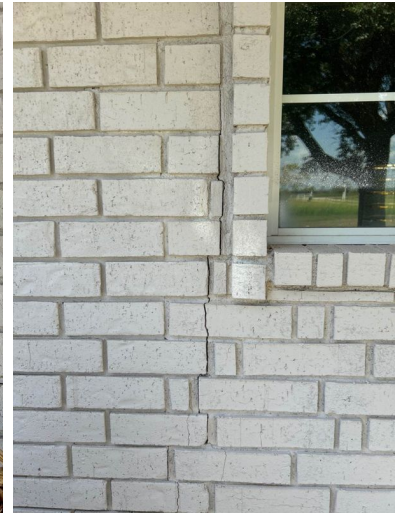
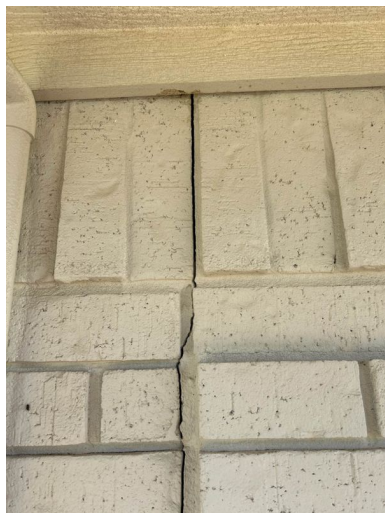
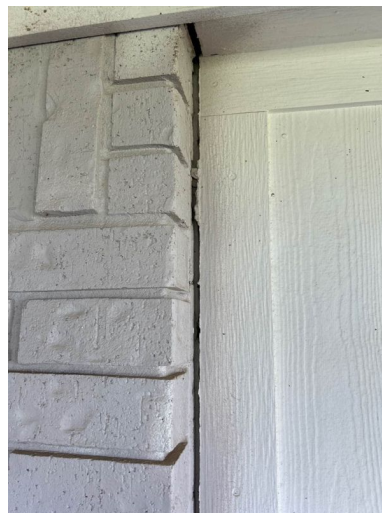
5: Exterior Wall Cracks

Exterior wall cracks observed (Evidence of structural movement). Further evaluation is recommended.

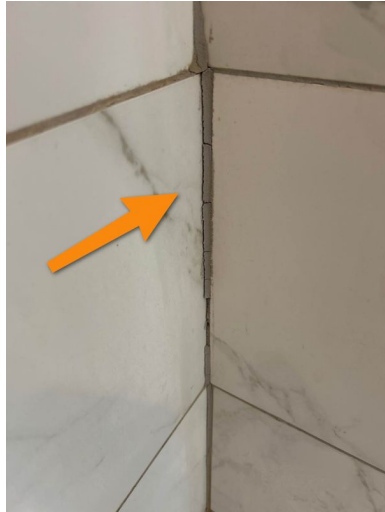
Master Bathroom

Grout or caulking improvements needed in the shower enclosure to prevent moisture from entering behind the wall.

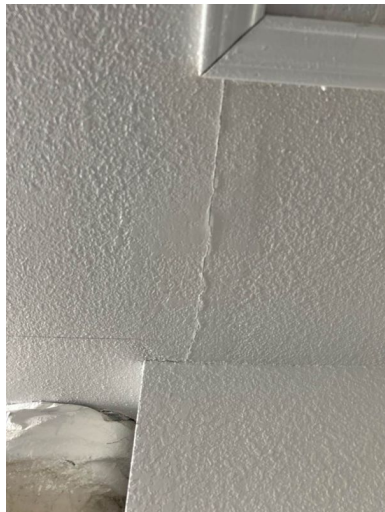
1: Interior Ceiling Cracks

Interior ceiling cracks and or movement at tape joints observed. This could be related to structural movement.

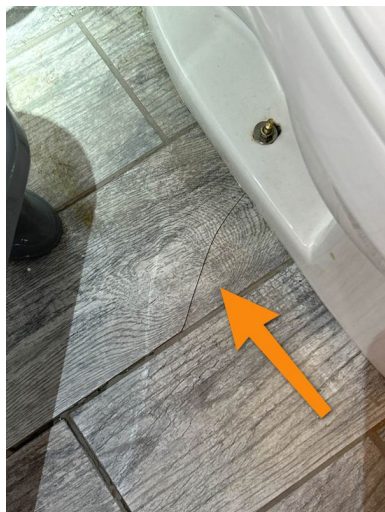
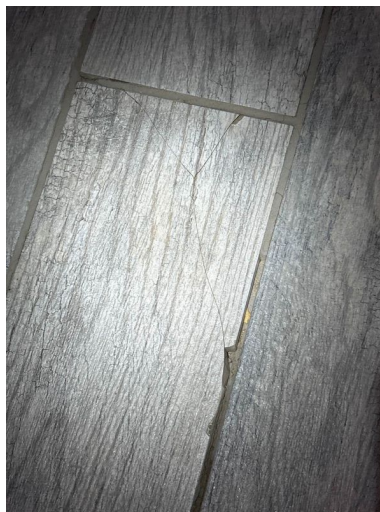
3: Cracked Floor Tile

Cracked floor tile observed. This may be related to structural movement.

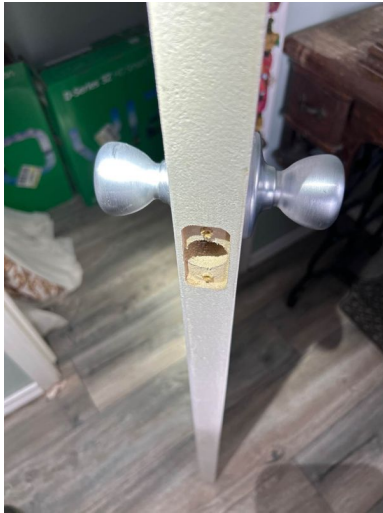
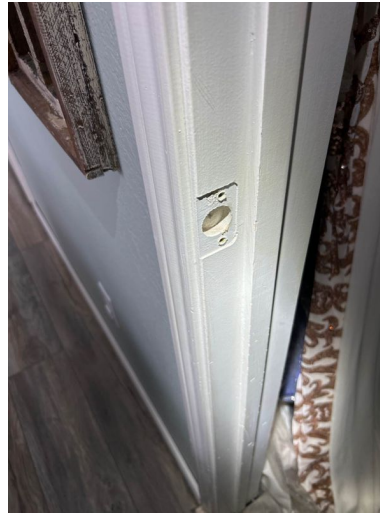
4: Door Hardware was Missing

Door hardware was missing.

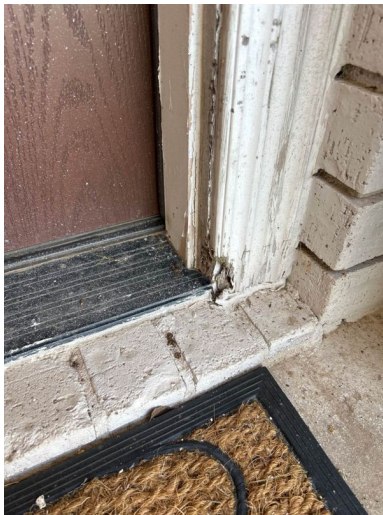
5: Damaged trim

Damaged trim observed.

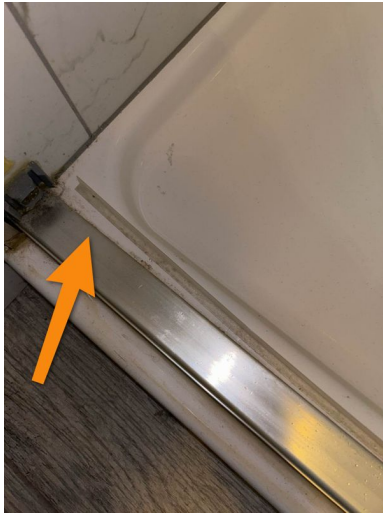
6: Loose Seal

Seal is loose at the shower door.

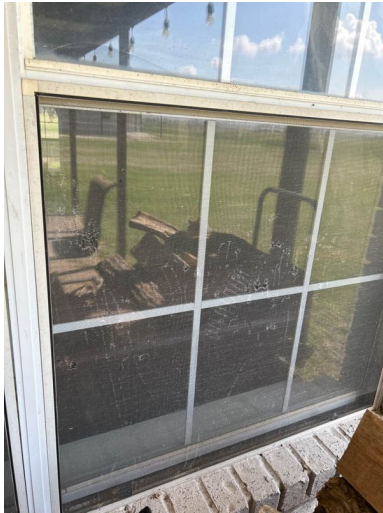
2: Screen Mesh Damaged

Damaged screen mesh observed at window exteriors.

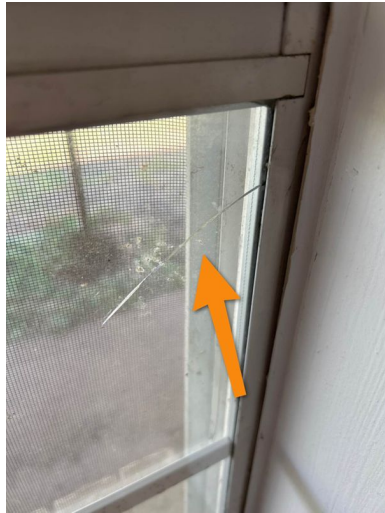
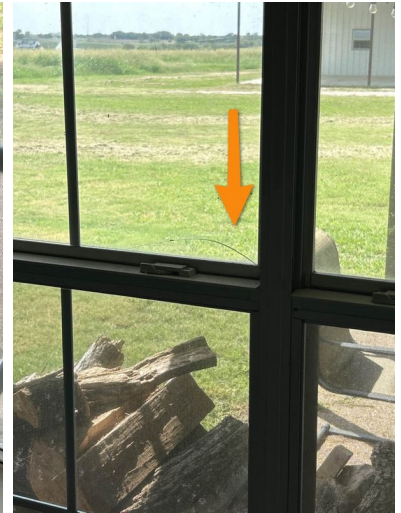
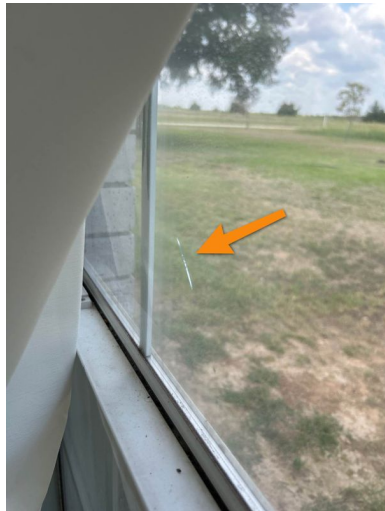
3: Cracked Window Glass

Cracked or broken window glass observed.

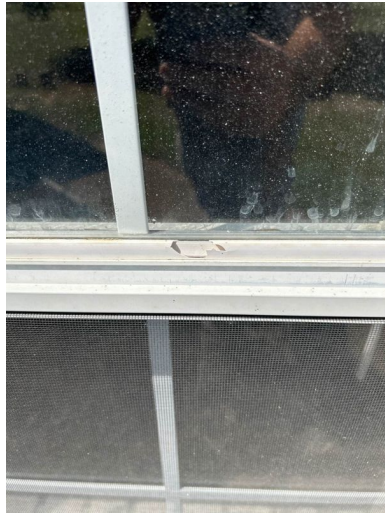
4: Glazing Beads Damaged

Loose and or damaged glazing beads observed on various windows.

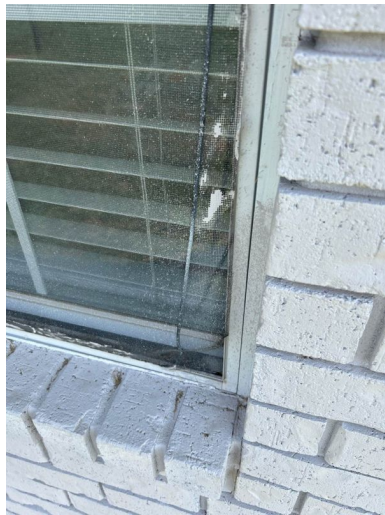
5: Screen Spline Loose

Window screen spline was loose. This is responsible for holding the screen mesh in place.

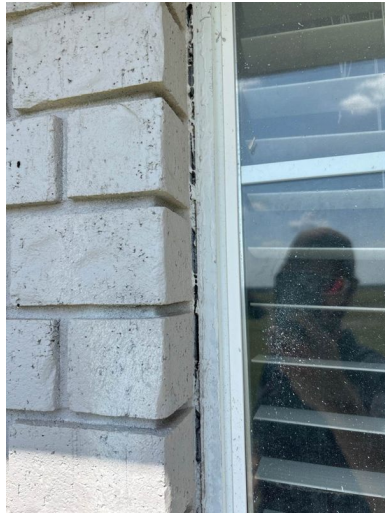
Windows were not caulked at exteriors where window frames meet exterior cladding.

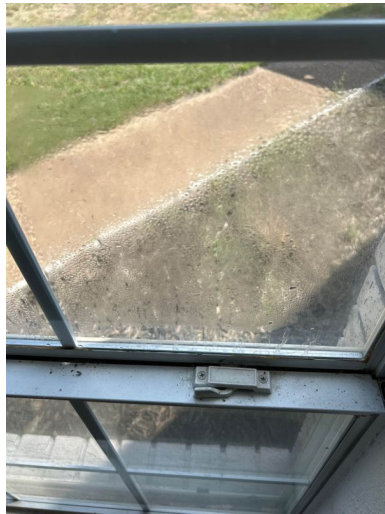
7: Seal Failure

Evidence of seal failure observed on thermal pane windows in one or more locations. This can result in condensation between the panes and reduced efficiency.

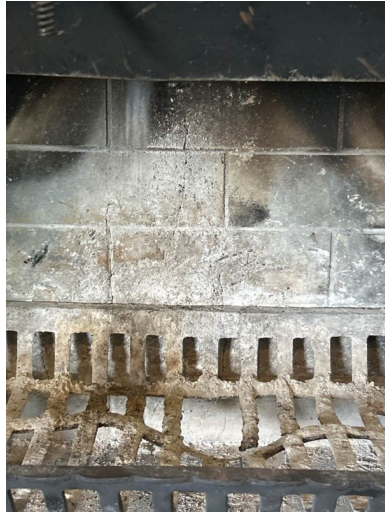
1: Refractory Cracks

Note: Typical cracks were observed at the rear refractory brick within the hearth.

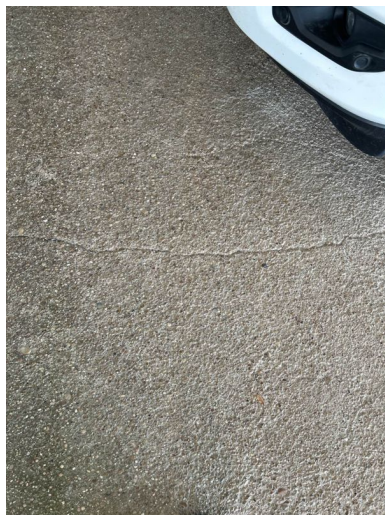
1: Typical Flatwork Cracks

Note: Typical settlement cracks were observed in exterior flatwork in various locations.

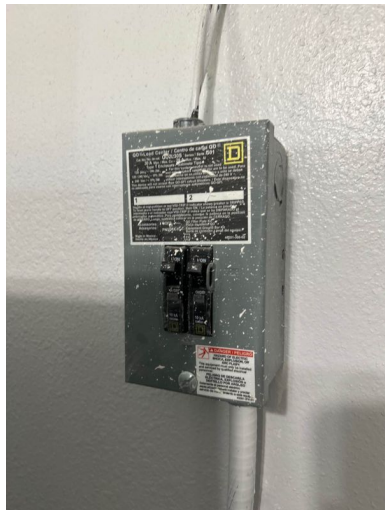
Sub Panel in Laundry Room

Service panel breaker labeling was incomplete.

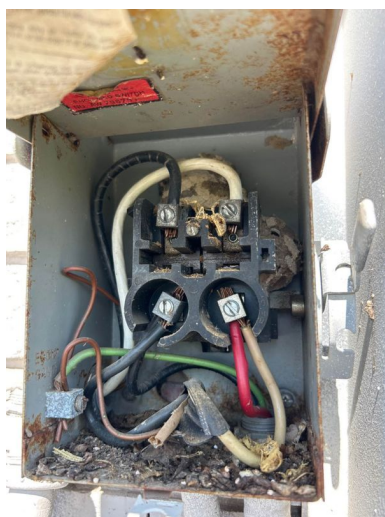
2: Vermin/Insect Activity

Evidence of vermin or insect activity was observed within the electrical panel. The panel should be cleaned and all potential vermin entry points to the panel should be sealed.

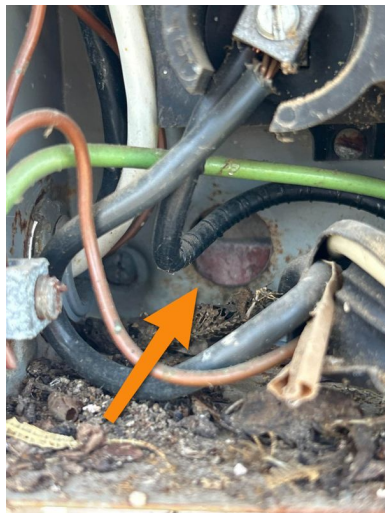
3: Knockouts Missing

Any unused openings (knockouts) in the electrical panel should be properly covered to prevent dust, moisture, insects, rodents, or other foreign objects from entering the panel.

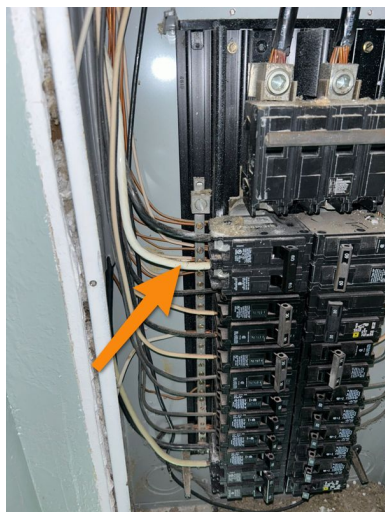
4: Neutrals not Separated

The electrical panel had one or more instances of neutral wires that were sharing the same terminal screw on the neutral bus bar. While this is common, it is not a proper wiring practice under current standards and could result in loose connections or possible arcing. The proper way to wire the neutral bus bar is to have one terminal screw for each neutral wire.

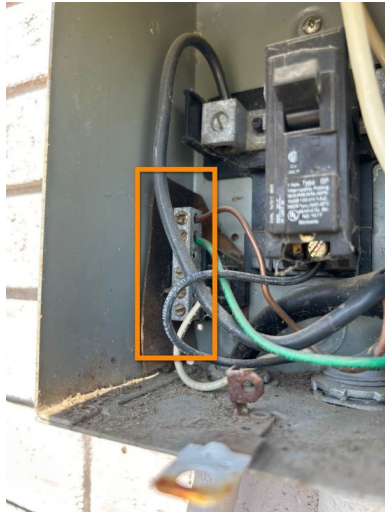
Septic Sub Panel

The electrical distribution sub panel had an improper wiring condition. The neutral wires and the ground wires were connected together on the same bus bar, which is not allowed for sub panels. This can create a potential shock hazard and interfere with the proper operation of the circuits. The neutral wires and the ground wires should be separated on different bus bars, and the neutral bus bar should be isolated from the panel enclosure.

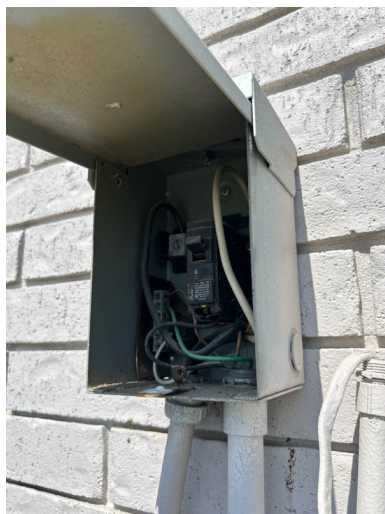
Septic Sub Panel

No visible bonding of the electrical panel box to the grounding system was observed. The presence of proper bonding could not be verified. Further evaluation is recommended.

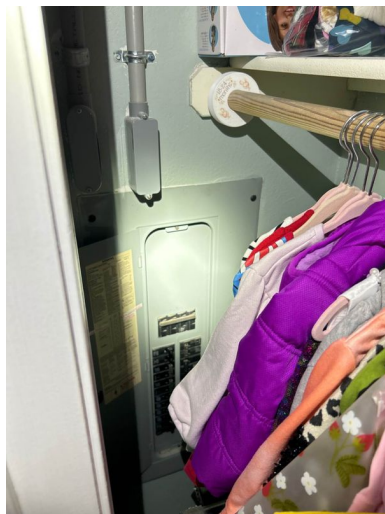
Main Panel

An electrical distribution panel was located in a clothes closet. This is considered a hazardous location by current standards.

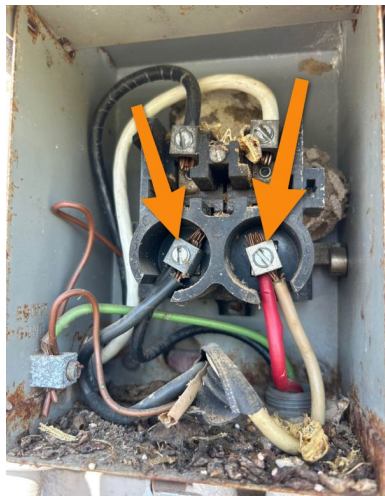
Disconnect Panel for Outdoor Cooling Unit

Double lugged wiring observed in panel. This is an improper wiring practice. Further evaluation by a qualified electrician is recommended.

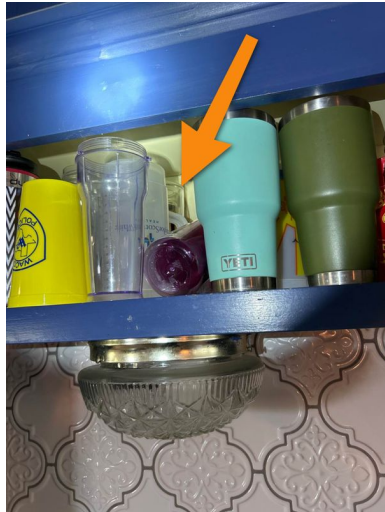
Kitchen

Exposed wiring that was not protected within conduit was observed.

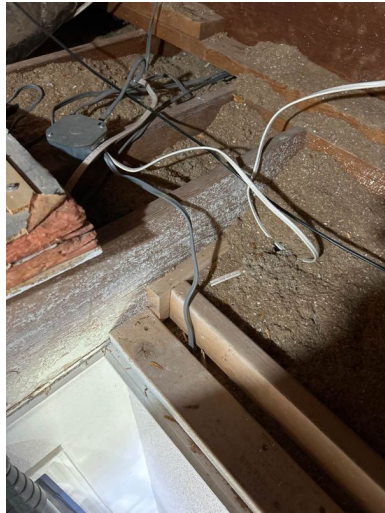
The attic access was located within six feet of exposed wiring, which could pose a risk of electric shock or injury to anyone entering or exiting the attic. The wiring should be enclosed in a protective conduit or moved away from the access area to prevent accidental contact and ensure safety.

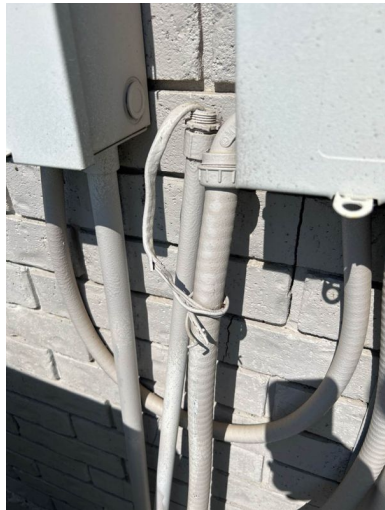
8: Abandoned Wiring

Abandoned wiring was observed. This should be replaced or appropriately terminated to prevent causing a safety hazard.

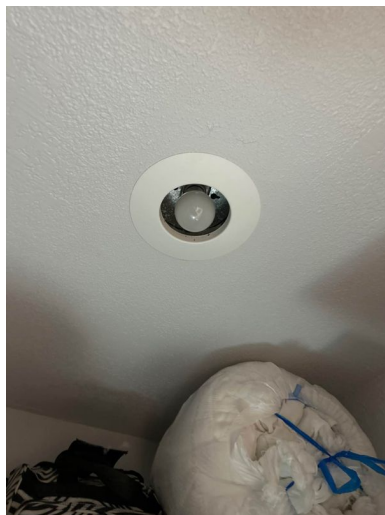
Master Bathroom

Incandescent light fixtures in closets need bulbs completely enclosed within a globe.

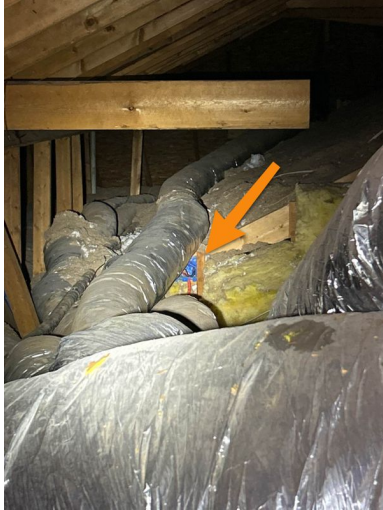
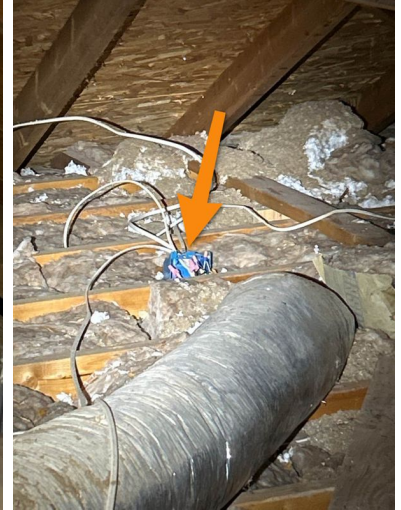
12: Junction Box Cover Missing

Junction box covers and or gang box covers missing. All junction boxes should be fitted with cover plates in order to protect the wire connections.

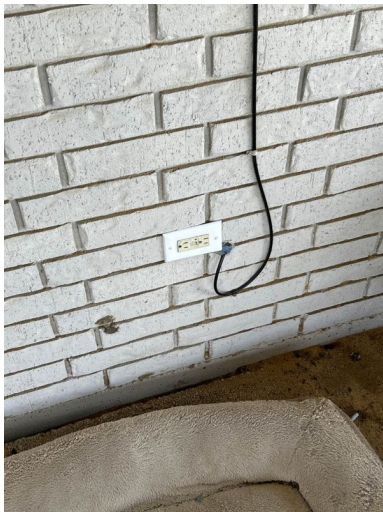
14: Damp Location Covers Missing

Damp location covers not installed on exterior electrical receptacles where needed.

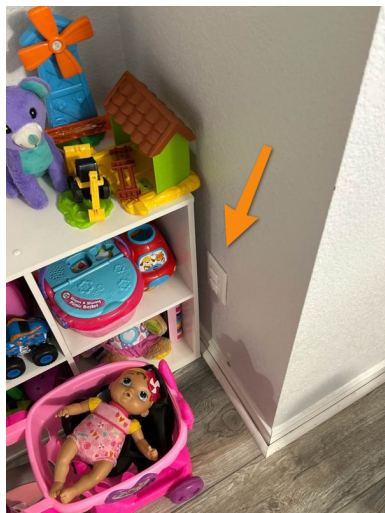
Garage Conversion

An electrical receptacle was found to have reversed polarity, which means that the hot and neutral wires were connected to the wrong terminals. This is a potential safety hazard that can cause electric shock or damage to sensitive devices. Reversed polarity can be easily corrected by a qualified electrician.

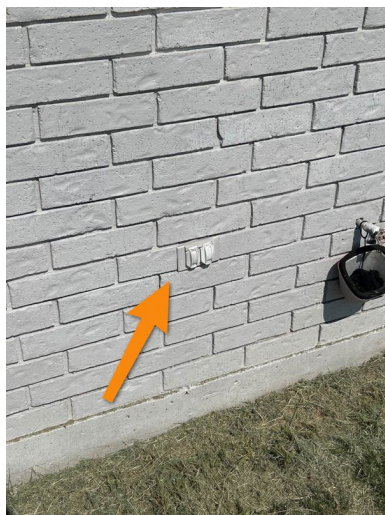
South Exterior

The installation of wet location covers is recommended over receptacles with exposure to rain fall, irrigation systems or splashing water from any other source. This will give added protection if something is plugged into these receptacles.

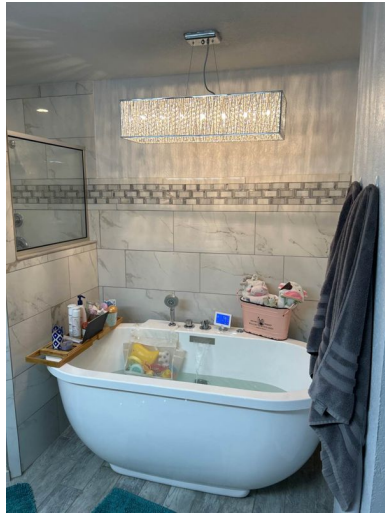
Master Bathroom

Light fixture located above tub is considered hazardous due to proximity to the tub.

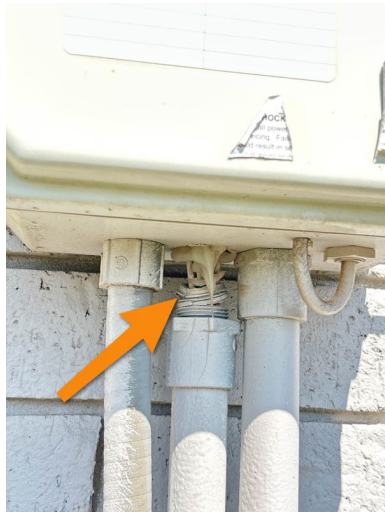
18: Conduit Separated

Conduit beneath the septic control panel has separated from the panel. Wiring is exposed as a result. Repair recommended.

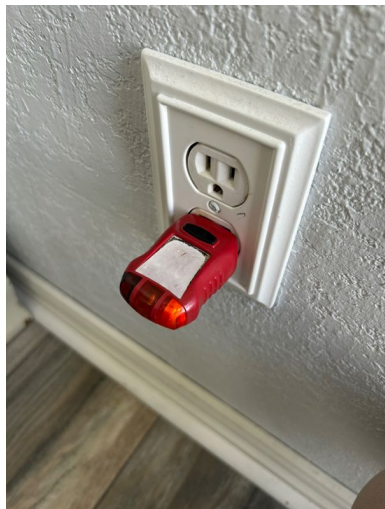
Kitchen Dining Room

A receptacle appeared to have an open neutral when tested. Further evaluation is recommended.

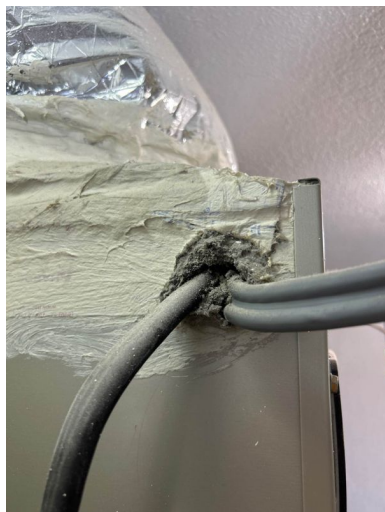
1: Cable Clamp Missing

A cable clamp or bushing was missing where the electrical wiring passes into the furnace housing.

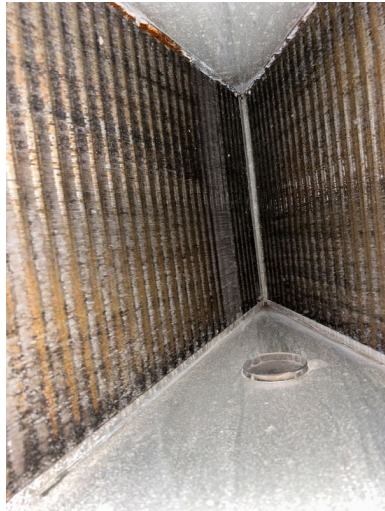
The evaporator coil was excessively dirty. Servicing is needed.

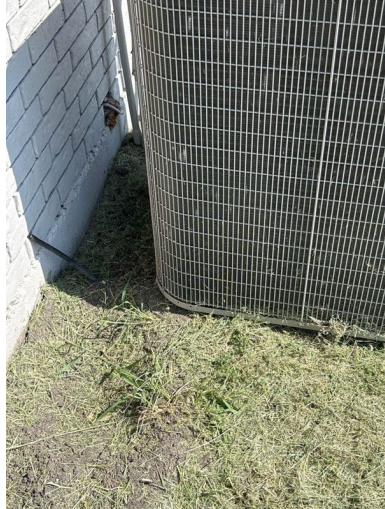
2: Raise to 3 Inches

Exterior unit pad was not the proper height off grade. Bottom of AC unit should sit three inches above grade. This will reduce conditions conducive to corrosion and or physical damage.

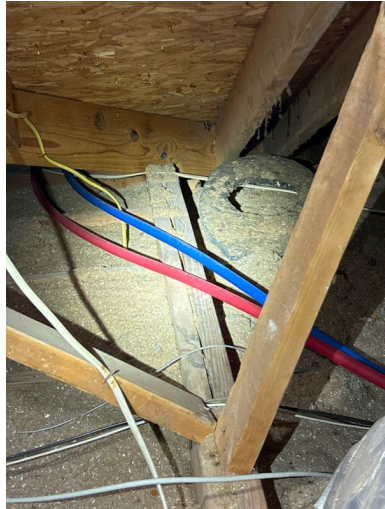
Attic

Water supply lines were not insulated. This increases the potential for damaging water lines during periods of freezing weather.

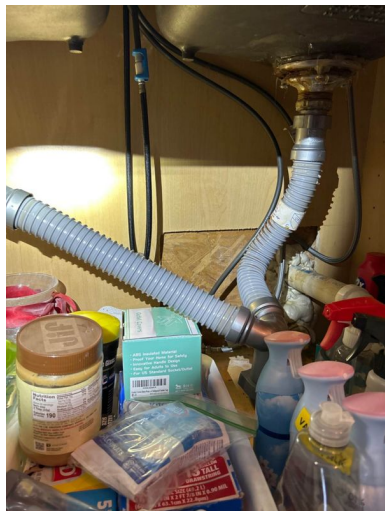
Kitchen

Flexible drain pipe observed installed under the sink. This type of drain line should not be installed in this location and tends to build up debris at the interior.

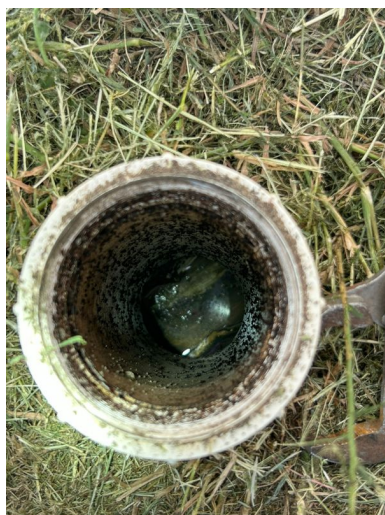
Standing water observed in the drain pipe leading to the septic. This could be a result of an improperly sloped drain. Further evaluation is recommended.

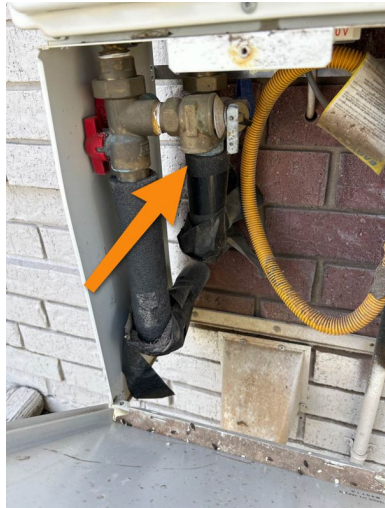
The discharge piping serving the temperature and pressure relief valve for the water heater was missing.

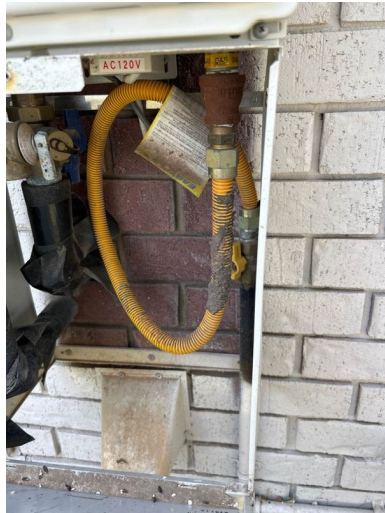
There were no visible sediment traps installed on the gas lines adjacent and leading to the gas appliances.

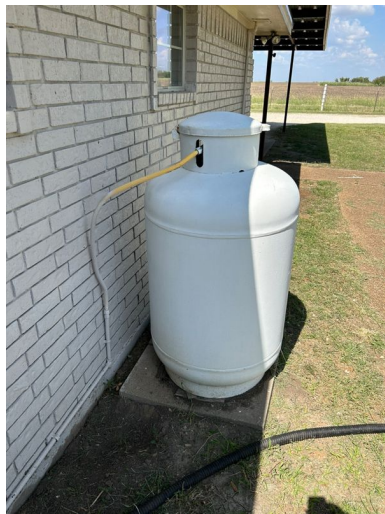
2: Propane Tank Too Close

The propane tank was too close to the house.

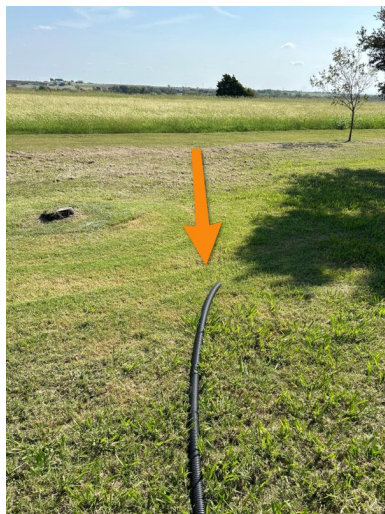
Gray Water Location and Type: Washing Machine Drain Termination, Laundry Sink Drain Termination Flexible Hose at Front Yard

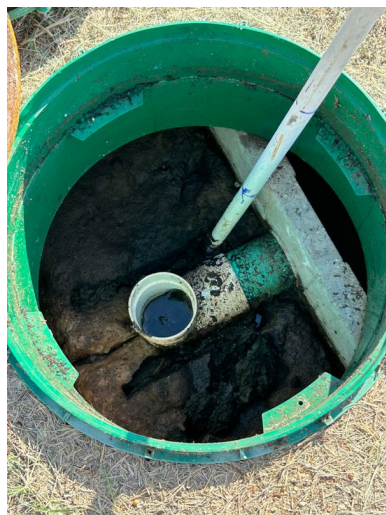
The level of scum on top of the water in one of the tank chambers was excessive (12 inches) The tank should be pumped out, as excessive scum can interfere with proper functioning of the system.
