FULL HOUSE INSPECTIONS

RESIDENTIAL HOME INSPECTION

1234 Main Street
Waco TX 76708

10/10/2023 9:00AM

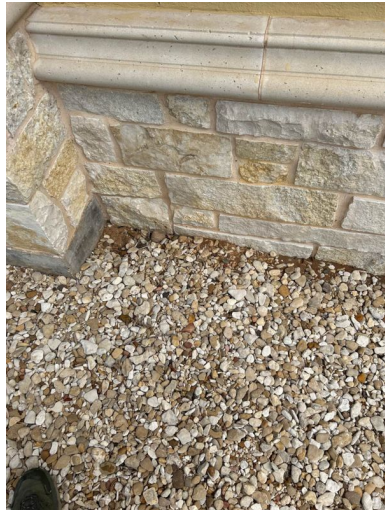
Front Exterior

Insufficient clearance from the ground to the exterior cladding was observed. Grading in contact with the exterior cladding is conducive to problematic water related issues and wood destroying insect activity. Ideally four (4) to six (6) inches of clearance should be maintained between the grading and the exterior cladding. The grading should then slope away from the structure at a rate of six (6) inches in the first ten (10) feet.

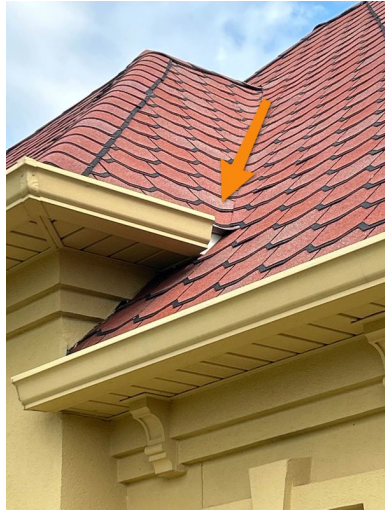
Downspouts or gutters that discharge onto the roof should be extended to discharge directly into the gutter below. This condition if left unattended can result in premature deterioration of the roofing, soffits, and or fascia adjacent to the end of the downspout or gutter.

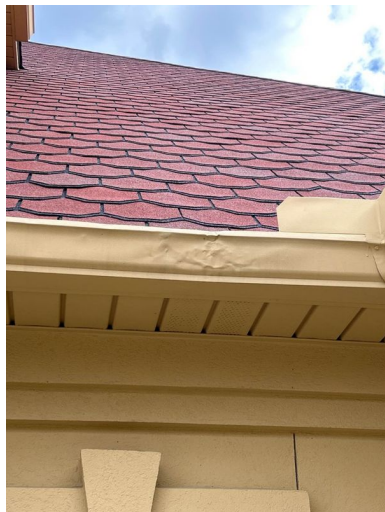
Front Exterior

Damaged gutters observed.

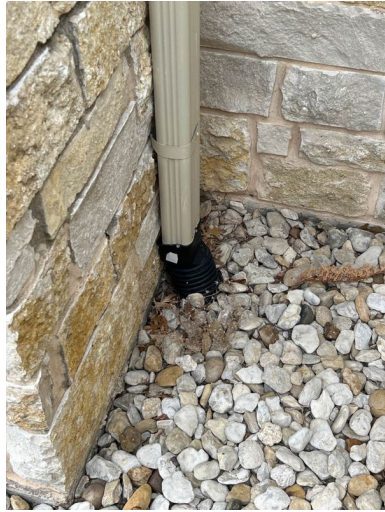
Note: Any downspouts that discharge below grade level should be monitored. If they are ever suspected to be clogged or disconnected below grade they should be redirected to discharge at least five (5) feet from the building.

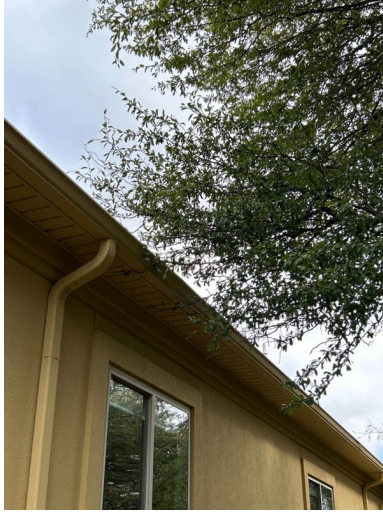
Note: Trees or vegetation close to or in contact with roof covering materials should be trimmed away to prevent damage to the roof covering materials.

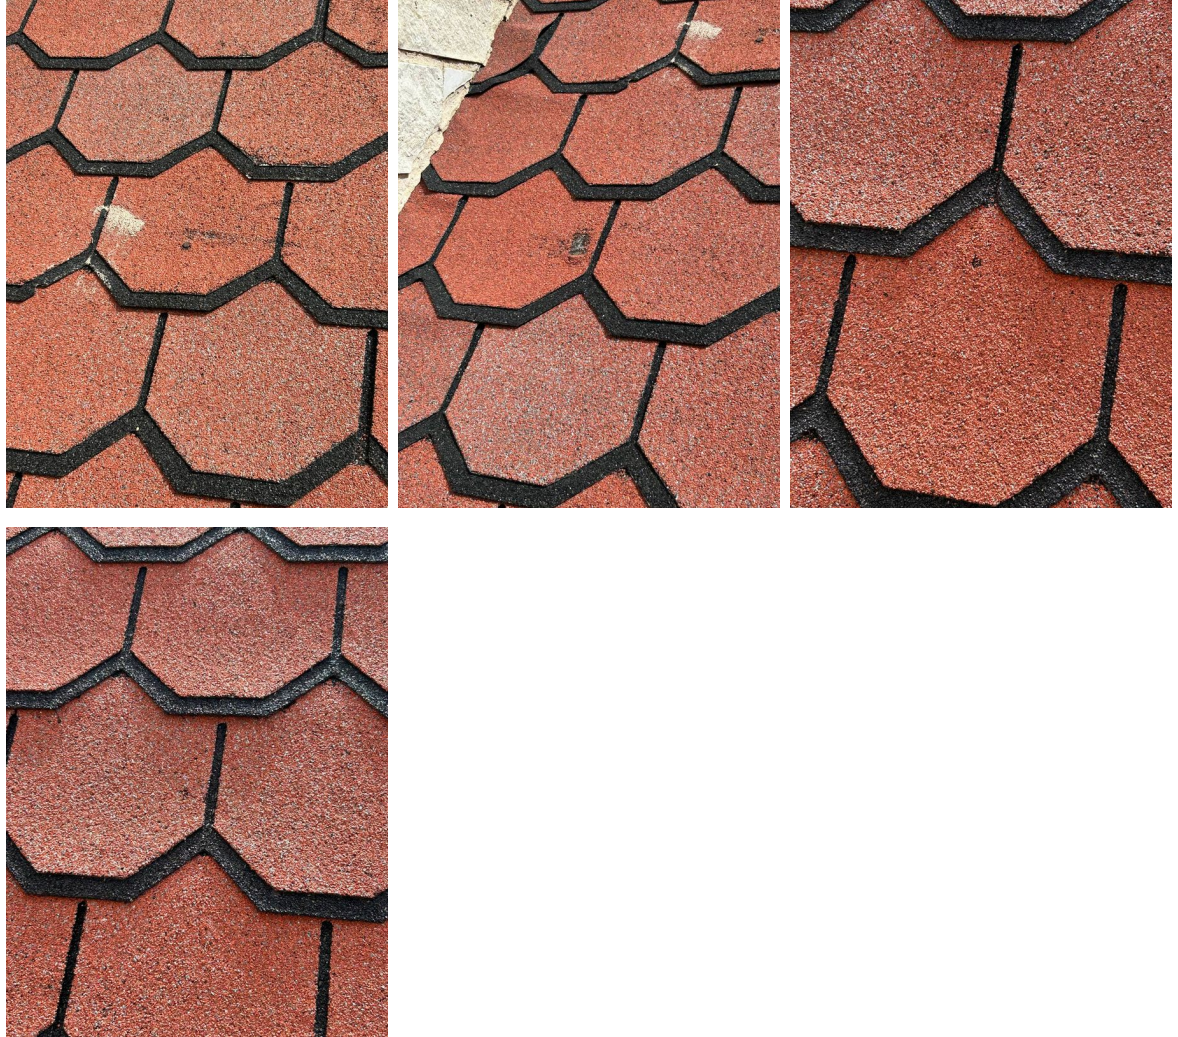
2: Damaged Shingles

Damage observed on shingles. Damaged shingles can affect the performance of the roof covering and lead to leaks into the structure. Recommend a qualified roofer evaluate and repair.

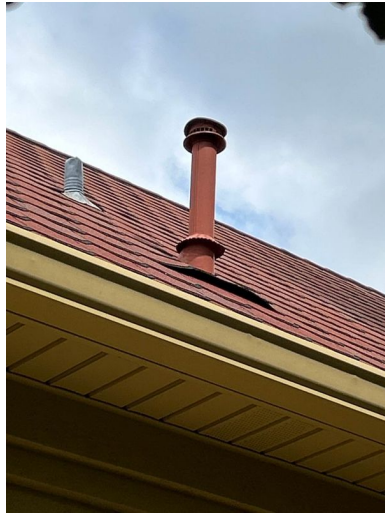
3: Loose Flashing

Loose or poorly secured flashing observed.

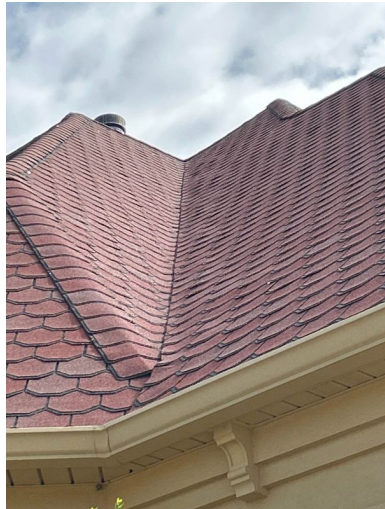
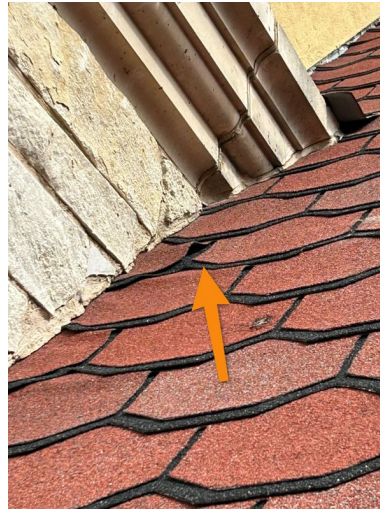
4: Curling or Lifted Shingles

Shingle edges were curled or lifted in various locations. Further evaluation by a qualified roofing professional is recommended.

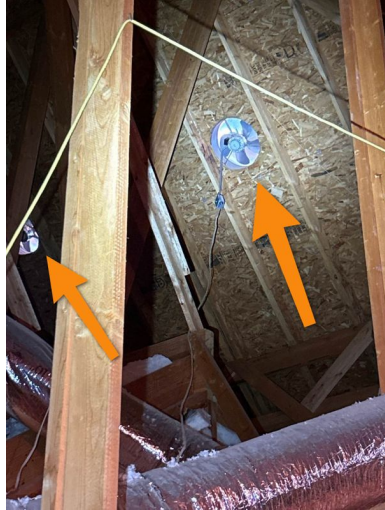
The attic power vents were not operating at the time of the inspection. Thermostats are not tested/adjusted on these devices during the inspection. Further testing is recommended.

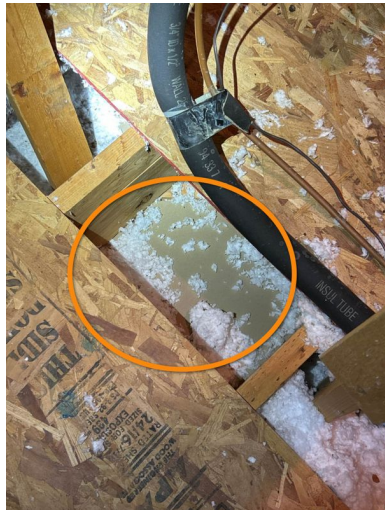
2: Missing Insulation

Missing insulation observed in the attic. This results in reduced insulating efficiency and typically higher utility bills.

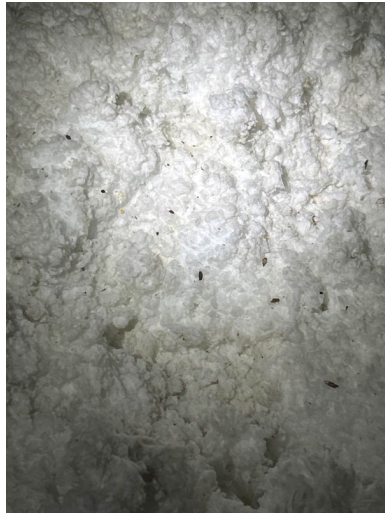
Evidence of previous vermin activity observed in attic. Further evaluation is recommended.

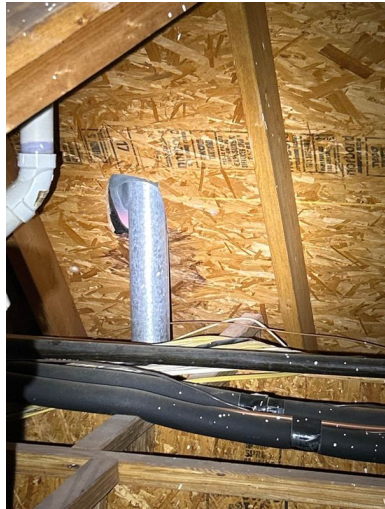
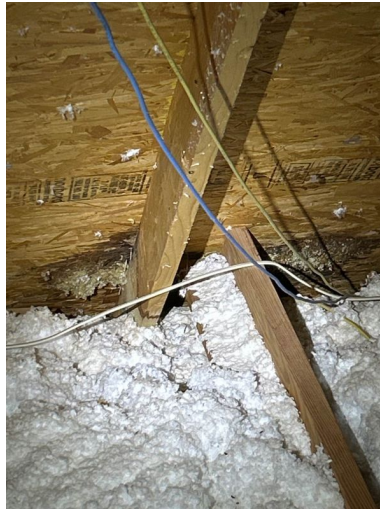
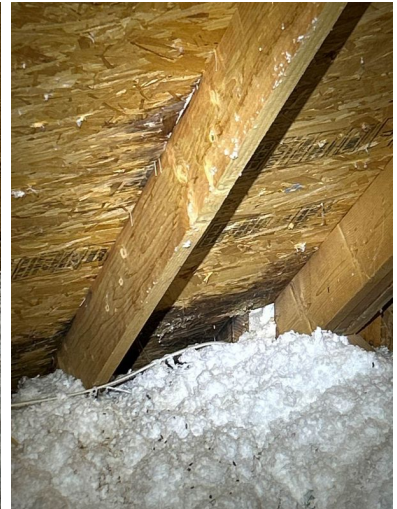
4: Water Stains

Water stains were observed in the attic. These may be the result of a previous leak at roof coverings and flashings; however, this could not be confirmed. Further evaluation is recommended.

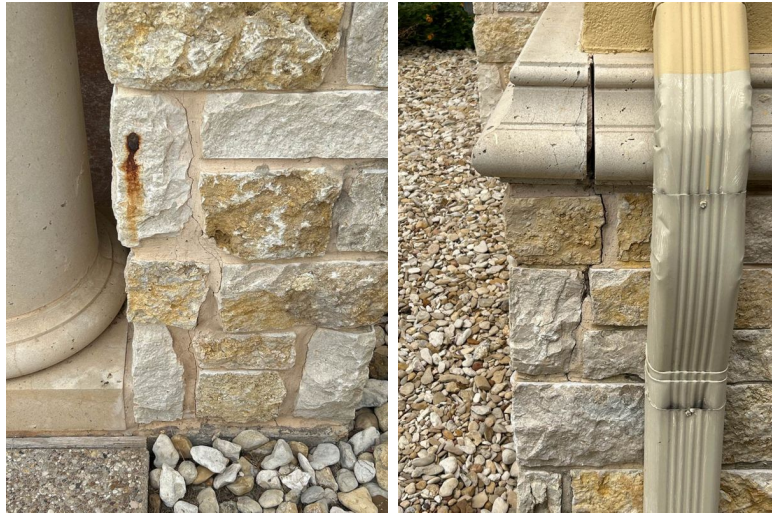
1: Typical Exterior Wall Cracks

Exterior wall and or mortar cracks observed. This is evidence of typical differential foundation movement.

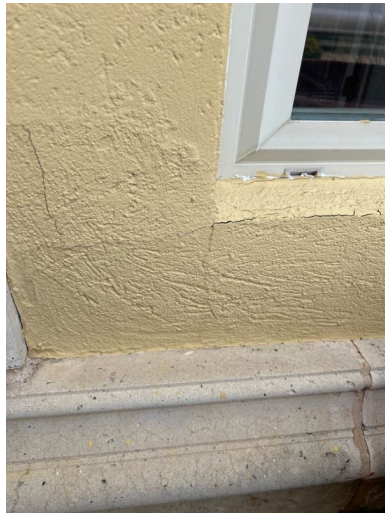
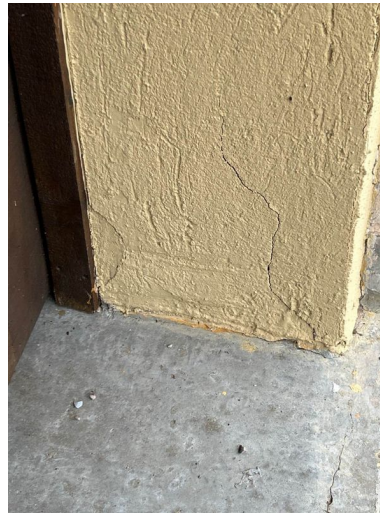
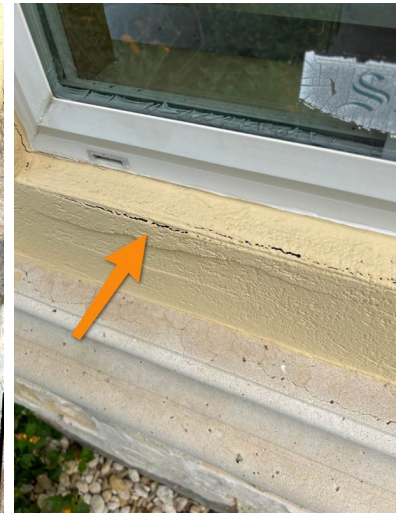
Cracks and Damage - Front Exterior

Stucco cladding observed in various exterior locations did not have proper clearance from grading and other materials and did not have a visible weep screed installed at the bottom to allow for moisture to escape. Expansion joints were not installed where it meets other materials such as stone or brick. Moisture related issues may occur. Damaged stucco material and cracks or gaps in or adjacent to the stucco should be properly repaired. All penetrations through the stucco should be examined and sealed as necessary. Further evaluation by a qualified stucco professional is recommended.

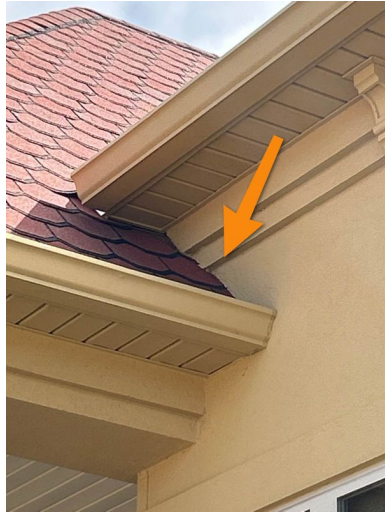
The clearance of the siding above the shingles is insufficient. This leaves the siding vulnerable to moisture damage.

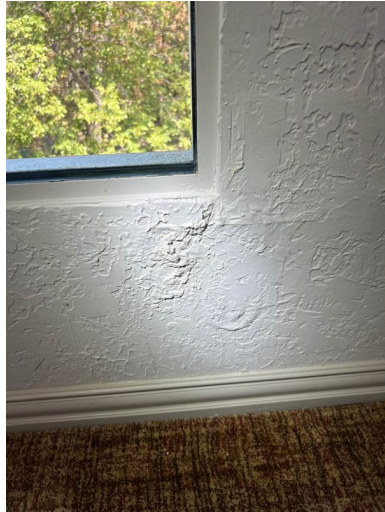
5: Water Damage at Wall

Water damage observed at interior wall finishes. Extent of damage behind wall finishes not determined. Further evaluation is recommended.

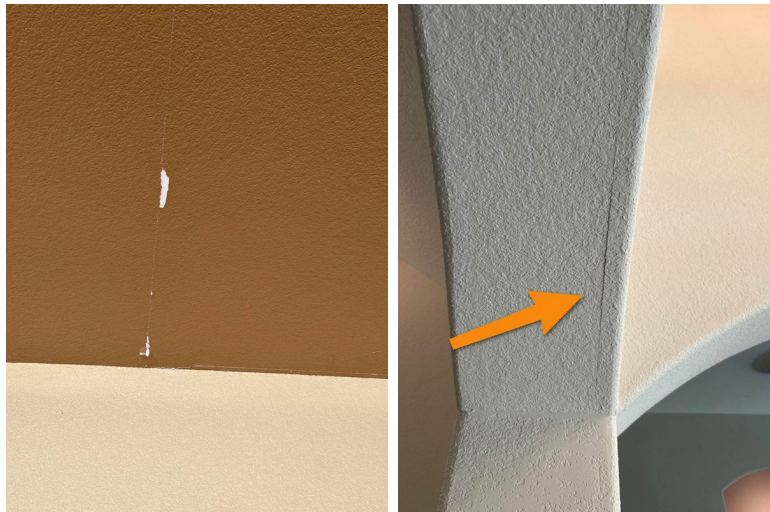
1: Loose Ceiling Finish

Loose and or weakened ceiling finishes observed.

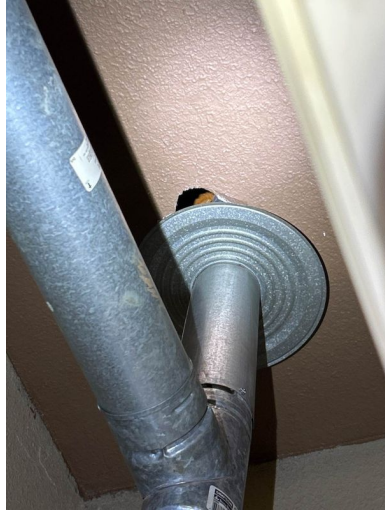
Penetrations in garage ceilings were observed. All penetrations through the garage ceilings should be sealed to maintain a proper fire rating.

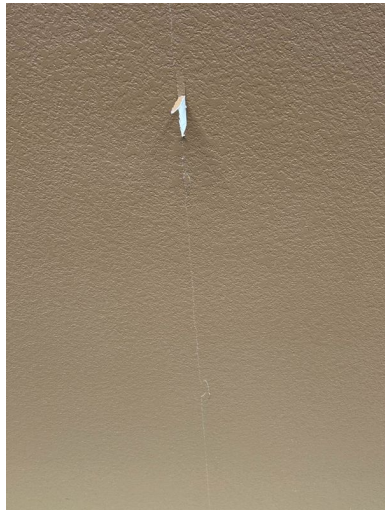
3: Interior Ceiling Cracks

Interior ceiling cracks and or movement at tape joints observed. This could be related to structural movement.

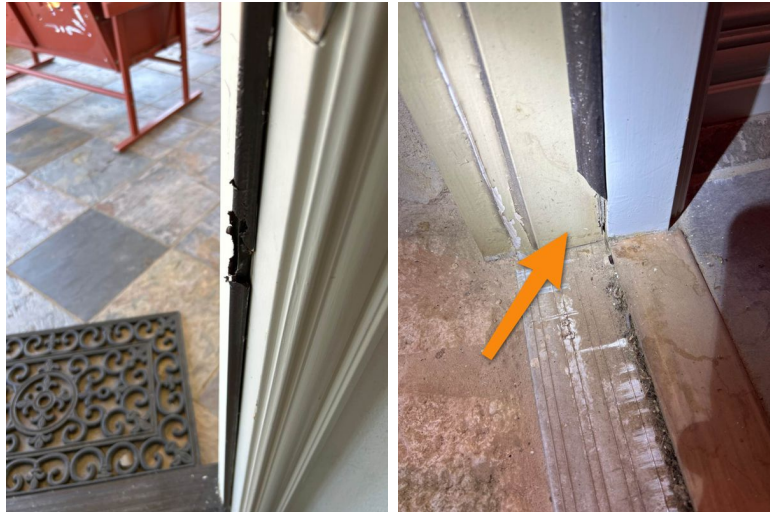
2: Weatherstripping Damaged

The weather stripping was damaged on the exterior door.

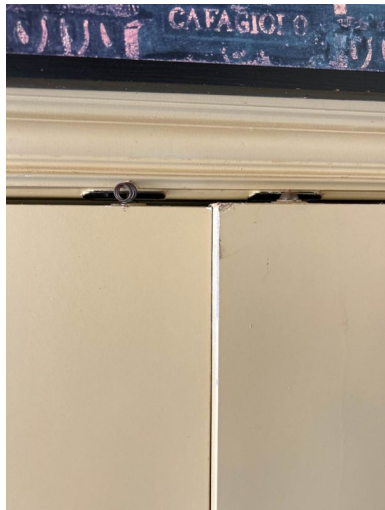
Hardware repairs and or adjustments were needed at doors.

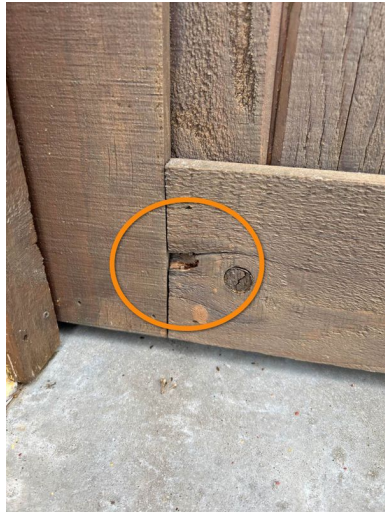
5: Minor Deterioration

Minor deterioration observed on garage overhead door.

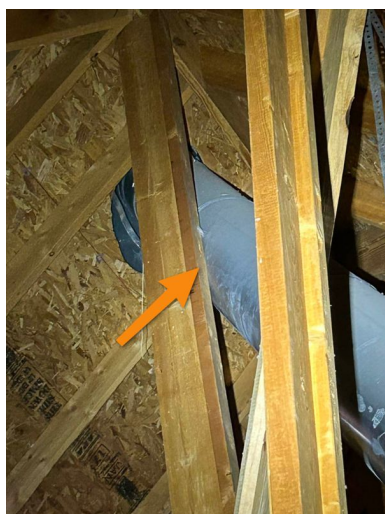
1: Improper Clearance from Combustible Materials

The fireplace chimney flue did not have proper clearance from combustible materials in the attic. A minimum of 2 inches is needed.

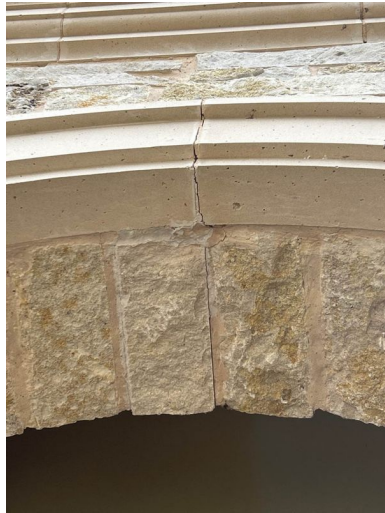
1: Cracks in Arch

Cracks observed in the porch archway. Further evaluation recommended.

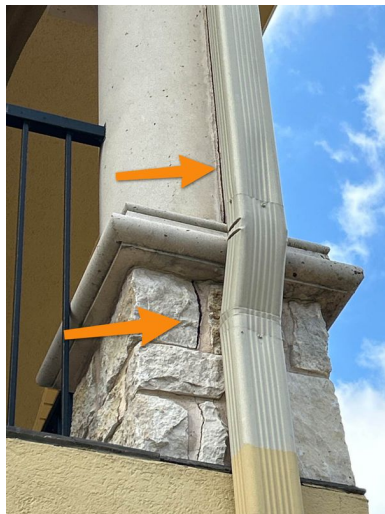
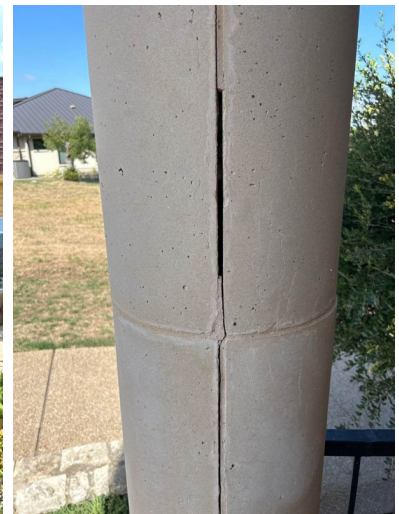
2: Cracks At Masonry Posts

Cracks and separations observed in the masonry deck and patio posts. Mortar pointing up needed.

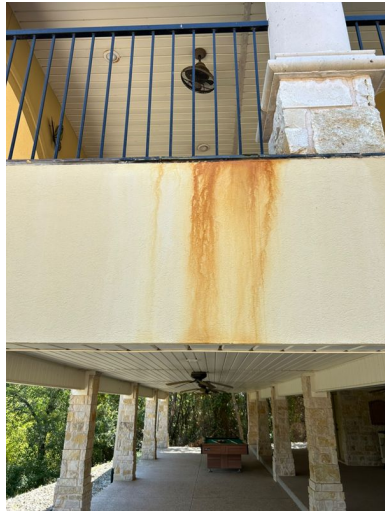
3: Rust

Rust and staining observed at side of rear deck. Further evaluation is recommended.

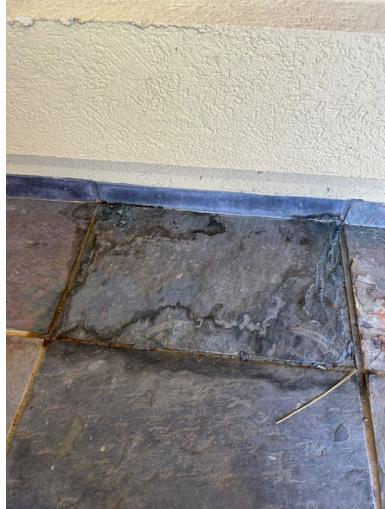
4: Water stains

Water stains and damaged slate observed at the balcony. The reason for this was not determined. Further evaluation is recommended.

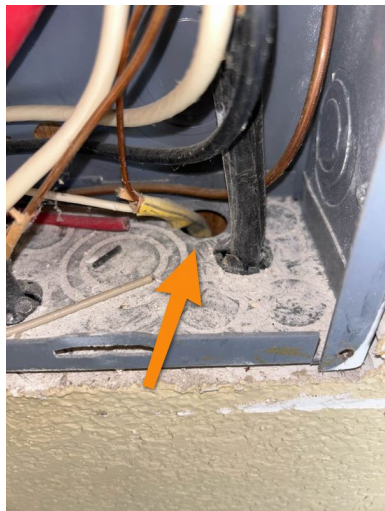
1: Cable Clamps Missing

Cable clamps or bushings were missing where wires pass through the panel. These are used to protect the wiring from the edges of the metal panel openings.

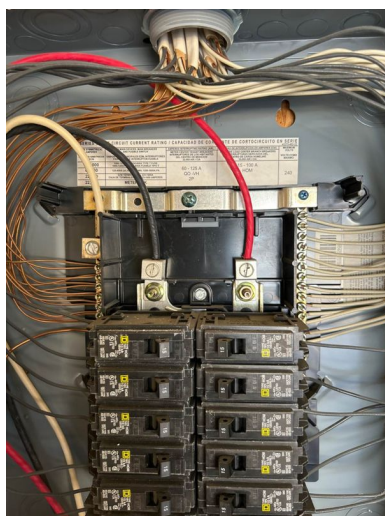
2: Neutrals and Grounds not Isolated

The electrical distribution sub panel had an improper wiring condition. The neutral wires and the ground wires were connected together on the same bus bar, which is not allowed for sub panels. This can create a potential shock hazard and interfere with the proper operation of the circuits. The neutral wires and the ground wires should be separated on different bus bars, and the neutral bus bar should be isolated from the panel enclosure.

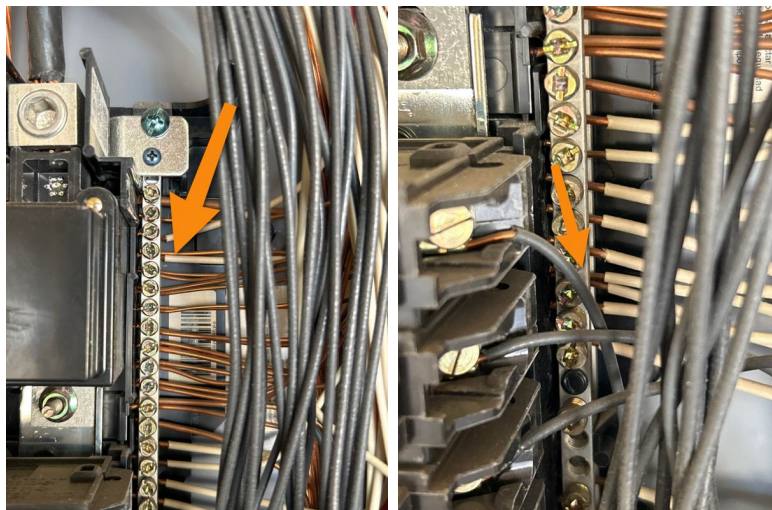
Main Panel

The electrical panel had one or more instances of neutral wires that were sharing the same terminal screw on the neutral bus bar. While this is common, it is not a proper wiring practice under current standards and could result in loose connections or possible arcing. The proper way to wire the neutral bus bar is to have one terminal screw for each neutral wire.

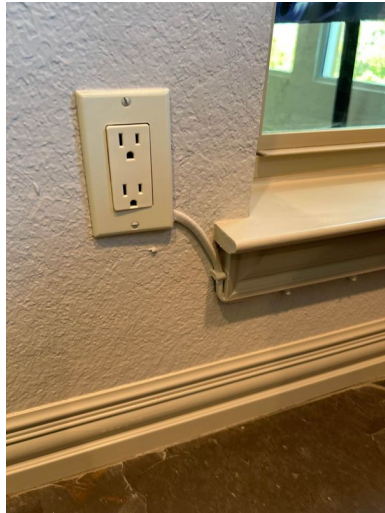
Master Bedroom

Exposed wiring that was not protected within conduit was observed.

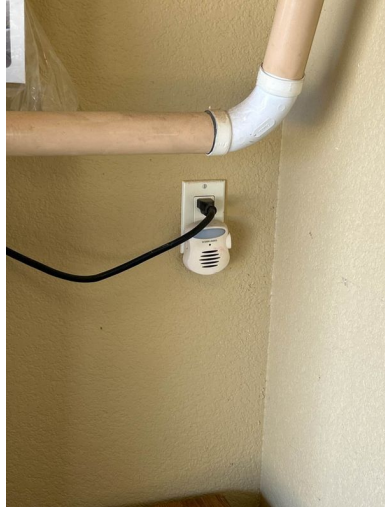
Garage

Ground fault circuit protection (GFCI) was not found for one or more receptacles at the required locations.

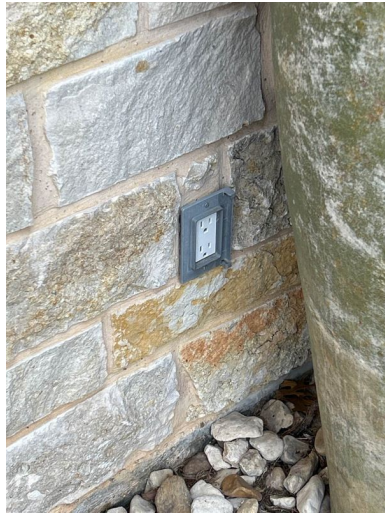
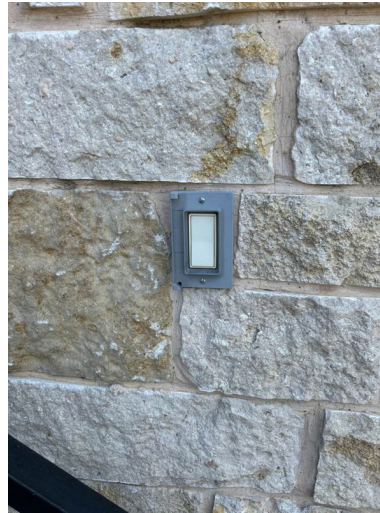
7: Receptacle Cover Plate Missing

Electrical receptacle cover plate was missing or not installed.

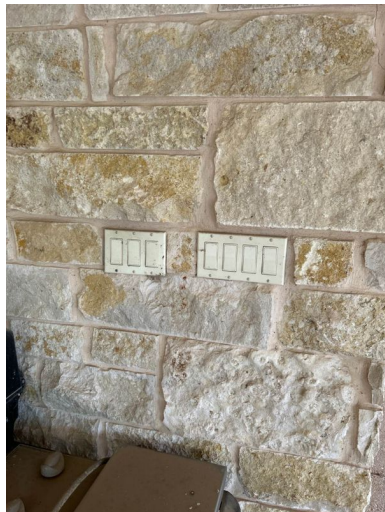
8: Damp Location Covers Missing

Damp location covers not installed on exterior electrical switches where needed.

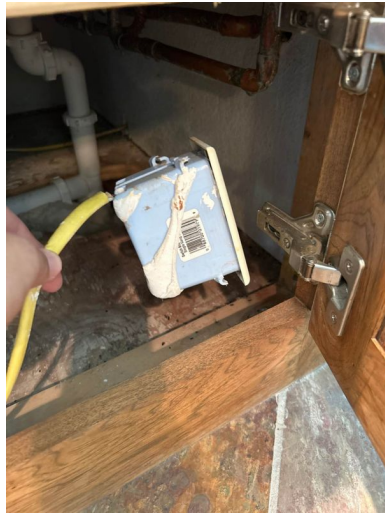
10: Loose Receptacle

Electrical receptacle observed to be loose or poorly secured.

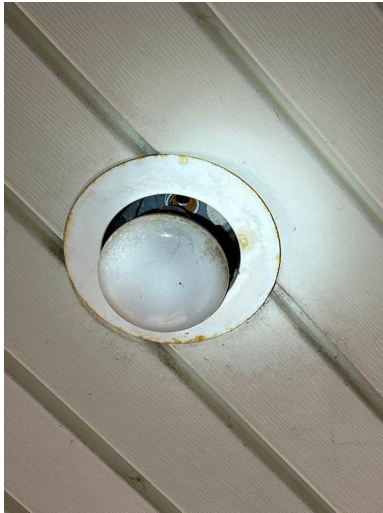
16: Broken Light Bulb

Broken light bulb observed at the balcony.

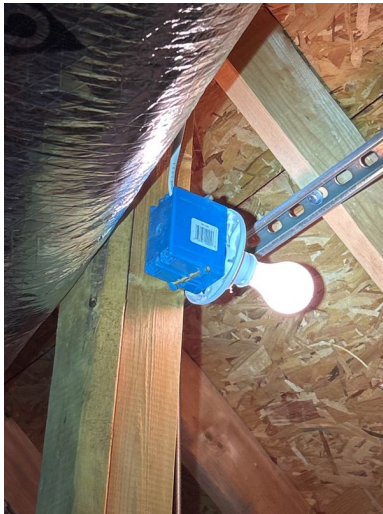
17: Improper Junction Box

An improperly sized junction box was installed on a light fixture.

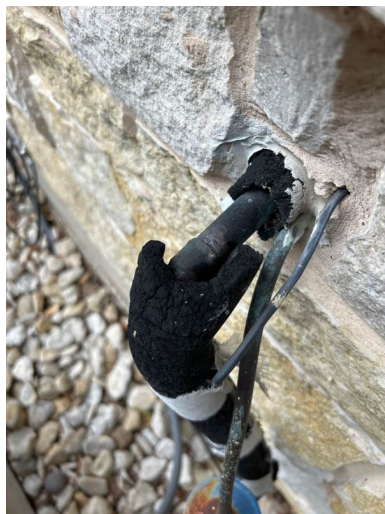
1: Insulation Missing or Damaged

Missing or damaged insulation on refrigerant line can cause energy loss and condensation. The insulation should be repaired/replaced.

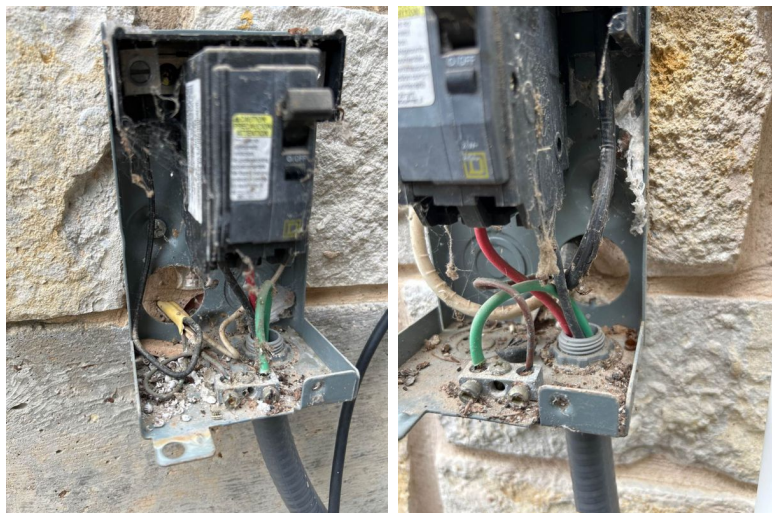
The electrical disconnect panel box for the outdoor unit had evidence of vermin activity at the interior of the panel. The panel should be cleaned and all entry points sealed. Panel also lacked a cable clamp where wiring enters at the back of the panel.

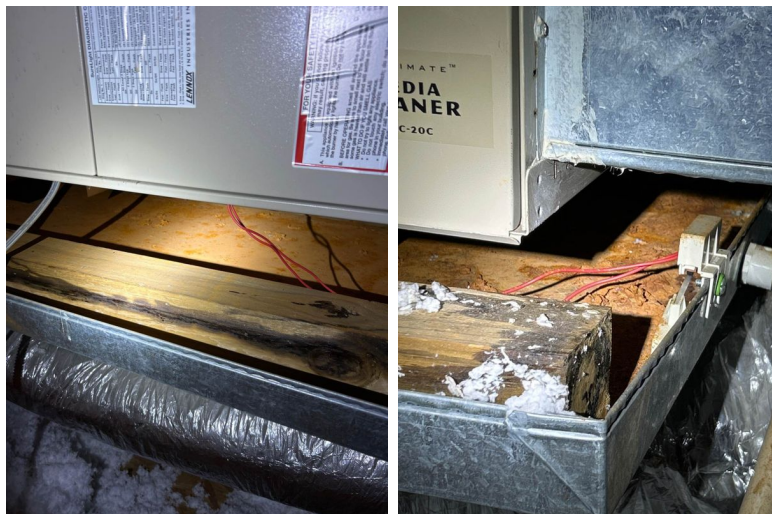
3: Rust in Pan

Note: The auxiliary drain pan was not free of rust or water stains. This indicates a problem has occurred with the condensation line or the evaporator coil. Further evaluation or documentation of previous repairs is recommended.

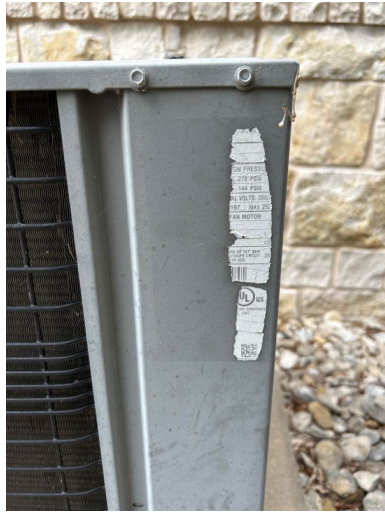
5: Data Plate Missing

Note: The outdoor unit data plate was missing, damaged, or faded.

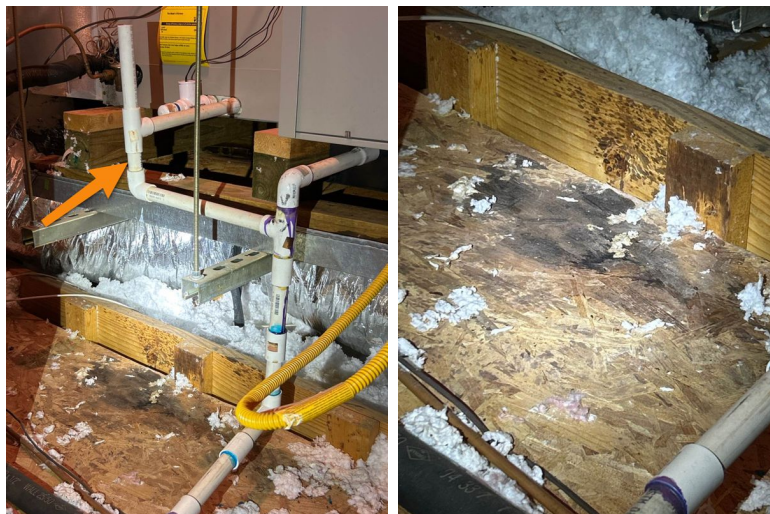
6: Condensation Drain Insulation Missing

Note: The primary condensation line was not insulated at the attic mounted unit. The drain line should be insulated to prevent condensation from forming on the outside of the cold drain and dripping into the attic.

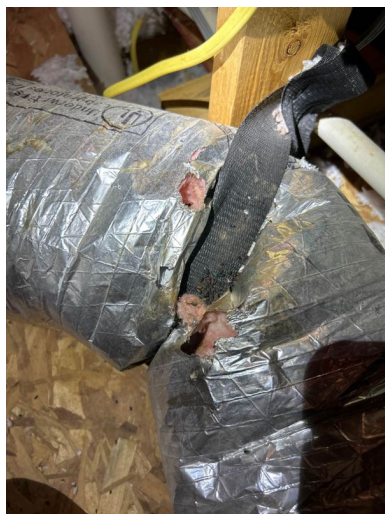
1: Damaged Moisture Barrier

Damaged moisture barrier observed on ducts in the attic.

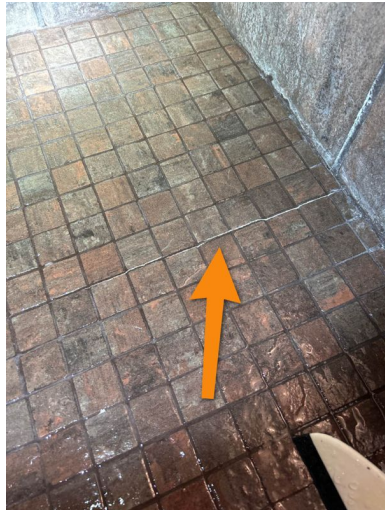
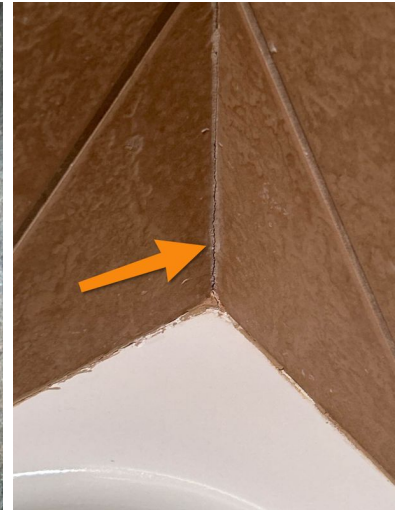
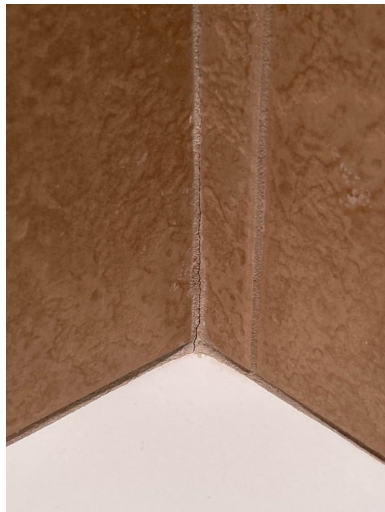
Grout or caulking improvements needed in the shower enclosure. Cracks or separations in the grout should be repaired.

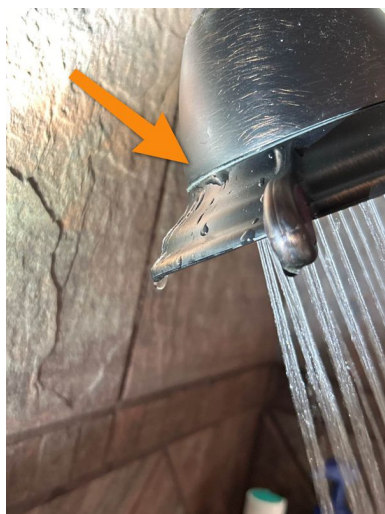
4: Showerhead Leaks

Showerhead leaked at the spray adjustor.

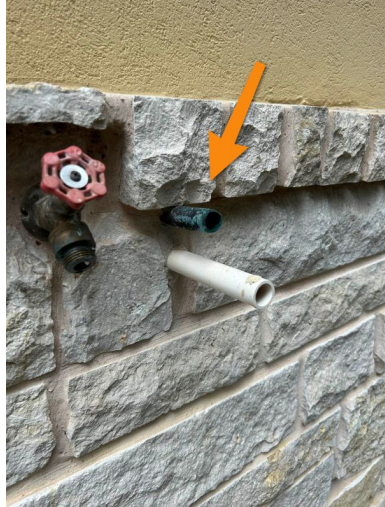
East Exterior

The temperature and pressure relief valve drain did not terminate pointing downward and within 6 inches of the ground.

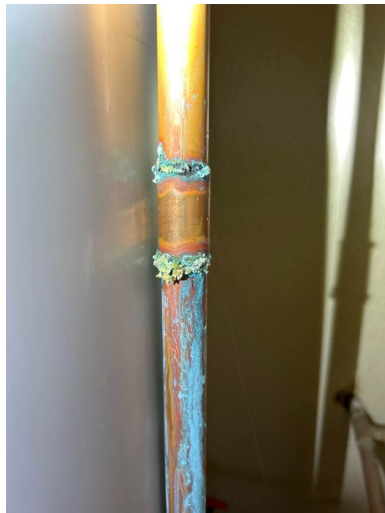
2: TPRV Drain Corrosion

Note: Corrosion observed at the temperature and pressure relief valve drain indicates a previous leak. The drain should be monitored and cleaning or repairs performed if leaking resumes.

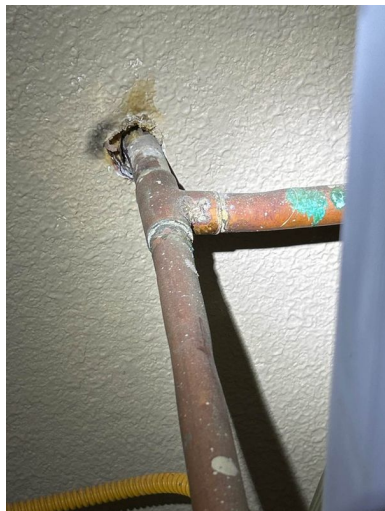
Both Units

The temperature and pressure relief valve drain did not terminate properly. The drain was connected to another drain. The drain termination should be changed so that it meets current standards.

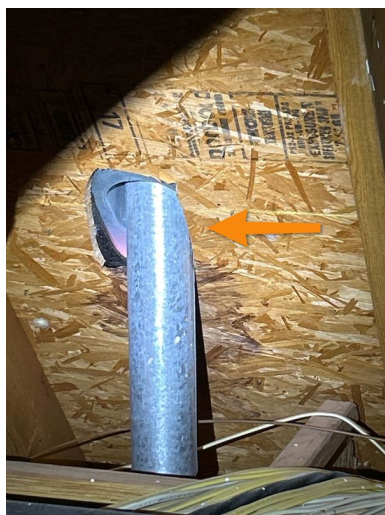
4: Vent Pipe Clearance

The vent pipe serving the water heater did not appear to have proper clearance from combustibles within the attic. This condition should be improved for safety reasons.

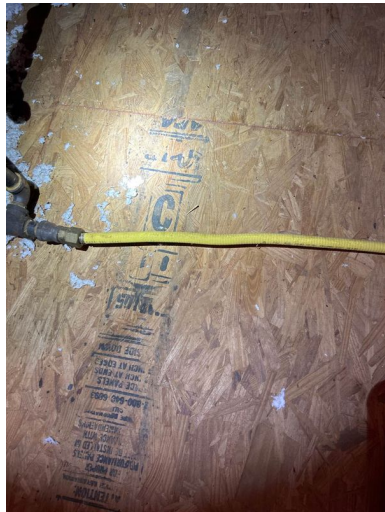
Attic

Note: A flexible gas piping known as corrugated stainless steel tubing (CSST) was observed. Manufacturers believe that CSST should be properly bonded per specifications for improved safety of the product. Further evaluation by an appropriate professional is recommended to determine if the CSST was installed and bonded properly.

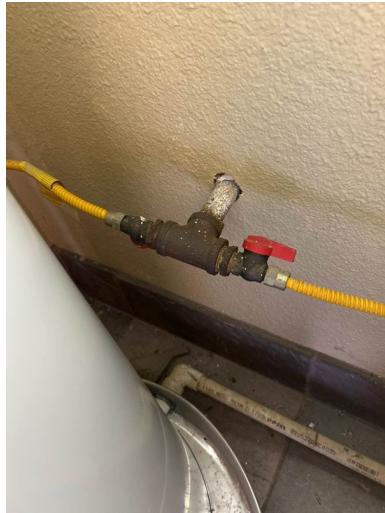
Water Heater Closet

There were no visible sediment traps installed on the gas lines adjacent and leading to the gas appliances.

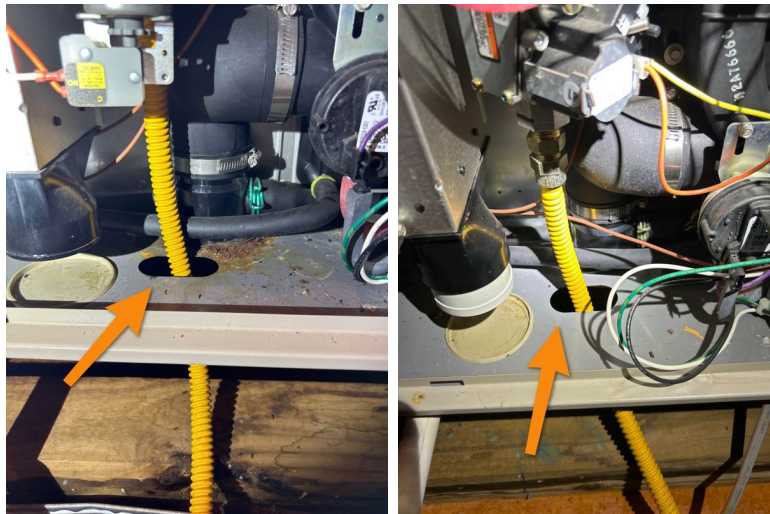
3: Flexible Appliance Connector Penetration

The flexible gas appliance connector was installed in a manner that is inconsistent with current regulations. The gas appliance connector should not pass through the cabinet wall.

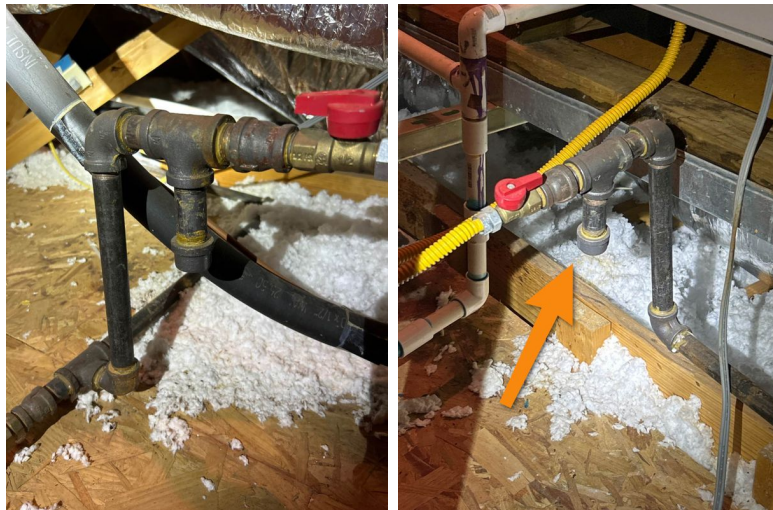
Attic

Improperly installed gas sediment traps observed. These were not installed in the intended way to perform their specified purpose.

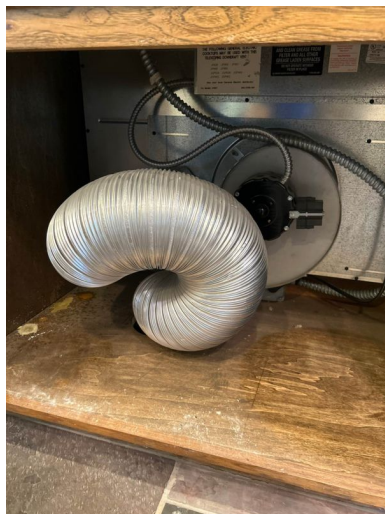
The range venting system was found to be using flexible exhaust vent, which is not in compliance with current requirements. Flexible exhaust vent can trap grease and dust, creating a fire hazard and reducing the efficiency of the venting system. Current standards require that the range hood venting system be constructed of smooth, rigid metal ducts that are airtight and have a backdraft damper. The flexible exhaust vent should be replaced with an appropriate metal duct to ensure safety and performance.

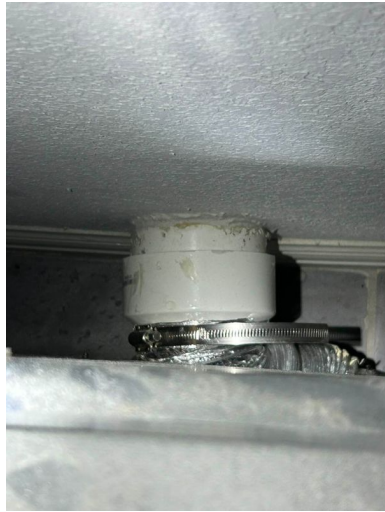
The dryer vent duct was not a properly rated material for the application.

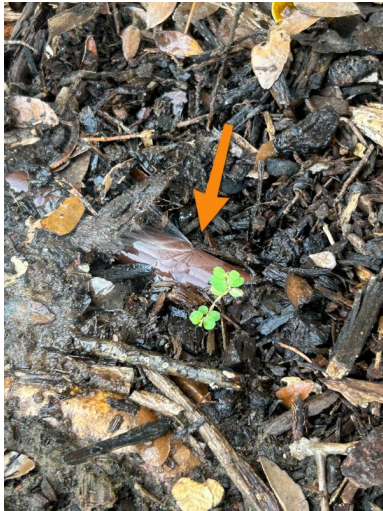
Zone 2

A damaged drip line was observed.

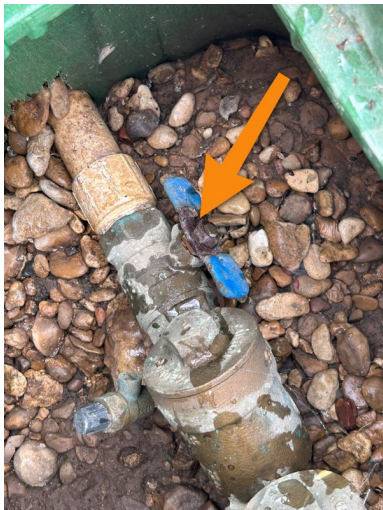
3: Rust on Backflow Valve Handles

Significant rust observed on backflow valve handles. The handles were damaged.
