ACCIDENT

Aircraft Type and Registration:	Ikarus C42 FB80 Ikarus, G-ULSY	
No & Type of Engines:	1 Rotax 912-UL piston engine	
Year of Manufacture:	2004 (Serial no: 0405-6603)	
Date & Time (UTC):	13 July 2018 at 1230 hrs	
Location:	Sandown Airfield, Isle of Wight	
Type of Flight:	Private	
Persons on Board:	Crew - 1	Passengers - 1
Injuries:	Crew - None	Passengers - None
Nature of Damage:	Left landing gear collapsed	
Commander's Licence:	National Private Pilot's Licence	
Commander's Age:	51 years	
Commander's Flying Experience:	183 hours (of which 101 were on type) Last 90 days - 50 hours Last 28 days - 24 hours	
Information Source:	Aircraft Accident Report Form submitted by the pilot and further enquiries by the AAIB

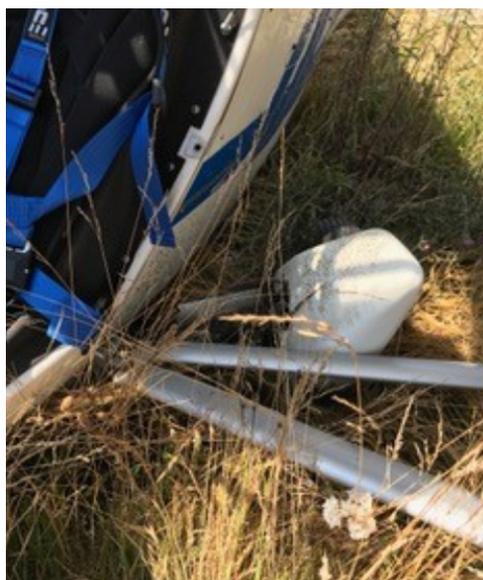
Figure 1

Shortly after touchdown, G-ULSY's left landing gear assembly failed, allowing the mainwheel to pivot rearwards and inwards towards the fuselage. The aircraft veered left uncontrollably, departed the prepared surface and came to rest in long grass adjacent to the runway (Figure 1). Neither occupant was injured and they vacated the aircraft unaided.

G-ULSY's left landing gear assembly after the accident

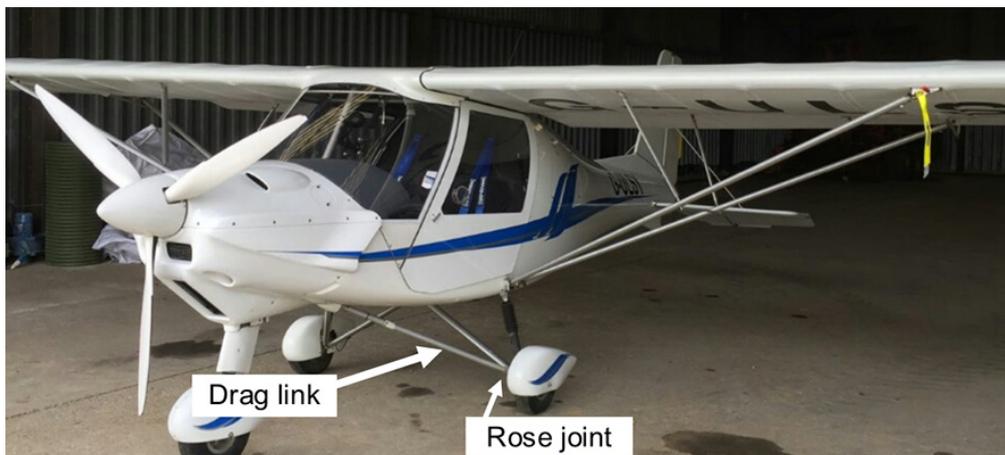
Figure 2

Investigation revealed that the rod end bolt connecting the drag link to the undercarriage assembly had sheared forward of the rose joint lock nut (Figures 2 and 3).

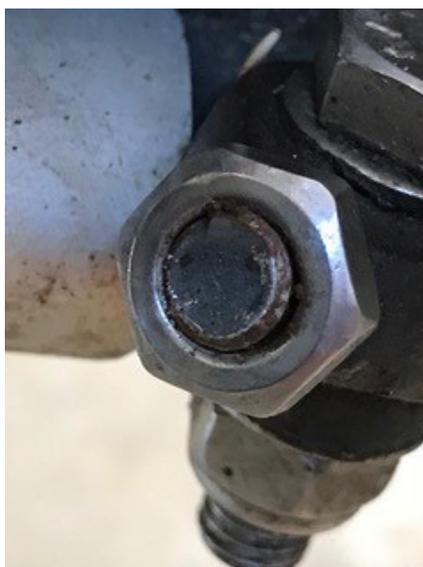
Figure 3

Rose joint/rod end bolt fracture face

The pilot reported that the touchdown was not unduly heavy and that he had not started braking at the time of failure. It was not possible to determine what caused the bolt to shear.

While other aircraft types, such as the Pietsenpol Air Camper, have experienced issues with undercarriage rod end bearing failures, this was the first such Ikarus C42 incident notified to the aircraft type's CAMO¹. The CAMO would continue to monitor component failure trends and would take action should rod end reliability become a cause for concern.
