**ACCIDENT**

<b>Aircraft Type and Registration:</b>	Rotorsport UK Cavalon, G-CKYV	
<b>No &amp; Type of Engines:</b>	1 Rotax 914-UL piston engine	
<b>Year of Manufacture:</b>	2018 (Serial no: RSUK/CVLN/026)	
<b>Date &amp; Time (UTC):</b>	9 August 2018 at 1306 hrs	
<b>Location:</b>	Wolverhampton Halfpenny Green Airport	
<b>Type of Flight:</b>	Private	
<b>Persons on Board:</b>	Crew - 1	Passengers - None
<b>Injuries:</b>	Crew - None	Passengers - N/A
<b>Nature of Damage:</b>	Damaged beyond economic repair	
<b>Commander's Licence:</b>	Private Pilot's Licence	
<b>Commander's Age:</b>	67 years	
<b>Commander's Flying Experience:</b>	701 hours (of which 13 were on type) Last 90 days - 95 hours Last 28 days - 24 hours	
<b>Information Source:</b>	Aircraft Accident Report Form submitted by the pilot

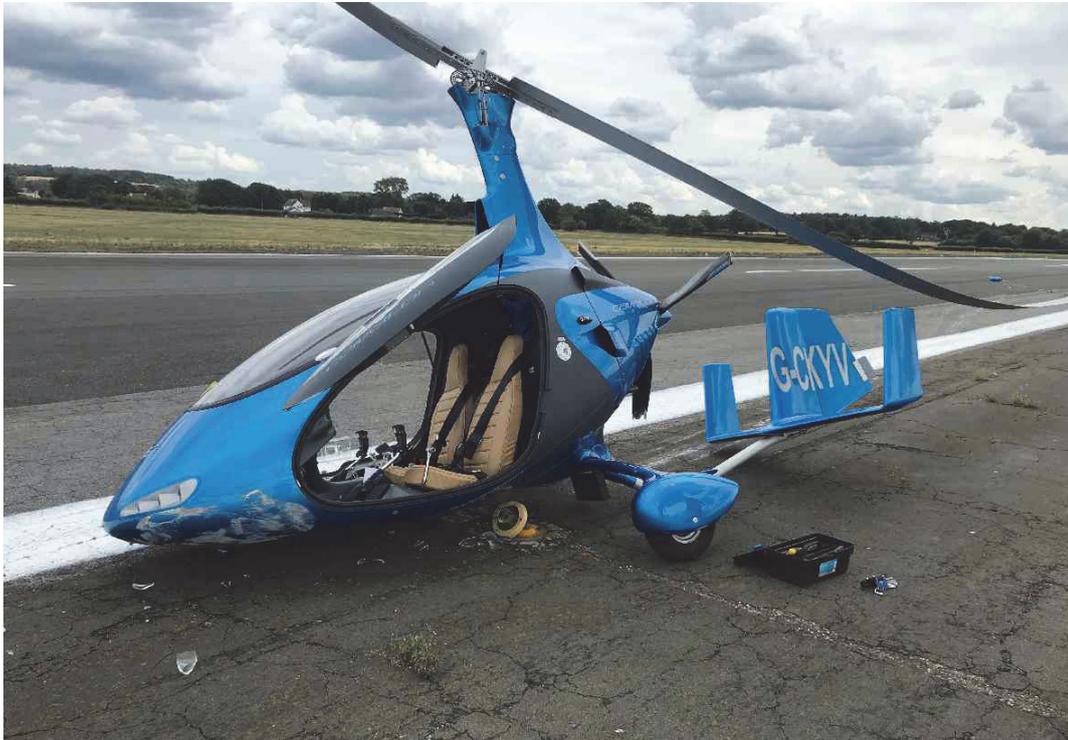
**Figure 1**  
Aircraft on the runway

At low rotor rpm, blade sailing can cause the rotor disc to move violently. It is probable that G-CKYV encountered a blade sailing event as the airspeed increased and the rapid movement of the rotor disc forced the controls from the pilots grasp. Though he reduced power, he was unable to effectively counter the motion of the aircraft.
