# RESERVE STUDY

**The Colony at Edina Condomonium Association**  
**6330 Barrie Road**  
**Edina, MN**

**Date of Inspection: November 28, 2020**

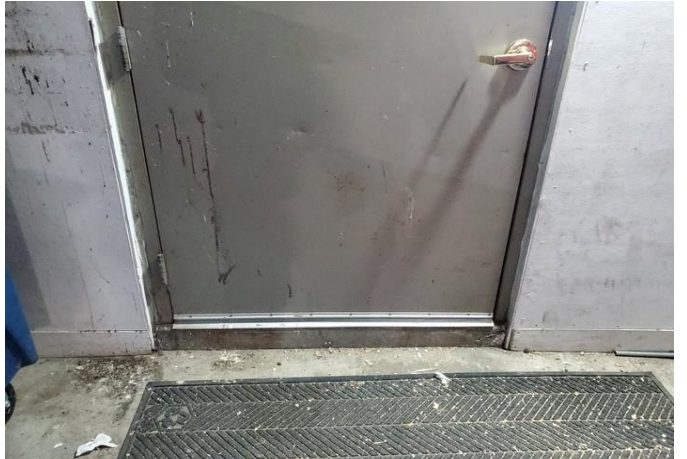
Exterior view of door to Galleries courtyard

Dented and rusting door surface

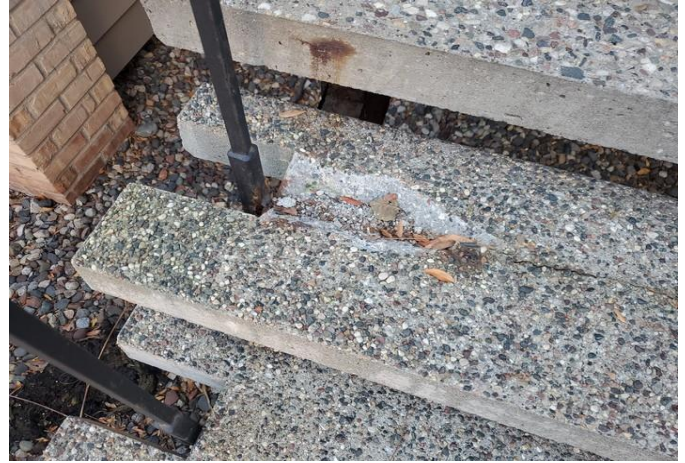
Front entry steps

Deterioration of tread

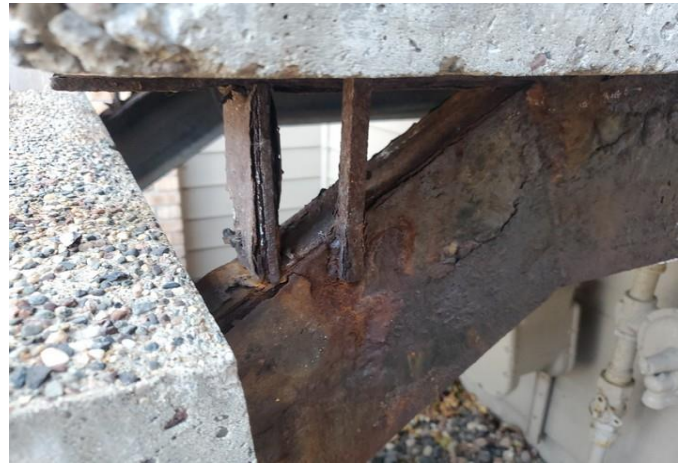
Rusted and flaking steel support

Typical condition of support steel

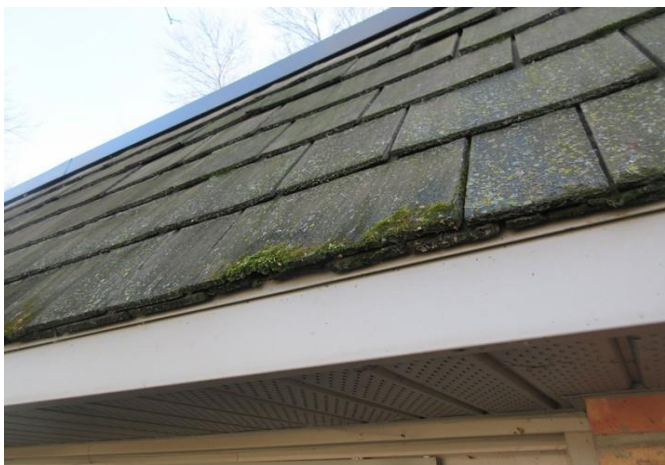
Missing shakes visible

Growths on edge of roof

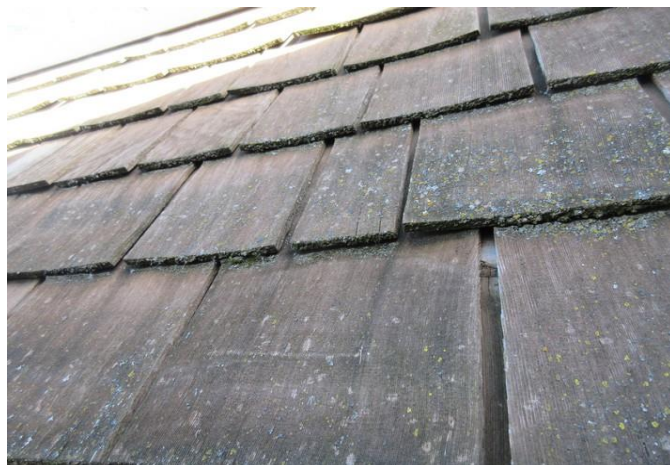
Surface of roof, with lichens growing (typical in shaded area)

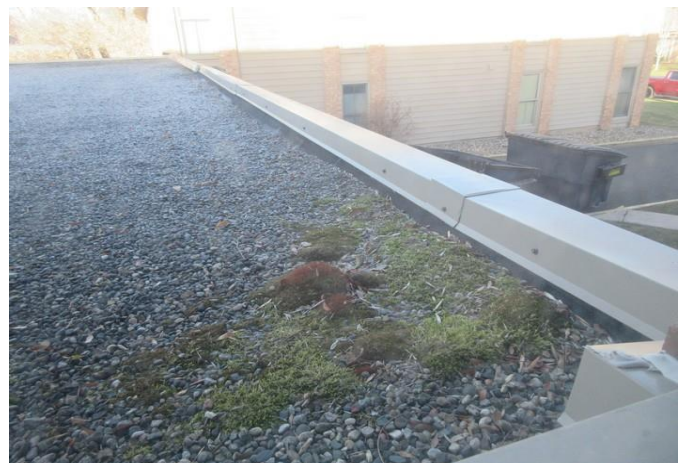
Bent coping

Moss growth on old roof (to be replaced)

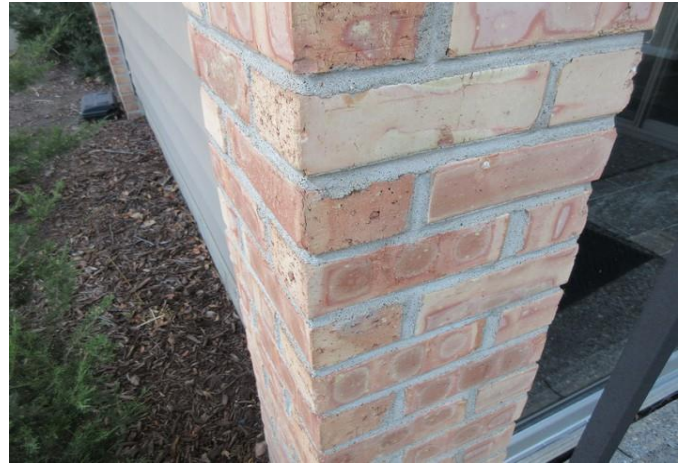
Efflorescence on brick

Repaired mortar at column

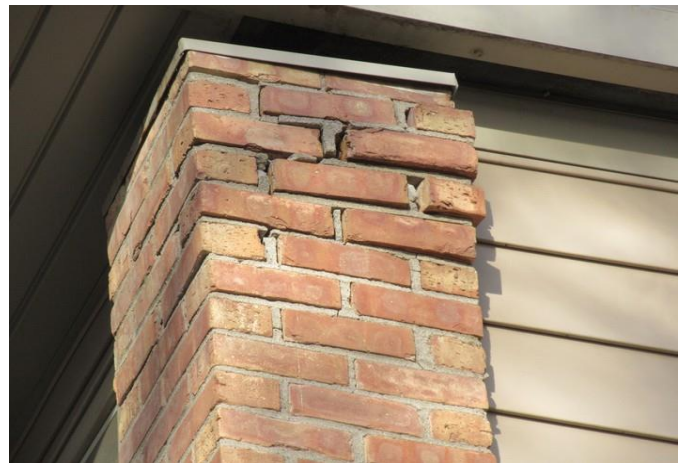
Repairs completed at edge of masonry

Shifted bricks and deteriorating mortar

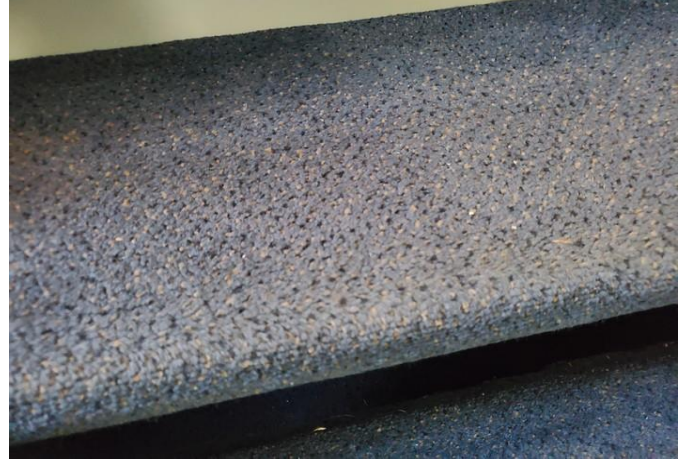
Faded stair carpet

Typical condition of carpet surface

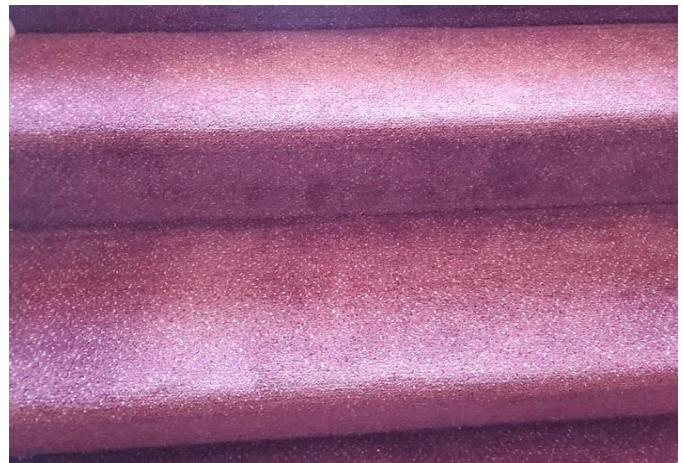
Carpets are faded in high traffic areas

Discolored carpet due to foot traffic

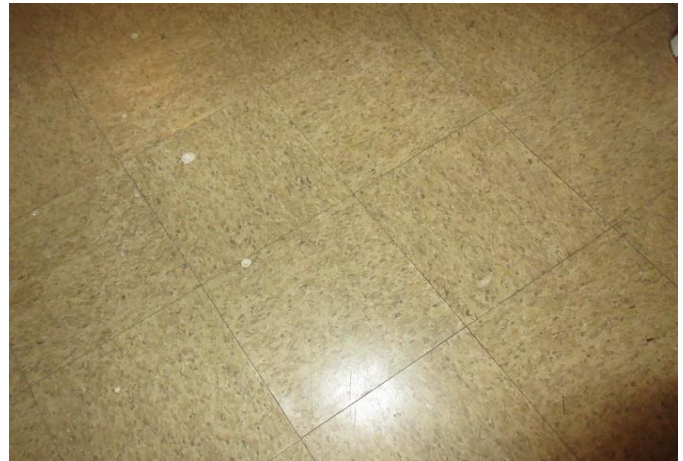
Discolored vinyl floor in storage

View of vinyl tile

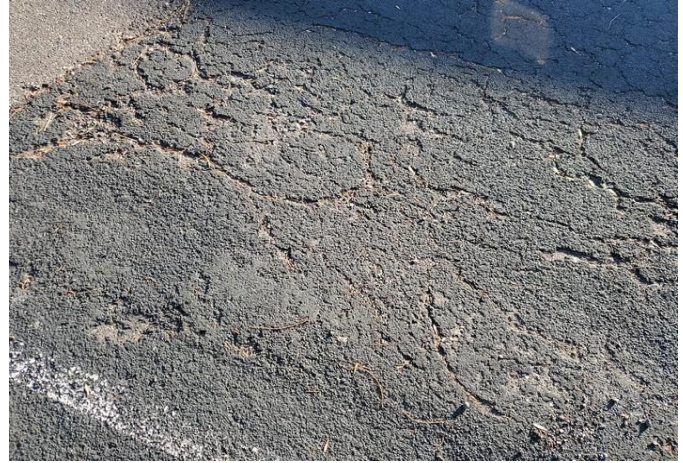
Deteriorating pavement

Deteriorating seal coat

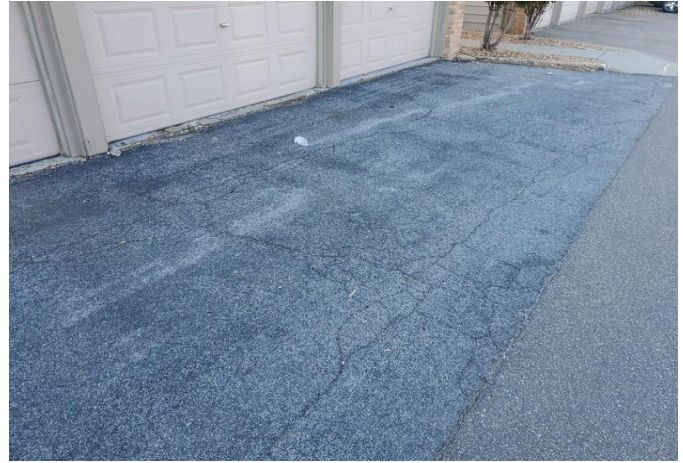
Potholes forming

Cracked driveway pavement

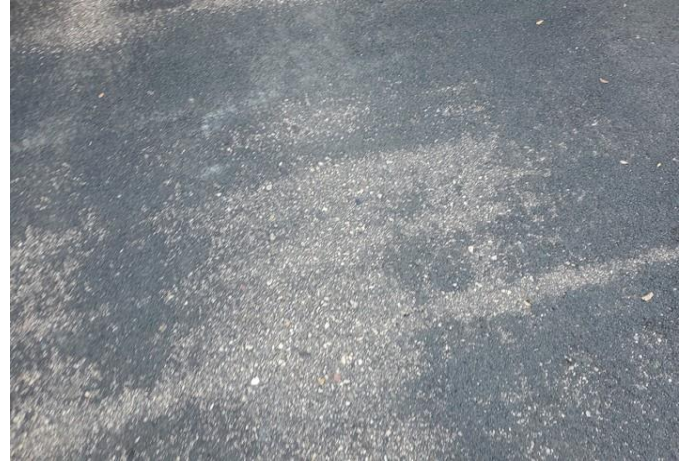
Typical pavement

Worn seal coat

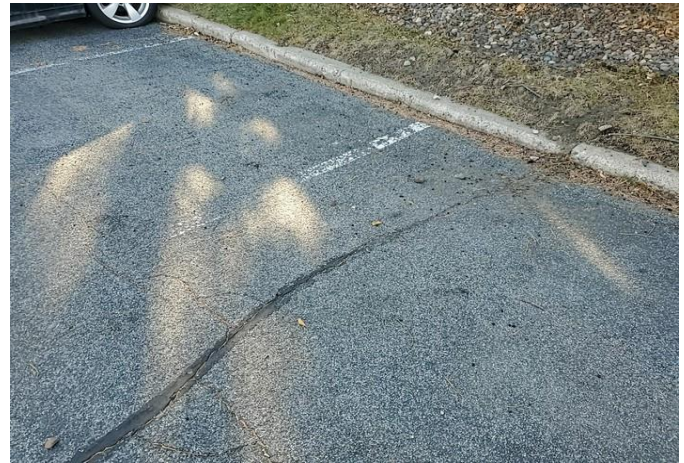
Cracking pavement

Crack in pavement near parking

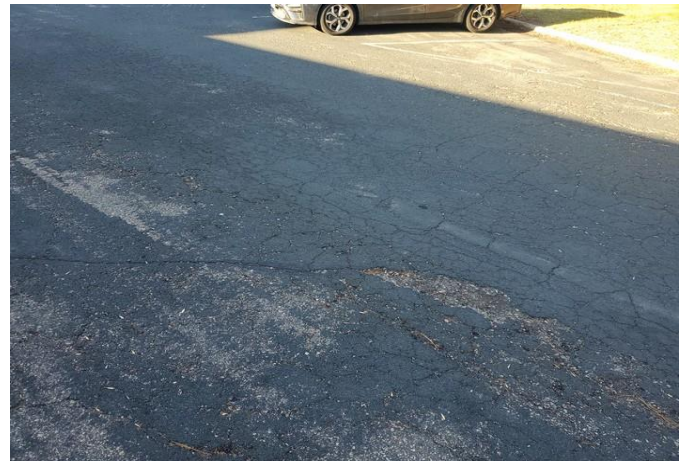
Typical pavement

Cracks in pavement

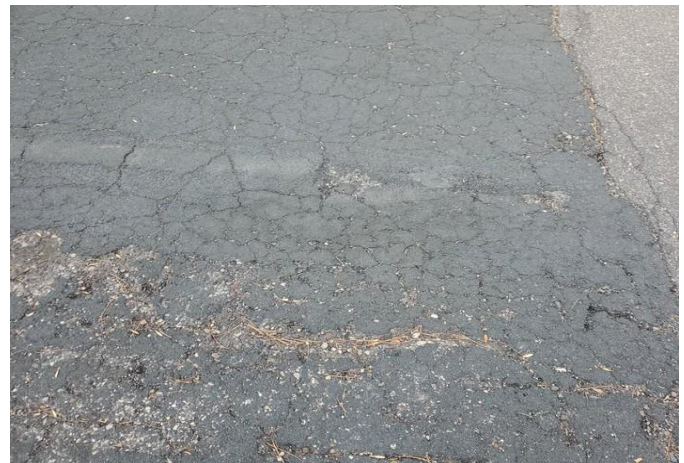
Patched pavement

Deteriorating pavement

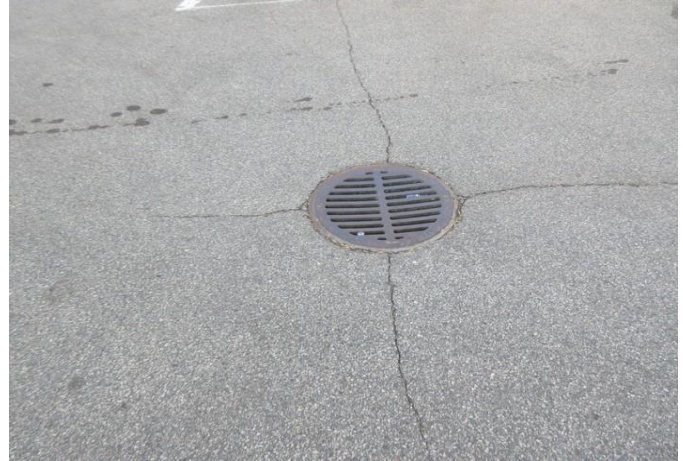
Catch basin that has been repaired at curb

Catch basin in parking area

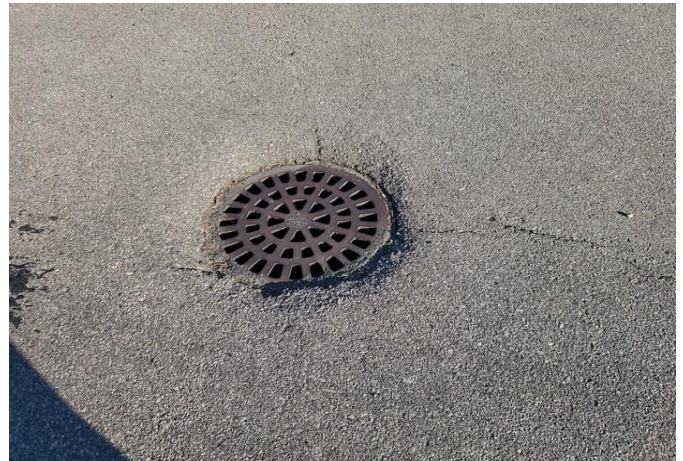
Catch basin in patched pavement

Settlement visible at catch basin

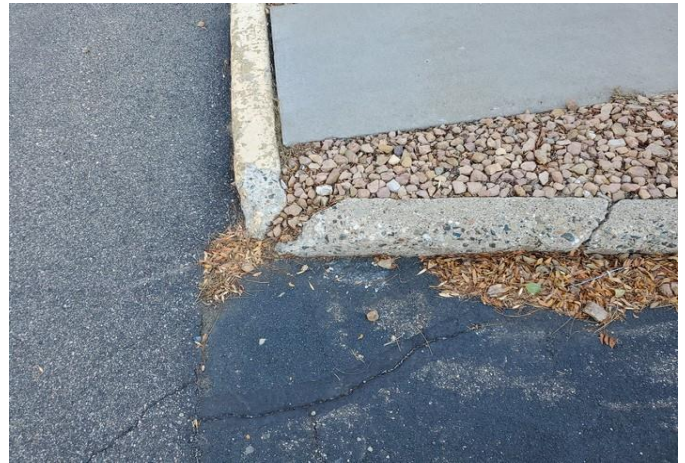
Cracks in curb

Typical condition of curb

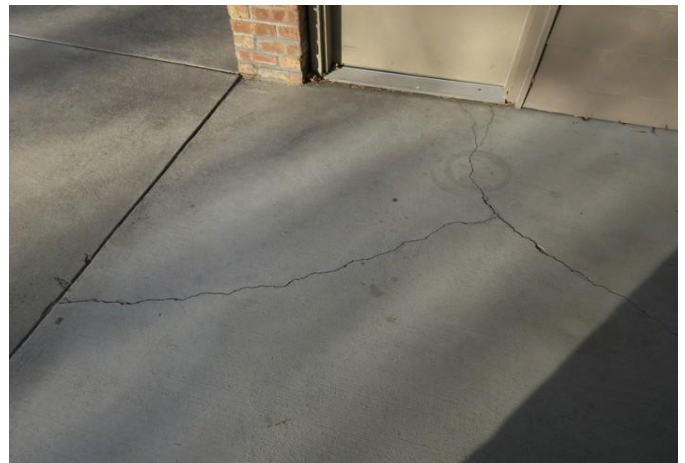
Older deck section with cracks visible

Cracked deck panels at poolhouse door

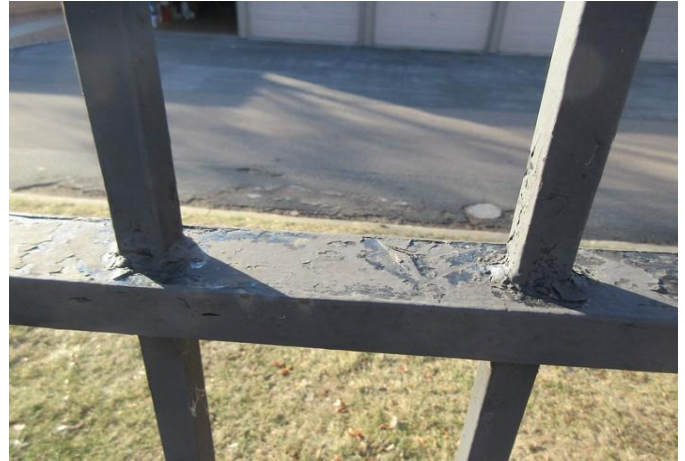
Typical condition of fence surfaces

Deterioration on paint

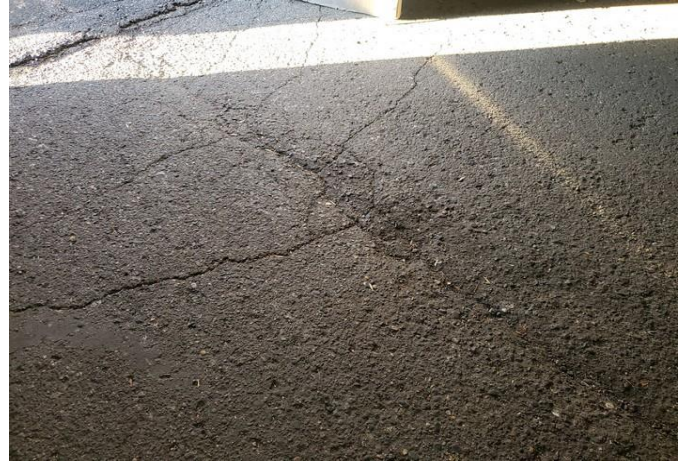
Pavement surface at parking stall

Cracks in garage floor

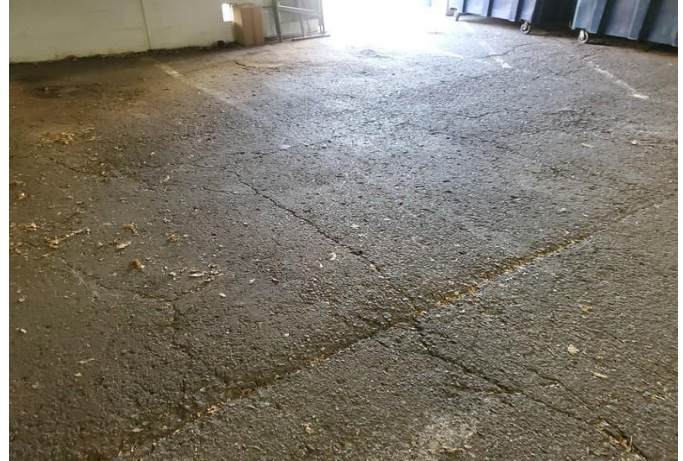
Paved garage floor

Cracks in garage floor

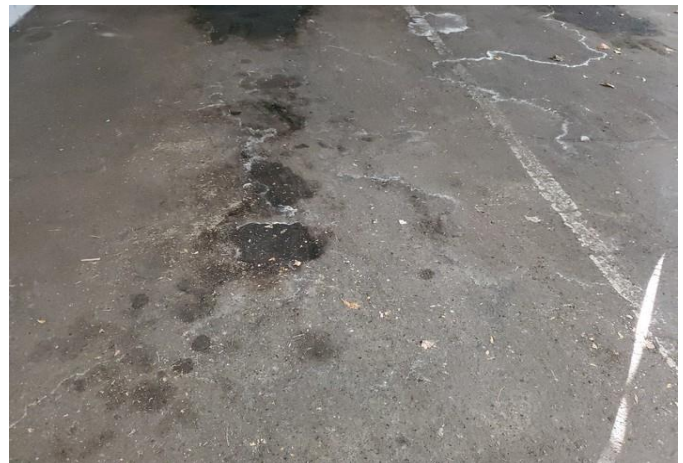
Typical asphalt is cracked and shows wear

Stained and deteriorated surface
