# Private Home Inspection Report

## Wright-Pro Home Inspection LLC

**22560 Country Ave.  
Anytown, MI 48000**

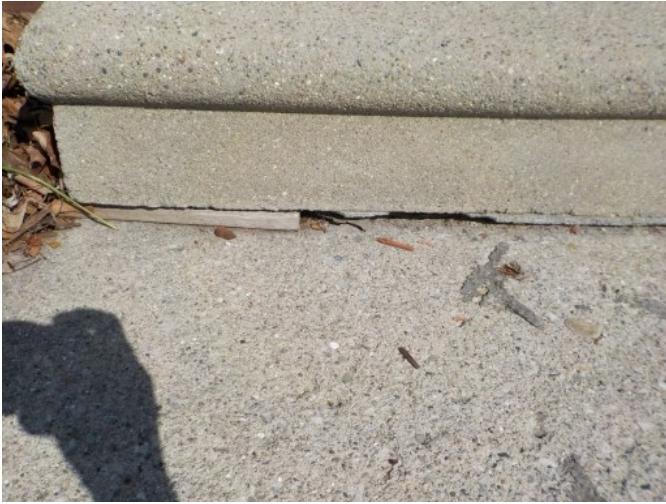
Porch step is wobbly, should be properly seated on a mortar bed or at a minimum, shimmed properly to avoid movement. Movement can cause a person to become unsteady. Will likely get worse over time without repair.

Step is wobbly when walked on, not properly supported.

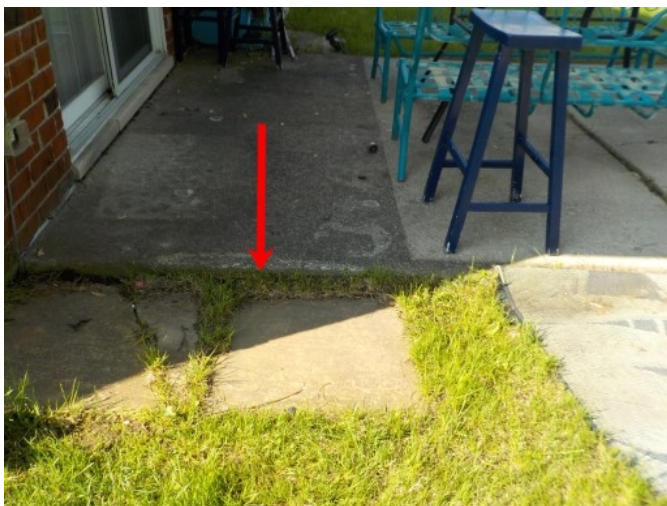
Concrete patio is cracked in places. Potential trip hazard where concrete is raised more than 1/2 inch.

Potential trip hazard at this point

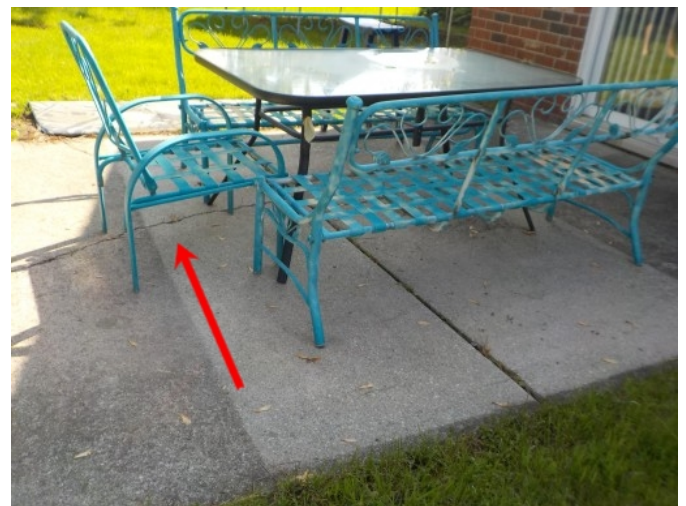
Cracked slab but no major movement or heaving of concrete present.

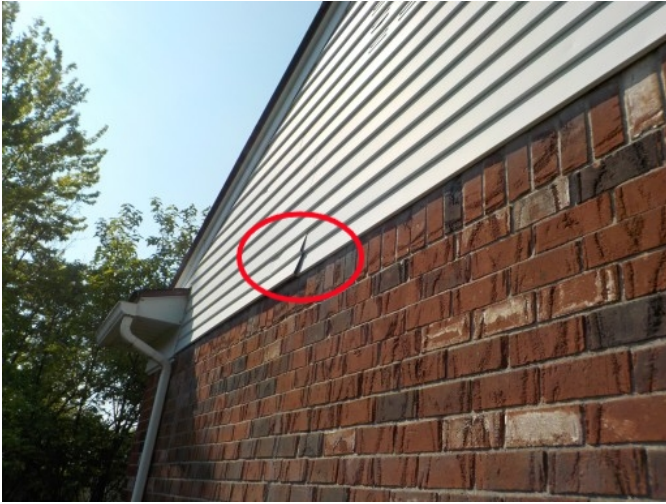
3. Aluminum is pulled away slightly on the last run on the Northeast side. Recommend repair as wind could catch it and cause damage, as well as the potential of nesting insects behind the

siding.

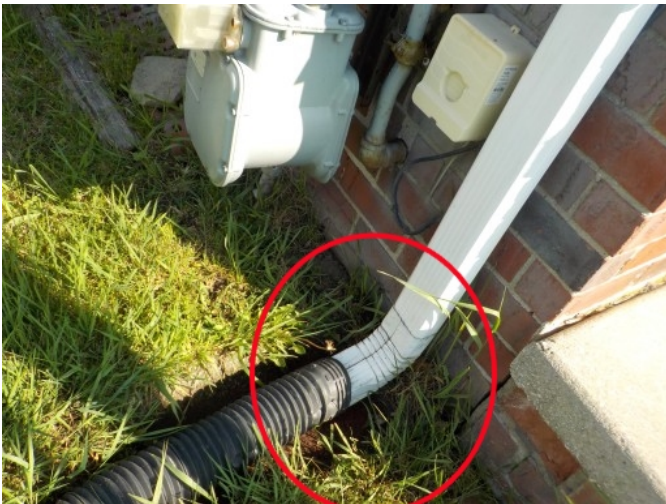
Overall the lot has positive grading. Only obvious low spot along the foundation is where the downspout extension has been dug down into the ground, this area should be built back up once the downspout extension is replaced. This will ensure no puddling in the area during heavy rains.

Low area against the foundation.

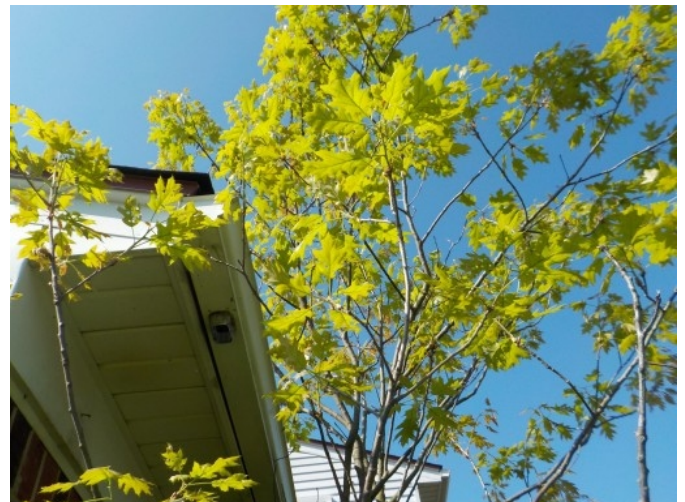
Recommend cutting vegetation back from the roof and structure. Root balls too close to the foundation can cause issues over time. Leaf movement on shingles can cause them to prematurely deteriorate.

Cut back vegetation from the structure

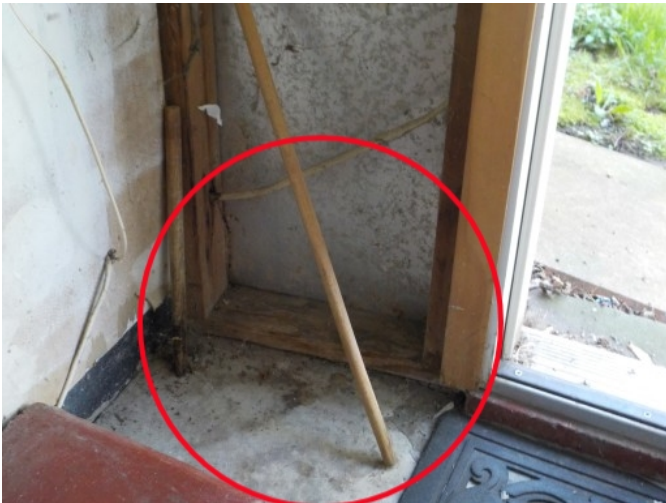
As discussed, we noted the wall at the service door showed movement at some point as mentioned in Exterior section. Recommend further evaluation when repairs are made.

Interior wall shows movement.

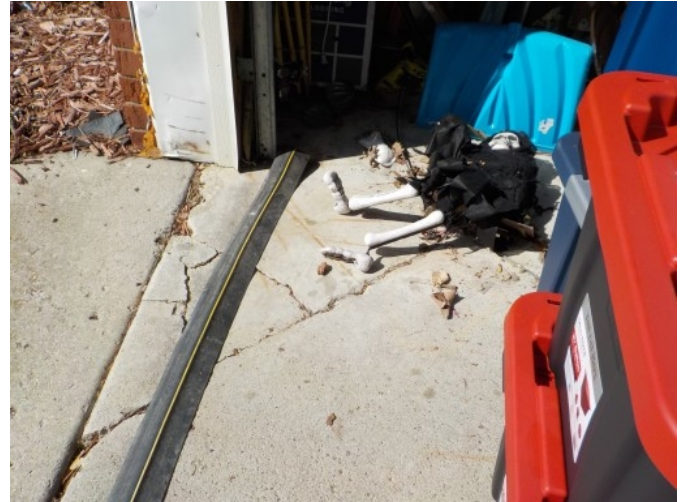
Concrete, cracked but no heaving or displacement. There is one area that is crumbling. Consider this area may deteriorate further with the seasonal freeze/thaw cycles.

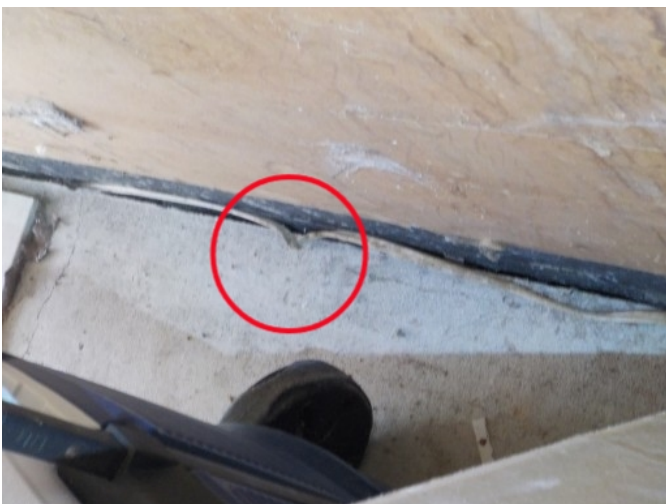
1. The wire along the floor is bent and shows an area of worn sheathing. Potential shock hazard. This wire running along the floor should be in conduit.
2. Sloppy wire runs present, doesn't appear to be a professional installation.

Wire is creased/bent

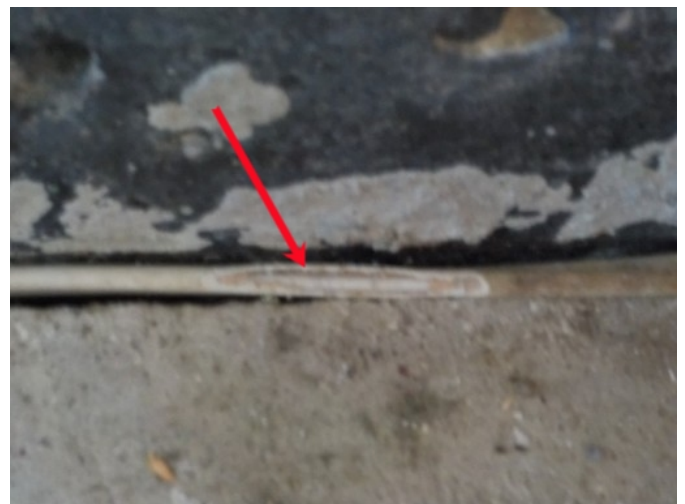
Wire sheathing is worn through

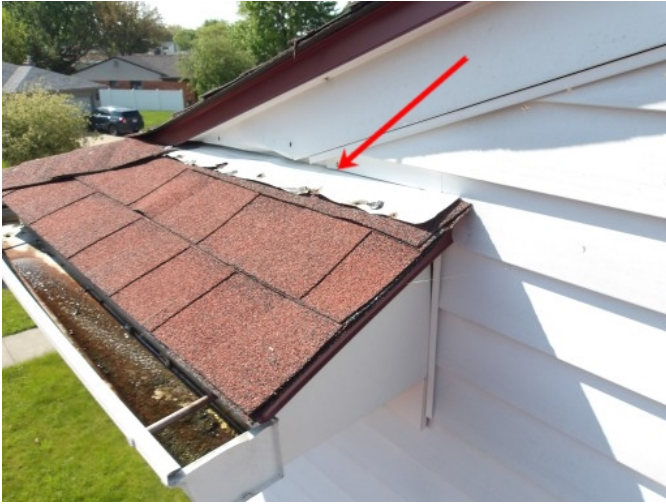
Overall ok. Drip edge flashing is present. step flashings are present. Gable end flashing and corner transition flashing were damaged when new roof shingles were installed. Recommend further evaluation by the installing contractor or other roofing / siding contractor and repair as necessary.

Original gable end flashing damaged from prying nails out from old roof covering.

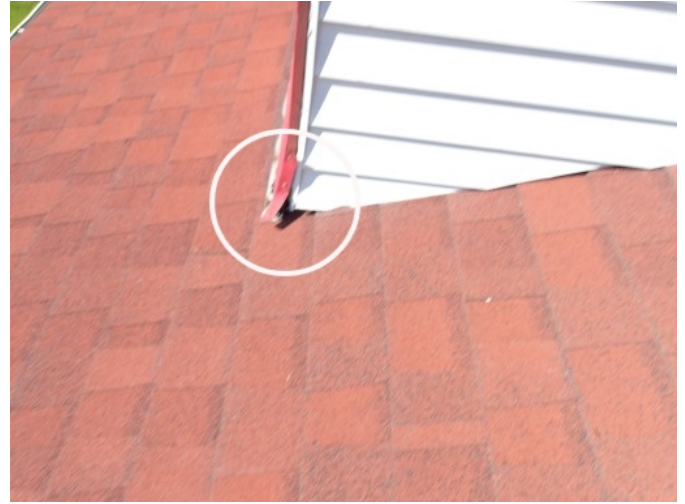
Corner trim damaged at east side corner at the garage.

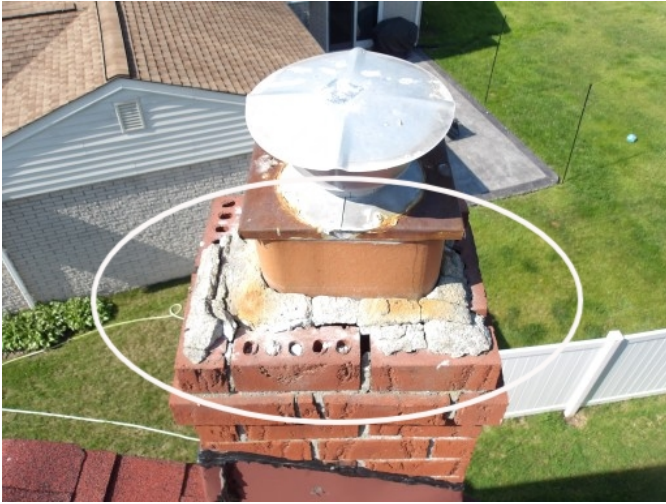
Both chimneys feature brick chase construction, which is currently in good overall condition. However, the mortar crowns on both chimneys show significant signs of age-related deterioration and will require repair. It is recommended to have a qualified brick mason, or a skilled handyman, perform further evaluation and complete the necessary repairs.

Furnace / water heater chimney crown is age deteriorated.

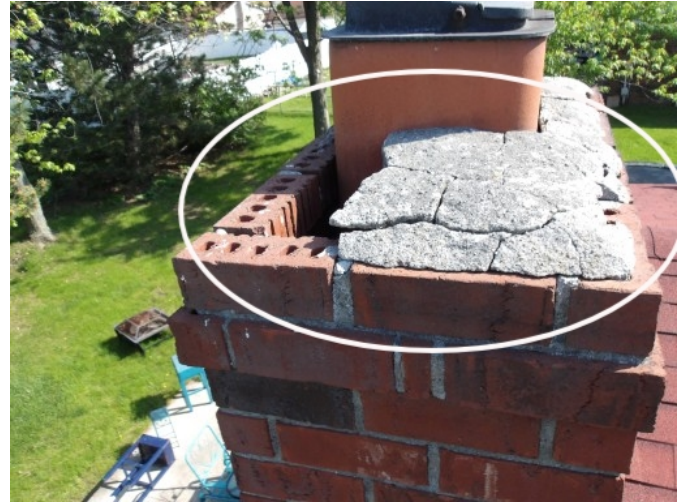
Fireplace chimney crown is age deteriorated.

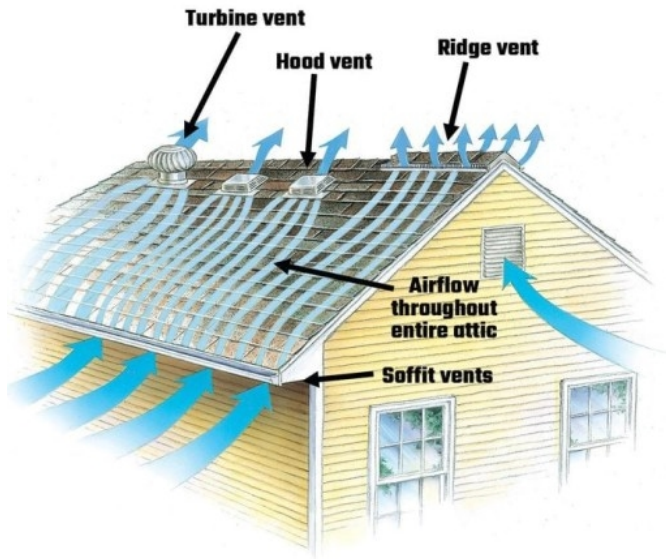
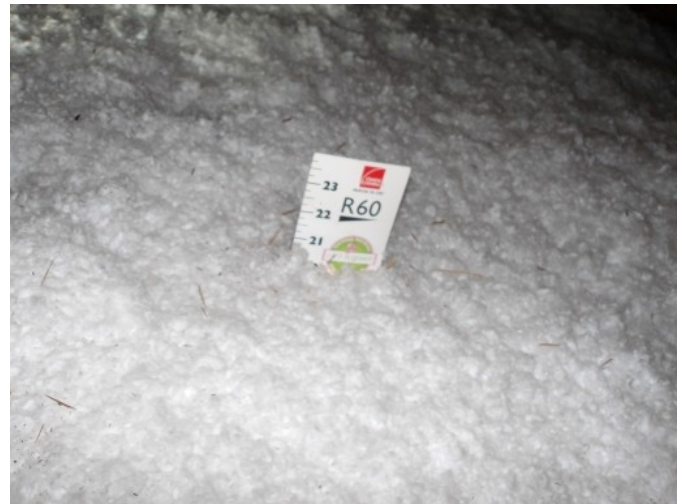
3.) Evidence of organic growth (likely mold or mildew) was observed on the roof sheathing in the area around the attic hatch entrance. While this growth appeared dry at the time of inspection, it can become active again if exposed to future moisture, particularly from condensation. This indicates a prior or ongoing moisture issue likely related to inadequate attic ventilation.

It is recommended to have a qualified insulation or ventilation contractor further evaluate the attic space. Corrections may include installing proper baffles at the soffits to maintain airflow, sealing any bypasses, and insulating or covering the attic fan opening during winter months. Addressing these issues will help maintain the integrity of the insulation system and prevent potential moisture-related problems. Mold / mildew growth as a result of moisture issues can be a health concern for some people.

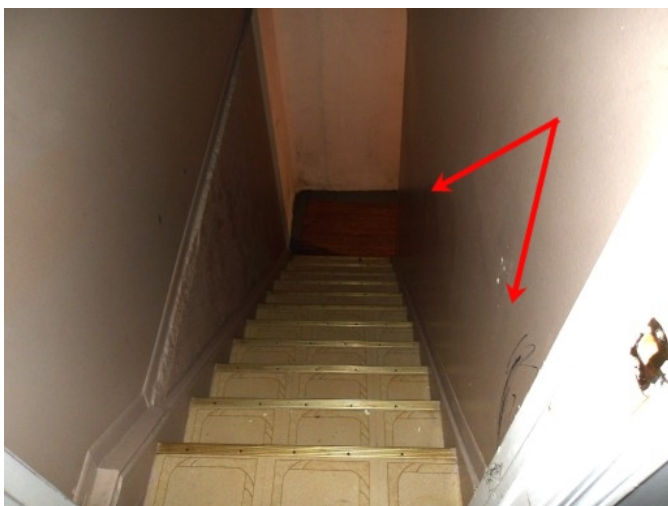
Requires a graspable hand rail. As mentioned, noted the hand rail was located behind the furnace against the basement wall and should be reinstated for safety.

Requires hand rail

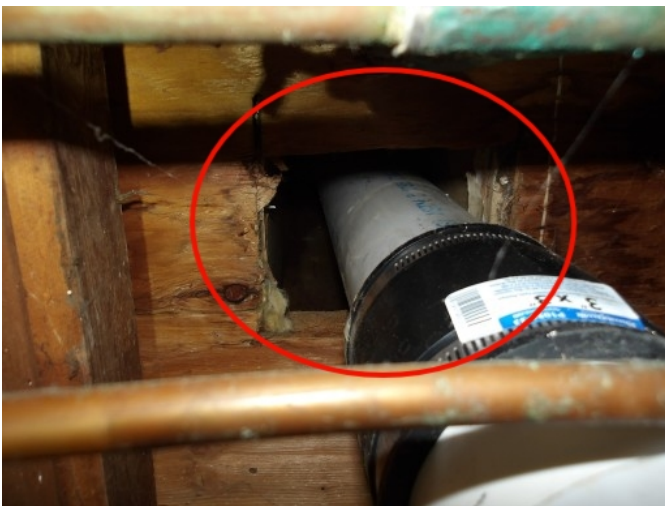
Around main waste line. Fire-blocking involves the use of fire-resistant materials—such as 1/2" to 5/8" drywall, 1/2" to 3/4" plywood, sheet metal, or fire-rated caulk to seal ceiling openings in the basement. It is important to cover all plumbing penetrations, floor openings, and clothes chutes, as these gaps can act like chimneys, allowing smoke and fire to rapidly spread into living areas above. Properly fire-blocking these areas can significantly slow the spread of fire, providing critical time for occupants to escape and for emergency responders to act.

Fireblock / close opening around the main waste line.

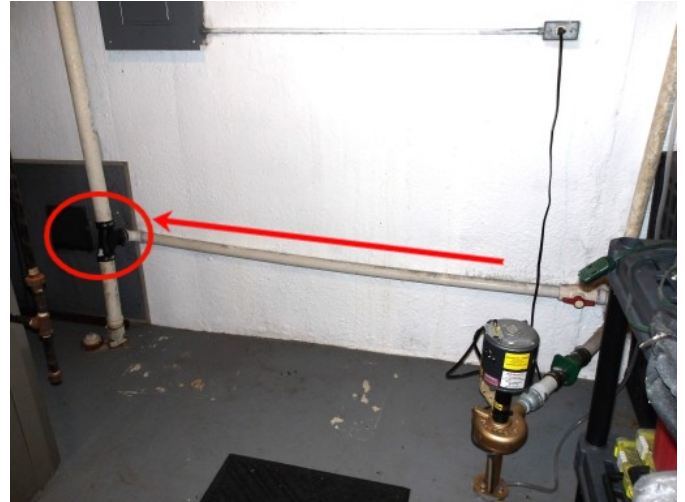
Pump overflow spliced into kitchen drain pipe.

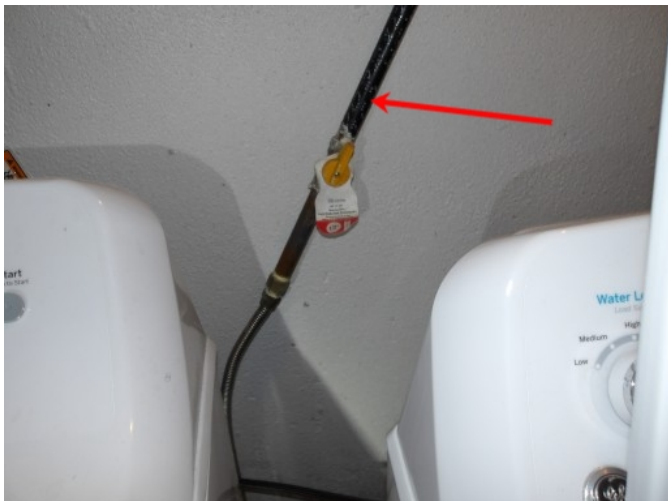
Steel black pipe with an accessible quarter turn gas supply shutoff valve and a stainless steel flexible gas appliance line. Steel gas line is loose from the wall. Recommend fastening the steel black pipe securely to the wall.

Dryer gas supply line needs to be properly secured.

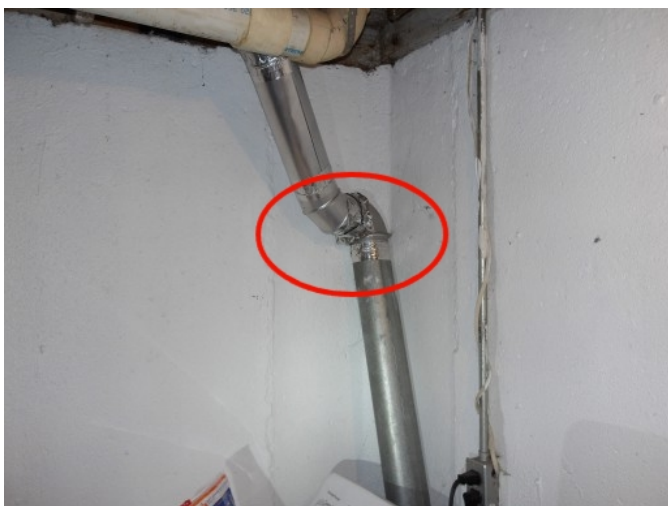
Potential safety issue - The smooth metal dryer vent material is in good condition and is the correct type for dryer venting. However, the current venting configuration includes sharp bends that may restrict airflow. For optimal performance and safety, dryer vent runs should be installed as straight as possible, minimizing sharp corners where lint can accumulate. Restricted airflow can reduce dryer efficiency and increase the risk of a fire hazard over time.

Dryer vent should be as straight as possible.

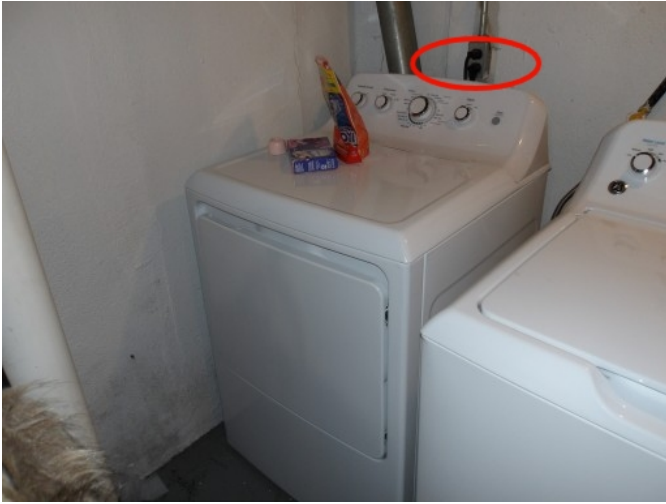
The washer and dryer outlet is required to be GFCI protected in accordance with current electrical safety standards. Recommend further evaluation and correction by a licensed electrician.

Washer / dryer outlet is required to be GFCI protected.

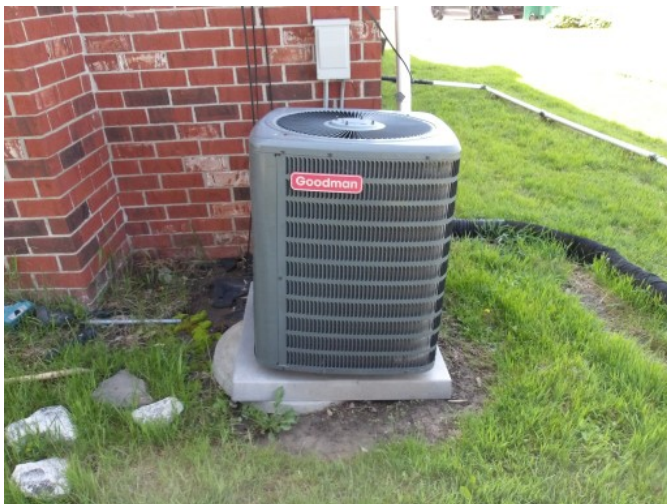
1. The air conditioning system will require service. While the compressor fan was operational at the time of inspection, the unit did not produce cooling when tested. This may indicate a refrigerant issue, compressor problem, or other mechanical/electrical fault. Further evaluation and repair by a licensed HVAC technician is recommended to restore proper function.
2. In addition, compressor unit needs to be levelled to ensure that any condensation or water that accumulates can drain away properly.

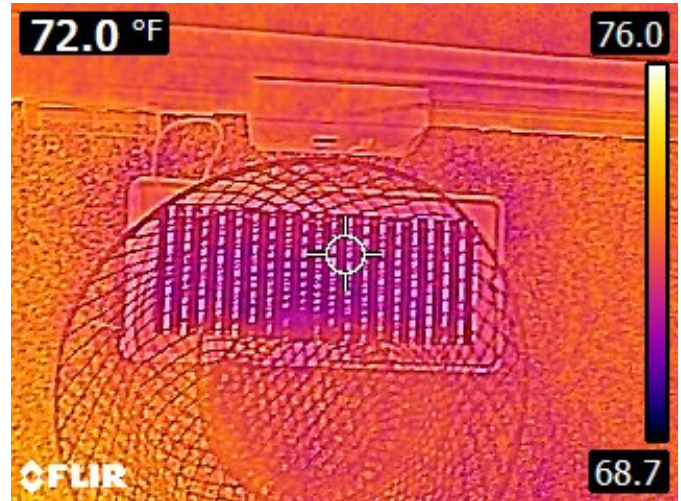
Metal ductwork is present, delivering airflow to the room HVAC registers. Thermal imaging was conducted while the system was in cooling mode. Although airflow to the registers was observed to be strong, the air was not adequately cooled.

Good airflow to room registers, however, not cooling.

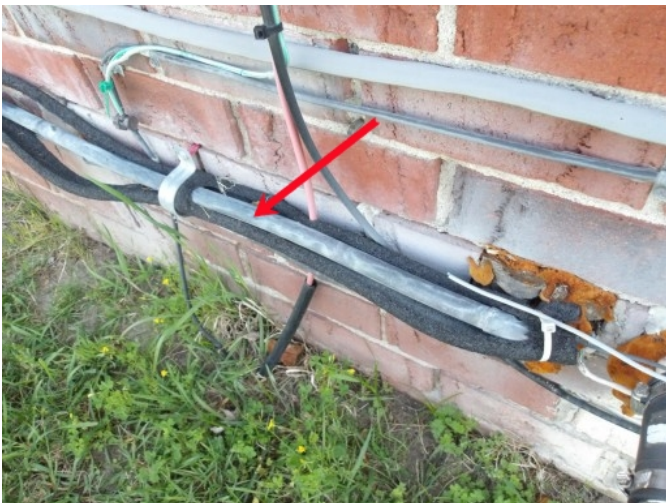
Insulation on the long line set run outdoors along the family room addition is deteriorated and needs to be replaced when the air conditioning system is serviced. Line insulation prevents condensation on the outside of the pipe and heat entering the line from outside air helping the refrigerant stay cool.

Insulation is deteriorated.

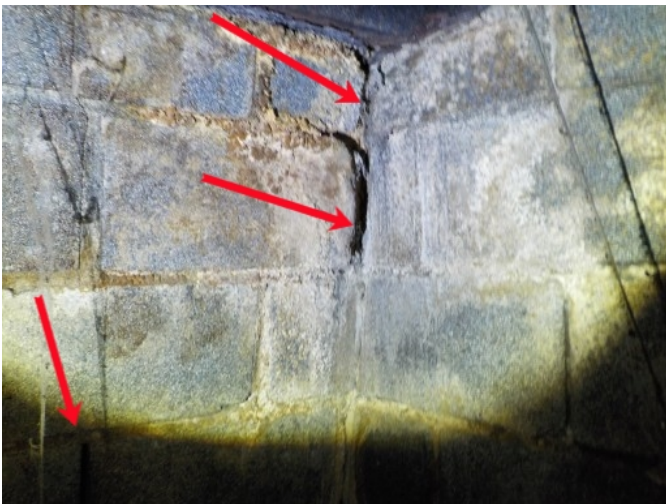
Block and mortar, needs mortar repair if fireplace is going to be used. Small gaps in the firebox can cause a fire to get into unprotected wall materials. Potential fire hazard.

Mortar gaps in firebox

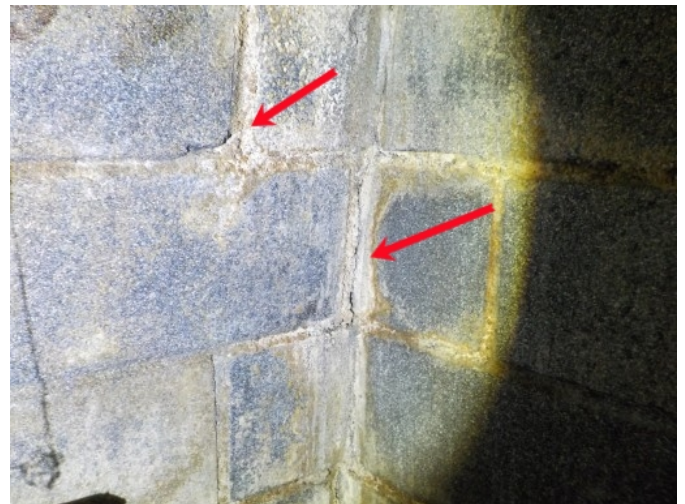
Small cracks will also need repair

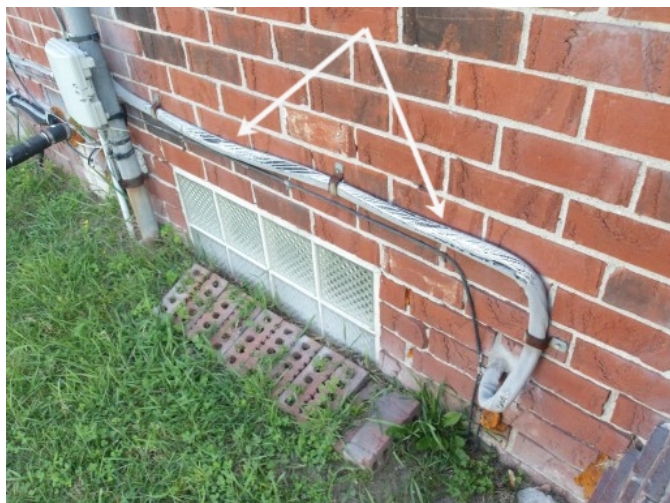
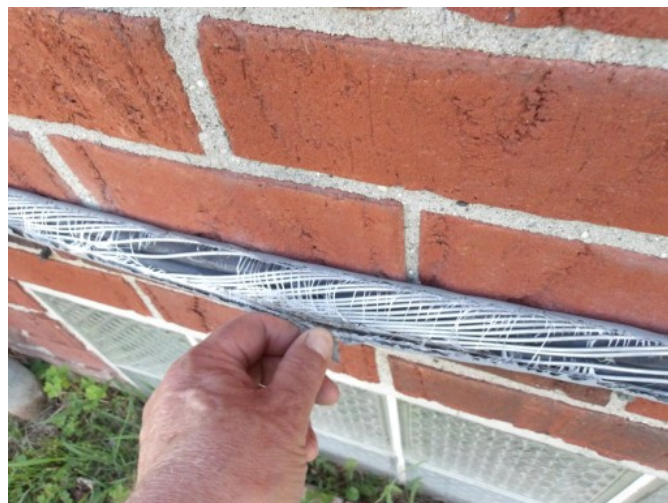
The outer sheathing on the main service entrance conductors is aged, deteriorated, and flaking, resulting in exposed wiring. Although the individual conductors remain sheathed, the compromised outer jacket leaves them vulnerable to environmental exposure and potential physical damage. This condition may pose a safety hazard. Evaluation and appropriate repair or replacement by a licensed electrician is recommended to ensure ongoing safe operation and adherence to electrical safety standards.

Service entrance wire sheathing is age deteriorated.

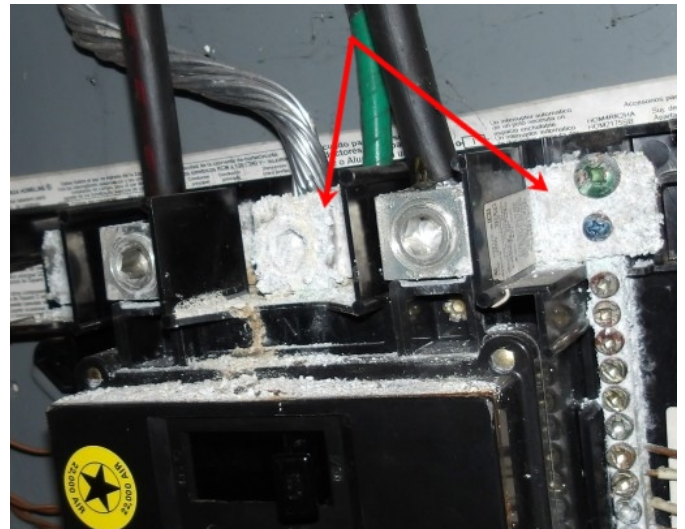
Corrosion as a result of moisture intrusion.

Closer view of corrosion.

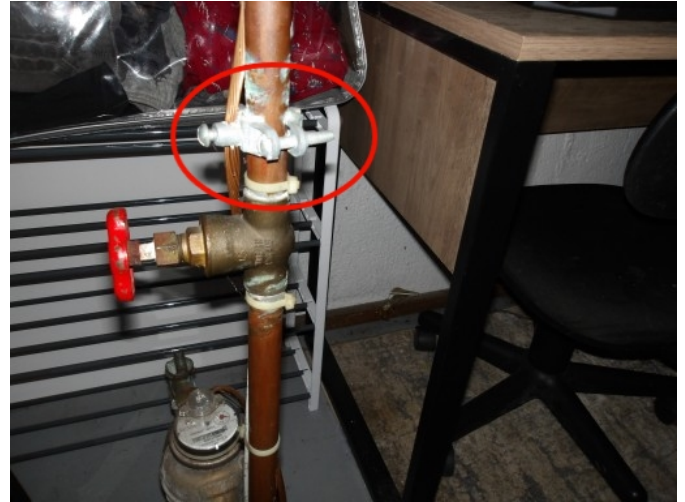
Corroded ground clamp at incoming copper water line.

Ground clamp before water meter.

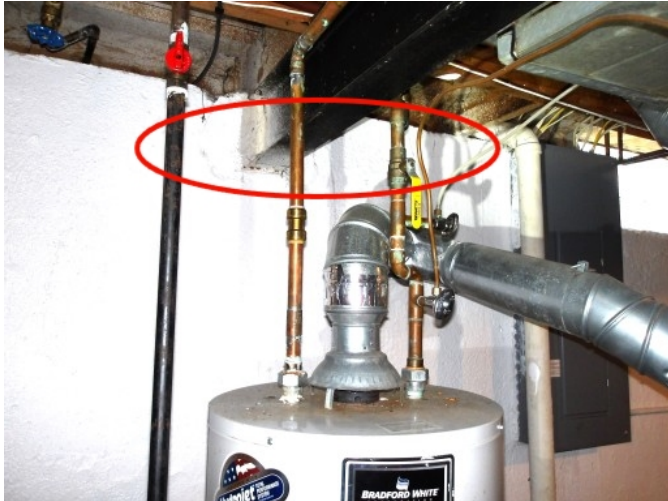
Bonding the water heater together with copper water lines and or steel gas lines is an additional safety measure to protect against electric shocks, prevent corrosion, and ensure compliance with electrical codes and regulations where required.

Bond water pipes and gas line.

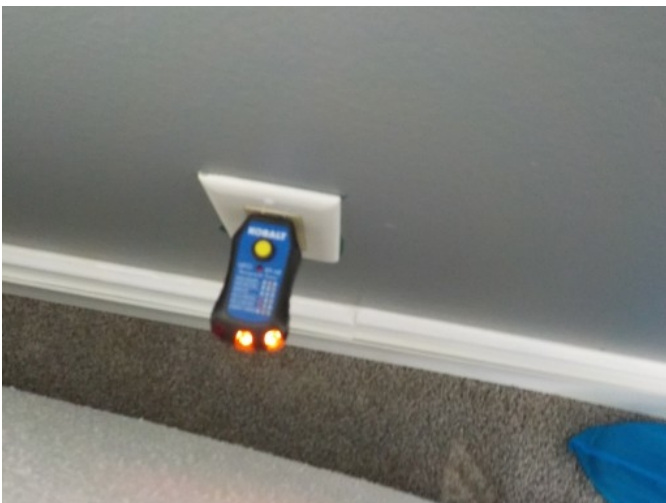
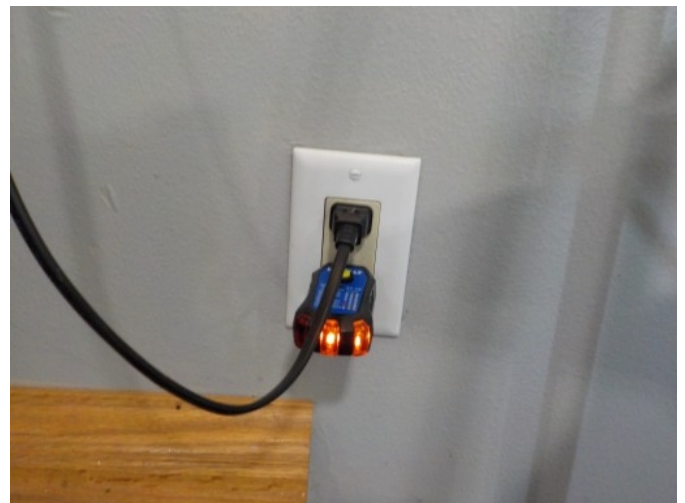
White Bedroom - Southeast Wall

Loose Outlets

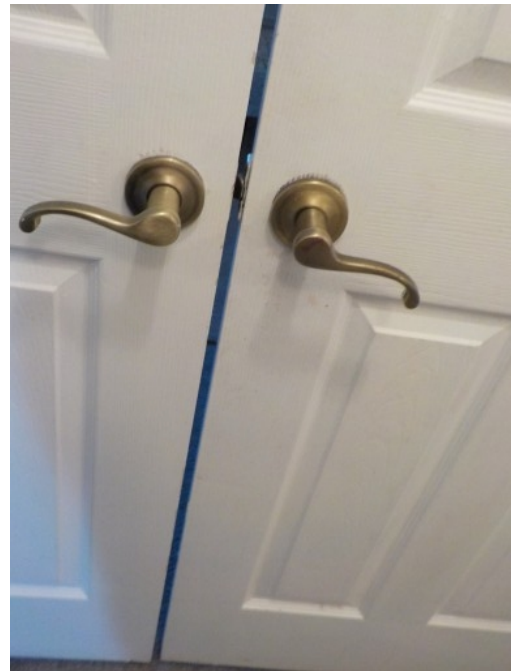
Entry door is gapped, not a proper fit for privacy.

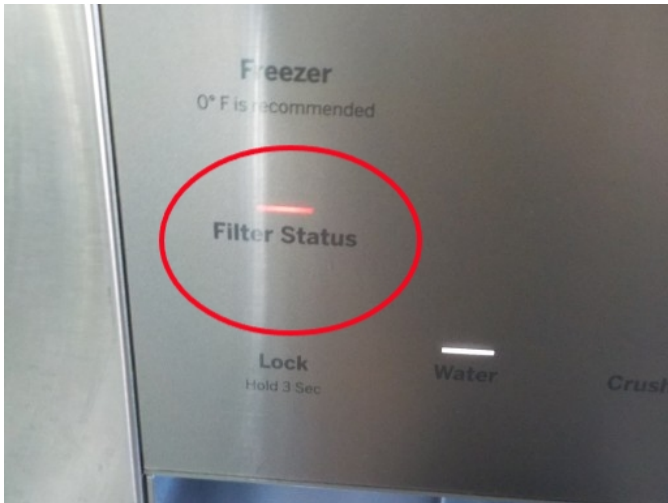
GE - Temperatures tested were normal. Water/ice dispenser worked when tested with no leaks found. Water flow was somewhat light and the filter light is on which suggests the filter will need to be replaced soon. This will improve the water flow as well.

Filter will need replacement

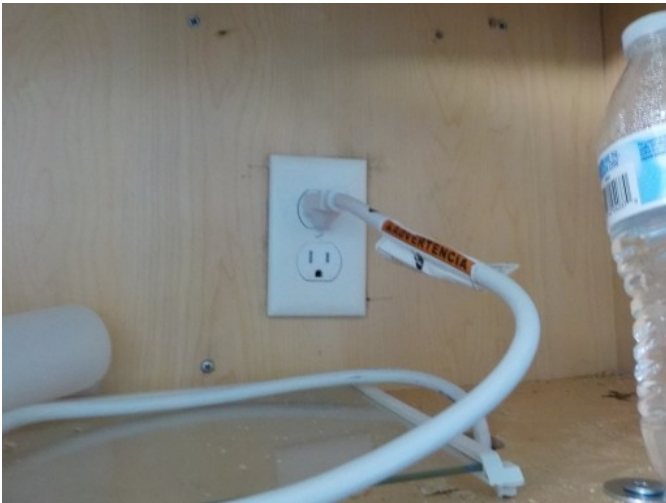
2. Loose outlets - Southeast wall, lower outlet; Microwave outlet in cabinet. Outlets should be secured before use. Using loose outlets can cause wires in the receptacle to come loose causing potential shock hazard.

Loose outlet - in cabinet above microwave.

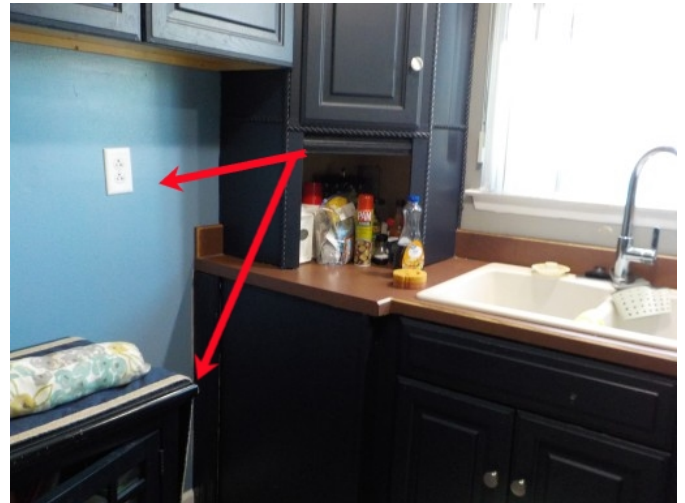
Outlets near sink should be GFCI protected.

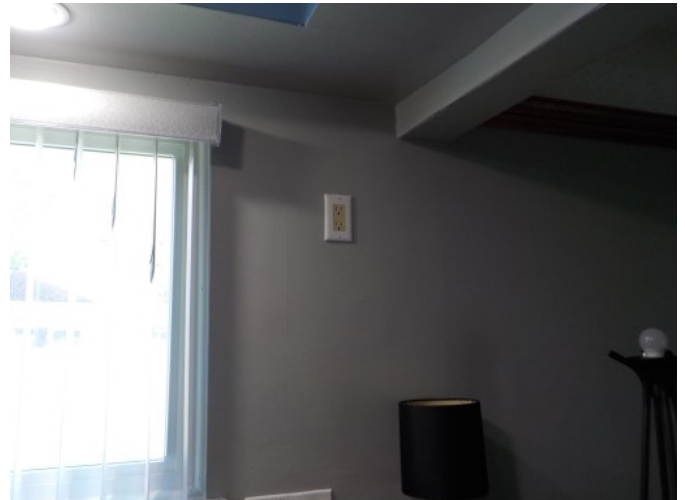
Outlet should be GFCI protected.

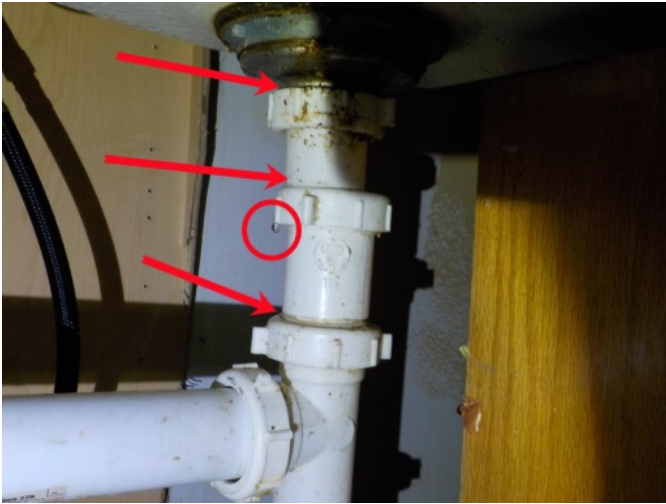
1. Sinks drained well, however, leaks detected at the drain pipe connections. Will need repair before use.
  2. Flexible tube should not be used in drainage applications. The ribs tend to hold debris and will clog easily.
- A licensed plumber should evaluate and correct all issues.

Drain pipe appeared to leak at all of the connections.

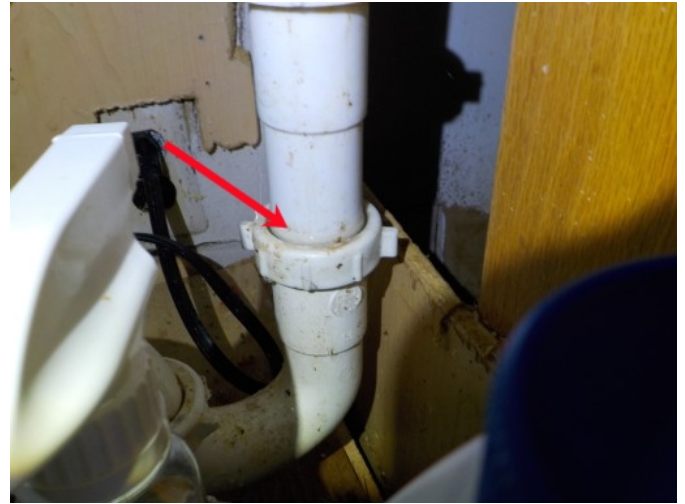
Leak detected.

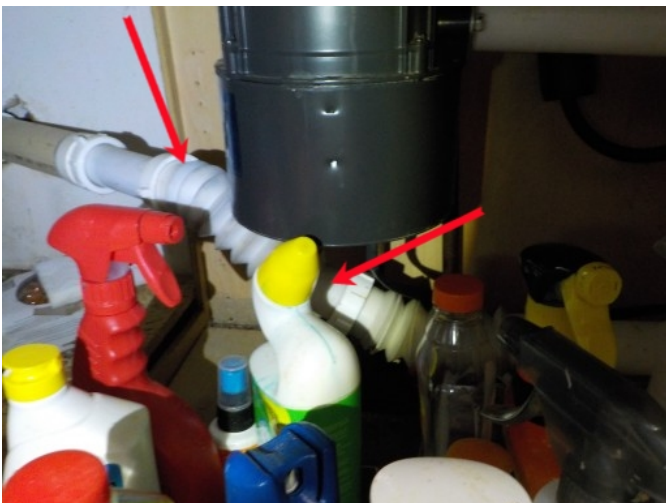
Flexible tube used for drainage.

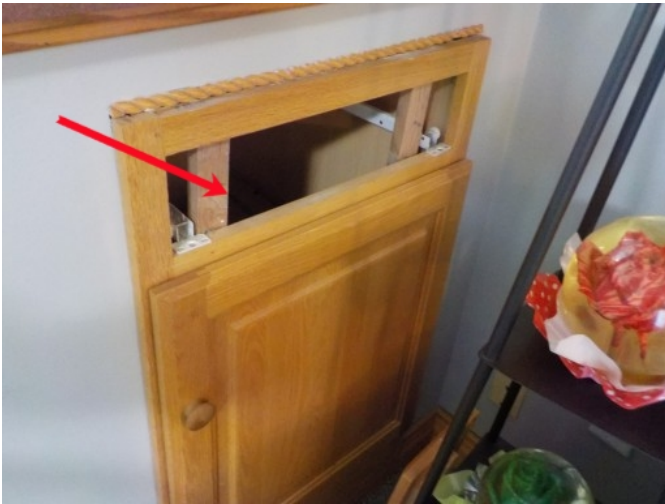
1. The sink cabinet floor shows some damage/deterioration (picture didn't turn out), likely from the plumbing leak which may have occurred over a period of time.
2. The cabinet that is on the other side of the peninsula, the top cover falls off, not properly attached.

Cabinet on kitchen peninsula in family room.

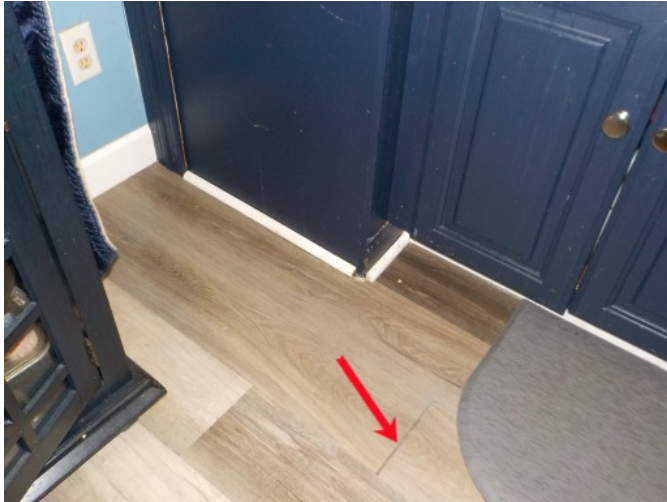
Vinyl Plank - a couple of shrinkage gaps noted. Mostly cosmetic (although some cities require wall-to-wall waterproof floors in kitchens and bathrooms). These small gaps can widen over time and may allow moisture to get to the underlayment during regular cleaning.

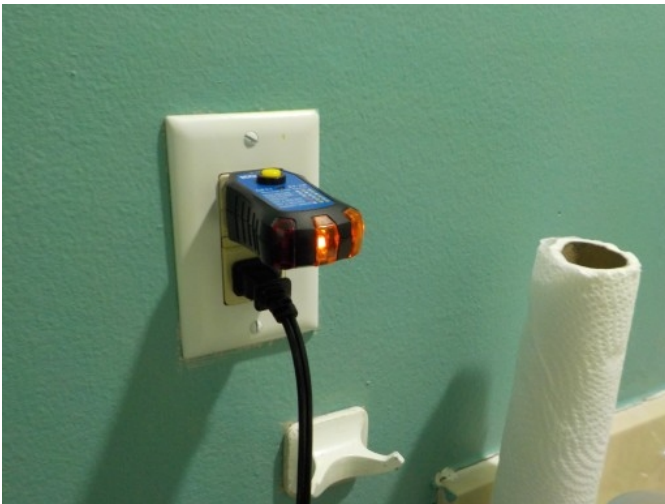
1. Loose outlet in the 1/2 bathroom should be better secured before use. Older outlet may require replacement as GFCI's should be replaced every 15-20 years. This outlet also trips the breaker in the main panel so if it trips, you'll have to reset it in the electrical panel as well.

Loose outlet, old GFCI outlet.

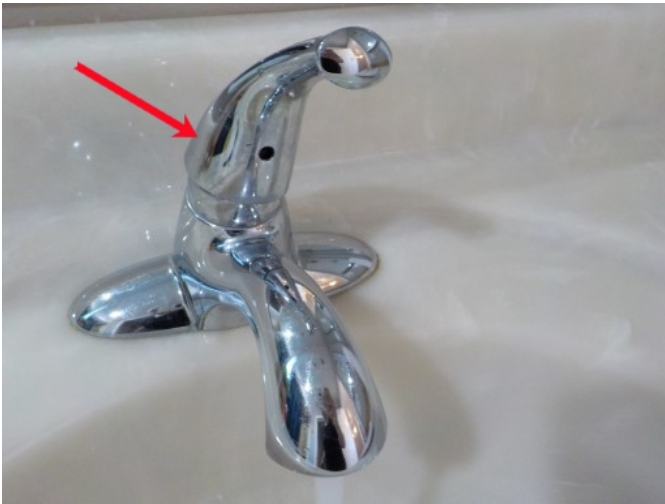
Loose handle

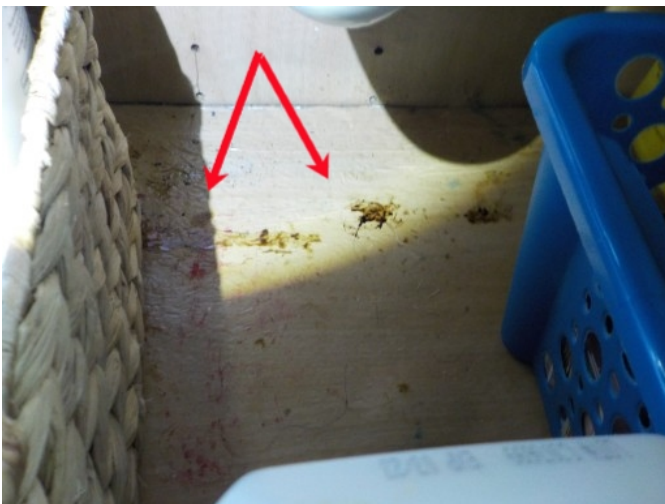
Wood & Laminate cabinets - some evidence of prior leaks or damage present on cabinet floor.

Possible moisture damage and stains.

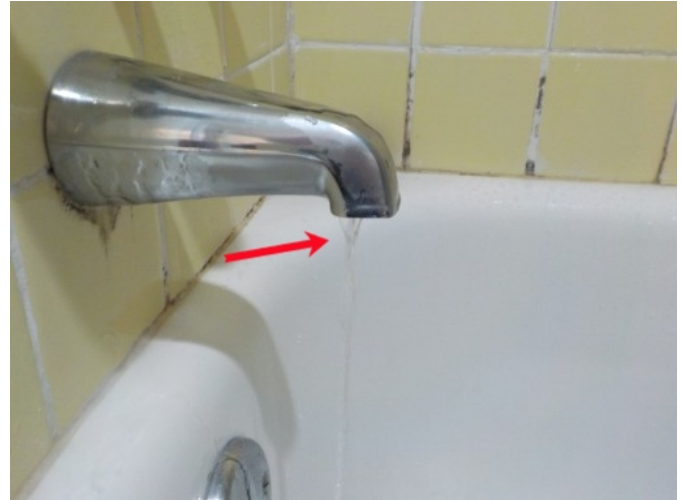
Not all water gets to showerhead - diverter works at about 80%

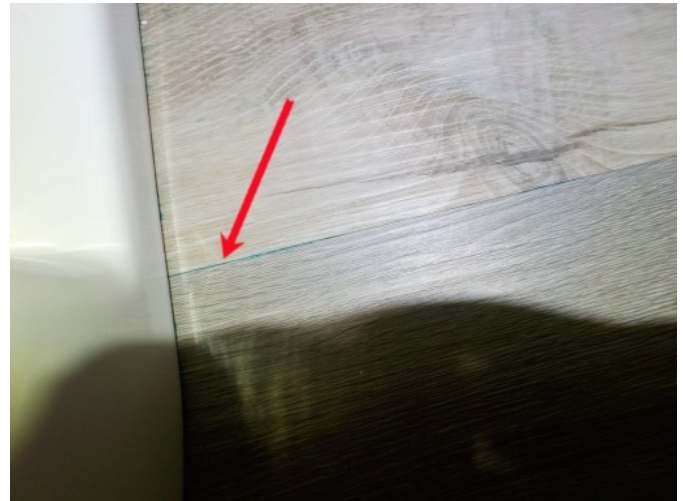
Blue color likely a sign of toilet leak at the base.

Blue color in floor, potential leak area.

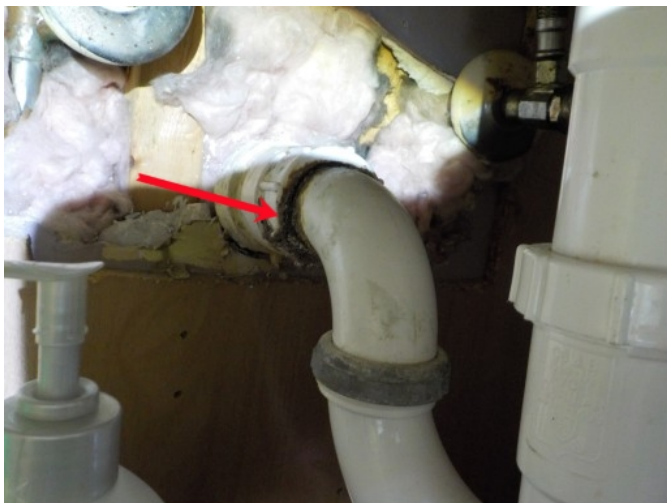
1. Though there was not an active leak found at time of inspection, we recommend monitoring the lower bathroom connection where there is evidence of a possible leak with mineral deposits present at the connection. A slow leak can cause these deposits to form over time. Sometimes slow or intermittent leaks are difficult to locate during limited inspection times and a single visit to the home. They may appear with regular and continued use.

Mineral deposits/build-up at connection may suggest a slow leak.

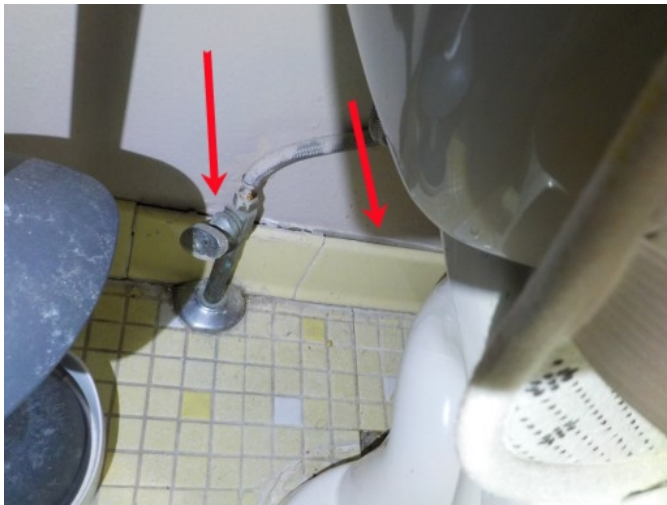
Ceramic tile - Upper bathroom floor has missing tile at the toilet and loose tile along the wall.

Loose Tile

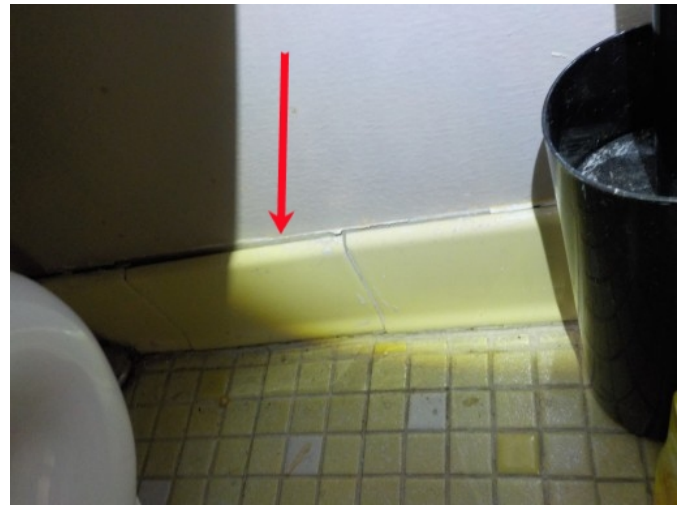
Loose Tile

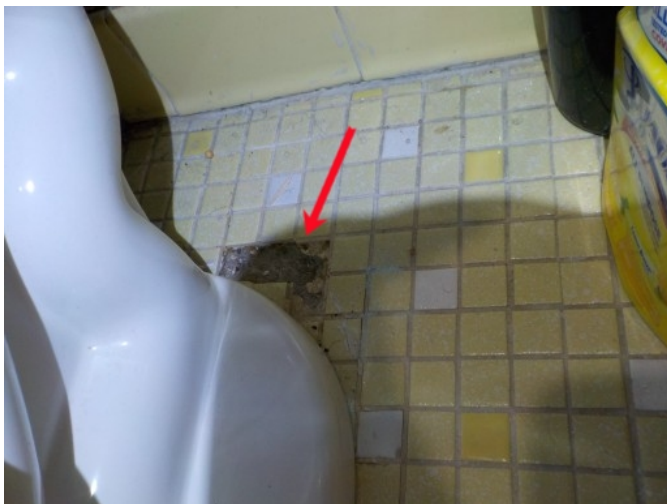
Missing floor tile at toilet
