## Wright-Pro Home Inspection, LLC

# Home Inspection Report

Inspection Date: March 12, 2020

**1234 Anytown St.  
Downriver, MI 48190**

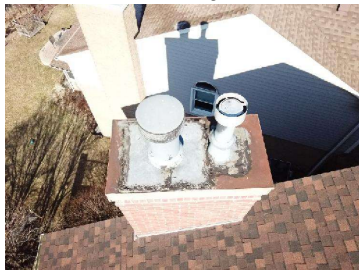
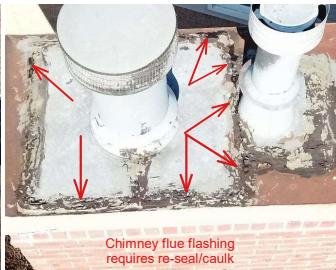
Chimney Crown: Metal - Chimney metal flue flashing caulk (tar) is weathered/cracked. Flashings should have old weathered caulk remover and new sealer installed to avoid any possible moisture intrusion. Wood crown side fascia is rotted. Recommend a chimney repair contractor or a qualified handyman to further evaluate.

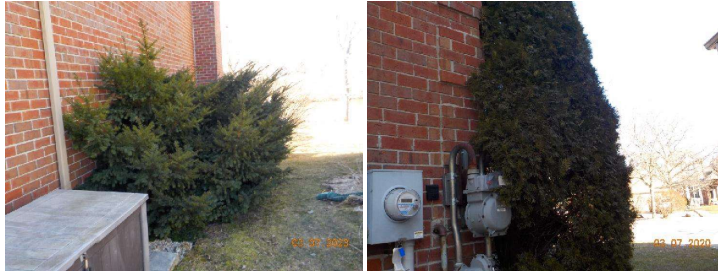
**Fair** Vegetation: Bushes too close to foundation - Bushes that rub against brick continuously will cause the brick to hold moisture and deteriorate the mortar over time. Also, the root balls should be at least 6' from the foundation walls. Larger bush roots can affect foundation walls over time.

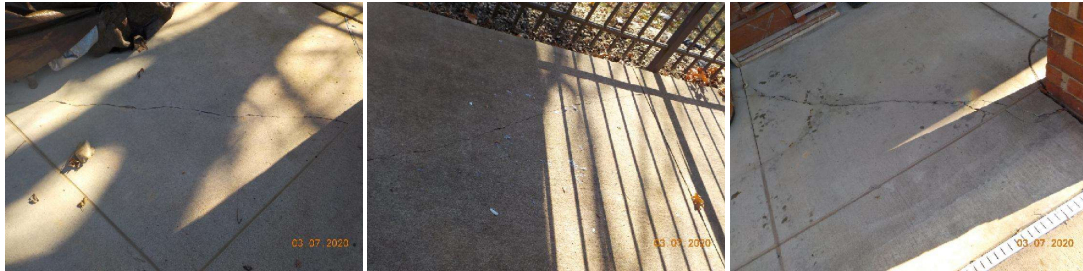
**Good** Fences: Aluminum  
**Good** Porch: Stamped Concrete  
**Minor Issue** Patio: Concrete - A couple of cracks present. No movement, gaps, or trip hazards.

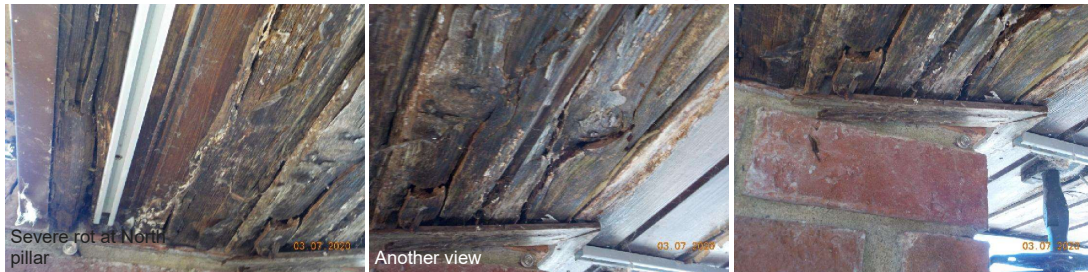
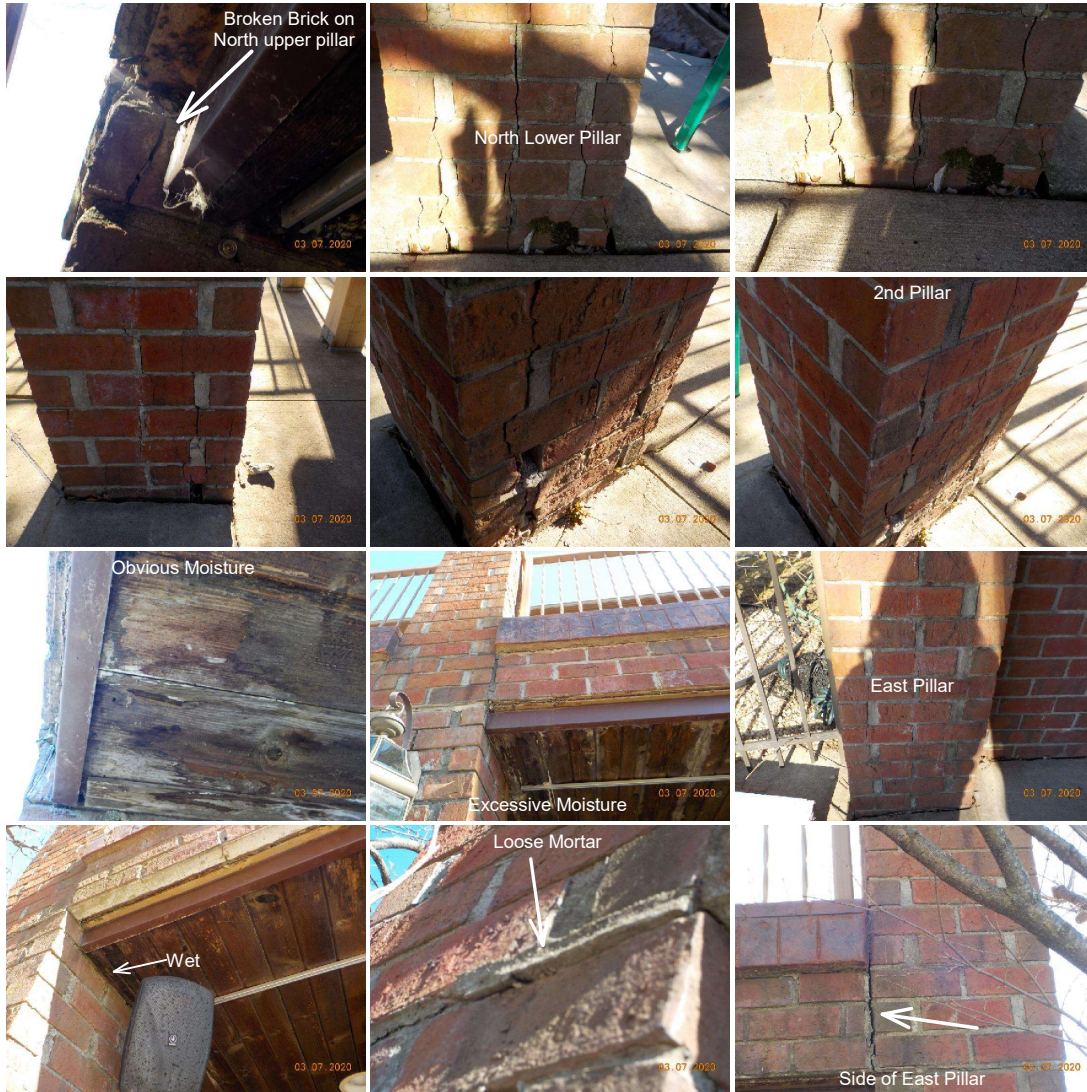
**Needs Repair** Deck: Wood & Pavers - **The underside of the deck floor is covered with wood which is rotting in a few places near especially near the pillars. Obvious water stains suggests water is not properly being directed away with flashing and appears to be running onto or between the layers of wood. Recommend a carpenter further evaluate and repair to direct water run-off away properly. The brick pillars are in need of mortar repair (tuckpoint) on the North and East ends. The North is especially deteriorated near the bottom. Unable to see the deck structure behind the wood and pillars to determine the condition of the posts and to be sure deck is properly secured to the home. The brick and mortar damage suggests movement. Recommend consulting a brick mason or deck contractor for further evaluation and repair.**

**Exterior Surface Deck: Wood & Pavers - The underside of the deck floor is covered with wood which is rotting in a few places near especially near the pillars. Obvious water stains suggests water is not properly being directed away with flashing and appears to be running onto or between the layers of wood. Recommend a carpenter further evaluate and repair to direct water run-off away properly. The brick pillars are in need of mortar repair (tuckpoint) on the North and East ends. The North is especially deteriorated near the bottom. Unable to see the deck structure behind the wood and pillars to determine the condition of the posts and to be sure deck is properly secured to the home. The brick and mortar damage suggests movement. Recommend consulting a brick mason or deck contractor for further evaluation and repair.**

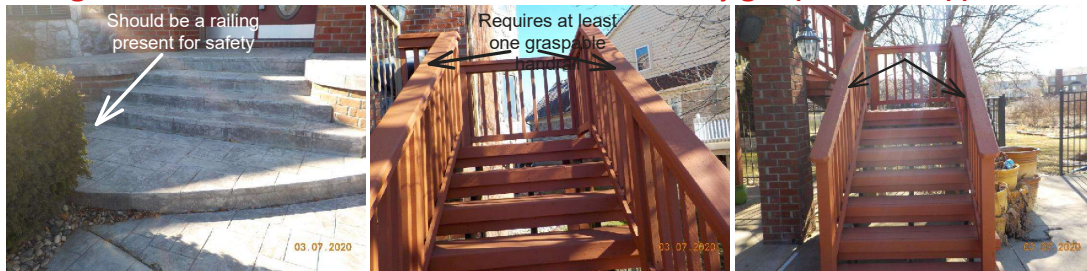
Steps & Stairways: Concrete, Wood - **Front stairs should have a graspable railing available (any stairway with more that 2 risers should have a railing). The deck stairway should have graspable railings on both levels. The rail board is too wide to easily grasp if a fall happens.**

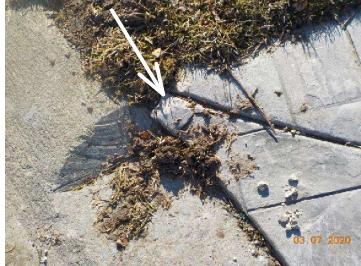
**Driveway:** Stamped Concrete - Small cracked area near street.

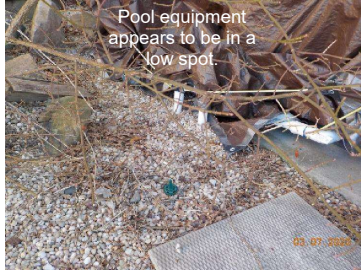
**Grading:** Slopes away from house - Except where pool filter is located next to deck. It appears the equipment is lower than the surrounding ground which may cause it to fill up during heavy rains and snow melt. Hard to see with equipment cover on.

**Exterior Surface Grading:** Slopes away from house - Except where pool filter is located next to deck. It appears the equipment is lower than the surrounding ground which may cause it to fill up during heavy rains and snow melt. Hard to see with equipment cover on.

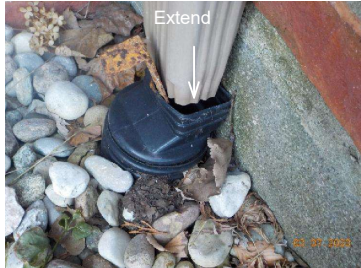
**Downspout Extensions:** Into drainage system - The downspout to the left of the porch is not properly directed into drain, may overflow during heavy rains and snow melt. Suggest extending down into drain to be sure water doesn't pool at foundation wall.

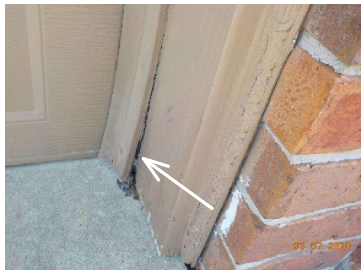
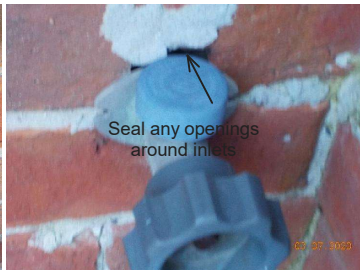
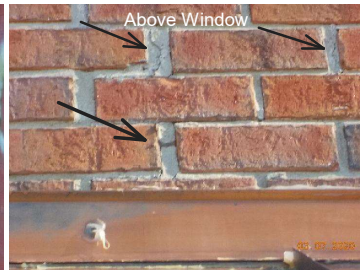
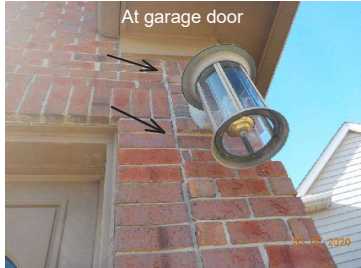
**Home Siding Type:** Brick, Wood - Overall, the brick is in good condition (other than deck pillars). However, there is a couple areas of cracked mortar above the front window and garage door. Caulk around any inlets such as around the hose faucets. Trim at garage overhead door is loose, reattach and seal.

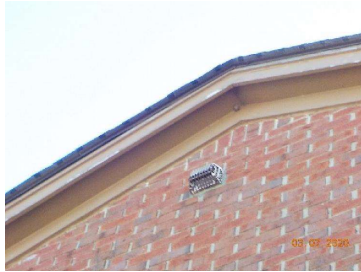
Fair Fascia: Wood - Paint peeling and missing in areas of the fascia boards, recommend resealing with a good exterior paint to protect the integrity of the wood.

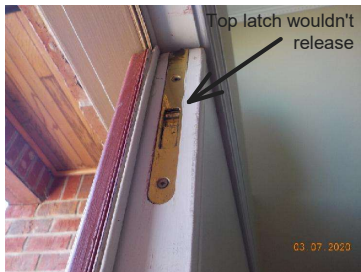
Questionable Entry Doors: Steel, French Door - Couldn't get right-hand door to open, top latch would not release. Ask seller to check it for proper function.

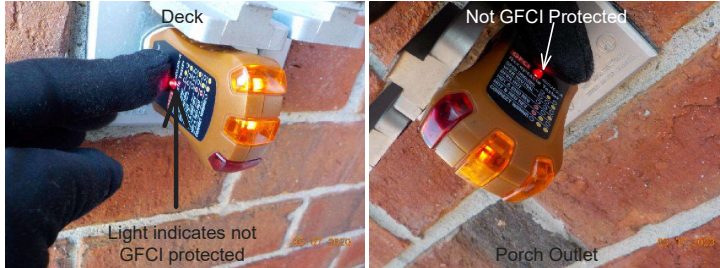
Safety Issue Exterior Electric Outlets: 3-Prong, GFCI & Non-GFCI outlets - **The porch outlet and the deck outlet left of the bay window are not Ground Fault (GFCI) protected. All exterior outlets are required to be protected for safe use, shock hazard exists. Recommend a licensed electrician change outlets with GFCI's. GFCI's are safety devices built in to receptacles which protect against electrical shock. When a ground fault (short circuit) occurs, the GFCI quickly, in a fraction of a second, shuts the power off. Also protects appliances and electronics.**

**Exterior Surface Exterior Electric Outlets:** 3-Prong, GFCI & Non-GFCI outlets - **The porch outlet and the deck outlet left of the bay window are not Ground Fault (GFCI) protected. All exterior outlets are required to be protected for safe use, shock hazard exists. Recommend a licensed electrician change outlets with GFCI's. GFCI's are safety devices built in to receptacles which protect against electrical shock. When a ground fault (short circuit) occurs, the GFCI quickly, in a fraction of a second, shuts the power off. Also protects appliances and electronics.**

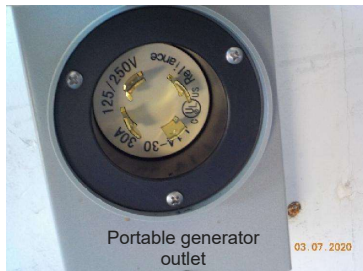
Minor Issue Electrical: 120 VAC GFCI Protected; Equipped for generator back-up - If a generator is run, be sure it is located outside of the home/garage. Do not run a generator in a closed garage as carbon monoxide will build up. The open box with exposed wires needs a cover.

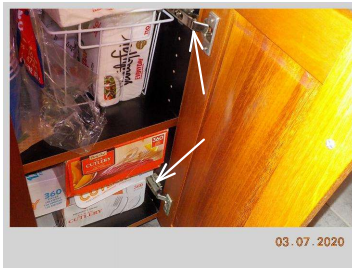
Minor Issue	Sink Drain: PVC - Minor leak. Connections need to be tightened.
Minor Issue	Faucet: Two handle. Faucet screen is clogged with debris causing poor water flow.
Good	Bar Counter Top: Granite
Minor Issue	Bar Cabinets: Wood - End cabinet door is loose.

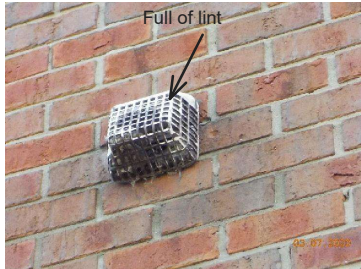
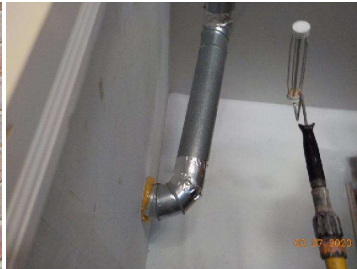
Good	Lighting Fixtures: Ceiling Mounted
Not Present	Laundry Tub:
Good	Washer Hose Bib: Rotary
Good	Washer Drains to: Wall mounted drain
Questionable	Dryer Vent: Rigid metal - Appears from outside view that the dryer vent needs to be cleaned. There are several turns where it is mounted in the garage where lint can get trapped – suggest having it professionally cleaned.

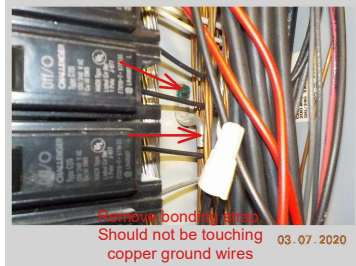
Good, Safety Issue Is Panel Bonded?: No As discussed, bonding strap is present in main sub-panel but is not secured to ground bus bar, however is touching bare copper ground wires and should be removed. Recommend a licensed electrical to further evaluate

**Electric Panel Is Panel Bonded?:** No **As discussed, bonding strap is present in main sub-panel but is not secured to ground bus bar, however is touching bare copper ground wires and should be removed. Recommend a licensed electrical to further evaluate**

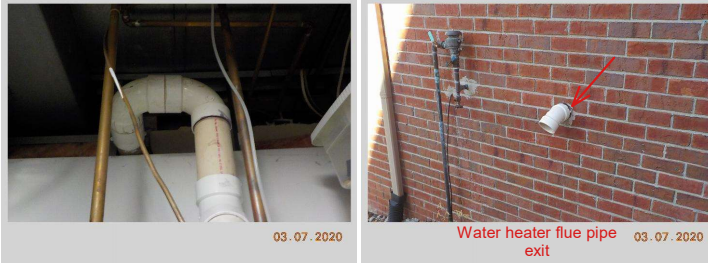
Water Temperature: 160 Degrees - **Water above 120 is considered a scalding hazard.**  
Flue Pipe: Electric inducer / fan blower, PVC

**Water Heater Water Temperature:** 160 Degrees - **Water above 120 is considered a scalding hazard.**

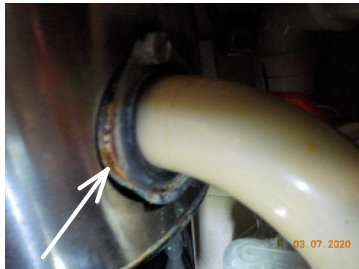
Good Ovens: Whirlpool  
 Good Stove Fan/Vent: Broan  
 Fair Disposal: In-Sinkerator - Disposal works but is older, may need replacement in near future. Unit has loud operation, especially when turning on and off. Showing signs of rust at connector.

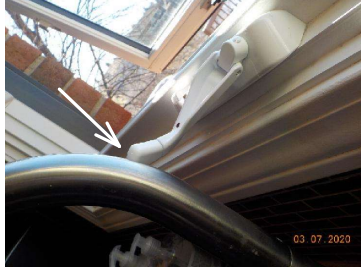
Good      **Windows:**    Wood Casement - Noted that window crank hits faucet during operation. Still functions but an inconvenience.

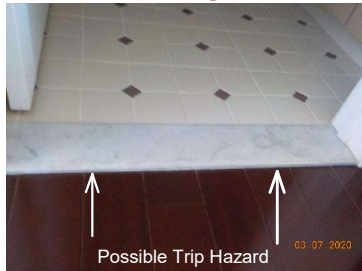
Floor: Ceramic tile - **Threshold at entry is a possible trip hazard, raised 1/2". Should be tapered so foot glides over instead of catching.**

**1st floor, Hallway Bathroom Floor:** Ceramic tile - **Threshold at entry is a possible trip hazard, raised 1/2". Should be tapered so foot glides over instead of catching.**

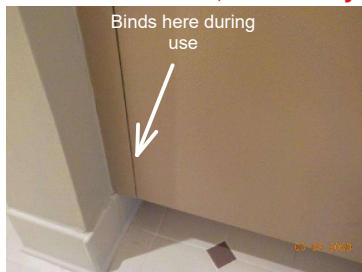
Cabinet(s): Composite & Laminate - **Lower left-hand door binds on frame, may cause damage to laminate as is, needs adjustment.**

**1st floor, Hallway Bathroom Cabinet(s): Composite & Laminate - Lower left-hand door binds on frame, may cause damage to laminate as is, needs adjustment.**

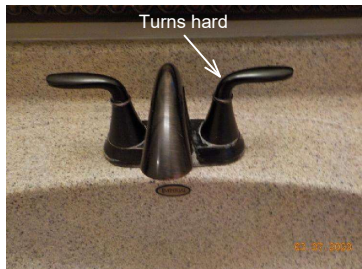
Sink Faucet: 2-handle faucet with stopper - Cold water handle has a hard operation.

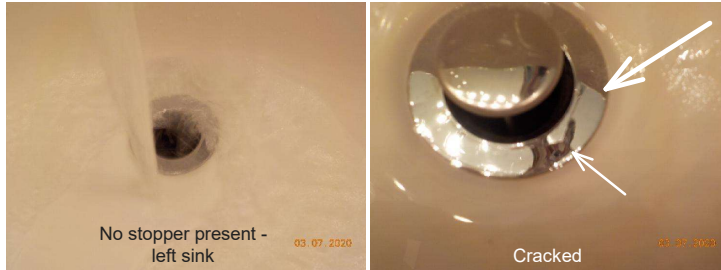
Sink Faucet: 2-handle faucets with stopper - Left-hand stopper is missing. Right-hand sink drain flange is cracked – no leaks noted under sink. Monitor during regular use. Sometimes slow leaks and back-ups can't be detected during limited inspection testing.

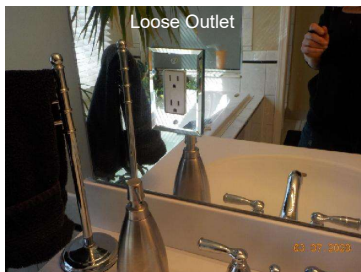
Safety Issue Electrical: 120 VAC GFCI Protected - **Outlet at left-hand sink is loose, needs to be secured for safe use.**

**Master Bathroom Electrical:** 120 VAC GFCI Protected - **Outlet at left-hand sink is loose, needs to be secured for safe use.**

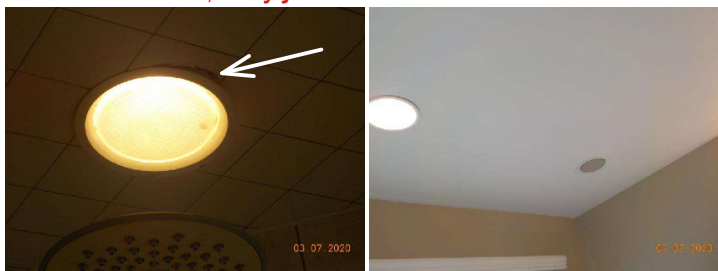
Safety Issue Lighting Fixtures: Ceiling Mount, Wall Mount - **Light in shower stall is coming away from ceiling, needs to be secured for safe use. Lights above showers should be completely sealed. Light above tub is out, may just need new bulb. Ask seller.**

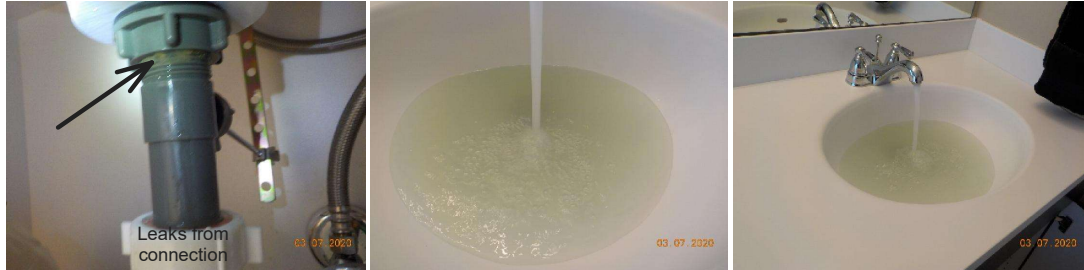
Sink Plumbing/Traps: PVC Trap - Leak at connection on left-hand sink plumbing, needs repair. Green water coming out of copper plumbing. Determined reason is likely that sinks have not been used in some time. Water cleared up after use. If this issue reoccurs suggest contacting a licensed plumber for further evaluation.

**Master Bathroom Sink Plumbing/Traps: PVC Trap - Leak at connection on left-hand sink plumbing, needs repair. Green water coming out of copper plumbing. Determined reason is likely that sinks have not been used in some time. Water cleared up after use. If this issue reoccurs suggest contacting a licensed plumber for further evaluation.**

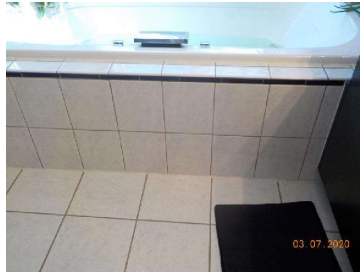
Tub Plumbing: No Access Present - There is no access to the jet mechanisms. Consider that tile & backing would have to be removed to access plumbing. Jets were tested and worked during inspection on all speeds. Tub drained slowly – suggest a licensed plumber further evaluate.

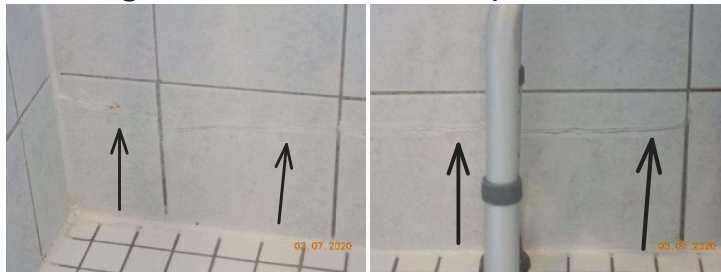
Shower/Surround: Ceramic Tile, Floor and Walls - Grout and caulk are good, noted that lower tiles along back of shower has been repaired.

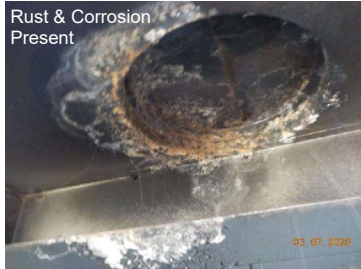
Flue: Metal - Rust present from use. Limited view, could only see top (at chimney) and bottom of flue (at damper), not between. Suggest further evaluation by a qualified fireplace installer to be sure fireplace flue is clean and safe for use.

**Living Room Fireplace Flue:** Metal - Rust present from use. Limited view, could only see top (at chimney) and bottom of flue (at damper), not between. Suggest further evaluation by a qualified fireplace installer to be sure fireplace flue is clean and safe for use.

Recommend evaluation by a fireplace contractor before use due to rust and corrosion on flue as mentioned below.

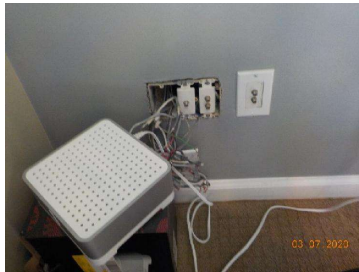
Not Present	Closet:
Not Present	Doors:
Good	Floor: Carpet
Good	Walls: Painted Drywall
Good	Ceiling: Painted Drywall
Good	Ceiling Fan Controlled by remote, Switched, tested
Good	Windows: Fixed, non opening
Minor Issue	Electrical: 3-Prong, 120 VAC - Open outlet needs a cover.

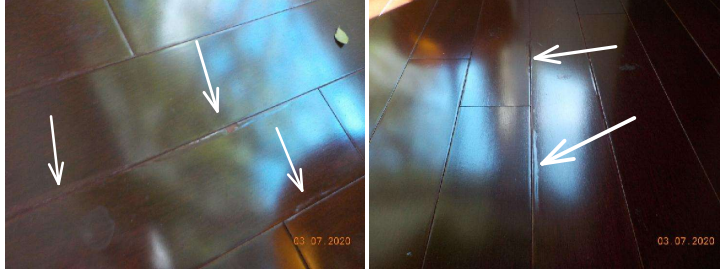
Not Present	Closet:
Not Present	Doors:
Fair	Floor: Engineered Flooring - An area of the finish is bubbling. Unable to see entire floor due to area rug and furniture.

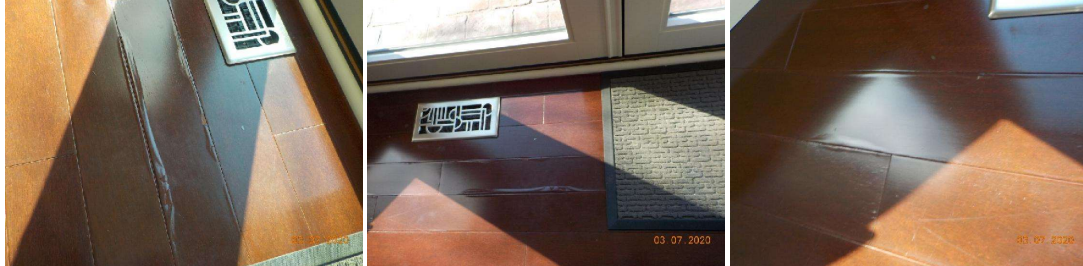
**Fair** Floor: Engineered Flooring - Areas of bubbled finish near door.

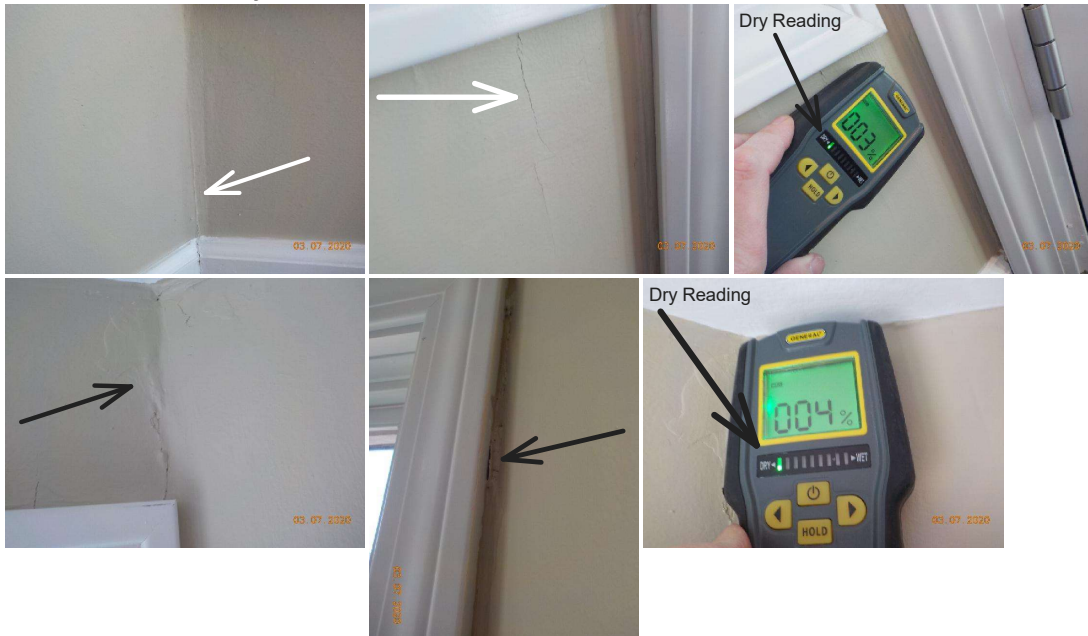
**Good** Walls: Painted Drywall - Cosmetic flaws on walls, tested for moisture, no moisture found.

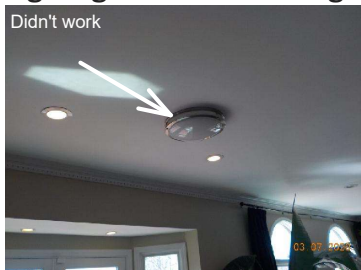
**Good** Ceiling: Painted Drywall  
**Not Present** Ceiling Fan:  
**Good** Windows: Wood Casement  
**Good** Electrical: 3-Prong, 120 VAC  
**Questionable** Lighting Fixtures: Ceiling Mounted - Ceiling mounted light didn't work at time of inspection.

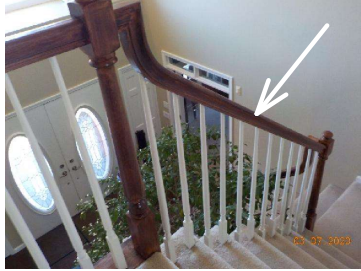
**Fair** Railings: Wood rails & spindles - Railing is somewhat loose, could use additional support for safety.

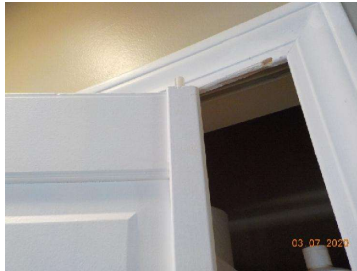
**Fair** Doors: Bi-fold - Closet door comes out of track during operation.

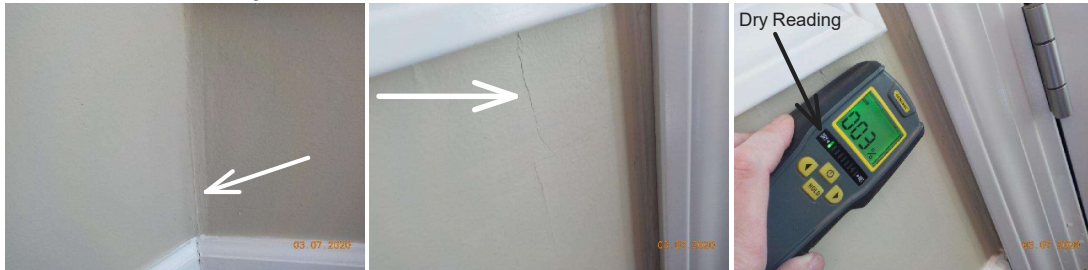
**Good** Walls: Painted Drywall - Cosmetic flaws on walls, tested for moisture, no moisture found.

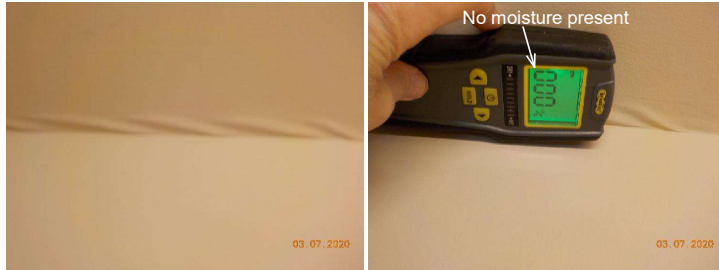
Good Closet: Large - Drywall tape puckered in closet. Tested for moisture, none present. Considered cosmetic.

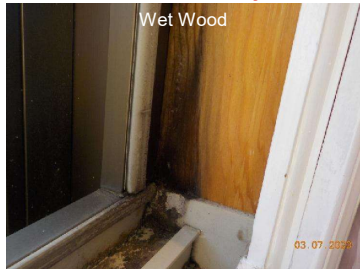
Deficiency Window(s): Wood slider, Fixed, non opening - **Though weatherstrip is in place, water is weeping into frame. Wood was wet at time of inspection. Caulk appears to be in place on exterior. Recommend consulting a window contractor for further evaluation and repair to stop any leak which will eventually cause the wood to rot and could possibly allow moisture into wall below.**

- West (Green) Bedroom Window(s): Wood slider, Fixed, non opening - **Though weatherstrip is in place, water is weeping into frame. Wood was wet at time of inspection. Caulk appears to be in place on exterior. Recommend consulting a window contractor for further evaluation and repair to stop any leak which will eventually cause the wood to rot and could possibly allow moisture into wall below.**
- East, Tan Bedroom Window(s): Wood slider - **Window would not open, appears to be painted shut.**

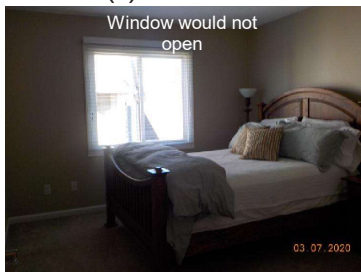
Good Closet: Walk In  
 Good Doors: Solid wood  
 Good Floor: Carpet  
 Good Walls: Painted Drywall  
 Good Ceiling: Painted Drywall  
 Not Present Ceiling Fan:  
 Deficiency Window(s): Wood slider - **Window would not open, appears to be painted shut.**

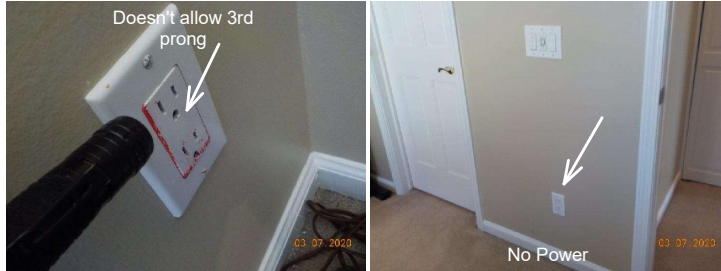
Electrical: 3-Prong, 120 VAC - **Outlet right of window, top plug doesn't allow 3rd prong to be plugged in. Hard to see, but likely something may be broken off inside of it. Recommend replacement of outlet for proper use. Outlet between entry and closet doors had no power going to it at time of inspection. Recommend further evaluation by a licensed electrician to repair or replace.**

**East, Tan Bedroom Electrical:** 3-Prong, 120 VAC - **Outlet right of window, top plug doesn't allow 3rd prong to be plugged in. Hard to see, but likely something may be broken off inside of it. Recommend replacement of outlet for proper use. Outlet between entry and closet doors had no power going to it at time of inspection. Recommend further evaluation by a licensed electrician to repair or replace.**

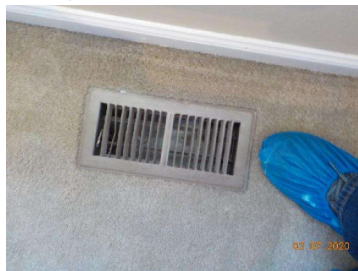
Lighting Fixtures: Ceiling Mounted  
HVAC Source: HVAC System Register, Cold air return vent - Airflow regulator on register doesn't work, frozen.

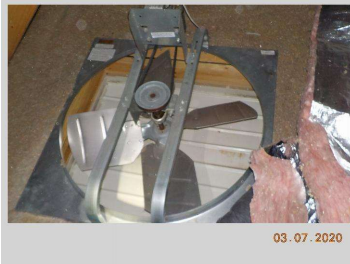
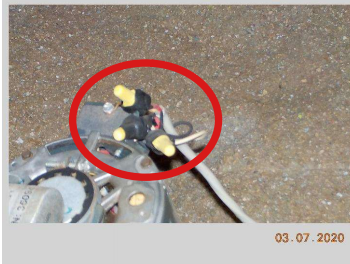
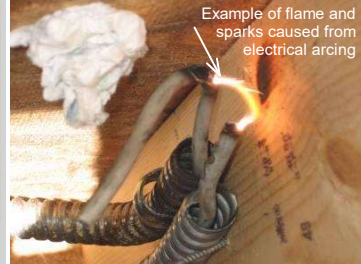
Attic Fan: Belt drive - Fan works ok (loud). Safety issue is related to open electrical splices connecting the fan motor to the electrical supply. All electrical splices are to terminate in a properly secured and covered electrical junction box. Possible loose wiring could cause arcing which if not contained in a junction box may cause a fire hazard from sparks falling onto the insulation.

**Attic Attic Fan:** Belt drive - **Fan works ok (loud). Safety issue is related to open electrical splices connecting the fan motor to the electrical supply. All electrical splices are to terminate in a properly secured and covered electrical junction box. Possible loose wiring could cause arcing which if not contained in a junction box may cause a fire**

**hazard from sparks falling onto the insulation.**
