## Windsor Home Inspections

## **Property Inspection Report**

, Robbinsdale, MN 55422

Date of Inspection: 7/3/2018 Time: 9:00 am,

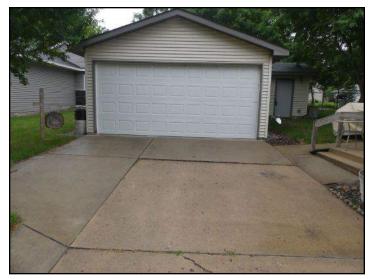
Driveway is cracked and pitted.

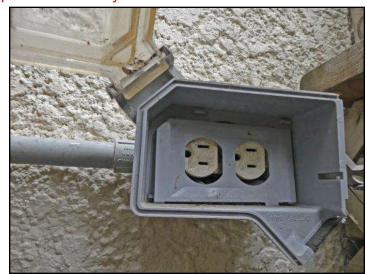
Outdoor receptacles on the house are not <u>GFCI</u> protected They should be updated for safety.

Exterior outlets on the house are not GFCI protected.

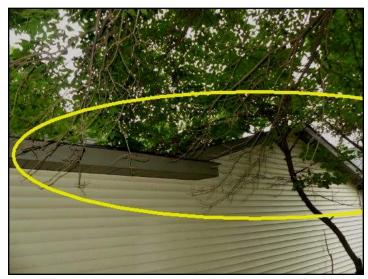
Tree branches are in direct contact with the Garage siding and roof.

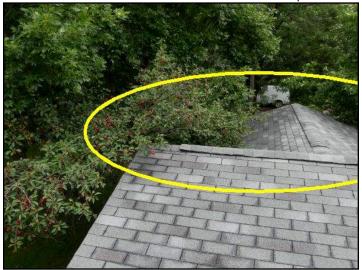
Tree branches are against the roofing and siding materials. Recommend trimming these trees back to avoid abrasion.

Branches are in direct contact with the structure / roof.

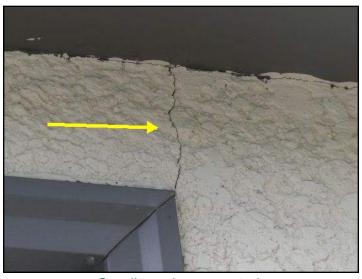
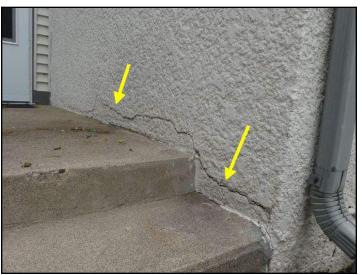
Minor cracks are noted in several locations on the <u>Stucco</u>. Recommend sealing /painting to close the gaps to prevent any water infiltration.

Small cracks are noted.

Cracking is noted in the Stucco.

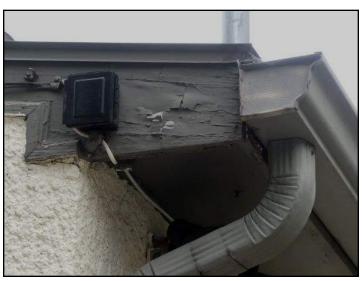
Some deterioration and peeling paint is noted.

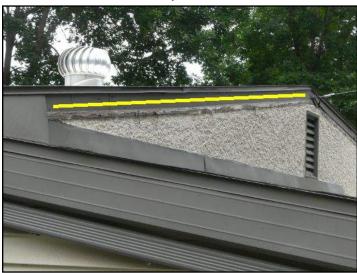
Peeling paint observed, suggest scraping and painting as necessary.

Peeling paint is noted.

All exterior painted wood trim surfaces should be annually examined and sealed, re-caulked and re-painted as needed.

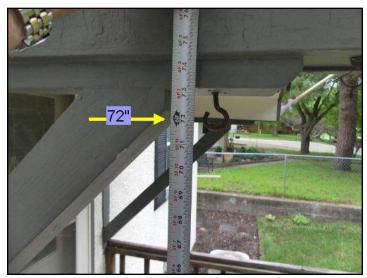
Supports for the Front Entry Canopy are only 72" off the landing.

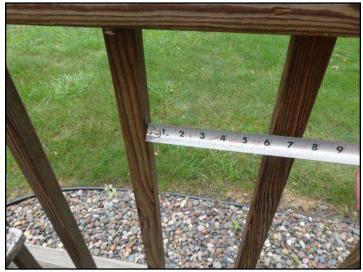
Balusters are more than 4" apart at the front entry landing.

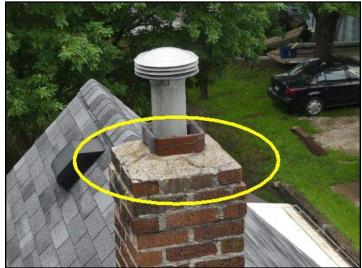
The concrete chimney crown is cracked in several locations. Repair as necessary.

The Hot Water Heater vents through the Chimney. A wire mesh has been installed around the vent pipe at the top of the chimney to presumably prevent animals from entering. This wire mesh is damaged and missing in areas. Repair is recommended.

Concrete crown is cracked.

Wire mesh is damaged and missing.

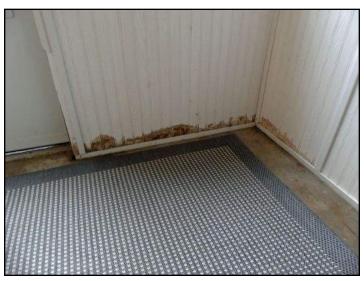
Water staining is noted.

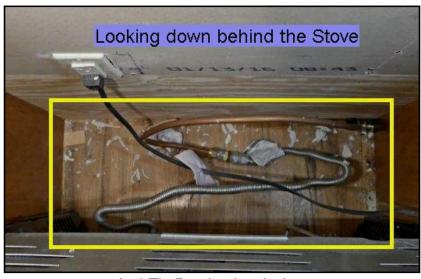
Anti-Tip Bracket is missing.

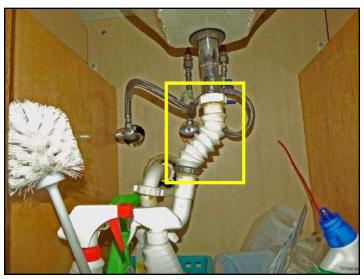
Flex drain pipe should be replaced.

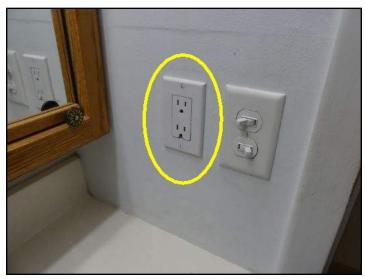
Outlets should be upgraded to GFCI for safety.

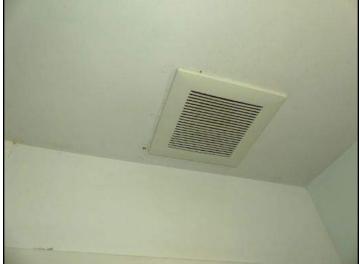
The bath fan is not vented properly. It terminates inside the under <u>Eaves</u> storage closet in the 2nd Bedroom by a fixed roof vent. This should be vented to a dedicated bath fan roof vent. Repair as necessary.

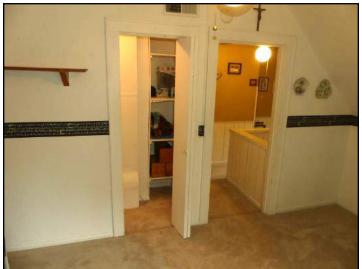
Storage area under the Eave is blocked.

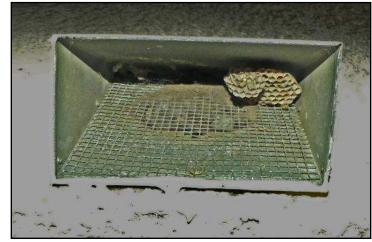
The dryer vent is sealed with <u>duct</u> tape. This product is flammable and should be replaced with proper HVAC foil tape.

Improperly sealed with flammable Duct-Tape.

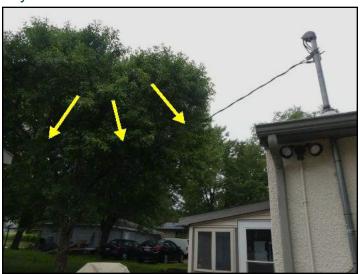
Cable feeds is running through the trees.

When utility company wires coming into the service mast are sagging, frayed, strung through trees, or otherwise appear improper, the client is advised to contact the utility company prior to closing to correct the condition or verify its safety.

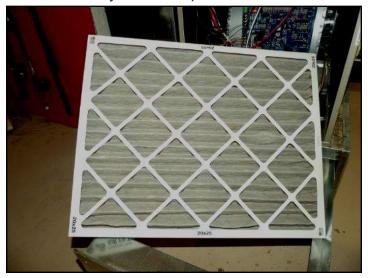
Furnace filter dirty. Needs replacement.

filter is dirty and should be replaced.

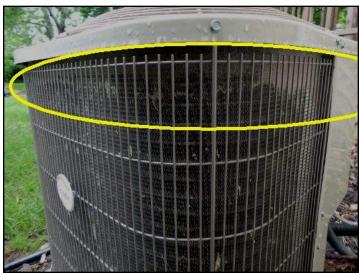
The exterior condenser is slightly dirty and needs to be cleaned.

Compressor is slightly dirty.
