Windsor Home Inspections

Property Inspection Report

, Eagan, MN 55123

Date of Inspection: 6/22/2018 Time: 8:30 am,

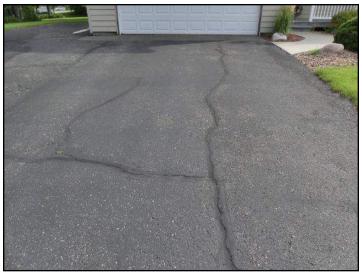
Asphalt driveway is cracked and pitted.

The Driveway is cracked and pitted.

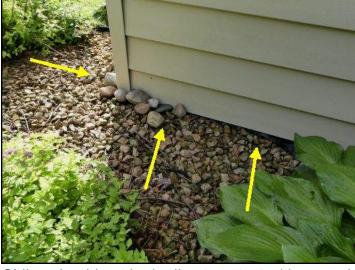
The siding is in direct contact with the soil in a few areas.

Siding should not be in direct contact with ground.

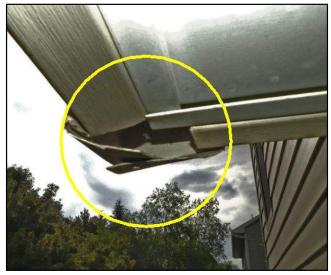
A couple of the vinyl corner pieces are not properly secured at the bottom of the corners at the rear of the structure. Repair as necessary to help prevent insects from entering these areas.

Gaps at the bottom of the corner trim. It is not properly secured.

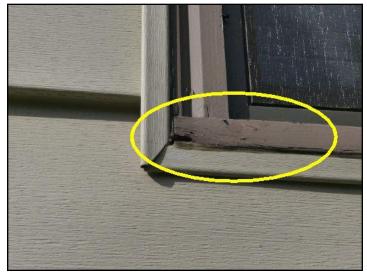
There is significant deterioration due to moisture on the exterior wood trim on several of the windows.

Deterioration at the exterior wood frame.

Recommend further review by a <u>qualified</u> contractor for repairs or replacement and to determine if there may be additional unseen damage.

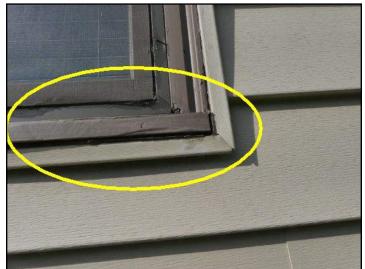
Deterioration noted at the exterior window frame.

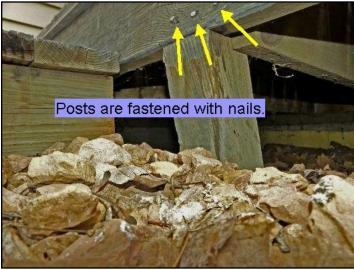
4" x 4" support posts are not properly fastened to the beam.

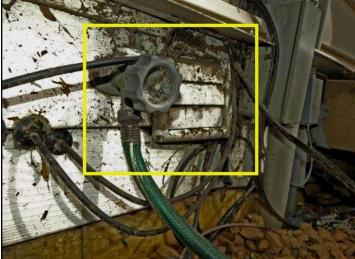
Access panel to the Hose Bib and Dryer Vent.

Hose Bib and Dryver vent are beneath the Deck.

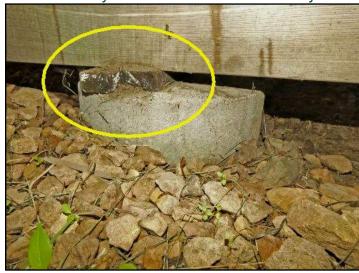
It looks like large flat stones have been placed on top of the concrete footing to act as shim for the <u>beam</u> and <u>loists</u>. There location makes access very difficult.

Beams and joist are not properly supported.

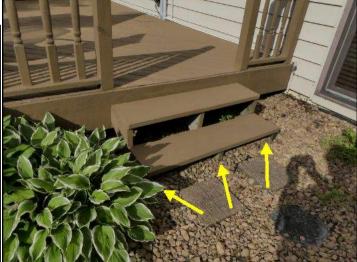
Stair <u>stringer</u>s should be set on concrete pads which sits above the ground to ensure that water does not accumulate at the base of the <u>stringer</u>s causing deterioration.

Stair stringers are in direct contact with the ground.

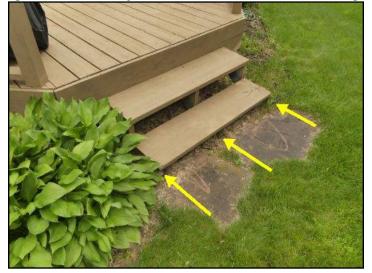
Stair pad at the front of the Deck is in direct contact with the ground.

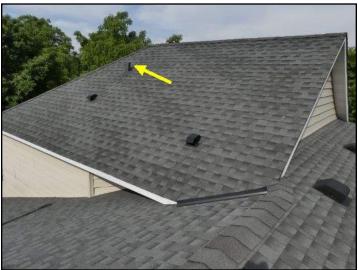
Vent stack with poorly fitting lead ring.

The adjustable lead ring on the vent pipe cover is not fitting properly. Currently there is a gap between the lead ring and the vent pipe. This would allow water to run down the outside of the vent pipe into the home. Repair.

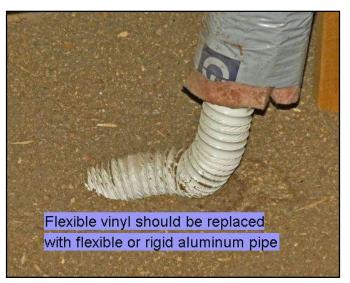
2nd Bathroom exhaust vent.

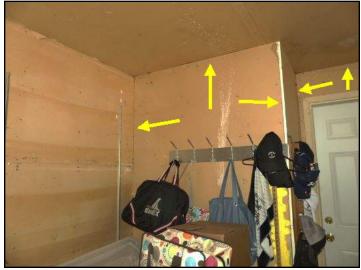
Fire walls are not properly finished.

Firewalls are not taped and sealed.

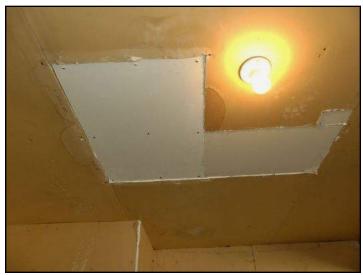
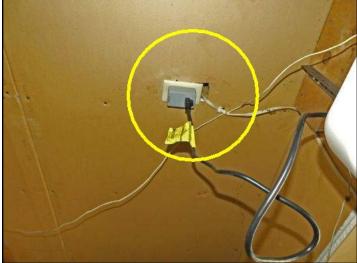
Firewalls ceiling are not taped and sealed.

Gaps in the drywall ceiling by the Door Opener outlet.

All Garage ceilings that have direct contact with the house must be finished with <u>drywall</u>, taped and sealed for maximum fire protection.

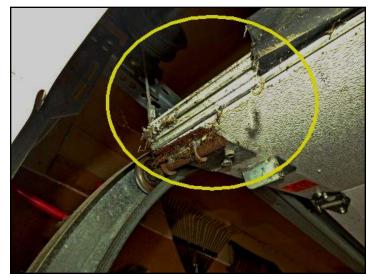
Bottom weatherstripping should be replaced.

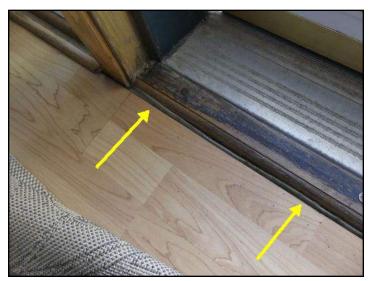
Poor finishing at the Front Entry Door.

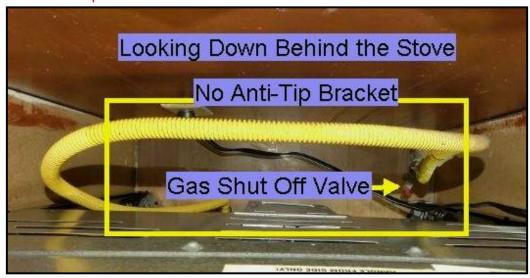
Anti-tip bracket is missing from range installation. See label inside oven door. All free standing, slide-in ranges include an anti-tip device and is essential in the safe operation of the range. It provides protection when excess force or weight is applied to an open oven door. Carried by home building centers. Anti-tip devises became a UL (Underwriters Laboratories) safety standard requirement in 1991.

No Ant-Tip bracket in place.

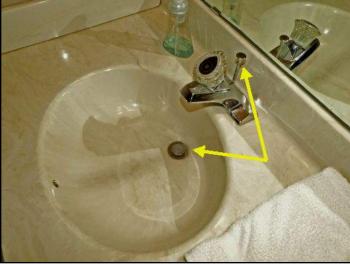
Drain diverter does not function.

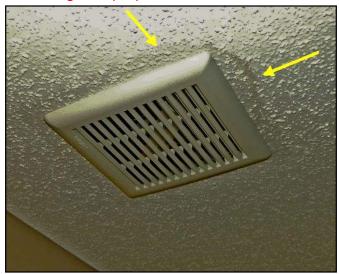
Moisture staining is noted on the ceiling around the Bath Exhaust fan. The exhaust fan vent pipe in the Attic is made with flexible vinyl pipe and is not properly insulated. This will allow moisture to collect in and around the pipe then fall back onto the ceiling causing water staining. Recommend repairing and insulating with proper materials.

Water staining is noted around the exhaust fan.

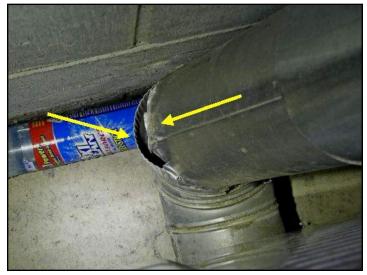
It is not connected properly at the transition.

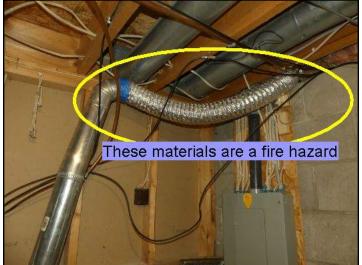
Dryer vent should be repaired with proper materials for fire safety.

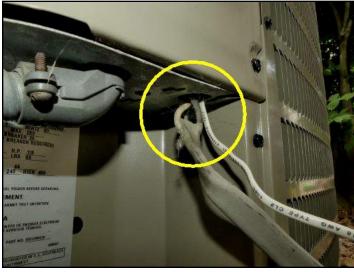
The armored cable that provides power to the A/C is not properly secured to the structure. Recommend repairs by a qualified technician.

The power supply line is not properly connected to the compressor. A bushing is missing. This is a significant hazard. Recommend repairs by a qualified Electrician.
