# Inspection Report

100 Neptune Dr, Hypoluxo, Florida 33462

**Inspection Date** July 15, 2018  
**Client** Andrew Orndorff  
**Inspector** Brad Bergoine  
561.425.6300  
[brad@mixconsultants.com](mailto:brad@mixconsultants.com)

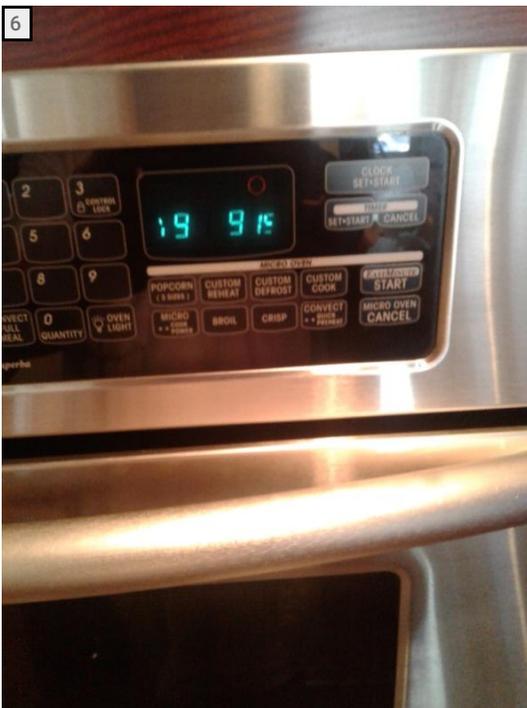
**Not Working. The clock is lighted, assuming power to the unit is on.**

Location Kitchen

Suggested Action Repair / Replace the unit as desired.

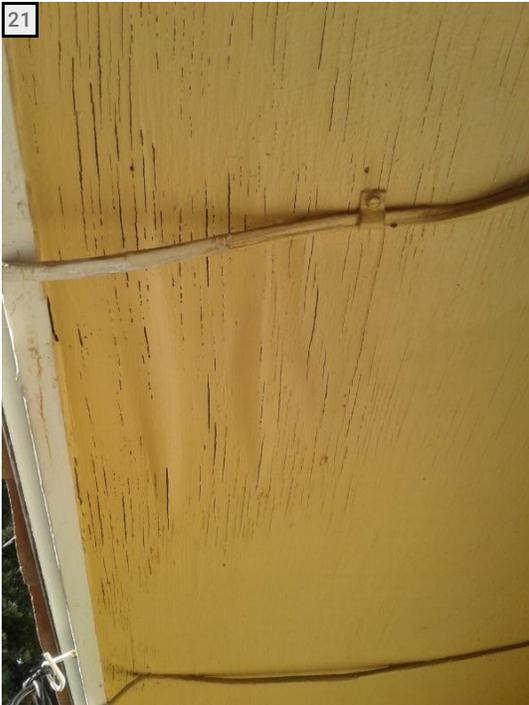
#### Wood soffit shows signs of water damage

Location	Exterior: Ground View
Suggested Action	Replace damage soffit

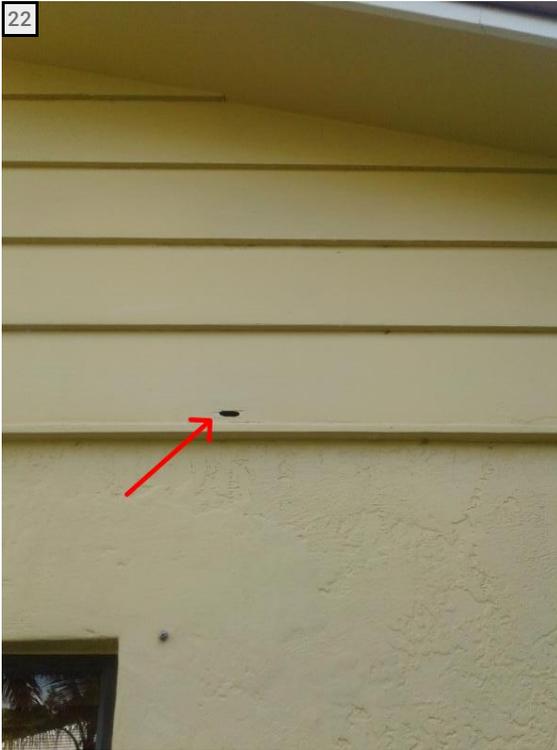
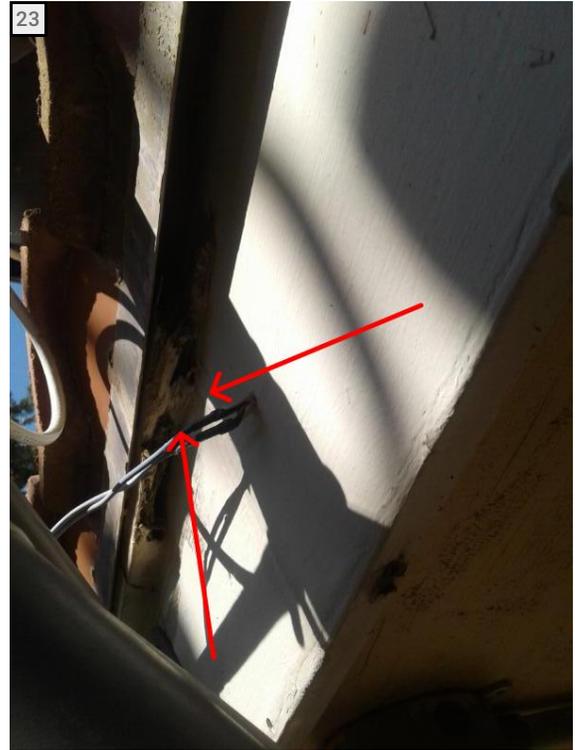
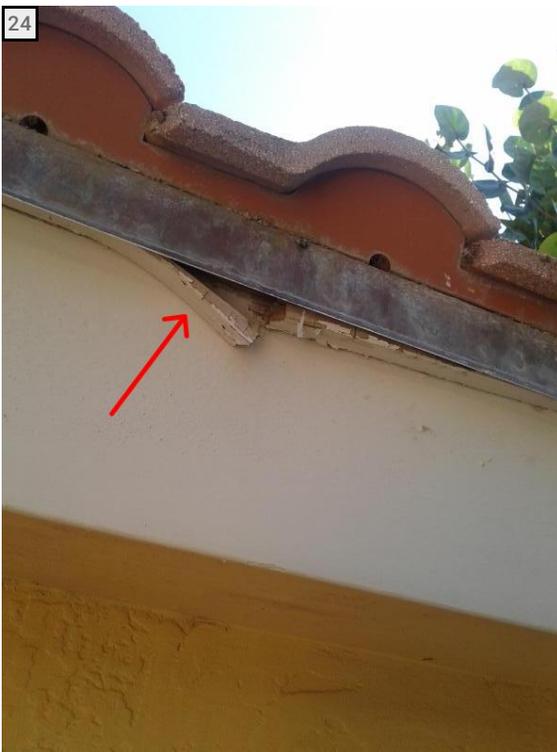
Damaged

Location Exterior: Ground View  
Suggested Action Replace the damaged trim

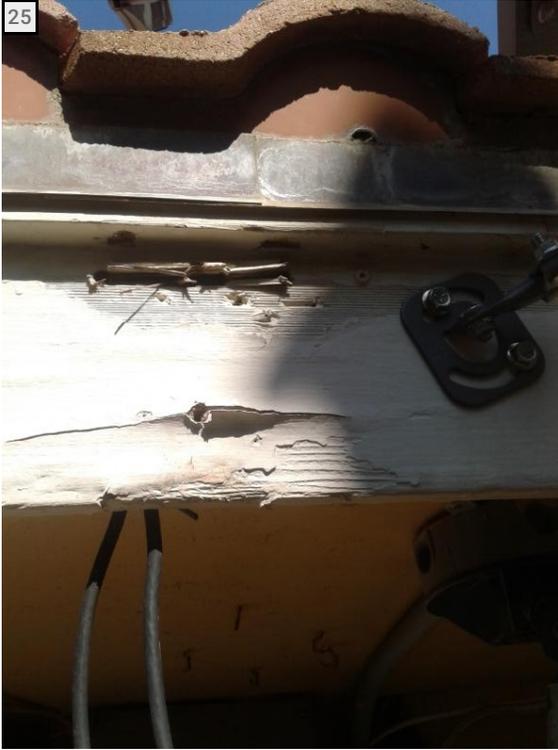
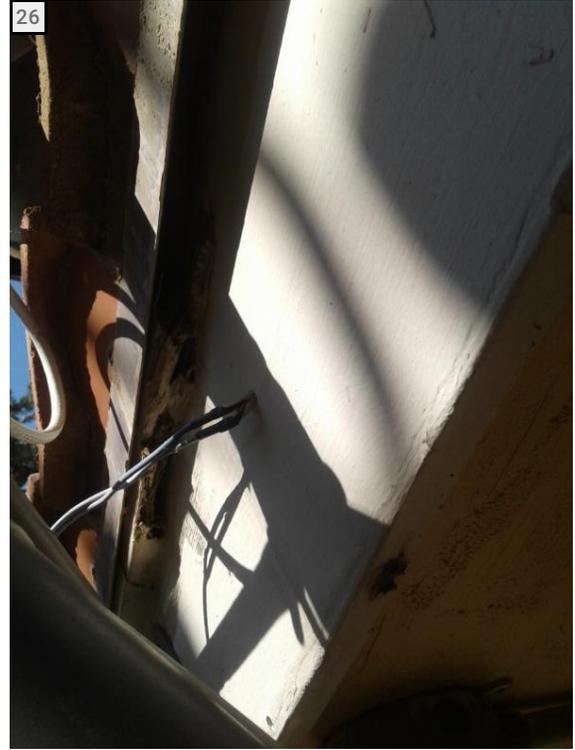
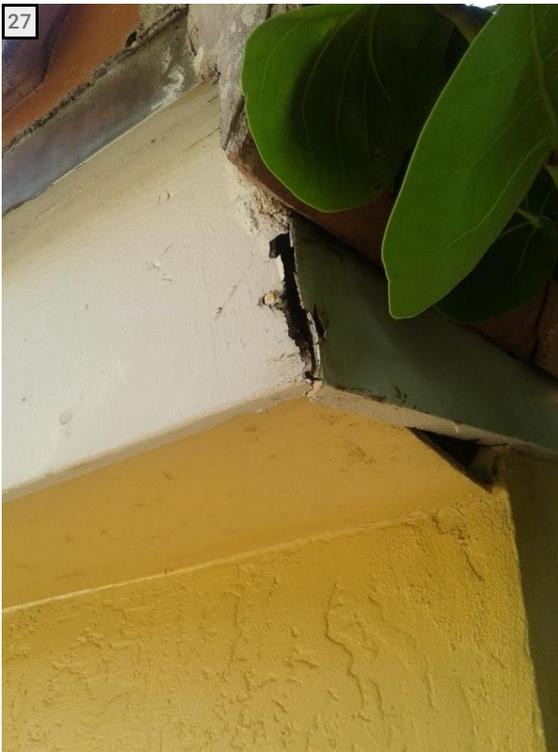
### Rotting

**Location** Exterior: Ground View  
**Suggested Action** Have qualified roofer replace the rotting fascia board.

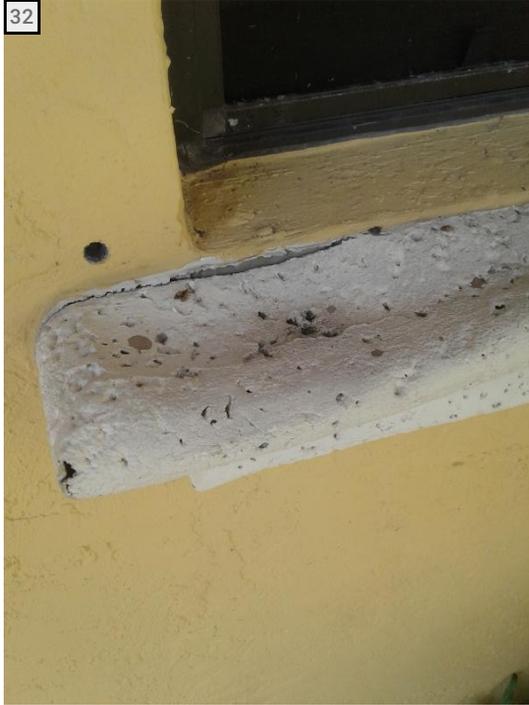
**Material is damaged - Scattered**

**Location** Exterior: Ground View  
**Impact** With damaged siding, the home lacks protection from insects, animals and the elements and it may negatively affect the thermal boundary of the home  
**Suggested Action** Replace the damaged area

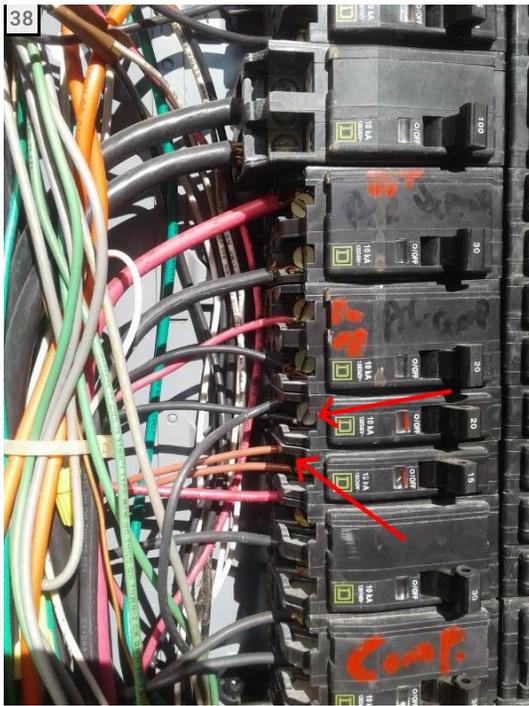
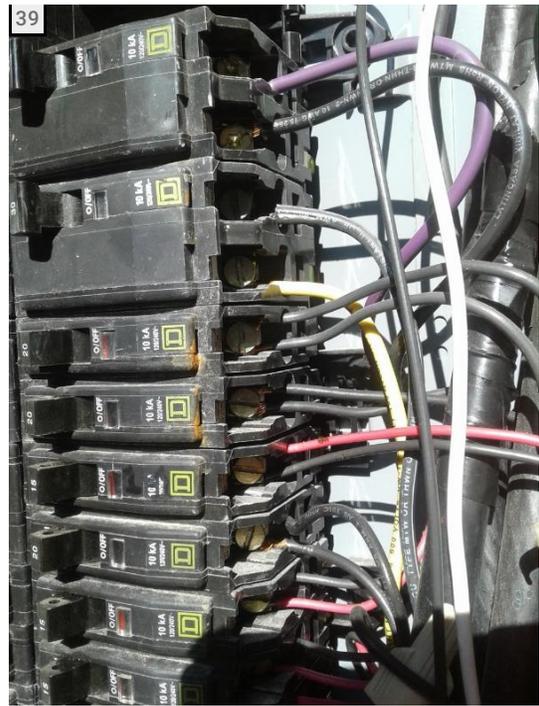
Location Exterior: Ground View

Impact A double tapped breaker is when two wires connect to one breaker. The problem is that it can cause loose connections, arcing, and potentially a fire.

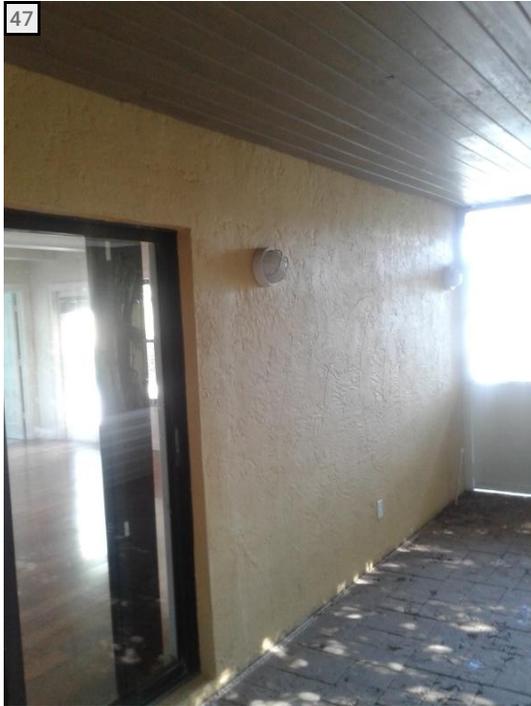
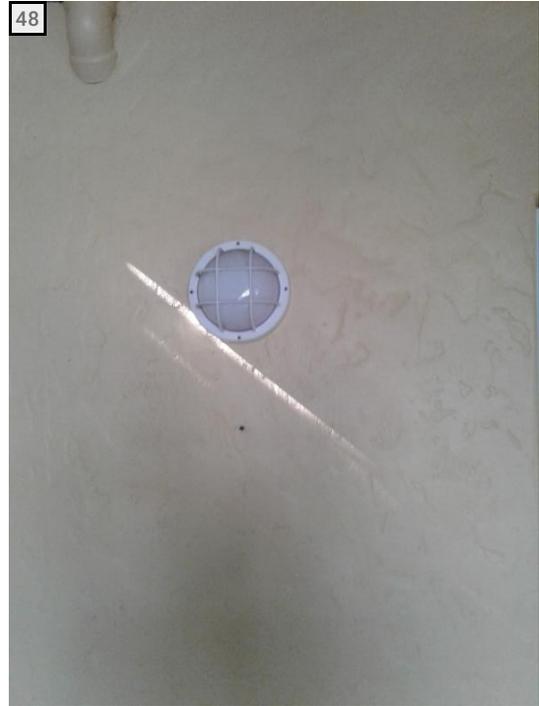
**Not working**

**Location** Exterior: Ground View  
**Suggested Action** We found the switch of the outside lights around the pool. These lights are either not working or on a switch that is not in a logical spot.

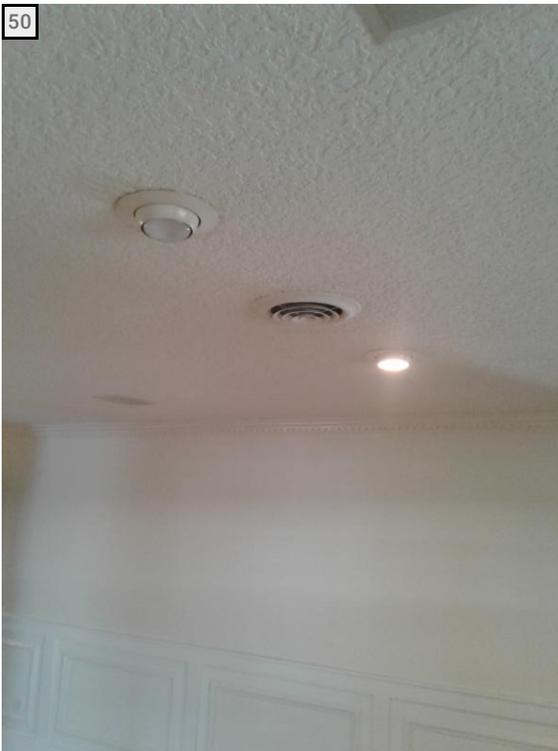
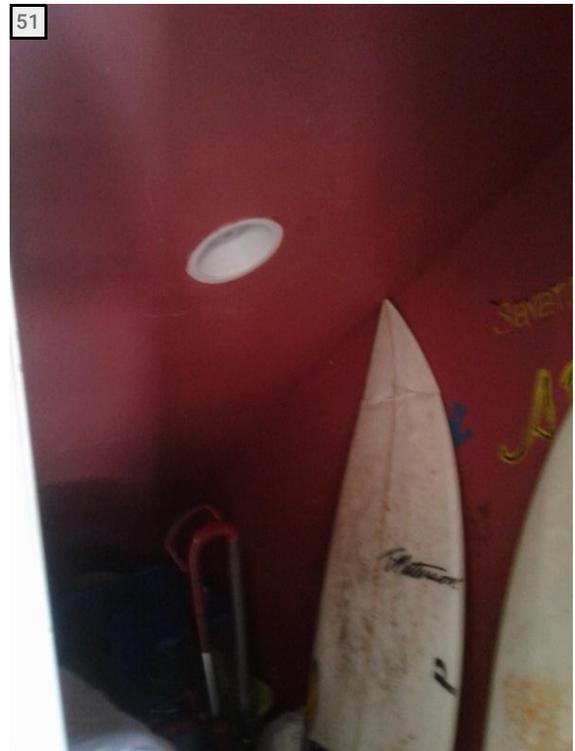
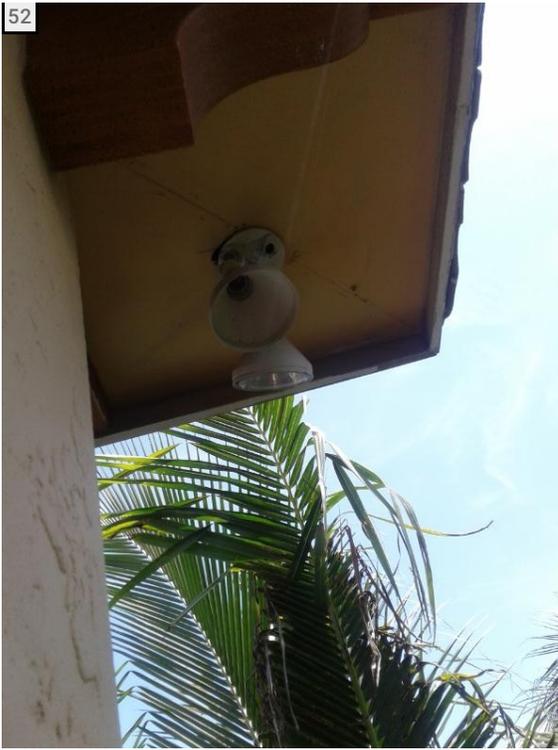
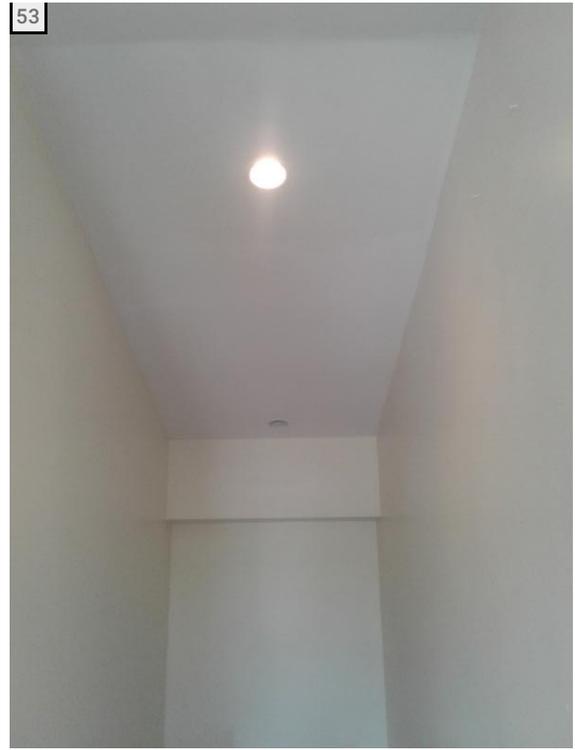
**Bulb is burned out**

Location	Hallway and Stairs, Living Room, Loft
Suggested Action	Replace the bulb

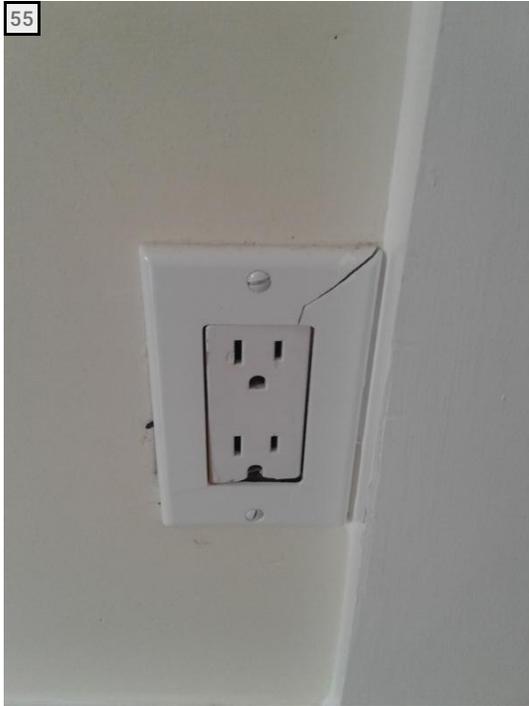
**Cover plate is damaged and missing in parts - Scattered**

**Location** 5th Bedroom  
**Impact** With missing parts of the cover plate, electrical shock may result if touched  
**Suggested Action** Replace the cover

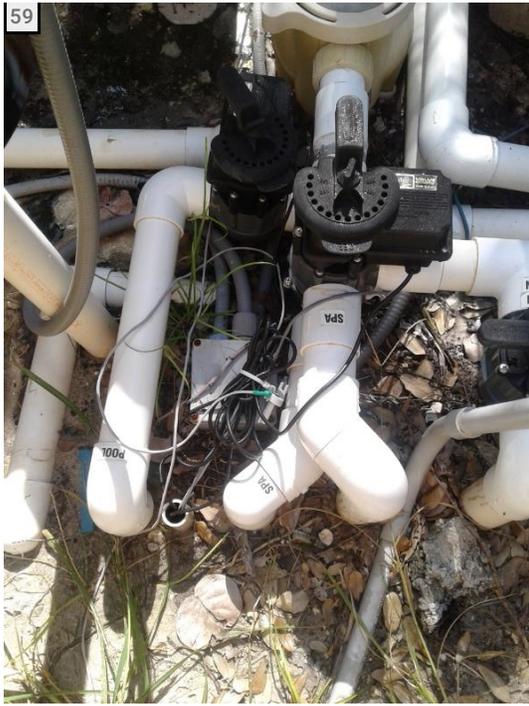
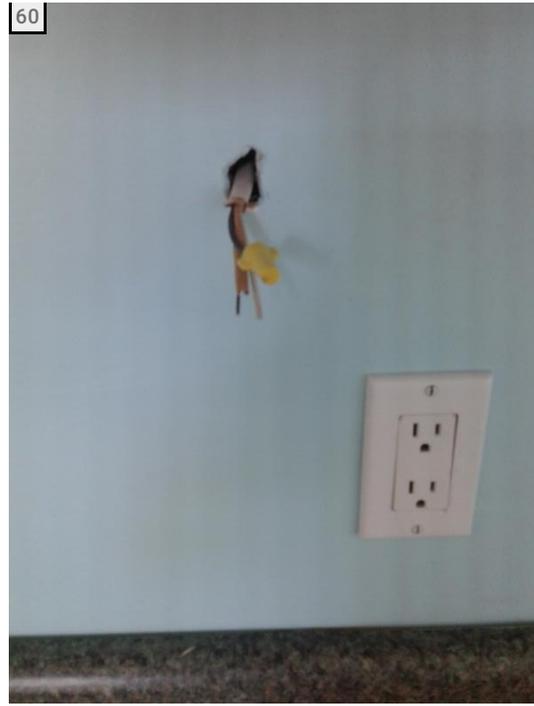
### Exposed

Location	Laundry Room / Mudroom, Pool Area
Impact	Exposed wiring can cause electrical shock if touched
Suggested Action	Place the wiring in a junction box with a cover plate
Other Information	Exposed wiring should be capped and in a junction box with a cover plate or removed

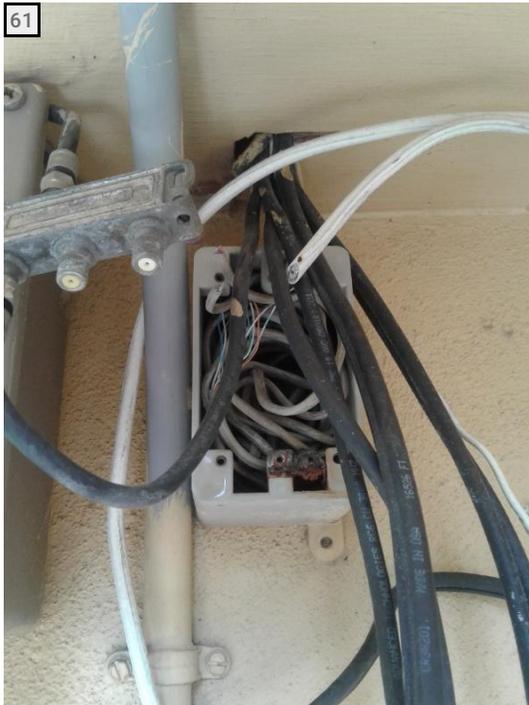
#### Junction box is missing a cover plate

Location	Exterior: Ground View
Impact	Without a junction box cover the wiring is exposed thus lacking protection from shock or arcing
Suggested Action	Install a cover plate

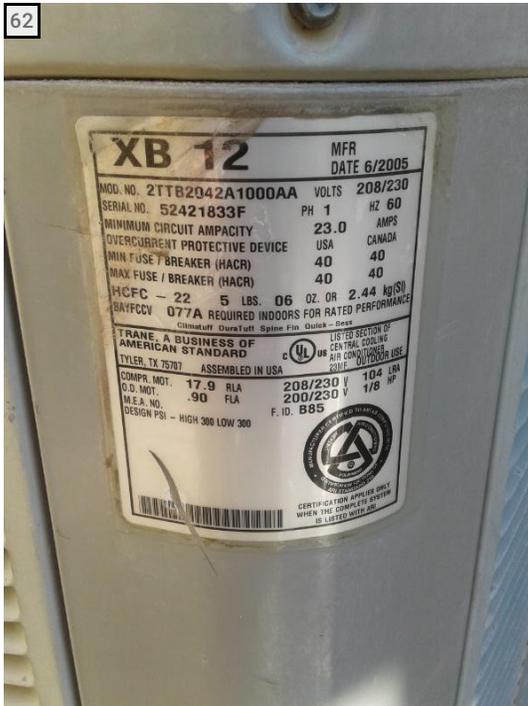
Your system is 10 or more years old: If your system is 10 years or more in age and you're experiencing the need for repairs, it may make more sense to go ahead and replace your system since it's nearing the end of its service life. Plus, replacing an older system with a newer one offers higher efficiency, plus warranty, saving you money compared to your existing equipment.

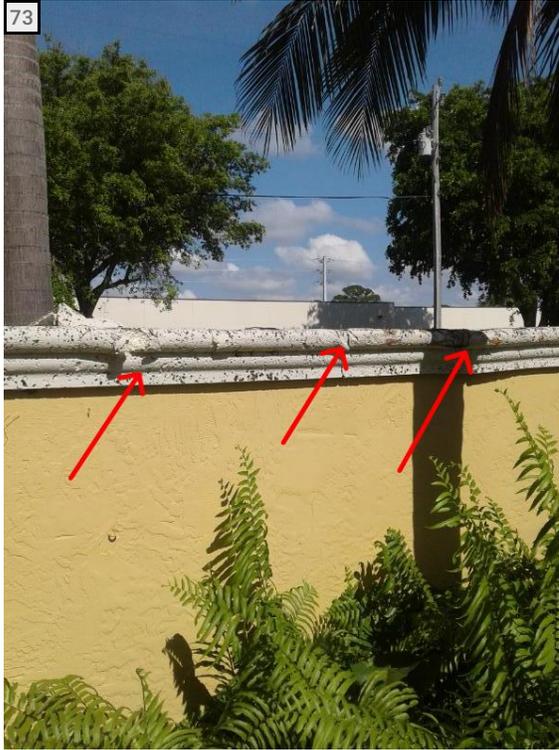
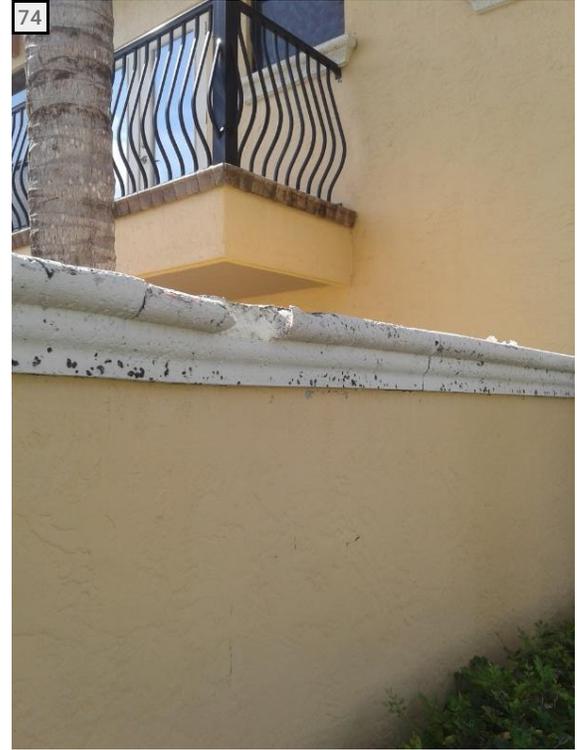
**Damaged. The top of the wall is damaged in several locations. It is a foam top with stucco finished.**

Location	Exterior: Ground View
Impact	Water intrusion into wall.
Suggested Action	Repair the damaged areas of the wall.

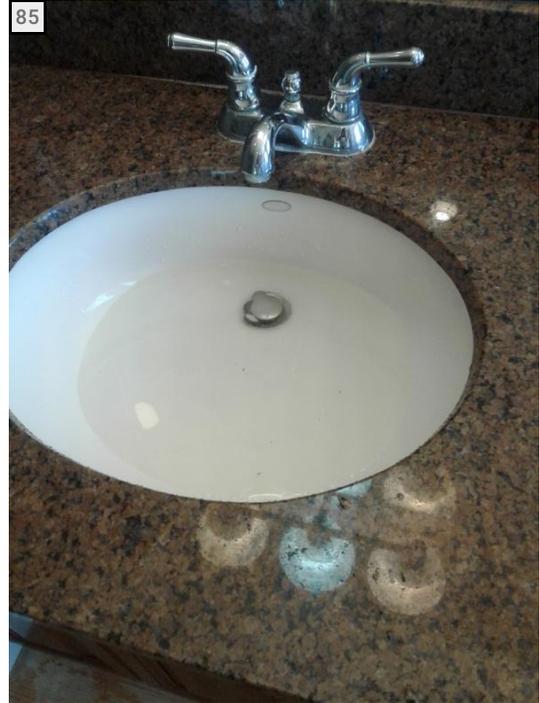
**Drains slow**

**Location** 2nd Bathroom, 4th Bathroom  
**Suggested Action** Clear the drain of debris with a rodder (vs. chemical)

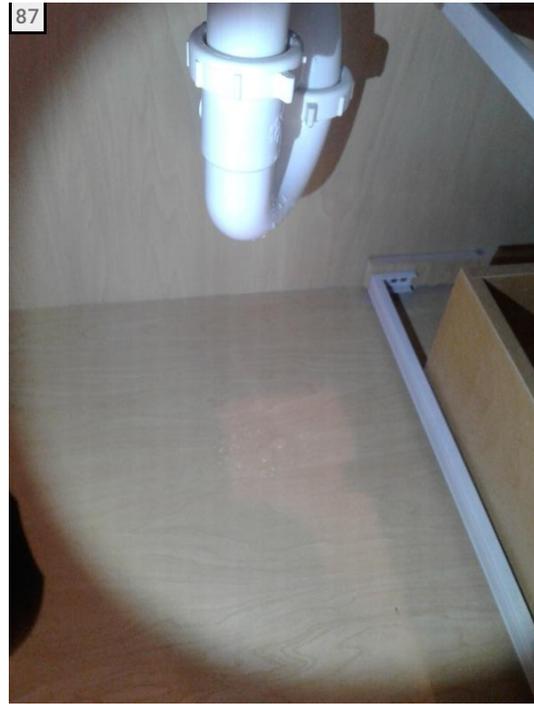
**Pipes are leaking at the connecting joint**

**Location** 4th Bathroom  
**Impact** The water may damage the surrounding areas  
**Suggested Action** Remove the connecting joint and reinstalling with plumbers putty or nylon tape

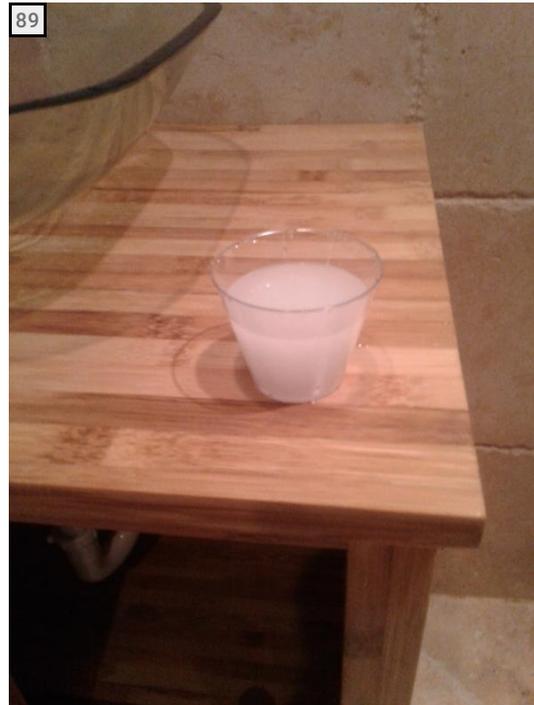
#### Water is milky.

Location	1st Bathroom
Impact	I have not seen this before, however I suspect that the water heater and pipes has built up sediment from not being run.
Suggested Action	Strongly recommend having a qualified plumber review and repair.

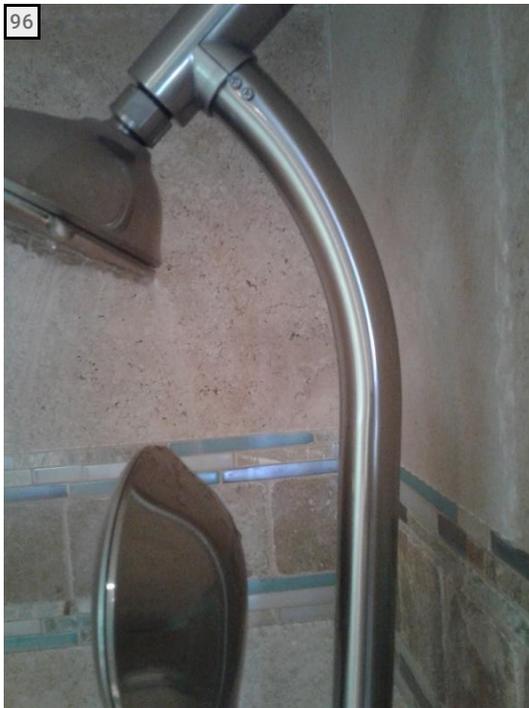
Shower head is leaking

Location 1st Bathroom

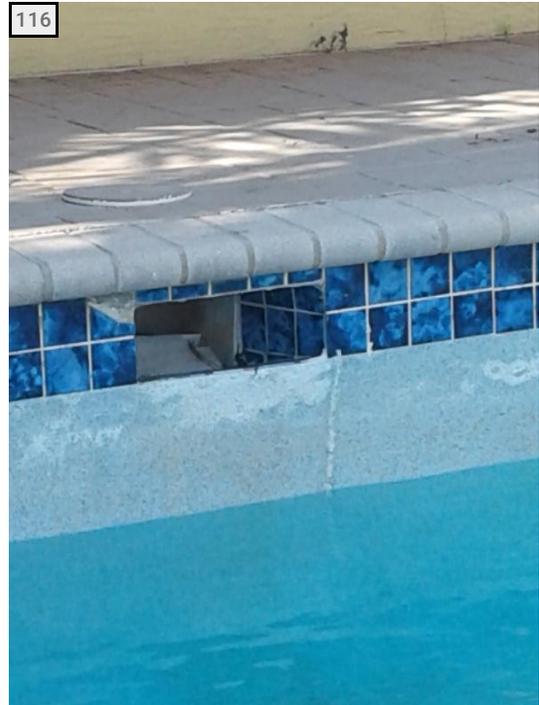
**Cracked / Broken tile**

**Location** Pool Area  
**Impact** Possible location of leak. Potential safety hazard

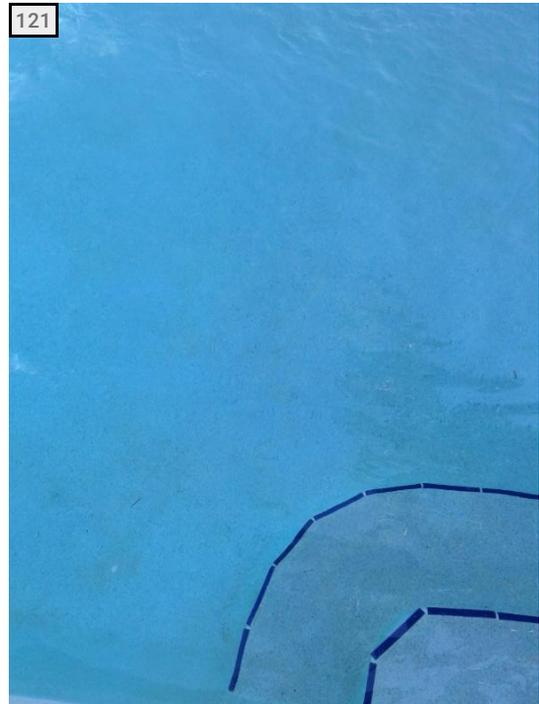
**Stained / discolored**

Location Pool Area

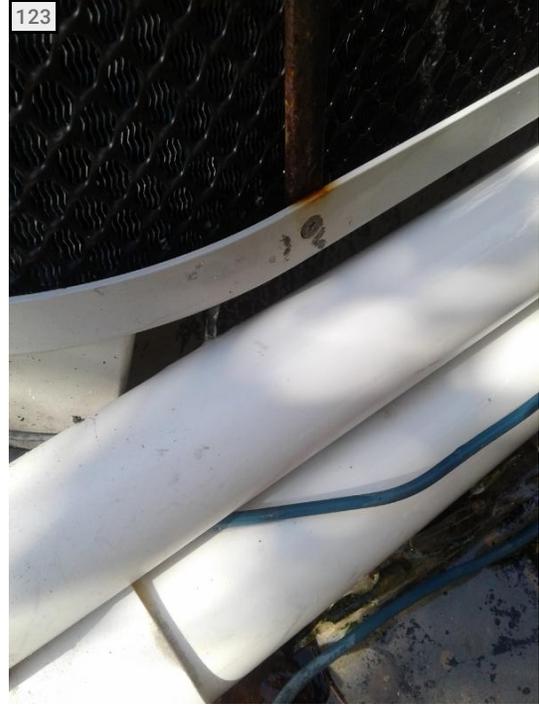
**Major Leak**

Location	Pool Area
Impact	Leaking from heater.
Suggested Action	Repair or replace heater.

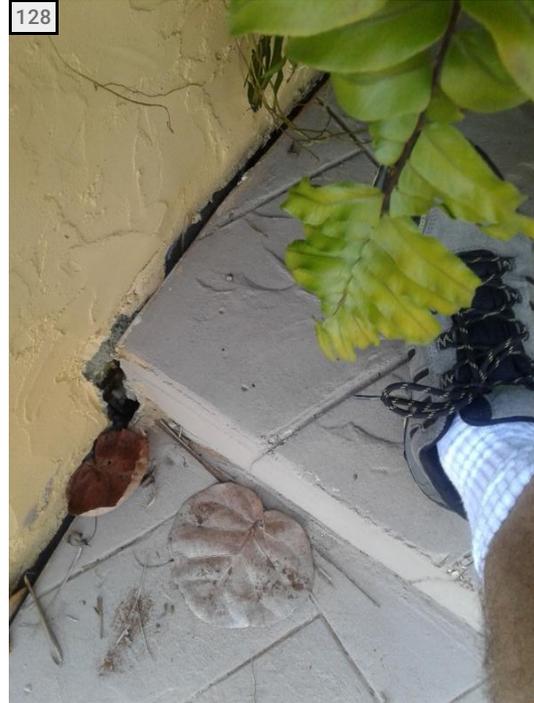
### Deck separation

Location	Pool Area
Impact	Tripping hazard

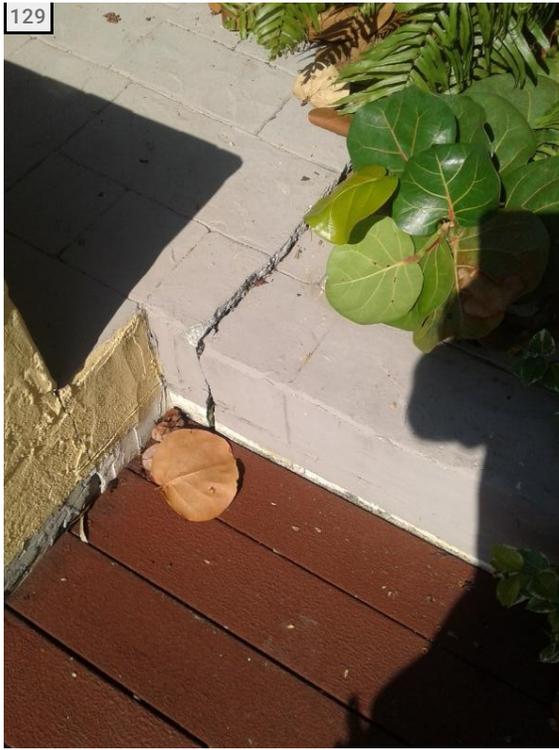
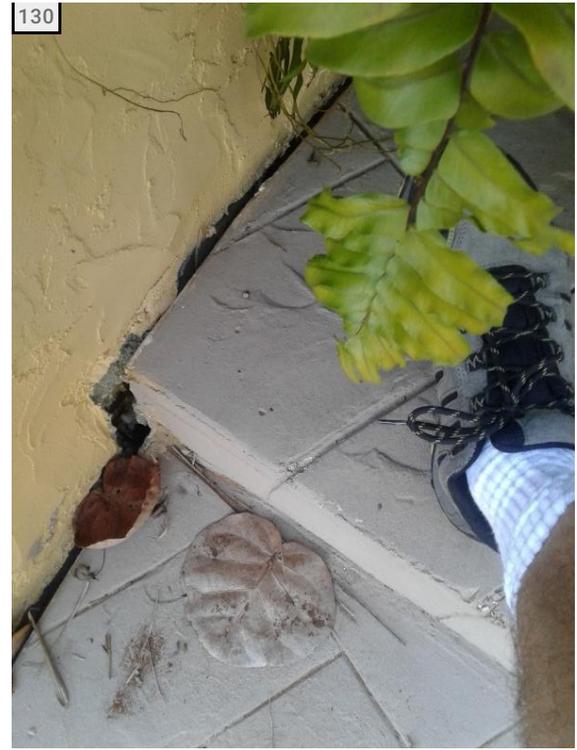
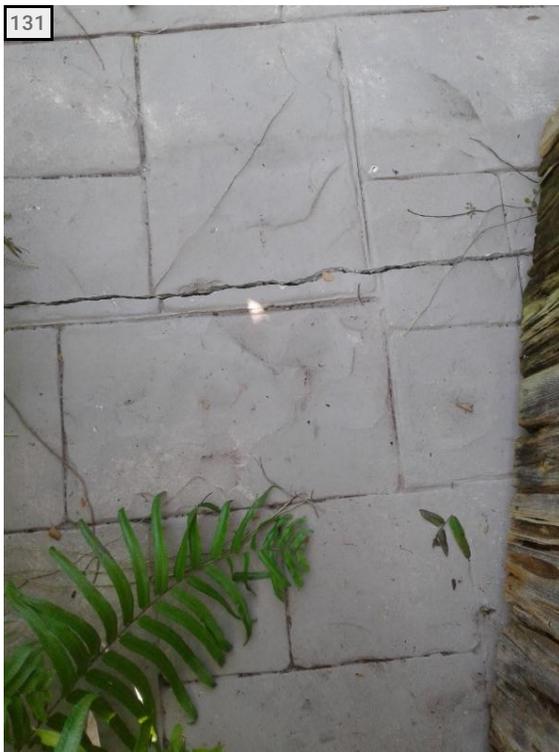
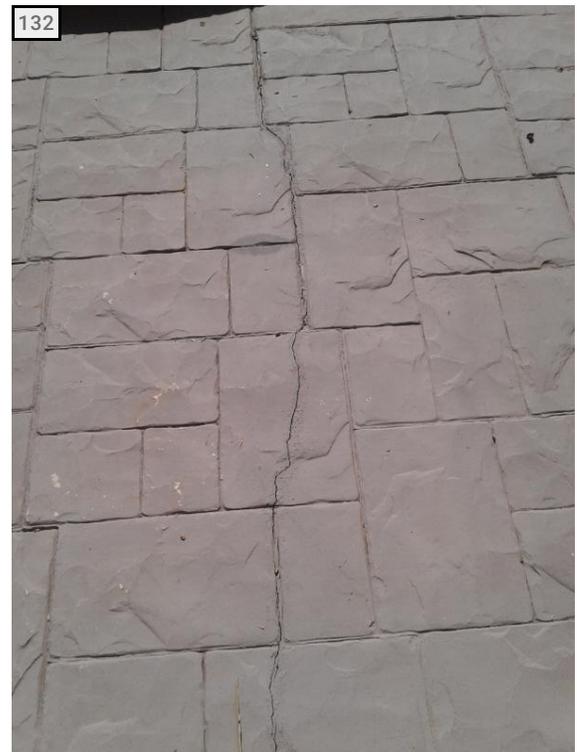
### Cracked

Location	Pool Area
Impact	Severe deck heaving

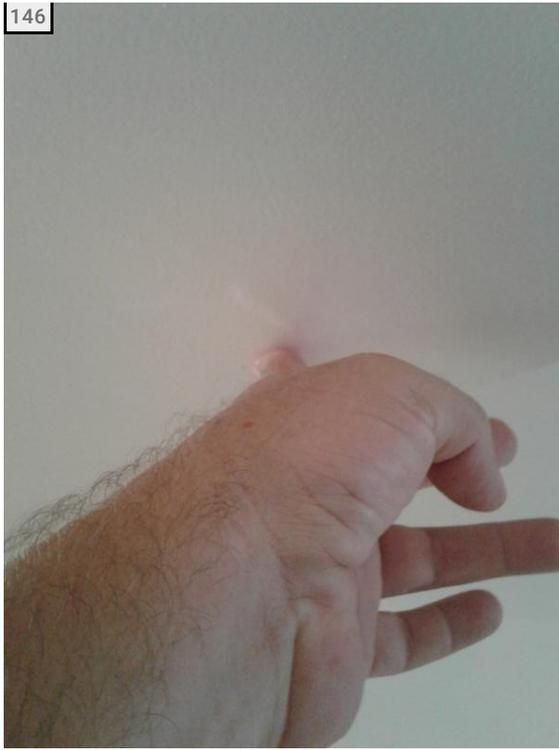
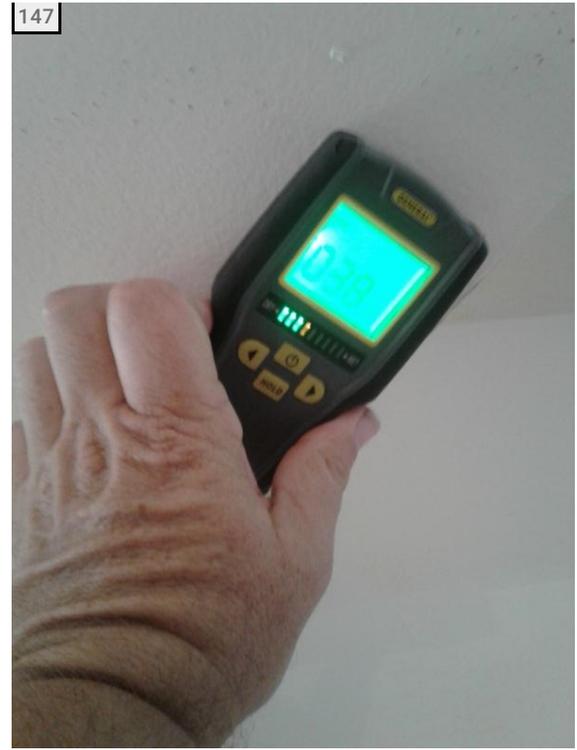
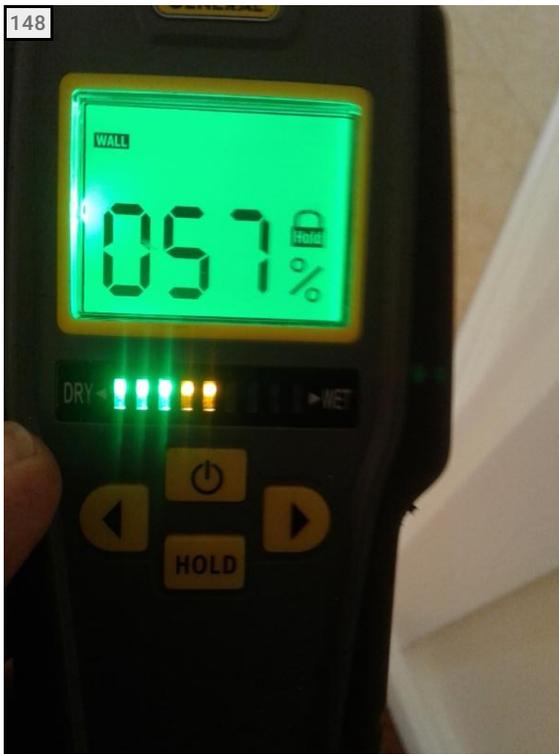
#### Shows signs of a current water leak

Location	Living Room
Impact	The leak could cause further damage to the wall
Suggested Action	Have repaired by a qualified plumber

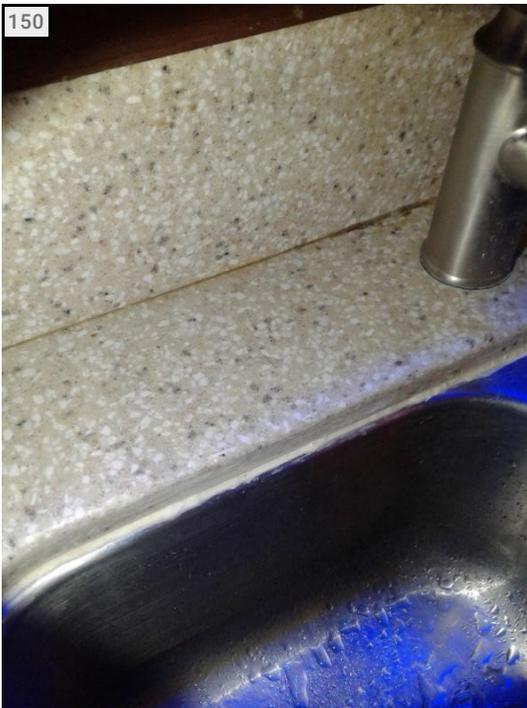
Missing chalk

Location Kitchen

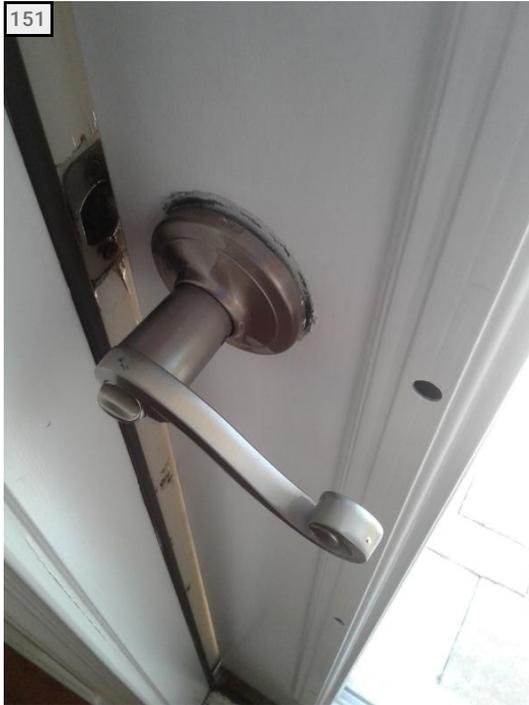
### Handle is damaged

**Location** 5th Bedroom  
**Suggested Action** Replace the handle

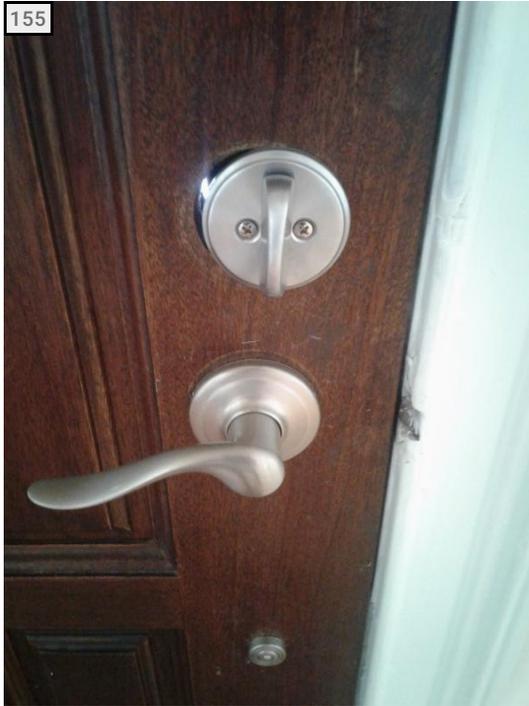
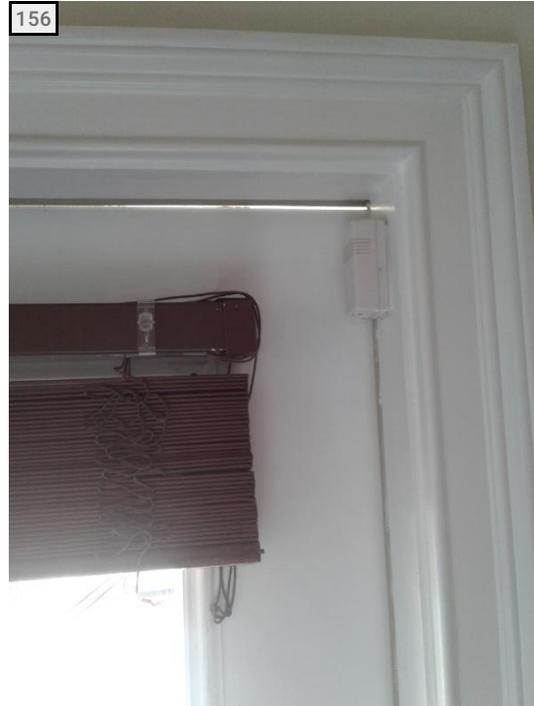
### Not weather sealed

Location	Family Room, Living Room
Impact	Without proper protection, the door is not protected from the elements
Suggested Action	Protect with weather-resistant seal, stain or paint

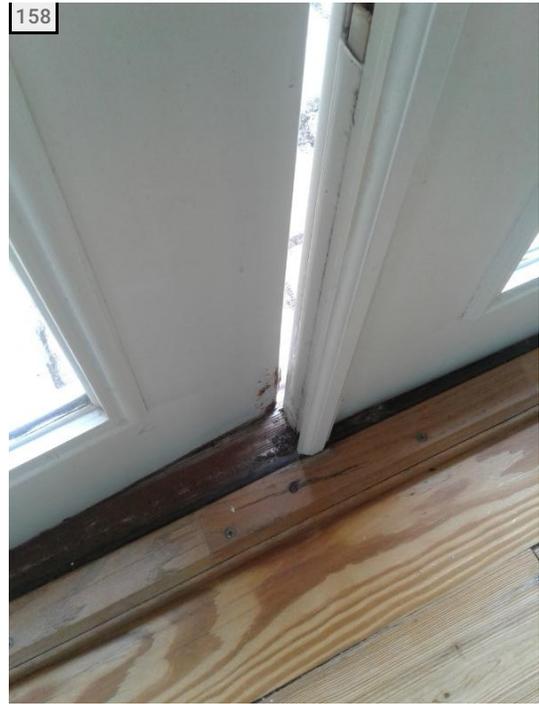
### Damaged

Location	Master Bedroom, Living Room
Suggested Action	Repair the damage or replace the door depending on your preference

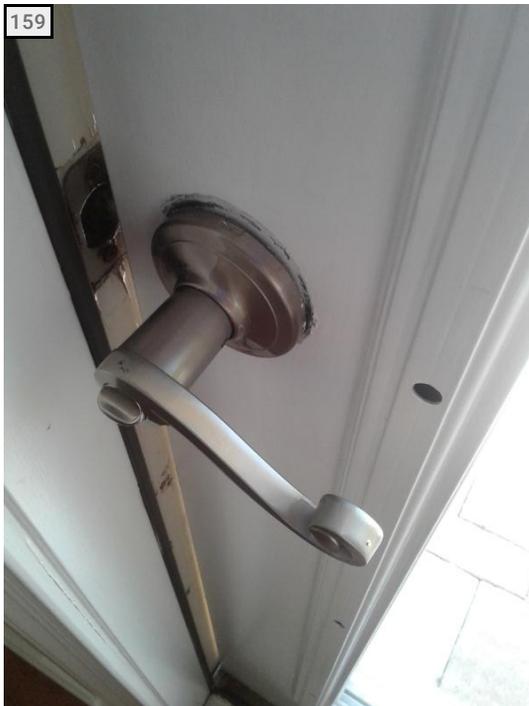
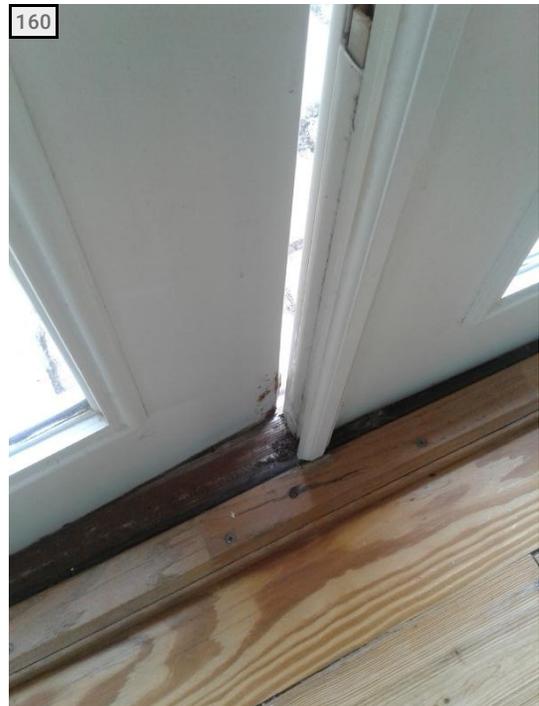
**Does not open and close properly**

Location Master Bedroom, 5th Bedroom

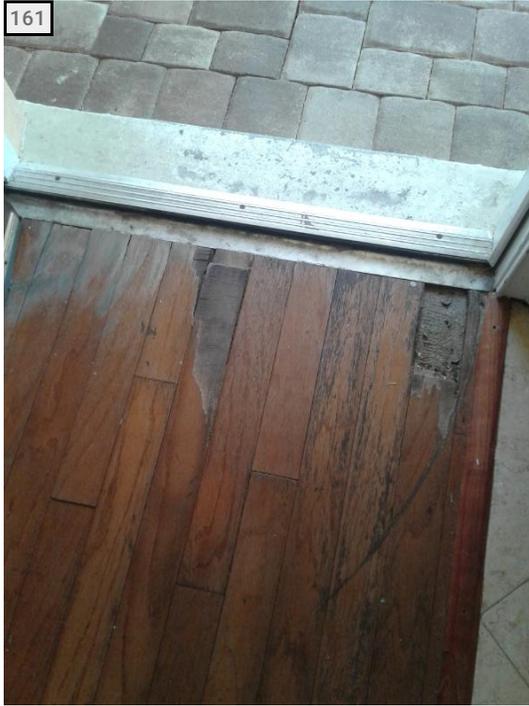
### Damaged

Location Living Room

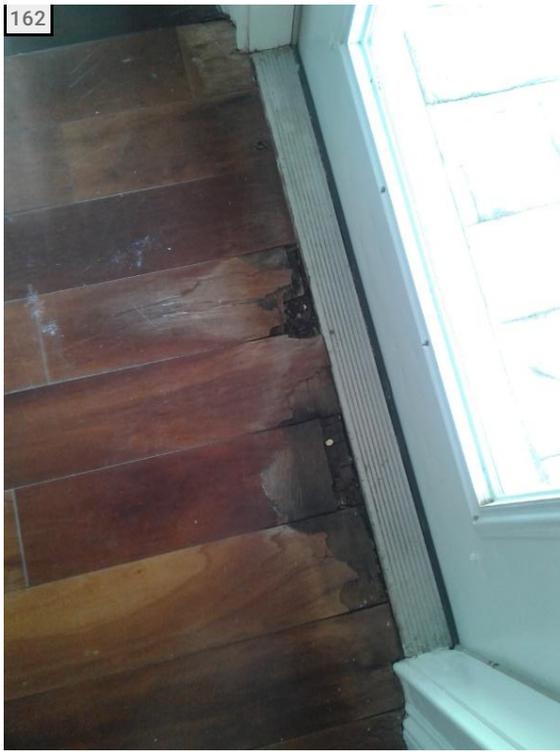
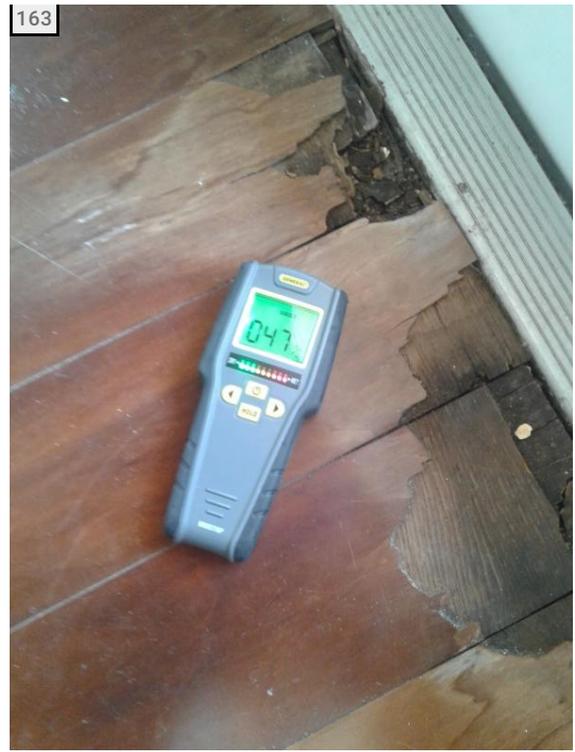
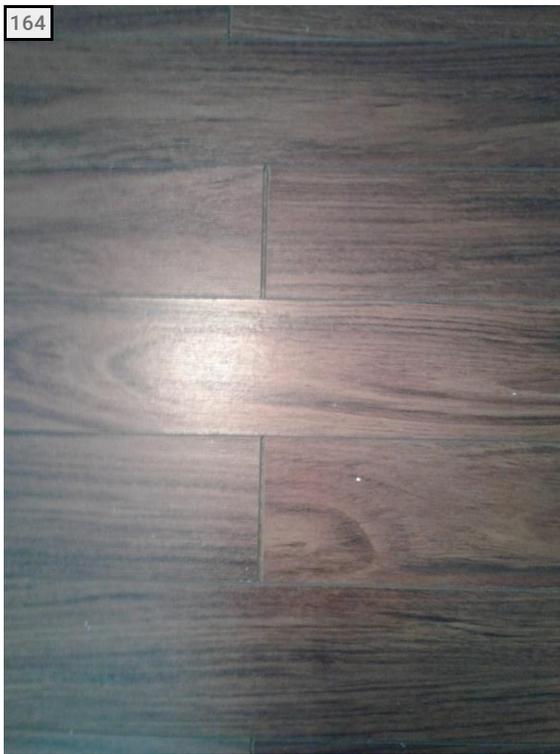
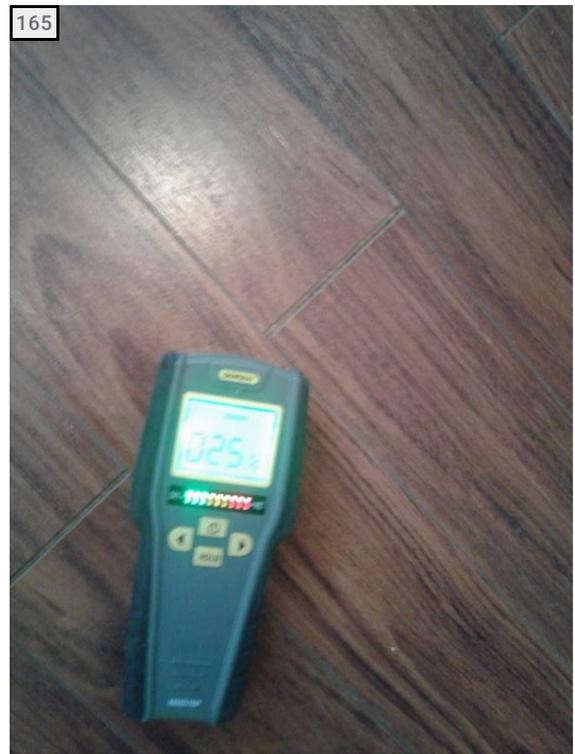
### Laminate is warped and indicates a "wet" condition when tested with the \_\_\_\_\_ moisture meter

Location	Living Room, 4th Bedroom
Impact	Warped floors lack asthetic appeal and may be a trip hazard
Suggested Action	After repairs are made to eliminate the moisture intrusion, monitor the floor to determine if the warping is eliminated when dried. If it is not, replace the warped area
Other Information	When a laminate floor is warped and still wet, the warping may settle

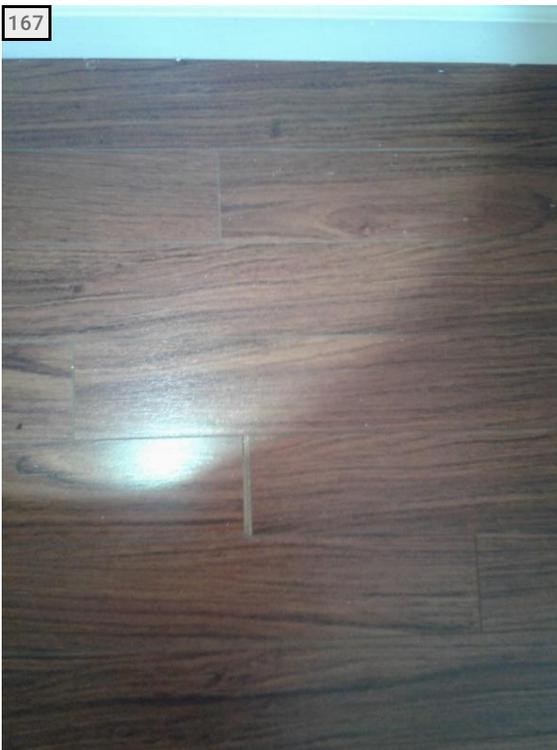
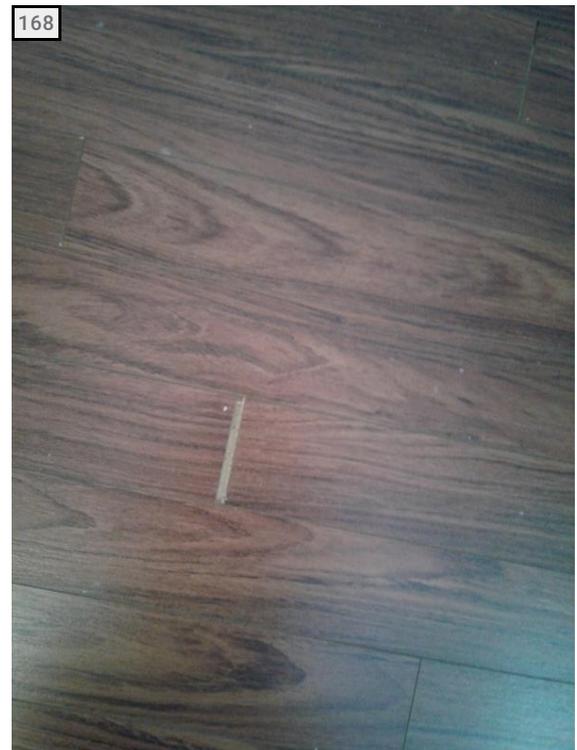
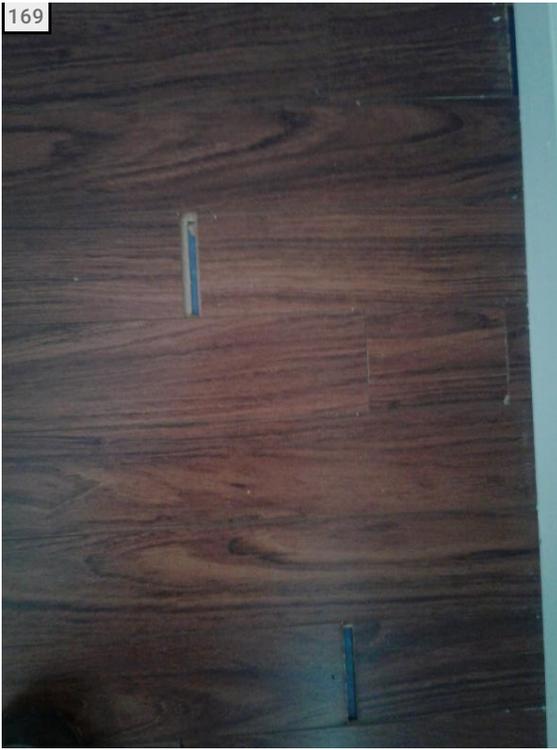
#### Exhibits gaps between the floor boards

<b>Location</b>	3rd Bedroom
<b>Impact</b>	If not repaired, the floor boards may loosen
<b>Suggested Action</b>	Initially increase humidity levels to be between 35% and 50%. If that does not reduce the gaps sufficiently, have repaired by a flooring specialist
<b>Other Information</b>	This is likely caused by a low humidity level causing the flooring to dry and shrink
