# Inspection Report

100 Neptune Dr, Hypoluxo, Florida 33462

**Inspection Date** July 15, 2018  
**Client** Andrew Orndorff  
**Inspector** Brad Bergoine  
561.425.6300  
[brad@mixconsultants.com](mailto:brad@mixconsultants.com)

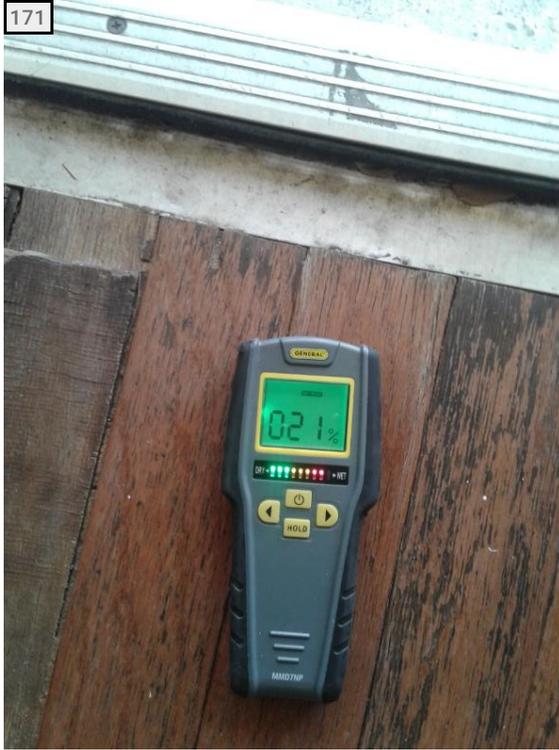
**Laminate is warped and indicates a "dry" condition when tested with the \_\_\_\_\_ moisture meter**

**Location** Living Room  
**Impact** Warped floors lack astethic appeal and may be a trip hazard  
**Suggested Action** Replace the warped area

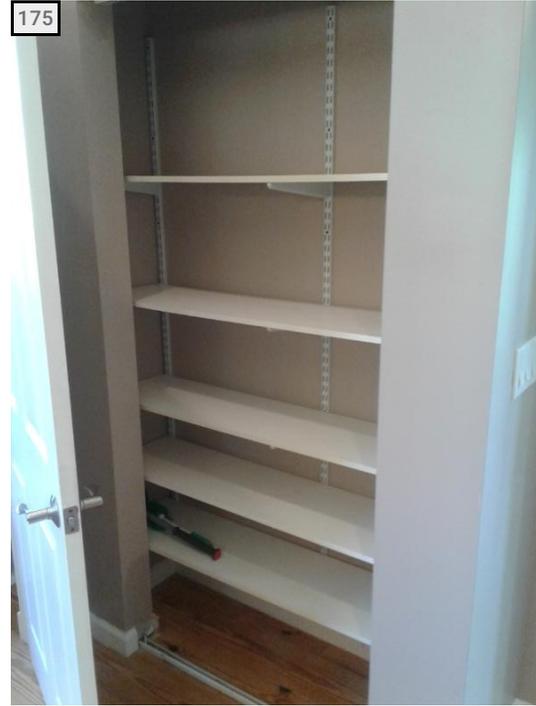
### Missing

Location 4th Bathroom, 5th Bedroom

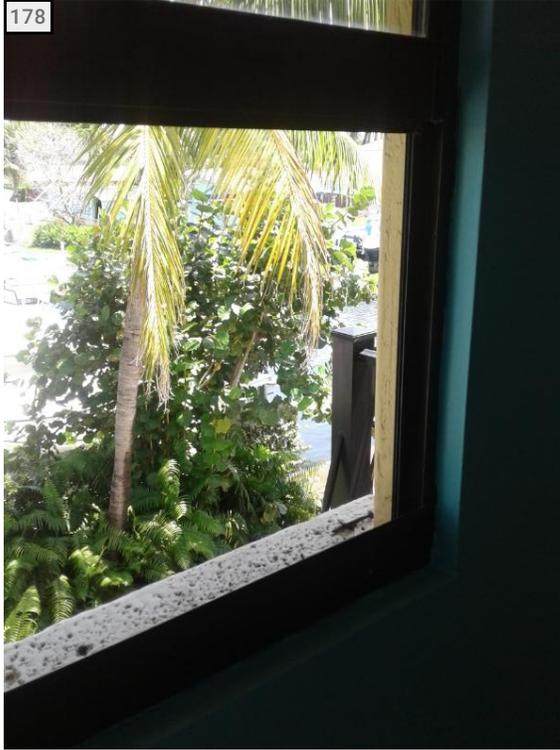
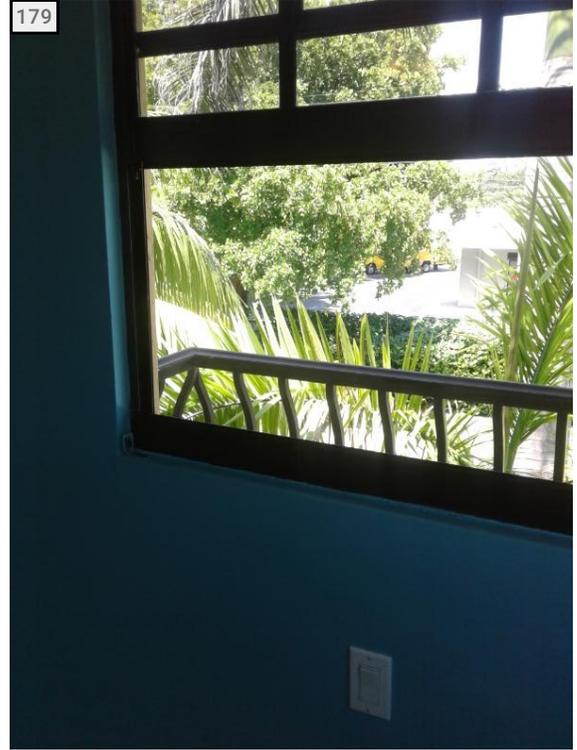
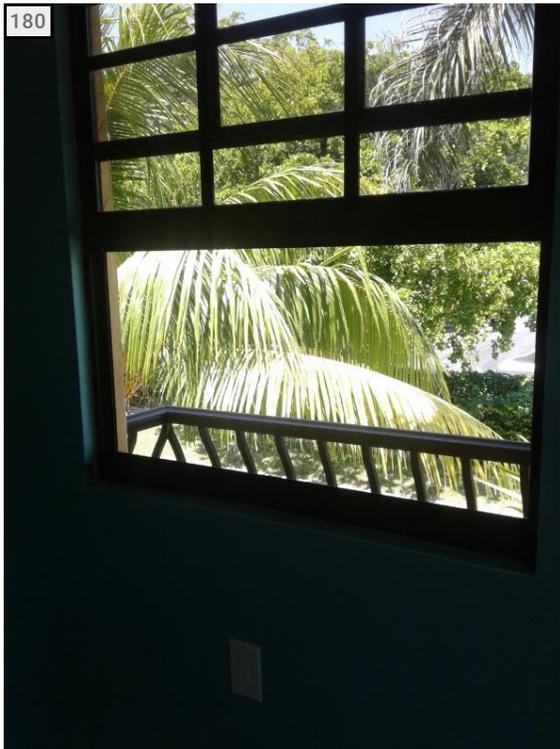
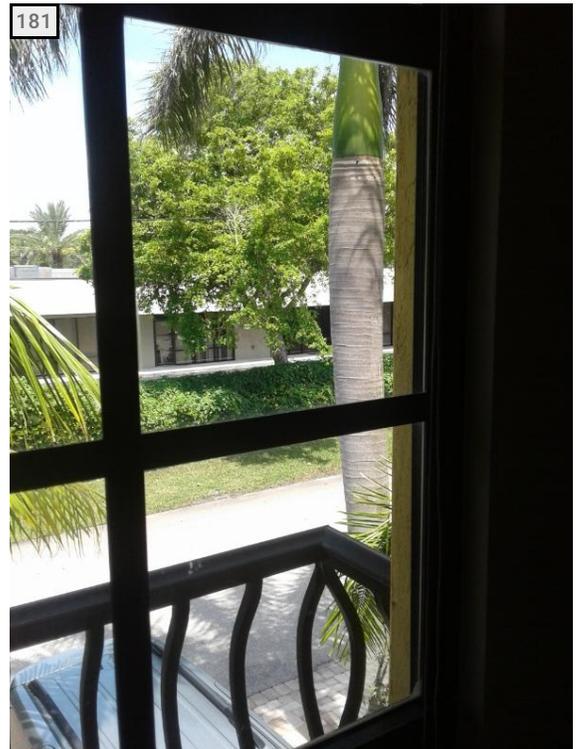
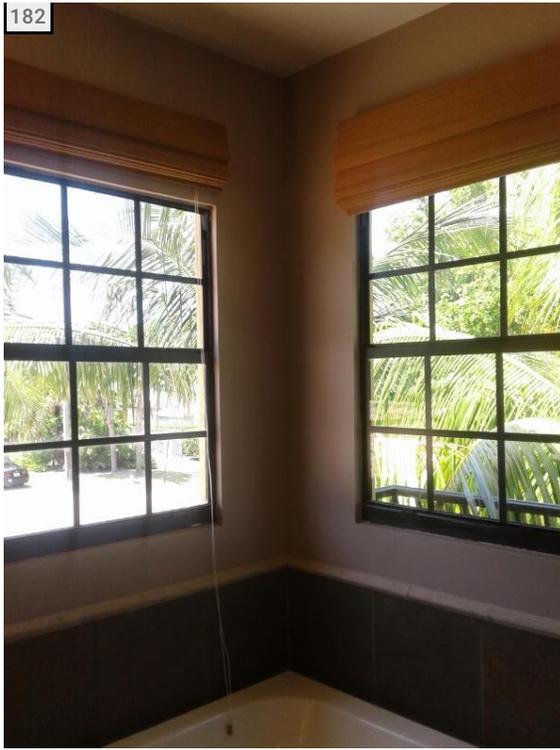
Missing

Location	Master Bedroom, 4th Bathroom
Impact	Should the window be open, lacks protection from insects
Suggested Action	Consult with seller to identify if screens exist. If they do not, install screens as needed

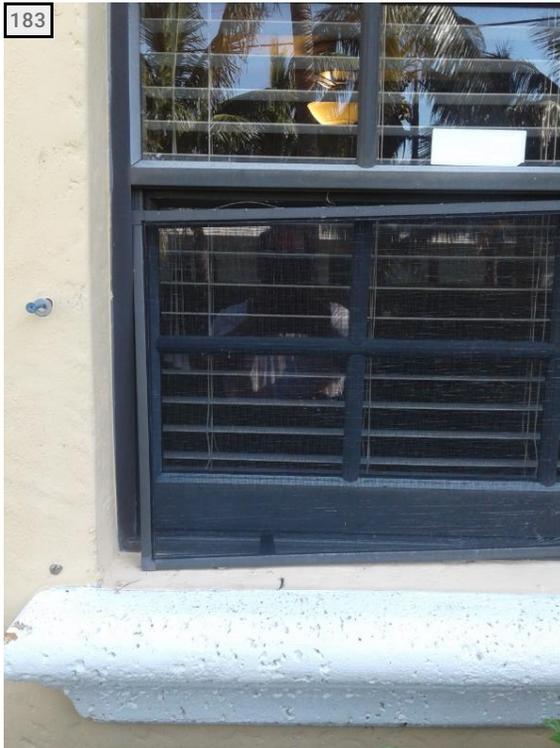
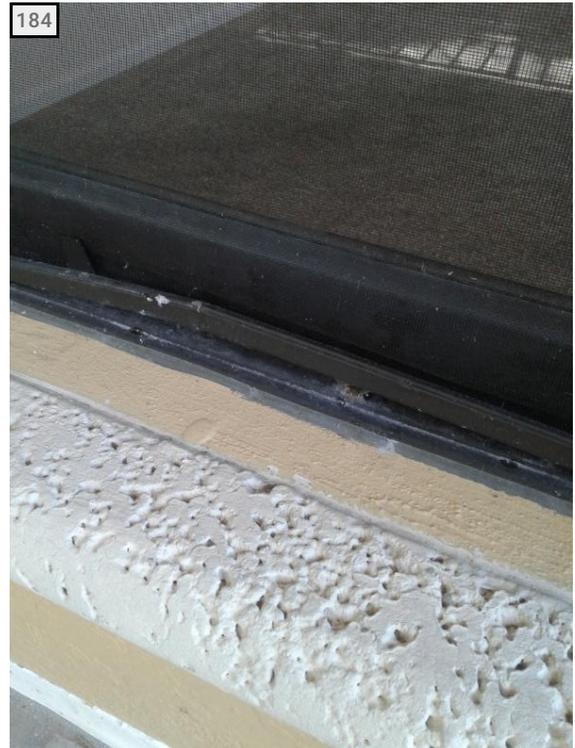
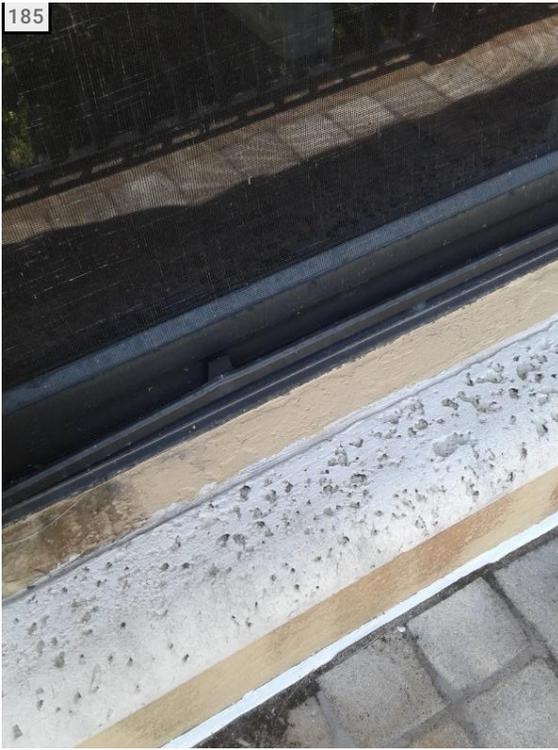
#### Frame is damaged

Location	Exterior: Ground View, Loft
Impact	Should damage continue to grow, screen could be affected
Suggested Action	Replace the screen frame

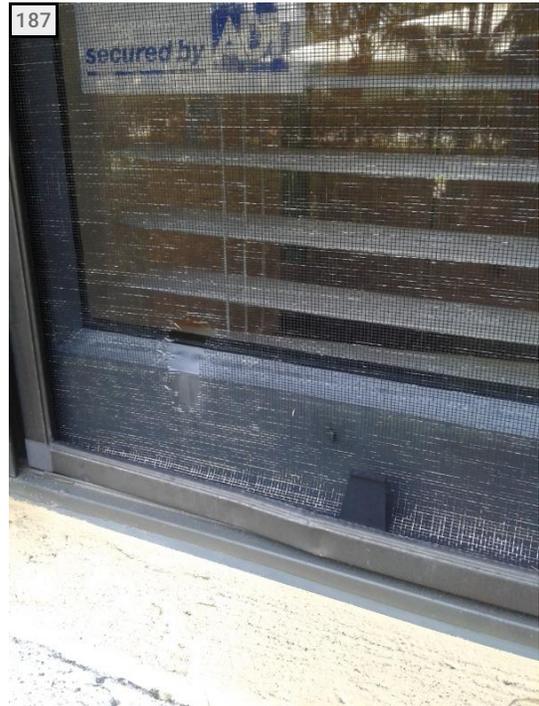
#### Torn or damaged

Location	Exterior: Ground View
Impact	Should the window be open, lacks protection from insects
Suggested Action	Replace the screen

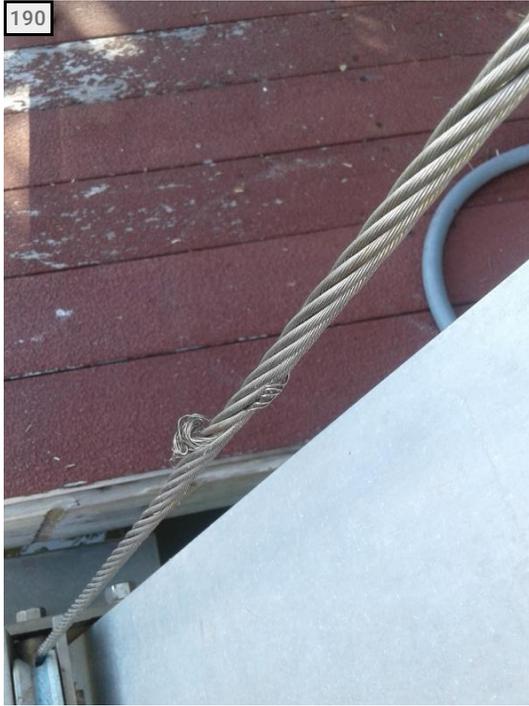
### Damaged

Location Boat Lift

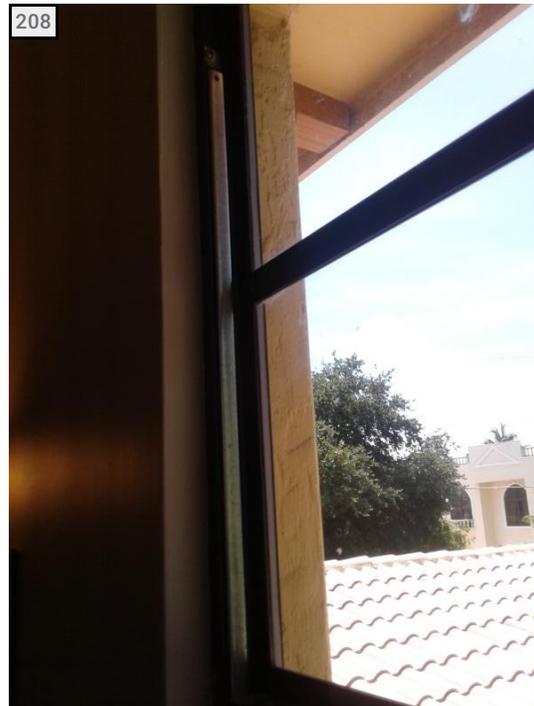
#### Lift mechanism is broken

Location	4th Bathroom
Impact	Without a lift mechanism, the window can not be opened
Suggested Action	Repair or replace the lift mechanism
