This installation had an iFLO unit on it, feeding into the drain line.

This system had previously overflowed and destroyed the garage ceiling below.

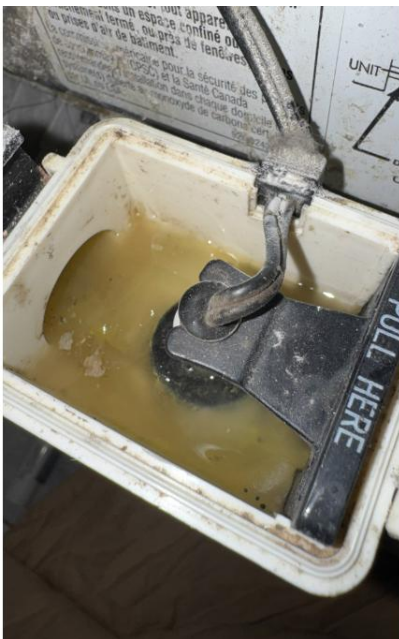
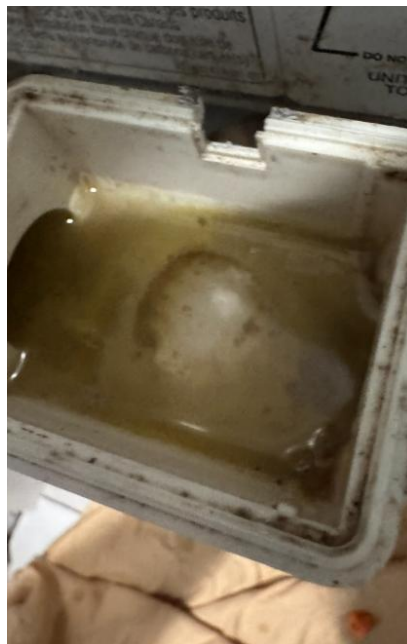
Just looking at the system quickly, there is an in-line Float switch that was completely engulfed with Zoogloea To the point where the float switch was mired in bacteria and could not float:

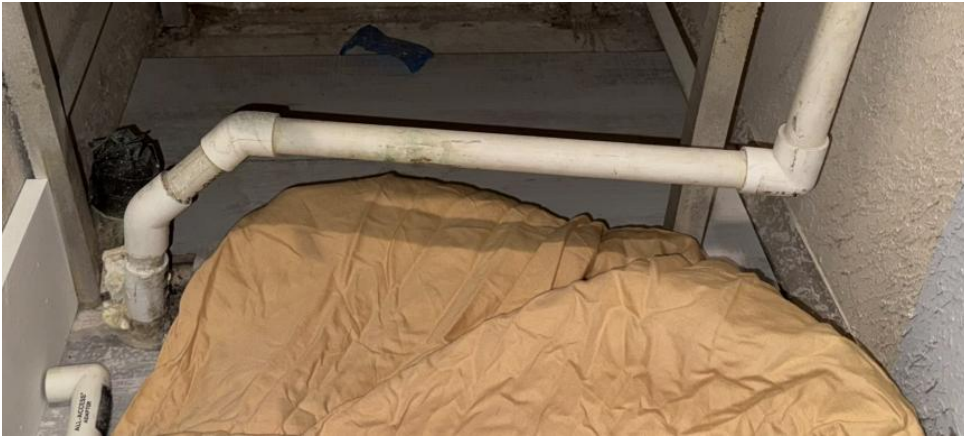
2nd there was a reverse pitch on the drain line. The line is sloped upwards:

The slope of the pipe was maintained as much as possible due to the filter slot, and flexible tubing was used to provide a smooth sloped line to the exit. A union was also added to the line so the whole line can be easily removed and cleaned:

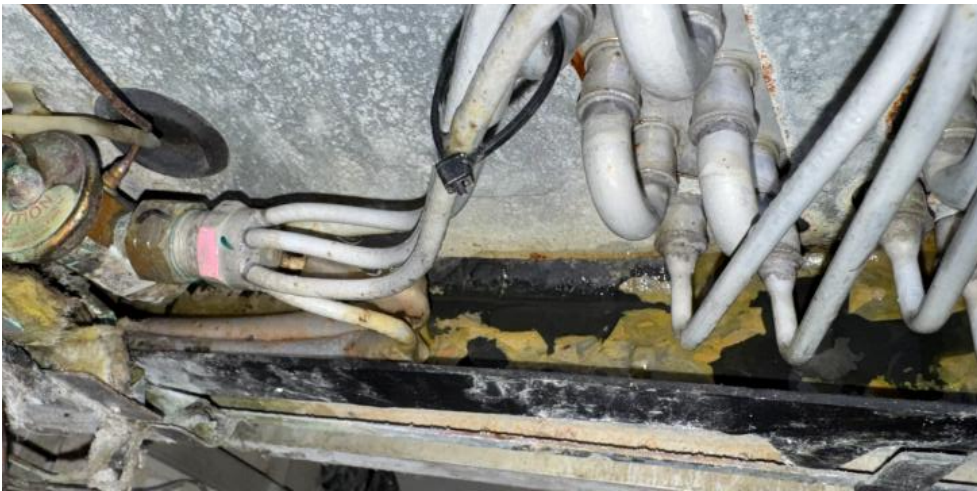
Opening the system, the drain pan held a large amount of bacteria in the side troughs and had some bacteria in the front troughs – again – on a system that was just serviced:

It was evident by the amount of bacteria in the pan that the pan overflowed and the condensate dropped down onto the floor and then down into the garage ceiling.

It took a bit of effort to clear the entire drain pan of Zoog which consisted of using long brushes to reach to the back of the pan and flushing repeatedly with hot water. We use a long rubber vacuum nozzle to reach the back of the pan and flush the Zoog forward after we brush.

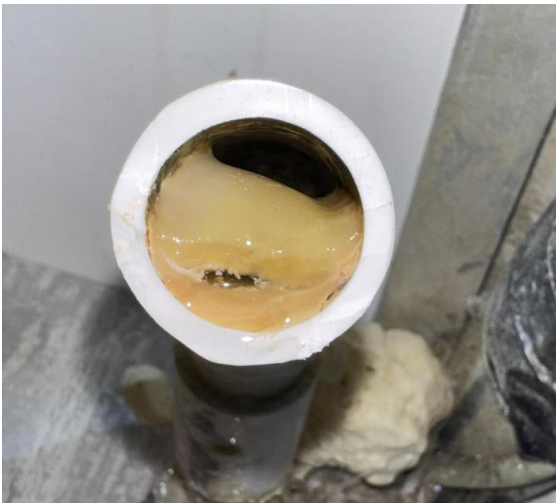
The pipe at the floor was cut so a union could be added:

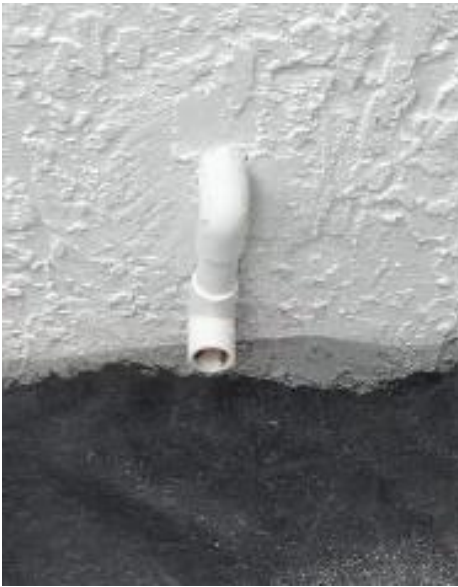
The original piping was rerouted, and a new line was run through the (then open) garage ceiling and routed out the ceiling down the interior side wall of the garage and then out the wall with these fittings outside:

So no trap anywhere in the line...

When the unit was running air was being sucked into the outside fitting, so there was no outflow of condensate while the AC system was running. Therefore condensate was remaining in the drain pan until the AC system turned off, or the float switch tripped, *which was impossible with the float switch stuck in the bacteria...*

A “P-trap” was added to the line on the outside and the condensate now streams from the line and is no longer a slow drip:

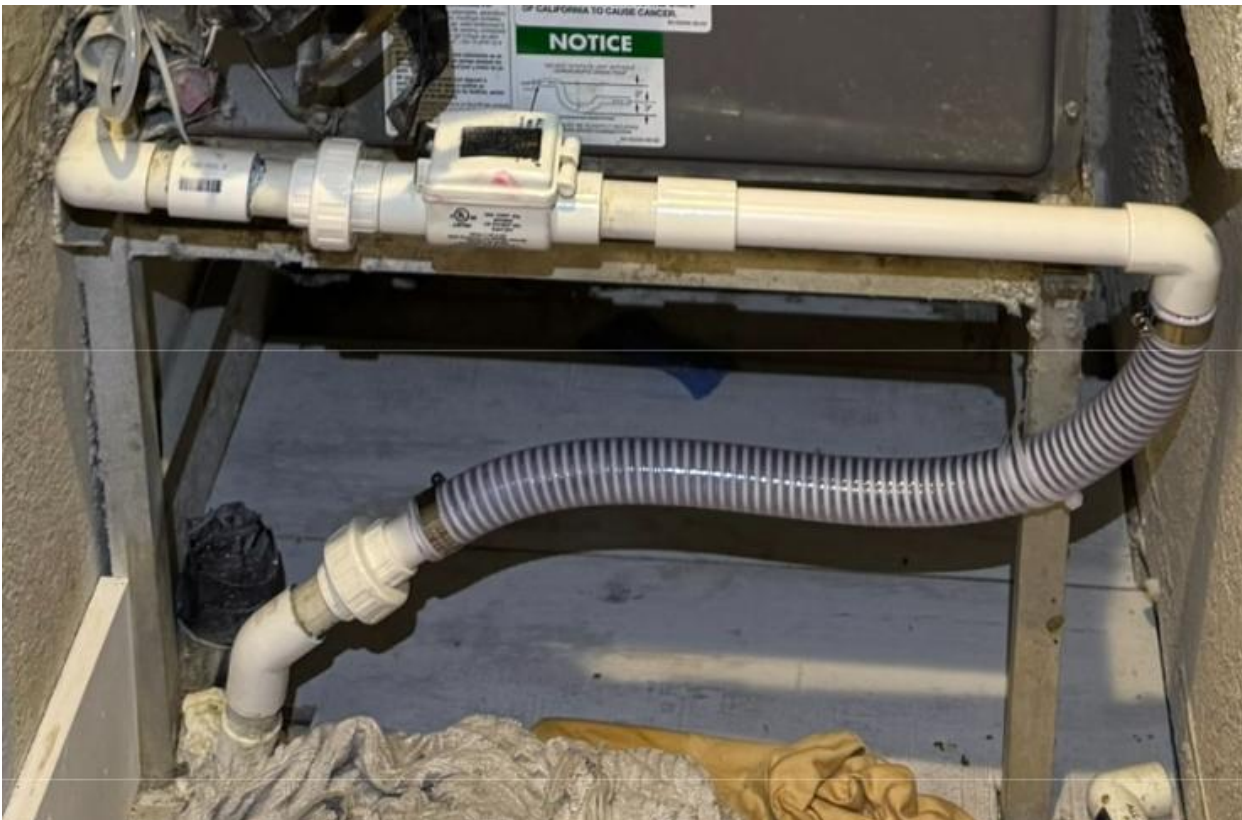
The piping from the drain outlet was rebuilt – as there was a hole in the pipe from the iFLO.
