285 Home Inspection Services LLC

Home Inspection Report

117 Elk Creek Drive

Inspected on Tue, Apr 2 2019 at 10:09 AM

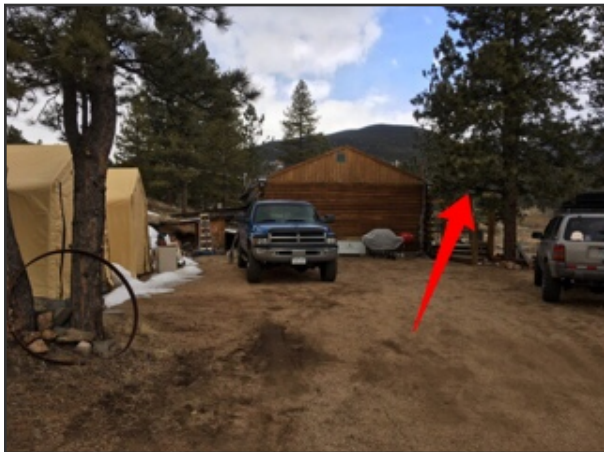
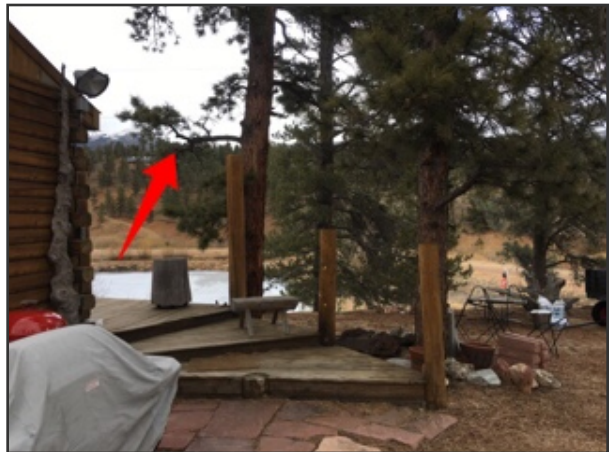
Not Growing Against Structure
Condition: Marginal

For the most part the vegetation at this property is well-maintained there are a couple of areas where indicated in the photographs that the trees should be limbed up away from the structure.

1) For the most part the vegetation at this property is well-maintained there are a couple of areas where indicated in the photographs that the trees should be limbed up away from the structure.

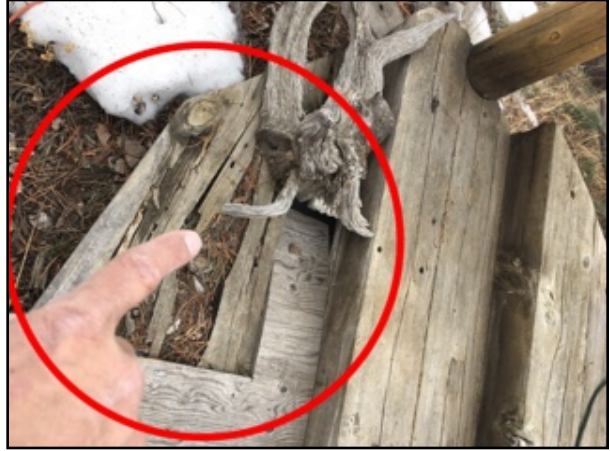
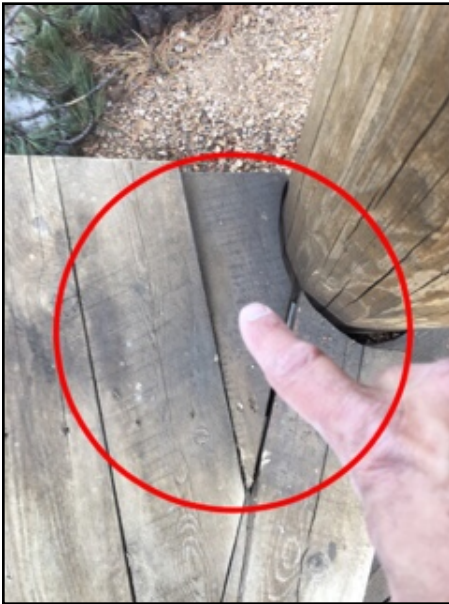
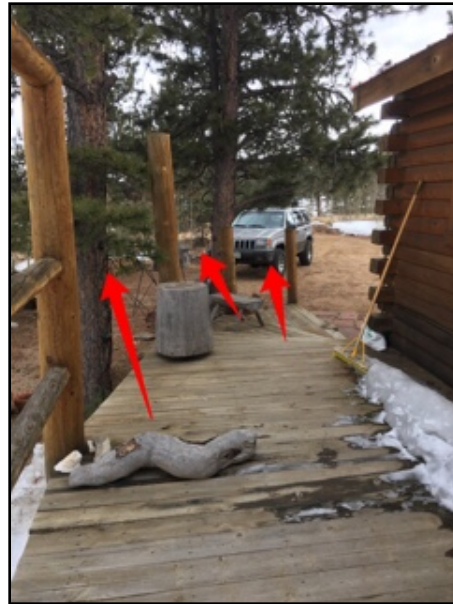
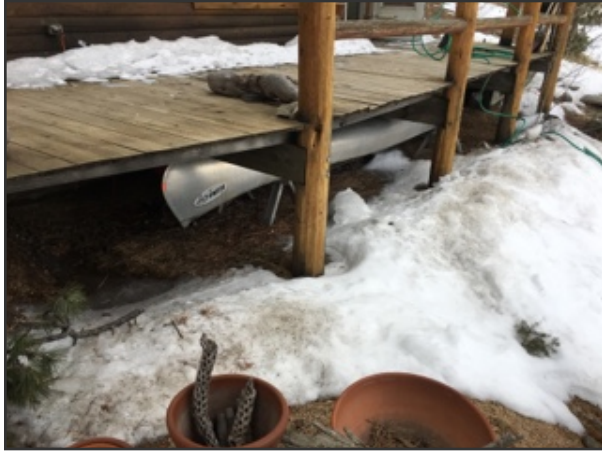
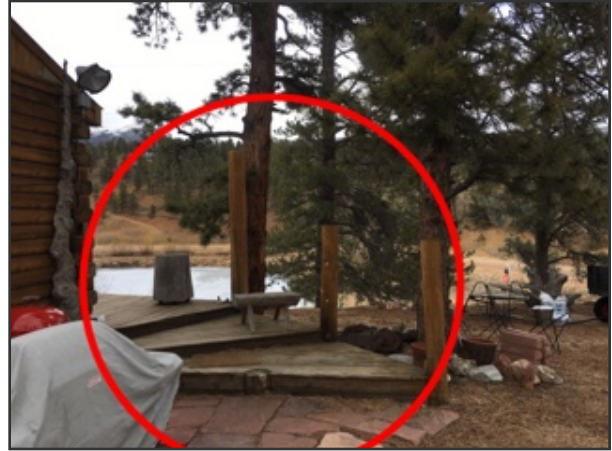
Condition: Repair or Replace

The deck at this house on the northside leading to the front door is older and is showing its age there are areas where the wood is loose and could be a tripping hazard. Where indicated in the photographs there is no handrail which could be a hazard and should be corrected.

2) The deck at this house on the northside leading to the front door is older and is showing its age there are areas where the wood is loose and could be a tripping hazard. Where indicated in the photographs there is no handrail which could be a hazard and should be corrected.

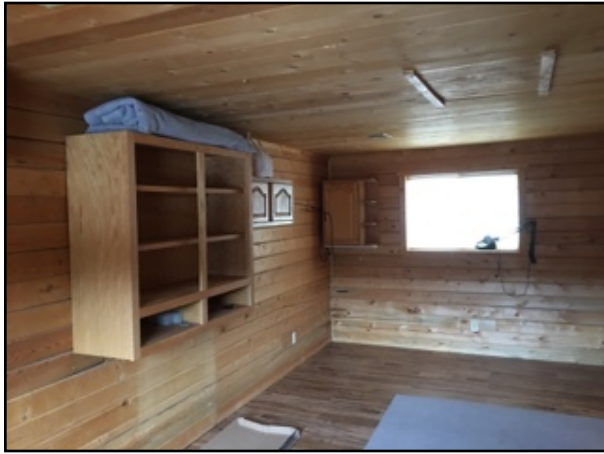
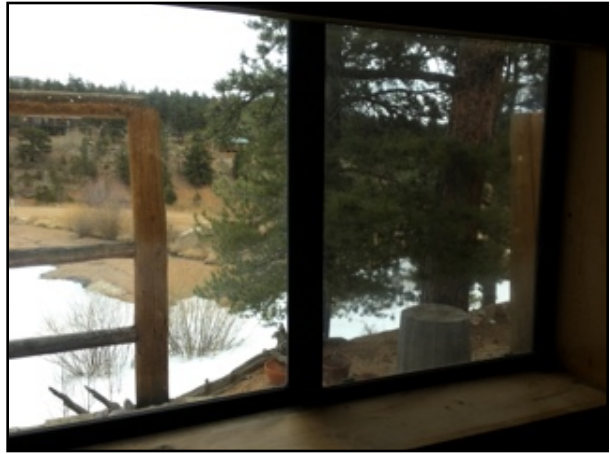
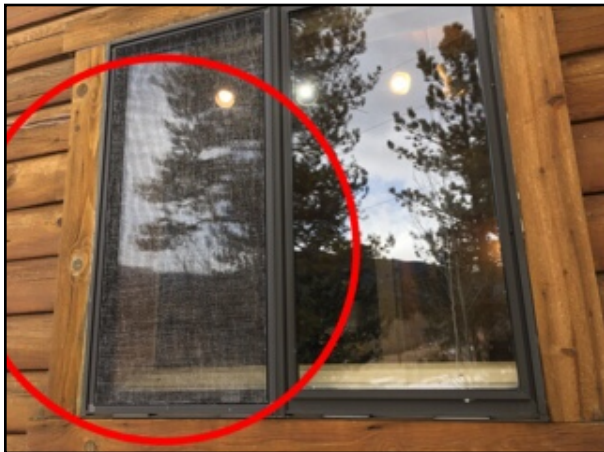
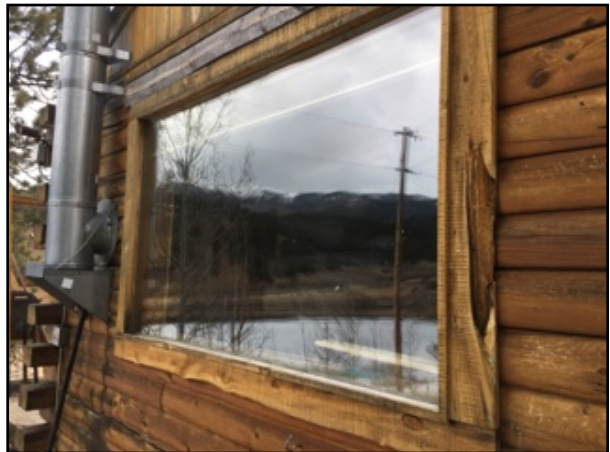
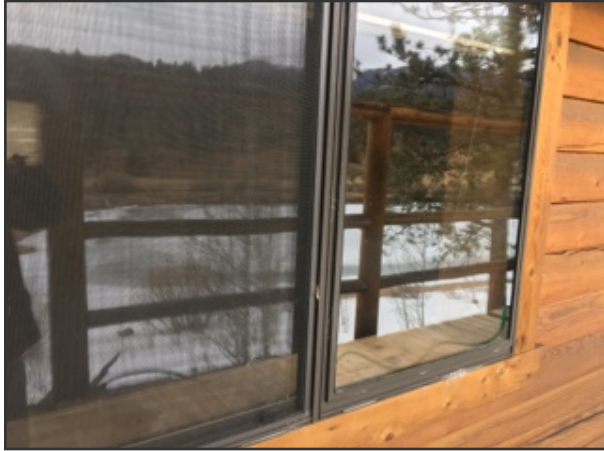
Condition: Marginal

The windows at this home are older aluminum double pane windows I did not notice any leaking seals on these windows. There are some screens that are torn and should be replaced.

3) The windows at this home are older aluminum double pane windows I did not notice any leaking seals on these windows. There are some screens that are torn and should be replaced.

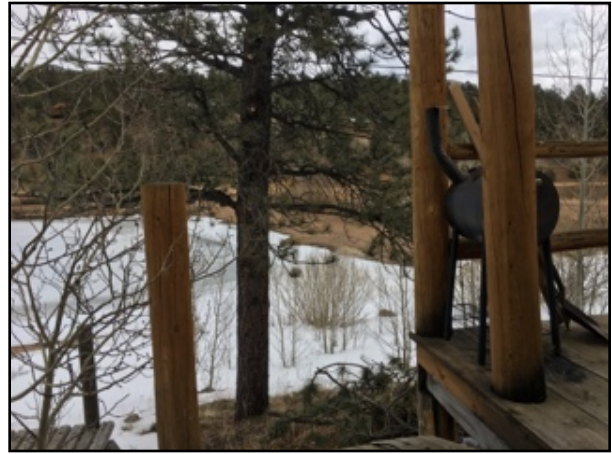
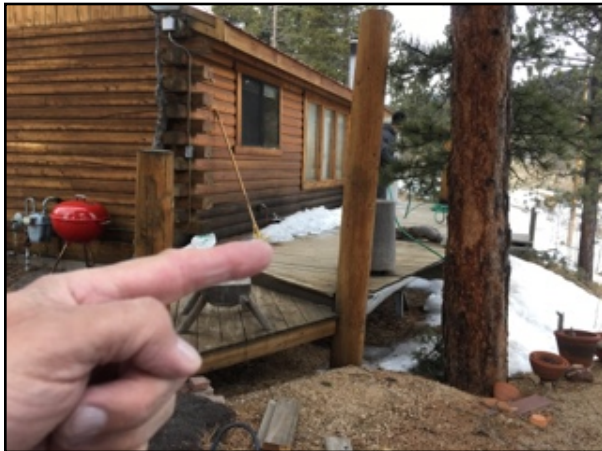
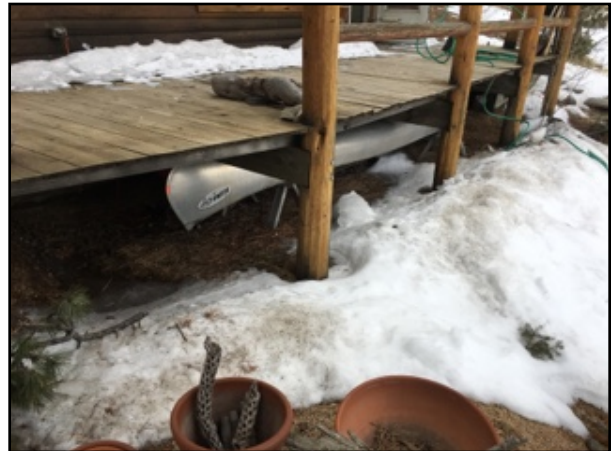
Condition: Marginal

On the north east side of the home where the deck meets the driveway there are no handrails. This could be hey hazardous condition considering that the deck is raised more than 18 inches off the ground it is highly recommended that some sort of handrail be added to this section.

4) On the north east side of the home where the deck meets the driveway there are no handrails. This could be a hazardous condition considering that the deck is raised more than 18 inches off the ground it is highly recommended that some sort of handrail be added to this section.

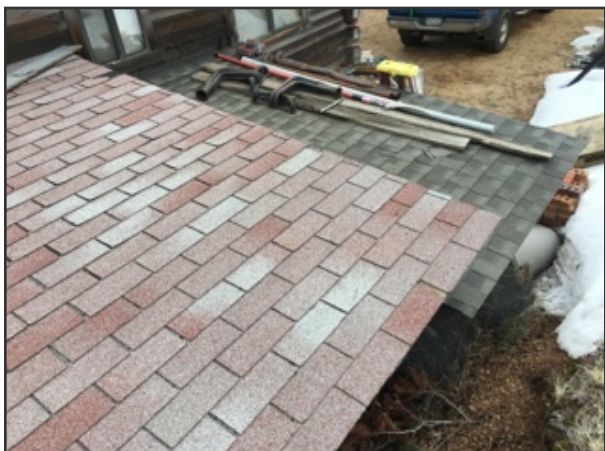
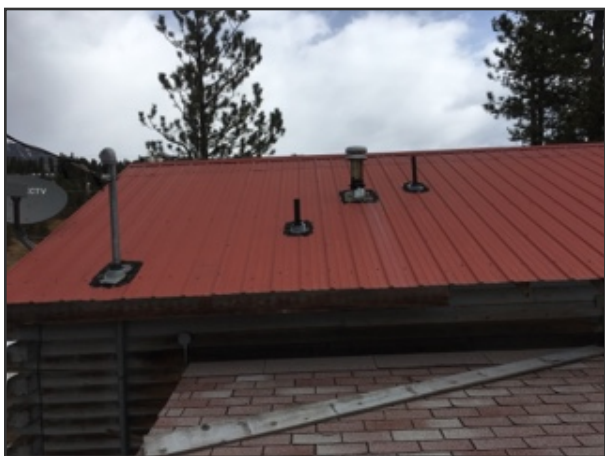
Roof Design: Gable
Roof Covering: 3 Tab Shingle, Metal
Condition: Marginal

The roof on this home is a combination of metal and three tab shingle which is located on the southern lean to section. The shingles are showing wear and should eventually be replaced. The metal roof shows some age as well but appears to be in good condition overall.

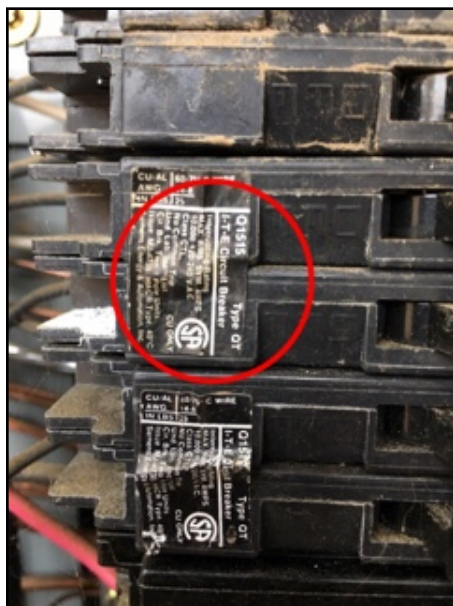
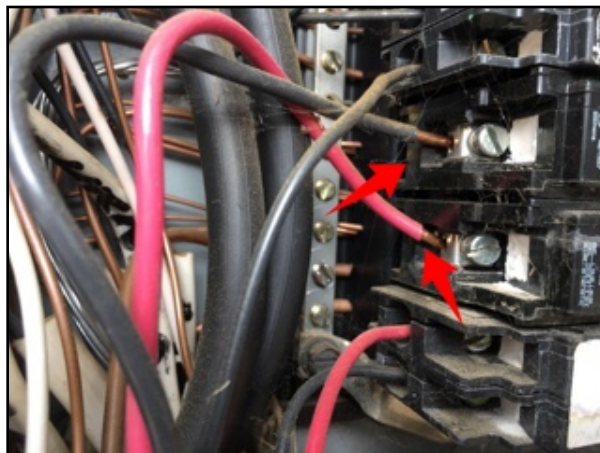
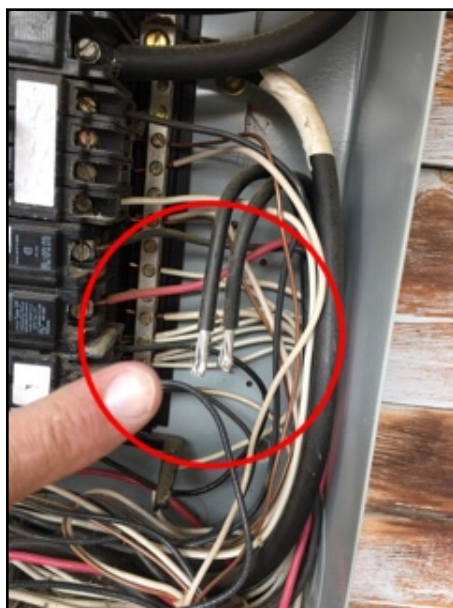
Condition: Further Evaluation Required

The service panel is located on the southwest part of the home, upon opening the service panel it is noted that there is no dead front protection to this panel. This is a possible shock hazard and should be addressed by a licensed electrician as soon as possible.

5) The service panel is located on the southwest part of the home, upon opening the service panel it is noted that there is no dead front protection to this panel. This is a possible shock hazard and should be addressed by a licensed electrician as soon as possible.

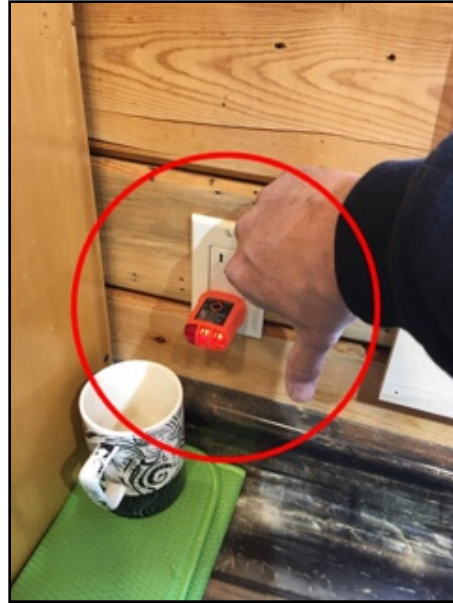
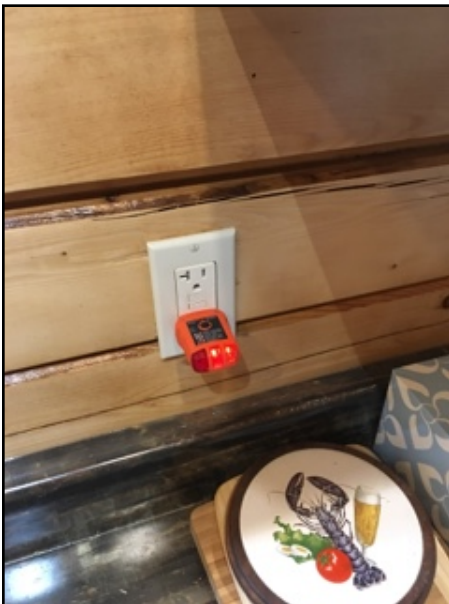
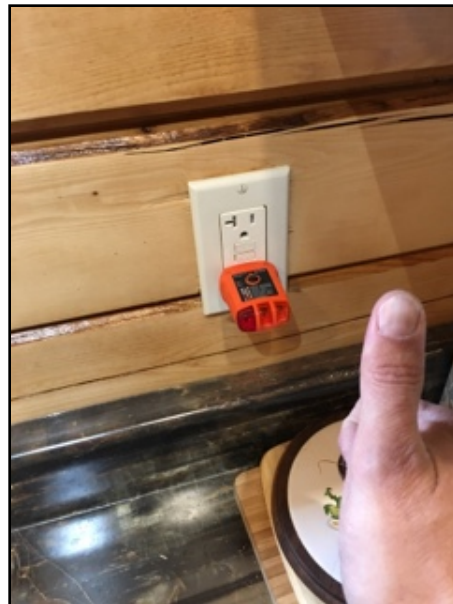
Condition: Repair or Replace

In the kitchen area to the left of the sink one outlet does not have a GFCI breaker connected to it. It is highly recommended that a licensed electrician review this and re-connect to an available breaker. All other outlets near the water source are GFCI and are acceptable.

6) In the kitchen area to the left of the sink one outlet does not have a GFCI breaker connected to it. It is highly recommended that a licensed electrician review this and re-connect to an available breaker. All other outlets near the water source are GFCI and are acceptable.

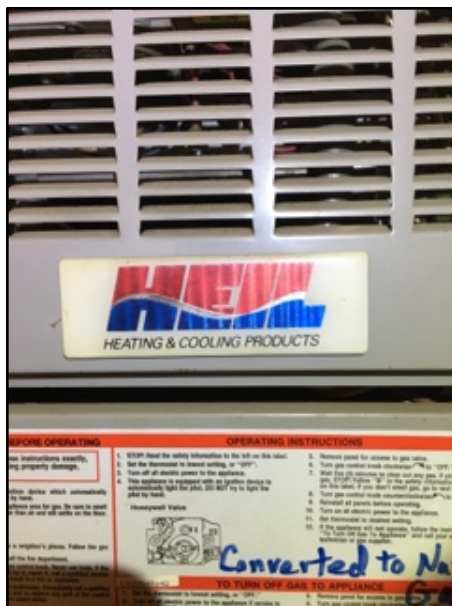
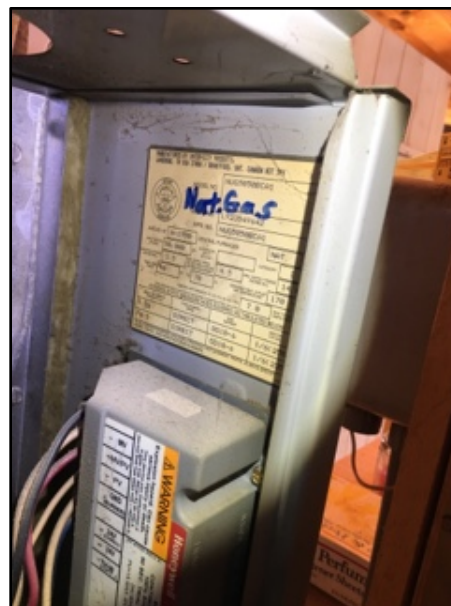
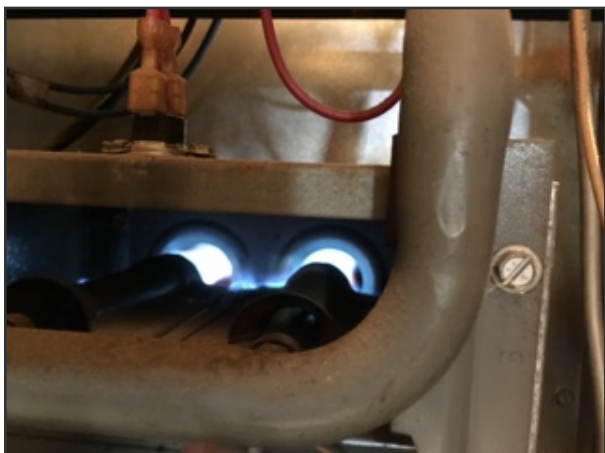
The furnace in this home has been converted to natural gas and does appear to be the original unit for this home. It is highly recommended that the furnace be cleaned and certified by a HVAC professional.

Furnaces over 10 years old should be checked, cleaned and serviced yearly by a licensed contractor.

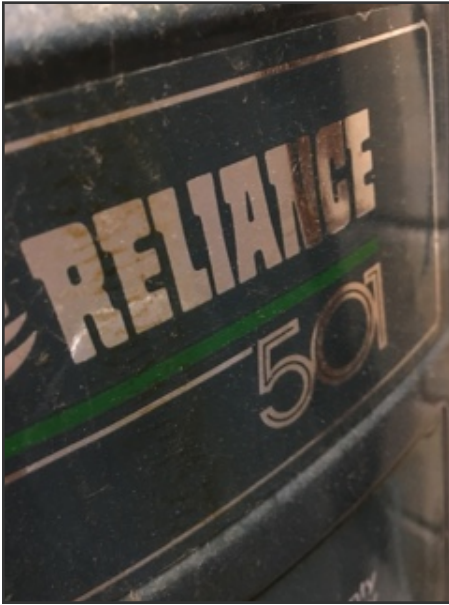
During the inspection the owner of the property asked to have the plumbing system inspected first so that he can winterize prior to his leaving. I did an initial check and noticed that hot water temperature was acceptable and water pressure was within the normal range. It is highly recommended that a well flow test and a water potability test be performed at some point.

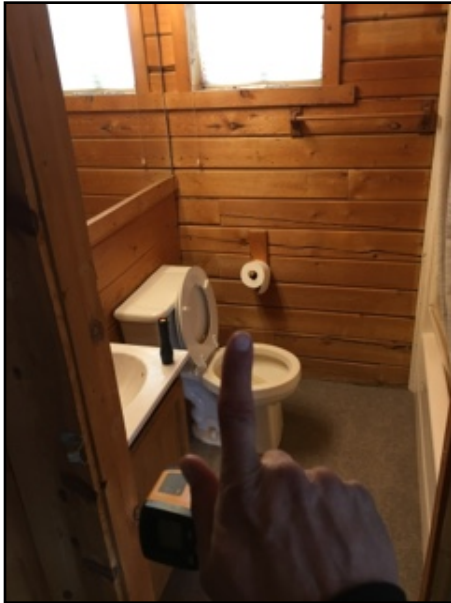
Figure 11-1

The homes full bathroom is located in the main hallway the toilet is a bit loose and should be tightened. The shower fixture is leaking slightly but all in all the bathroom is fully functional.

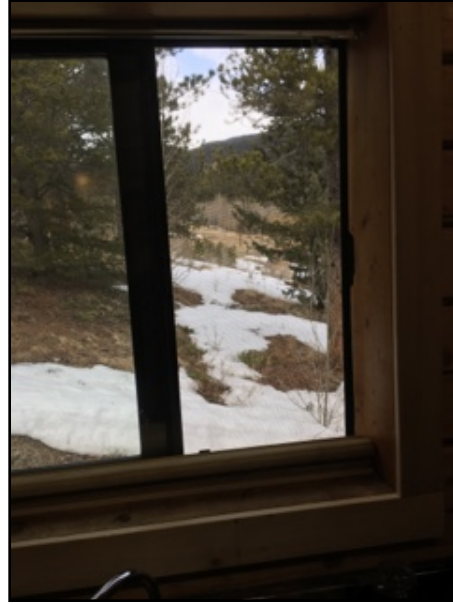
Windows are a double pane aluminum design there are a few torn screens that should be replaced.

8) Windows are a double pane aluminum design there are a few torn screens that should be replaced.

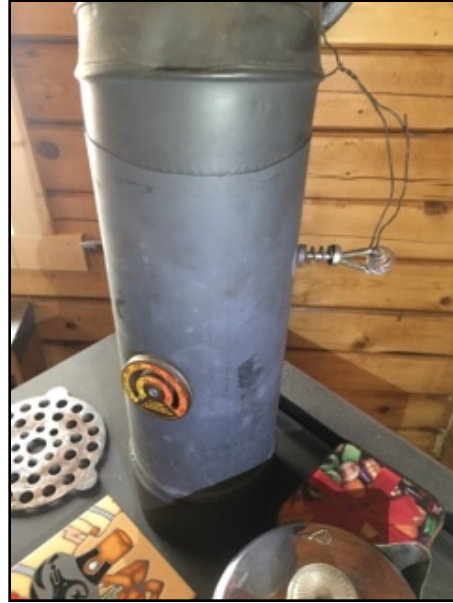
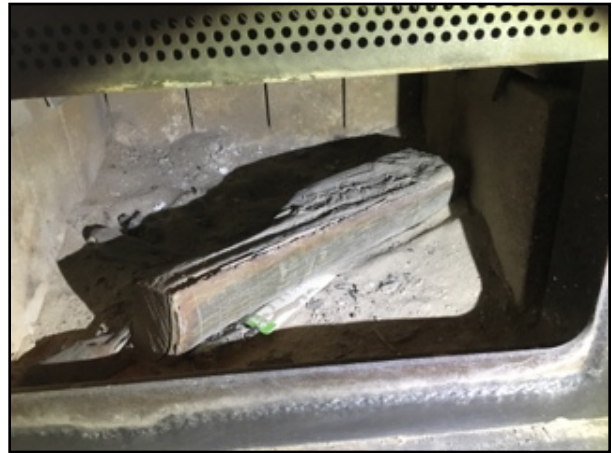
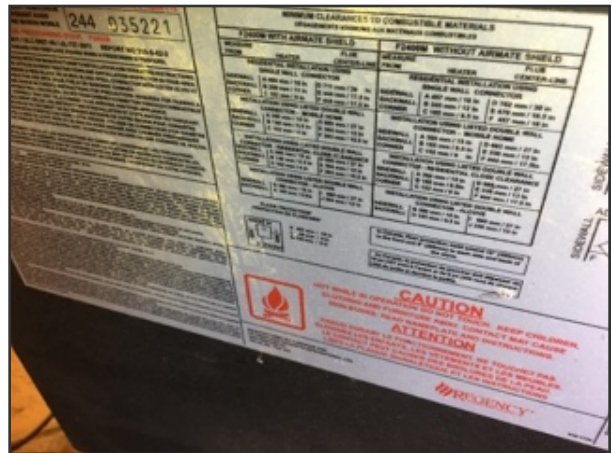
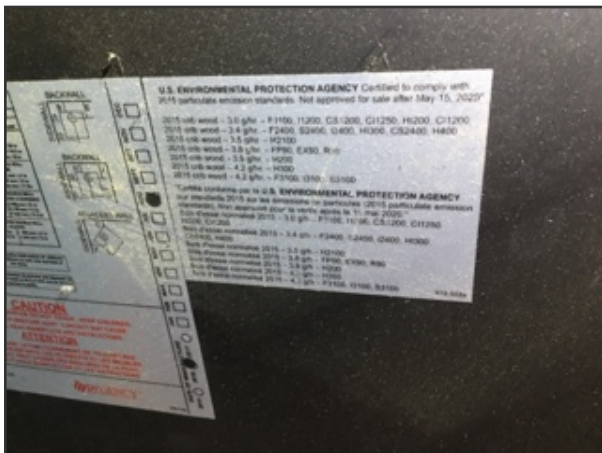
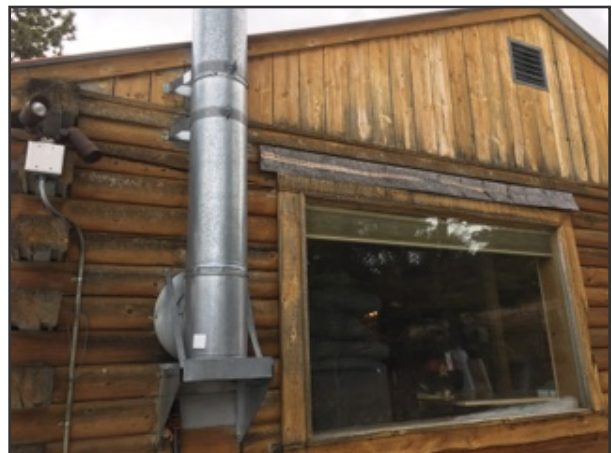
With all wood-burning stoves it is highly recommended that a professional chimney sweep clean the flue and certify the woodstove prior to first use.
