Home Inspection Report

1288 Royal Ridge Drive

Inspected on Fri, Jul 24 2020 at 2:14 PM

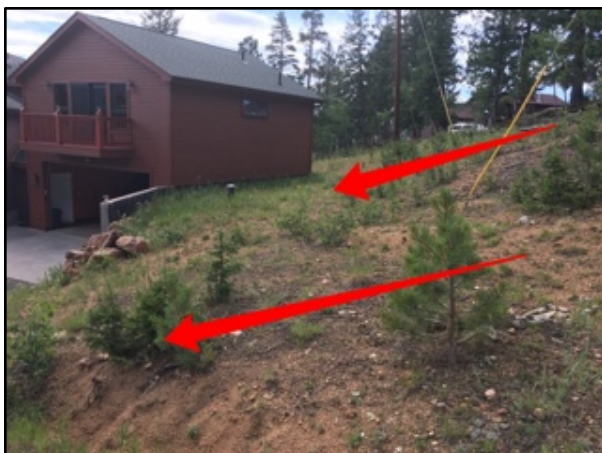
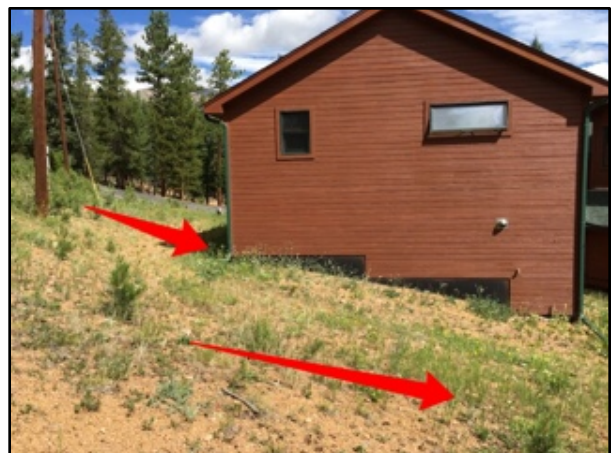
Site Grading: Sloped Toward Structure
Condition: Marginal

This home is built into a hillside with two levels above grade and a walk out basement. The site drainage is well planned and doesn't provide a particularly bad water pathway.

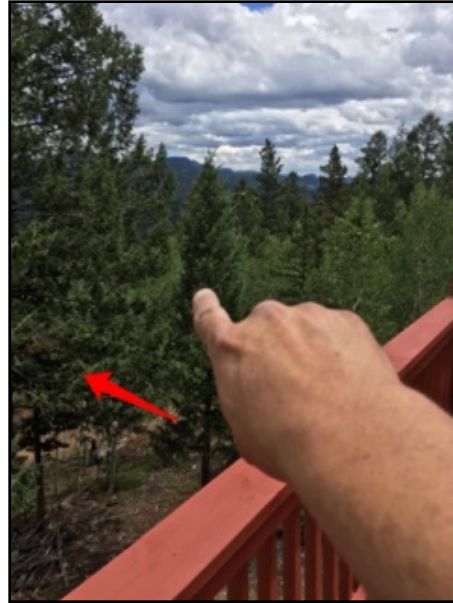
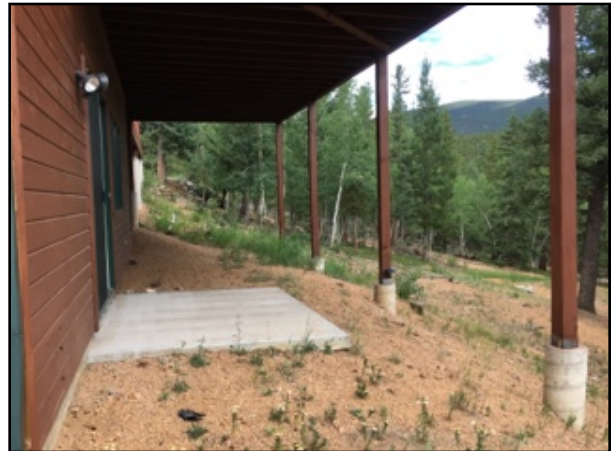
Not Growing Against Structure
Condition: Satisfactory

Generally the vegetation around this home is in very good condition there are a few pine trees that could be limbed up to a height of approximately 15' from the ground, however there are no glaring issues for fire mitigation concerns.

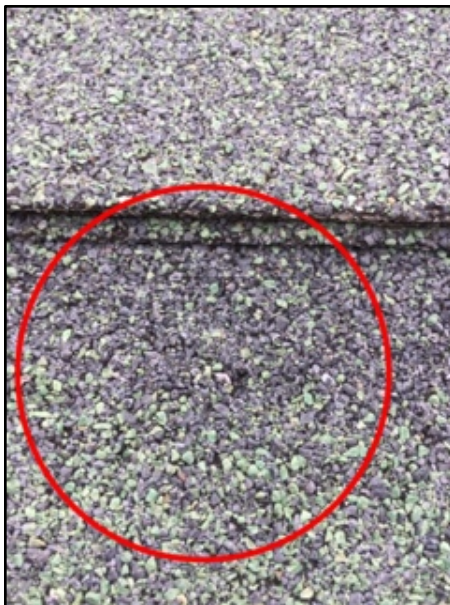
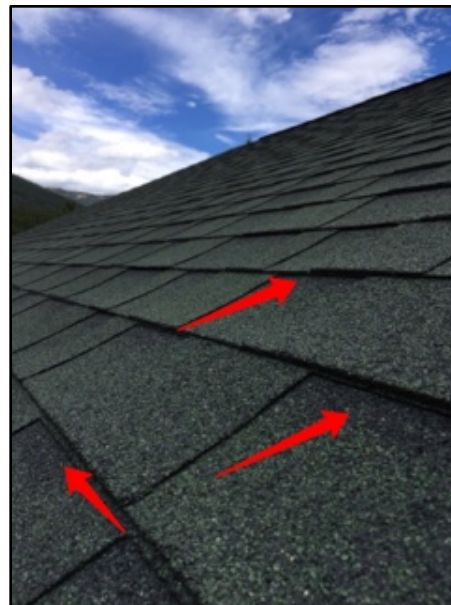
Condition: Marginal

The roof on this home is beginning to show its age and is estimated to be approximately 10 to 12 years old. Although the roof does have life left in it it is recommended that the roof be further evaluated by a qualified roofing contractor.

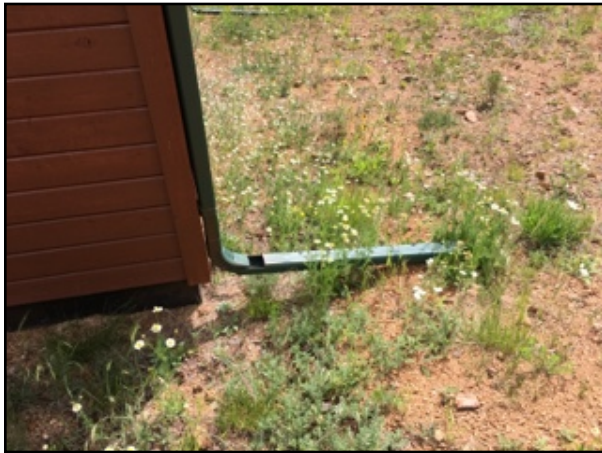
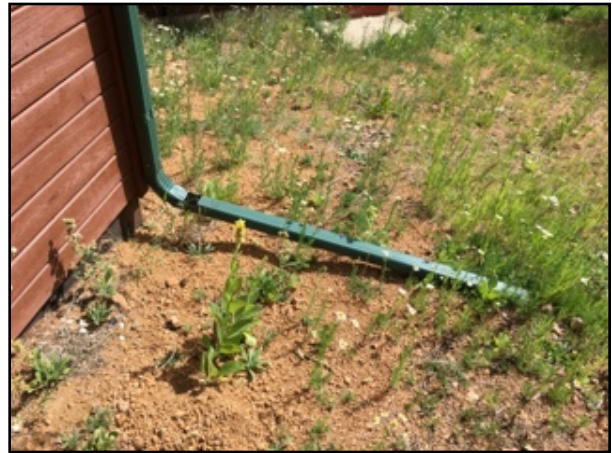
Condition: Marginal

Gutters on this home should be cleaned as they do contain some Pineneedles and other debris.

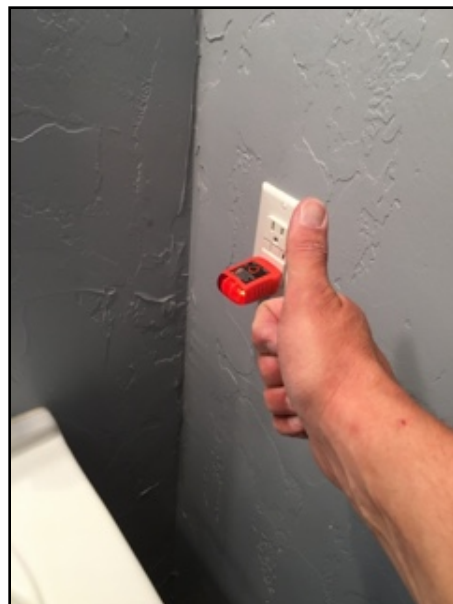
Yes
Condition: Repair or Replace

All GFCI outlets in the home the kitchen and the bathrooms all function normally. The only exception was in the guest suite at the wet bar there was no connection to GFCI and could not find a reset breaker. These two outlets in the guest suite should be re-wired properly to a GFCI outlet breaker.

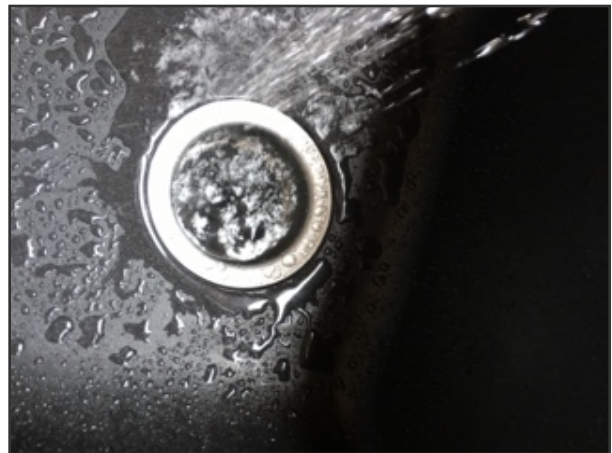
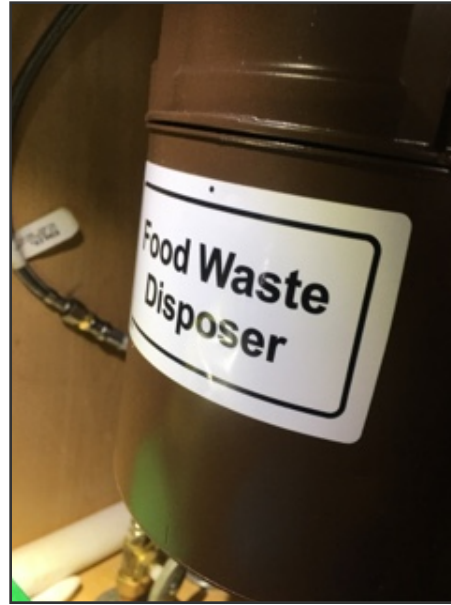
Condition: Repair or Replace

On activating the disposal electrical switch the disposal did not operate during this inspection it is recommended to have this removed and replaced as soon as possible.
