285 Home Inspection Services LLC

Home Inspection Report

196 Beaver Trail

Inspected on Fri, Feb 22 2019 at 9:16 AM

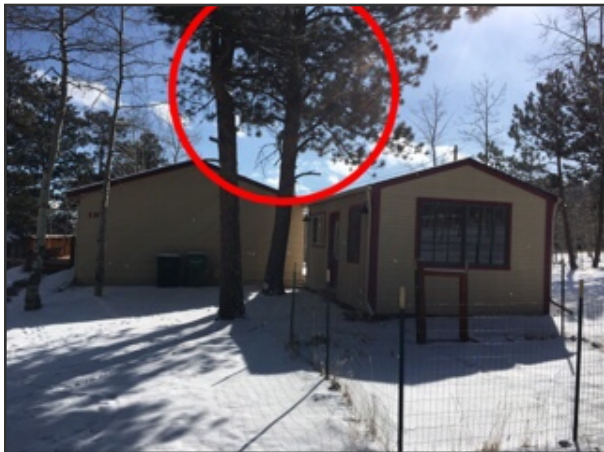
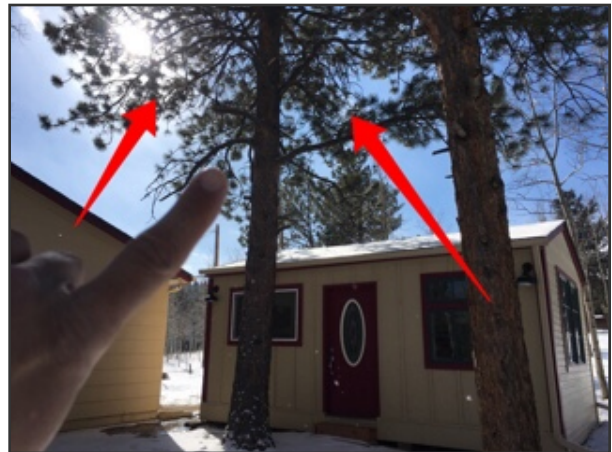
Not Growing Against Structure
Condition: Marginal

Generally there is no vegetation against the home or the detached workshop. However the one Pinetree located very near the home as pictured could be a fire hazard. It is recommended that this tree be removed as soon as practicable. All other trees are aspens and are except a bowl as they are not nearly as flammable as Pines.

1) Generally there is no vegetation against the home or the detached workshop. However the one Pinetree located very near the home as pictured could be a fire hazard. It is recommended that this tree be removed as soon as practicable. All other trees are aspens and are except a bowl as they are not nearly as flammable as Pines.

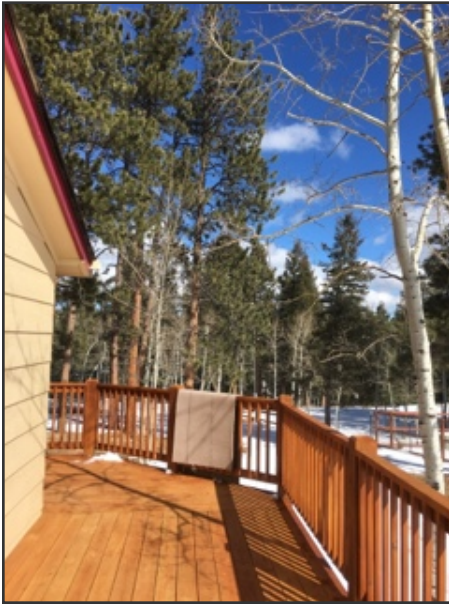
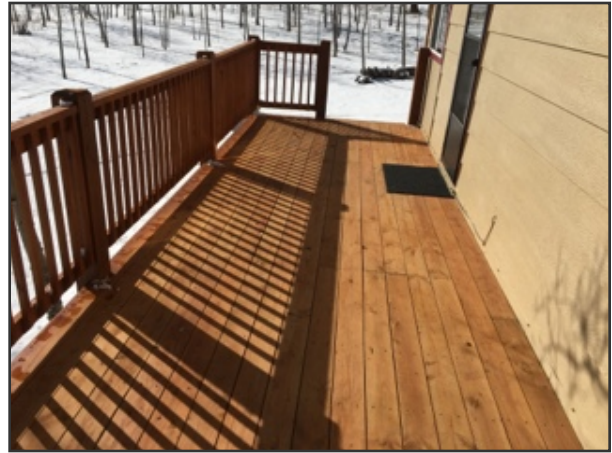
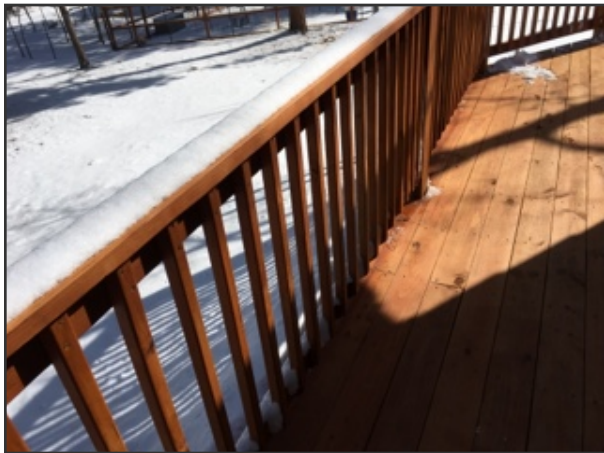
The wood deck at this home is in very good condition and appears to be very new. No problems found with construction of the stack handrail styles are an appropriate distance and do not pose any hazard.

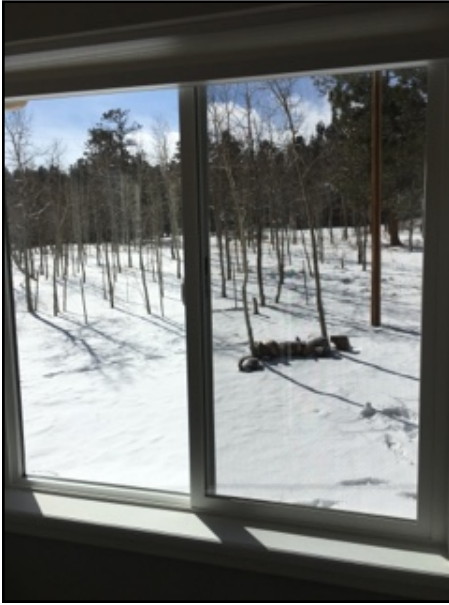
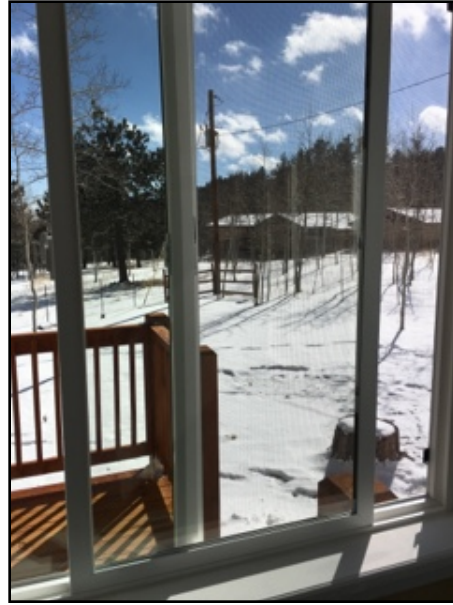
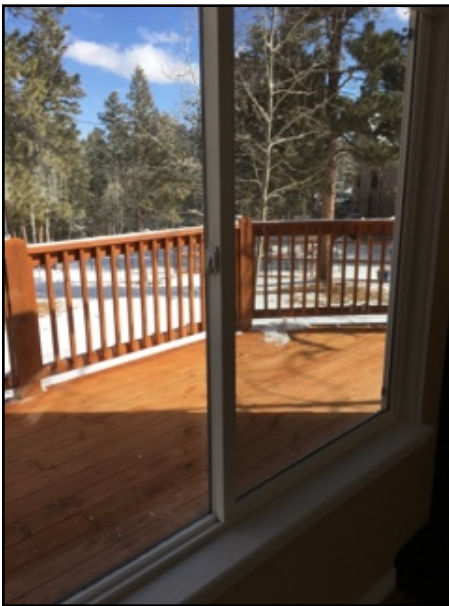
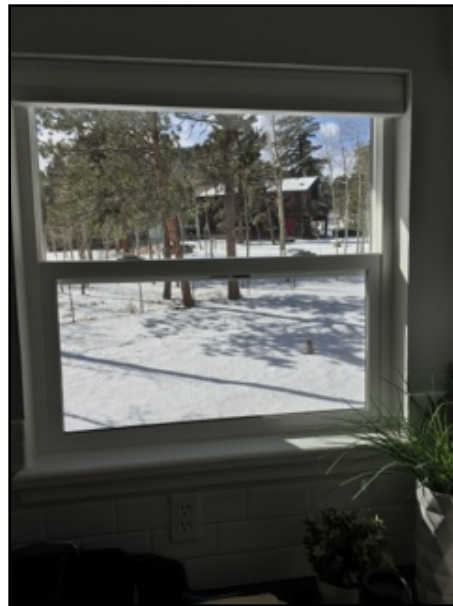
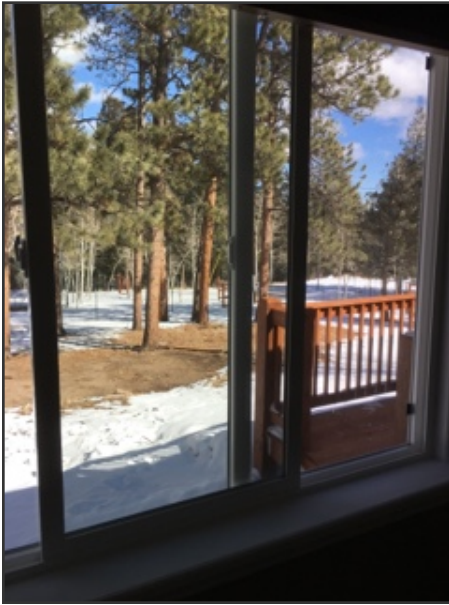
The windows in this home are all in very good condition and appear to be new. They are vinyl double pane design no broken seals or in operable windows were found at this property.

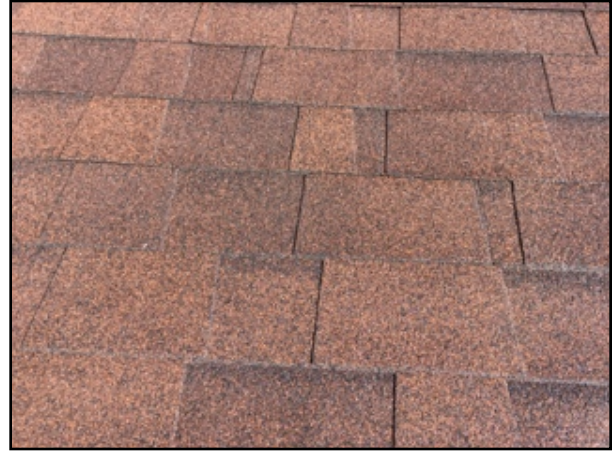
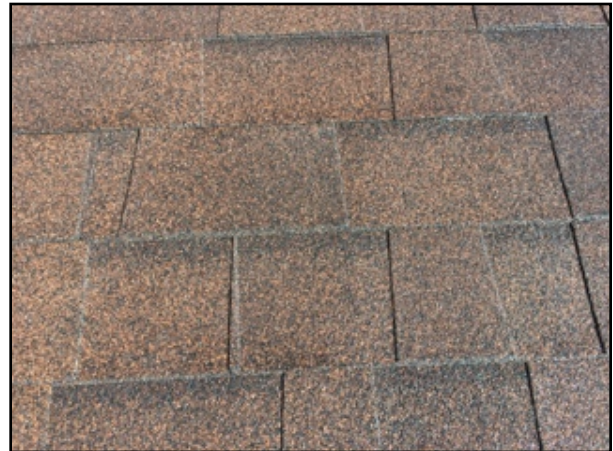
The roof at this property appears to be new and in very good condition.

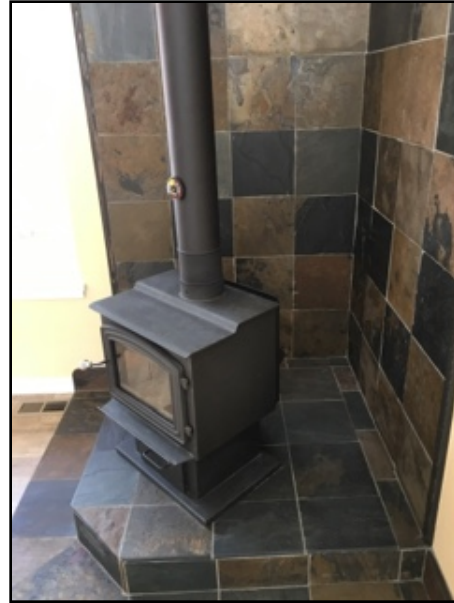
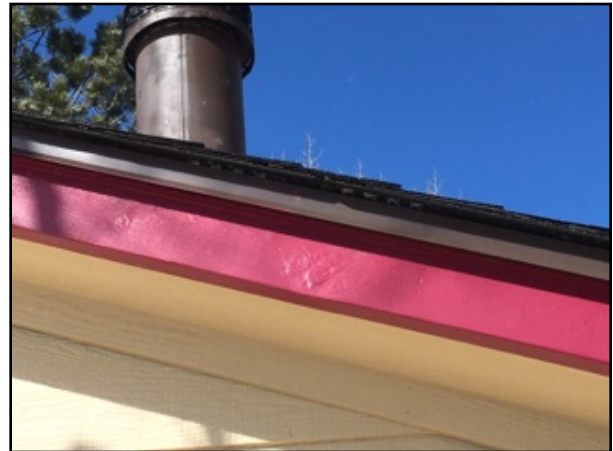
This property has a wood-burning stove chimney and flue, all appear to be in very good condition. It is always highly recommended that he certified chimney sweep clean and certify the wood-burning stove prior to first use.

3) This property has a wood-burning stove chimney and flue, all appear to be in very good condition. It is always highly recommended that he certified chimney sweep clean and certify the wood-burning stove prior to first use.

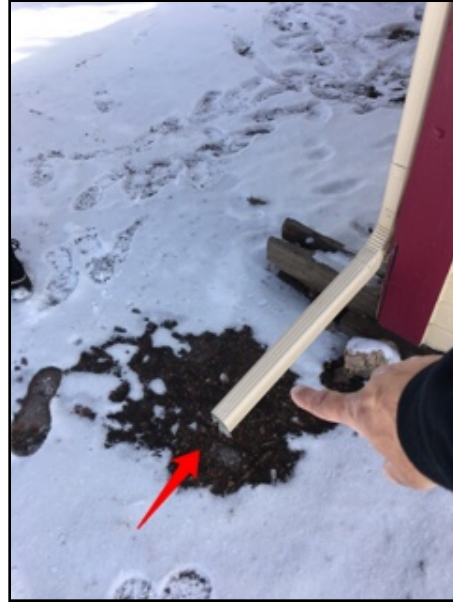
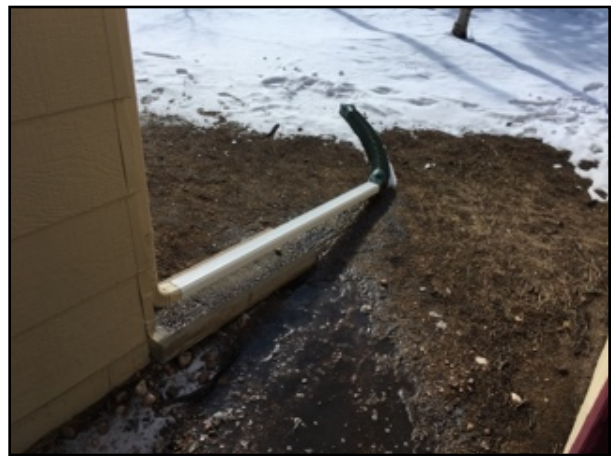
Condition: Marginal

The gutters and downspouts appear to be in very good condition however extensions should be added so that water flows from foundation a minimum of 5-7 feet. Problems were found on the extensions of both structures.

4) The gutters and downspouts appear to be in very good condition however extensions should be added so that water flows from foundation a minimum of 5-7 feet. Problems were found on the extensions of both structures.

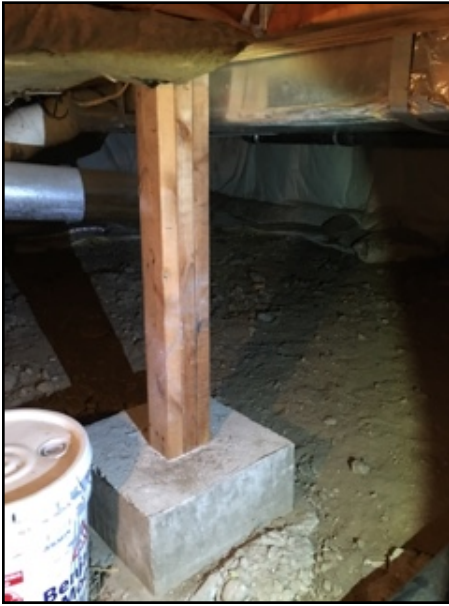
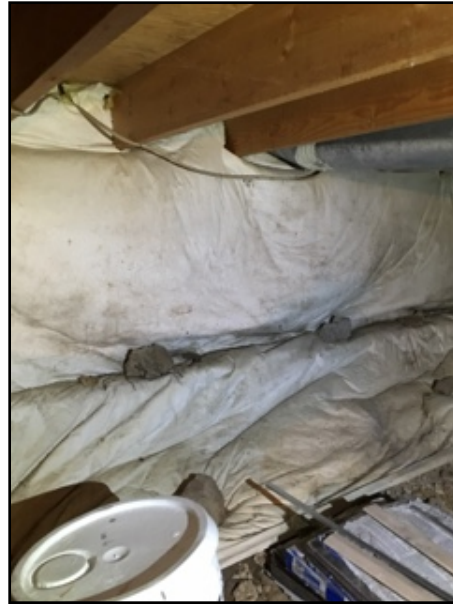
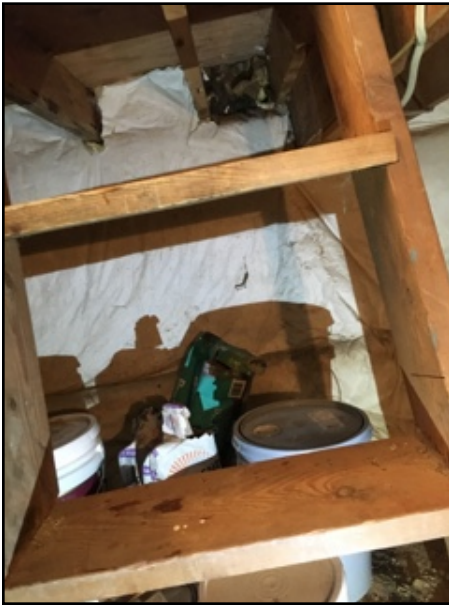
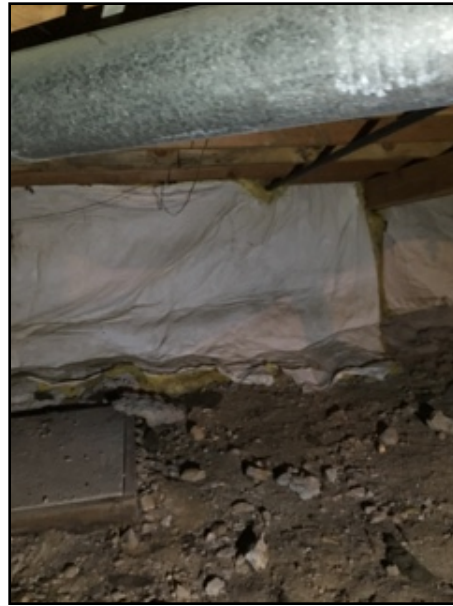
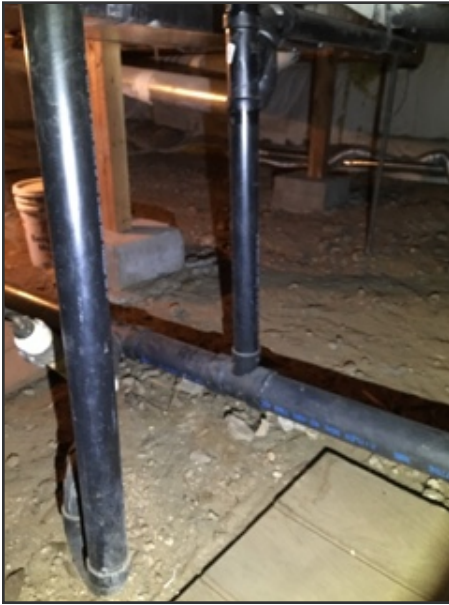
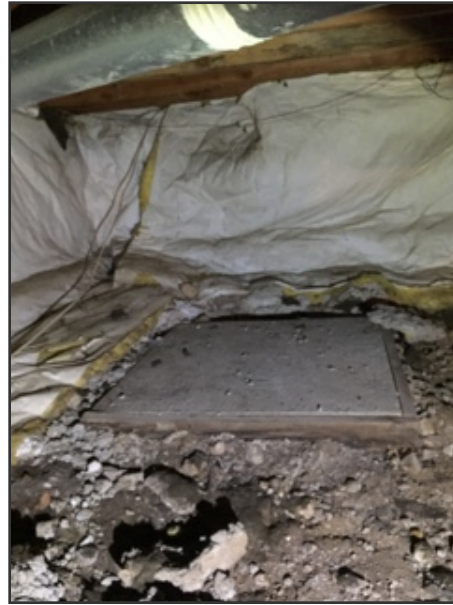
Crawl space access is through a panel located in the front closet. Direct inspection was performed insulation supports and access was free and clear. No problems found in the foundation of this home during this inspection.

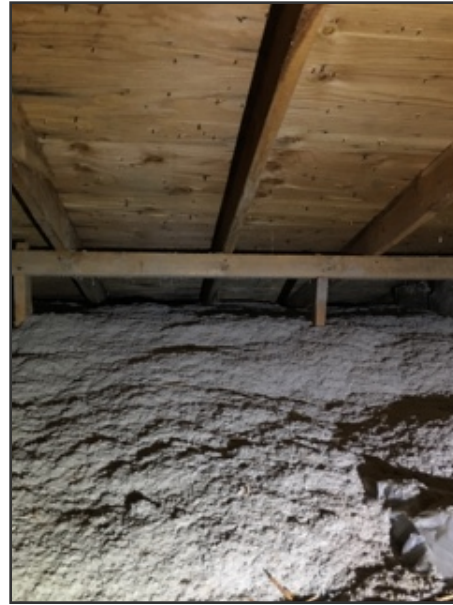
The attic entry is located in the main hallway please note prior damage as indicated in the photograph. There were no issues found in the attic during visual inspection no water stains insulation is very good at approximately 10 to 11 inches depth.

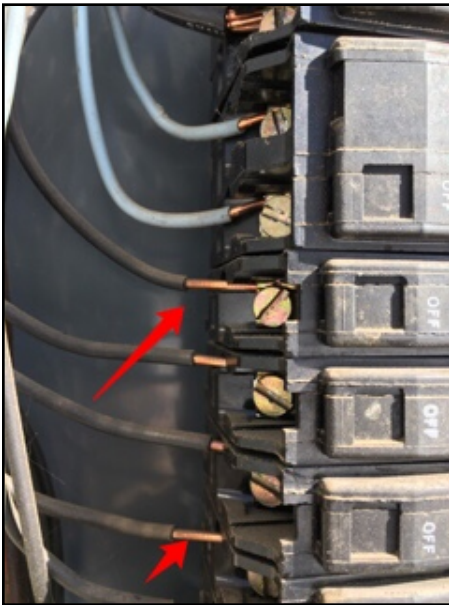
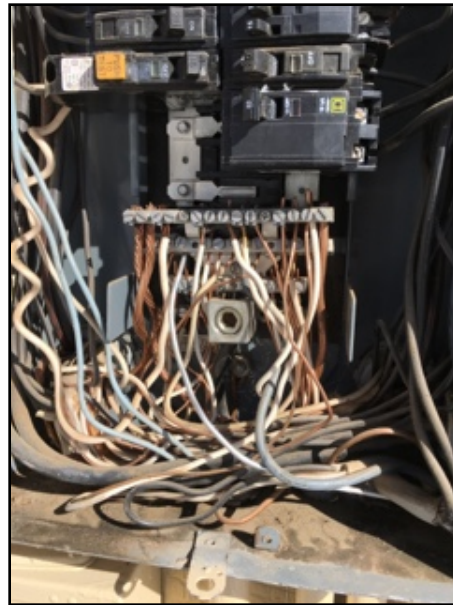
Condition: Further Evaluation Required

Conductors in the service panel should be insulated up to the point of insertion on the bus bar. In this panel there is quite a lot of exposed copper which could be a hazard. Further evaluation by licensed electrician is highly recommended.

5) Conductors in the service panel should be insulated up to the point of insertion on the bus bar. In this panel there is quite a lot of exposed copper which could be a hazard. Further evaluation by licensed electrician is highly recommended.

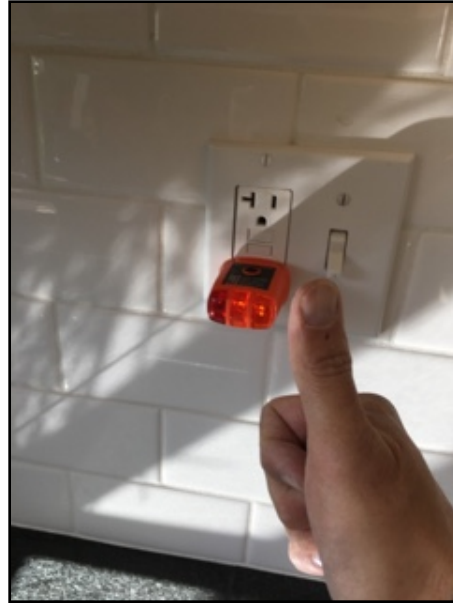
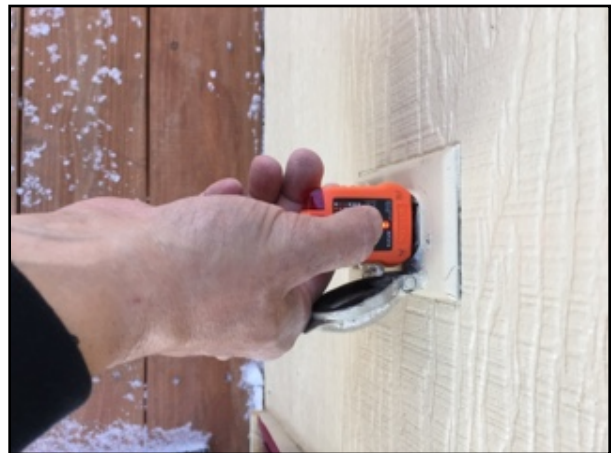
Condition: Repair or Replace

GFCI outlets are required within 5 feet of water source and outdoor locations. During inspection all GFCI outlets functioned properly except for the outlet located on the front deck that should be converted to GFCI by licensed electrician.

6) GFCI outlets are required within 5 feet of water source and outdoor locations. During inspection all GFCI outlets functioned properly except for the outlet located on the front deck that should be converted to GFCI by licensed electrician.

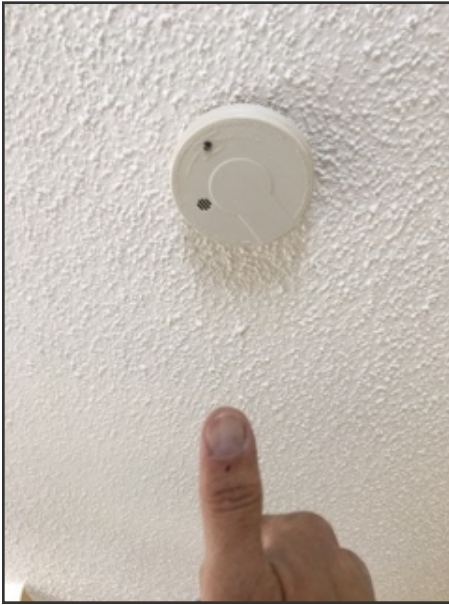
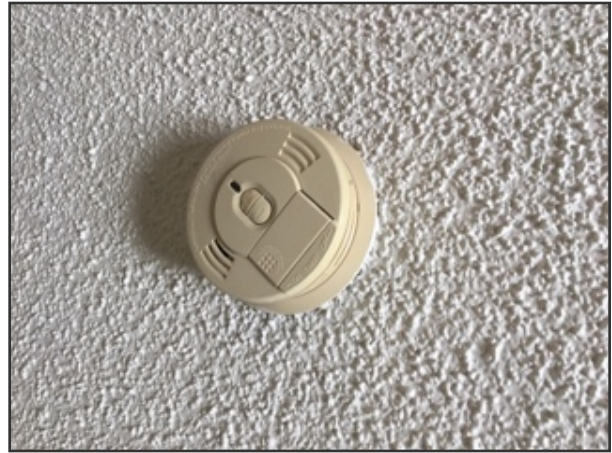
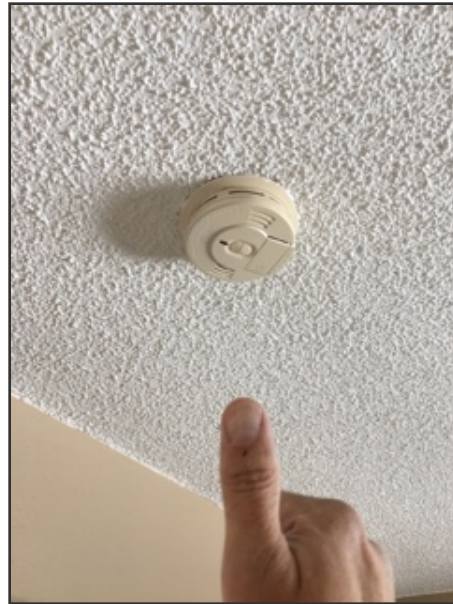
This property has an appropriate amount of smoke detectors and a carbon monoxide detector all devices tested properly during this inspection.

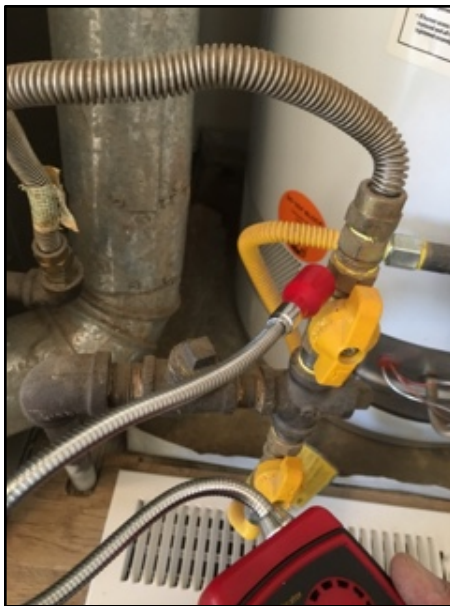
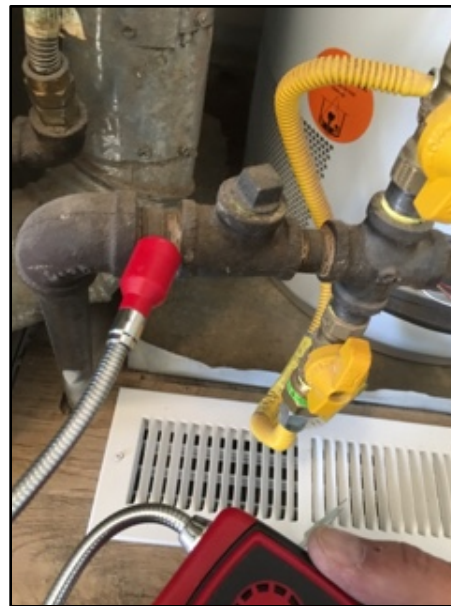
Natural gas supply line is located between water heater and gas forced air furnace a natural gas leak detector was used to test for any gas leakage. No gas leakage was detected during this inspection.

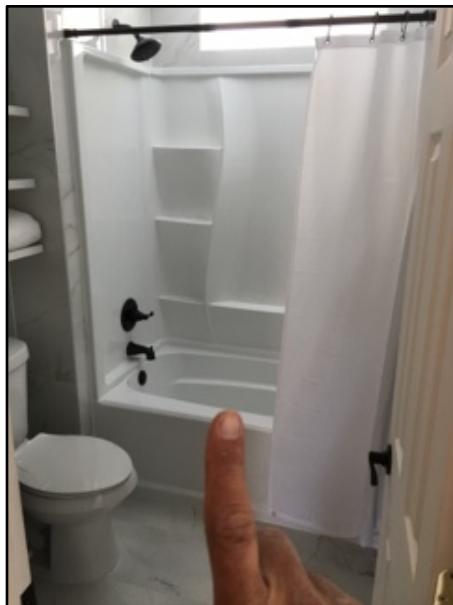
Main bathroom is in very good condition water flow and pressure and temperature are sufficient no leaks found toilet is secure and exhaust fan works properly. GFCI outlet near the sink water source is installed and functional.

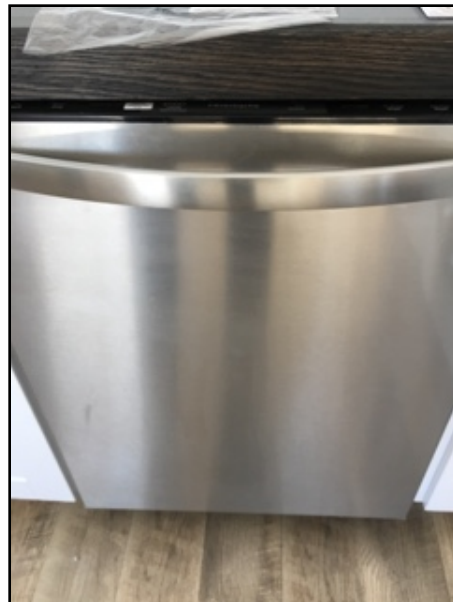
Dishwasher was run a full cycle no leaks found and operated normally during this inspection.

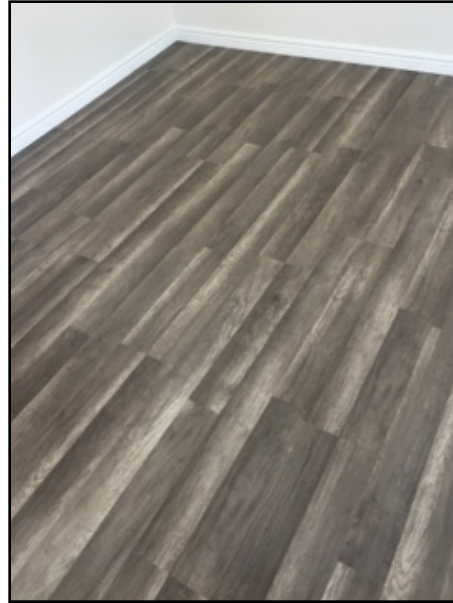
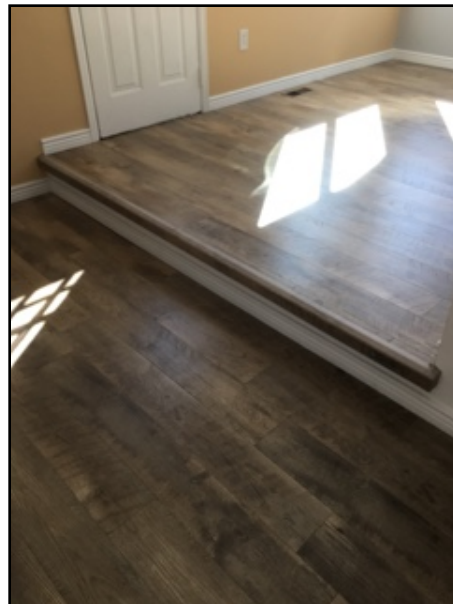
Flooring throughout this house is primarily a wood laminate design with the exception of the closets and bedrooms which have new carpeting installed.

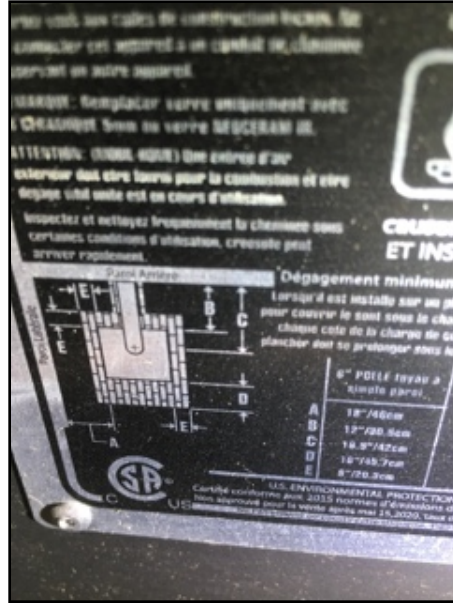
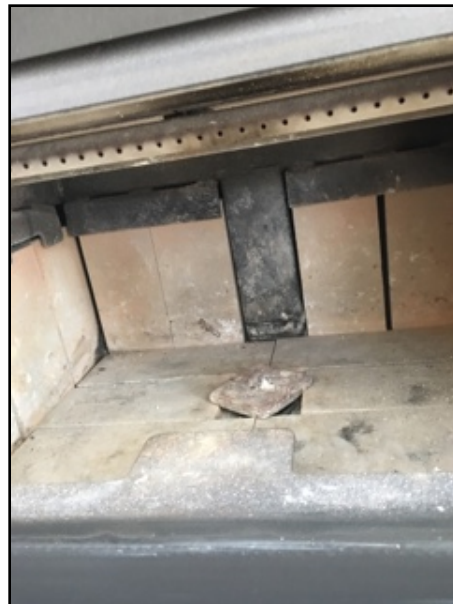
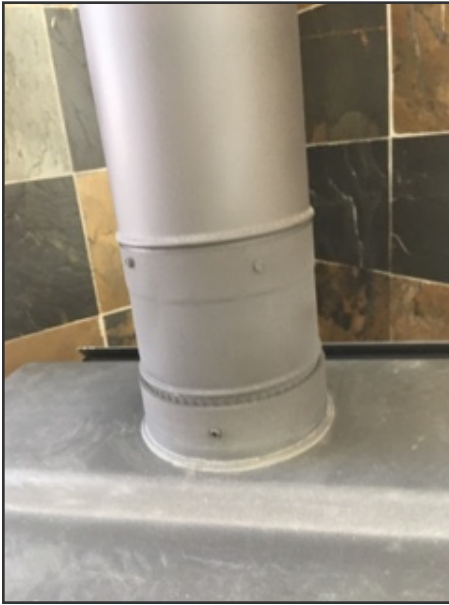
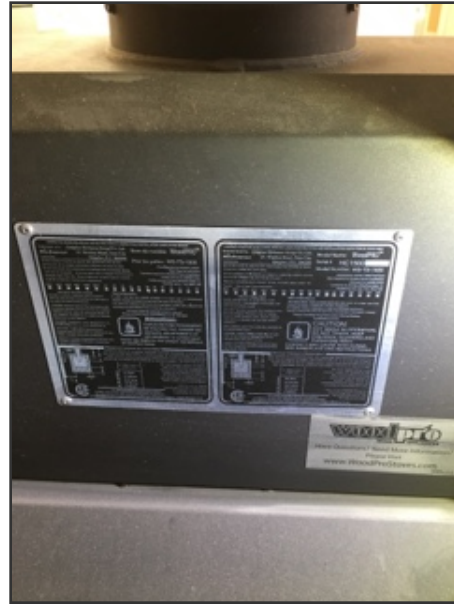
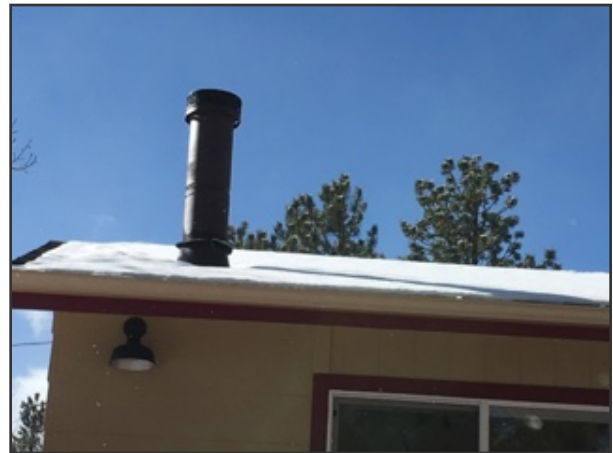
This home has a new wood-burning stove installed in the living room area. With all wood-burning stove's it is highly recommended that a certified chimney sweep clean and certify wood-burning stove prior to first use.

8) This home has a new wood-burning stove installed in the living room area. With all wood-burning stove's it is highly recommended that a certified chimney sweep clean and certify wood-burning stove prior to first use.
