Home Inspection Report

168

Glen Isle Road

Inspected on Fri, Sep 28 2018 at 5:08 PM

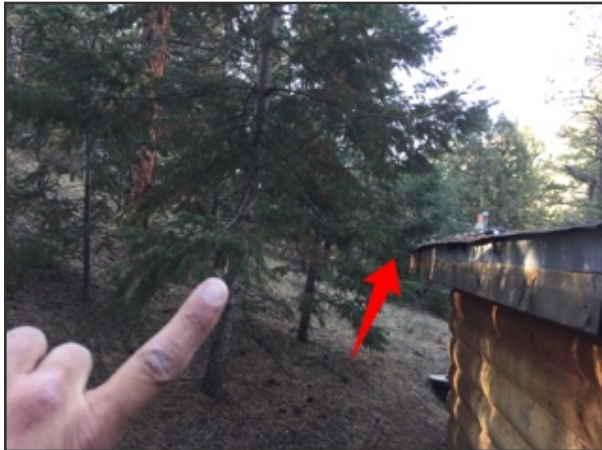
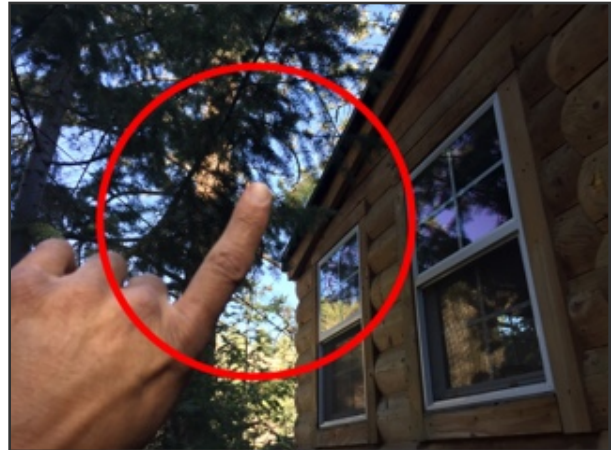
Growing Against Structure
Condition: Marginal

Generally the vegetation around the perimeter of this house is acceptable, with the exceptions of the north west and north portions of the home these trees should be trimmed back, limbed up to a minimum of 8-10 feet, or removed so as not to contact the exterior of the home or the roof.

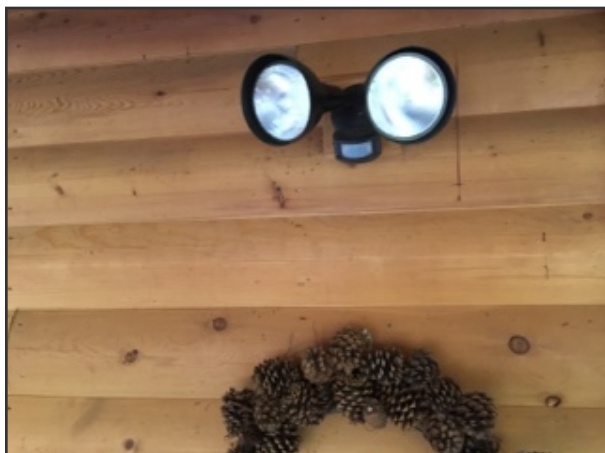
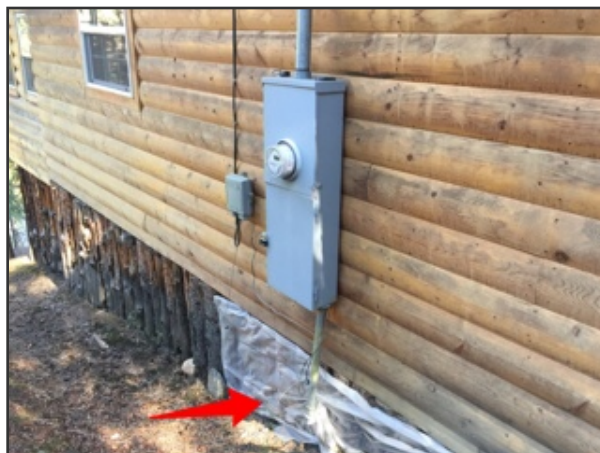
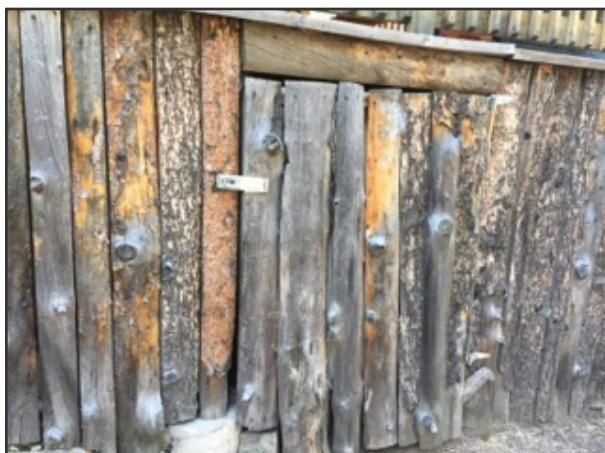
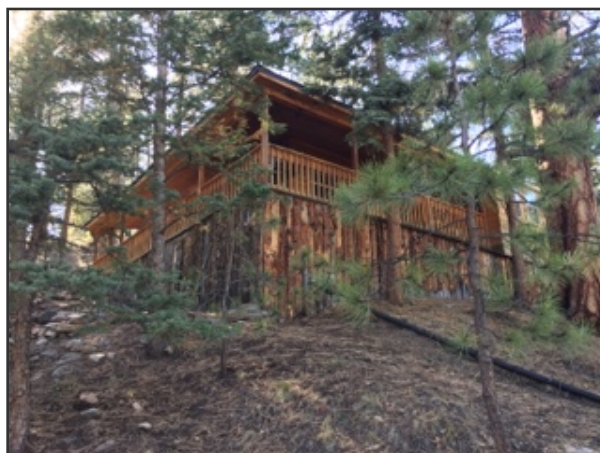
Exterior of this home is in good condition no signs of rotted wood or mold during this inspection. There is one area of concern on the south west corner of the house where the closet extends out there is possible moisture intrusion at this corner as evidenced by moisture in the crawlspace and the presence of a liner on the exterior of this home further evaluation is recommended.

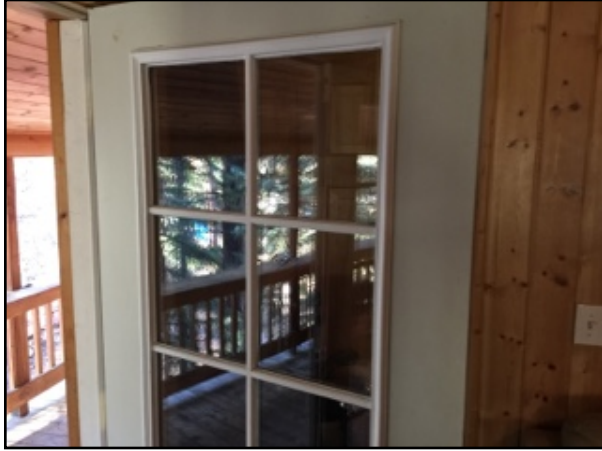
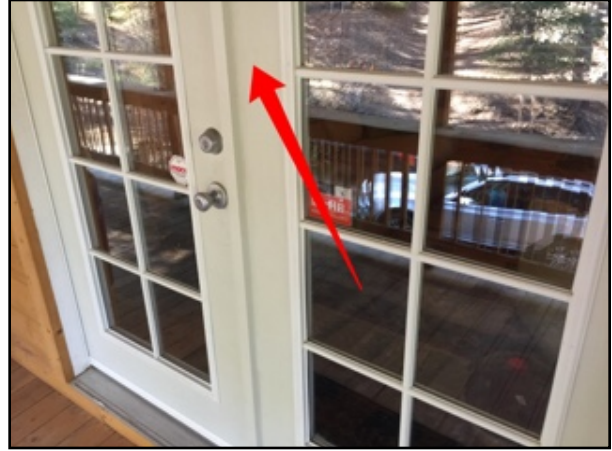
Entry doors in this home are in good condition the exception to this is the double door leading to the living room which indicates possible frame swelling and sticks when attempting to open.

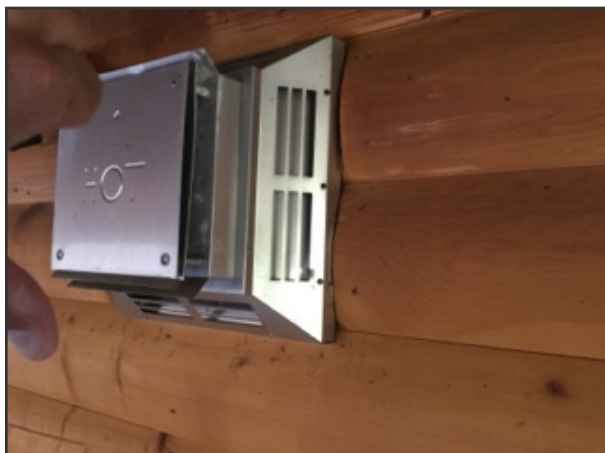
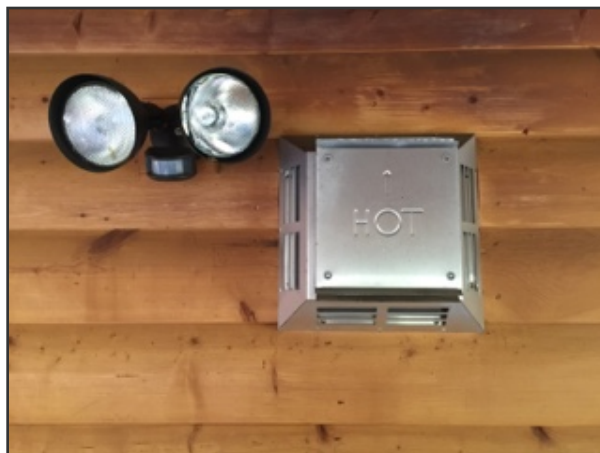
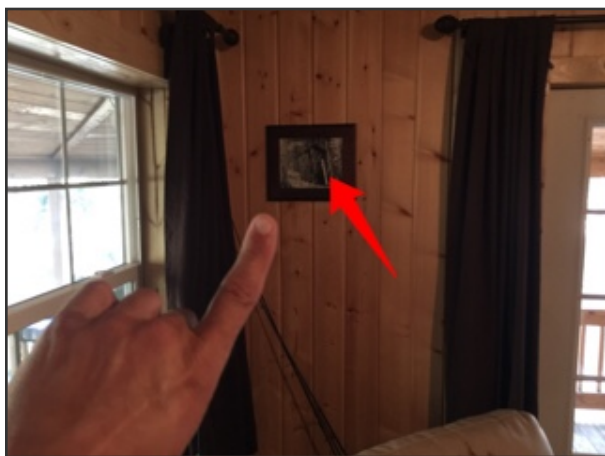
This home currently has no wood-burning stove fireplace or other combustion device the wall vent is located in the living room and was from some previous installation. It is advised that if the new purchaser wishes to have a fireplace that this exhaust vent be further inspected prior to use.

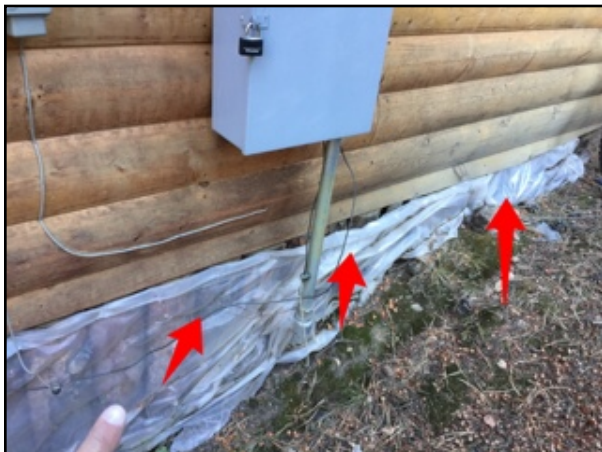
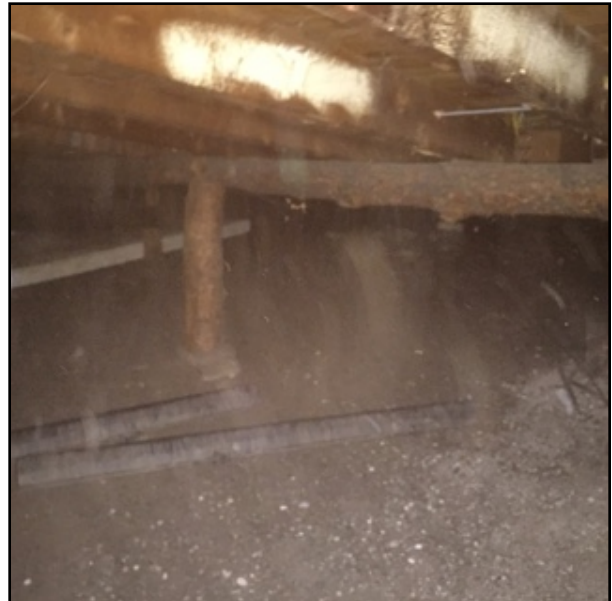
Moisture
Condition: Marginal

There is a possibility of moisture intrusion on the south west corner of this home as indicated by the waterproofing material on the outside during the inspection in the crawlspace there is evidence of wet soil under the home. Further evaluation would be recommended.

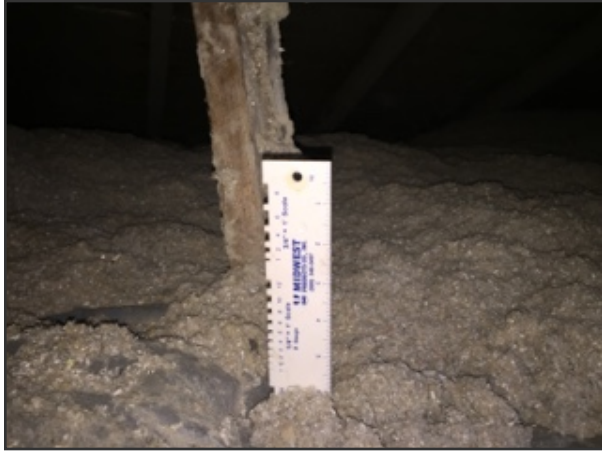
Attic access is through the bedroom and over the dresser area during this inspection the panel was removed and once the attic was fully inspected I attempted to replace the panel which fell apart it is recommended that this be screwed together rather than simply tongue and groove fitment as it currently is, in order to maintain structural integrity of the panel.

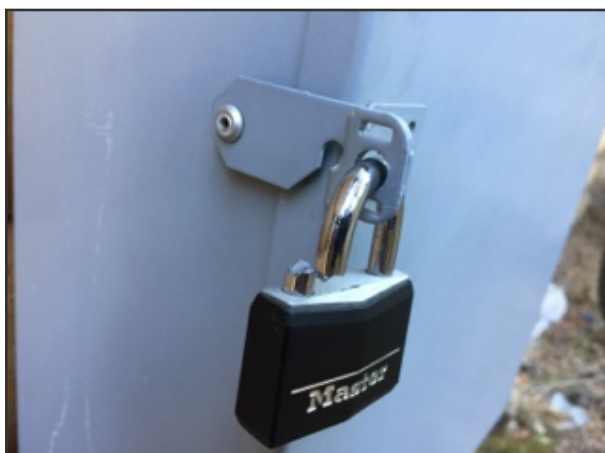
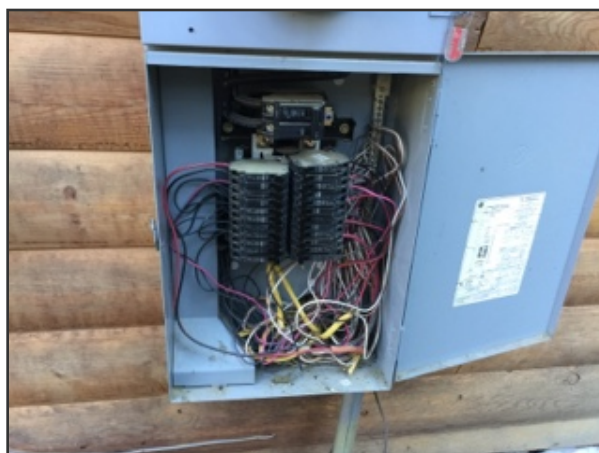
Upon attempting to open the service panel it was noted that it was padlocked. We contacted the owner who provided us with a pair of bolt cutters and instructed us to remove the padlock which we did in order to for fill this portion of the inspection.

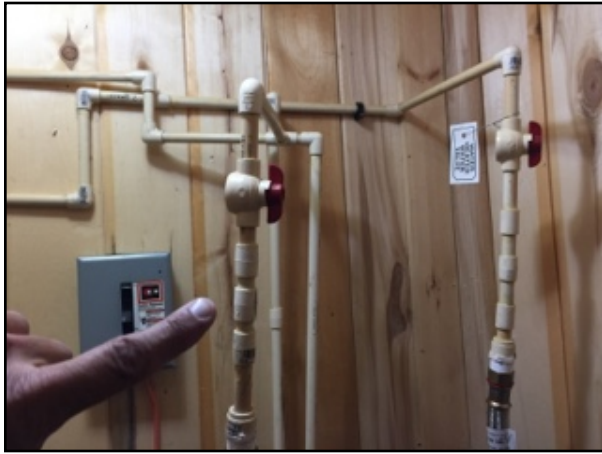
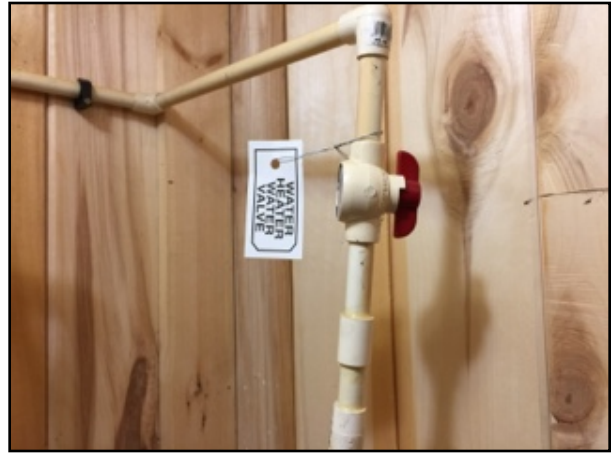
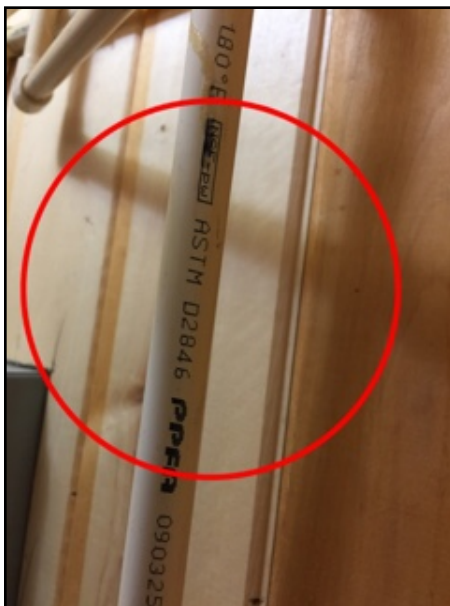
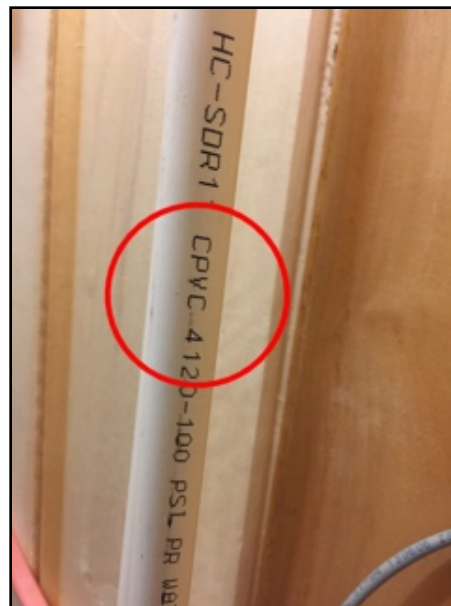
Condition: Repair or Replace

It is noted that CPVC materials are used in the distribution of the water throughout this home it is highly recommended that further evaluation be performed by a licensed plumber and possible replacement of this piping material.

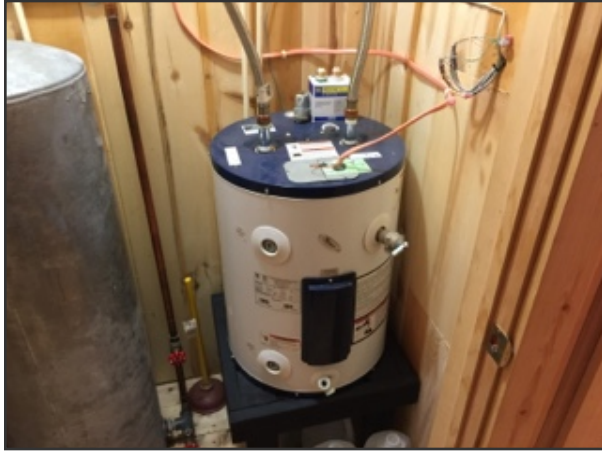
Capacity:	19 gallon
Approximate Age:	Unable To Determine Age
Temp & Pressure Relief Valve:	Present no blow off leg
	Condition: Satisfactory
Fuel Disconnect:	In Same Room
Seismic Straps Installed:	Not Present

It appears for the size of this home having two bathrooms, clothing washer, and a full kitchen that a 19 gallon water heater is insufficient. Highly recommend increasing capacity of water heater so that the new purchaser does not run out of hot water. Additionally CPVC materials connecting to the water heater should be replaced.

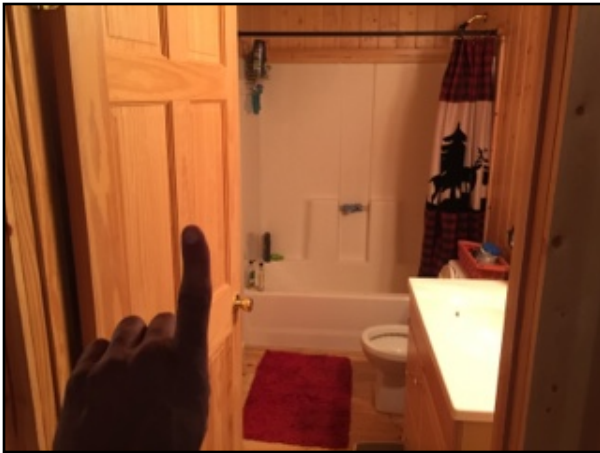
Figure 20-1

Main bathroom location has a full bathtub with shower, the valve and faucet is very loose and should be replaced or repaired. Light fixture has either a burned out bulb or other issue to be further evaluated. Under sink flex pipe appears to be leaking slightly as there were small water droplets on the bottom of the cabinet.

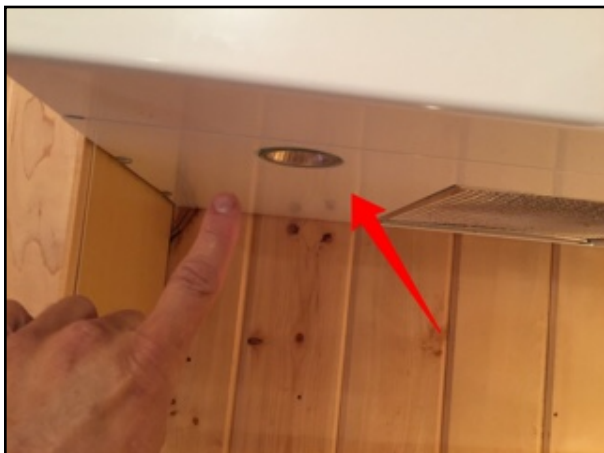
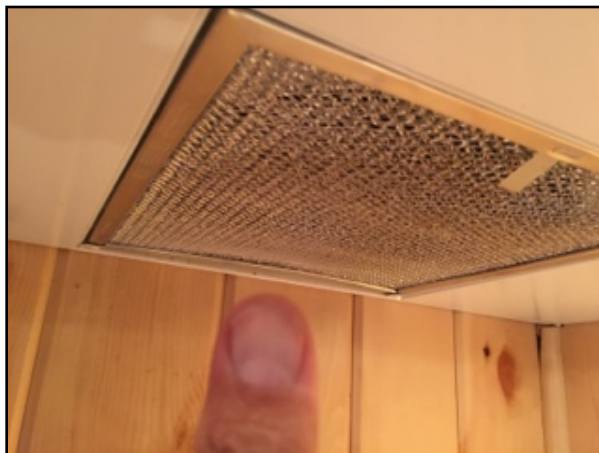
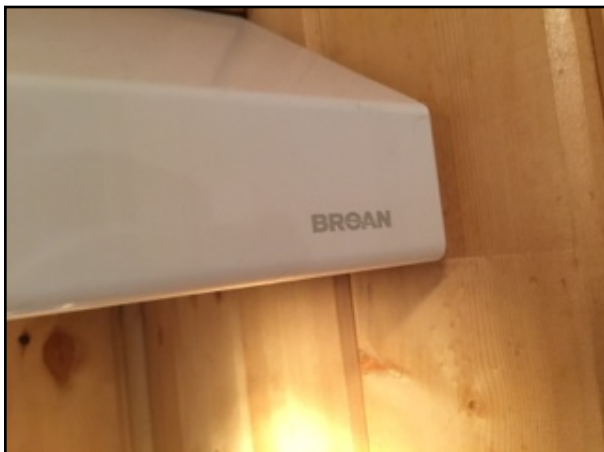
Broan
Condition: Marginal

One of the two bulbs on the range hood is burned out recommend replacing or repairing. The fan did operate normally.
