# 285 Home Inspection Services LLC

## Home Inspection Report

**9948 Fallen Rock Road**

Inspected on Fri, Aug 31 2018 at 12:48 PM

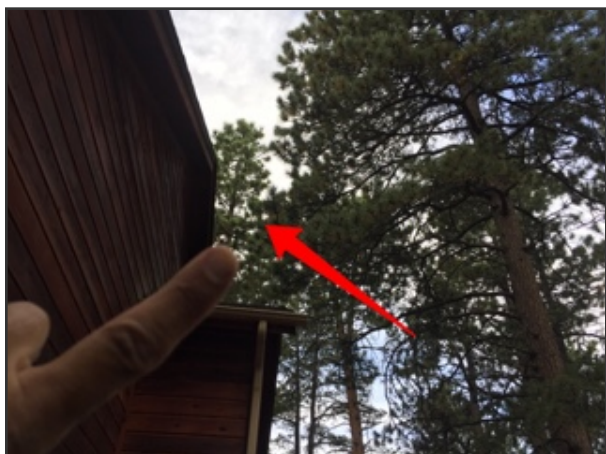
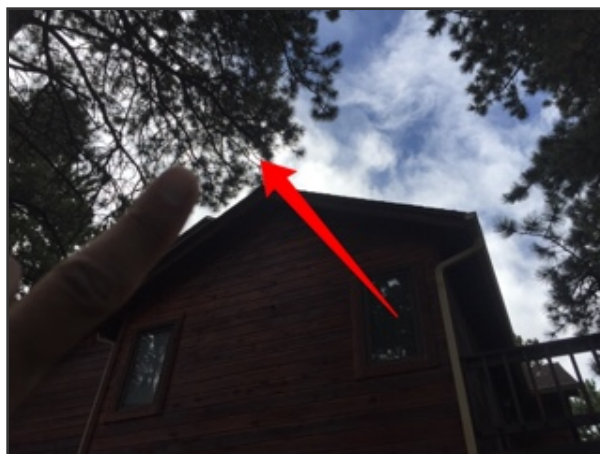
Growing Against Structure

Condition: Repair or Replace

Trees and vegetation are generally in good condition at this home there are a few instances of trees touching the roof or very near the roof line these branches should be trimmed back to allow for less Pineneedle drop into the gutters and on the roof.

1) Trees and vegetation are generally in good condition at this home there are a few instances of trees touching the roof or very near the roof line these branches should be trimmed back to allow for less Pineneedle drop into the gutters and on the roof.

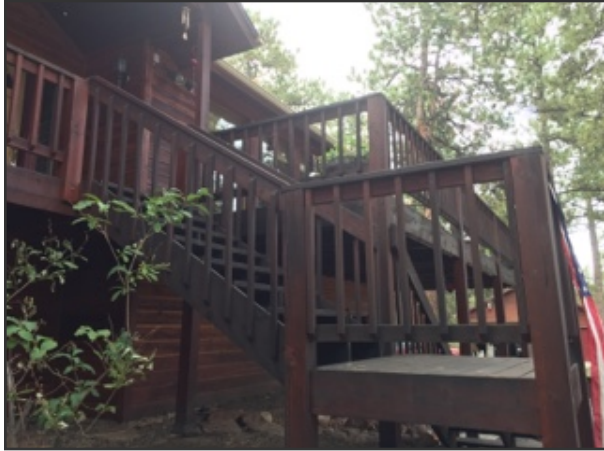
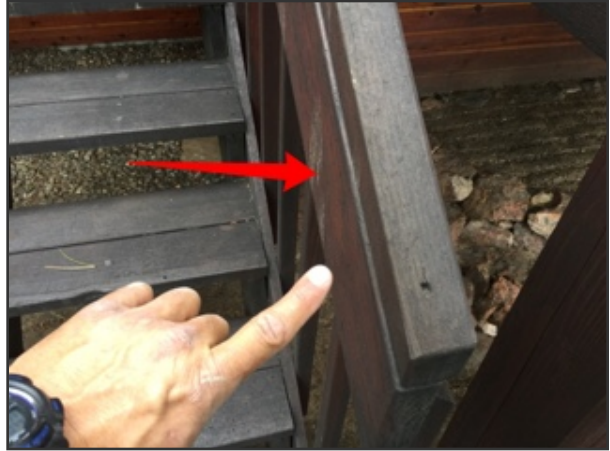
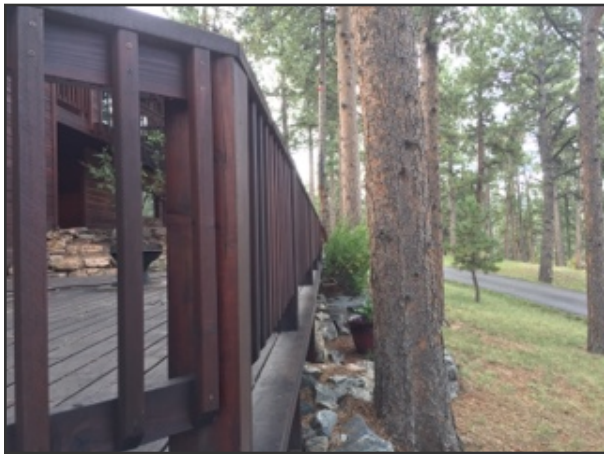
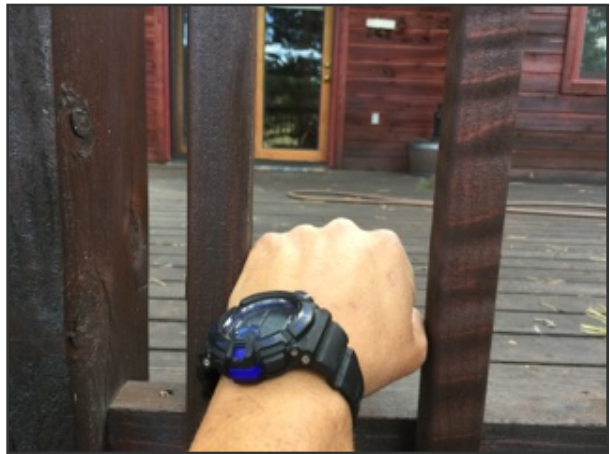
Deck is in very good condition and will stand there is one location where indicated that the handrail is slightly loose would recommend re-securing if possible.

2) Deck is in very good condition and will stand there is one location where indicated that the handrail is slightly loose would recommend re-securing if possible.

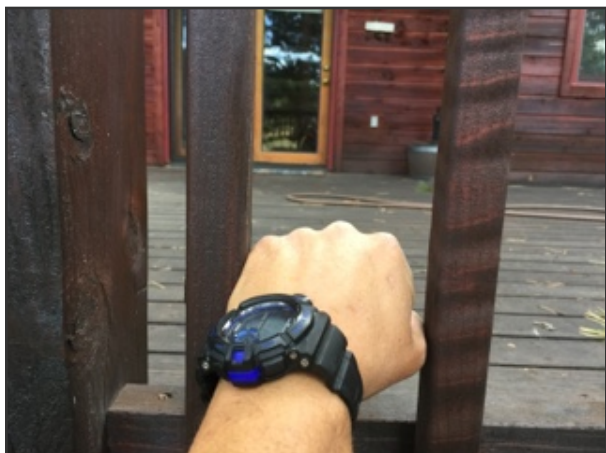
One handrail leading from the landing to the upper level deck is slightly loose on the right-hand side recommend retightening if possible.

3) One handrail leading from the landing to the upper level deck is slightly loose on the right-hand side recommend retightening if possible.

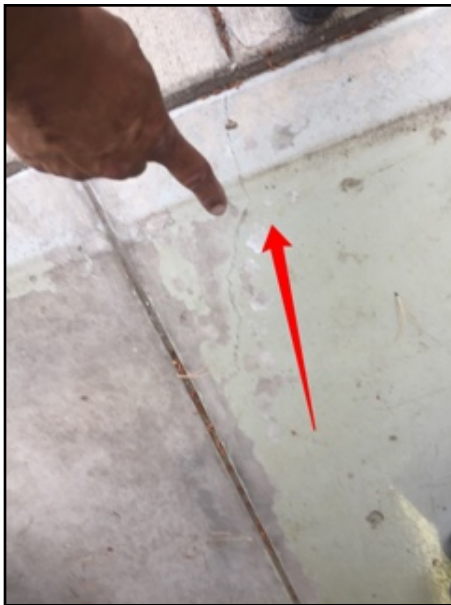
Figure 7-1

In the detached garage floor there is a minor crack near the roll up door location.

4) In the detached garage floor there is a minor crack near the roll up door location.

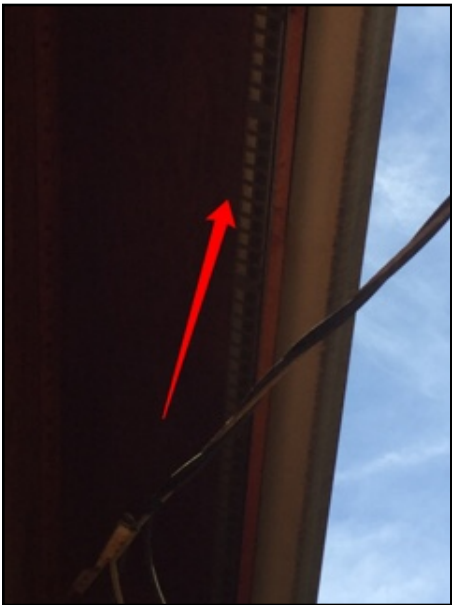
There are a number of pine trees near the roof and touching the roofing material in some area. It is highly recommended that these trees be trimmed back so that the Pineneedles do not gather on the roof.

5) There are a number of pine trees near the roof and touching the roofing material in some area. It is highly recommended that these trees be trimmed back so that the Pineneedles do not gather on the roof.

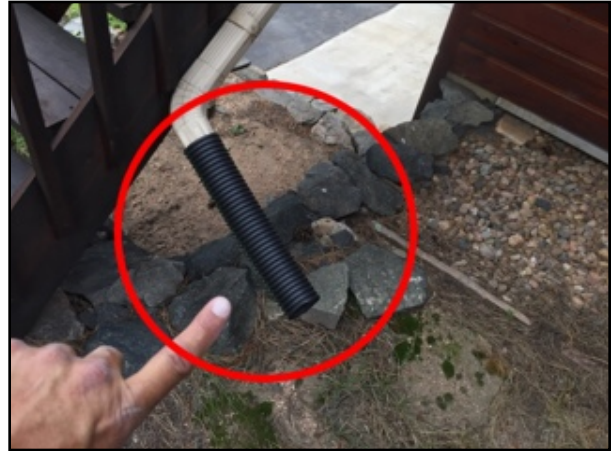
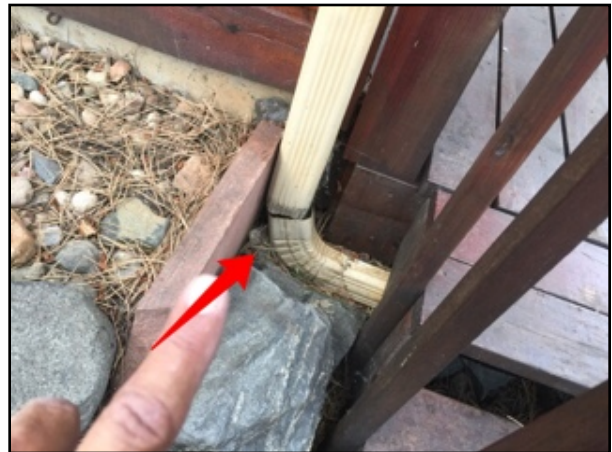
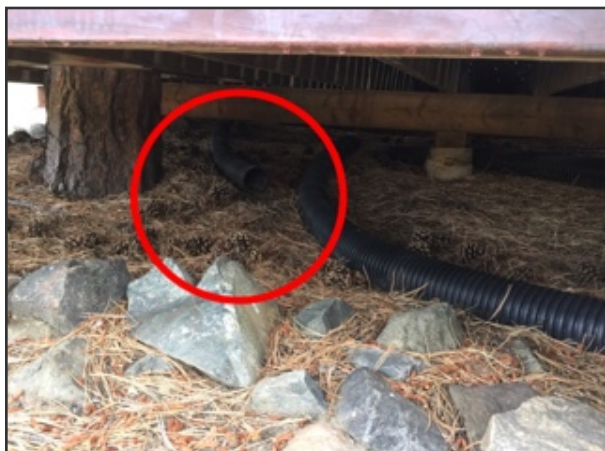
Flashings:	Metal
	Condition: Satisfactory
Soffit and Fascia:	Wood
	Condition: Satisfactory
Gutters & Downspouts:	Metal
	Condition: Marginal

It is recommended that all downspouts coming from roof to the ground should be extended away from foundation to ensure no moisture enters the foundation.

6) It is recommended that all downspouts coming from roof to the ground should be extended away from foundation to ensure no moisture enters the foundation.

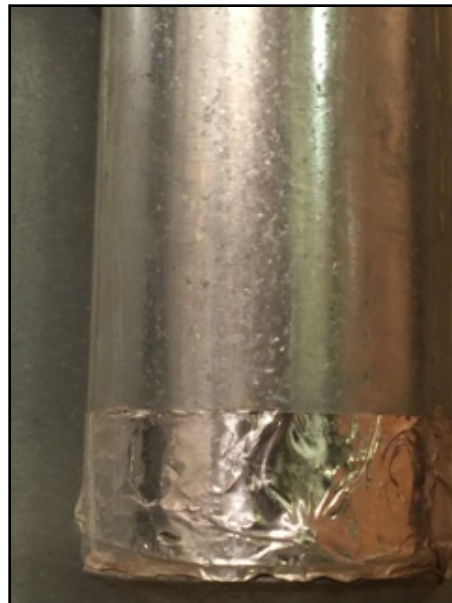
Ducting at top of furnace should be rewrapped where indicated with red arrow.

7) Ducting at top of furnace should be rewrapped where indicated with red arrow.

Furnaces over 10 years old should be checked, cleaned and serviced yearly by a licensed contractor.

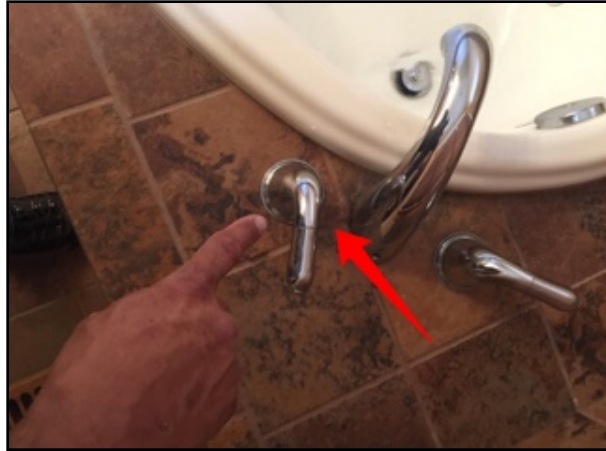
Recirculating  
Condition: Repair or Replace

On the recirculating tub in this bathroom the right hand or heart valve appears to be stripped out is still functional but recommend it be further evaluated by a licensed plumber.

9) On the recirculating tub in this bathroom the right hand or heart valve appears to be stripped out is still functional but recommend it be further evaluated by a licensed plumber.

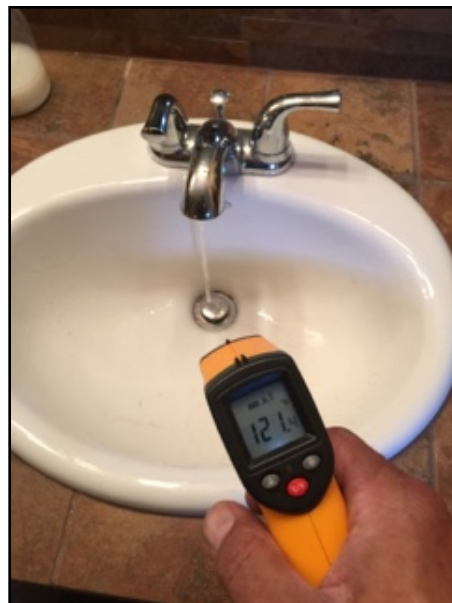
Double Vanity  
Condition: Repair or Replace

Right hand sink water pressure is very low recommend a licensed plumber to further evaluate.

10) Right hand sink water pressure is very low recommend a licensed plumber to further evaluate.

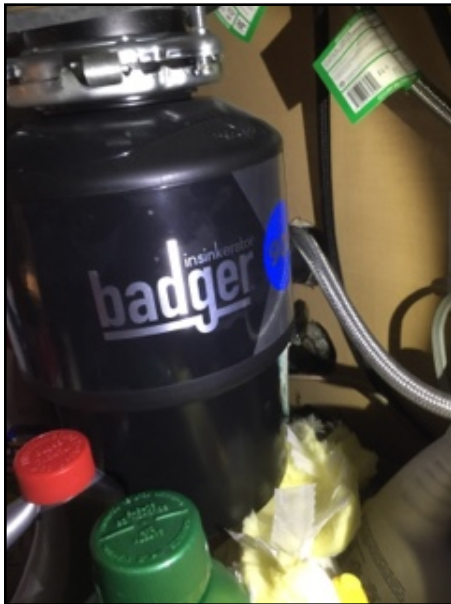
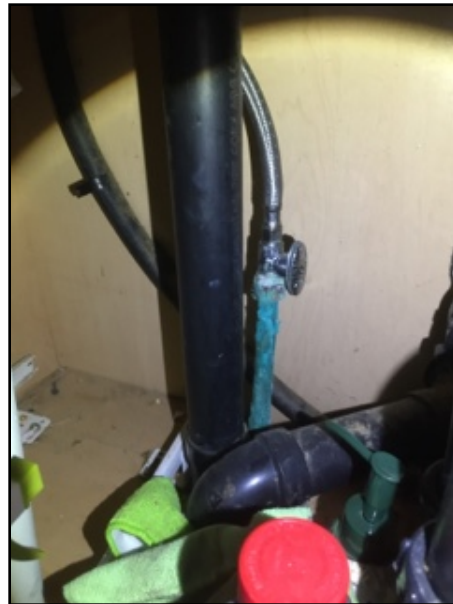
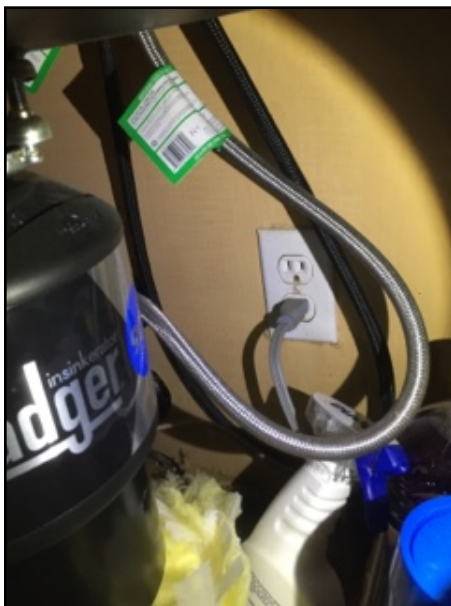
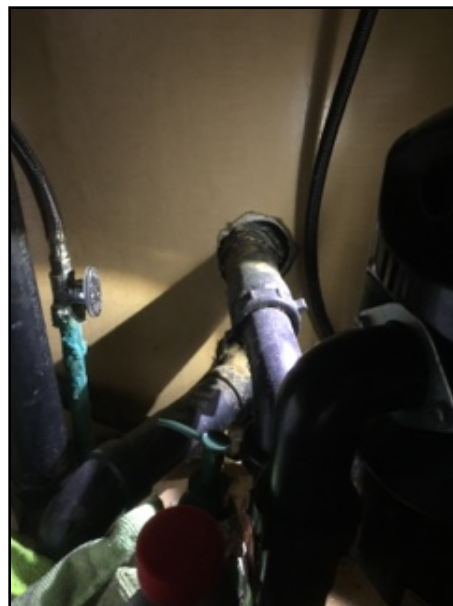
Disposal operated quietly and properly please note in photograph there is some corrosion on waterline suspect it is just surface corrosion.
