285 Home Inspection Services LLC

Home Inspection Report

1671

Little Bear Creek Rd

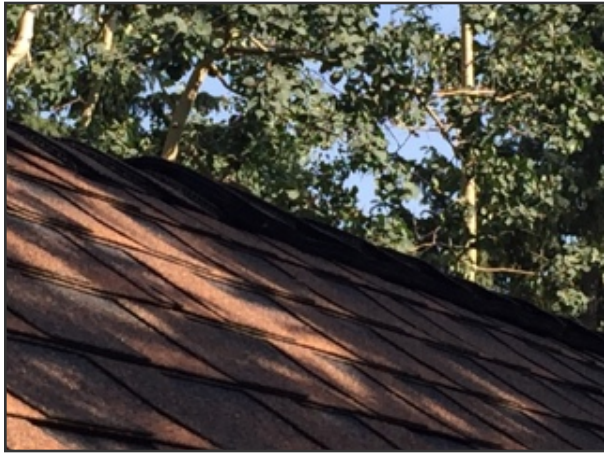
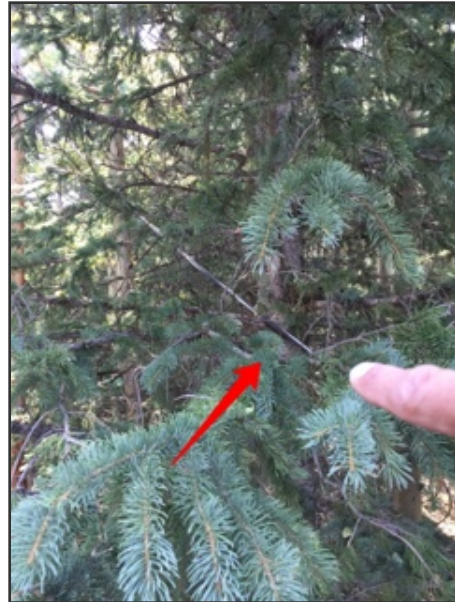
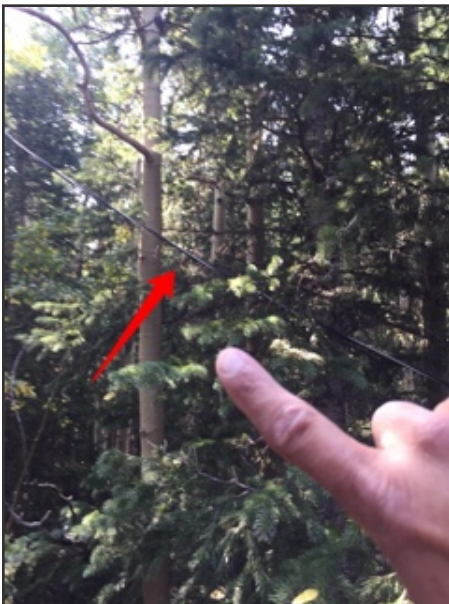
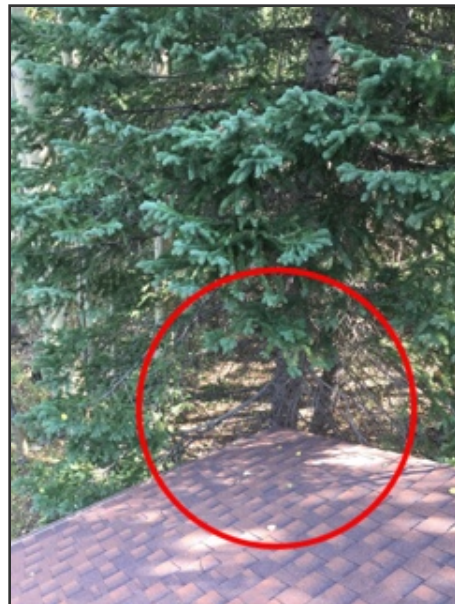
Evergreen trees are in contact with power line and the roof on the northeast and northwest location. They should be trimmed back and mitigated to ensure no electrical grounding issues as well as limiting pine needles in gutters.

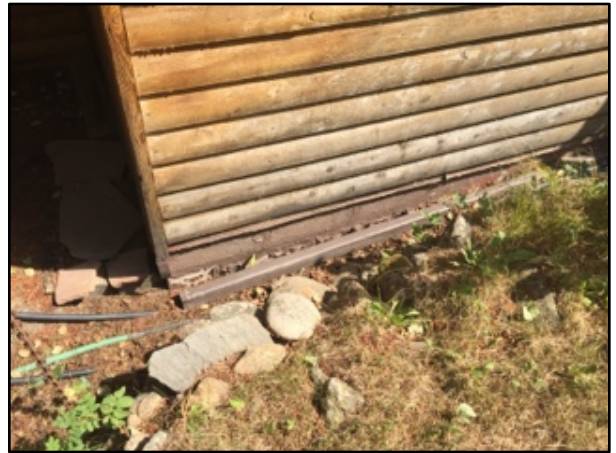
Figure 3-1

Log construction .

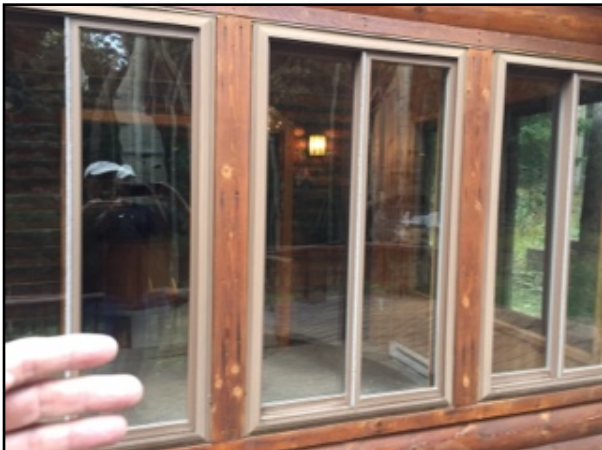
Figure 4-1

Windows are a combination of vinyl and original wood casement windows. Most of the wood windows are sealed shut and weren't operational during this inspection. All appear in good condition.

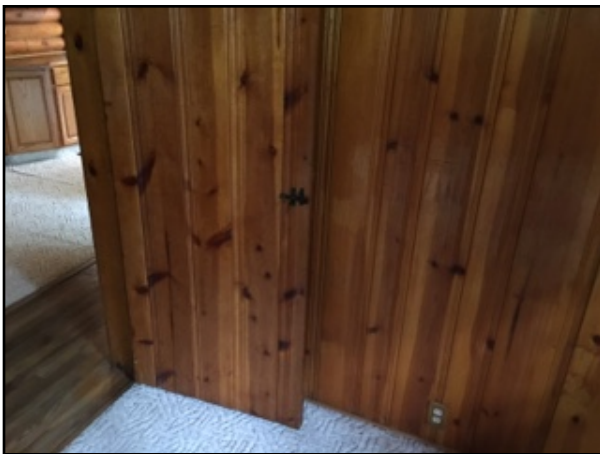
Figure 6-1

Interior wood entry doors and exterior wood with glass inserts both are in good condition.

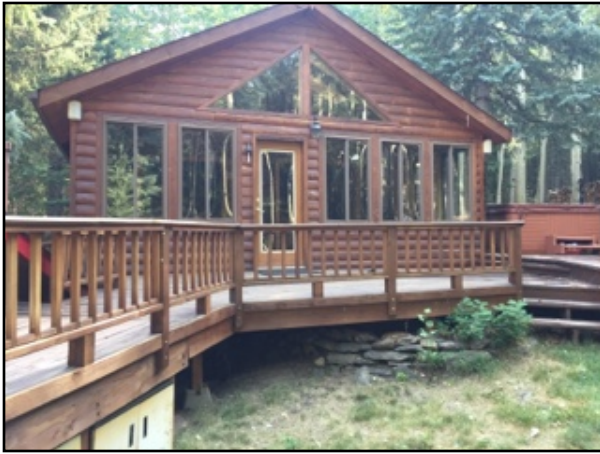
Figure 7-1

Railing spacing is acceptable and in good condition.

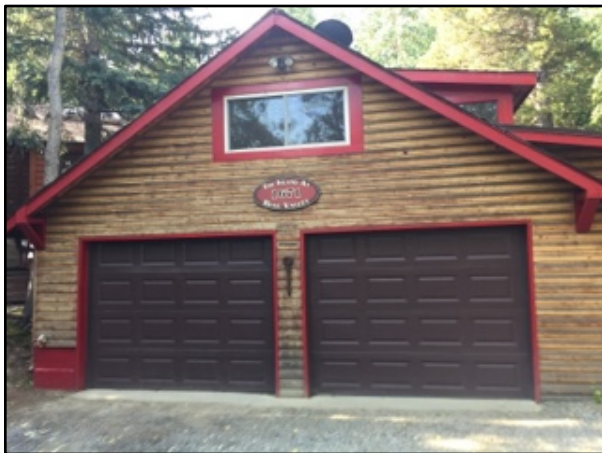
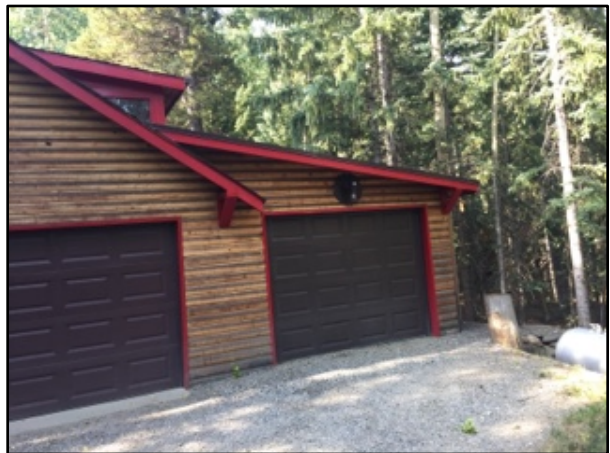
Garage is a detached 3 car with connection for LP gas heater, electrical sub panel for living structure above garage. All 3 garage door opener operating normally and safety features are operational as well.

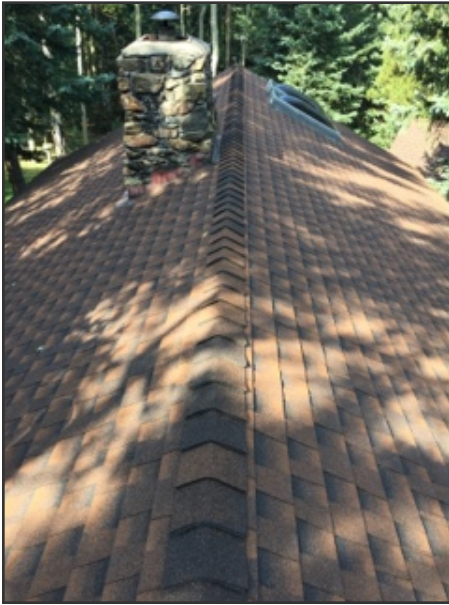
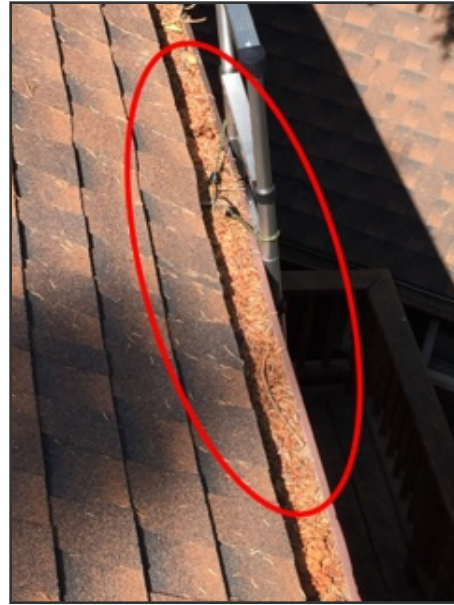
There is a great deal of debris from pine needles in gutter. They should be cleaned and the trees near the area should be trimmed back. The roof is generally in good condition.

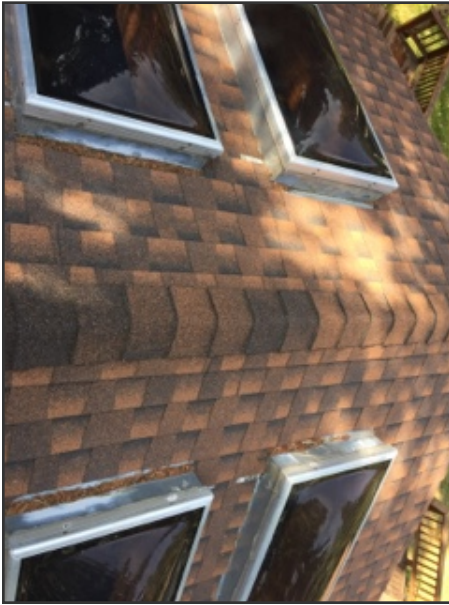
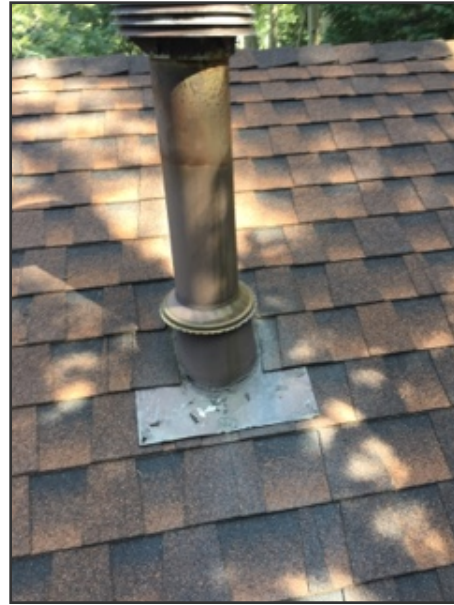
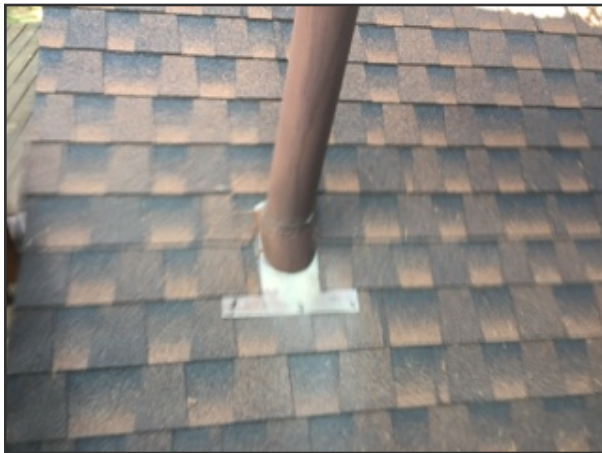
Vent stacks, skylights and chimney appear to be sealed well and are in good condition.

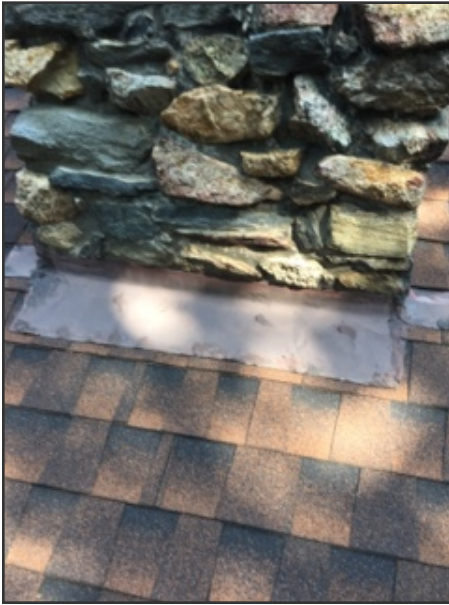
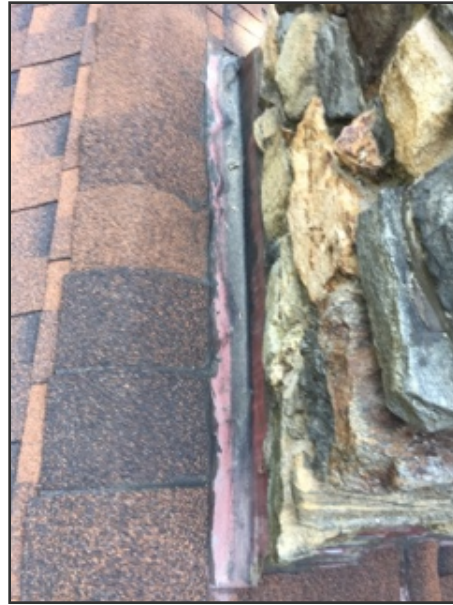
Chimney cricket, cap and flashing are in good condition.

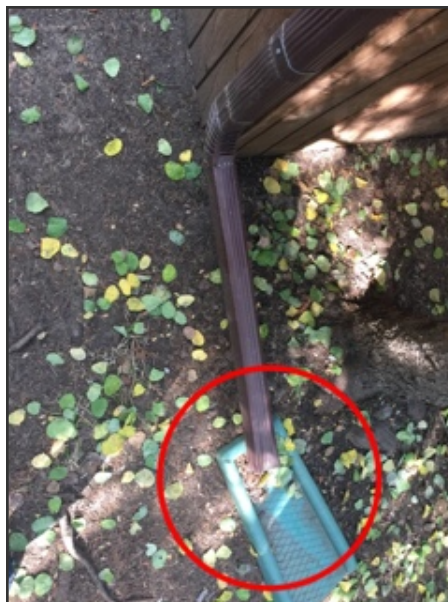
Downspout should be extended further from structure so moisture will not penetrate foundation at northeast corner of home.

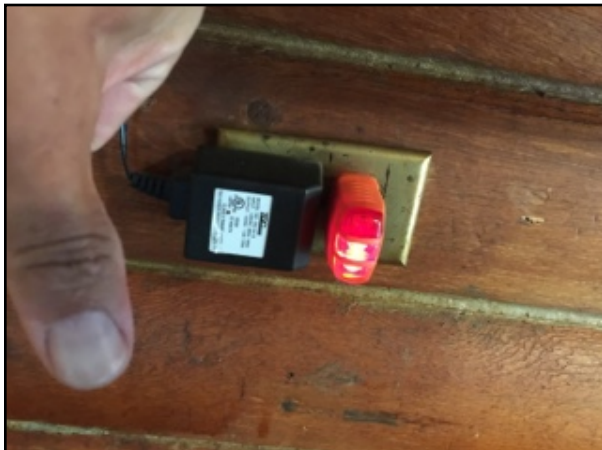
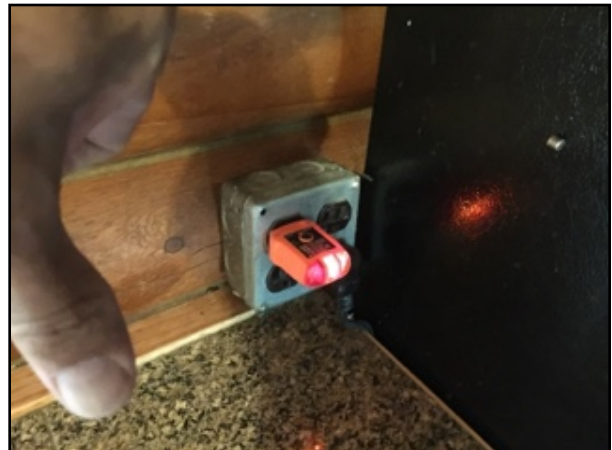
Kitchen counter near sink and bathroom location both require GFCI circuits should be further evaluated by licensed electrician and corrected.

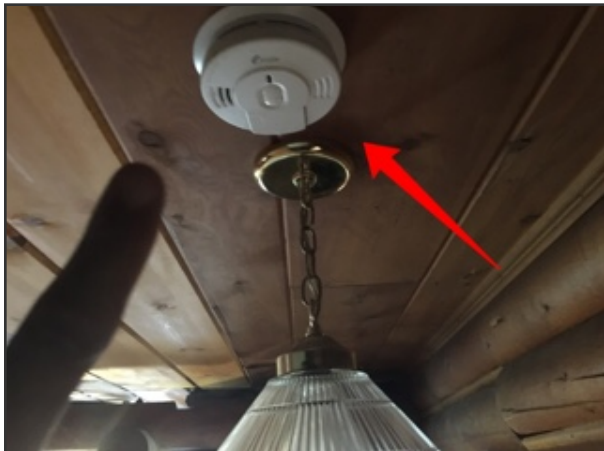
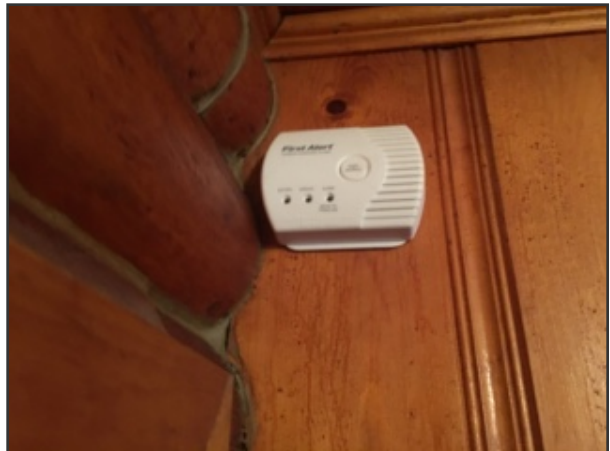
Carbon monoxide detector in bedroom is functional the smoke detector in hallway is currently not operational perhaps battery is dead.

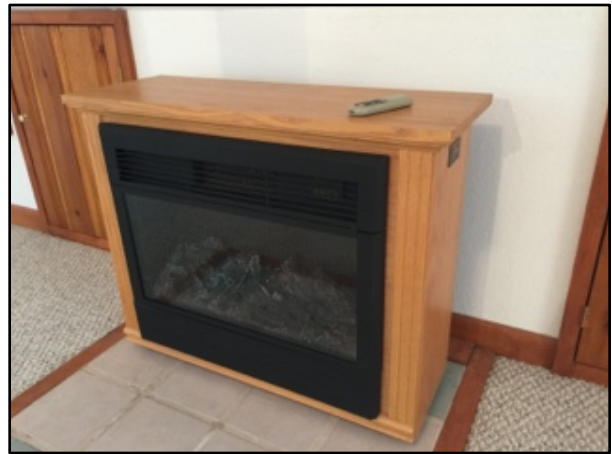
Main unit has LP gas fed forced air furnace and front sunroom expansion is fitted with electric baseboard heater units. Both systems operating normally during inspection period.

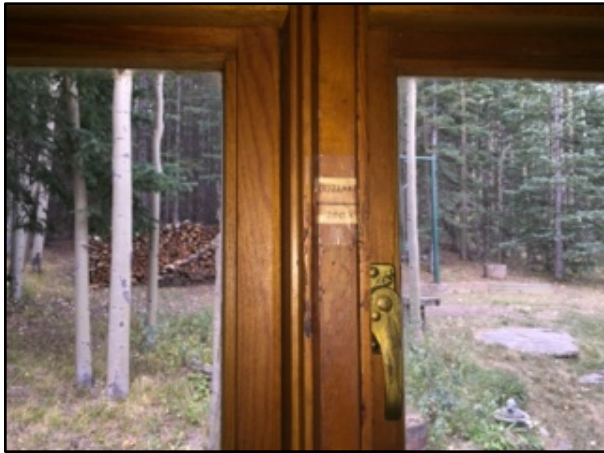
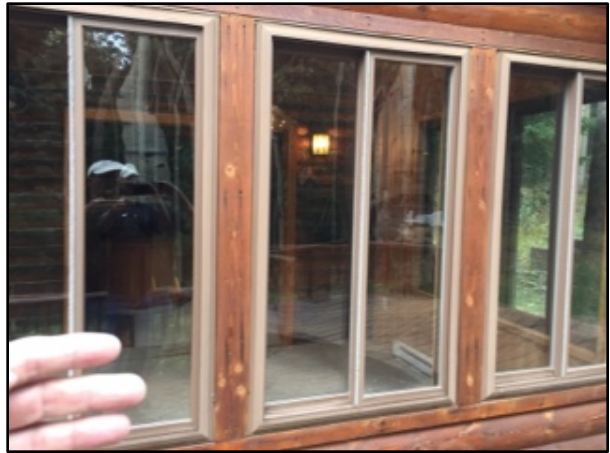
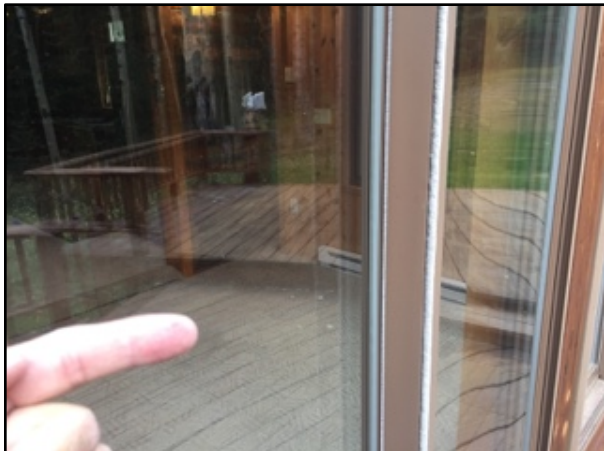
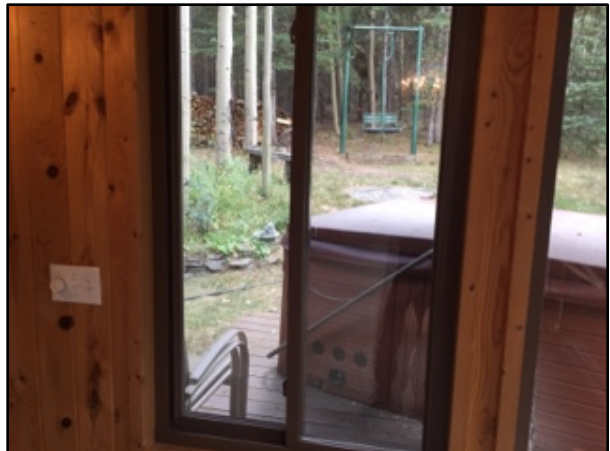
Combination of wood casement and vinyl windows. Wood casement appears painted or stained shut recommend light scoring to remove seal and further evaluation windows.

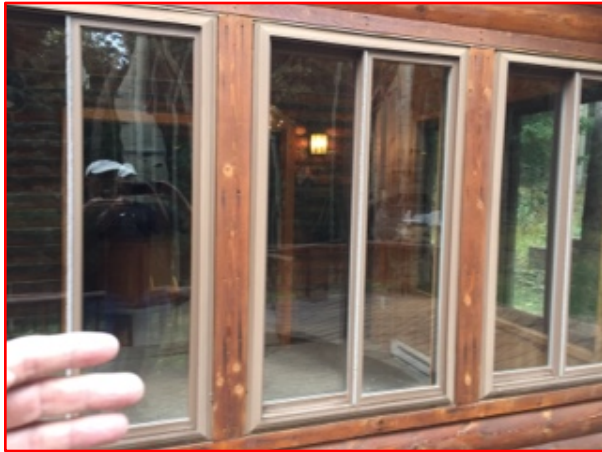
Figure 4-1

2) Windows are a combination of vinyl and original wood casement windows. Most of the wood windows are sealed shut and weren't operational during this inspection. All appear in good condition.
