285 Home Inspection Services LLC

Home Inspection Report

2287

Roland Drive

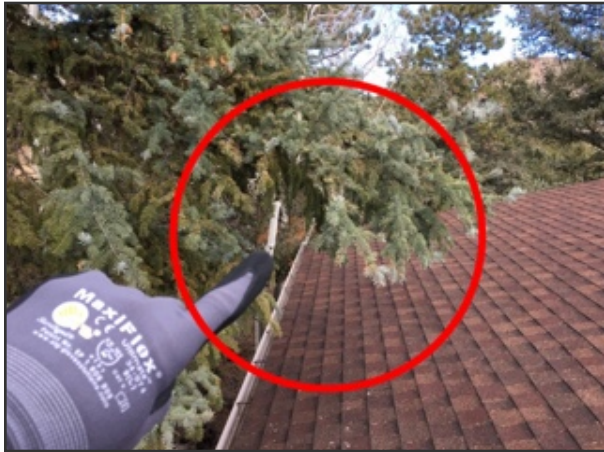
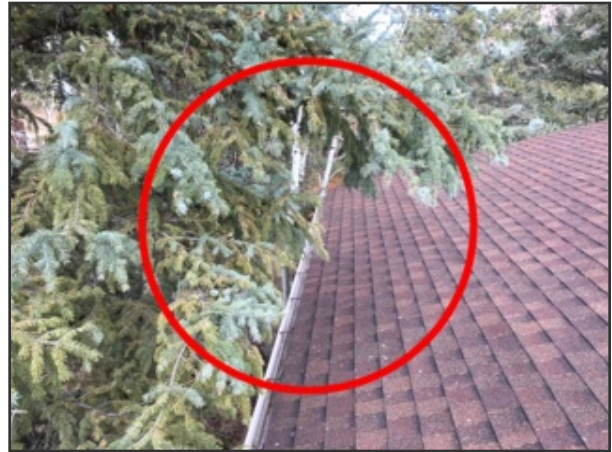
Growing Against Structure
Condition: Marginal

It is highly recommended that all Evergreen, conifer, and spruce trees be limbed up properly or completely removed when near the structure. These trees act as accelerants in a fire situation and should be removed or mitigated professionally.

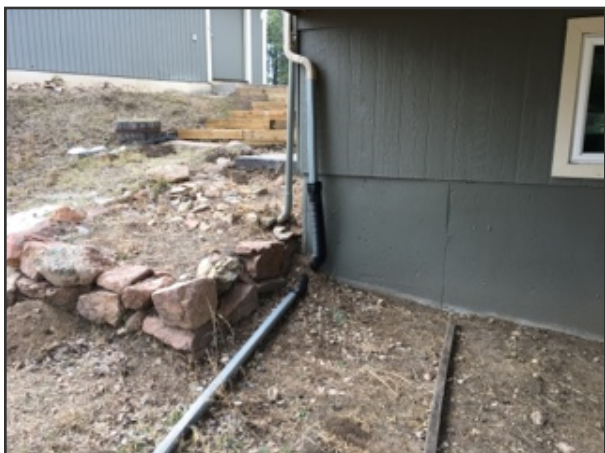
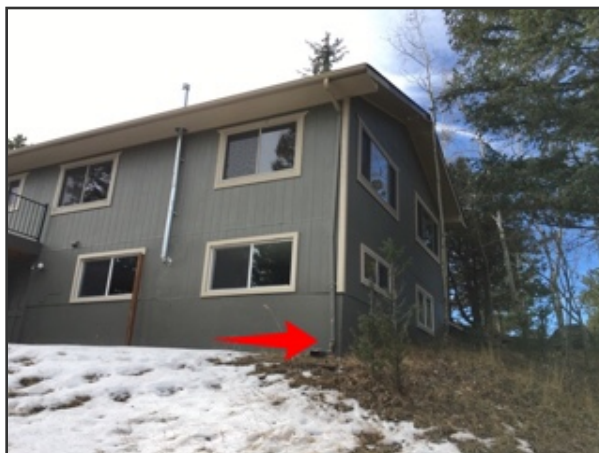
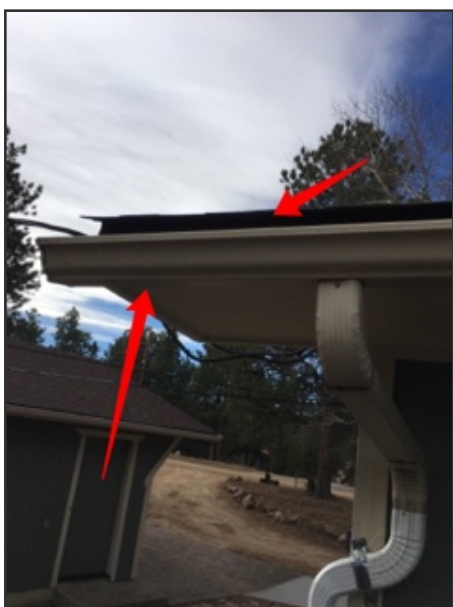
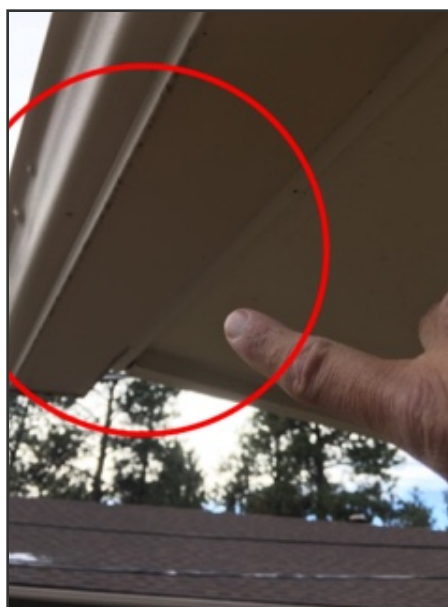
Where indicated with the red highlights the downspout should be extended away from the home approximately 5 to 7 feet minimum. The gutter on the rear of the home towards the north east corner is loose and should be tightened.

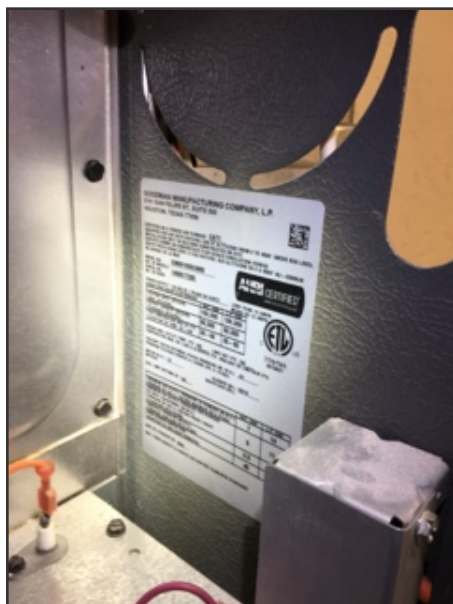
The natural gas forced air furnace operated very well throughout this inspection. It is noted that this is a high altitude unit from Goodman created in 2008 and installed in 2014 no problems found. It is always recommended that a furnace should be cleaned and certified prior to use.

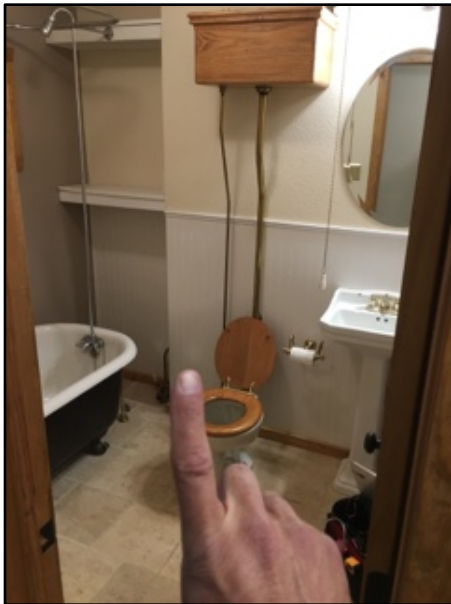
Figure 9-1

Bathroom number one is located near the master bedroom. All were found to be serviceable except for the toilet which is loose all items function properly during this inspection.

Comment 10:
Water closet toilet needs tightening.

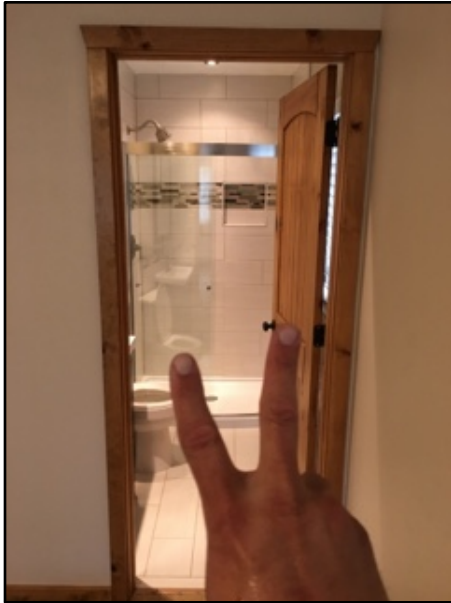
Figure 11-1

Bathroom number two had no issues found everything work properly in this location.
