# 285 Home Inspection Services LLC

## Home Inspection Report

**27295 Spruce Lane**

Inspected on Fri, May 3 2019 at 4:24 PM

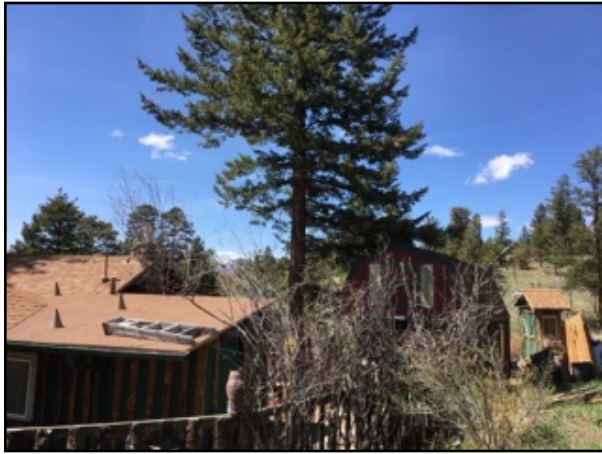
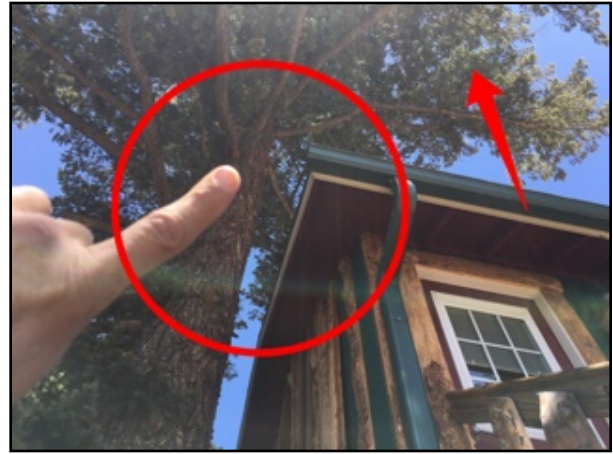
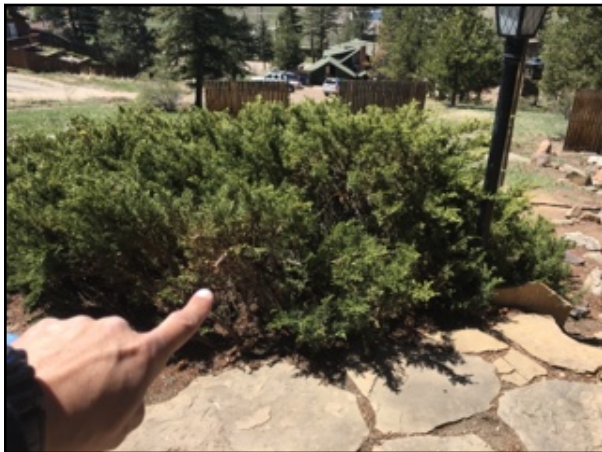
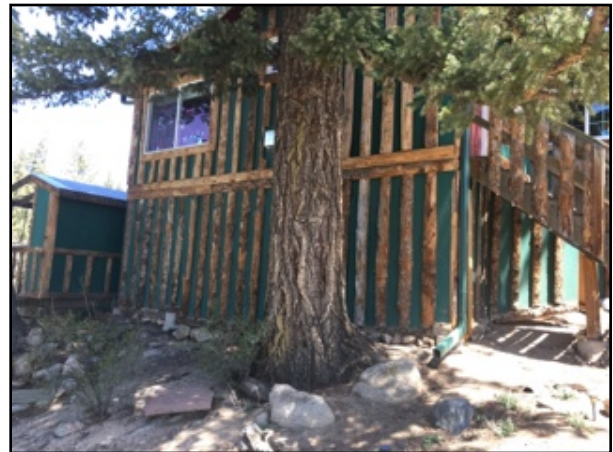
Growing Against Structure  
Condition: Marginal

Generally the pine trees surrounding the property are in good condition and limbed up properly, however there are some locations were indicated in the photographs where the large spruce tree should continue to be trimmed in order to address future fire mitigation concerns.

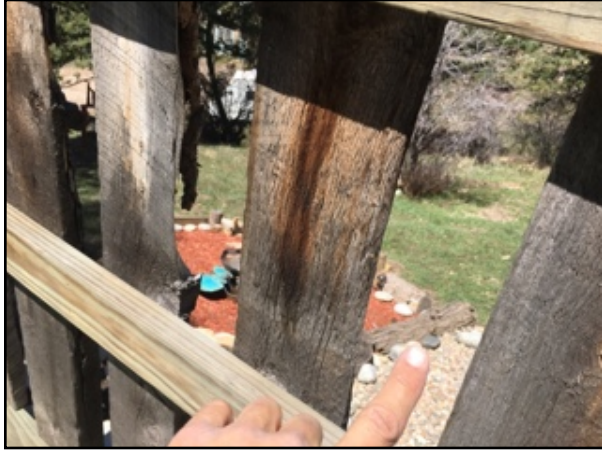
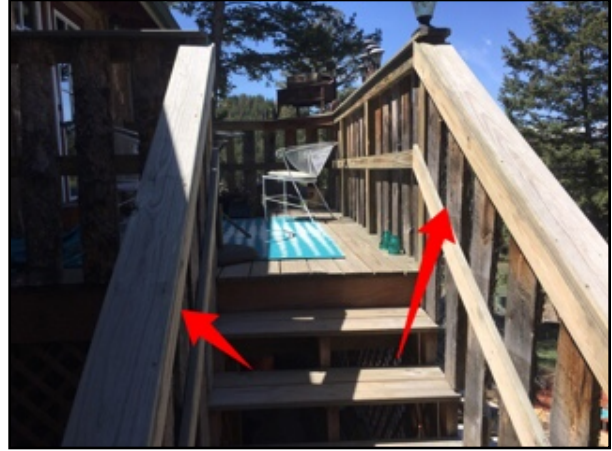
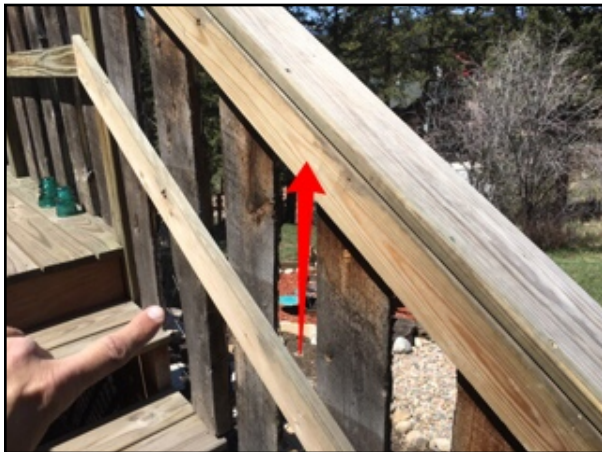
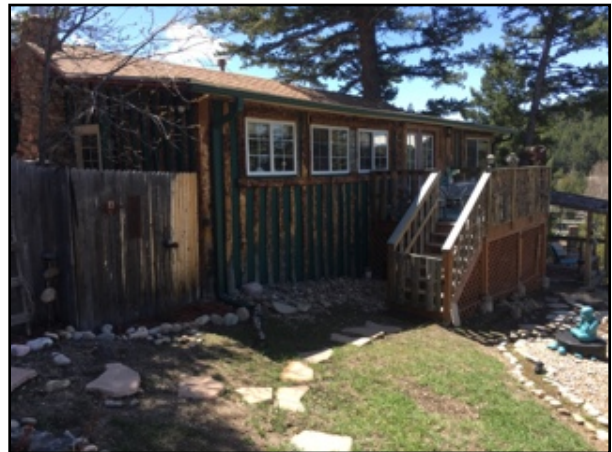
Condition: Marginal

The handrails for the deck leading up to the property on the north side are a bit loose and could use some reinforcement. Nothing major was found with regard to the deck.

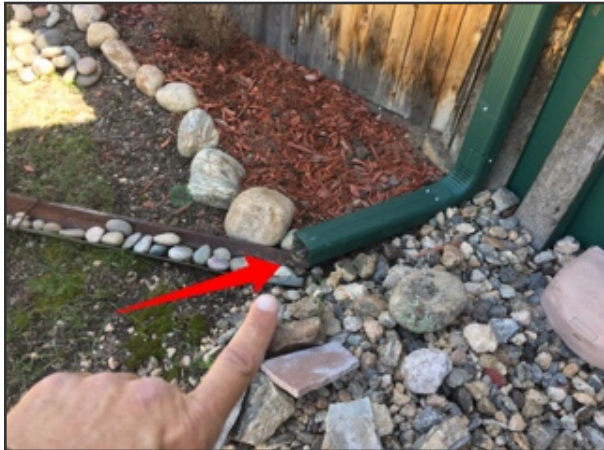
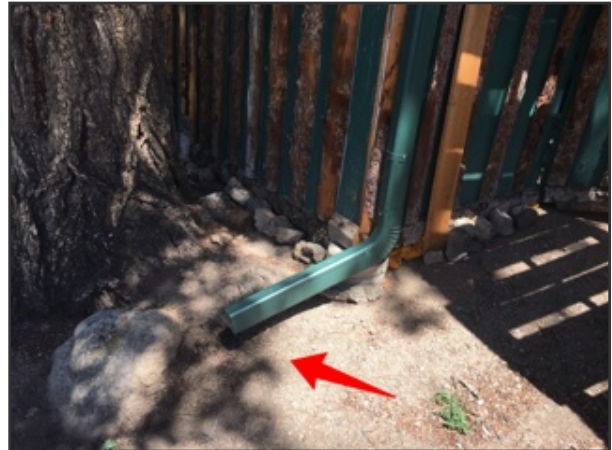
Condition: Marginal

As water is not helpful to a foundation it is always recommended that downspouts be extended away from the property a minimum of 5 to 7 feet this is easily accomplished by adding an extension. This property does need extension tubes added to the downspouts.

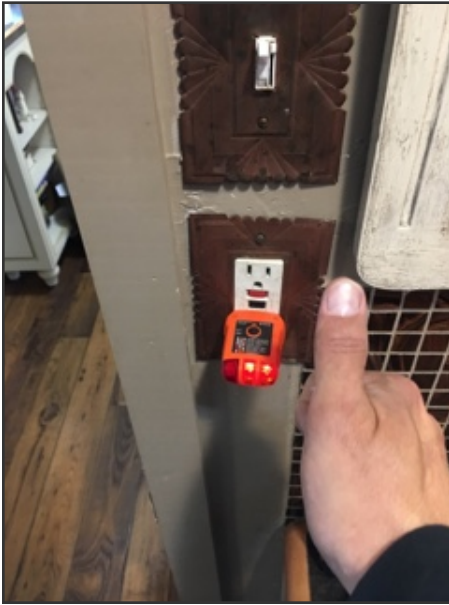
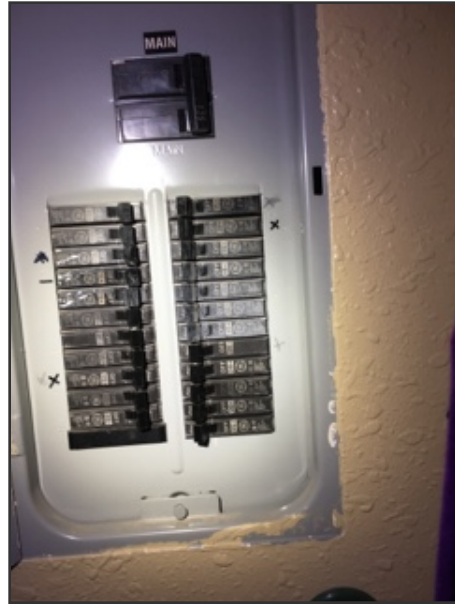
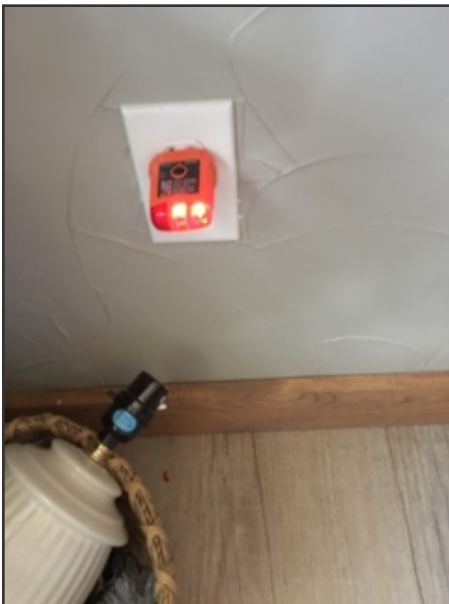
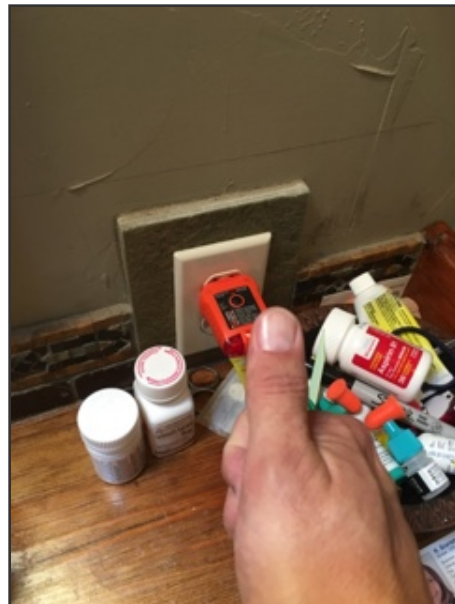
Condition: Marginal

The three locations in the house where GFCI should be in place are the bathroom near any water sources and in the kitchen. As indicated in the photograph both bathrooms have GFCI outlets that work properly. The kitchen to the left of the main sink location does not have GFCI connection and should be further evaluated by a licensed electrician.

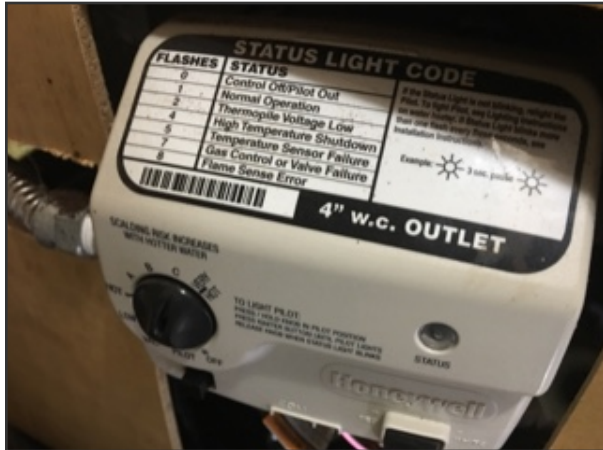
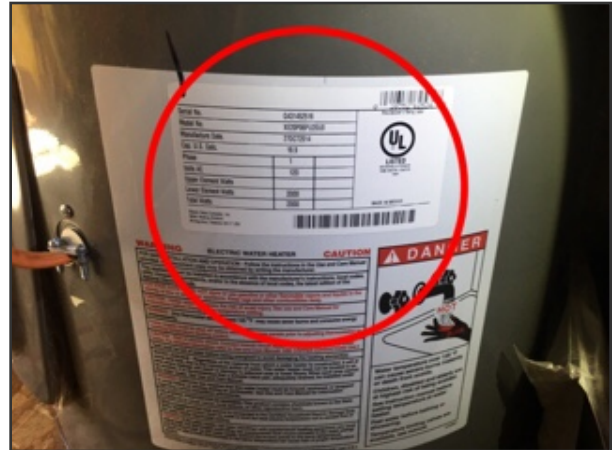
At this property there are two water heaters one is in the crawl space which is approximately 20 gallons and the other is located near the gas stove in the kitchen which is a 50 gallon water heater. Both appeared to be in functional condition and worked well during inspection.

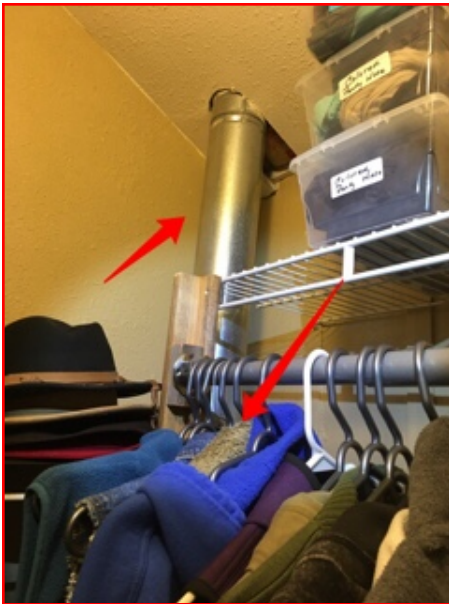
Figure 9-1

8) In addition to the heater not functioning properly during the inspection it is noted that there is a ventilation pipe running directly through the closet on the main floor this should be addressed by a licensed HVAC professional to determine if this pipe should be enclosed or insulated.
