285 Home Inspection Services LLC

Home Inspection Report

409 Ward Street

Inspected on Sun, Mar 10 2019 at 1:16 PM

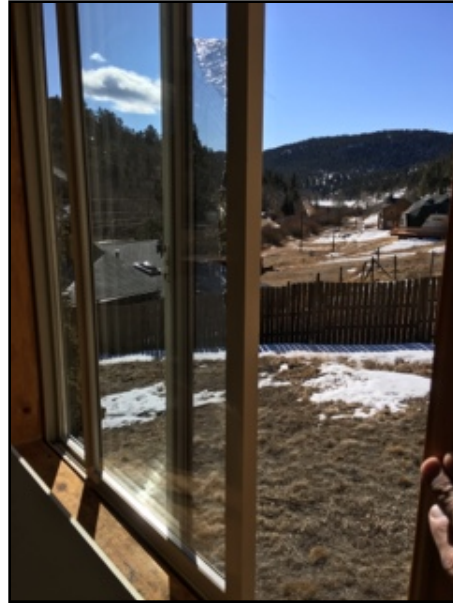
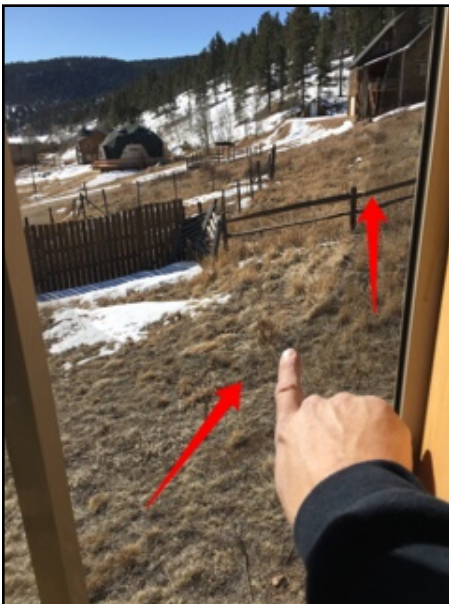
Windows in this home appeared to be in good condition and operate properly they are vinyl double pane windows. Where indicated in the photograph there is a torn screen which should be replaced.

1) Windows in this home appeared to be in good condition and operate properly they are vinyl double pane windows. Where indicated in the photograph there is a torn screen which should be replaced.

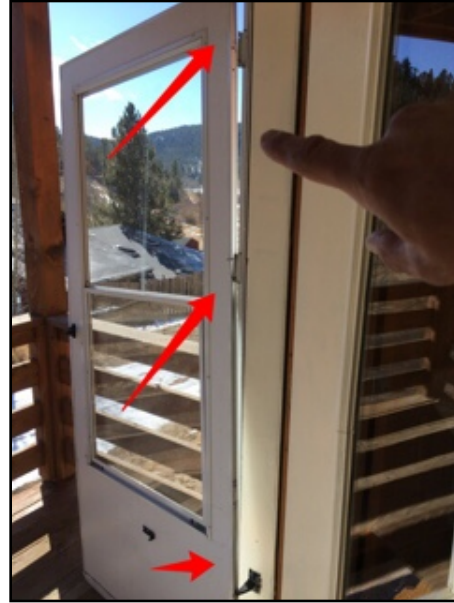
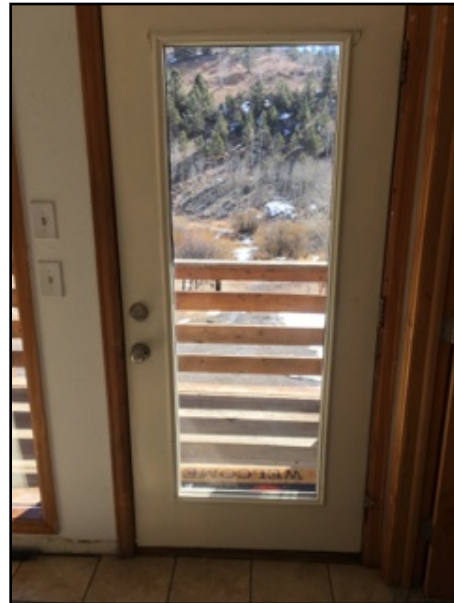
The main entry to the home is up at stairwell onto the upper level entry. Where indicated in this photograph the screen door is off its hinges and should be replaced otherwise the doors appear to seal properly and close correctly.

2) The main entry to the home is up at stairwell onto the upper level entry. Where indicated in this photograph the screen door is off its hinges and should be replaced otherwise the doors appear to seal properly and close correctly.

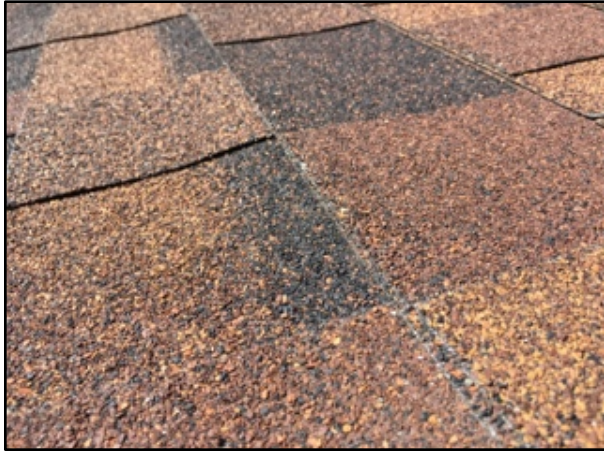
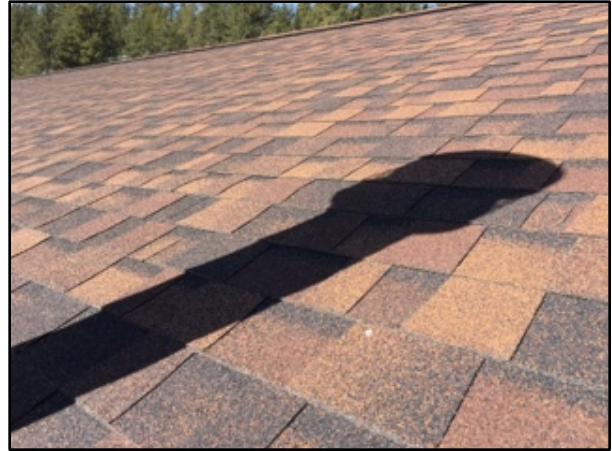
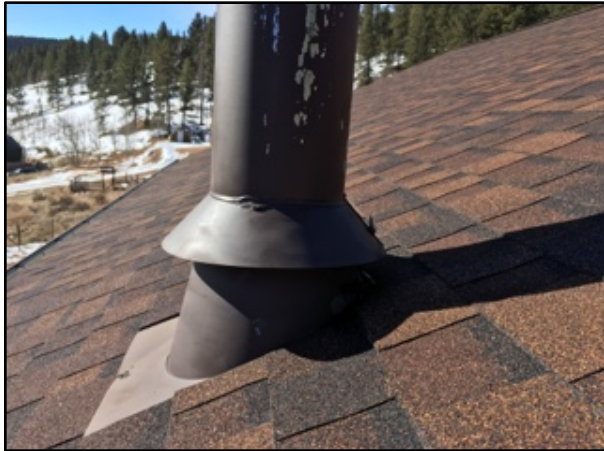
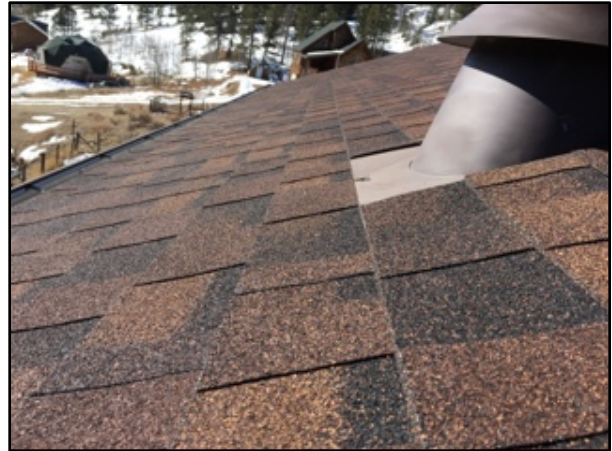
The roof on this home appears to be in very good condition and is probably 1 to 2 years old. No signs of granular loss were found during this inspection.

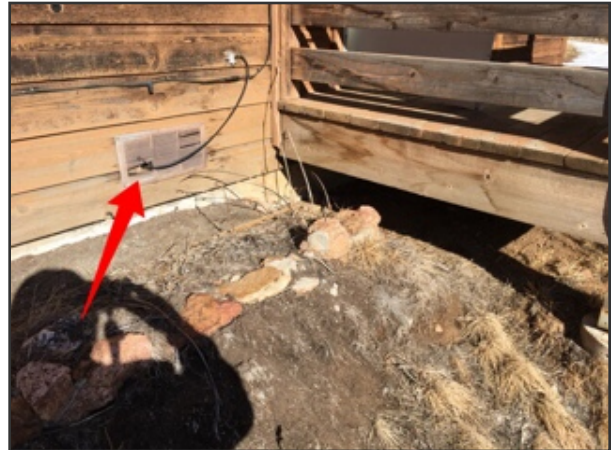
Wet

In this home the crawlspace access was not investigated as all appliances such as water heating unit, well water pump, and water heater are all located on the main level. as this home has an active water leak it is highly recommended that all plumbing work be completed prior to crawlspace investigation.

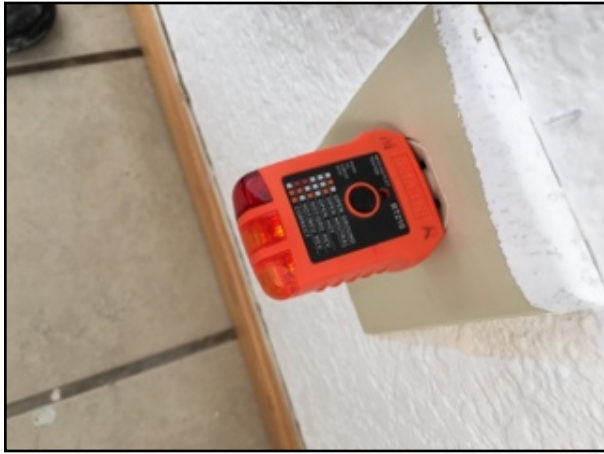
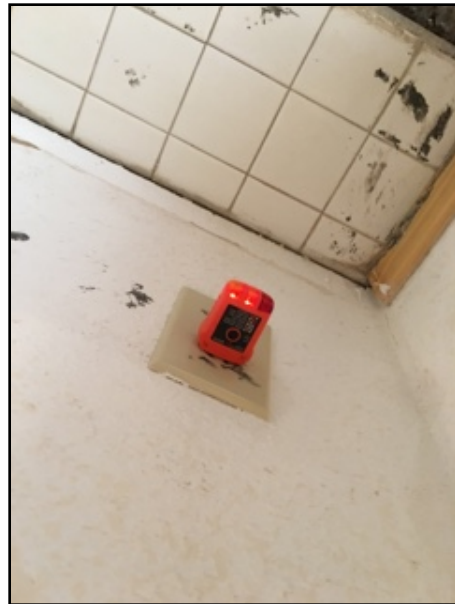
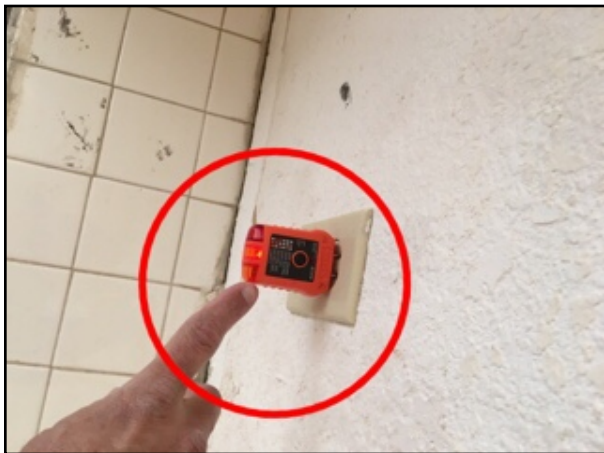
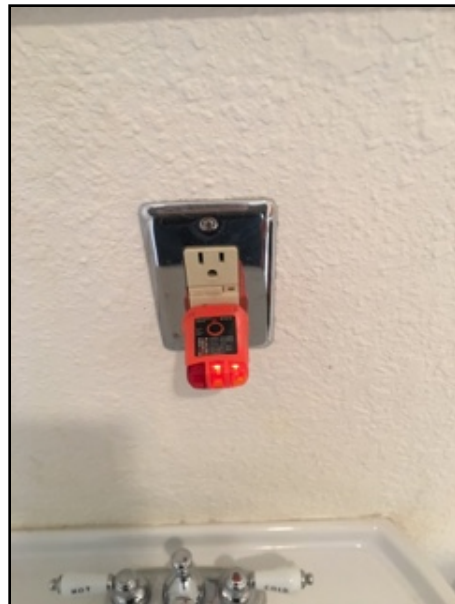
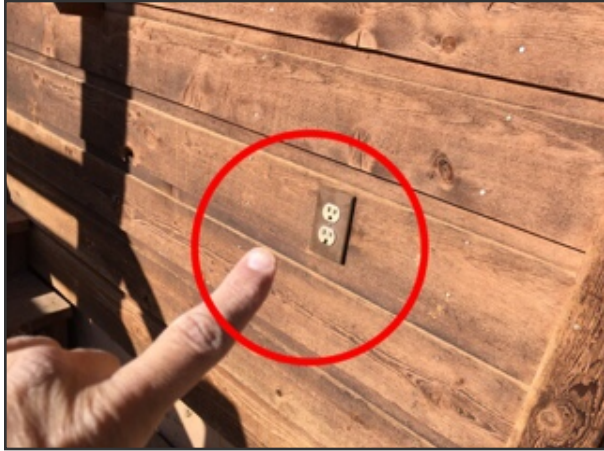
Generally speaking the outlets in this home are either AFCI or GFCI ground fault current interrupt as required. The highlighted photographs indicate a missing ground and an exterior non-weatherproof outlet box he should be corrected by a licensed electrician.

5) Generally speaking the outlets in this home are either AFCI or GFCI ground fault current interrupt as required. The highlighted photographs indicate a missing ground and an exterior non-weatherproof outlet box he should be corrected by a licensed electrician.

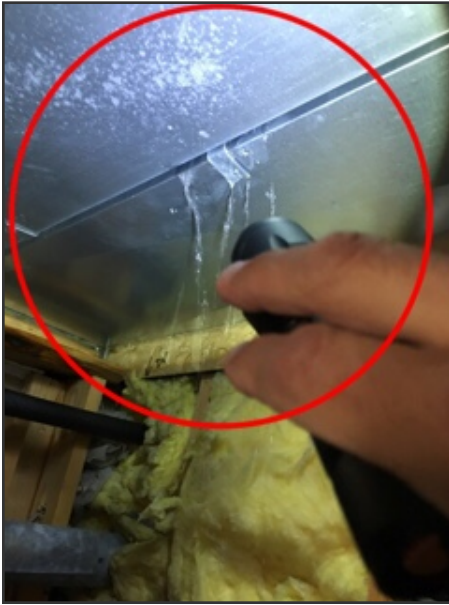
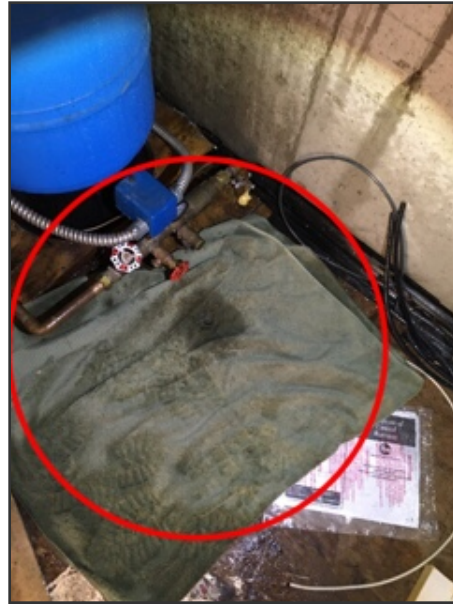
Pertaining to the water service the well may be working properly, however the supply line coming into the home is leaking very badly right above the water heater room. When the electrical connection is restored to the pump it severely overflows from the kitchen all the way down into the utility room. It is highly recommended that a professional plumber review and correct all supply line problems in this home as it will cause moisture issues.

9) Pertaining to the water service the well may be working properly, however the supply line coming into the home is leaking very badly right above the water heater room. When the electrical connection is restored to the pump it severely overflows from the kitchen all the way down into the utility room. It is highly recommended that a professional plumber review and correct all supply line problems in this home as it will cause moisture issues.

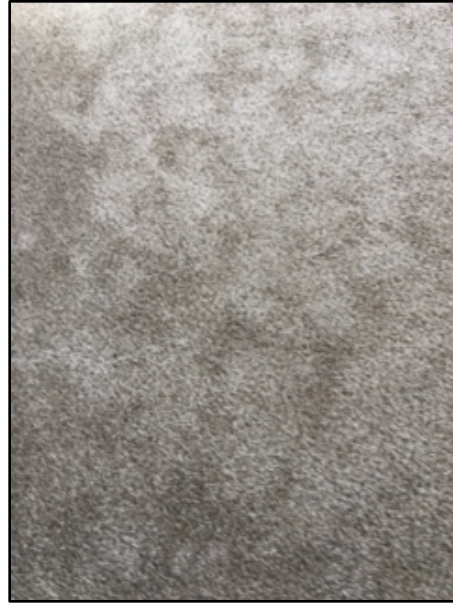
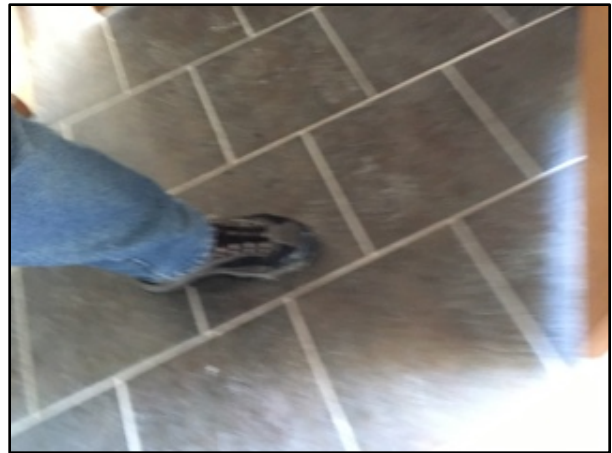
This home has a mixture of newer carpeting on the upper level and a mixture of stone and tile and linoleum on the lower level. Some of the tiles are cracked and broken as pictured and require removal and replacement.

18) This home has a mixture of newer carpeting on the upper level and a mixture of stone and tile and linoleum on the lower level. Some of the tiles are cracked and broken as pictured and require removal and replacement.

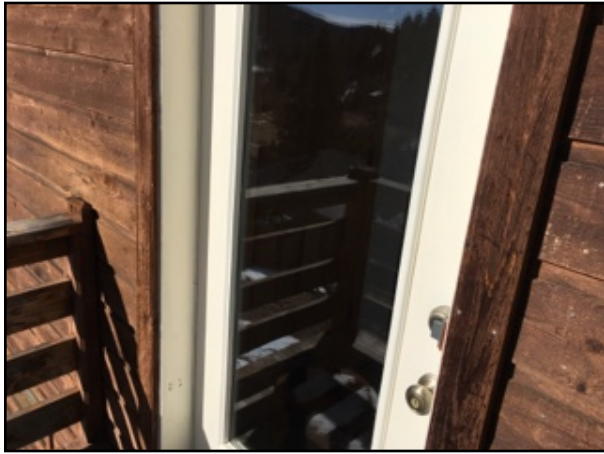
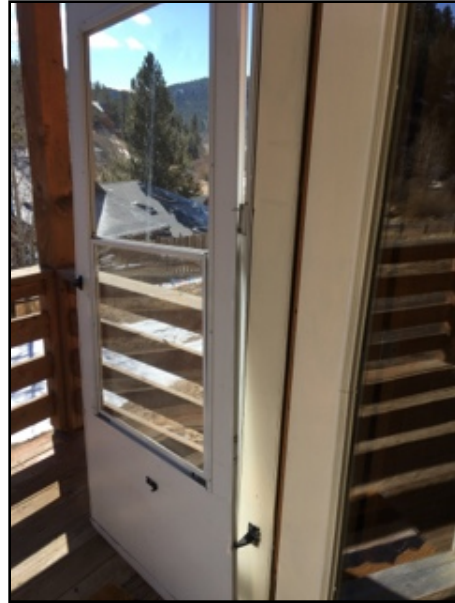
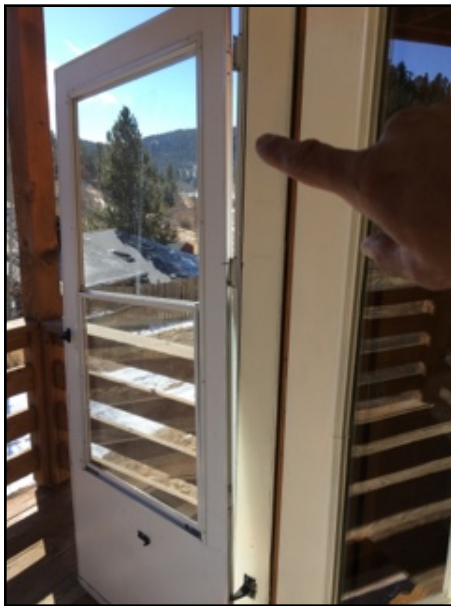
The entry doors to this home or generally in good condition the screen door should be rehung as it's coming out for changes as pictured.

19) The entry doors to this home or generally in good condition the screen door should be rehung as it's coming out for changes as pictured.

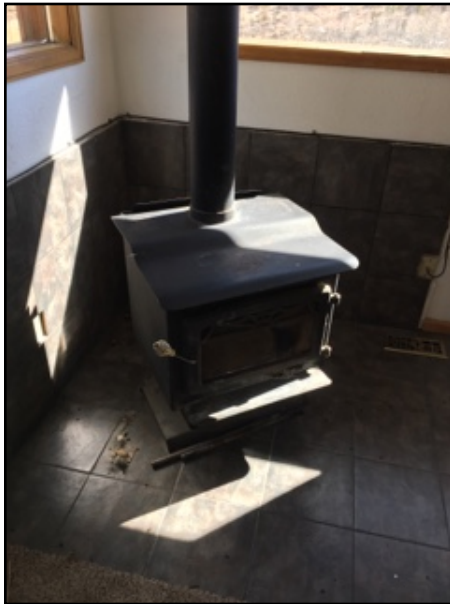
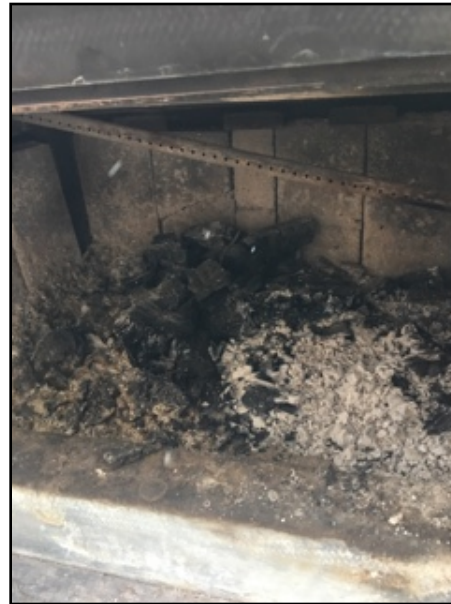
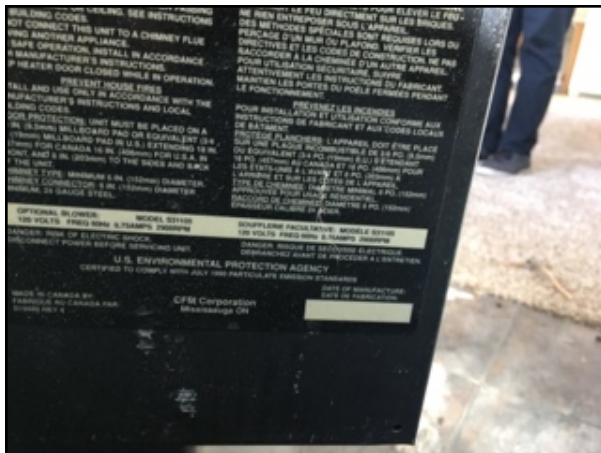
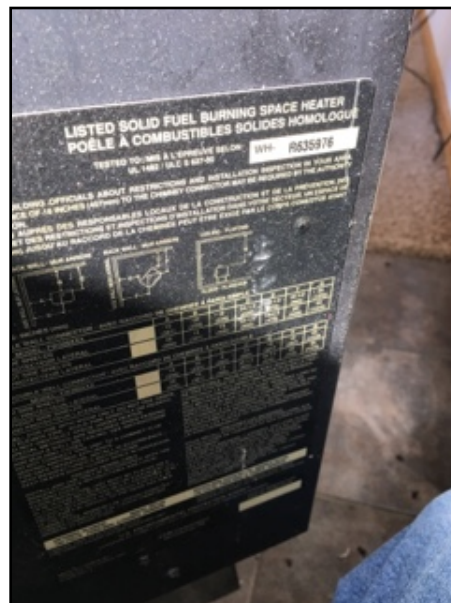
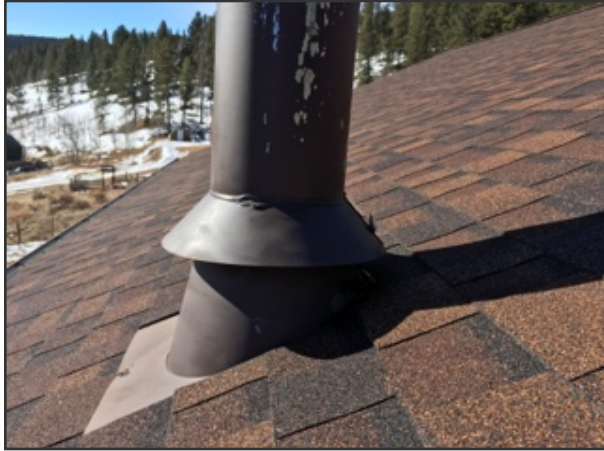
As with all wood-burning stove's they should be cleaned and certified by a professional chimney sweep for safety prior to first use.
