285 Home Inspection Services LLC

Home Inspection Report

471 Bell Road

Inspected on Sat, Apr 27 2019 at 8:38 PM

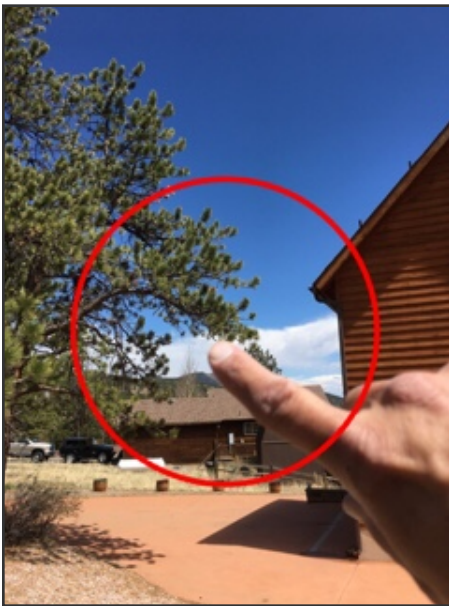
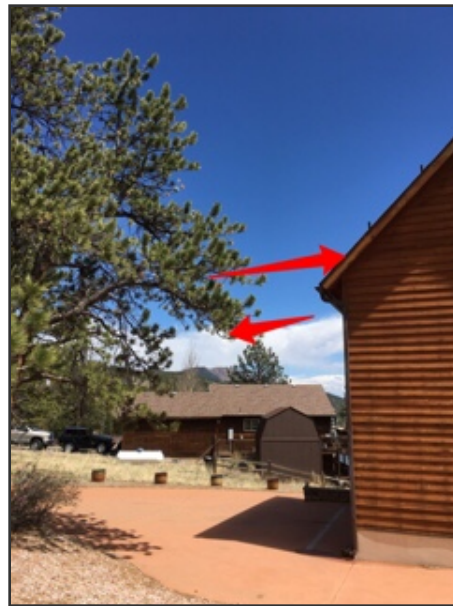
Generally Maintained
Condition: Marginal

Generally this home landscaping is very good there is one tree as indicated in the photograph that should be trimmed back.

1) Generally this home landscaping is very good there is one tree as indicated in the photograph that should be trimmed back.

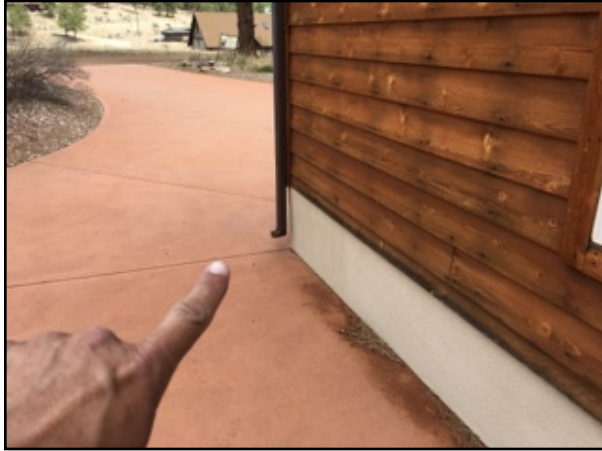
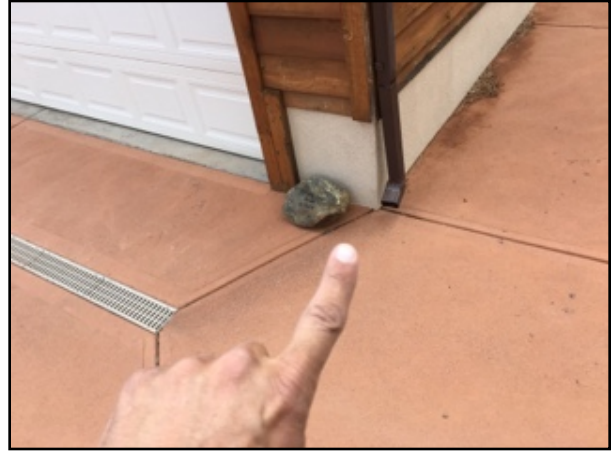
On the front right of the home the one downspout should be extended from the home 5 to 7 feet although there is a drain it could ice up.

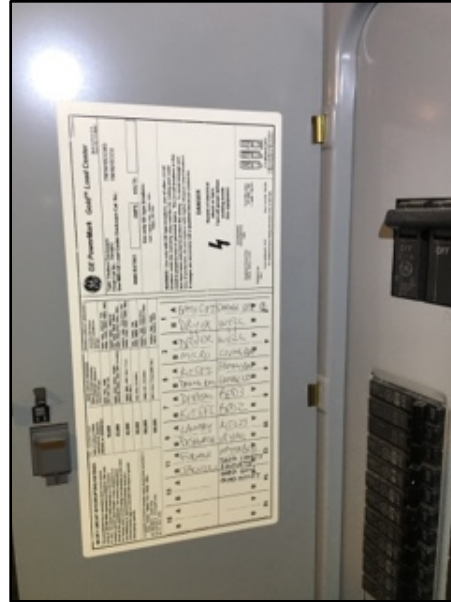
Service panel access was blocked by a desk as illustrated in the photograph the dead front panel cover was not removed.

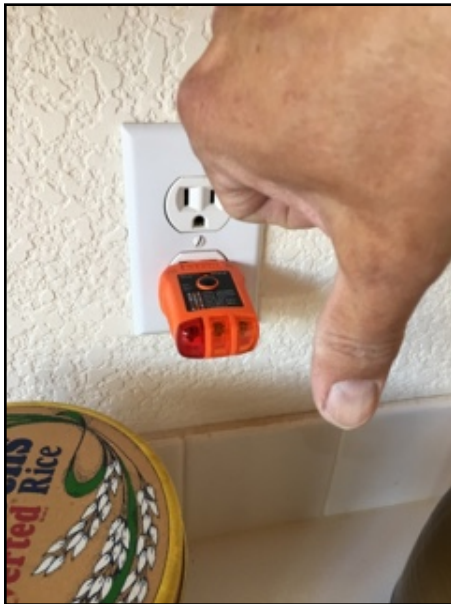
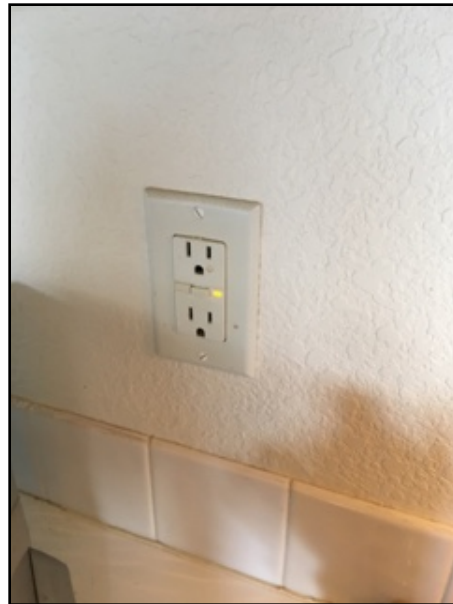
Condition: Further Evaluation Required

in this home GFCI breakers are in use and bathrooms and kitchen. The outlet to the left of the sink in the kitchen is faulty and should be repaired by a licensed electrician.

3) in this home GFCI breakers are in use and bathrooms and kitchen. The outlet to the left of the sink in the kitchen is faulty and should be repaired by a licensed electrician.

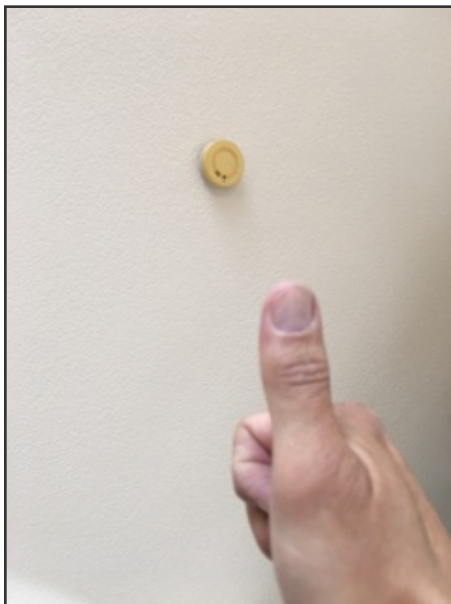
During the inspection it is noted that there were no carbon monoxide sensors located in the interior of the home. It is highly recommended that CO detectors be added.

4) During the inspection it is noted that there were no carbon monoxide sensors located in the interior of the home. It is highly recommended that CO detectors be added.

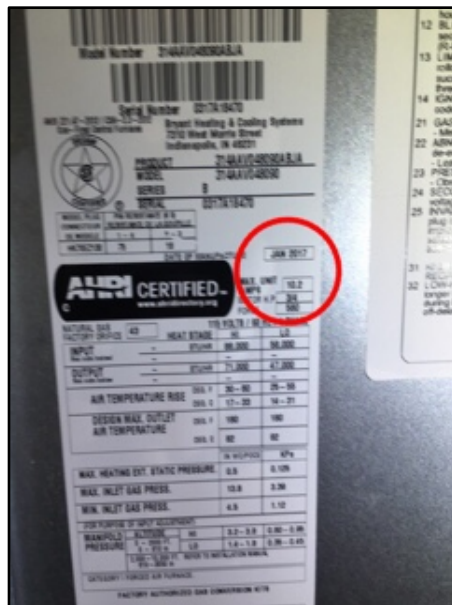
Figure 7-1

Comment 7:
2017.

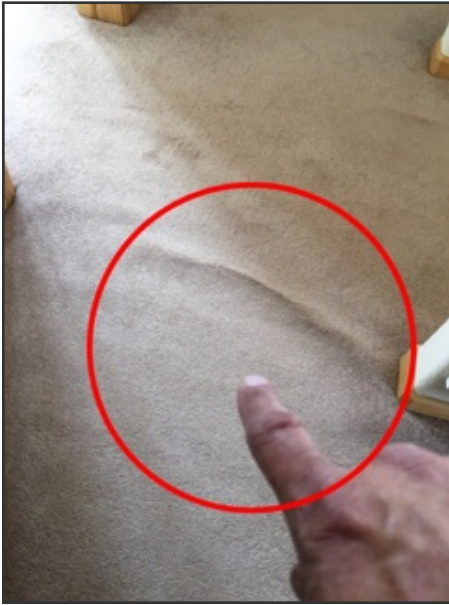
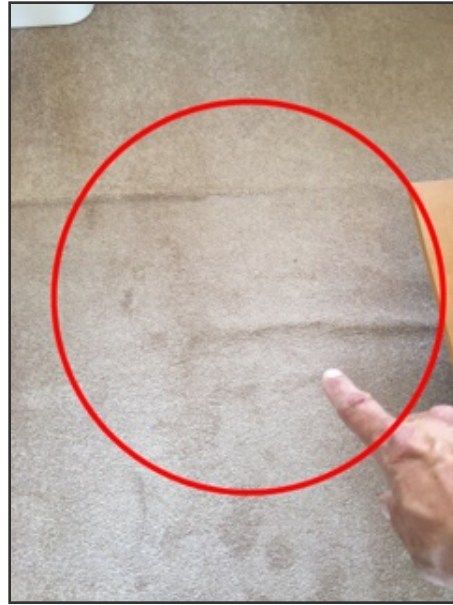
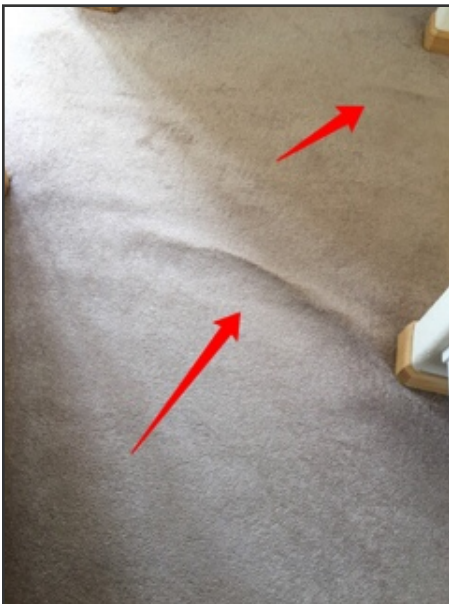
As noted in the photographs the carpeting on the upper level needs to be re-stretched were fastened properly as it is gathering up near the stairway, and may be a tripping hazard.

5) As noted in the photographs the carpeting on the upper level needs to be re-stretched were fastened properly as it is gathering up near the stairway, and may be a tripping hazard.

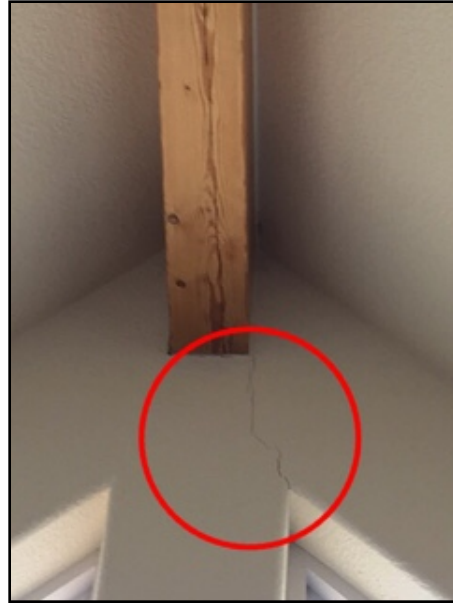
Textured Over Drywall
Condition: Marginal

In the master bedroom as well as the main living room support beam areas as pictured there are surface cracks that appear to be from winds and roof loading. As the roof itself should be replaced in the near future it is highly recommended that the drywall be patched and repainted.

6) In the master bedroom as well as the main living room support beam areas as pictured there are surface cracks that appear to be from winds and roof loading. As the roof itself should be replaced in the near future it is highly recommended that the drywall be patched and repainted.
