Home Inspection Report

51 Suffolk Way

Jefferson, CO 80456

Inspected on Sun, Jul 26 2020 at 1:49 PM

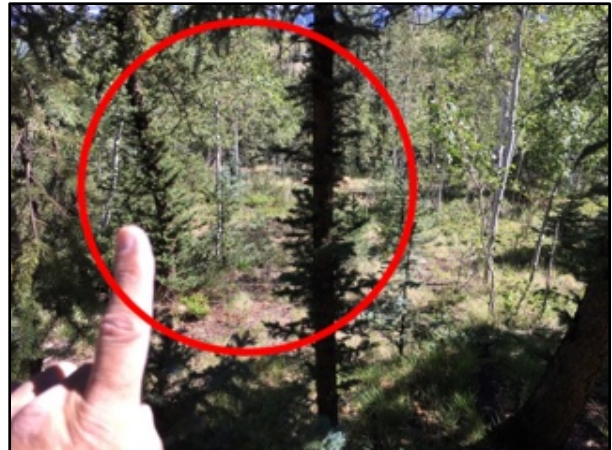
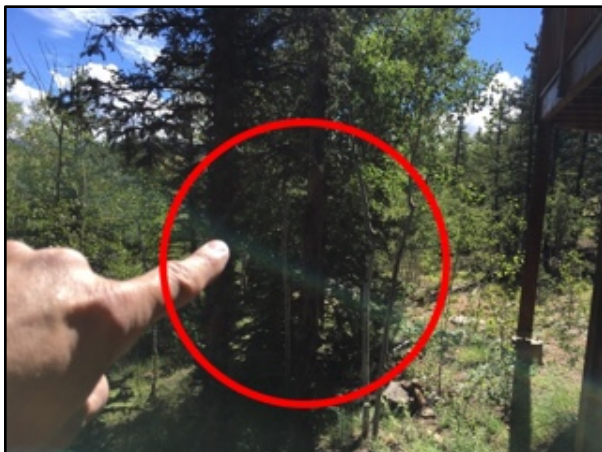
Vegetation:

Condition: Marginal

Generally speaking the house is very well-maintained with regard to fuel for wildfire. As indicated in photographs there are a number of smaller pine trees that should be removed as they are very close to the deck on the north side of the home.

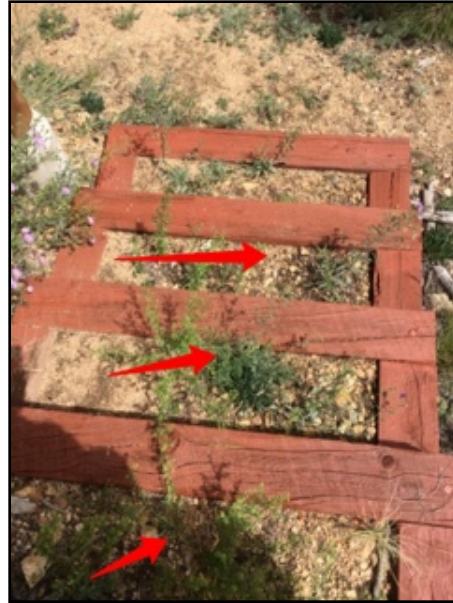
Walkways:

During the inspection there were really no problems found with walkways around the home there is a series of steps on the east side of the home that should be cleared out from any brush so as to not have a tripping hazard.

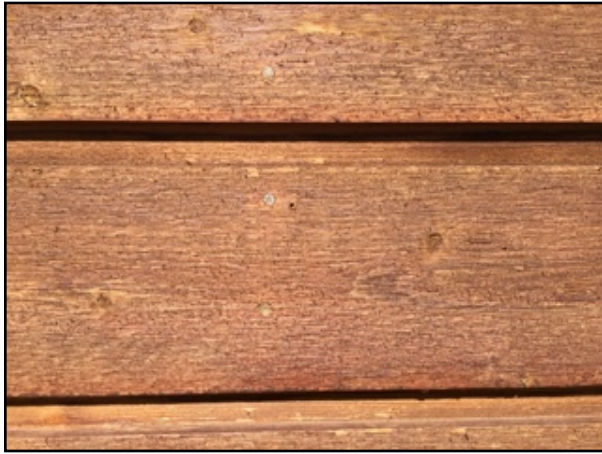
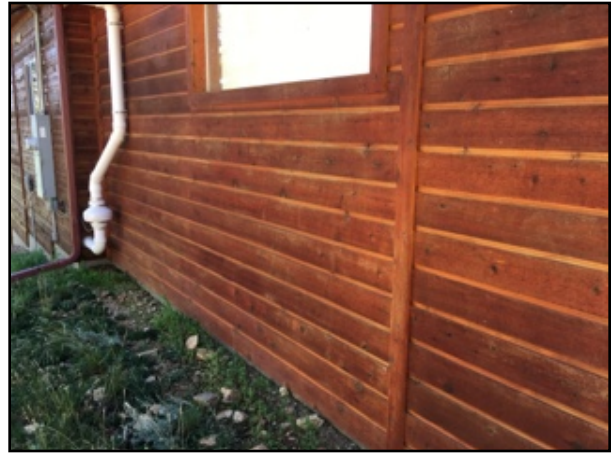
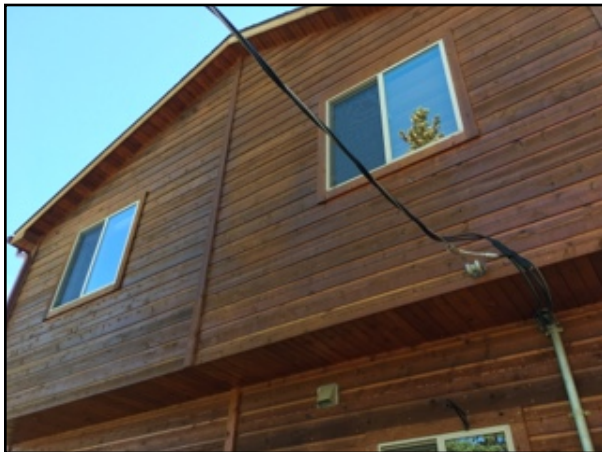
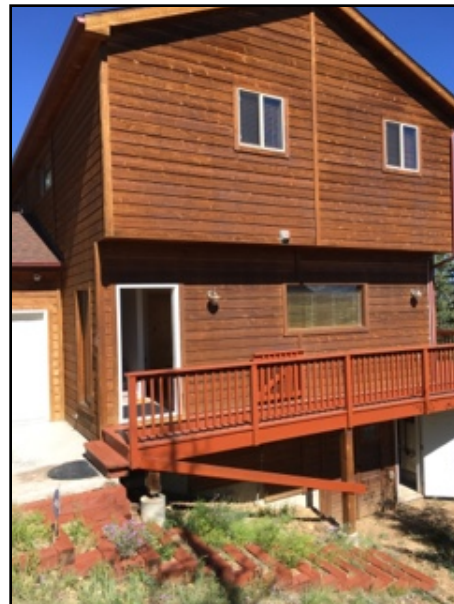
Exterior Covering:

The exterior of the home is clad with wood siding that is in good condition. Care of the exterior is an ongoing task of periodic water proofing and use of proper products. No current issues found during this inspection.

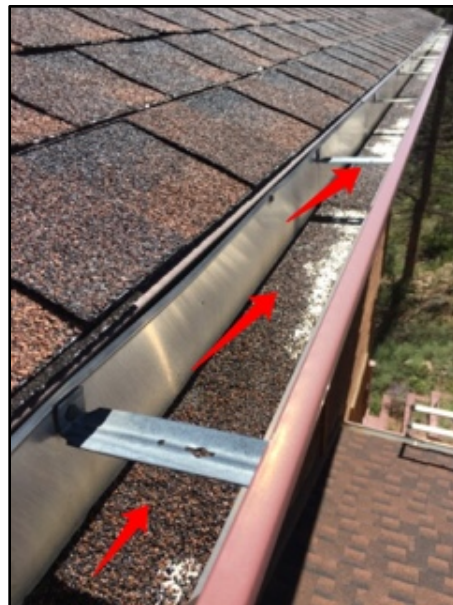
Roof Covering:

The roof on this home is in good condition it is estimated to be between five and seven years old there is some granular structure that has lost in the gutters as seen in the photographs. The roof is serviceable and in reasonably good condition.

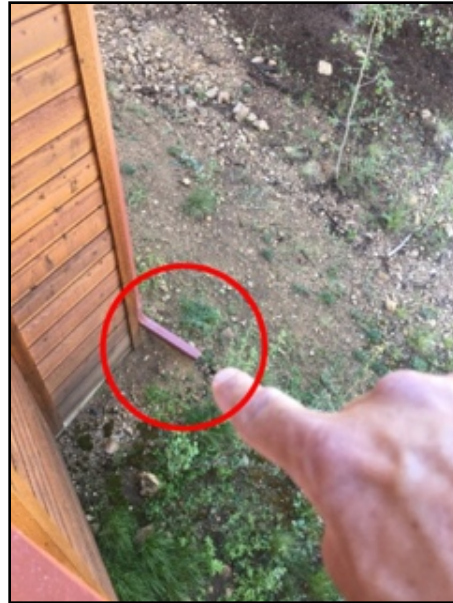
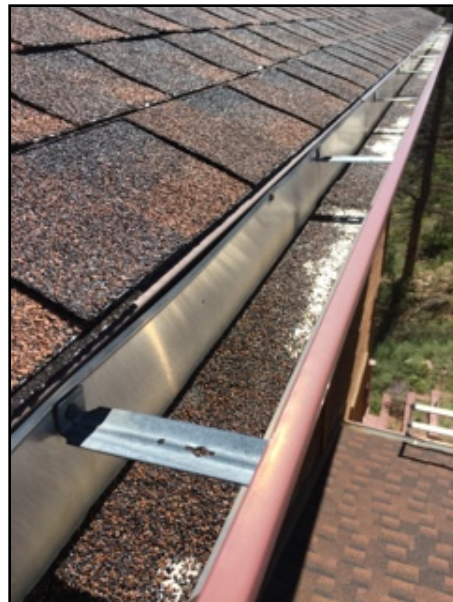
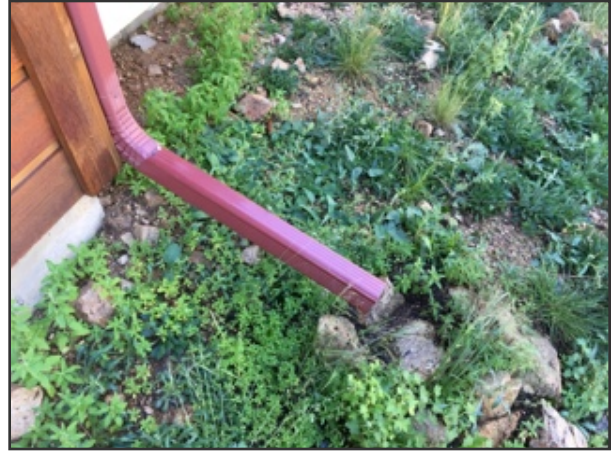
Gutters & Downspouts:

Condition: Marginal

Generally speaking the gutters and the downspouts of this home are in good condition. There are a couple of instances where the downspout should be extended away from the foundation a minimum of 5 to 7 feet there are two locations where they need to be extended.

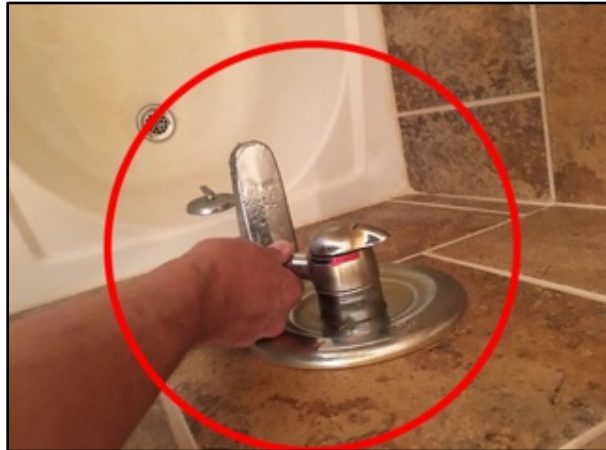
Location:	Upstairs Hallway
Bath Tub:	Recessed
	Condition: Satisfactory
Shower:	In Tub
	Condition: Marginal

The shower control valve handle was loose during this inspection it should be further evaluated by a plumber.

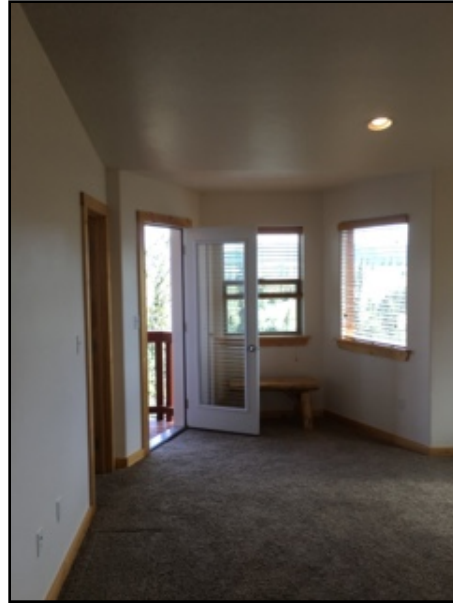
Walls:

The walls in this home are a combination of textured drywall and knocked down plaster which is very well done and looks great. There is one location upstairs in one of the bedrooms that some patching should occur otherwise very good condition.

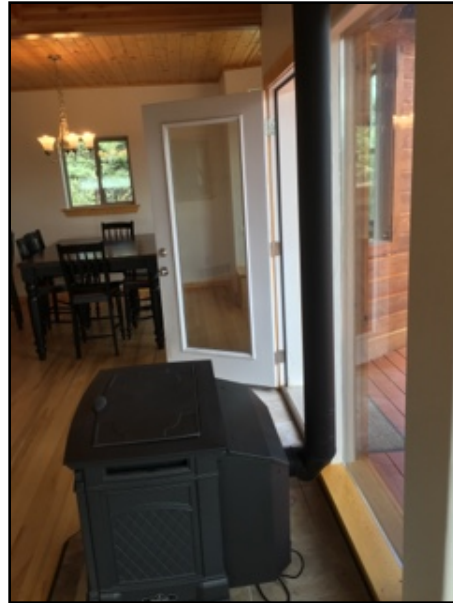
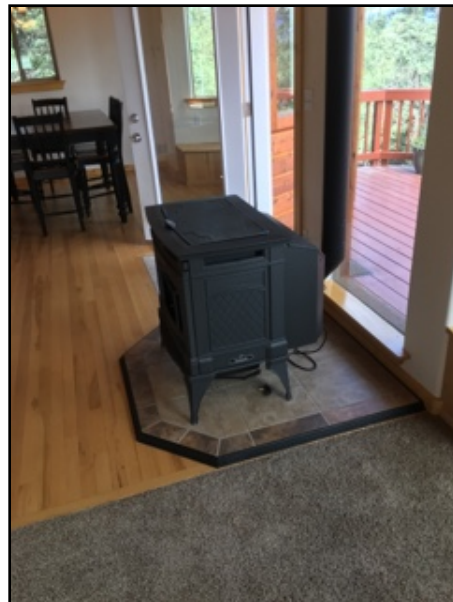
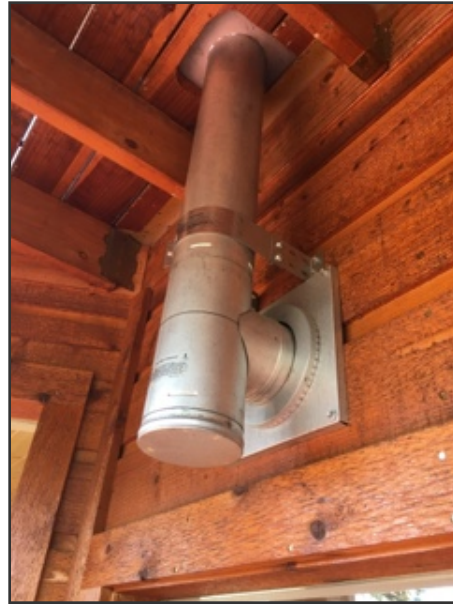
Fireplace:

Condition: Further Evaluation Required

As with all wood-burning appliances, wood-burning stoves, and pellet stoves, it is highly recommended that a certified chimney sweep clean and certify the appliance prior to first use.
