Dam Concrete Repair 2025

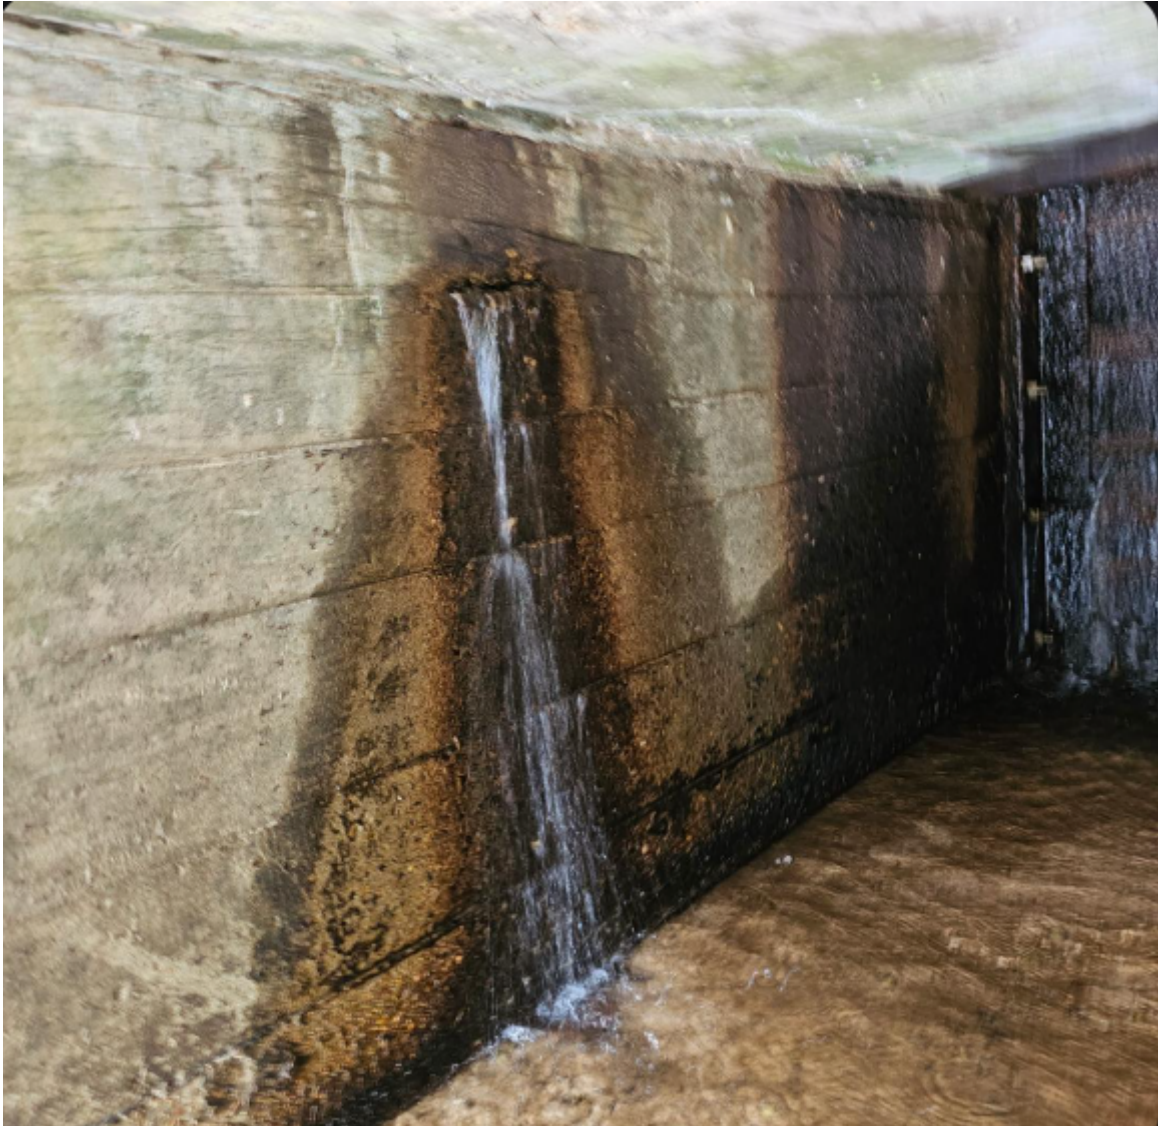
During a routine inspection of the spillway on June 8th, 2025, one member noticed water coming out of the sidewall in the shoot of the spillway. There was a leak in the spillway that needed to be addressed. The leak in the spillway shoot was on the South side of the spillway shoot as shown in figure 1.

Figure 1 – Water leaking out of the spillway

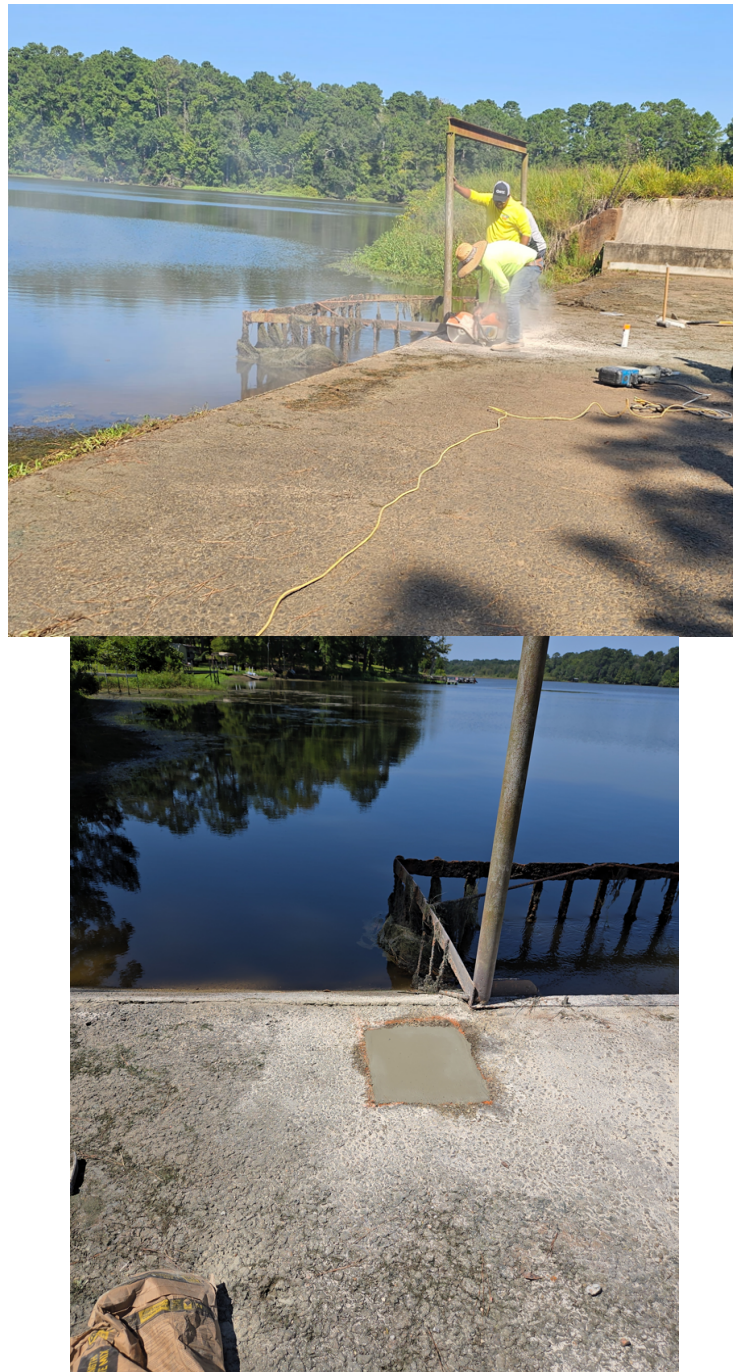
drill holes in the spillway. The board awarded the contract to Double A concrete out of Beaumont. This is the contractor that worked on the spillway for the Wildwood lake community. On September 8th, the contractor came out and started to cut out some holes in the spillway to find the leak. They started at the front of the spillway on the lake side of the spillway close to where the spillway slope meets the top of the spillway. The cut out was a 12 inch by 12 inch square hole. Figure 2 shows the location of the first hole.

Figure 2 – Location of the first hole that was cut out

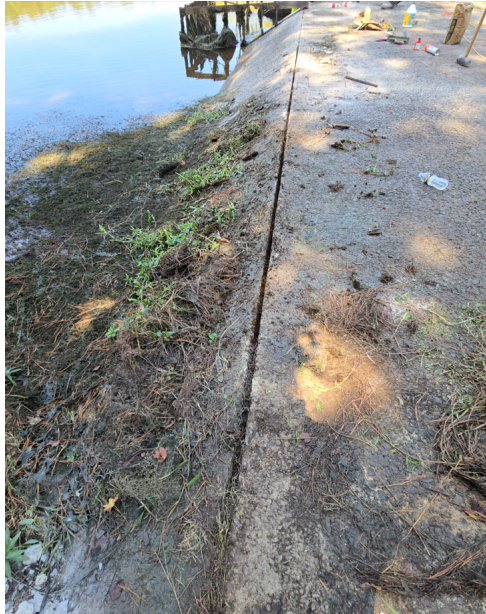
The contractor chose this location because there is a gap in the concrete. Figure 3 shows the gap in the slope and the top of the spillway.

Figure 3 – Gap in the dam

There was signs of water leaking into the spillway where the crack is between the slope of the spillway meets the top of the spillway. The first hole that was cut out was good. There was no sign of leaking in this area. The next hole to be cut out was on the downward slope of the spillway away from the lake near the spillway. Figure 4 shows the location of the 2nd cut out.

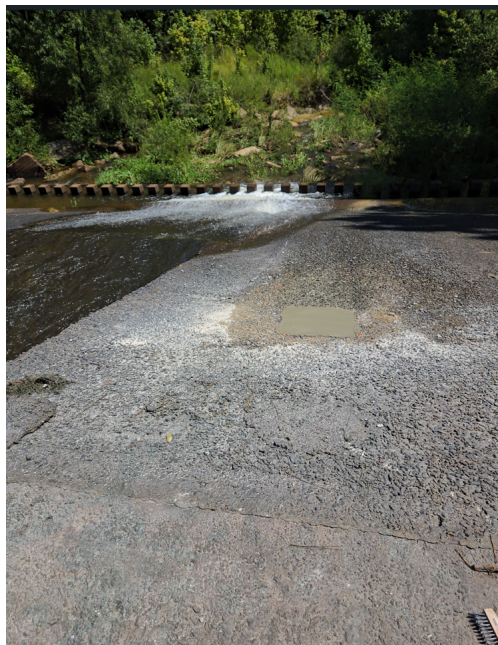
Figure 4 – cut out location number 2

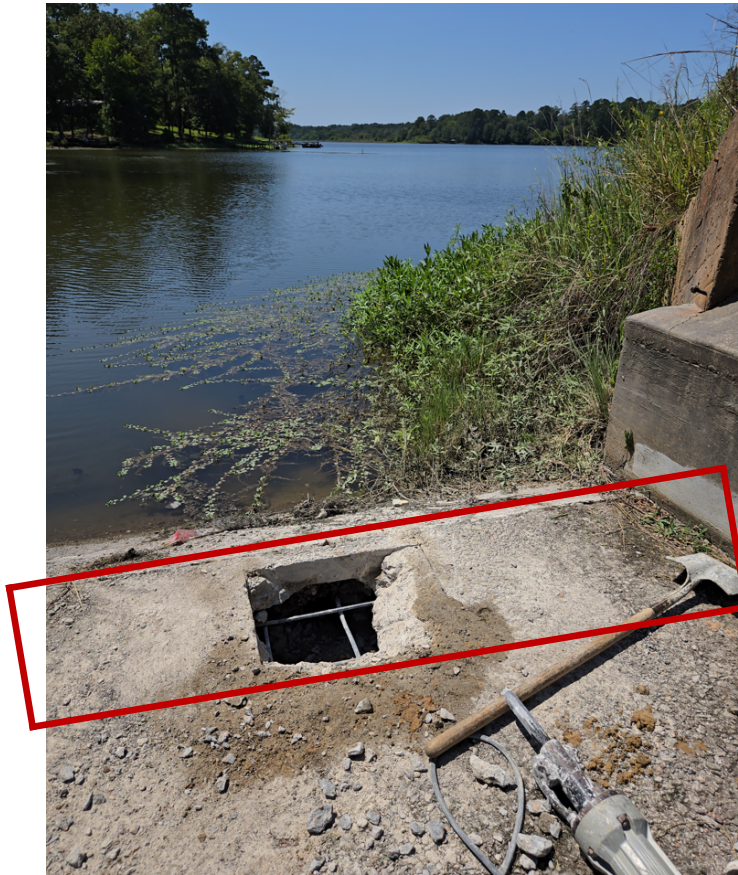
The next cut out was on the North side of the spillway. The cut out on the North side of the spillway is where we started finding erosion. Figure 5 shows the location of the cut out in the spillway. There was a channel that had been eroding out of the spillway. The red box out in the picture outlines the channel in the spillway. Most of the erosion was toward the lake side of the spillway. The water had been seeping in at the crack and eroding the concrete and dirt toward the lake side of the spillway. The erosion was about a 12 inch channel that ran from the cut out hole location all the way to the side wall on the right of the picture and roughly 10 feet to the left of the cut out in figure 5.

Figure 5 – cut out on North side of the spillway.

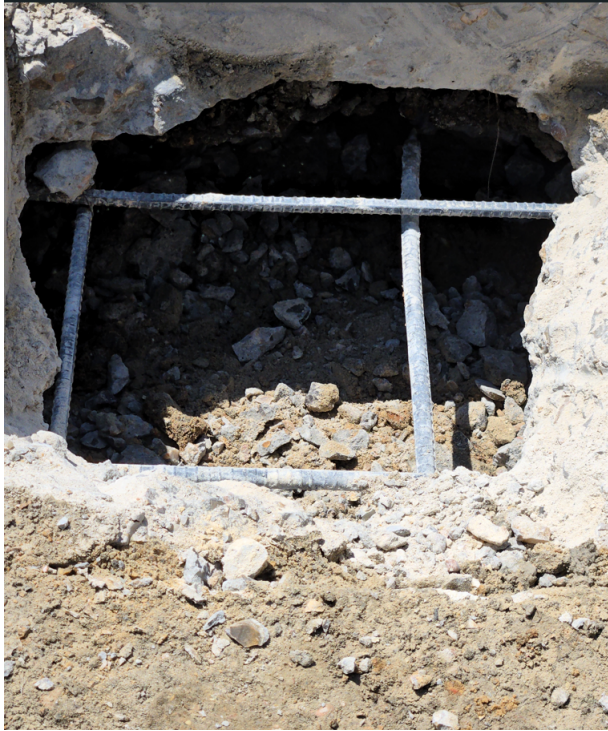
Figure 6 – Zoom in picture of the erosion on the North side of the spillway.

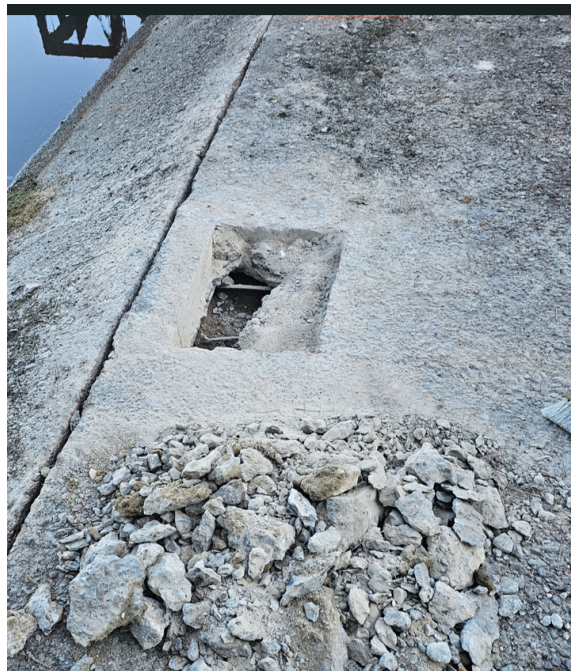
There was also a similar gap on the south side of the spillway. Figure 7 shows the location of the cut out and the water erosion. The South side of the spillway did not have as much erosion as the North side of the spillway but the North side of the spillway is a little lower and has water flowing over the top of the spillway most of the year.

Figure 7 – Cut out on the South side of the spillway.

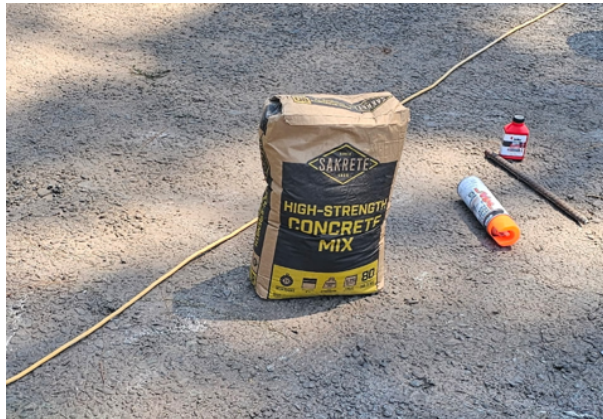
Figure 8 – Concrete product

The concrete contractor filled the holes with high strength concrete. Figure shows the product that was used to fill the gaps in the spillway.

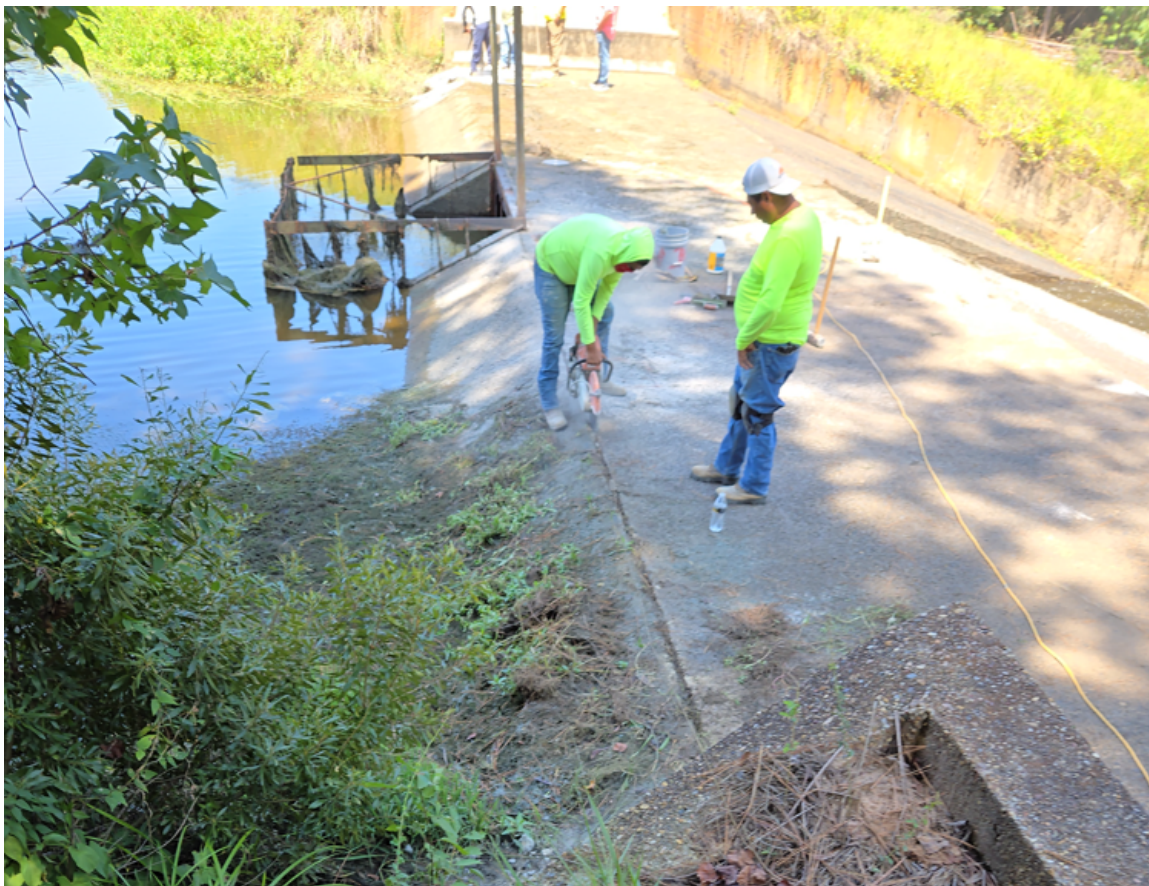
Figure 9 – Prepping the gaps in the spillway

The contractor filled all of the holes in the spillway that were found. Then the next part of the work was to clean out and seal the gaps in the spillway to prevent water ingress. The contractor used the concrete saw to clean out the gaps. Figure 9 shows the workers cleaning out the gaps to prep for the caulk.

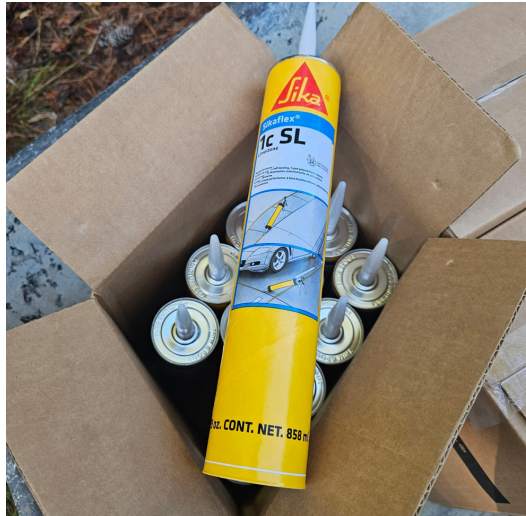
Figure 10 – Caulk used to seal the gaps in the slopes of the spillway

The contractor then sealed the gaps in the slopes of the spillway on both the lake side and the back side of the spillway using a concrete caulk. Figure 10 shows the product that was used and figure 11 shows the final result of the work that was done.

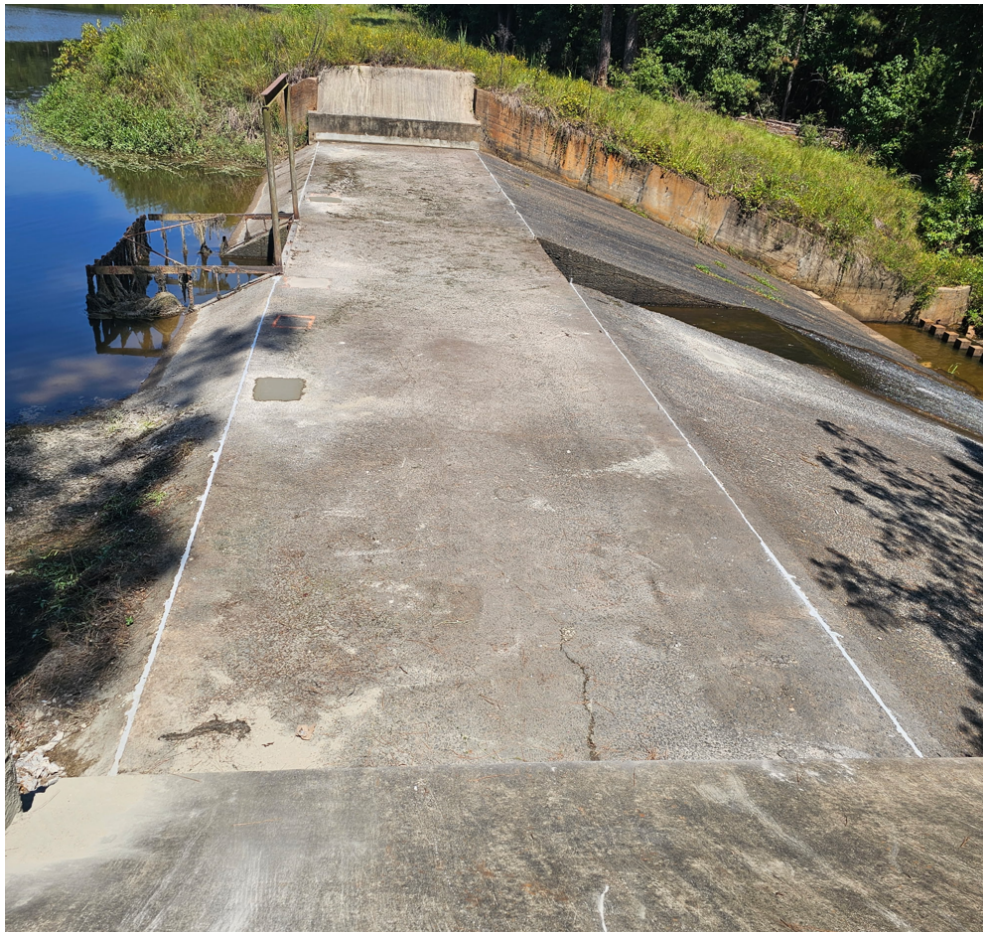
Figure 11 – Gaps in the spillway sealed
