RE: Dam and Spillway Condition Assessment
Final Report

DAM & SPILLWAY ASSESSMENT REPORT

DAM: Frog Pond Lake Dam

FROG POND LAKE DAM, COLMESNEIL, TX 75938

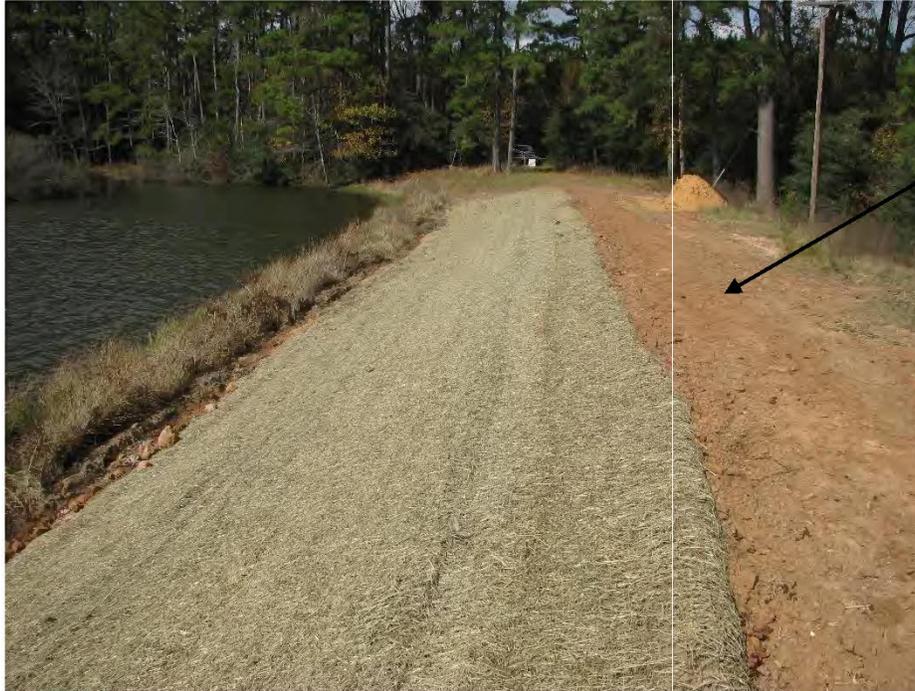
Photograph No. 1 – Left side of the dam looking North West. Large trees growing along the downstream slope, big bare areas.

No vegetative cover on the crest

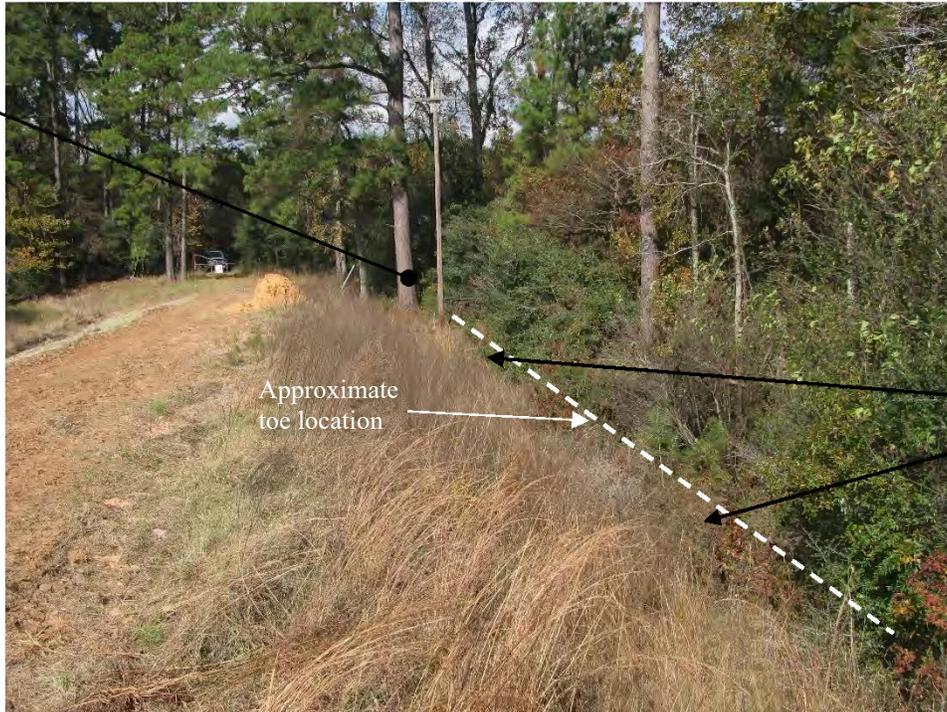
Photograph No. 2 – Left side of the dam looking North West. A view of bare crest and a tree growing on the downstream slope.

The tree growth on the downstream slope

Overgrowth of brush and trees along the toe

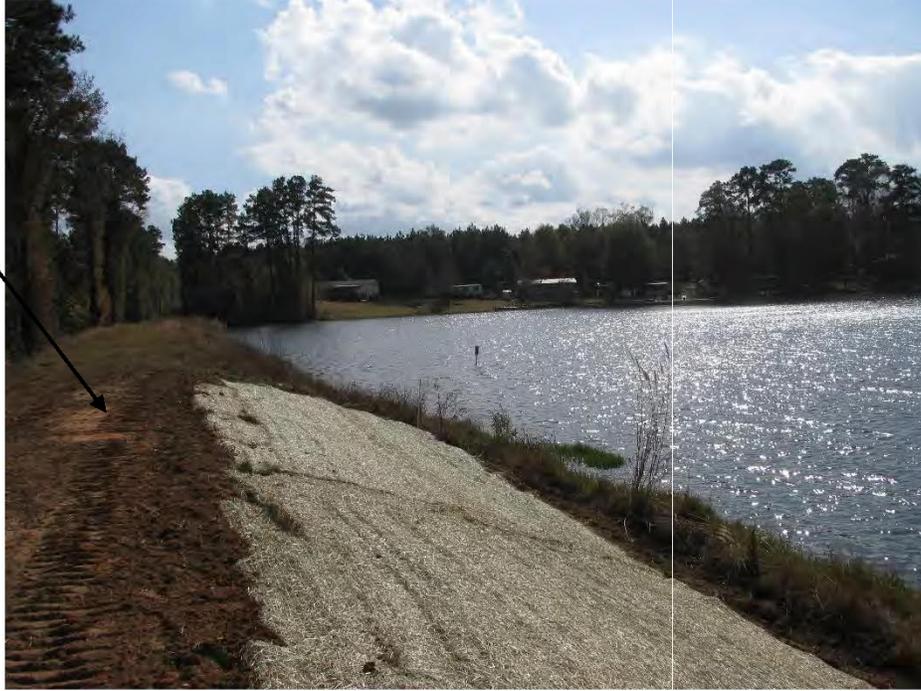
Photograph No. 3 – Standing on the left side of the dam looking South. A view of bare crest (poorly maintained vegetative cover) and an upstream slope.

No vegetative cover on the crest

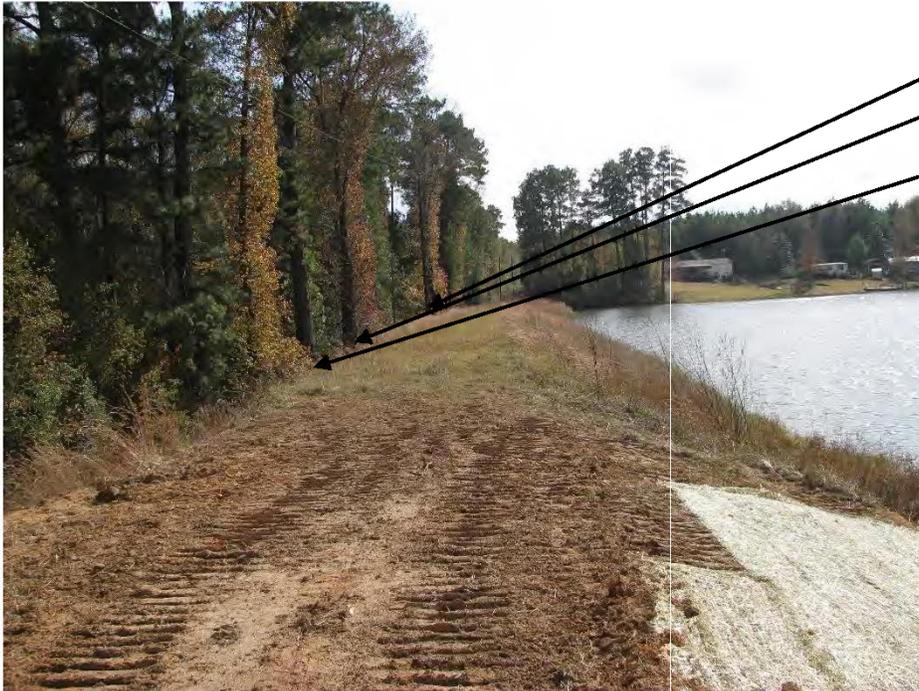
Photograph No. 4 – Standing on the left portion of the dam looking South East.

Trees growing on the downstream slope

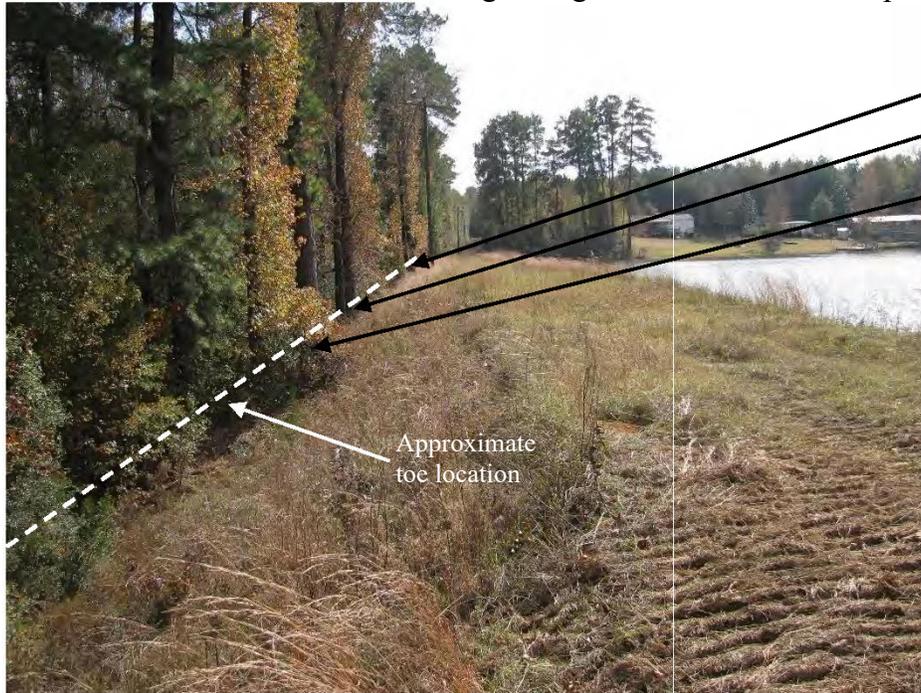
Photograph No. 5 – Standing on the left side of the dam looking South East. A view of bare crest and a tree growing on the downstream slope.

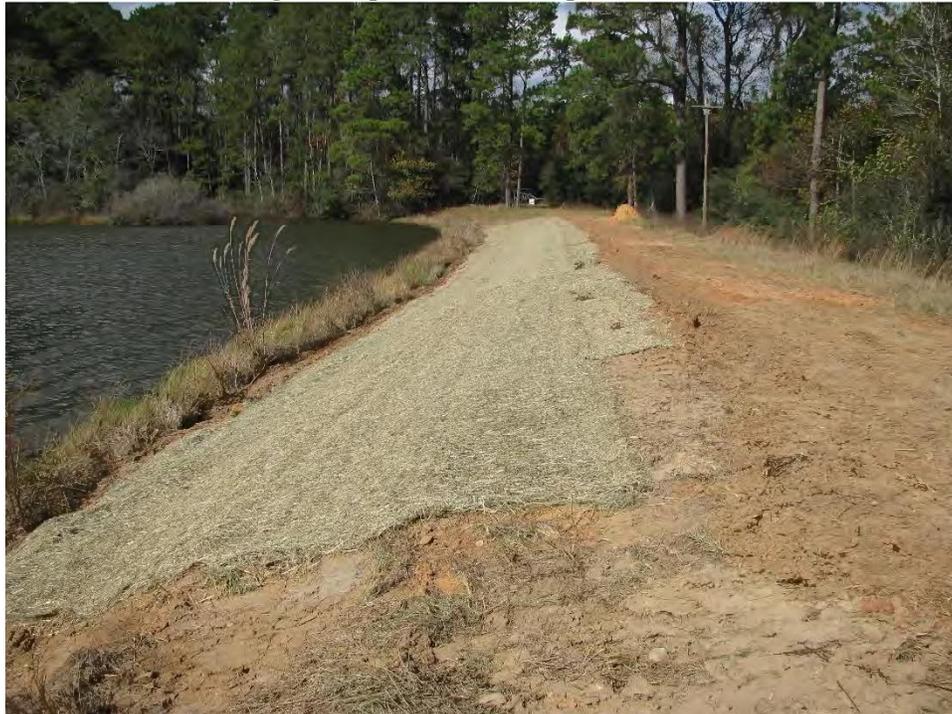
Photograph No. 6 – Standing near a midpoint looking North West. A view of the 3H:1V non-vegetated portion of the upstream slope and crest.

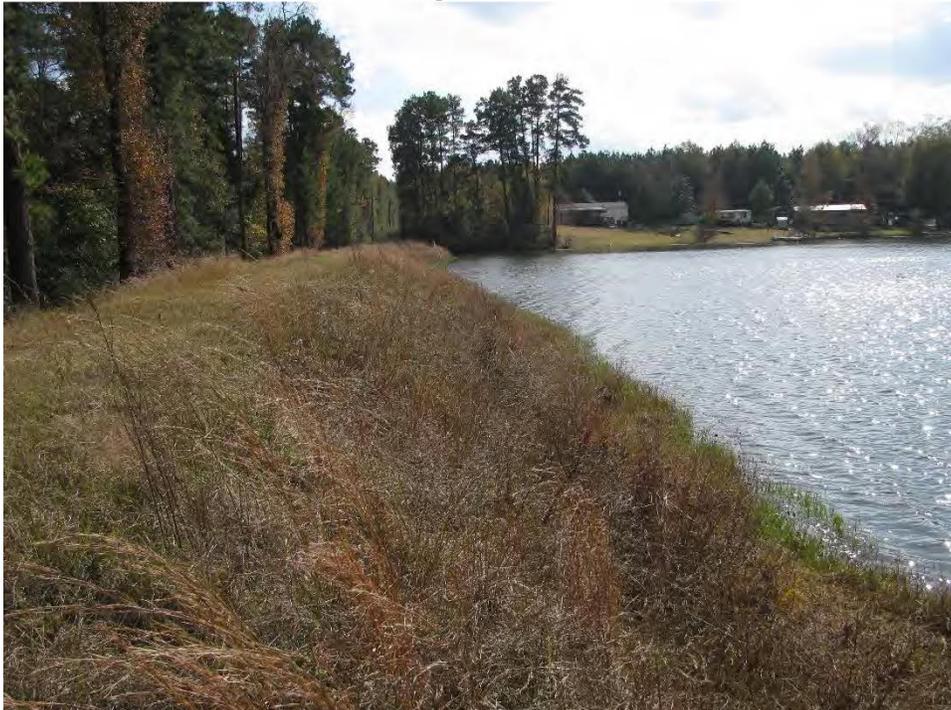
Photograph No. 8 – A view of Frog Lake bank protected by vegetative cover. Budget for rock riprap to protect slope against wind action erosion looking South West.

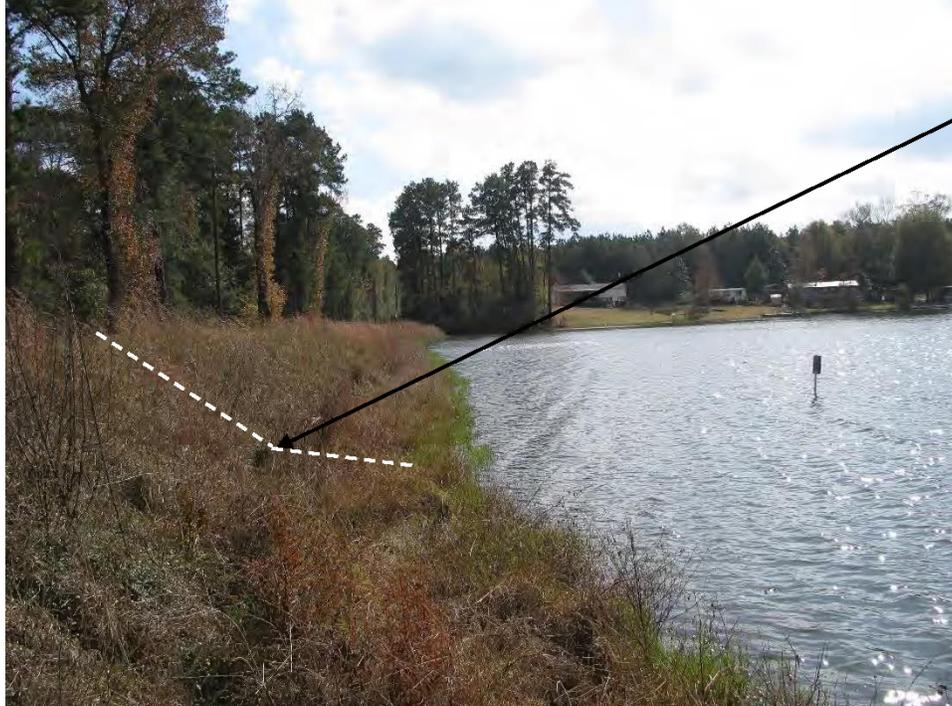
Photograph No. 9 – Standing near the midpoint of the dam looking South East. A view of the 1H:1V vegetative cover of the upstream slope. Note the sag near the midpoint of the dam caused by slide.

Slump
on the
upstream
slope

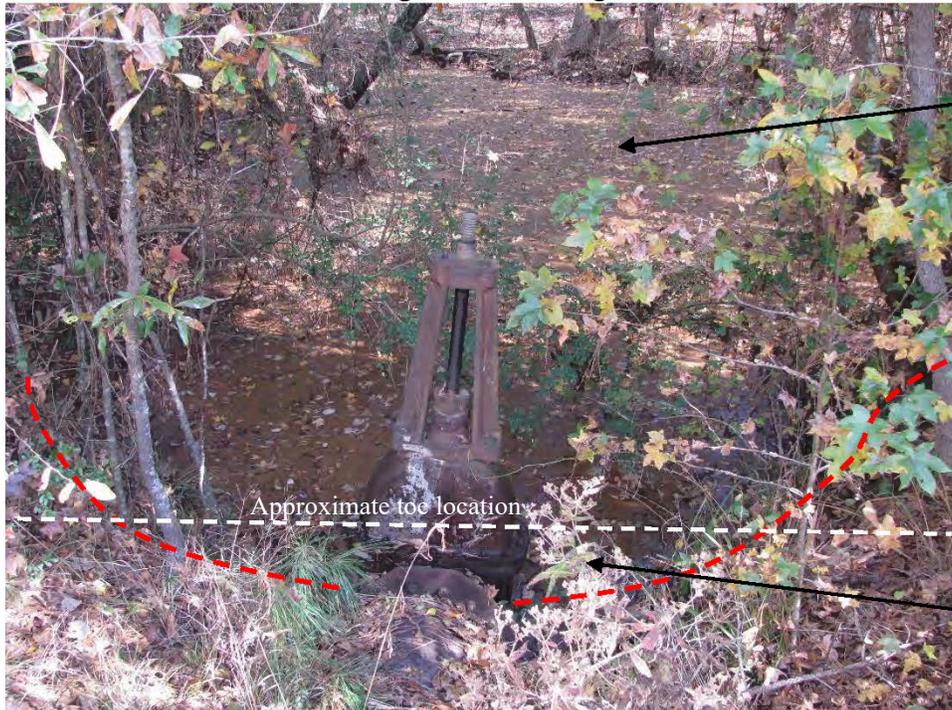
Photograph No. 10 – A view of the reservoir drain valve looking North East. A view of standing water standing and the toe erosion.

Standing
water
within the
discharge
channel of
the drain

Water
stands
behind the
outlet of
valve – the
toe is
eroded

| PRIORITY | DESCRIPTION | OPC |
|---|--|---|
| 9 | Drain Valve: <ul style="list-style-type: none">- Check operation of the drain valve and repair or replace if necessary.- Install concrete apron and rock riprap to slow velocity and move the discharge 20-30 ft away from the toe.- Use SCUBA to check valve inlet and plug prior to working on valve.- Get closed circuit TV inspection of the drainpipe. | \$30,000 (Ref Q#4) |

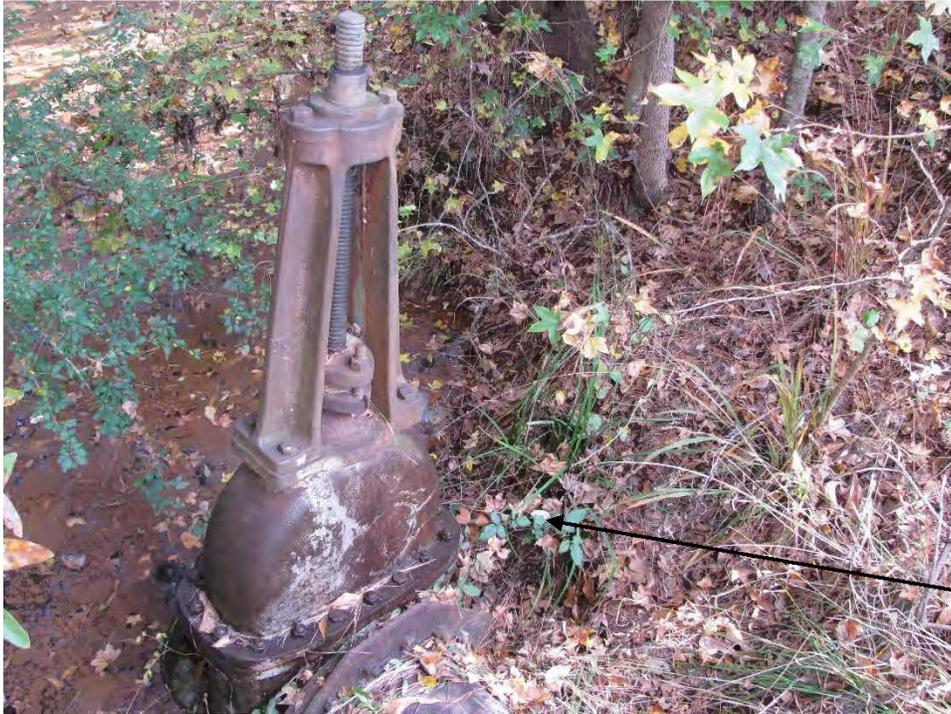
Photograph No. 11 – A view of the reservoir drain valve looking East. A view of standing water standing and the toe erosion.

Erosion, as an indicator of high velocity turbulent flow

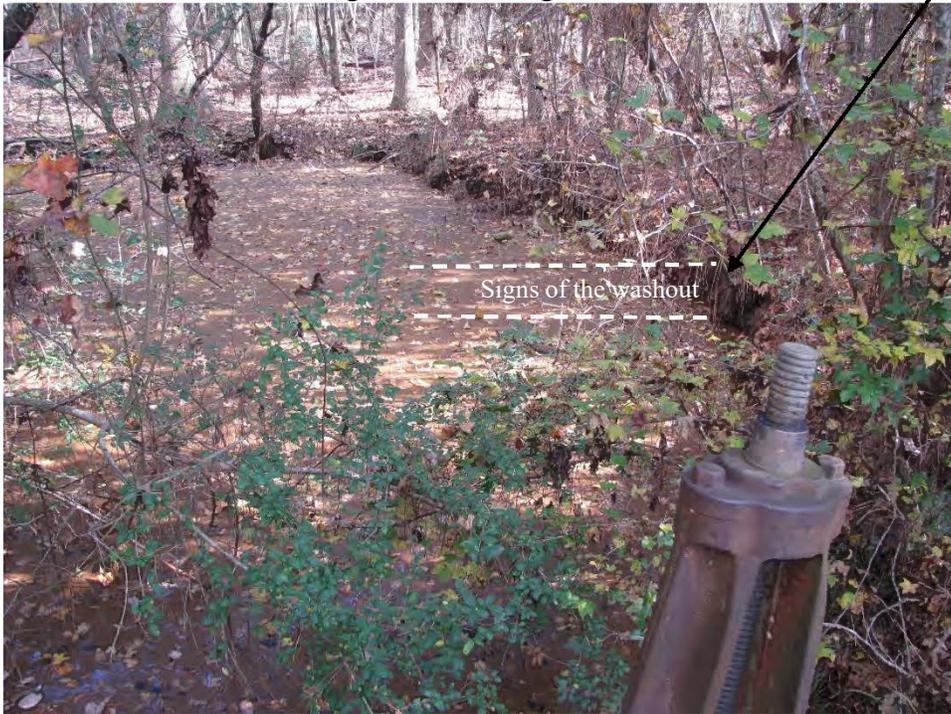
Photograph No. 12 – A view of the reservoir drain valve looking East. A view of standing water standing and the toe erosion.

Signs of the washout

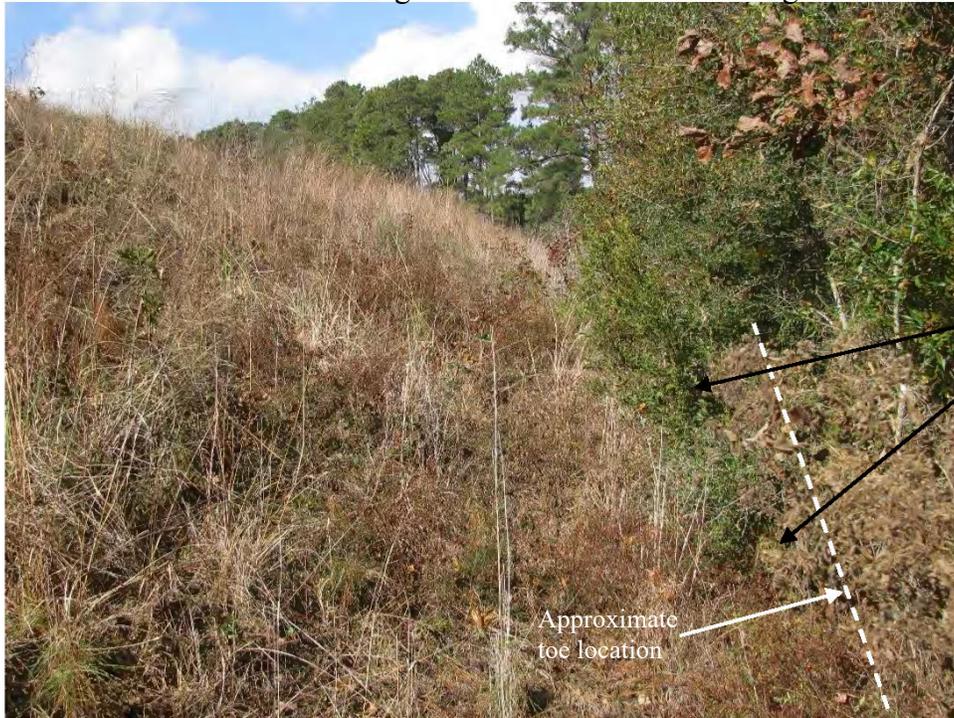
Photograph No.13 – Standing near the midpoint of the dam looking North West. A view of the overgrowth of trees and brush along the toe

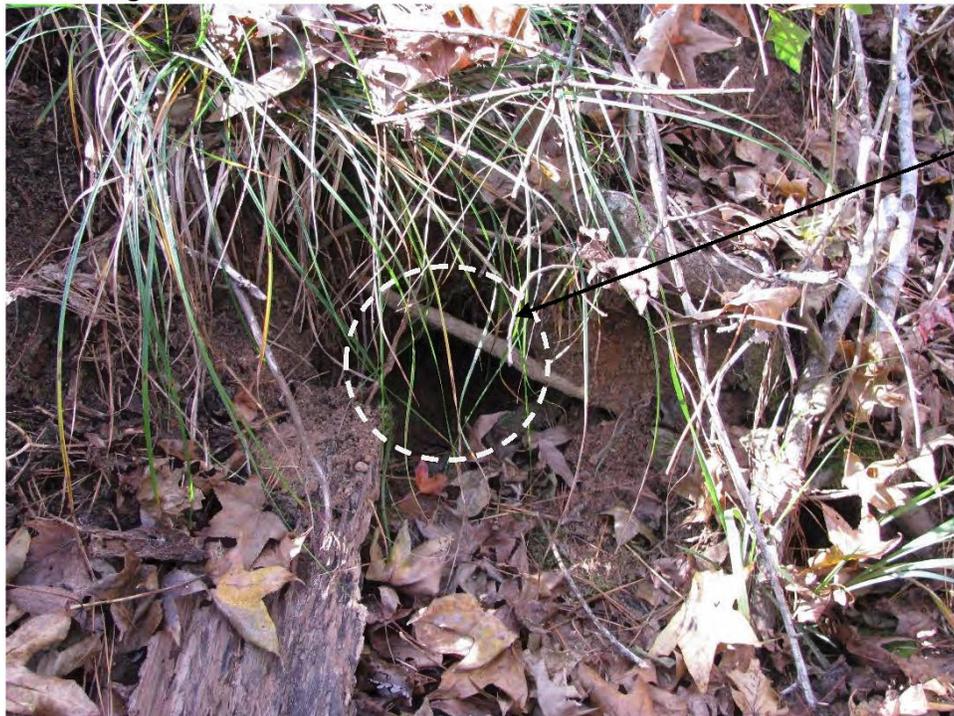
Photograph No. 14 – Standing at the toe near the midpoint of the dam looking West. A view of a varmint burrow 2 feet above the dam toe.

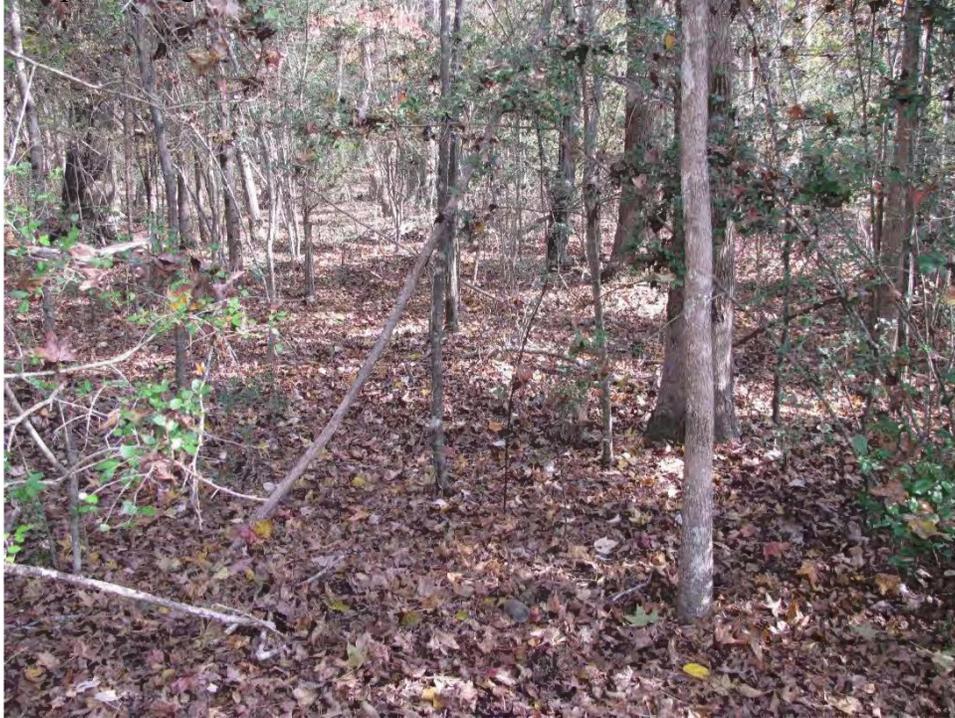
Photograph No. 15 – Standing back to varmint’s holes on the downstream slope looking East. A view cattail-field areas and trees close to the dam.

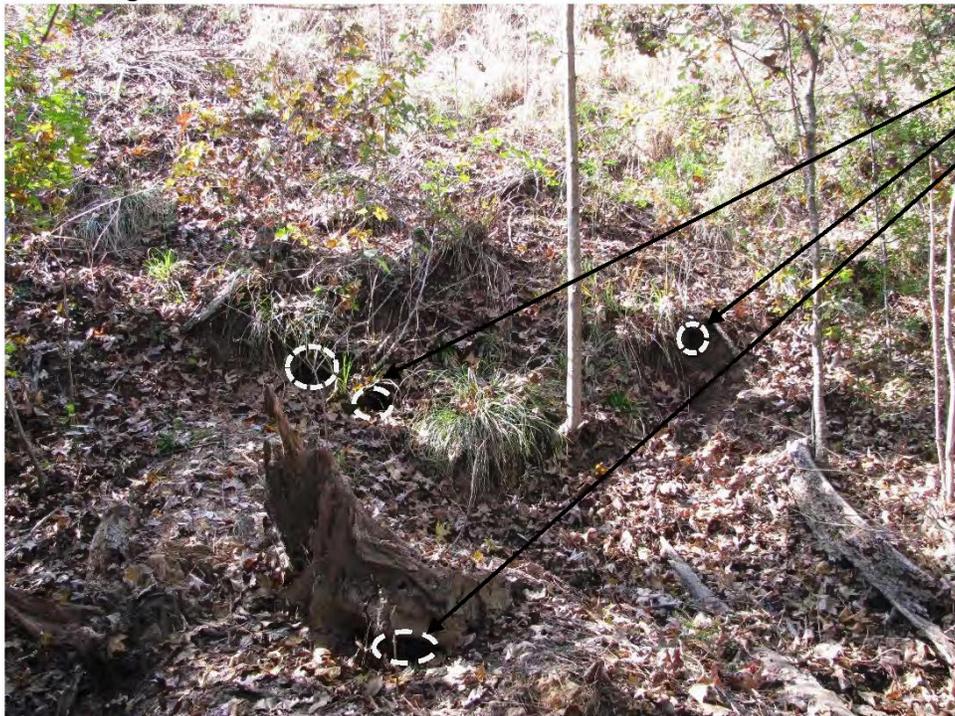
Photograph No. 16 – Standing near the midpoint of the dam at the foot looking West. A view of a varmint burrow 2 feet above the dam toe.

Signs of
varmints
activity

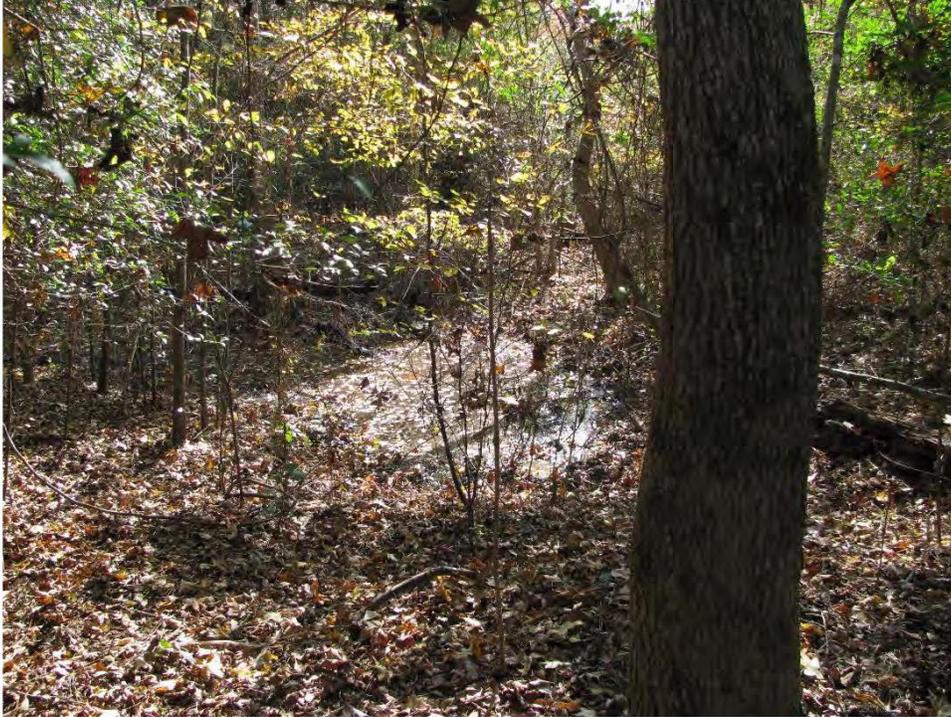
Photo No. 17 – Standing on the right portion of the dam at the toe looking North East. A view of the standing water at the same elevation with a toe.

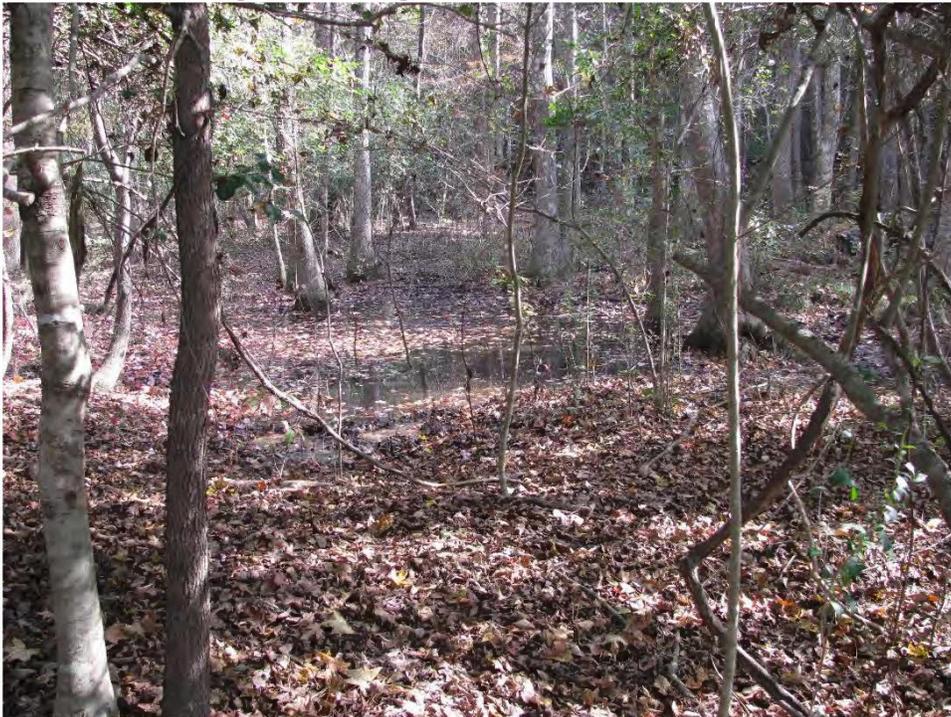
Photo No. 18 – Standing on the right side of the dam at the toe looking East, observing the standing water at the same elevation with a toe.

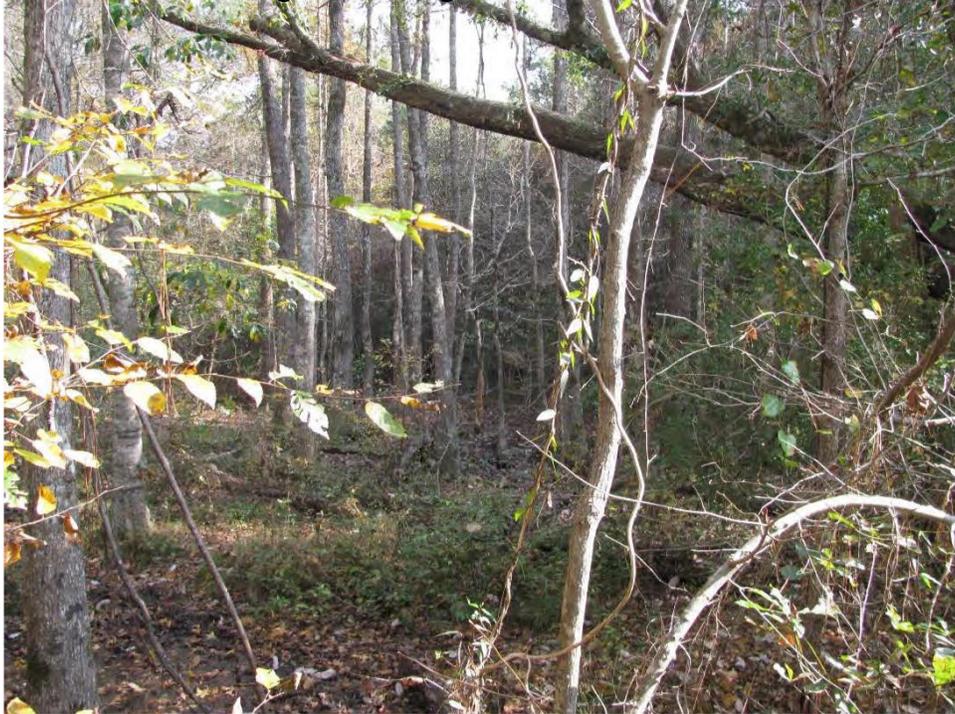
Photo No. 19 – Standing on the right side of the dam at the toe looking South East, observing the standing water at the same elevation with a toe.

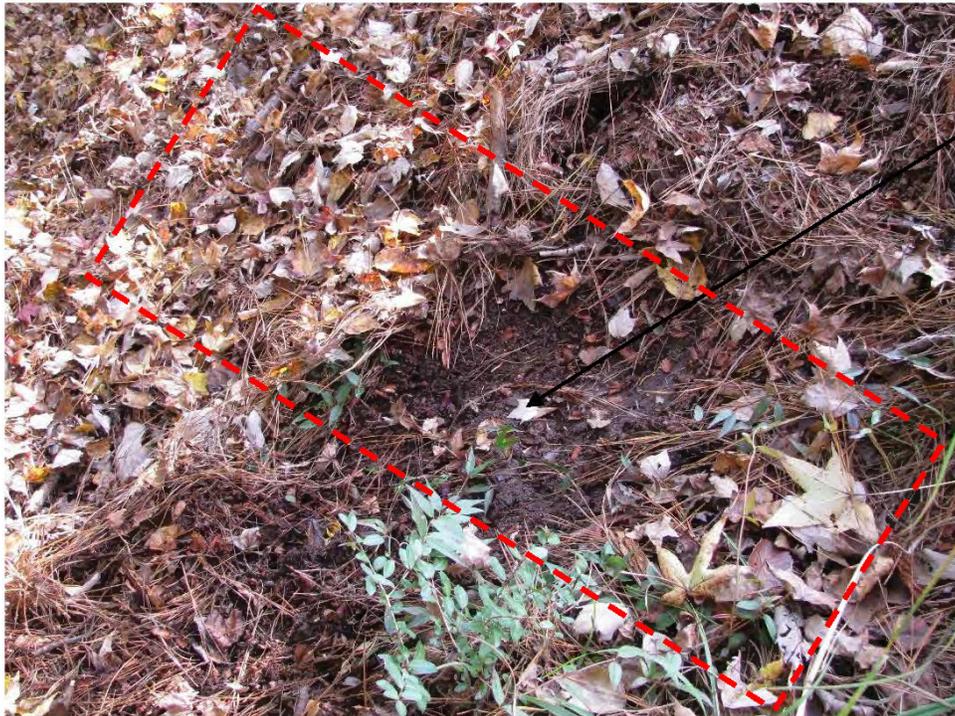
Photographs No. 20 – Standing about 300 ft away North from the spillway looking South West. A view of a wet area in horizontal band under the dry leaf litter.

Seepage through the horizontal band 2 ft above the toe

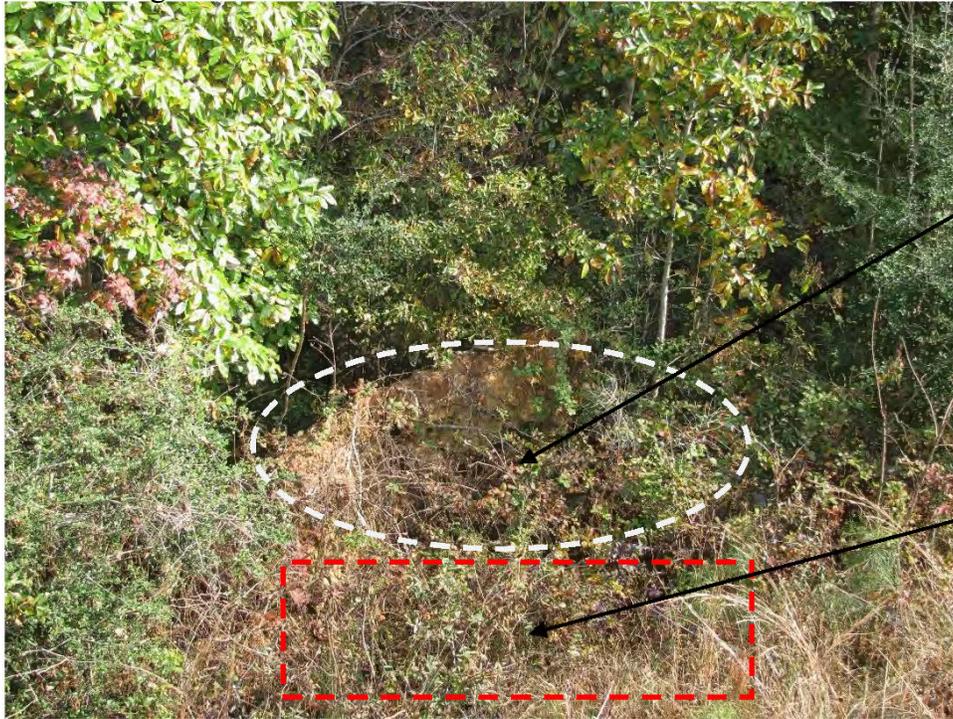
Photograph No. 21 – Standing about 250 ft away North from the spillway looking East. A view of a fallen tree roots with the soil residuals.

Tree #1
Roots with
the soil
residuals

Downstream
dam slope
surface is
corrupted

| PRIORITY | DESCRIPTION | OPC |
|---|--|---|
| 1 | Remove and dispose of fallen trees and fill voids left by their root balls with select soil fill material, well compacted, with a minimum of 50% passing a #200 sieve and a plasticity index of 15-30. | \$5,000 |

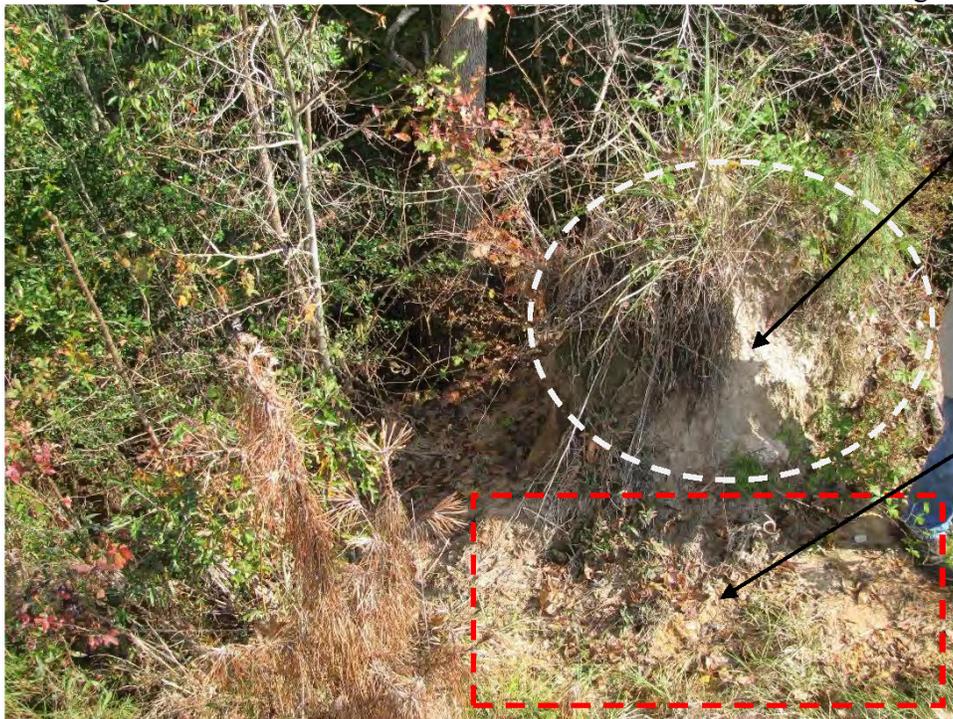
Photograph No. 22– Standing about 200 ft away North from the spillway looking East. A view of a second fallen tree and an embankment damage.

Tree #2
Roots with
the soil
residuals

Downstream
dam slope
surface is
corrupted

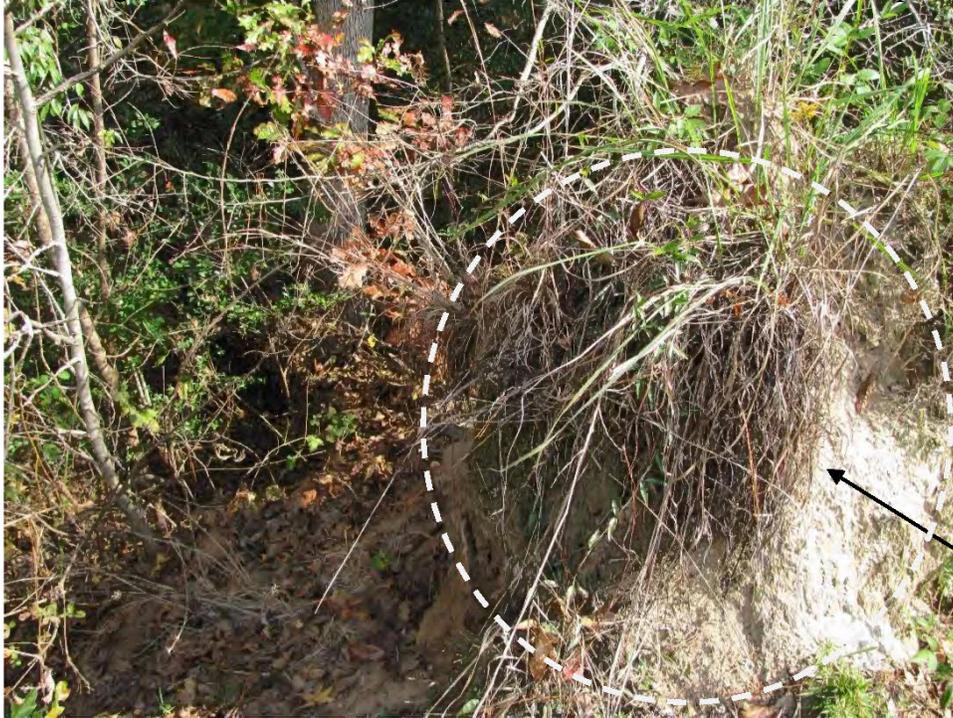
Photograph No. 23 – Standing about 200 ft away North from the spillway looking East. A view of the soil pulled out from the downstream slope.

Tree #2
Roots with
the soil
residuals

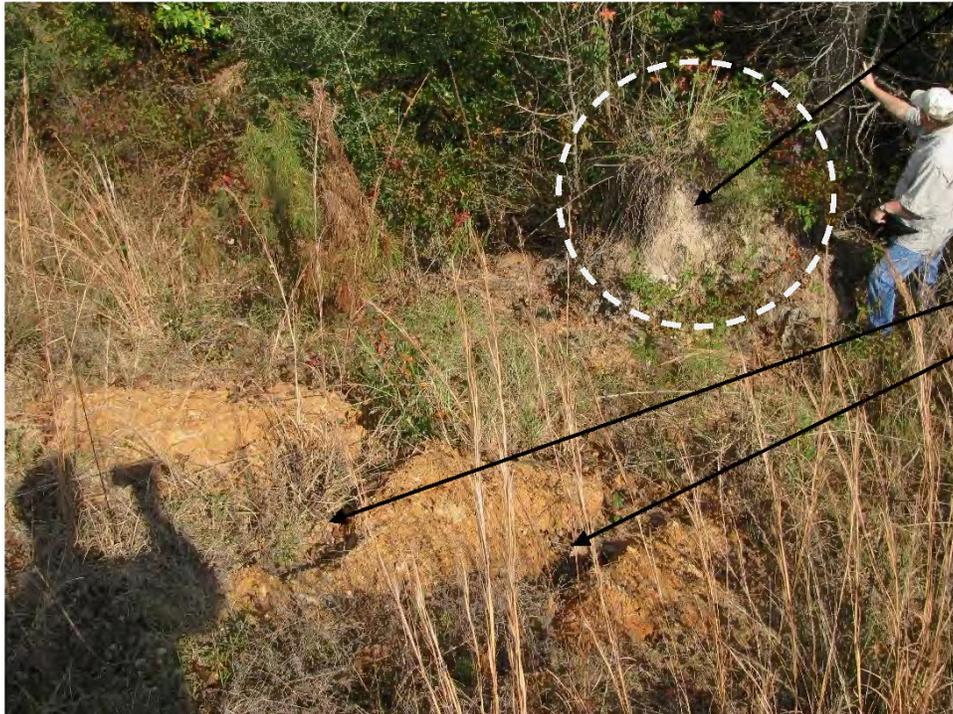
Photograph No. 24 – Standing about 200 ft away North from the spillway looking East. A view of an erosion and soil pulled out from the dam slope.

Signs of
erosion

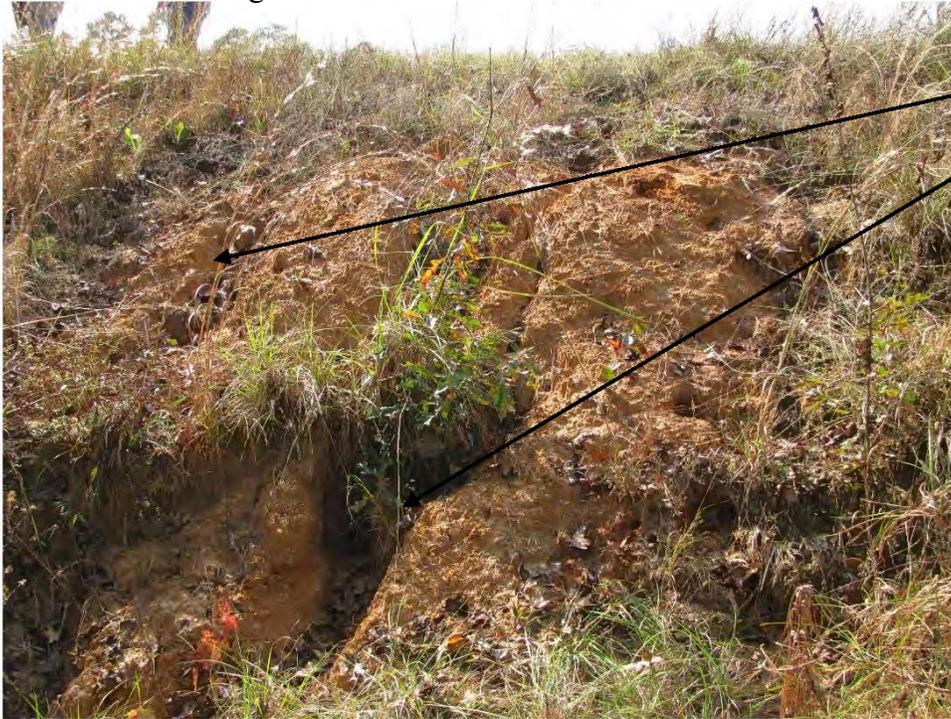
Photograph No. 25 – Standing about 200 ft away North from the spillway looking West. A view of an eroded embankment.

Signs of erosion

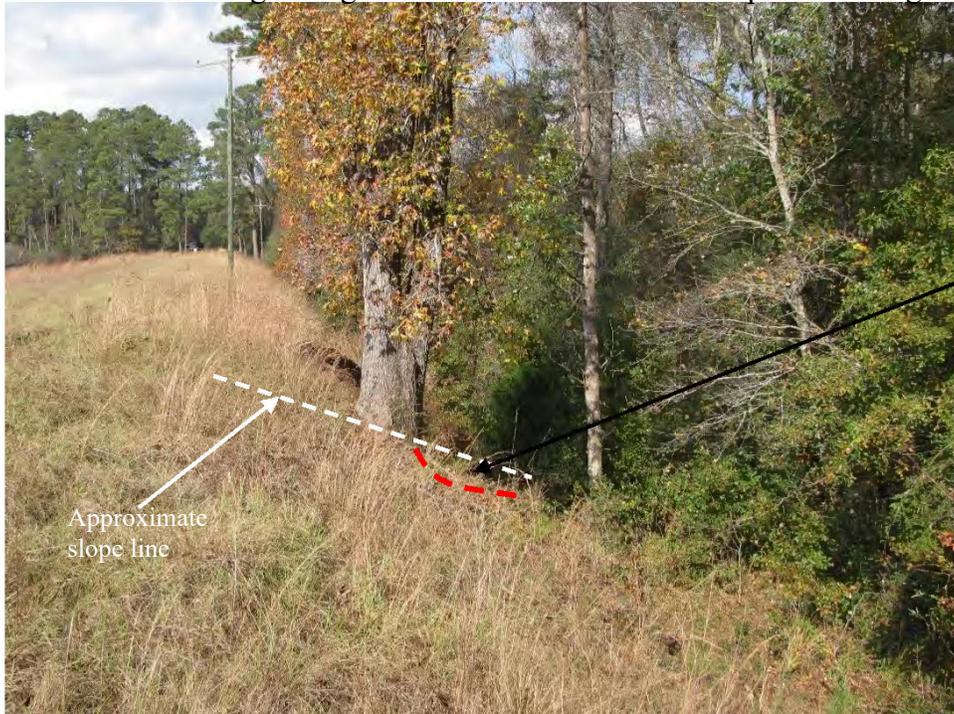
Photograph No. 27 – Standing on the right side of the dam looking North.
A view of a tree growing on the 3H:1V downstream slope caused sag.

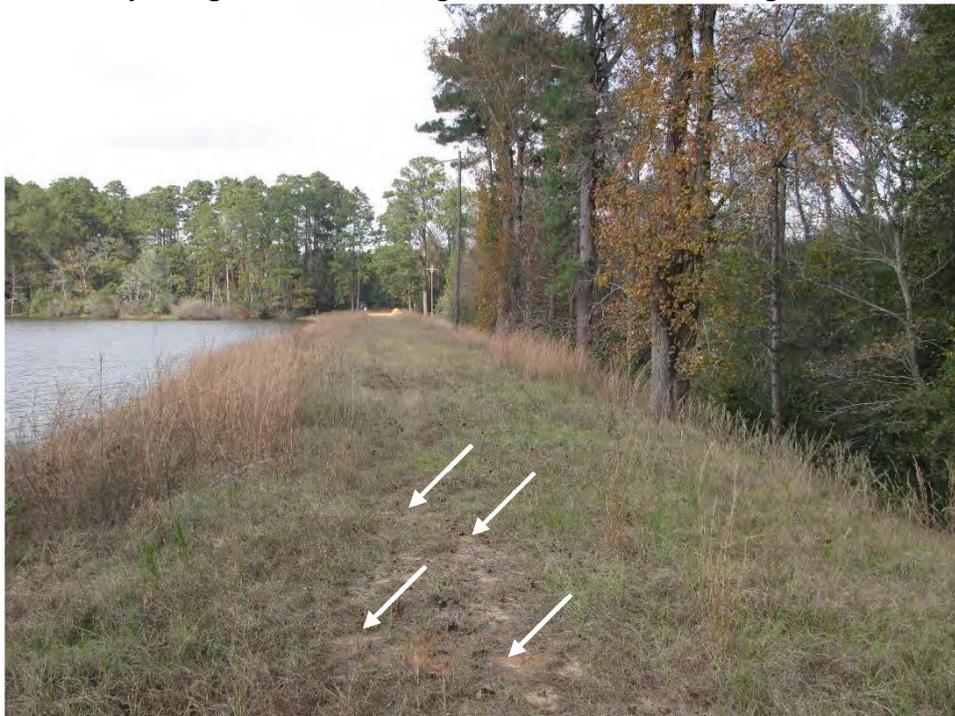
Photograph No. 32 – Another view of the minor bare areas (arrows) randomly along the crest from right end of the dam looking North West.

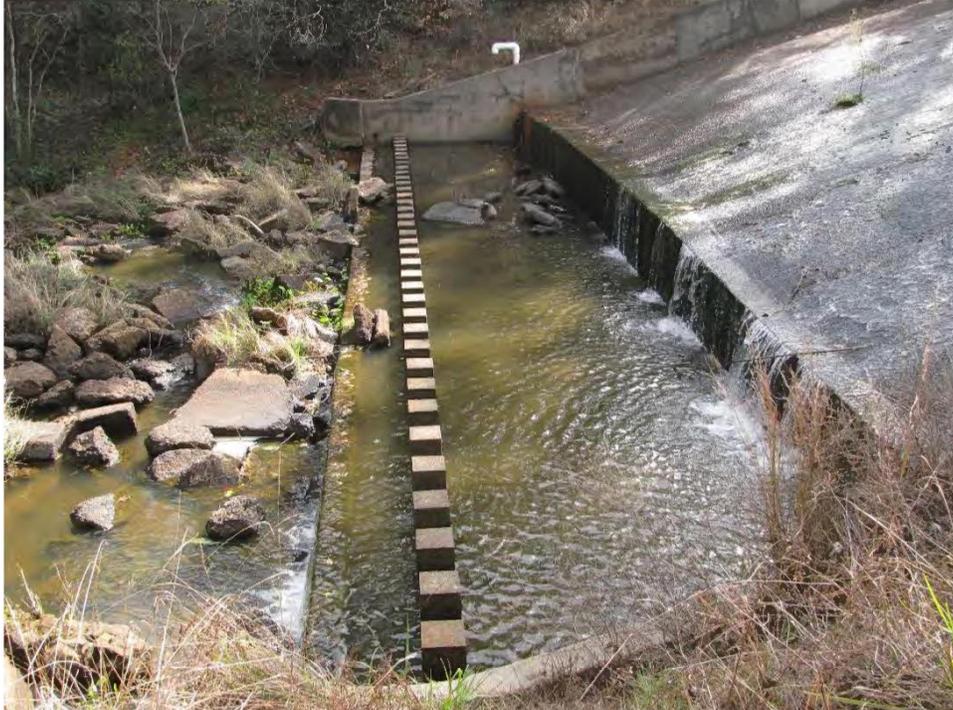
- A pair of 4-inch diameter PVC pipes (one on per side wall) exited the side walls of the discharge basin. It was speculated that the pipes were the outlets of the drain system installed in 1995; however, no flow was discharging from the pipes. Nonetheless, due to the seepage discharging from under the right end wall, there is a potential that the drain system could be clogged or nonfunctional (Photos 41, 45).

- The downstream end of the left side wall was undermined about 2-ft deep (Photos 43, 44).
- Portions of the riprap within the earthen channel were displaced resulting in multiple areas of minor erosion and voids within the channel (Photos 41, 42).

Photograph No. 41 – Standing on the left side wall of the spillway looking South East. A view of the concrete discharge slab, right 4-inch diameter drainpipe and riprap lined earthen channel.

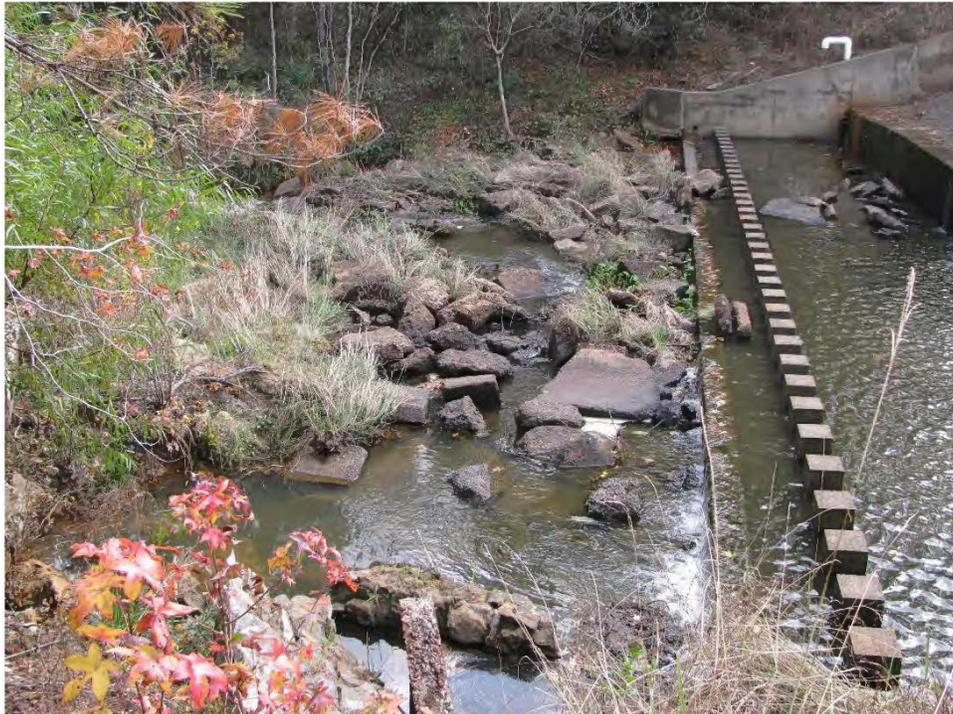
Photograph No. 42 – A view of the farther downstream condition of the riprap lined earthen channel.

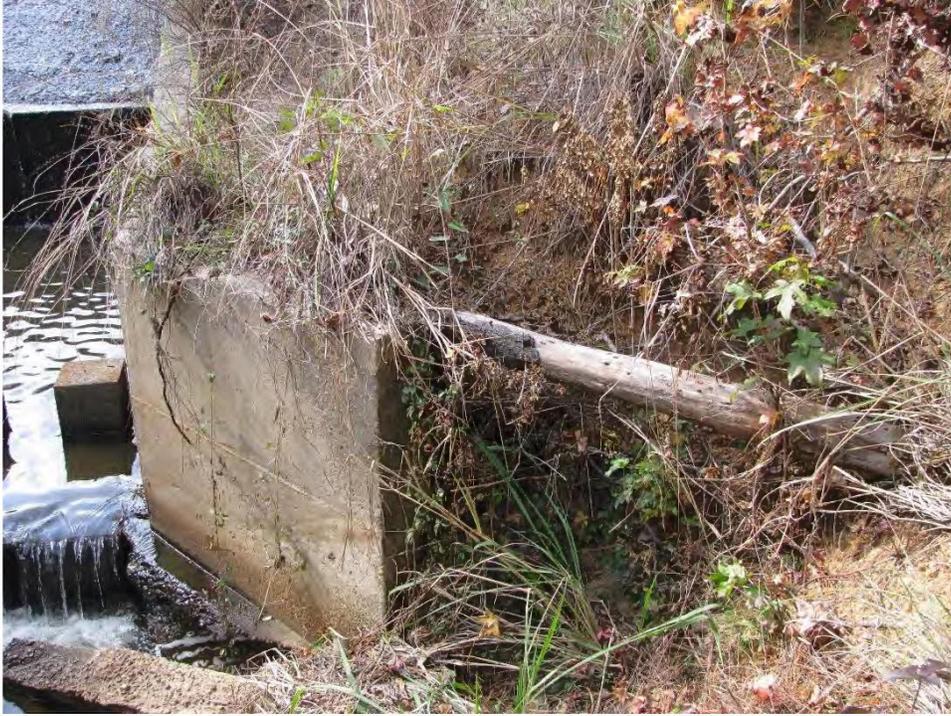
Photograph No. 43 – Standing just downstream of the spillway discharge looking West. A view of an erosion behind the left spillway concrete wall.

| PRIORITY | DESCRIPTION | OPC |
|---|--|---|
| 4 | Repair concrete walls of service spillway. Add toe walls if necessary. | \$10,000 |

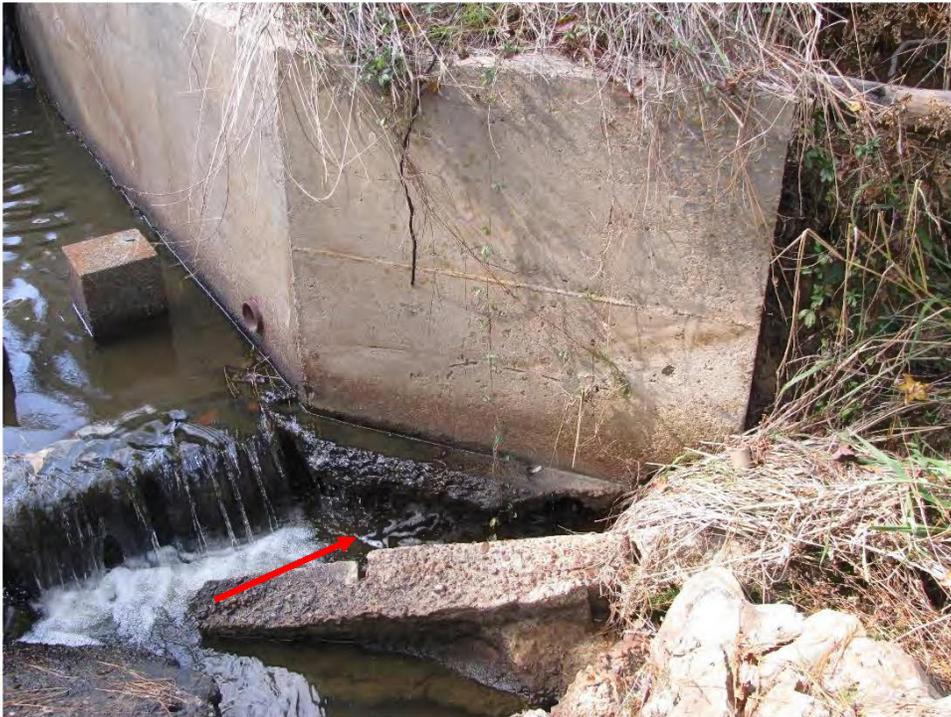
Photograph No. 44 – Standing just downstream of the spillway discharge looking North. A view of an undermined end wall (arrow).

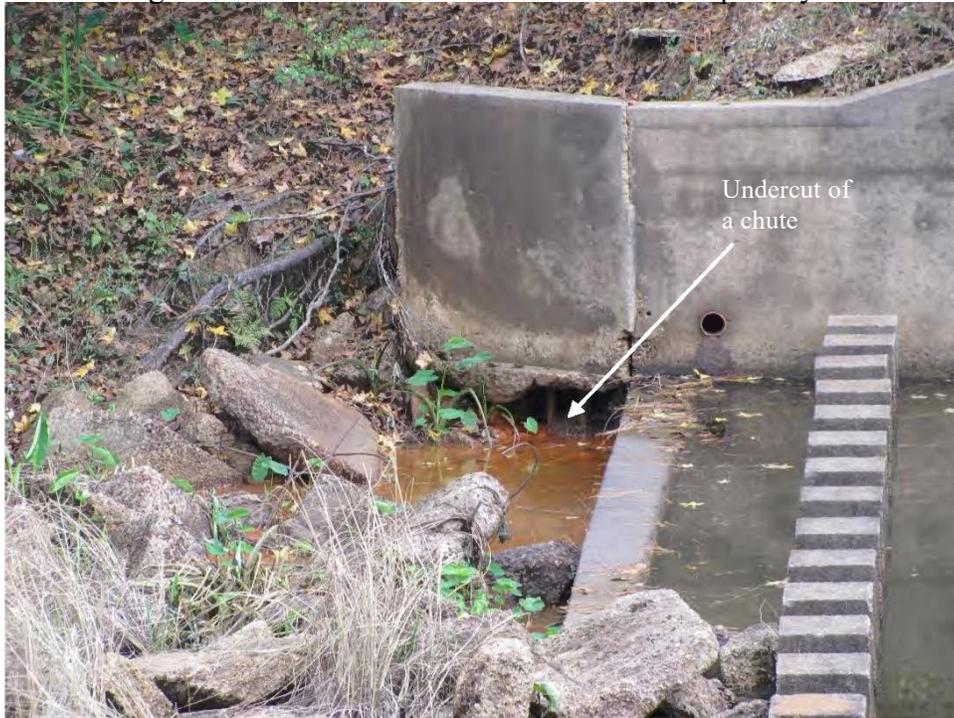
- Seepage was discharging from underneath the right end wall and the right abutment just beyond the spillway; however, with the spillway flowing during the inspection, complete evaluation of the seepage could not be conducted (Photos 45 - 48).

Photograph No. 45 – Standing on the downstream edge of the spillway looking South East. A view of the undercut of the spillway chute.

Question #12: For the seepage control blanket behind the concrete spillway walls, we would recommend excavation along the entire length of the wall from top to bottom. Then, fill that void with a free draining granular fill enclosed with a geotextile fabric such as Mirafi 140N. The fabric should allow for water flow through the fabric and prevent pressing of smaller soil particles into the granular fill. We would not recommend a concrete apron be constructed over the excavated area, just erosion protection with good grass cover.
