RE: Dam and Spillway Condition Assessment
Final Report

DAM & SPILLWAY ASSESSMENT REPORT

DAM: Frog Pond Lake Dam

FROG POND LAKE DAM, COLMESNEIL, TX 75938

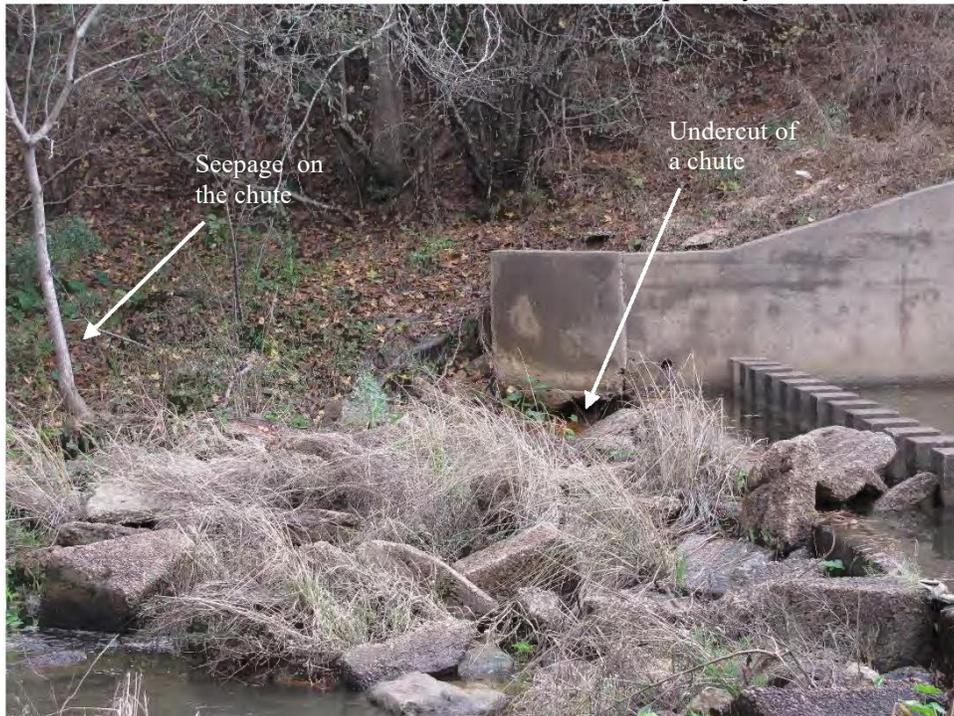
Photograph No. 46 – A view of the seepage on the right side of the downstream channel and undercut of the spillway chute.

Question #12: For the seepage control blanket behind the concrete spillway walls, we would recommend excavation along the entire length of the wall from top to bottom. Then, fill that void with a free draining granular fill enclosed with a geotextile fabric such as Mirafi 140N. The fabric should allow for water flow through the fabric and prevent pressing of smaller soil particles into the granular fill. We would not recommend a concrete apron be constructed over the excavated area, just erosion protection with good grass cover.

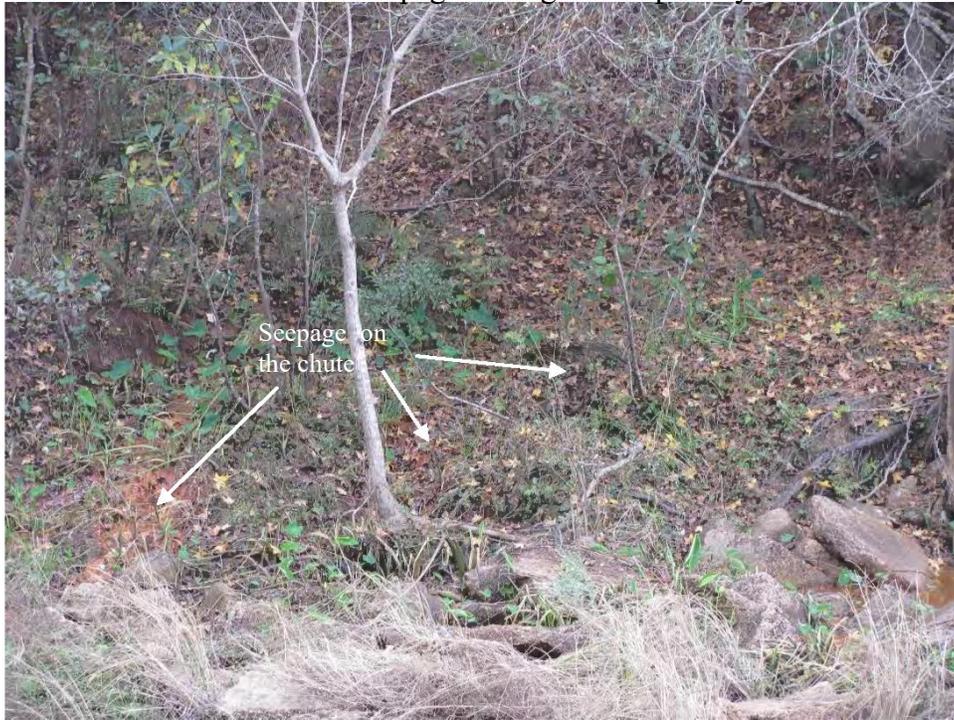
Photograph No. 47 – Standing at the right side of the spillway looking South East. A view of the seepage exiting at the spillway channel chute.

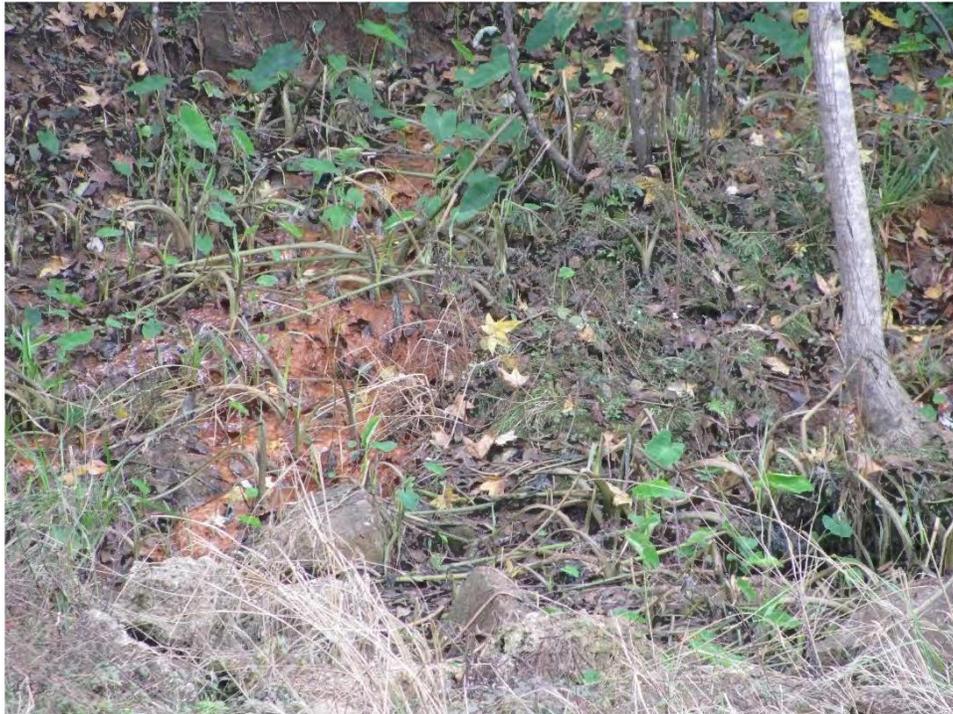
Photograph No. 48 – Closer view of the seepage exiting at the spillway downstream channel chute.
