Dam Safety Inspection Report

INVENTORY No.: TX03775

DAM: Frog Pond Lake Dam

CURRENT INSPECTION DATE: March 28, 2018

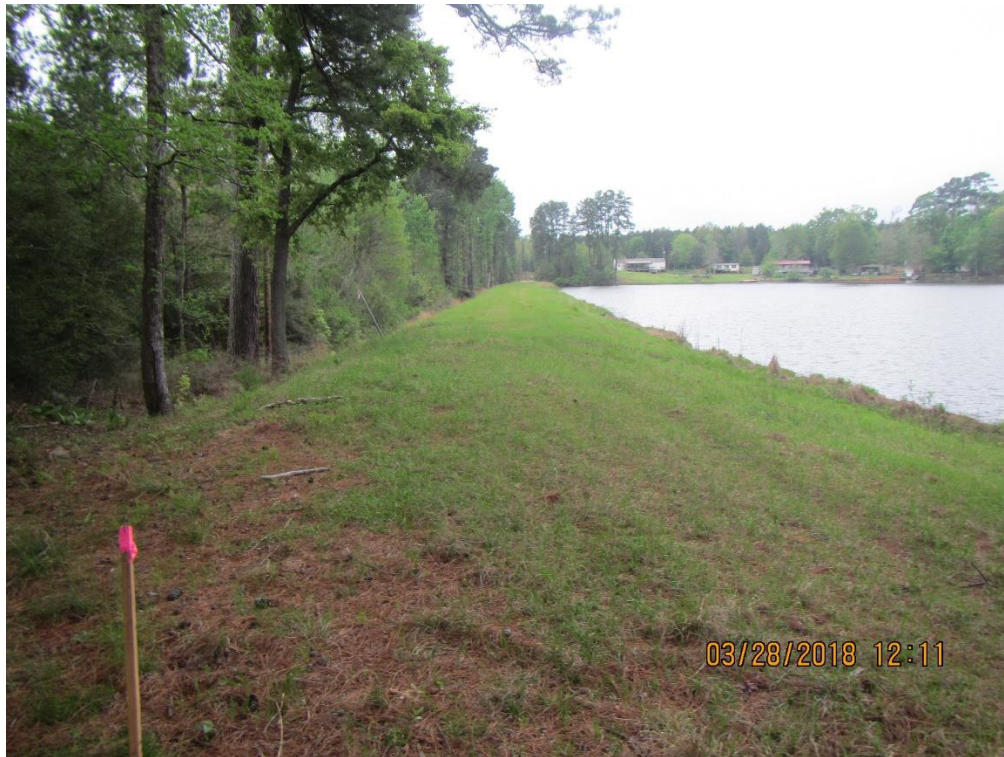
- The 15-ft wide crest of the dam had a well-maintained vegetated cover with no major deficiencies observed (Photos 1-2).
- A few minor bare areas were noted randomly along the crest; however, it should be noted the size and number of bare areas have decreased since the last inspection.
- The crest was found to be in good condition.

Photo 1: Standing on the left end of the dam looking southeast; a typical view of the well-maintained vegetated cover along the crest.

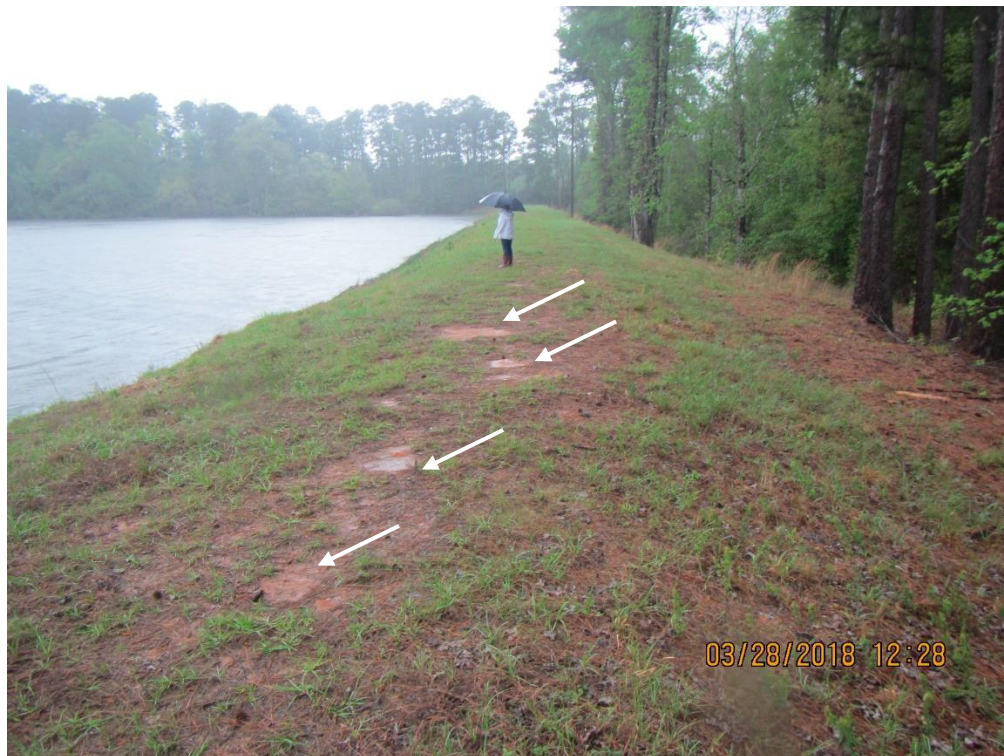
Photo 2: Another view of the crest from the right end of the dam looking northwest. Note the minor bare areas (arrows) randomly along the crest.

compacted soil. The resulting bare areas, as well as the multiple bare areas noted throughout the dam should have vegetated cover re-established.

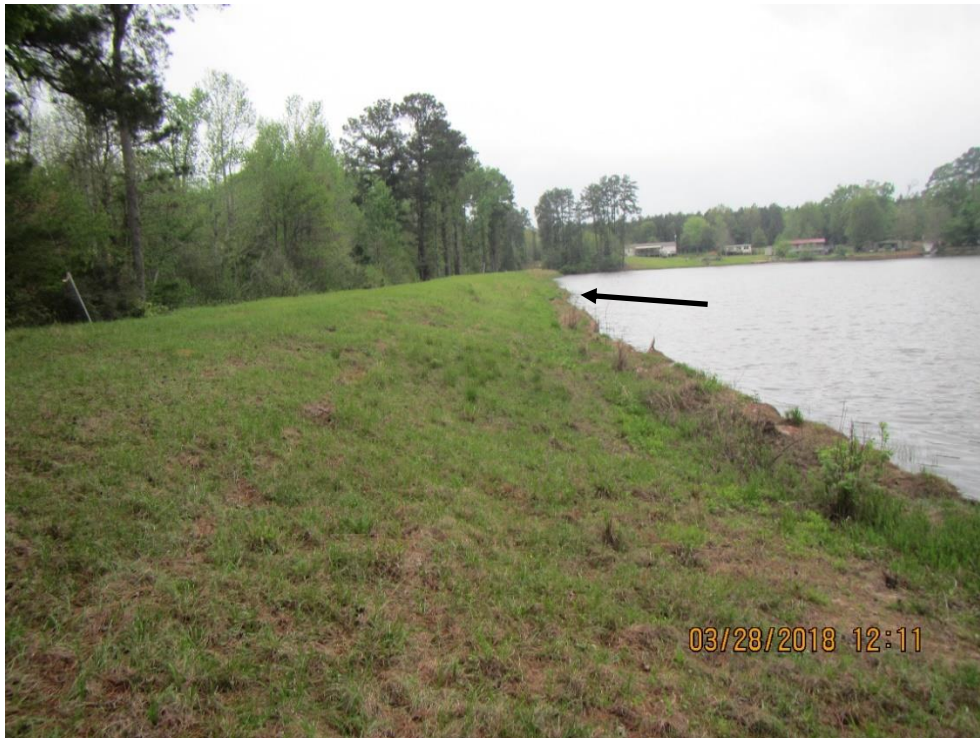
- The slope varied from 3 horizontal to 1 vertical [3H:1V] along the left side of the dam to 2H:1V along the right end of the dam. It should be noted that some areas of the slope appeared slightly steeper than 2H:1V adjacent to the spillway. Additionally, minor benching (less than 1-ft deep) was observed along the majority of the waterline (Photos 3-4).
- It was noted that the steeper slope (right half) exhibited areas of bare soil with surface erosion (Photo 5).
- A couple of minor erosion rills (approximately 3-ft wide and less than 1-ft deep) were noted randomly along the slope (Photo 6).
- A minor bulge was observed near the midpoint of the dam, which appeared to be from loose soil being placed along the slope.
- The upstream slope was found to be in fair condition.

Photo 3: Standing on the left end of the dam looking southeast; a view of the 3H:1V vegetated portion of the upstream slope. Note the approximate location of the bulge is depicted by the arrow.

- a. Benching along the upstream slope for an increase in height.
 - b. Seepage along the right end wall and downstream of the spillway for an increase in flow or evidence of suspended sediment.

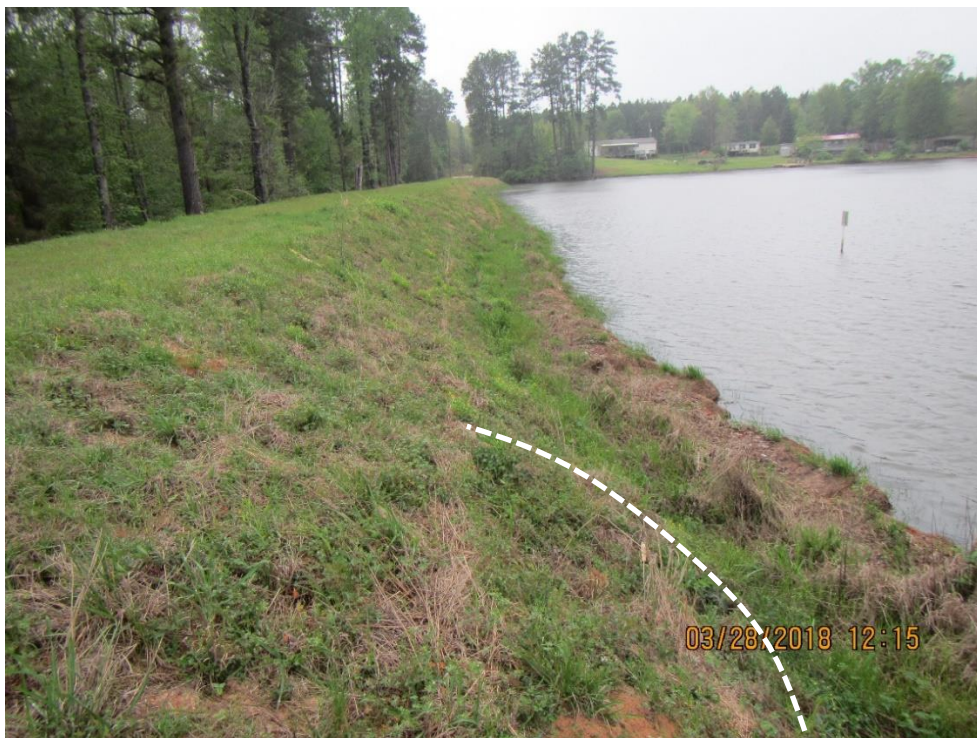
Photo 4: Standing near the midpoint of the dam looking southeast; a view of the 2H:1V vegetated portion of the upstream slope. Note the bulge near the midpoint of the dam (dashed-line).

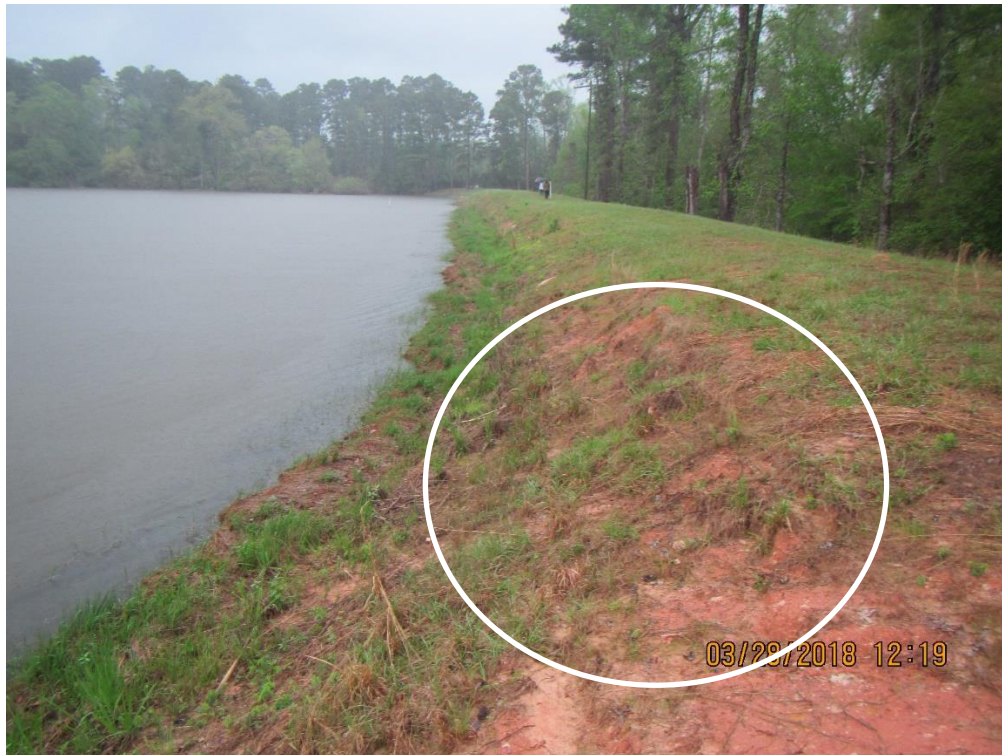
Photo 5: Standing on the right end of the upstream slope looking northwest; a view of the slope that lacked a vegetated cover and exhibited some minor surface erosion (circled).

- A. The erosion rills along the upstream slope and the surface erosion noted throughout the upstream and downstream slopes should be filled with

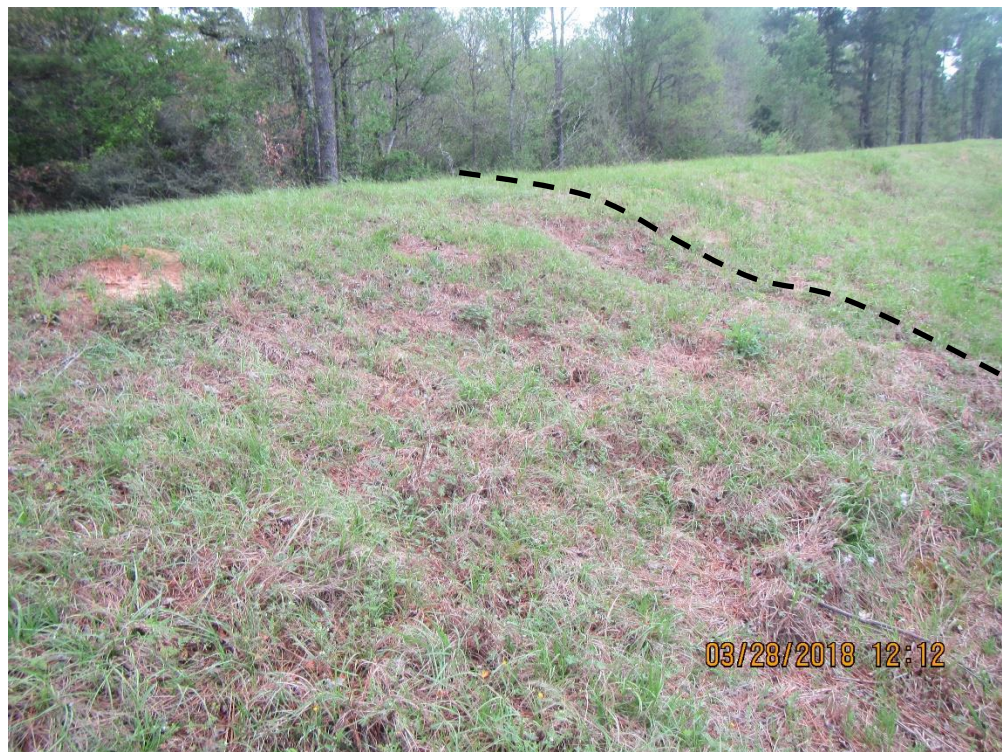
Photo 6: A view of a minor erosion rill (dashed-line) noted along the upstream slope.

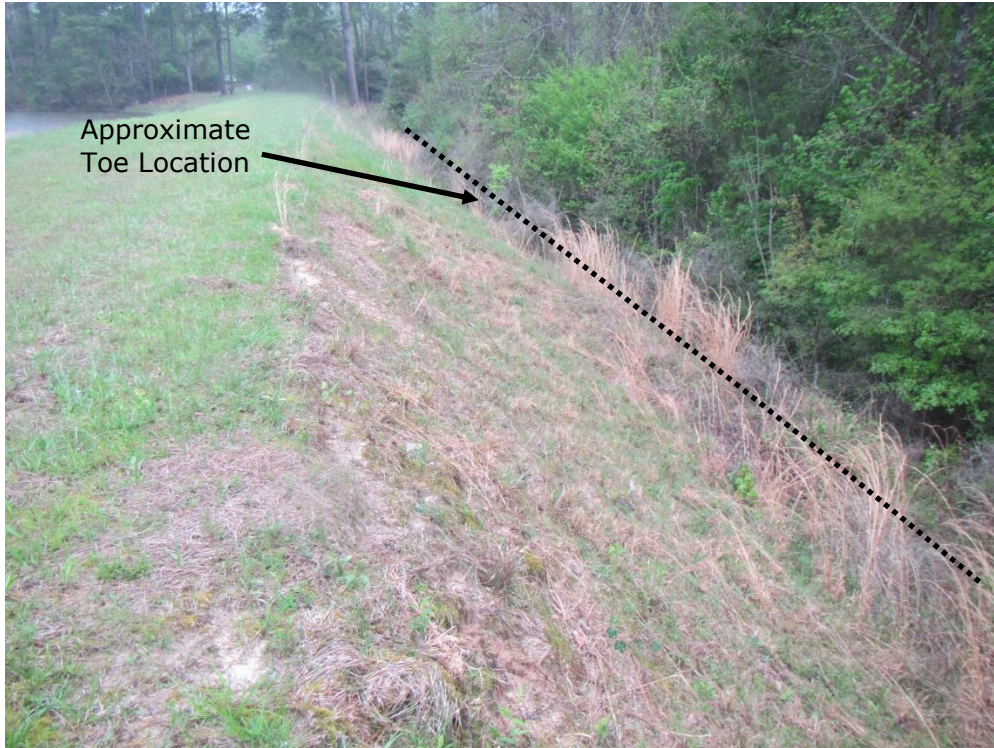
- The downstream slope generally had a 2H:1V slope with some areas slightly steeper that had an undulated appearance. The slope had a well-maintained vegetated cover with a few large trees; however, the toe was significantly overgrown with large trees and brush (Photos 7-8).
- A few bare areas and surface erosion were observed along the slope.
- It was raining during the inspection; therefore, the current condition of the seepage along the toe could not be determined.
- The downstream slope was found to be in fair condition.

Photo 7: Standing near the midpoint of the dam looking northwest; a view of the vegetated downstream slope. Note the overgrowth of trees and brush along the toe.

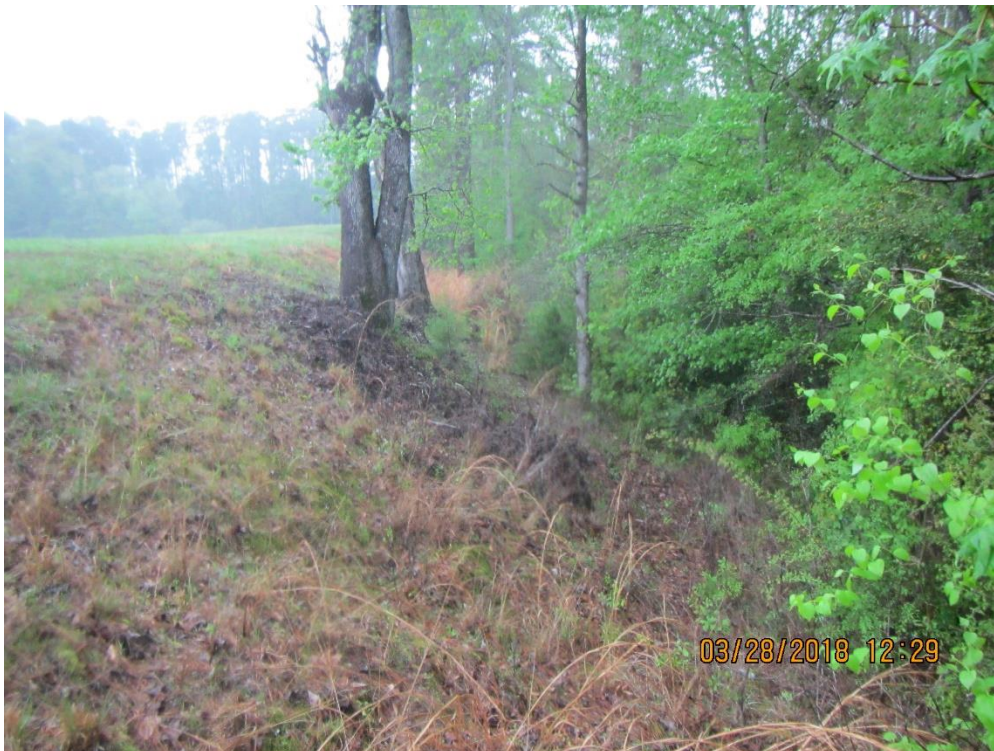
Photo 8: Standing on the right end of the dam looking northwest; a view of the large trees growing along the downstream slope.

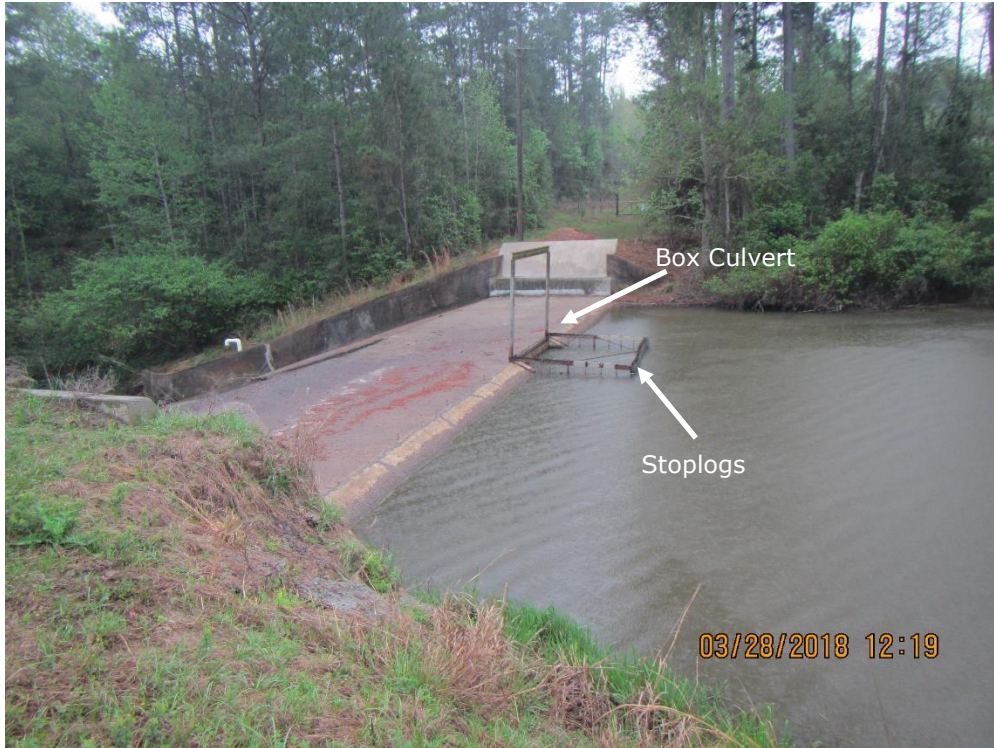
- The spillway is located along the right end of the dam and consists of an 80-ft wide concrete chute with a 3.5-ft tall by 10-ft wide concrete box culvert (pilot channel) near the midpoint of the spillway. The spillway chute and box culvert discharge into a riprap lined channel that was overgrown with large trees and brush. Additionally, the box culvert is controlled by a series of stoplogs that maintains the normal pool about 1-ft below the concrete control section of the spillway chute (Photos 9-10).

Photo 9: Standing to the left of the spillway inlet looking southeast; a view of the spillway and box culvert inlets.

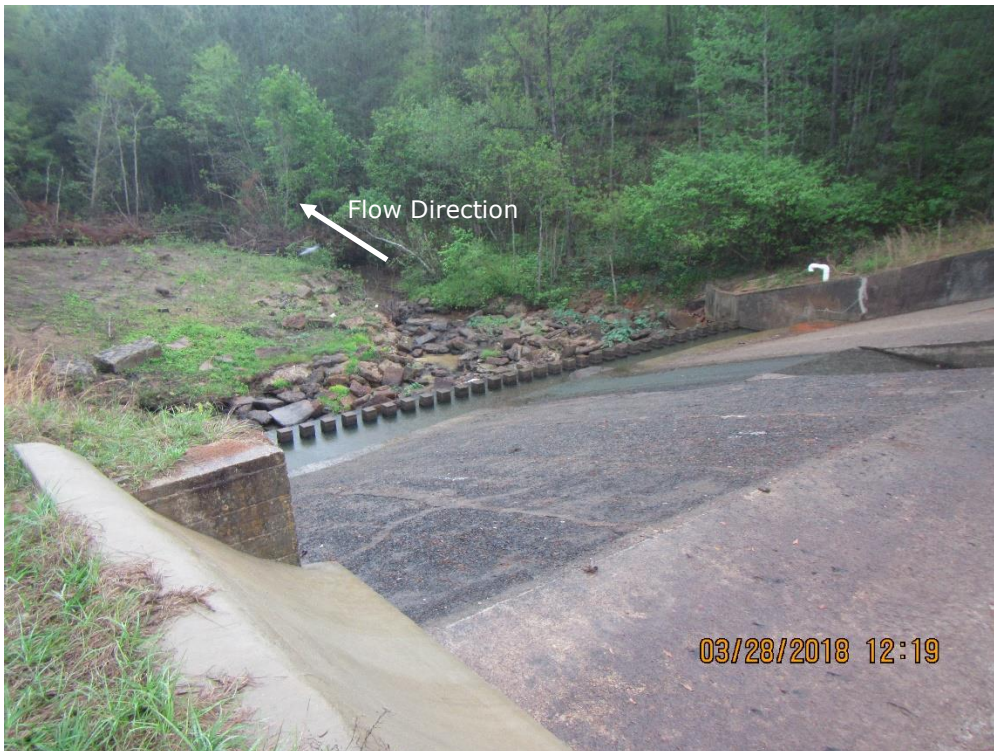
Photo 10: Standing on the left side wall of the spillway control section; a view of the concrete discharge slab and riprap lined earthen channel.

- B.** The trees and brush within the discharge channels of the drain and spillway should be removed to allow an unobstructed flow.
- C.** The undermining along the left end wall of the spillway should be filled with grout and a form of erosion protection installed to prevent a reoccurrence/continued erosion.

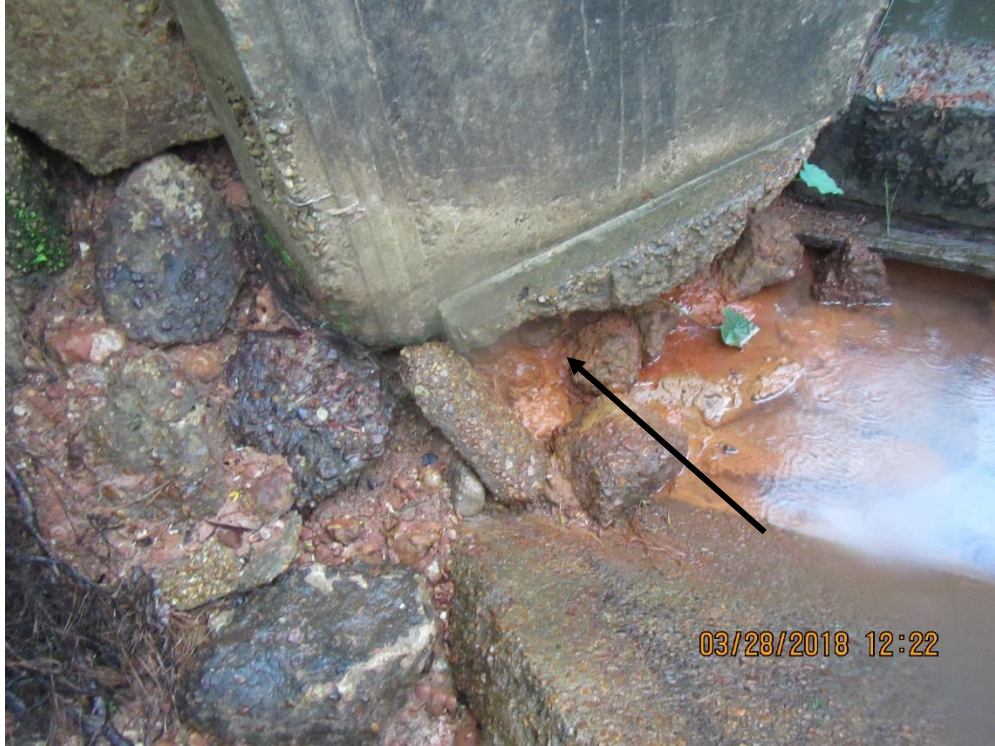
- Seepage was discharging from underneath the right end wall and the right abutment just beyond the spillway; however, it was raining during the inspection and a complete evaluation of the seepage could not be conducted (Photo 11).

Photo 11: Standing at the end of the right end wall looking southwest; a view of the seepage discharging from under the end wall (Arrow).

If conditions worsen with any of the deficiencies, then a LTPE should be consulted in order to determine the level of damage and provide improvements if needed.

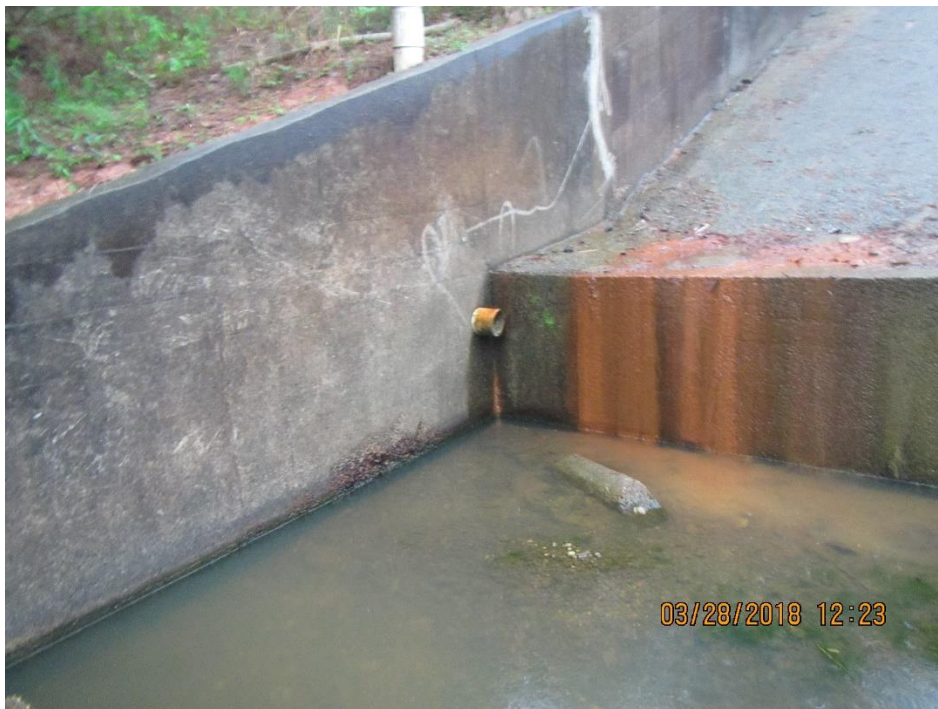
- A pair of 4-inch diameter PVC pipes (one on per side wall) exited the side walls of the discharge basin. It was speculated that the pipes were the outlets of the drain system installed in 1995; however, no flow was discharging from the pipes. Nonetheless, due to the seepage discharging from under the right end wall, there is a potential that the drain system could be clogged or non-functional (Photo 12).

Photo 12: Standing just downstream of the spillway discharge basin looking southwest; a view of one of the 4-inch diameter pipes exiting the sidewalls of the spillway channel.

- E.** The owner should have a Licensed Texas Professional Engineer (LTPE) evaluate the spillway drain system to ensure it is functional and not clogged.

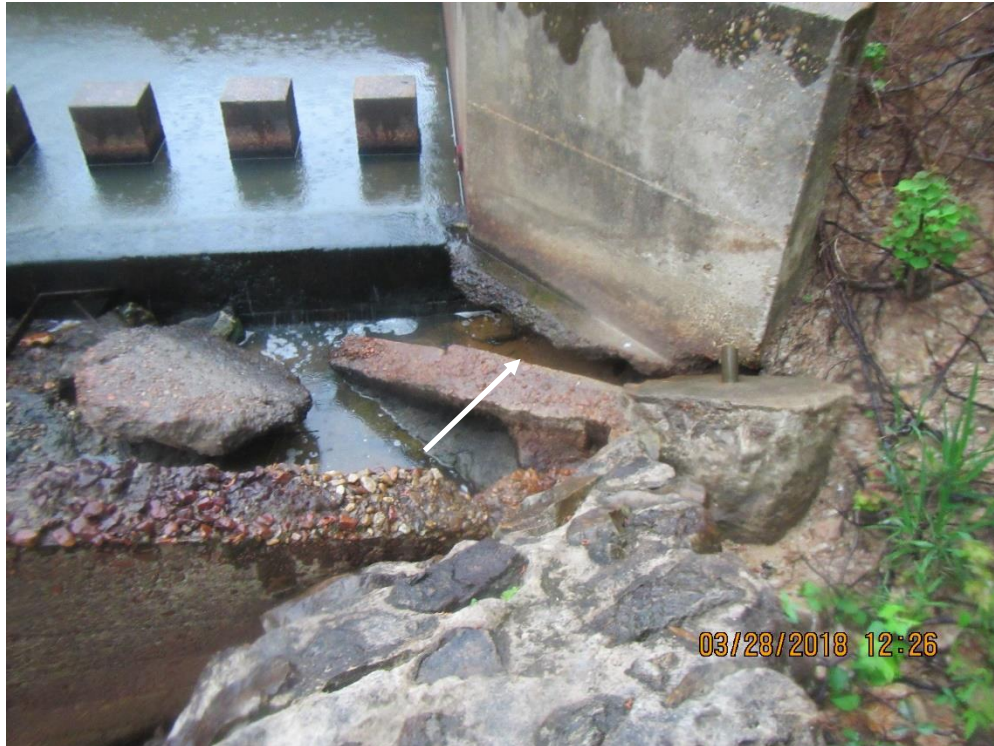
- The downstream end of the left side wall was undermined about 2-ft deep (Photo 13).
- Portions of the riprap within the earthen channel were displaced resulting in multiple areas of minor erosion and voids within the channel (Photo 14).

Photo 13: Standing just downstream of the left side wall of the spillway channel looking west; a view of the undermined end wall (arrow).

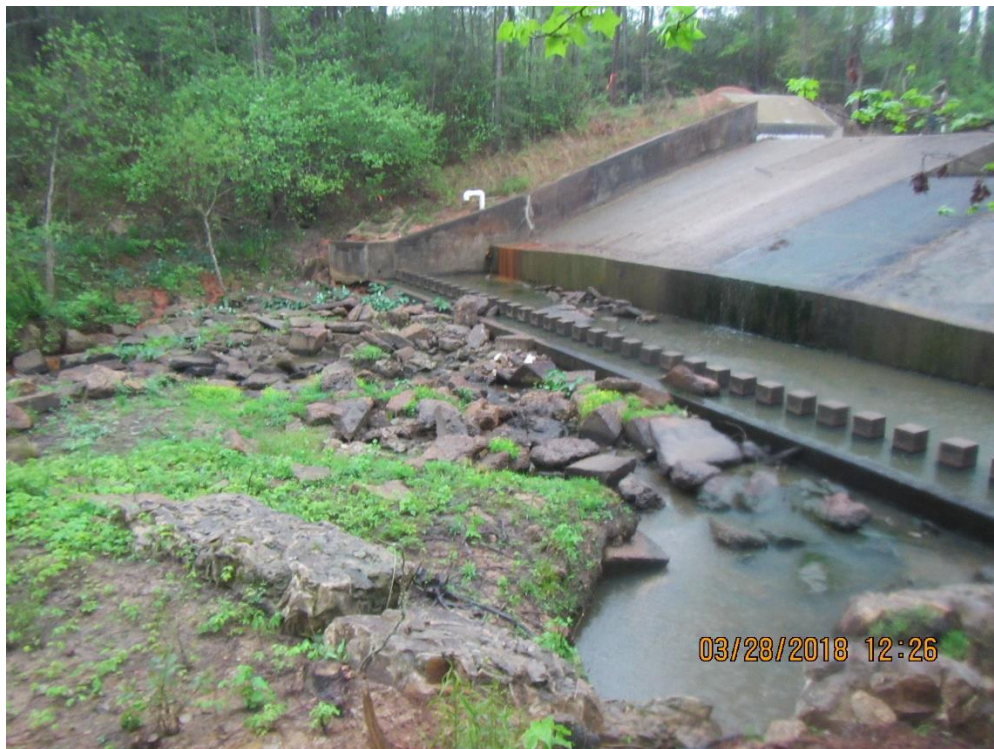
Photo 14: Standing just downstream of the spillway looking south; a view of the riprap lined channel. Note the areas where the riprap was displaced causing erosion and voids within the channel.

- D.** The areas of erosion and voids within the earthen channel of the spillway should be filled with additional riprap to limit further erosion/voids.

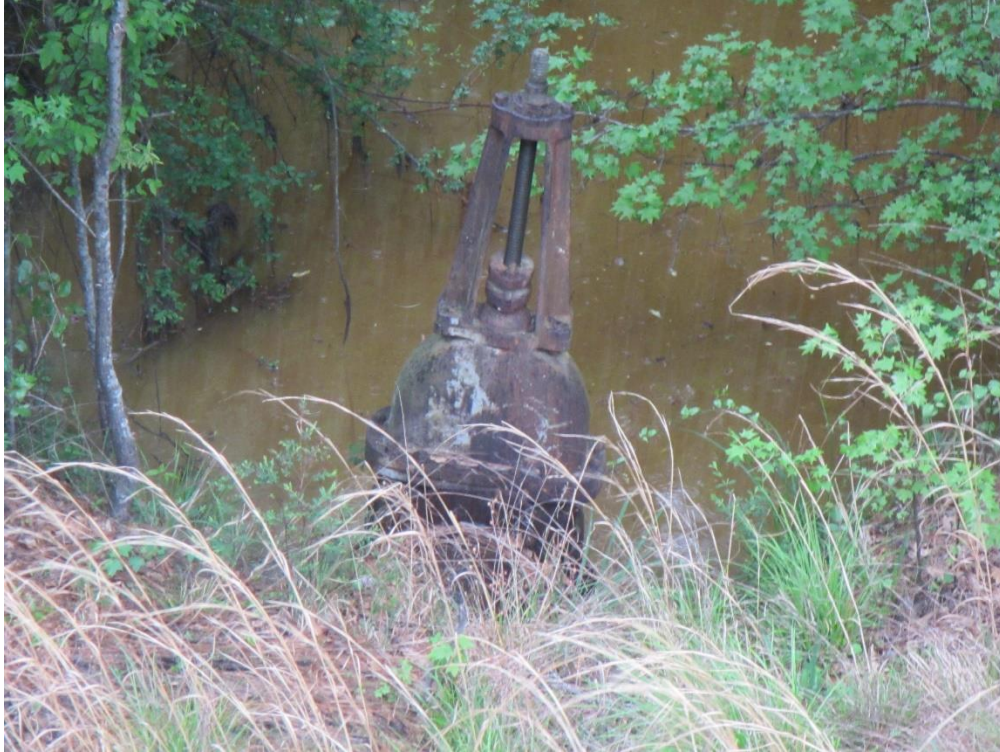
- The reservoir drain outlet is located to the left of the dam's midpoint and consists of a steel conduit (with a valve at the downstream end), which discharges into an earthen channel. Water was standing within the discharge

basin of the drain; however, it rained prior to the inspection, as well as during the inspection, and it could not be determined if the drain was leaking or if the standing water was from the rain. Nonetheless, the previous inspection also noted water standing within the channel; therefore, there is a potential that the valve is leaking and/or seepage is discharging along the pipe and exiting the toe within the channel (Photo 15).

Photo 15: Standing on the downstream slope looking northeast; a view of the reservoir drain valve located along the downstream toe. Note the standing water within the discharge channel of the drain.

- F.** The owner should have an LTPE evaluate the reservoir drain valve to ensure that it is not leaking and/or seepage is not present along the pipe. Additional recommendations may be required after the drain has been evaluated.
