# Inspection Report

**500 North Doolin Drive  
Roswell, Georgia 30076**

**Inspection Date** ~~October 2, 2020~~  
**Client** Sabra  
**Inspector** Julius Gresham  
goodvibeshomeinspections@gmail.com  
Hit-It Certified InterNachi Certified

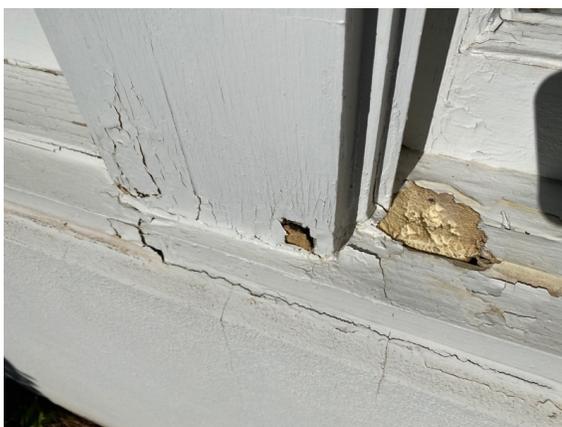
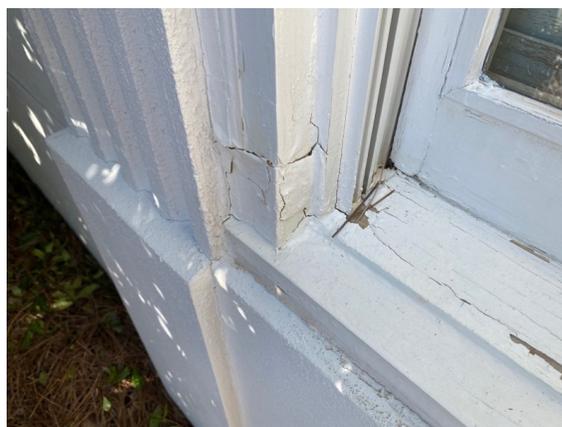
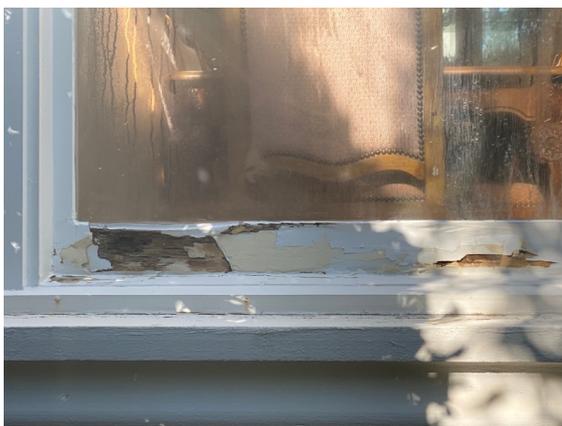
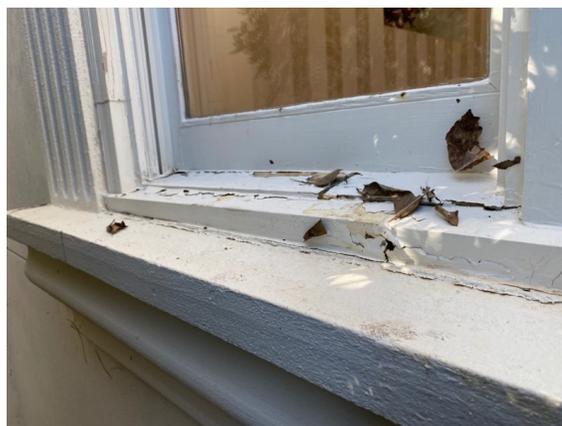
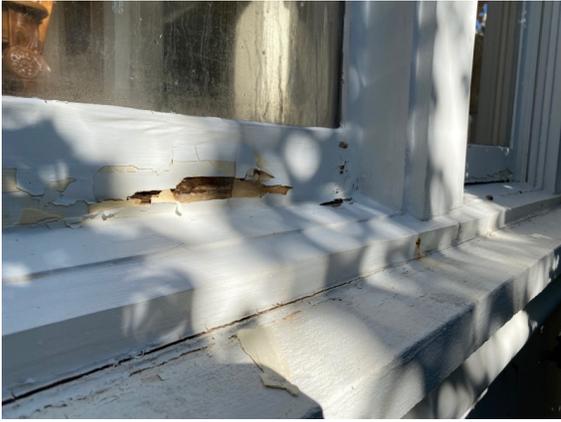
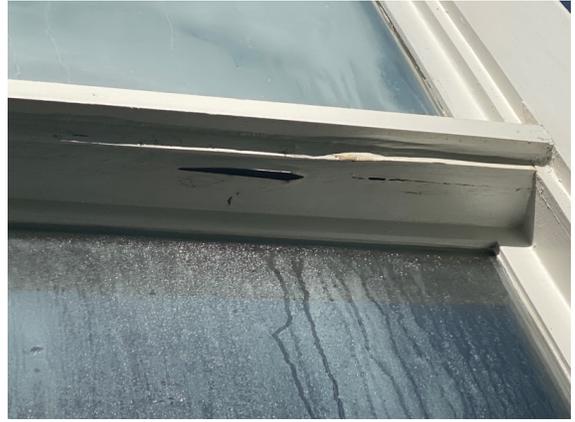
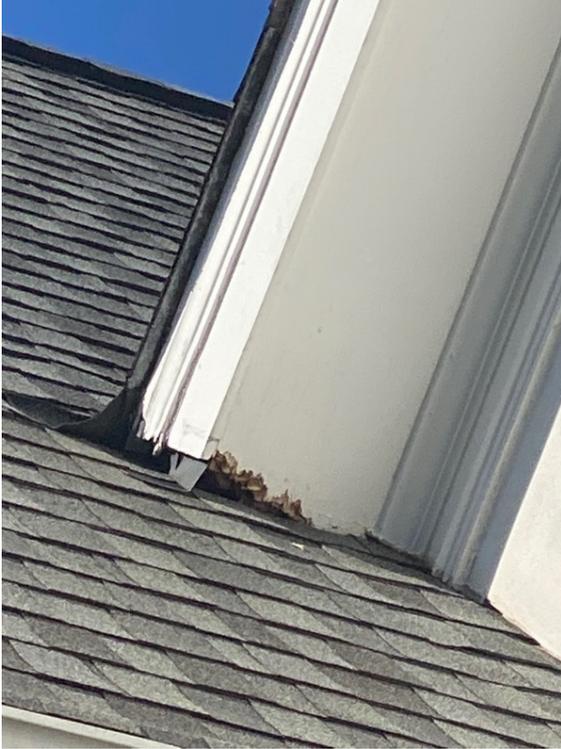
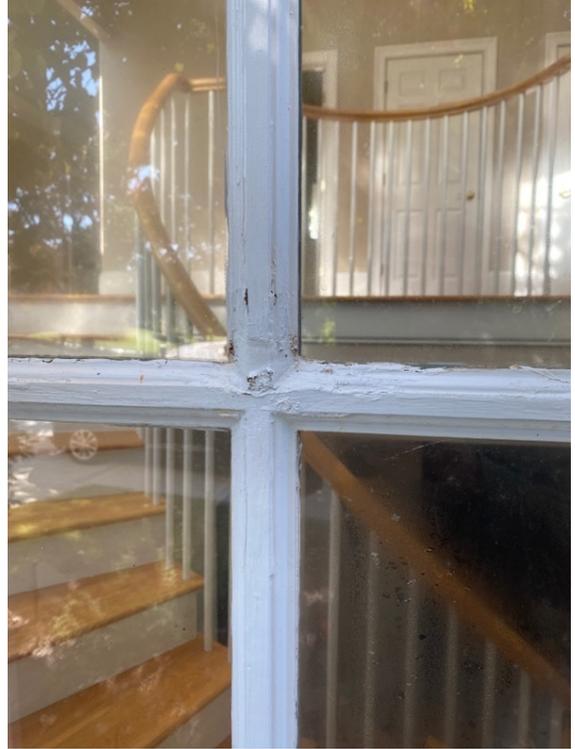
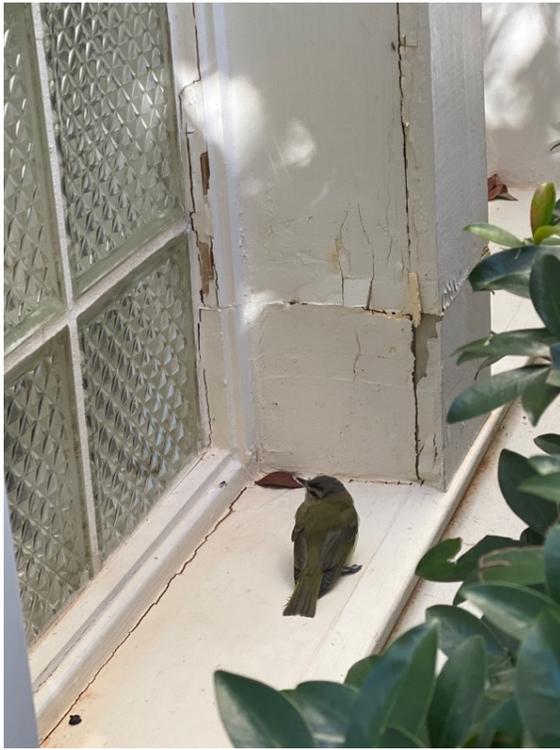
#### Chipped and rotted wood to wooden trim.

**Location** Exterior: Ground View

**Impact** Excessive wood rot found around windows, doors and other wood components. This is an environment that attracts destructive insects.

**Suggested Action** Replace wood and a termite inspection is recommended.

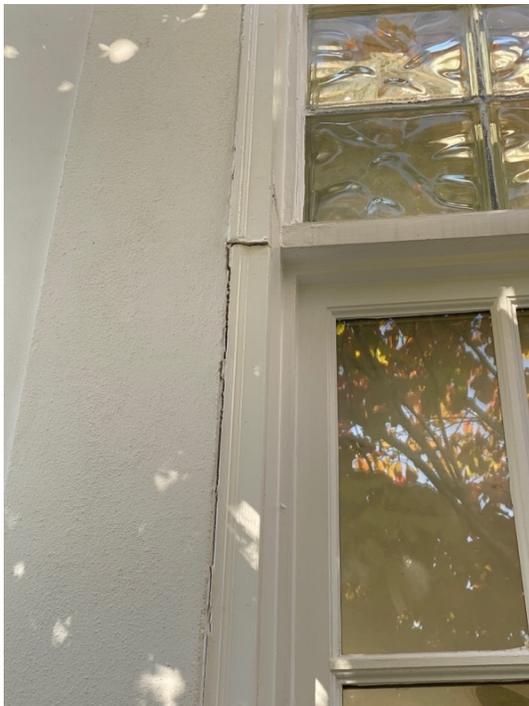
**Caulk has deteriorated with gaps and signs of water intrusion.**

**Location** Exterior: Ground View

**Impact** Without the seal that caulk provides, seams are unprotected and will allow continuous damage to trim. Leads to wood rot and attracts destructive insects.

**Suggested Action** Clean out old caulk, replace damaged wood.

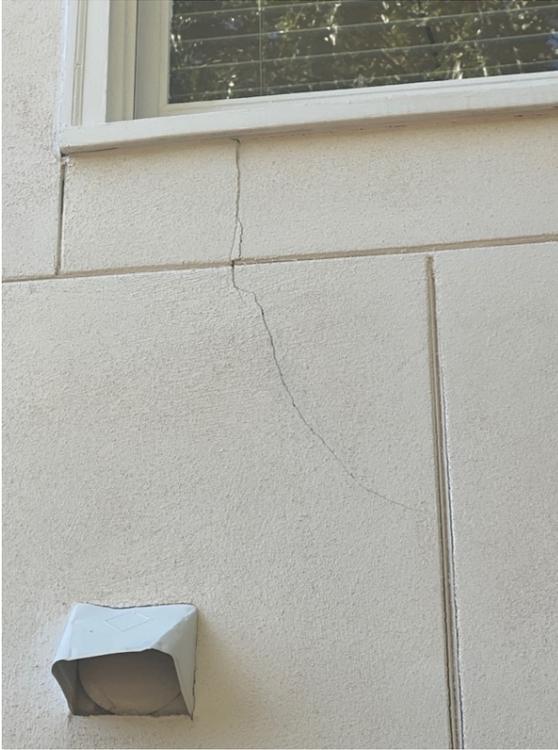
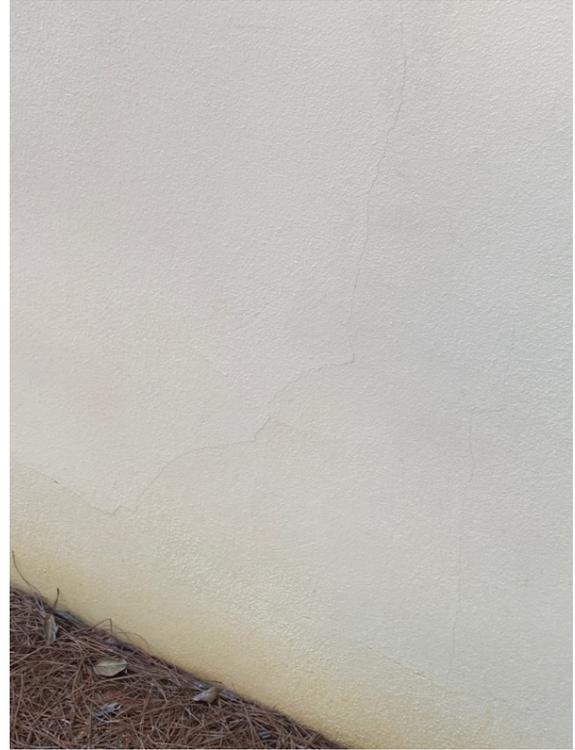
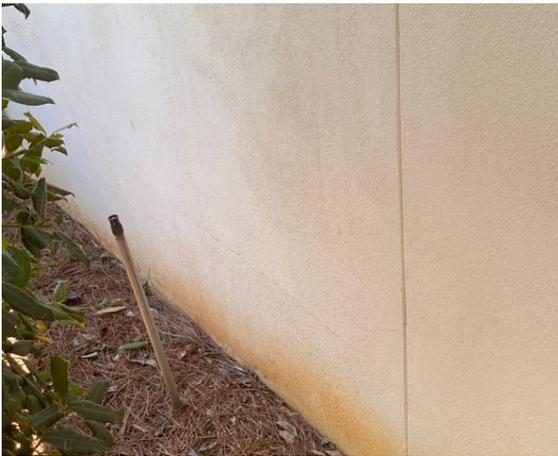
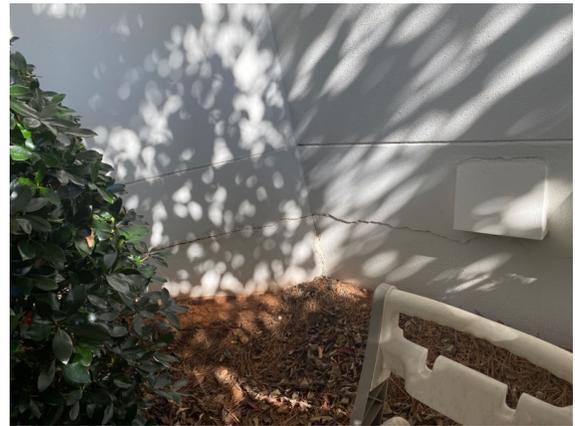
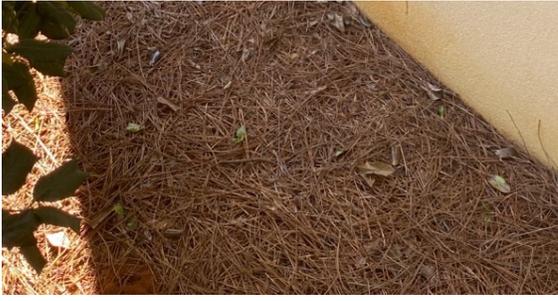
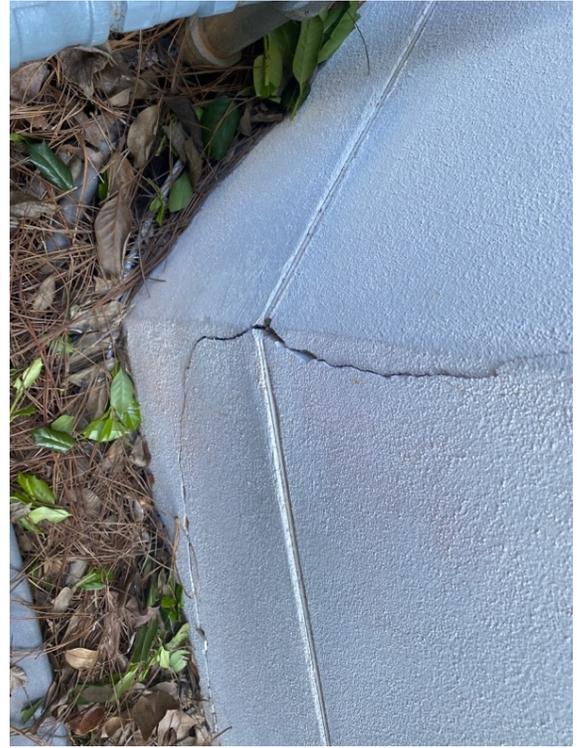
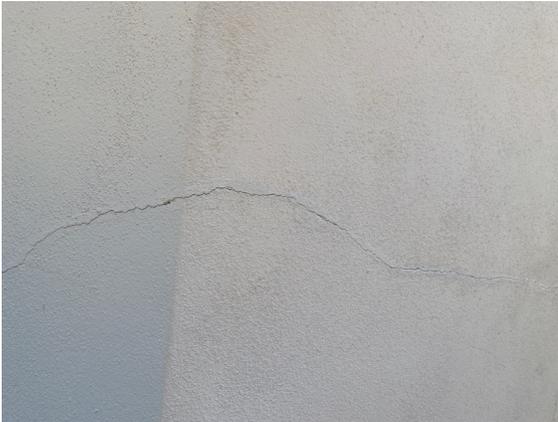
Stucco is cracked

**Location** Exterior: Ground View

**Impact** Cracked stucco may allow for moisture and insect intrusion

**Suggested Action** Have a certified stucco contractor repair the affected areas

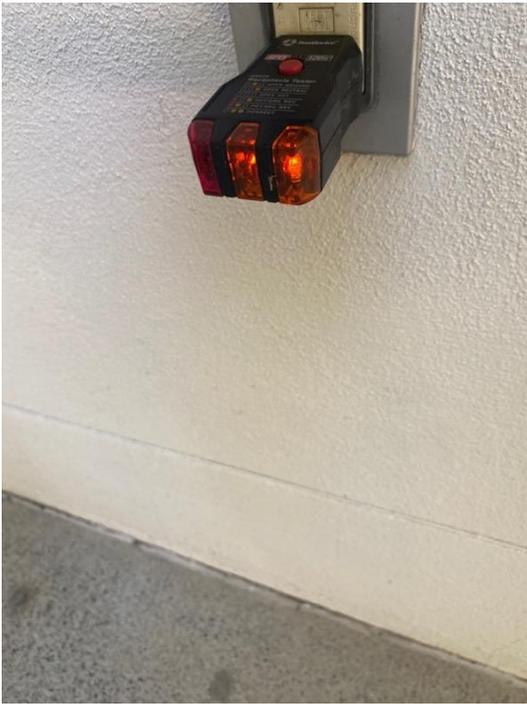
By back door

#### Not tripping

<b>Location</b>	Exterior: Ground View
<b>Impact</b>	When the GFCI does not trip, an electrical shortage may result
<b>Suggested Action</b>	Replace the GFCI
<b>Other Information</b>	GFCI receptacles prevent electric shocks from faults in electrical device

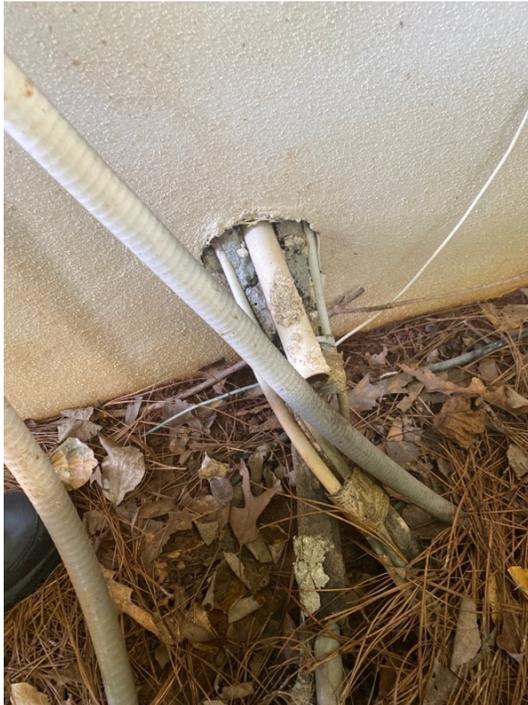
#### Condensate line drains too close to the foundation

**Location** Exterior: Ground View

**Impact** Should the condensation discharge be high, the water will pool near foundation. Potentially causing cracks and intrusion issues.

**Suggested Action** Add an elbow and extend the line away from home.

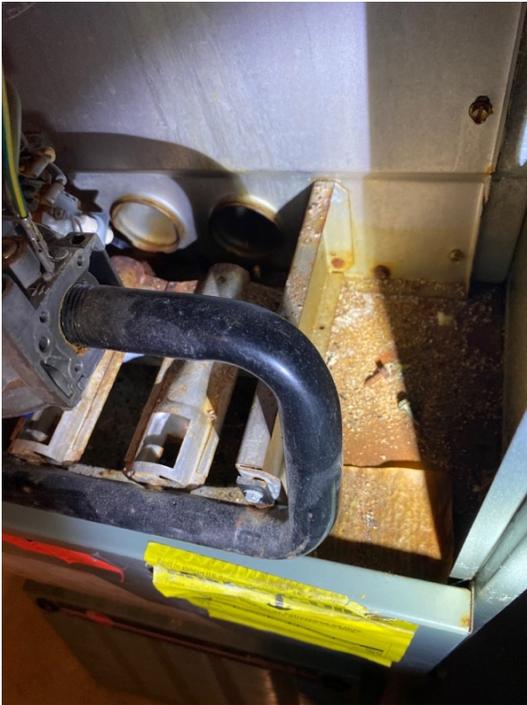
#### Rusting

**Location** Basement  
**Impact** Although no operational problems have been identified, if the furnace has not been well maintained, other components of the furnace may fail in the future

**Other Information** A rusty furnace implies moisture is entering the unit and/or has not been regularly cleaned or serviced

**Suggested Action** Have the furnace cleaned and serviced by an HVAC service professional. Put the furnace on an annual maintenance program to ensure long term safe and optimal operation

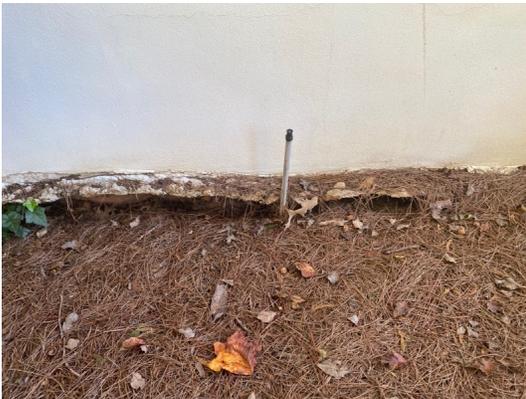
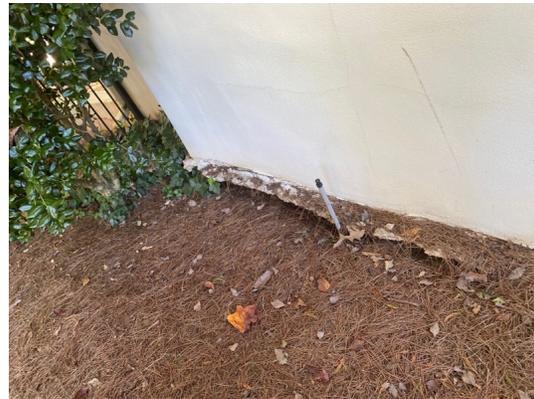
#### Erosion with pooling water

**Location** Exterior: Ground View

**Impact** Erosion found with pooling water. Can lead to cracks in concrete and shifts in foundation.

**Suggested Action** Build up area with dirt or landscaping material. Consult a drainage engineer to discuss options.

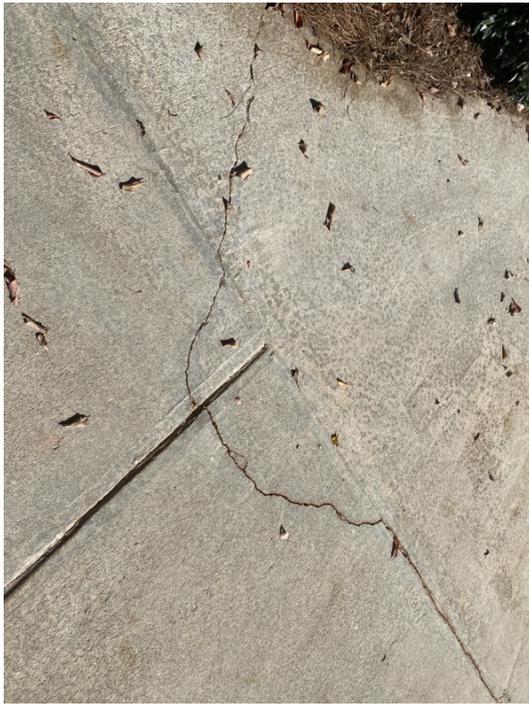
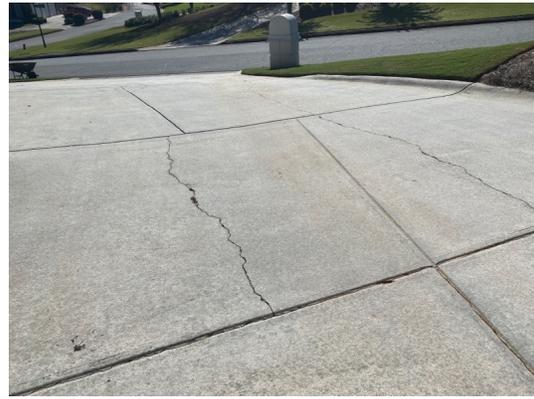
#### Concrete has minor cracks

**Location** Exterior: Ground View

**Impact** The cracks allow for water intrusion, which may cause the surrounding surfaces to also deteriorate.

**Suggested Action** Seal the crack(s) with weather-resistant pliable concrete sealer

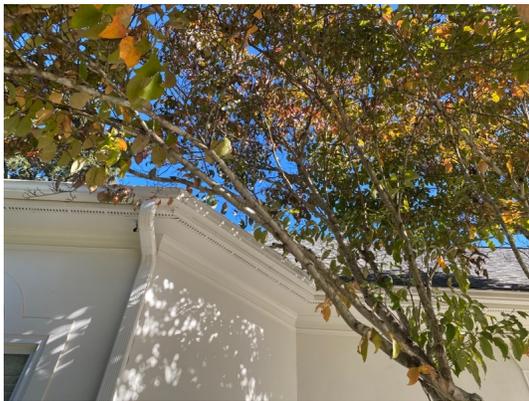
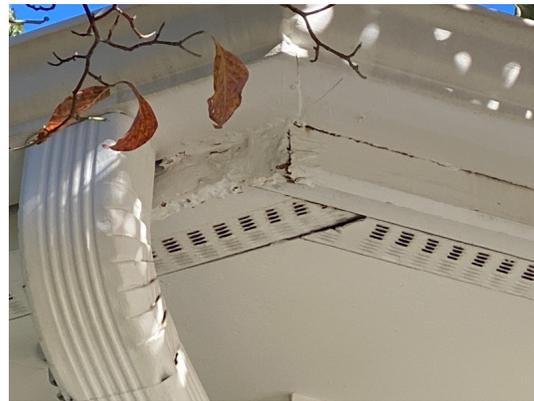
#### Tree branches are in contact with building

**Location** Exterior: Ground View

**Impact** Tree branches provide an environment where moisture and/or insects could intrude. Leading to damage and premature ageing to the siding or roofing material

**Suggested Action** Regularly trim the trees to achieve a clearance of at least 6 - 8 feet

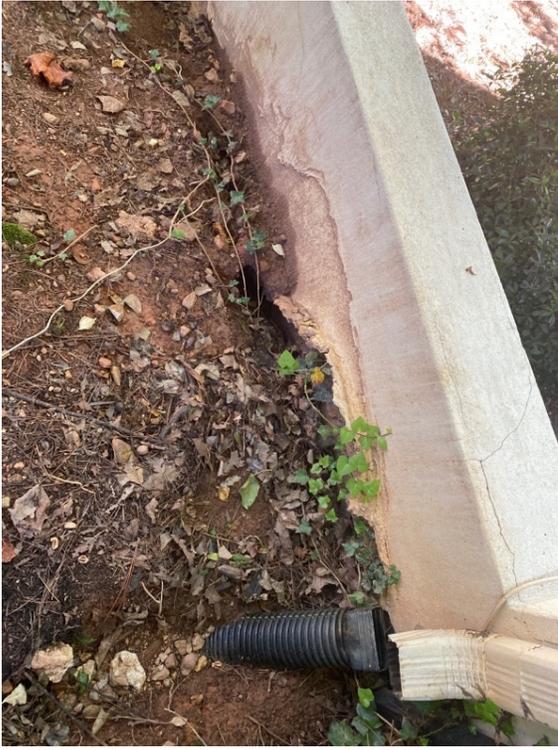
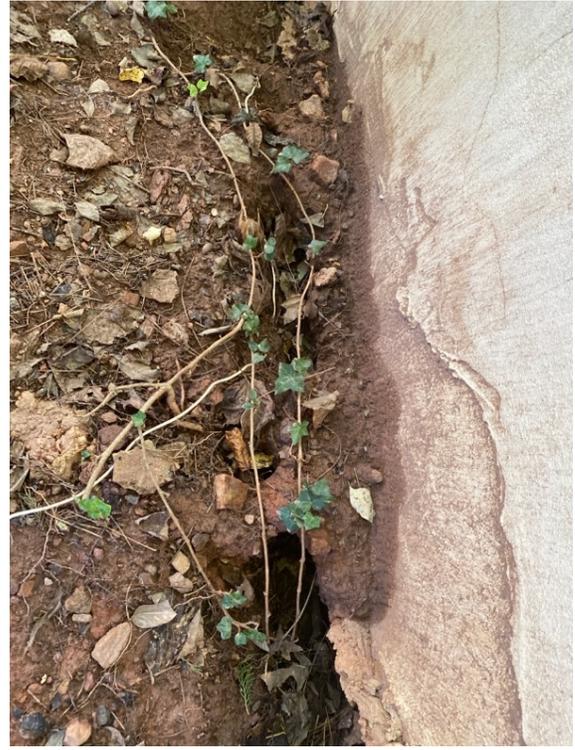
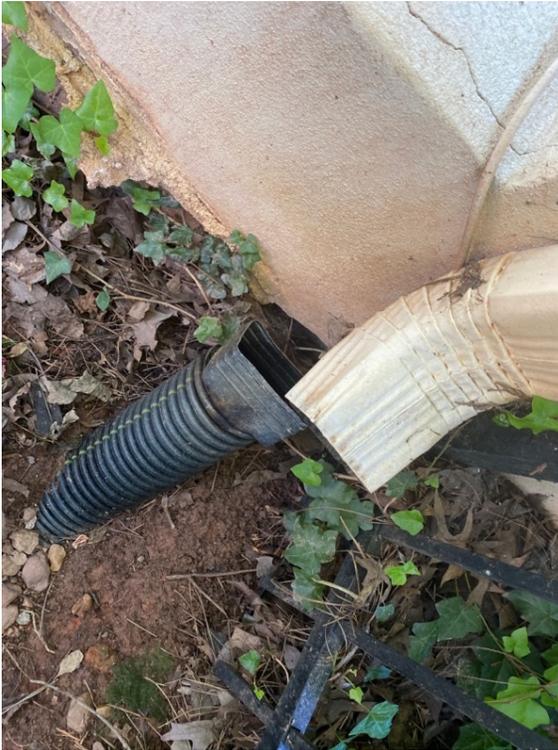
#### Water is pooling near retaining wall

**Location** Exterior: Ground View

**Impact** Downspout extension is disconnected. Causing water to pool near retaining wall. Some erosion has already occurred. Damage will worsen.

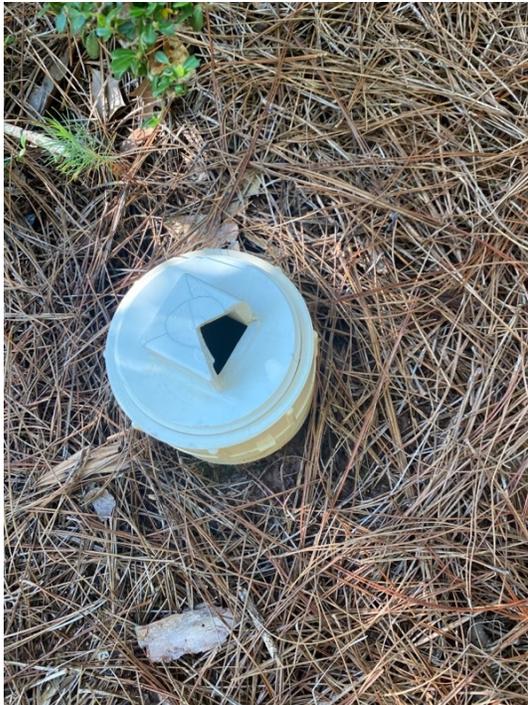
#### Cap is damaged

<b>Location</b>	Exterior: Ground View
<b>Impact</b>	Protection is compromised
<b>Suggested Action</b>	Replace cap
<b>Other Information</b>	The cap prevents small objects from entering the pipe

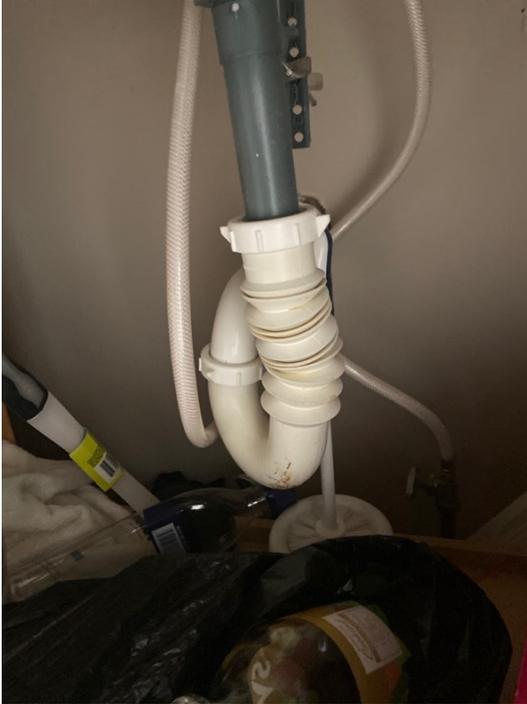
### Flex pipe

<b>Location</b>	Bedroom 1 Bathroom
<b>Impact</b>	Flex pipe is prone to clog
<b>Suggested Action</b>	Replace with a smooth walled pipe per proper plumbing installation

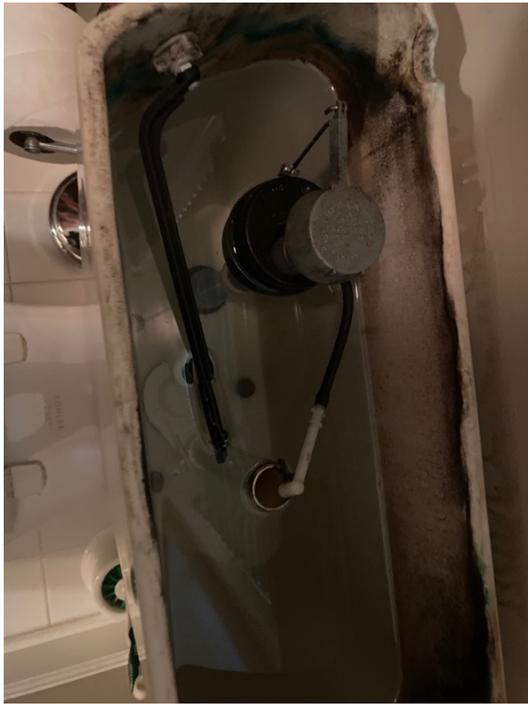
### Flapper chain needs reconnecting

<b>Location</b>	Jack and Jill Bathroom
<b>Impact</b>	Chain snapped and no longer in functional condition.
<b>Suggested Action</b>	Replace the chain

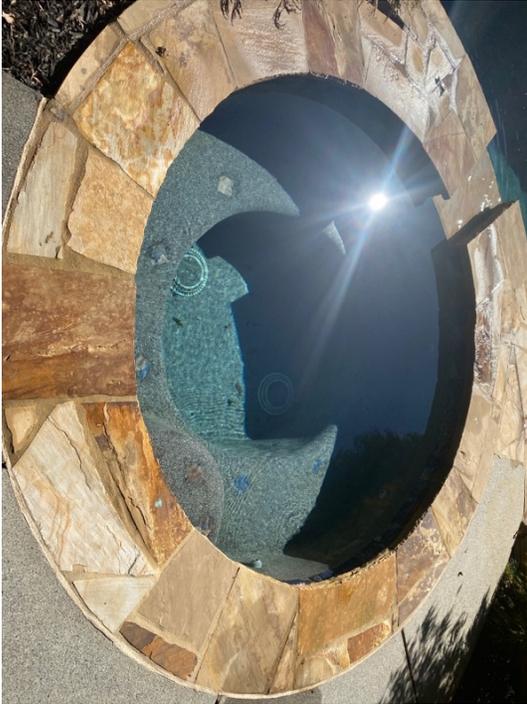
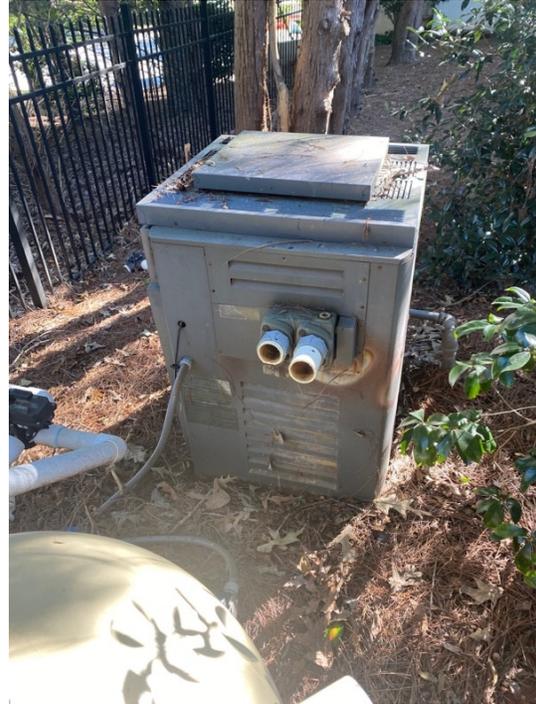
**Hot tub heater is not attached**

**Location** Pool Area

**Impact** Does not work in current condition.

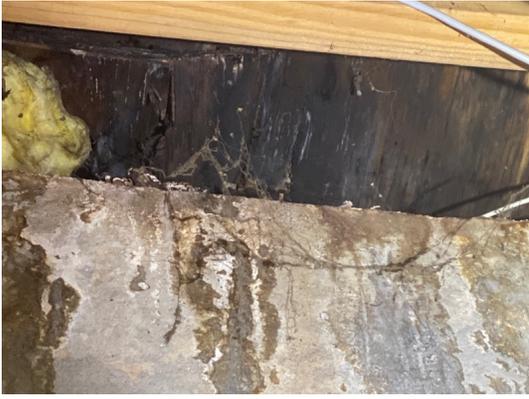
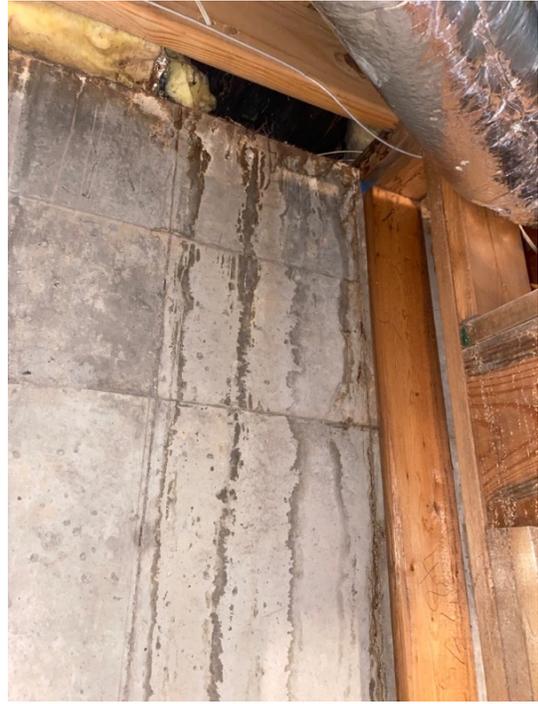
#### Rotted wood with signs of moisture intrusion

<b>Location</b>	Basement
<b>Impact</b>	Active leak into basement. Believed to be positioned below dining room window. Same area that is rotted.
<b>Suggested Action</b>	Wood needs to be replaced and area water proofed to prevent interior intrusion.

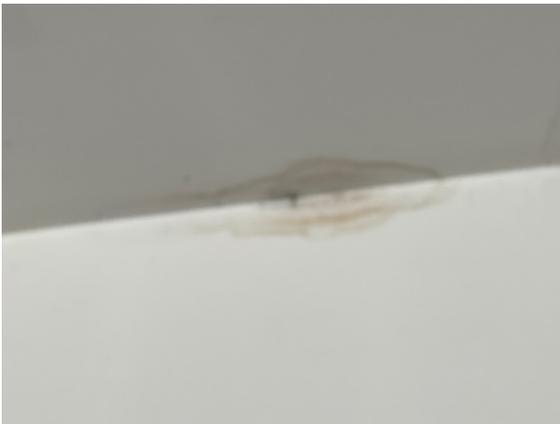
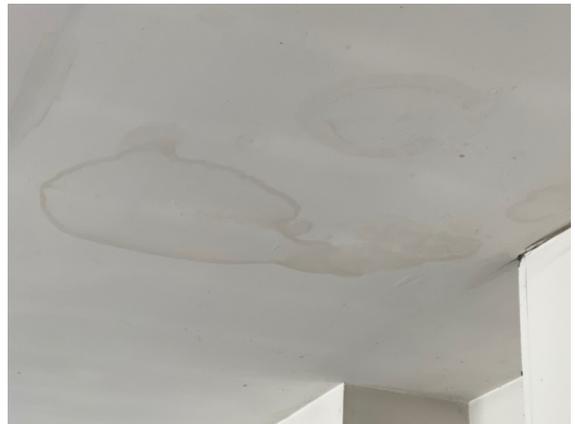
**Water stain found (not active)**

<b>Location</b>	Attached Garage, Basement
<b>Impact</b>	Moisture detector indicates non active. Damage is still visible.
<b>Suggested Action</b>	Repair drywall and monitor for possible future concerns.

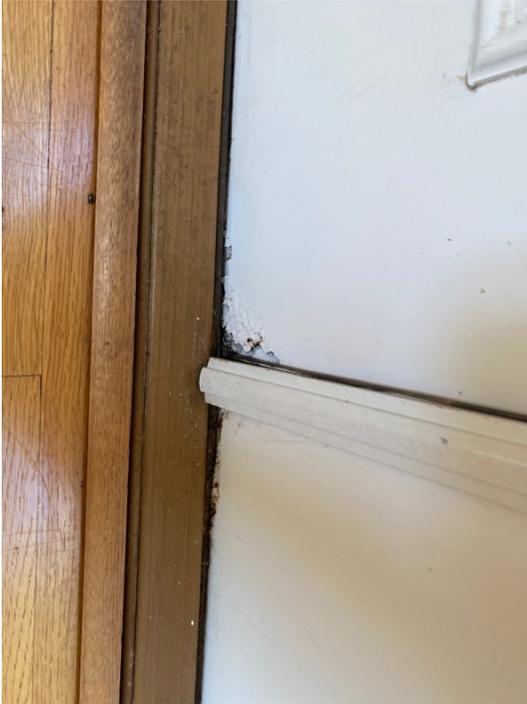
#### Moisture damage to door frame

**Location** Living Room

**Impact** Wood rots from the bottom up. Trim shows damage so there will be more damage found underneath frame.

**Suggested Action** Replace all damaged wood and install a storm door to protect against future concerns.

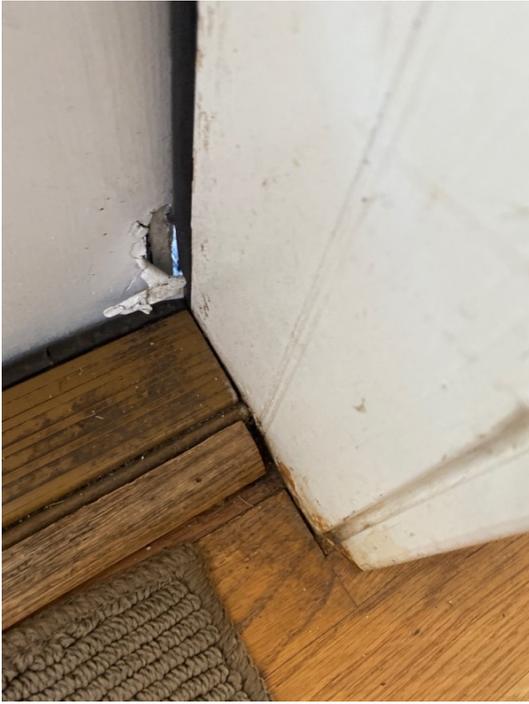
#### Visible light around door

**Location** Family Room

**Impact** If light is visible then air, water and insects can penetrate the gaps.

**Suggested Action** Replace or adjust weather stripping to insure a more complete seal.

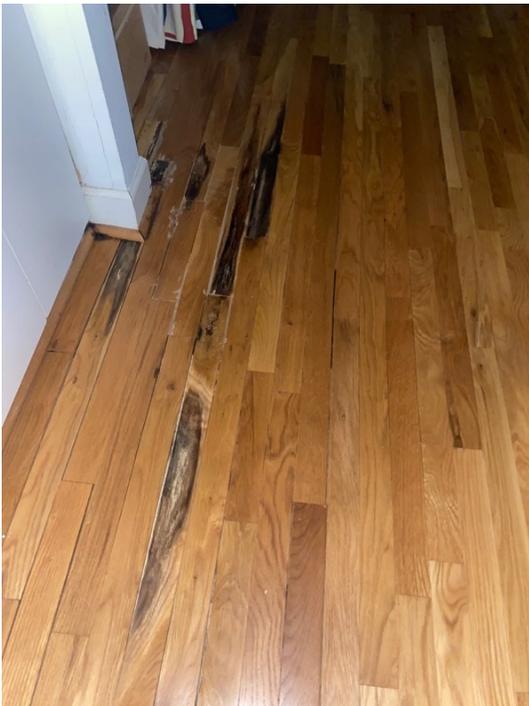
**Flooring damage in closet**

**Location** Master Bathroom  
**Impact** Will need flooring replacement.

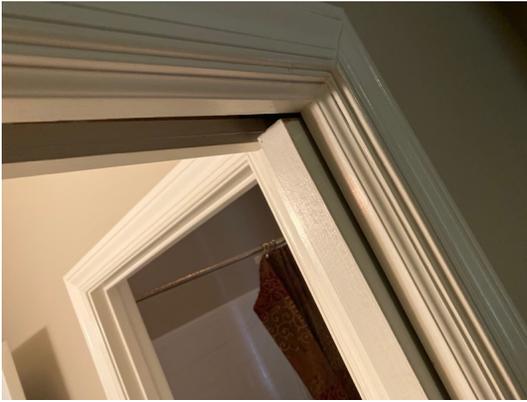
### Pocket door off track

<b>Location</b>	Jack and Jill Bathroom
-----------------	------------------------

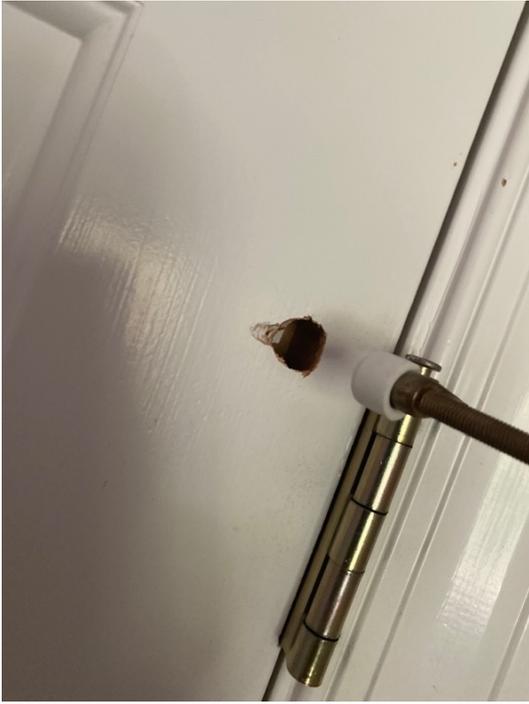
### Damaged

<b>Location</b>	4th Bedroom
<b>Suggested Action</b>	Replace the door as desired

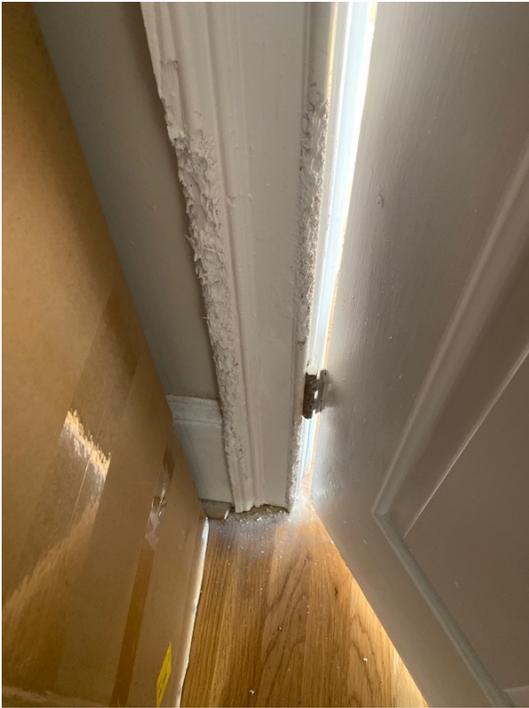
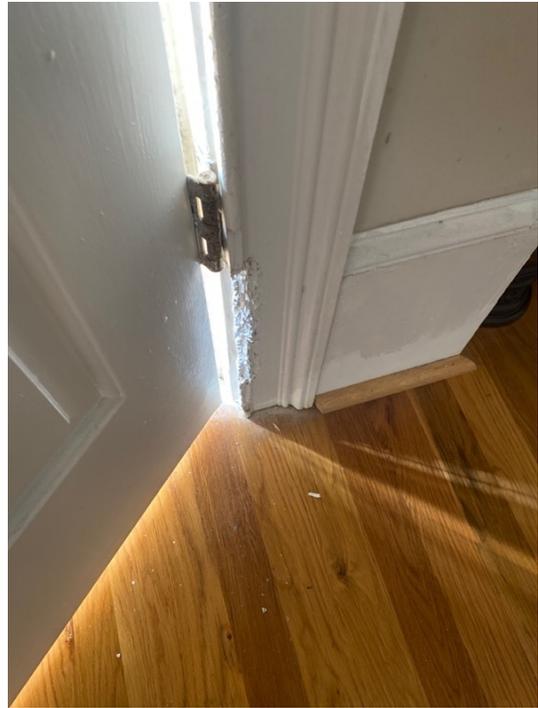
**Door trim has animal damage**

Location Master Bedroom

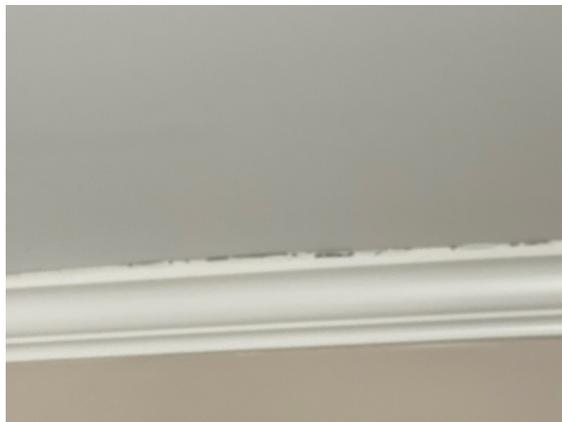
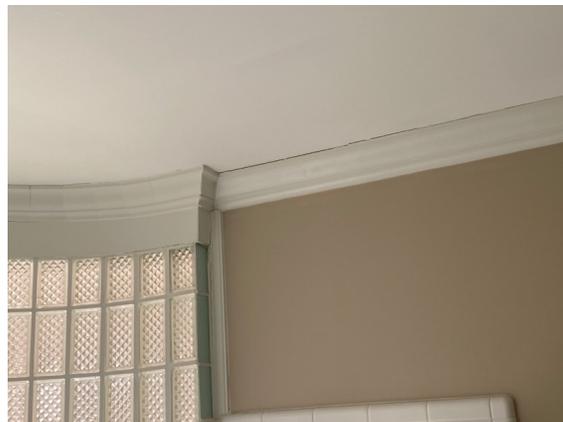
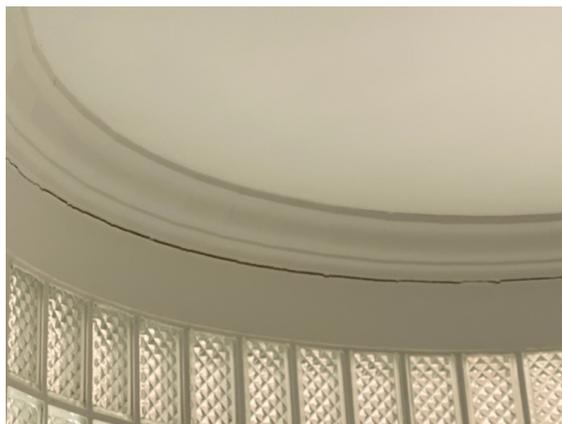
### Gap(s) in the molding

<b>Location</b>	Bedroom 1 Bathroom, 1st Bedroom
<b>Impact</b>	Molding connections show separation.
<b>Suggested Action</b>	Seal and paint for a more complete finish.

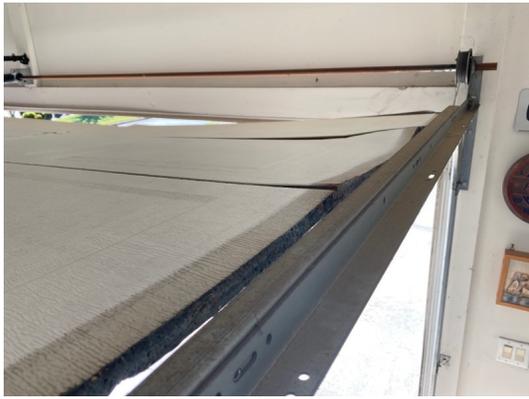
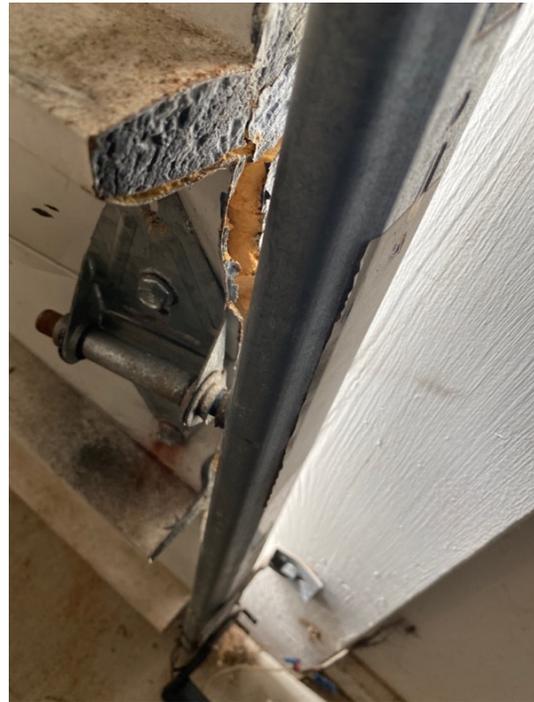
#### Damaged

<b>Location</b>	Attached Garage
<b>Impact</b>	While still functional, it bends everytime it opens and closes. Damage will worsen over time.
<b>Suggested Action</b>	Replace the panel

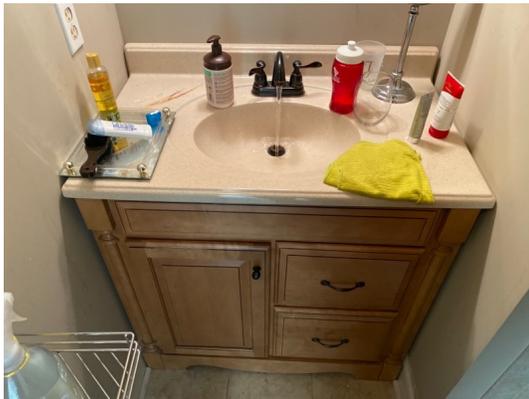
#### Countertop is loose

<b>Location</b>	Basement Bathroom
<b>Impact</b>	Countertop is loose and likely to dislodge with too much pressure.
<b>Suggested Action</b>	Have repaired by a qualified contractor

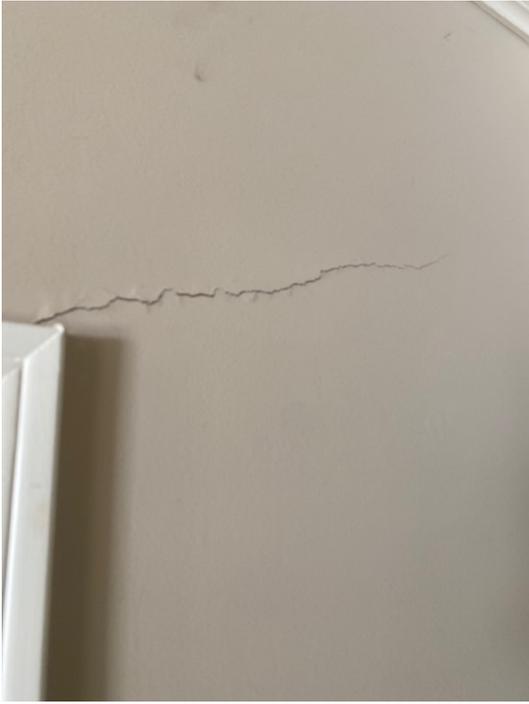
#### Shows signs of settling cracks

<b>Location</b>	1st Bedroom
<b>Impact</b>	With cracks, the wall lacks asthetic appeal
<b>Suggested Action</b>	Repair the cracked areas using drywall compound
<b>Other Information</b>	Some degree of settling cracks should be expected in every home

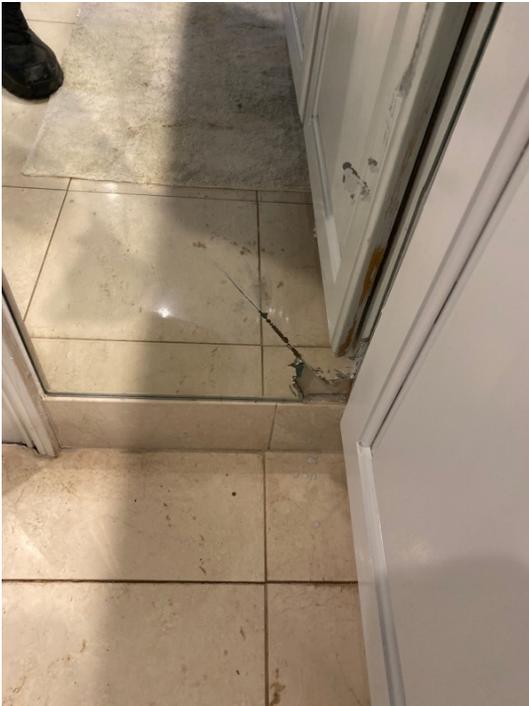
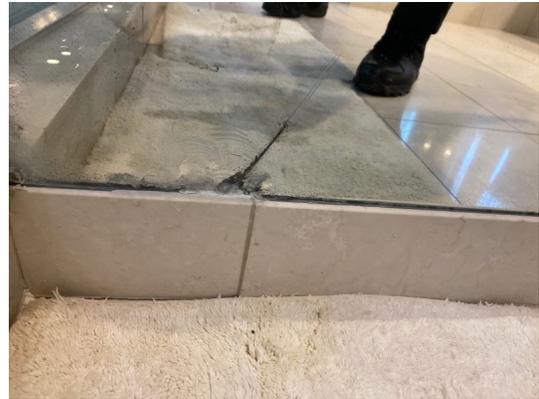
**cracked mirror wall covering**

**Location** Master Bathroom

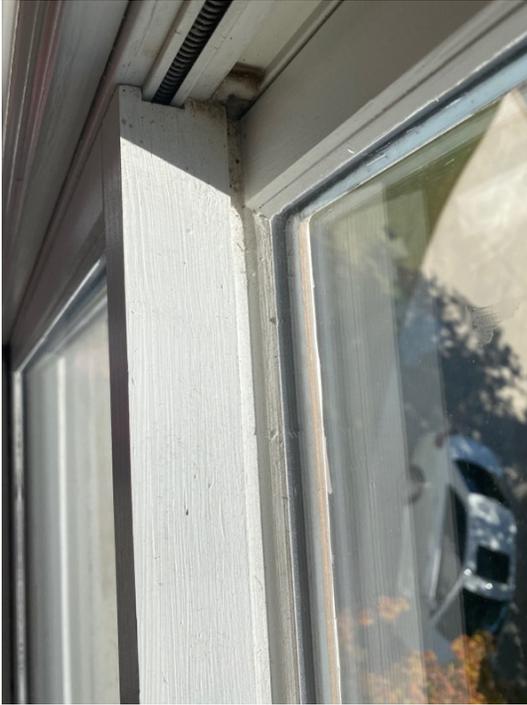
### Painted shut or swollen from water intrusion

**Other Information** This is a reoccurring concern throughout the home.

**Suggested Action** Use a blade to remove paint from tracks.

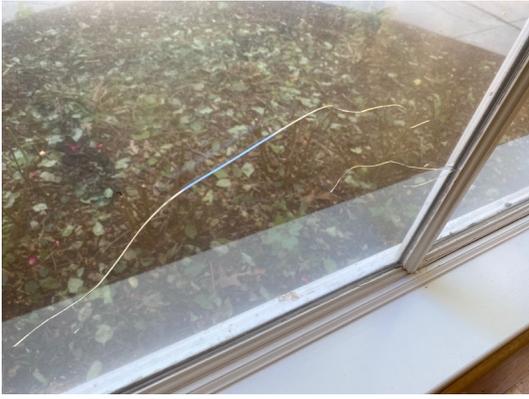
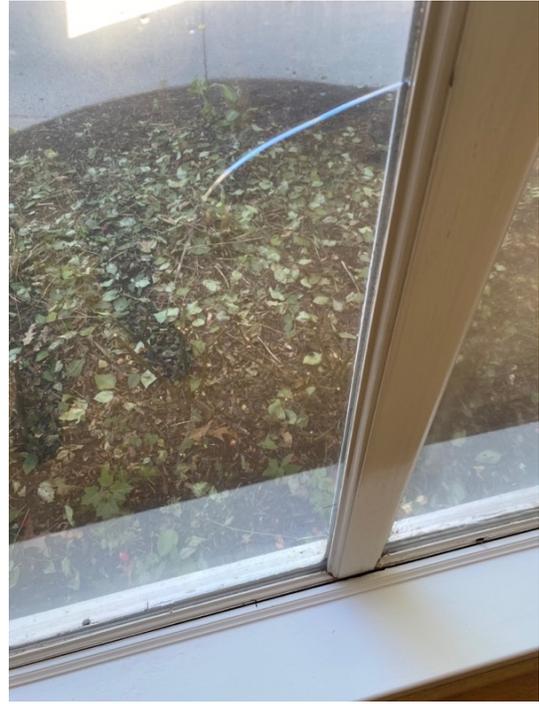
### Glass pane is cracked

**Location** Family Room

**Impact** The cracks may worsen and expose sharp edges.

**Suggested Action** Replace the glass

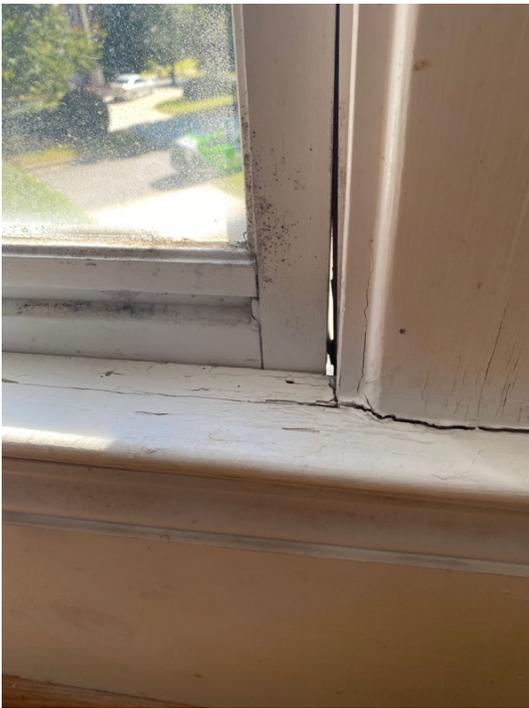
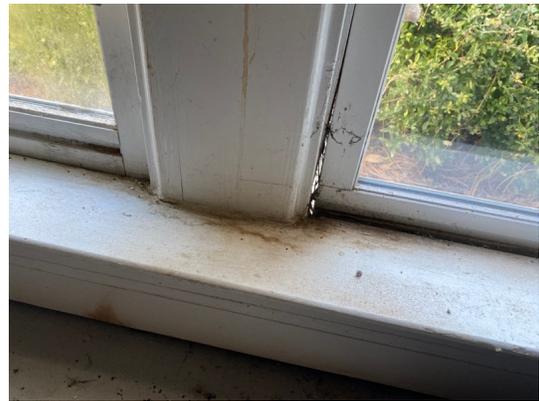
**Visible light around window**

**Impact** Will allow drafts and outside elements into the home.

**Suggested Action** Have sealed by a qualified contractor

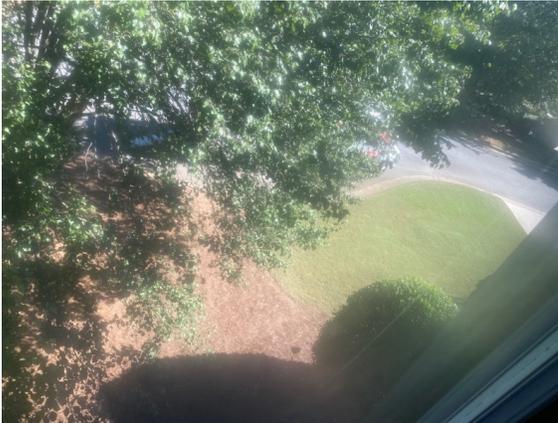
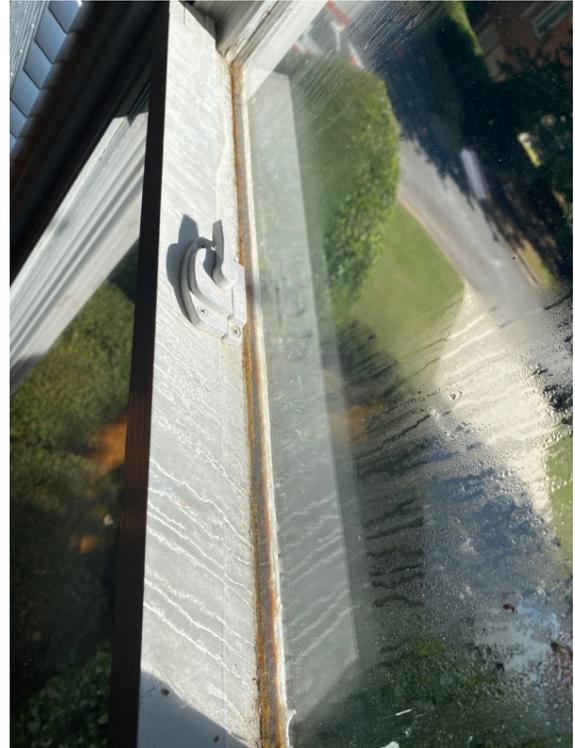
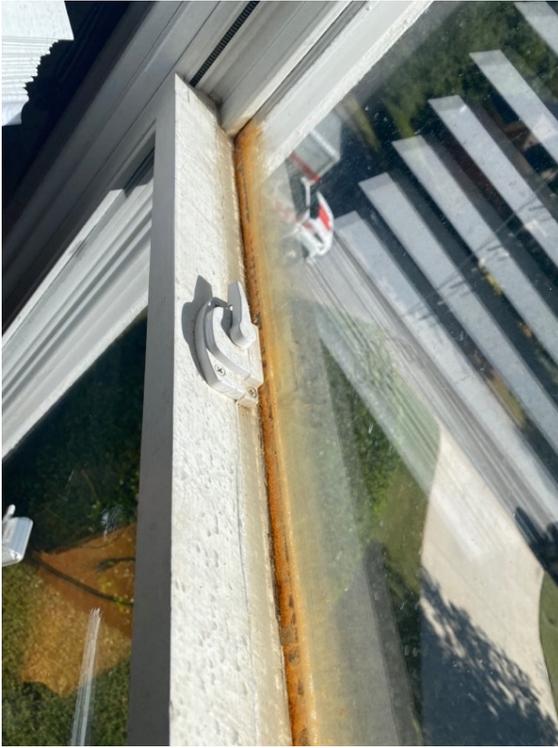
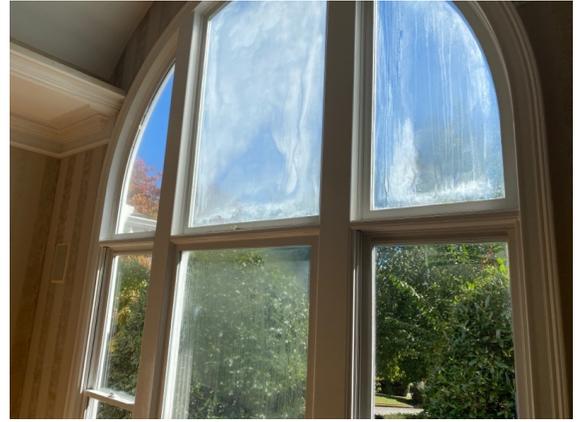
### Fogging or sweating

<b>Location</b>	Master Bedroom, Dining Room, 2nd Bedroom
<b>Impact</b>	Should it worsen, insulating value may be impacted.
<b>Suggested Action</b>	Monitor or replace to improve appearance
<b>Other Information</b>	This is likely caused by a broken seal. Windows get their insulating value by trapping air between two well-sealed panes of glass. Some insulated windows are actually filled with argon gas which provides a higher insulating value. When the seals break, moist air enters the space. However, as long as there is minimal air movement in the space, the insulating value remains high. Broken seals are caused by buildup of water and other debris (pine needles, dust, etc.) in the window frame. Temperature differences between the indoors and outdoors also puts stress on the seals by causing them to expand and contract in cold weather

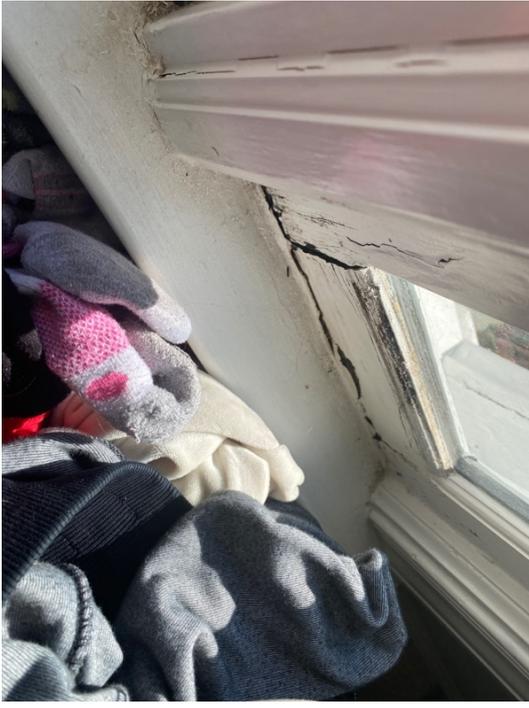
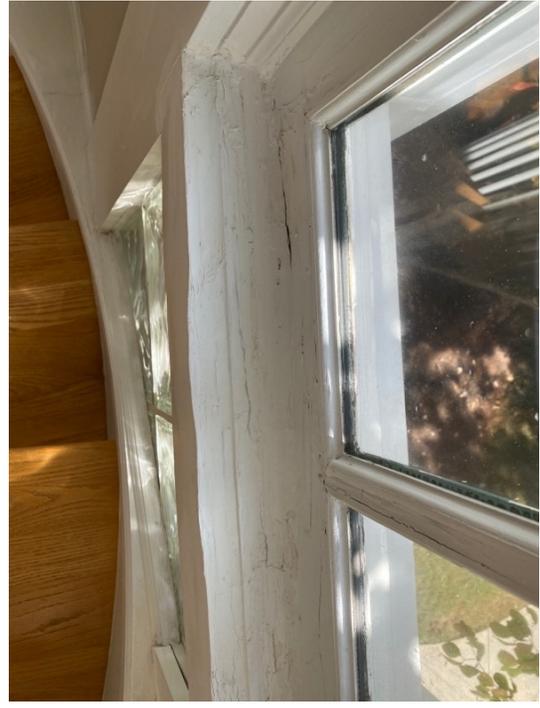
**Impact** Majority of the windows in the home will need replacement. A lot of moisture damage, visible light or just don't open.

**Suggested Action** Budget to replace all windows.
