Rosebud Power Plant Annual Engineer's Inspection Report

Prepared for Rosebud Operating Services, Inc.
by Allied Engineering Services, Inc.

January 19, 2017

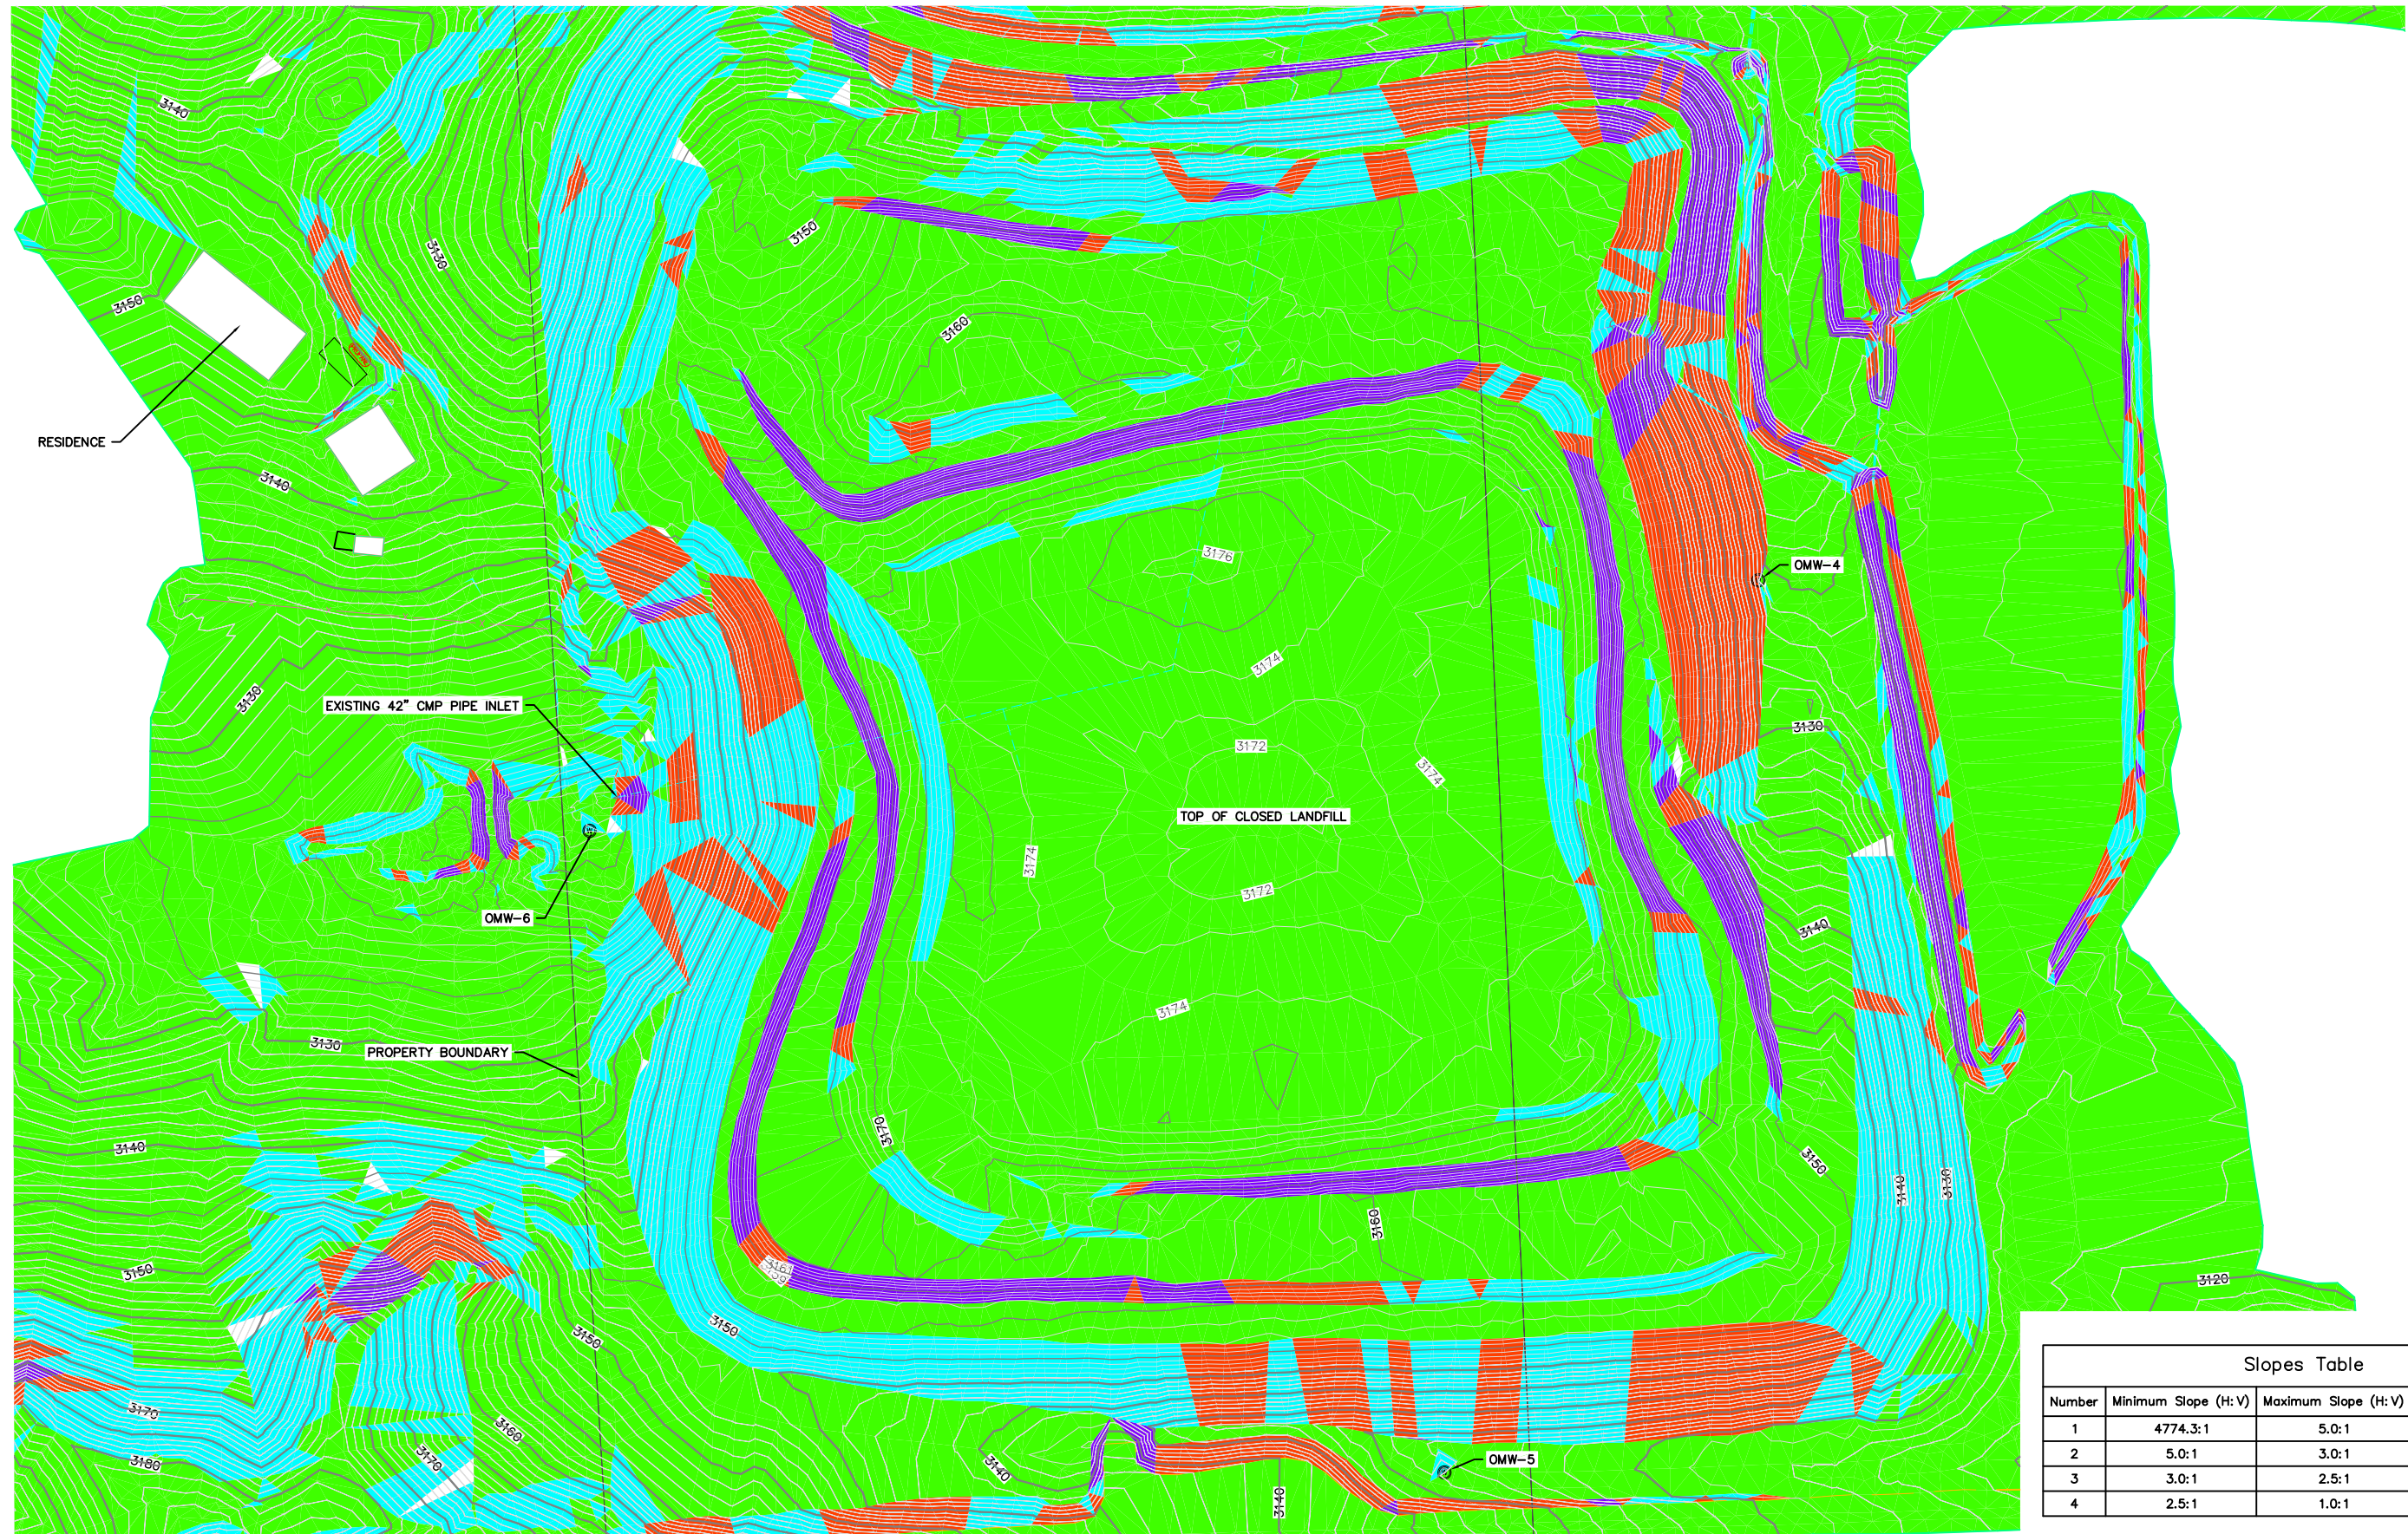
F:\2015\15-125 Rosebud Power Plant Ash Disposal Site\09 CAD Data\SLOPE FIGURE.dwg

Slopes Table				
Number	Minimum Slope (H:V)	Maximum Slope (H:V)	Area (SQ. FT.)	Color
1	4774.3:1	5.0:1	3294101.77	Green
2	5.0:1	3.0:1	883969.23	Blue
3	3.0:1	2.5:1	278558.95	Red
4	2.5:1	1.0:1	282093.24	Purple

- Reshaping and revegetation of slopes in the active landfill in order to provide 3H:1V slopes (see Slope Figure included in Appendix B).
- Complete design and construction of the closed CCR landfill bypass drainage channel in order to limit the infiltration of surface water in the area.
- Prior to final closure, complete design and construction of bypass channels and outlet stilling basin for the active CCR landfill.

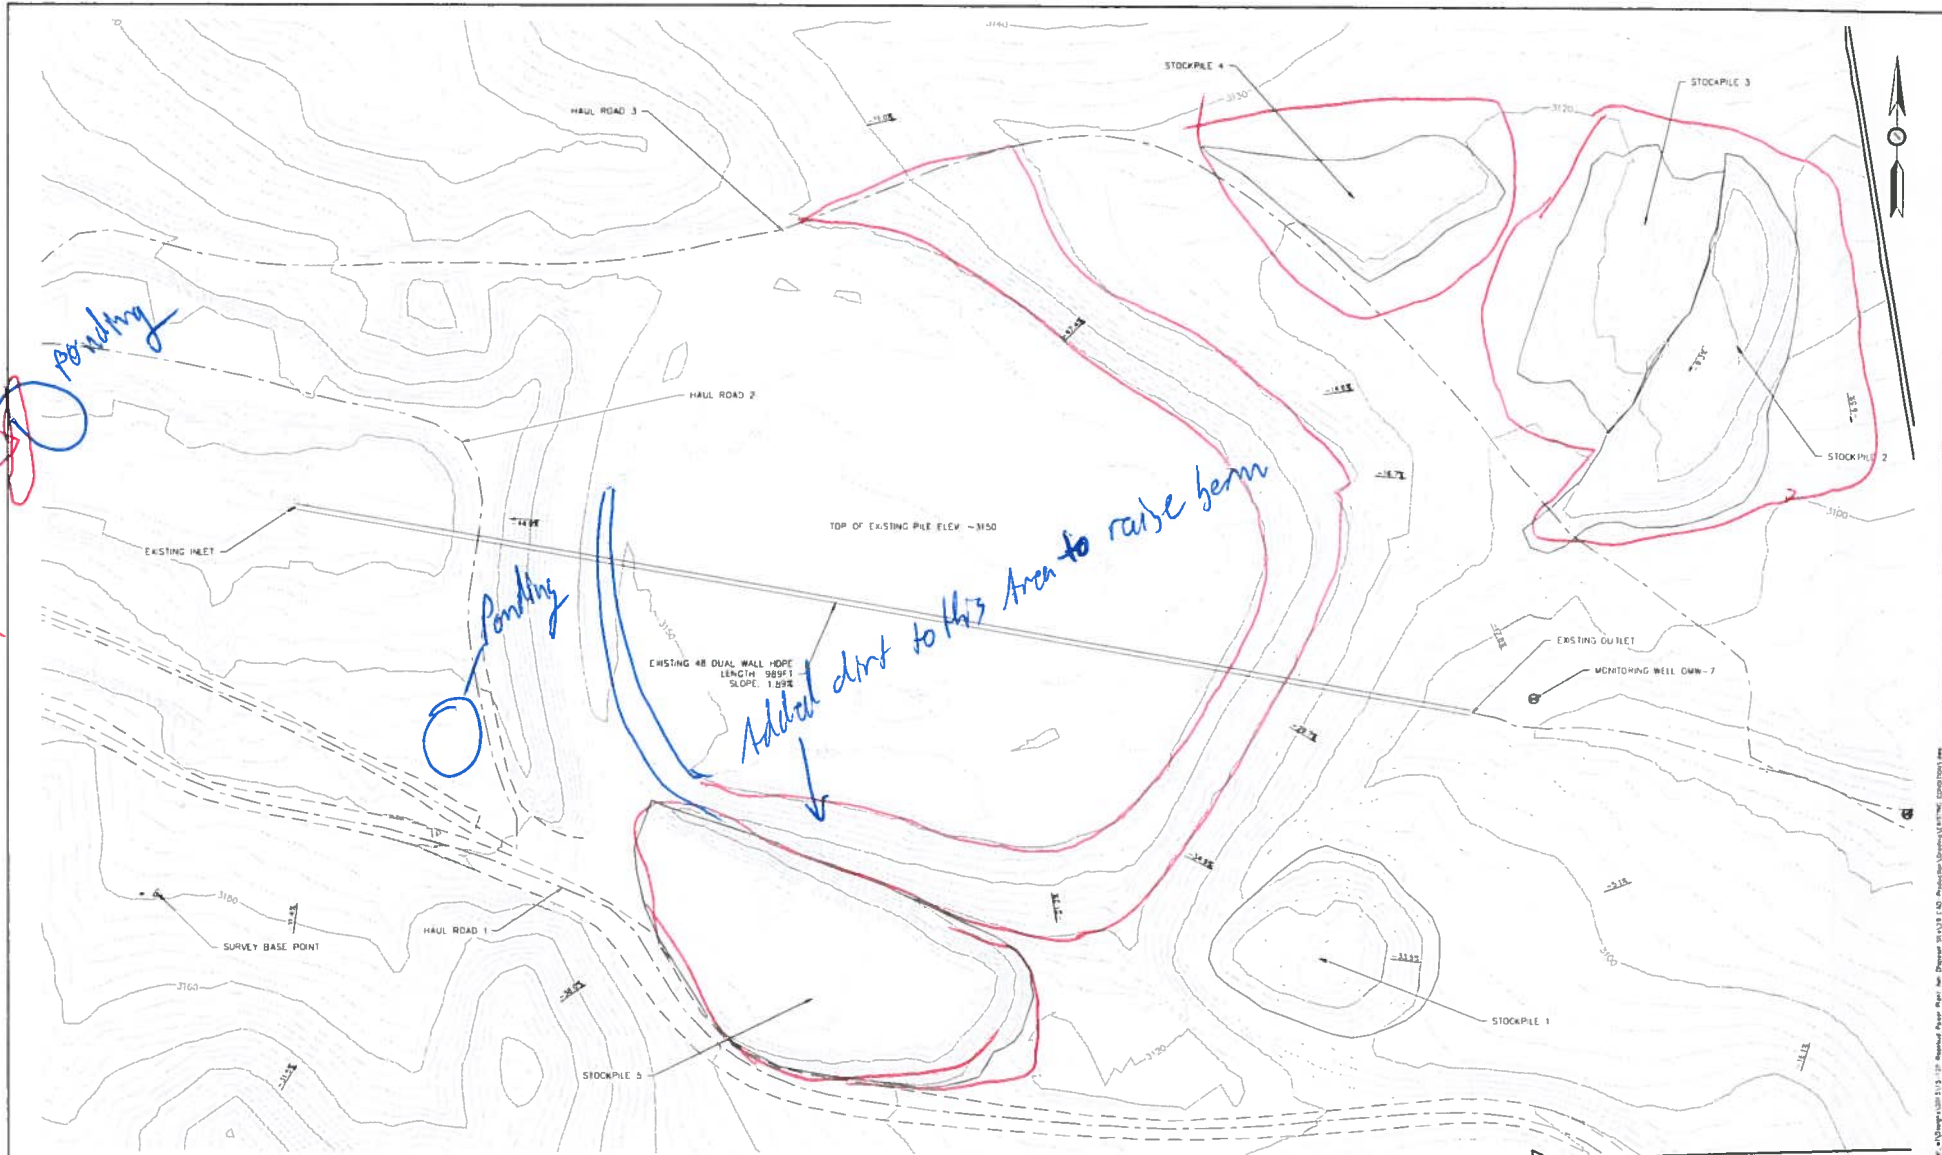
Areas Circled in Red were Hydro seeded

West drain
West berm

Ponding
