Rosebud Power Plant 2019 Annual Engineer's Inspection Report

Prepared for Rosebud Operating Services, Inc. by Allied Engineering Services, Inc. 2019 Report Posted: January 17, 2020 Project: 15-125

Annual Engineer's Inspection Report	Project: 15-125
Rosebud Power Plant	January 17, 2020

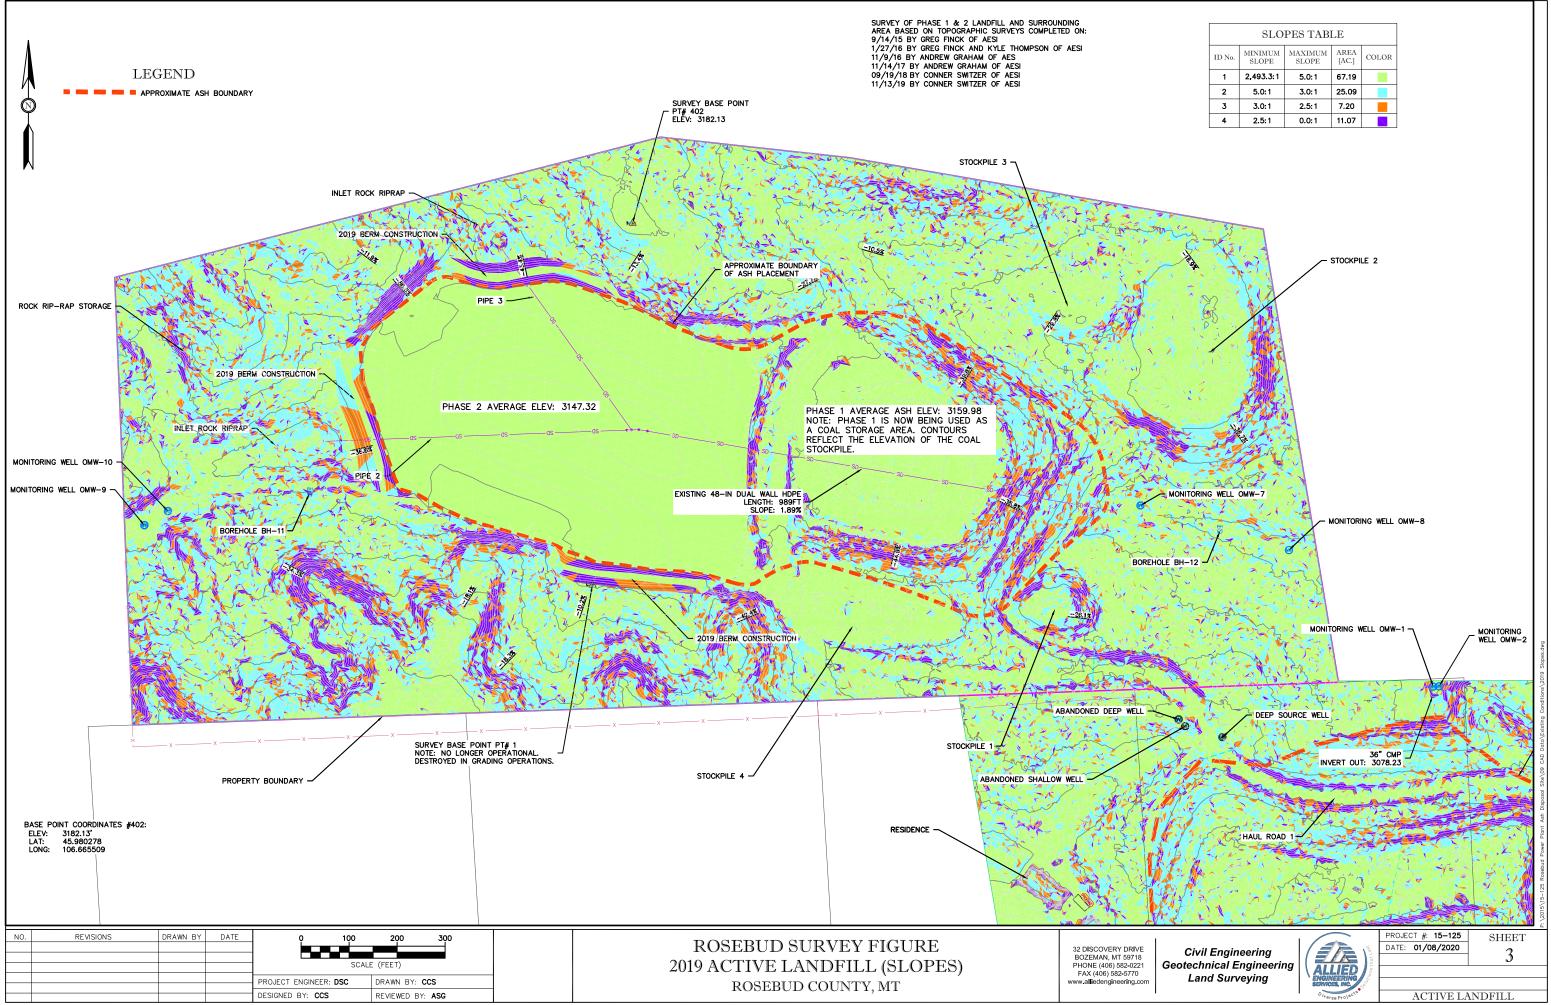
- Grade outward facing slopes on most recent berm construction (2019 and future) to insure a 3:1 side slope or flatter geometry. Any existing or future finished slopes steeper than 3H:1V will require flattening from the bottom (i.e. additional fill placement) during final closure. Avoiding exterior slopes/berms steeper than 3H:1V is efficient with respect to total earthwork and revegetation. Existing areas steeper than 3H:1V are shown in red and purple in Sheet 3.

- 2. Place top soil on outward facing slopes of finished berm areas.
- 3. Continue periodic maintenance grading to flatten all slopes steeper than 3H:1V (See Slope Figure).
