# Rosebud Power Plant 2020 Annual Engineer's Inspection Report

Prepared for Rosebud Operating Services, Inc. by Allied Engineering Services, Inc. 2020 Report

Project: 15-125

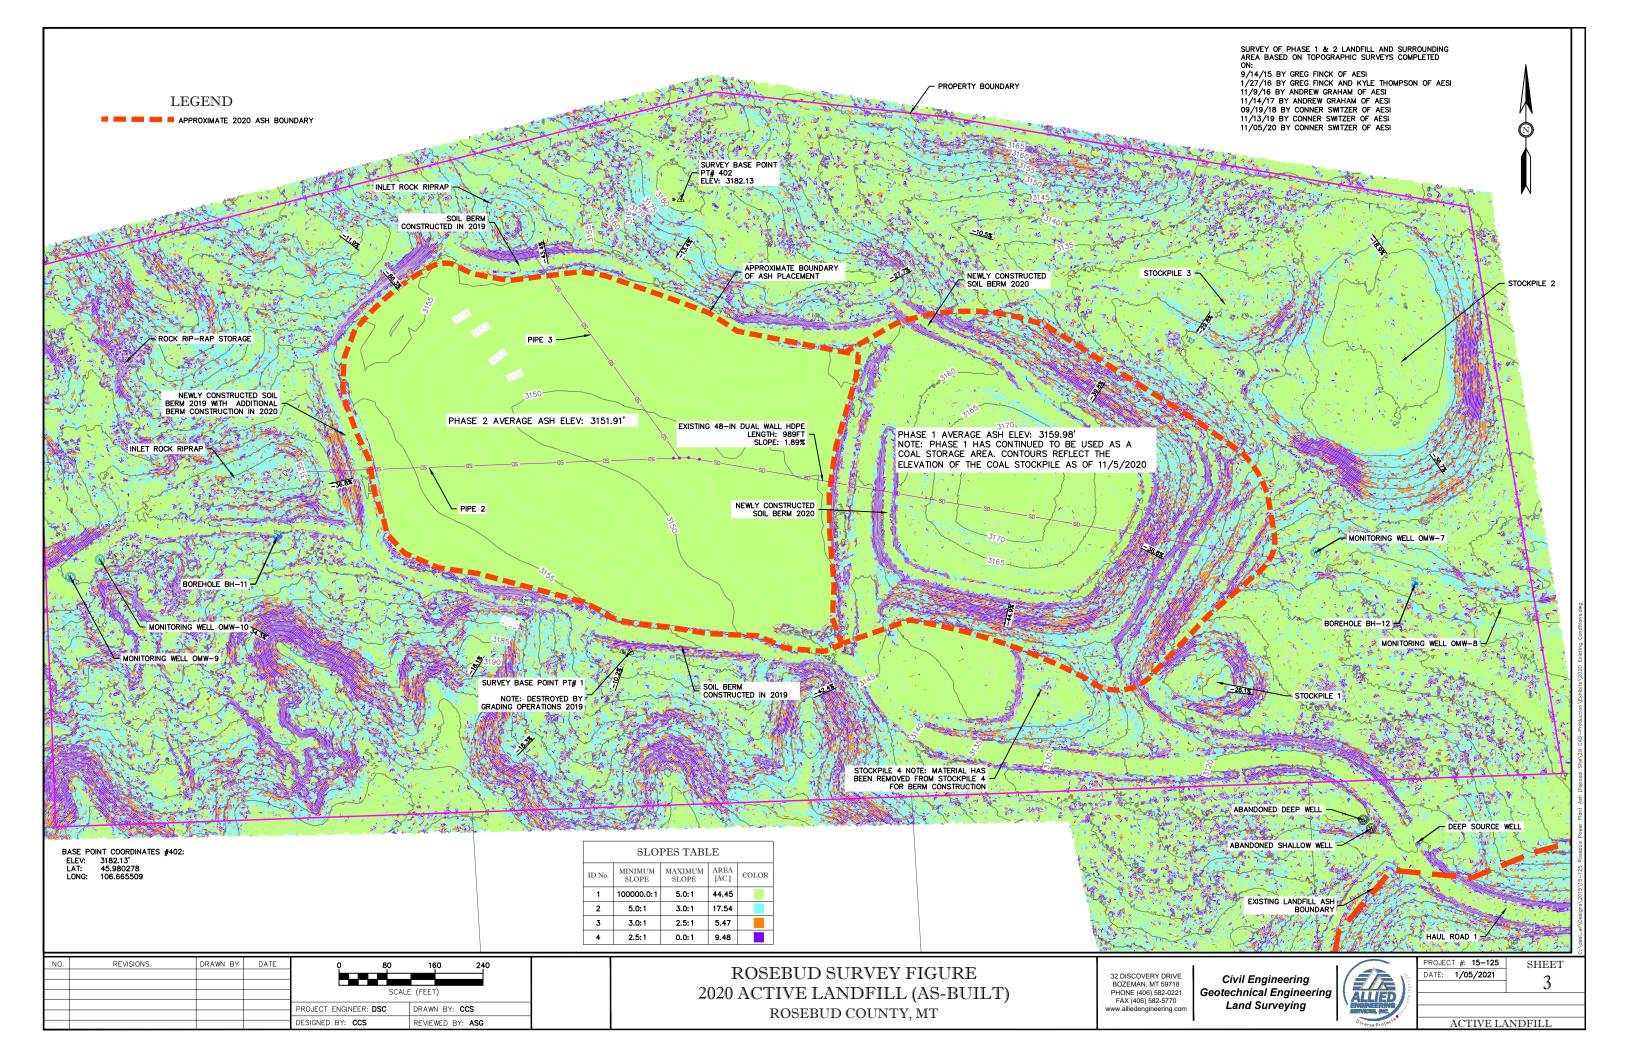
- 1. Grade outward facing slopes on most recent berm construction (2020 and future) to insure a 3:1 side slope or flatter geometry. Any existing or future finished slopes steeper than 3H:1V will require flattening from the bottom (i.e. additional fill placement) during final closure. Avoiding exterior slopes/berms steeper than 3H:1V is efficient with respect to total earthwork and revegetation. Existing areas steeper than 3H:1V are shown in red and purple in Sheet 3.

- 2. Place top-soil on outward facing slopes of finished berm areas.
- 3. Continue periodic maintenance grading to flatten all slopes steeper than 3H:1V (See Slope Figure).
