Rosebud Power Plant 2021 Annual Engineer's Inspection Report

Prepared for Rosebud Operating Services, Inc.
by Allied Engineering Services, Inc.
2021 Report
Posted: January 15, 2022
Project: 15-125

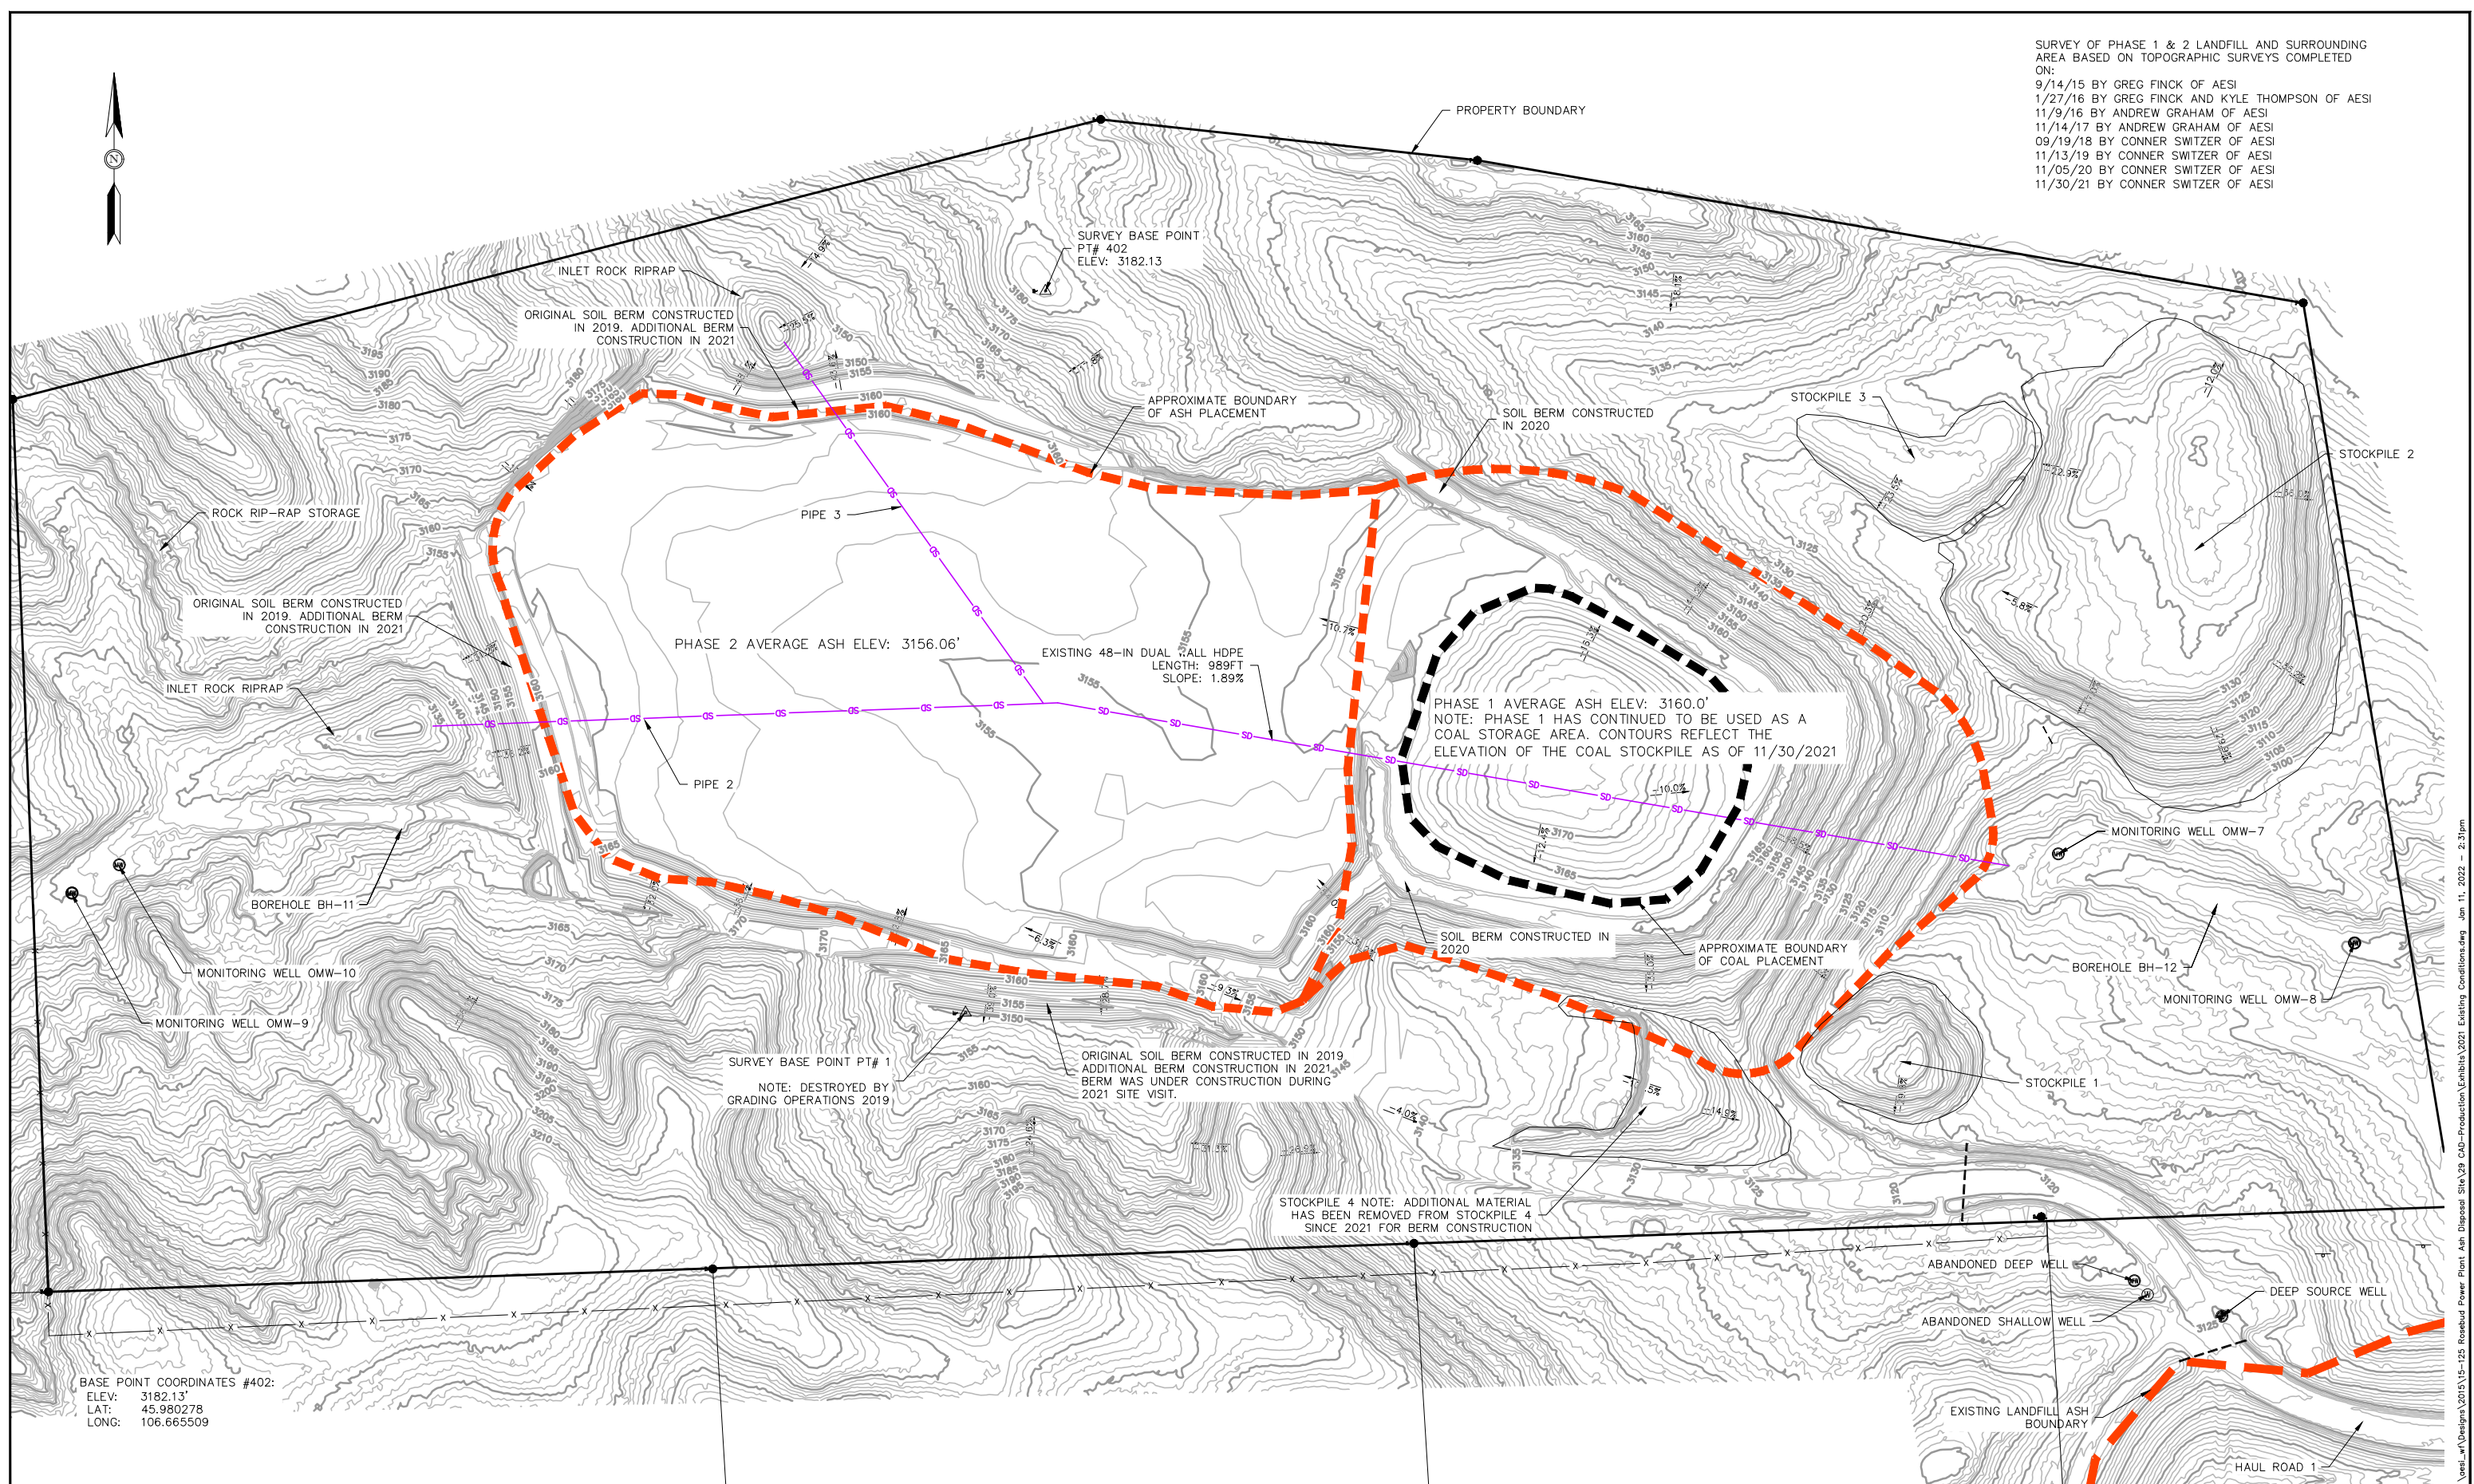
PROJECT #: 15-125	FIGURE 1
DATE: 1/4/2022	
ACTIVE LANDFILL

The geometry of the landfill is actively changing as CCR is placed in lifts and hydrated. The attached as-built survey sheets depict the topography of the ash surface as of November 30, 2021. The elevation of the ash placed in Phase 2 has risen an average of 4.2-ft since the last as-built survey on November 5, 2020. The general shape of Phase 2 is a depression which captures precipitation within the ash footprint and surrounding soil berms. The average ash elevation of Phase 1 remains the same as the previous year(s) (2018-2020) at 3160-FT. Phase 1 has been used as a coal storage area since 2018 and currently has about 12.5-FT of coal. Phase 2 has an average ash elevation of 3156-FT. A total of 80,160-CY of ash was placed in Phases 2 between as-built surveys. During this same time-frame, approximately 116.5 CY of ash was sold and not placed in the landfill area.

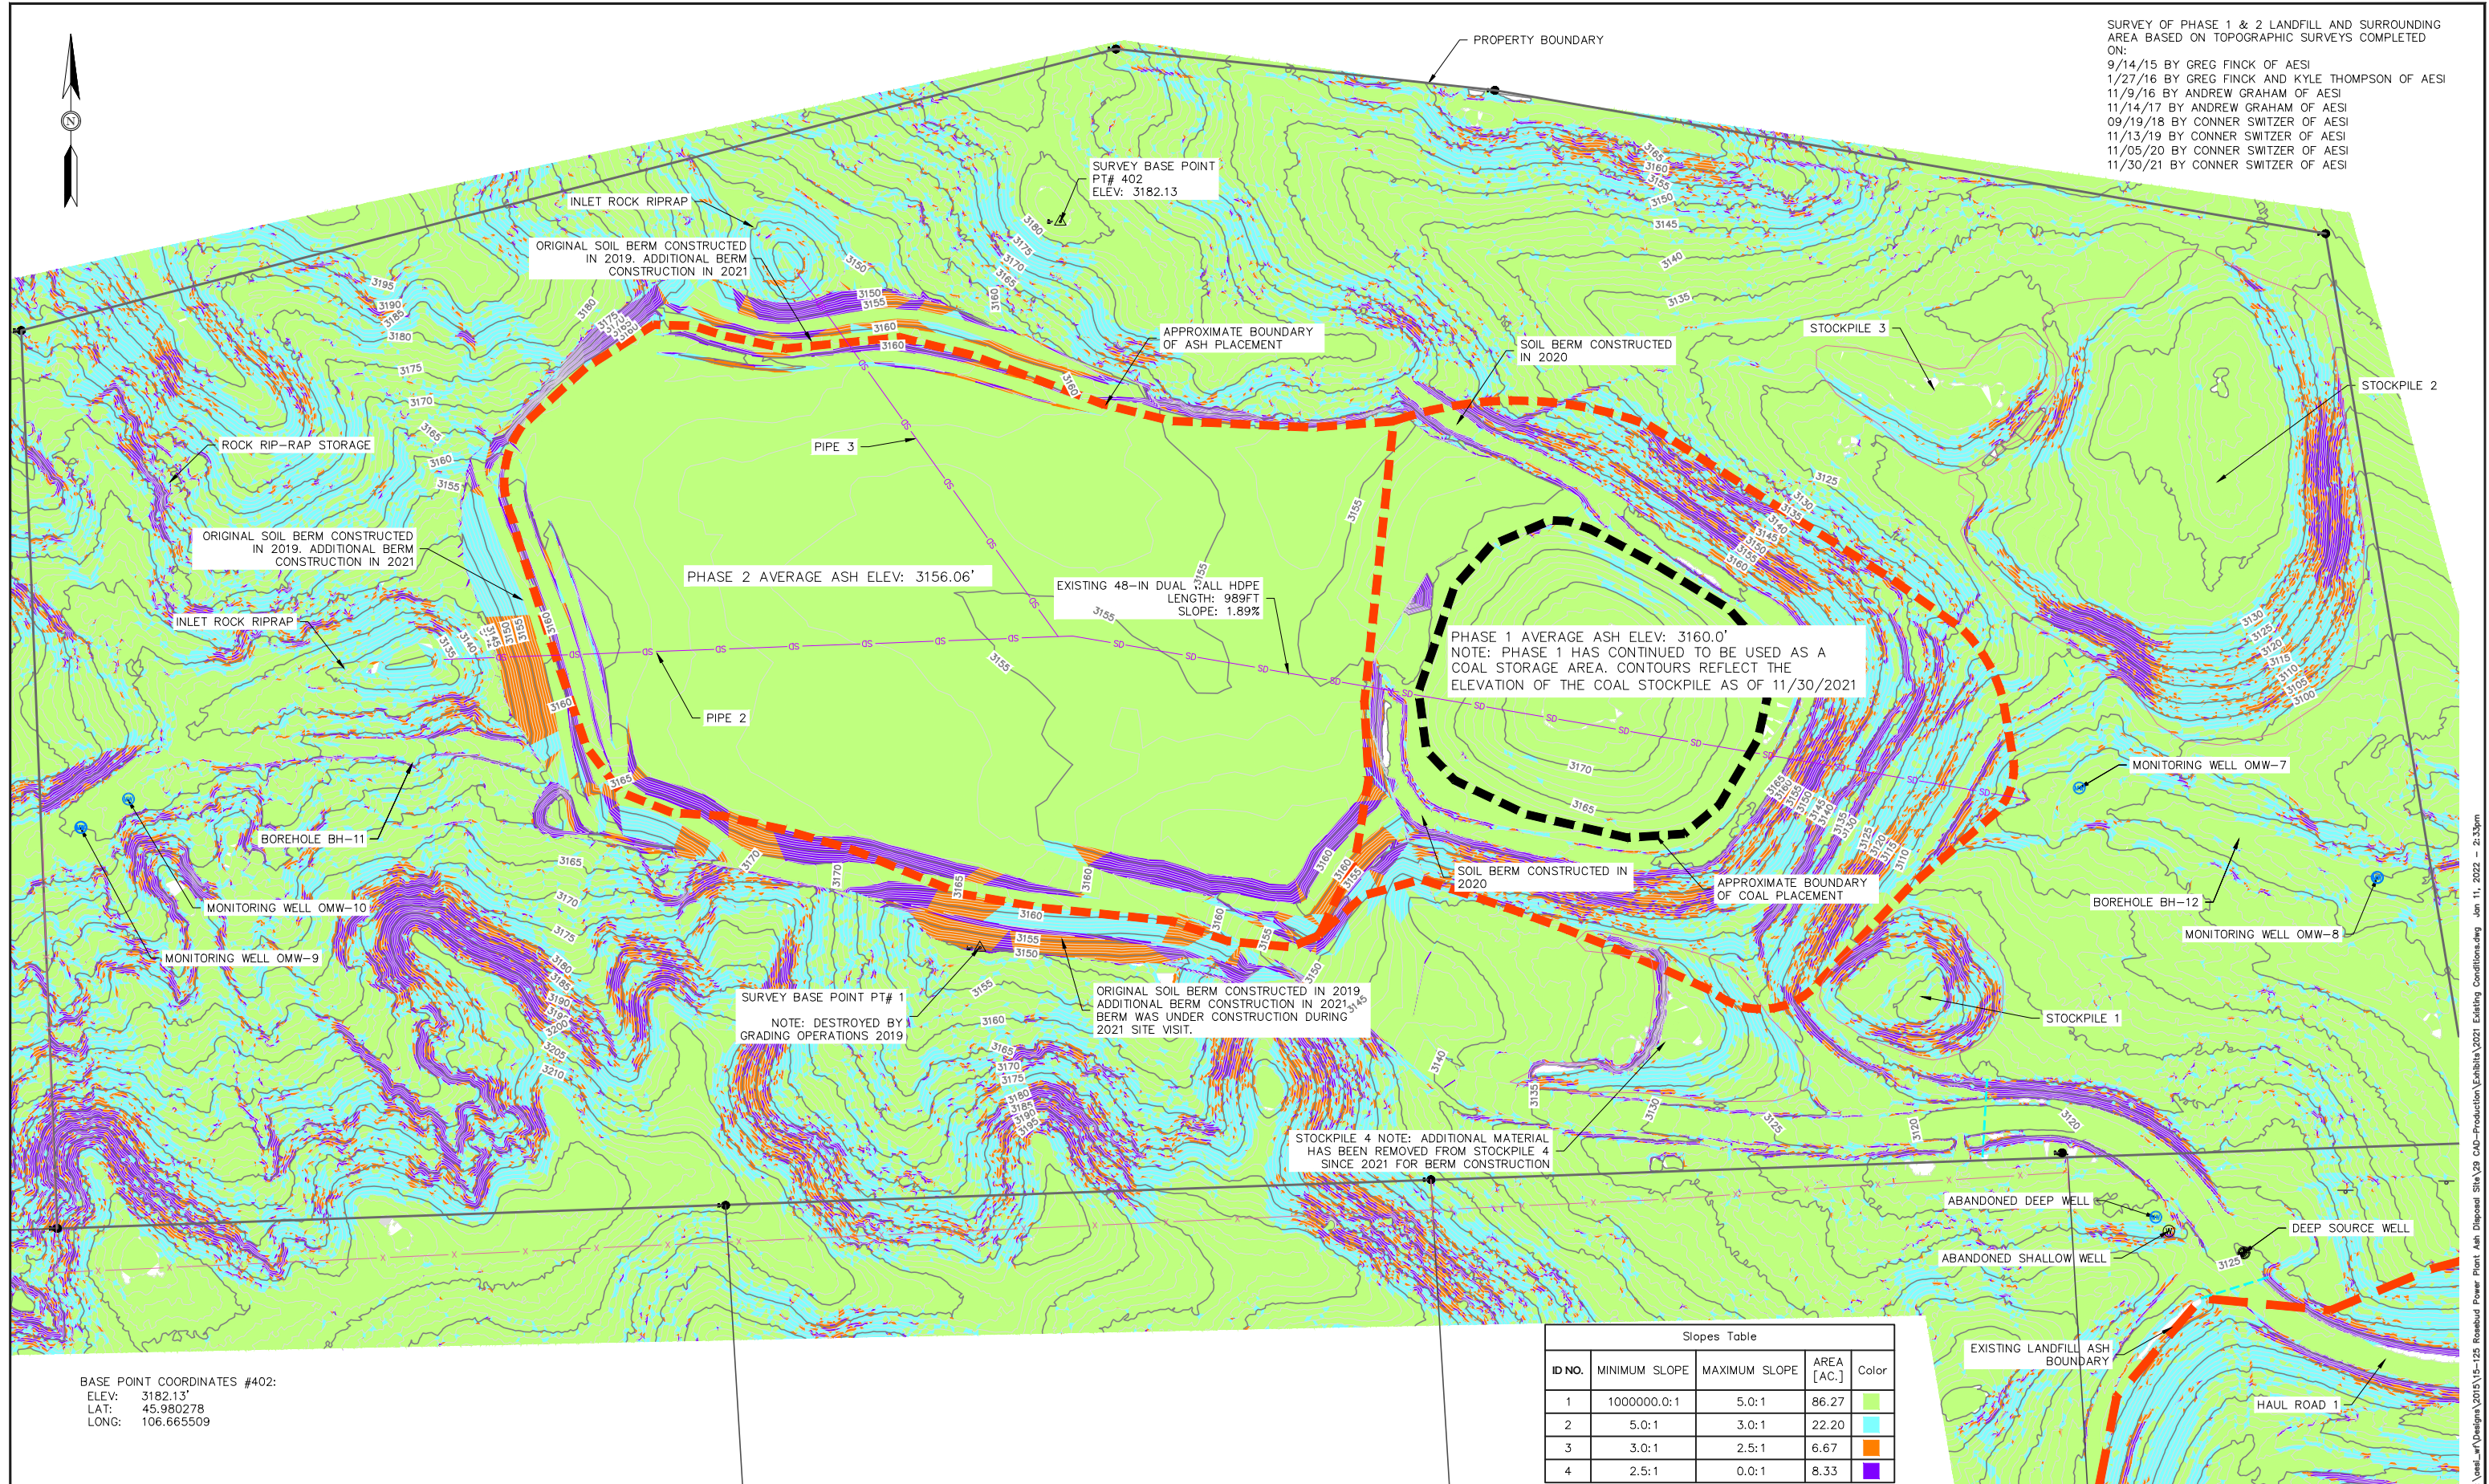
PROJECT #: 15-125	FIGURE
DATE: 1/4/2022	3
ACTIVE LANDFILL

1. Grade outward facing slopes on most recent berm construction (2021 and future) to insure a 3:1 side slope or flatter geometry. Any existing or future finished slopes steeper than 3H:1V will require flattening from the bottom (i.e. additional fill placement) during final closure. Avoiding exterior slopes/berms steeper than 3H:1V is efficient with respect to total earthwork and re-vegetation. Existing areas steeper than 3H:1V are shown in red and purple in Sheet 3.

4. Continue periodic maintenance grading to flatten all slopes steeper than 3H:1V (See Slope Figure).
5. Continue periodic maintenance grading to fix erosion that may be occurring on finished areas to prevent ash from being exposed.
