Rosebud Power Plant 2022 Annual Engineer's Inspection Report

Prepared for Rosebud Operating Services, Inc.
by Allied Engineering Services, Inc.
2022 Report
Posted: January 13, 2023
Project: 15-125

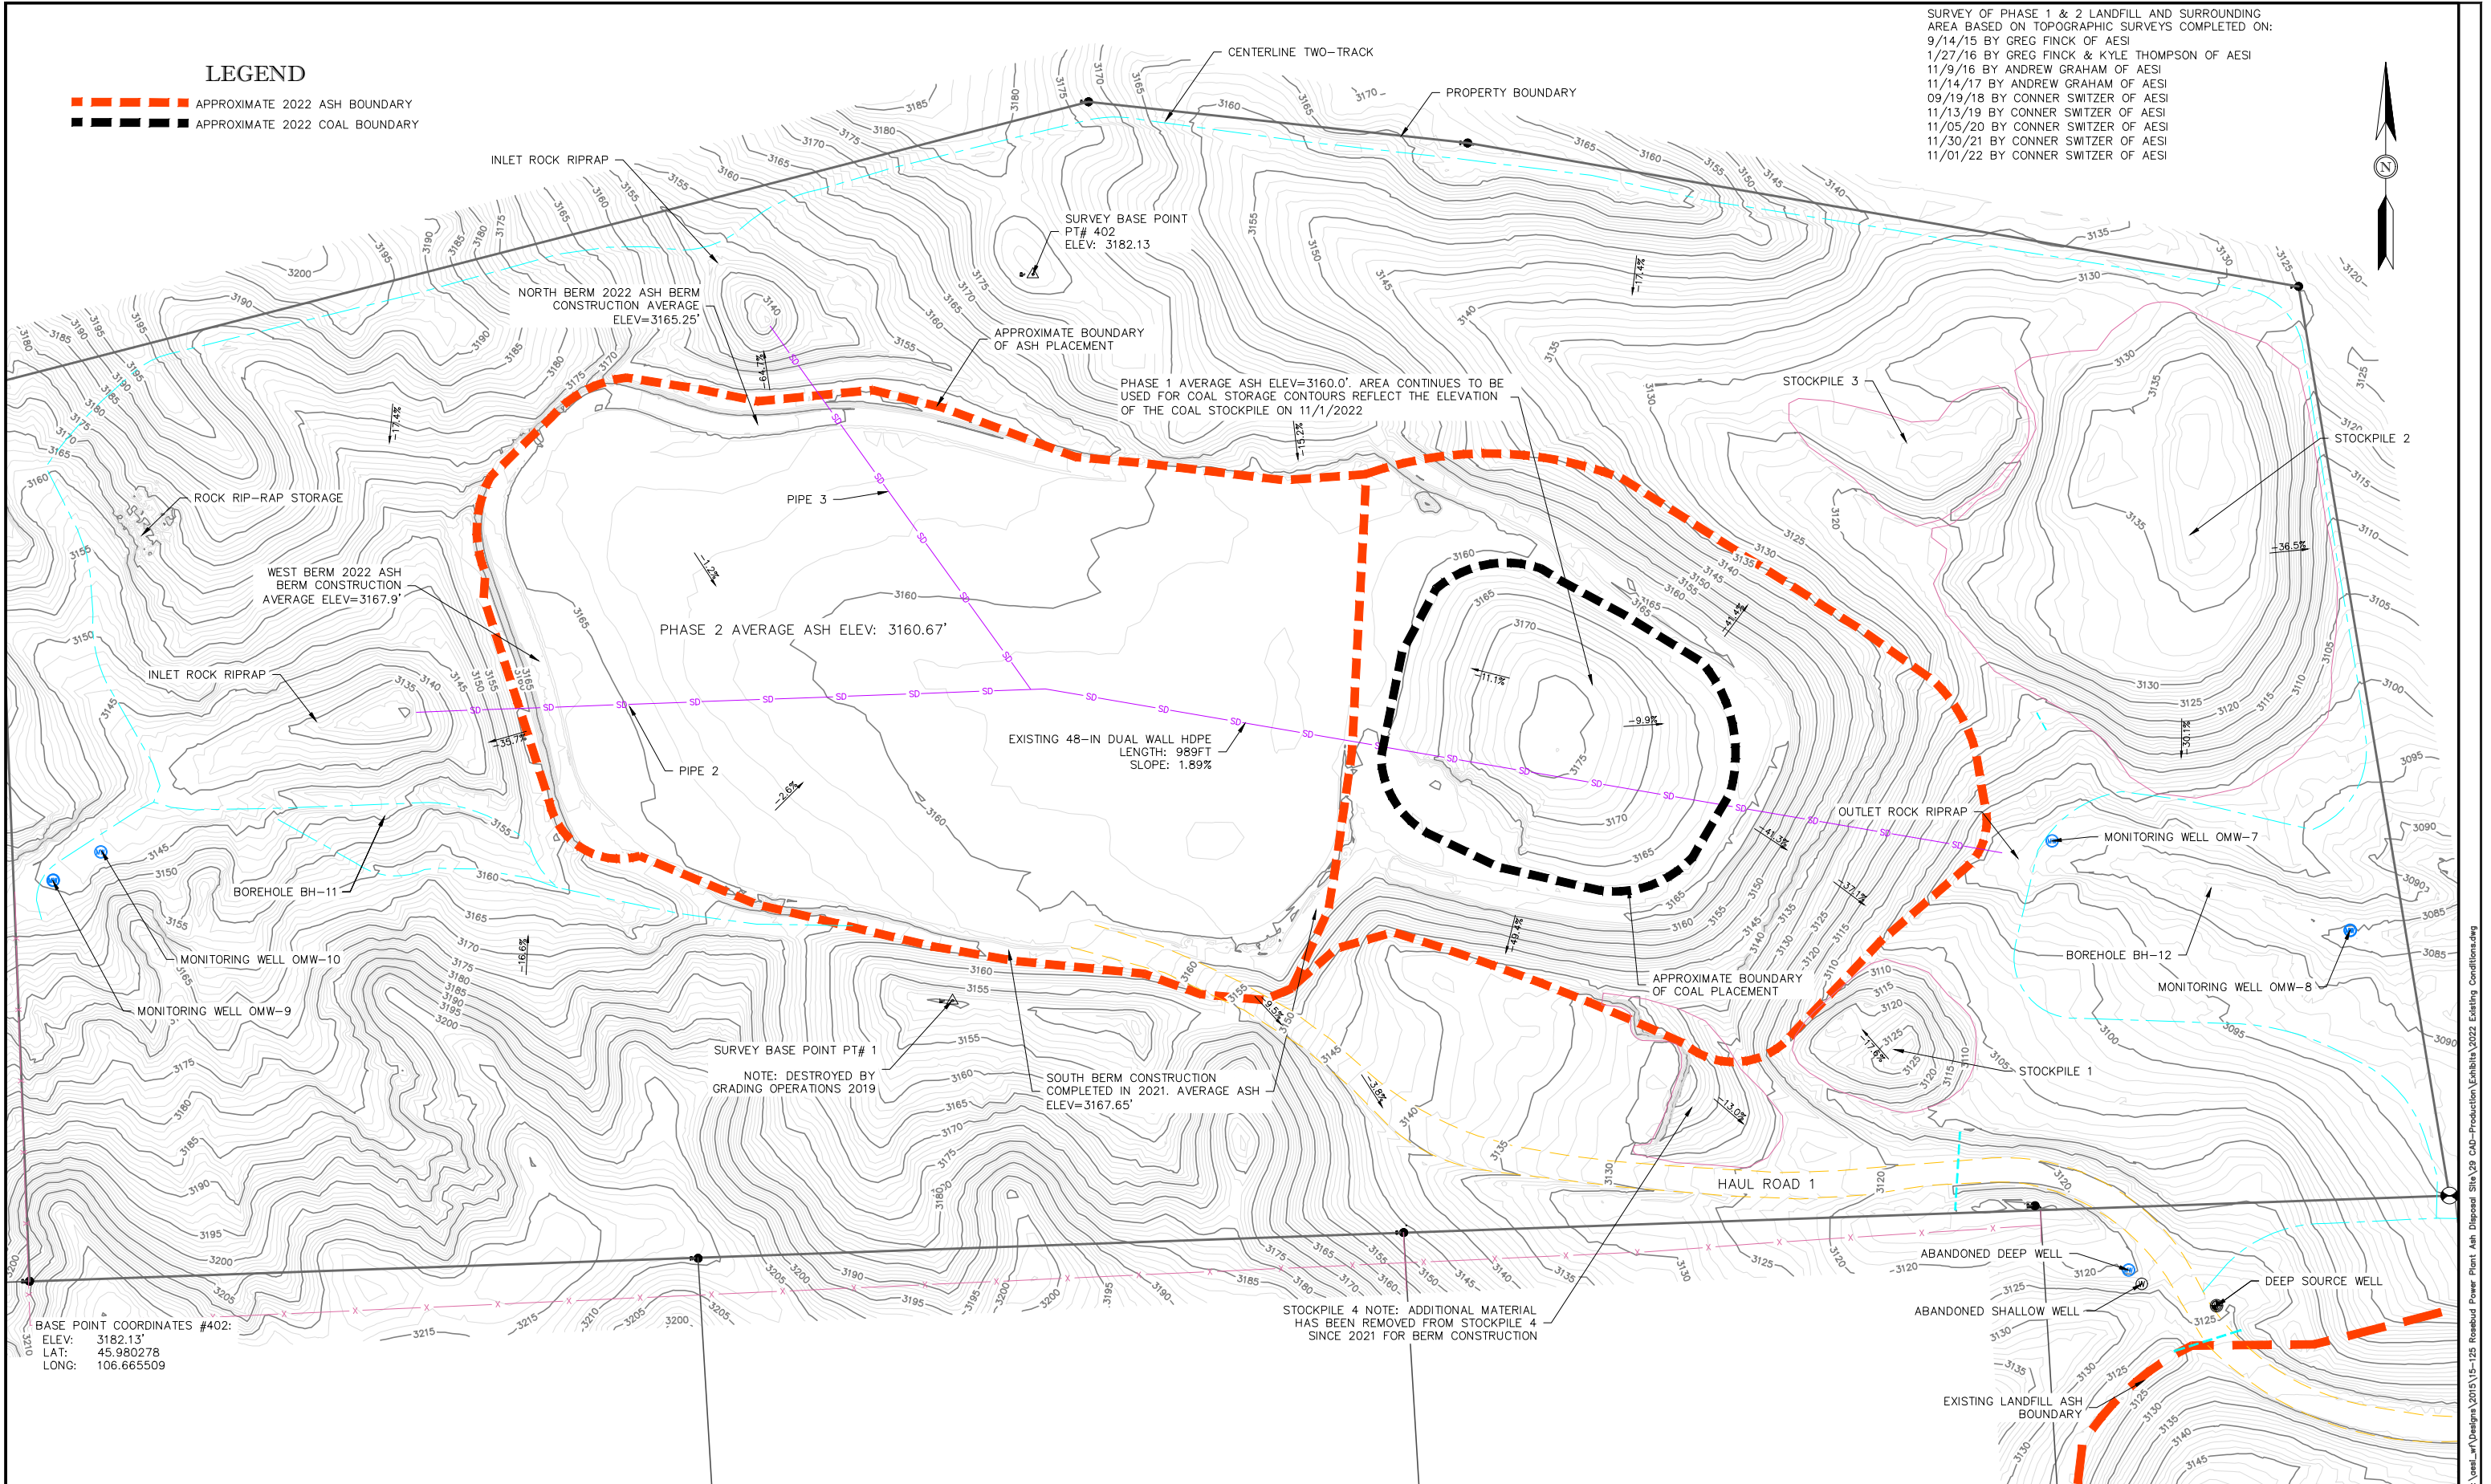
SHEET
1

The geometry of the landfill is actively changing as CCR is placed in lifts and hydrated. The attached as-built survey sheets depict the topography of the ash surface as of November 1, 2022. The elevation of the ash placed in Phase 2 has risen an average of 4.6-ft since the last as-built survey on November 30, 2021. The general shape of Phase 2 is a depression which captures precipitation within the ash footprint and surrounding soil berms. The average ash elevation of Phase 1 remains the same as the previous year(s) (2018-2021) at 3160-FT. Phase 1 has been used as a coal storage area since 2018 and currently has about 15.5-FT of coal. Phase 2 has an average ash elevation of 3160.67-FT. A total of 75,823-CY of ash was placed in Phase 2 between as-built surveys. During this same timeframe, approximately 149 CY of ash was sold and not placed in the landfill area.

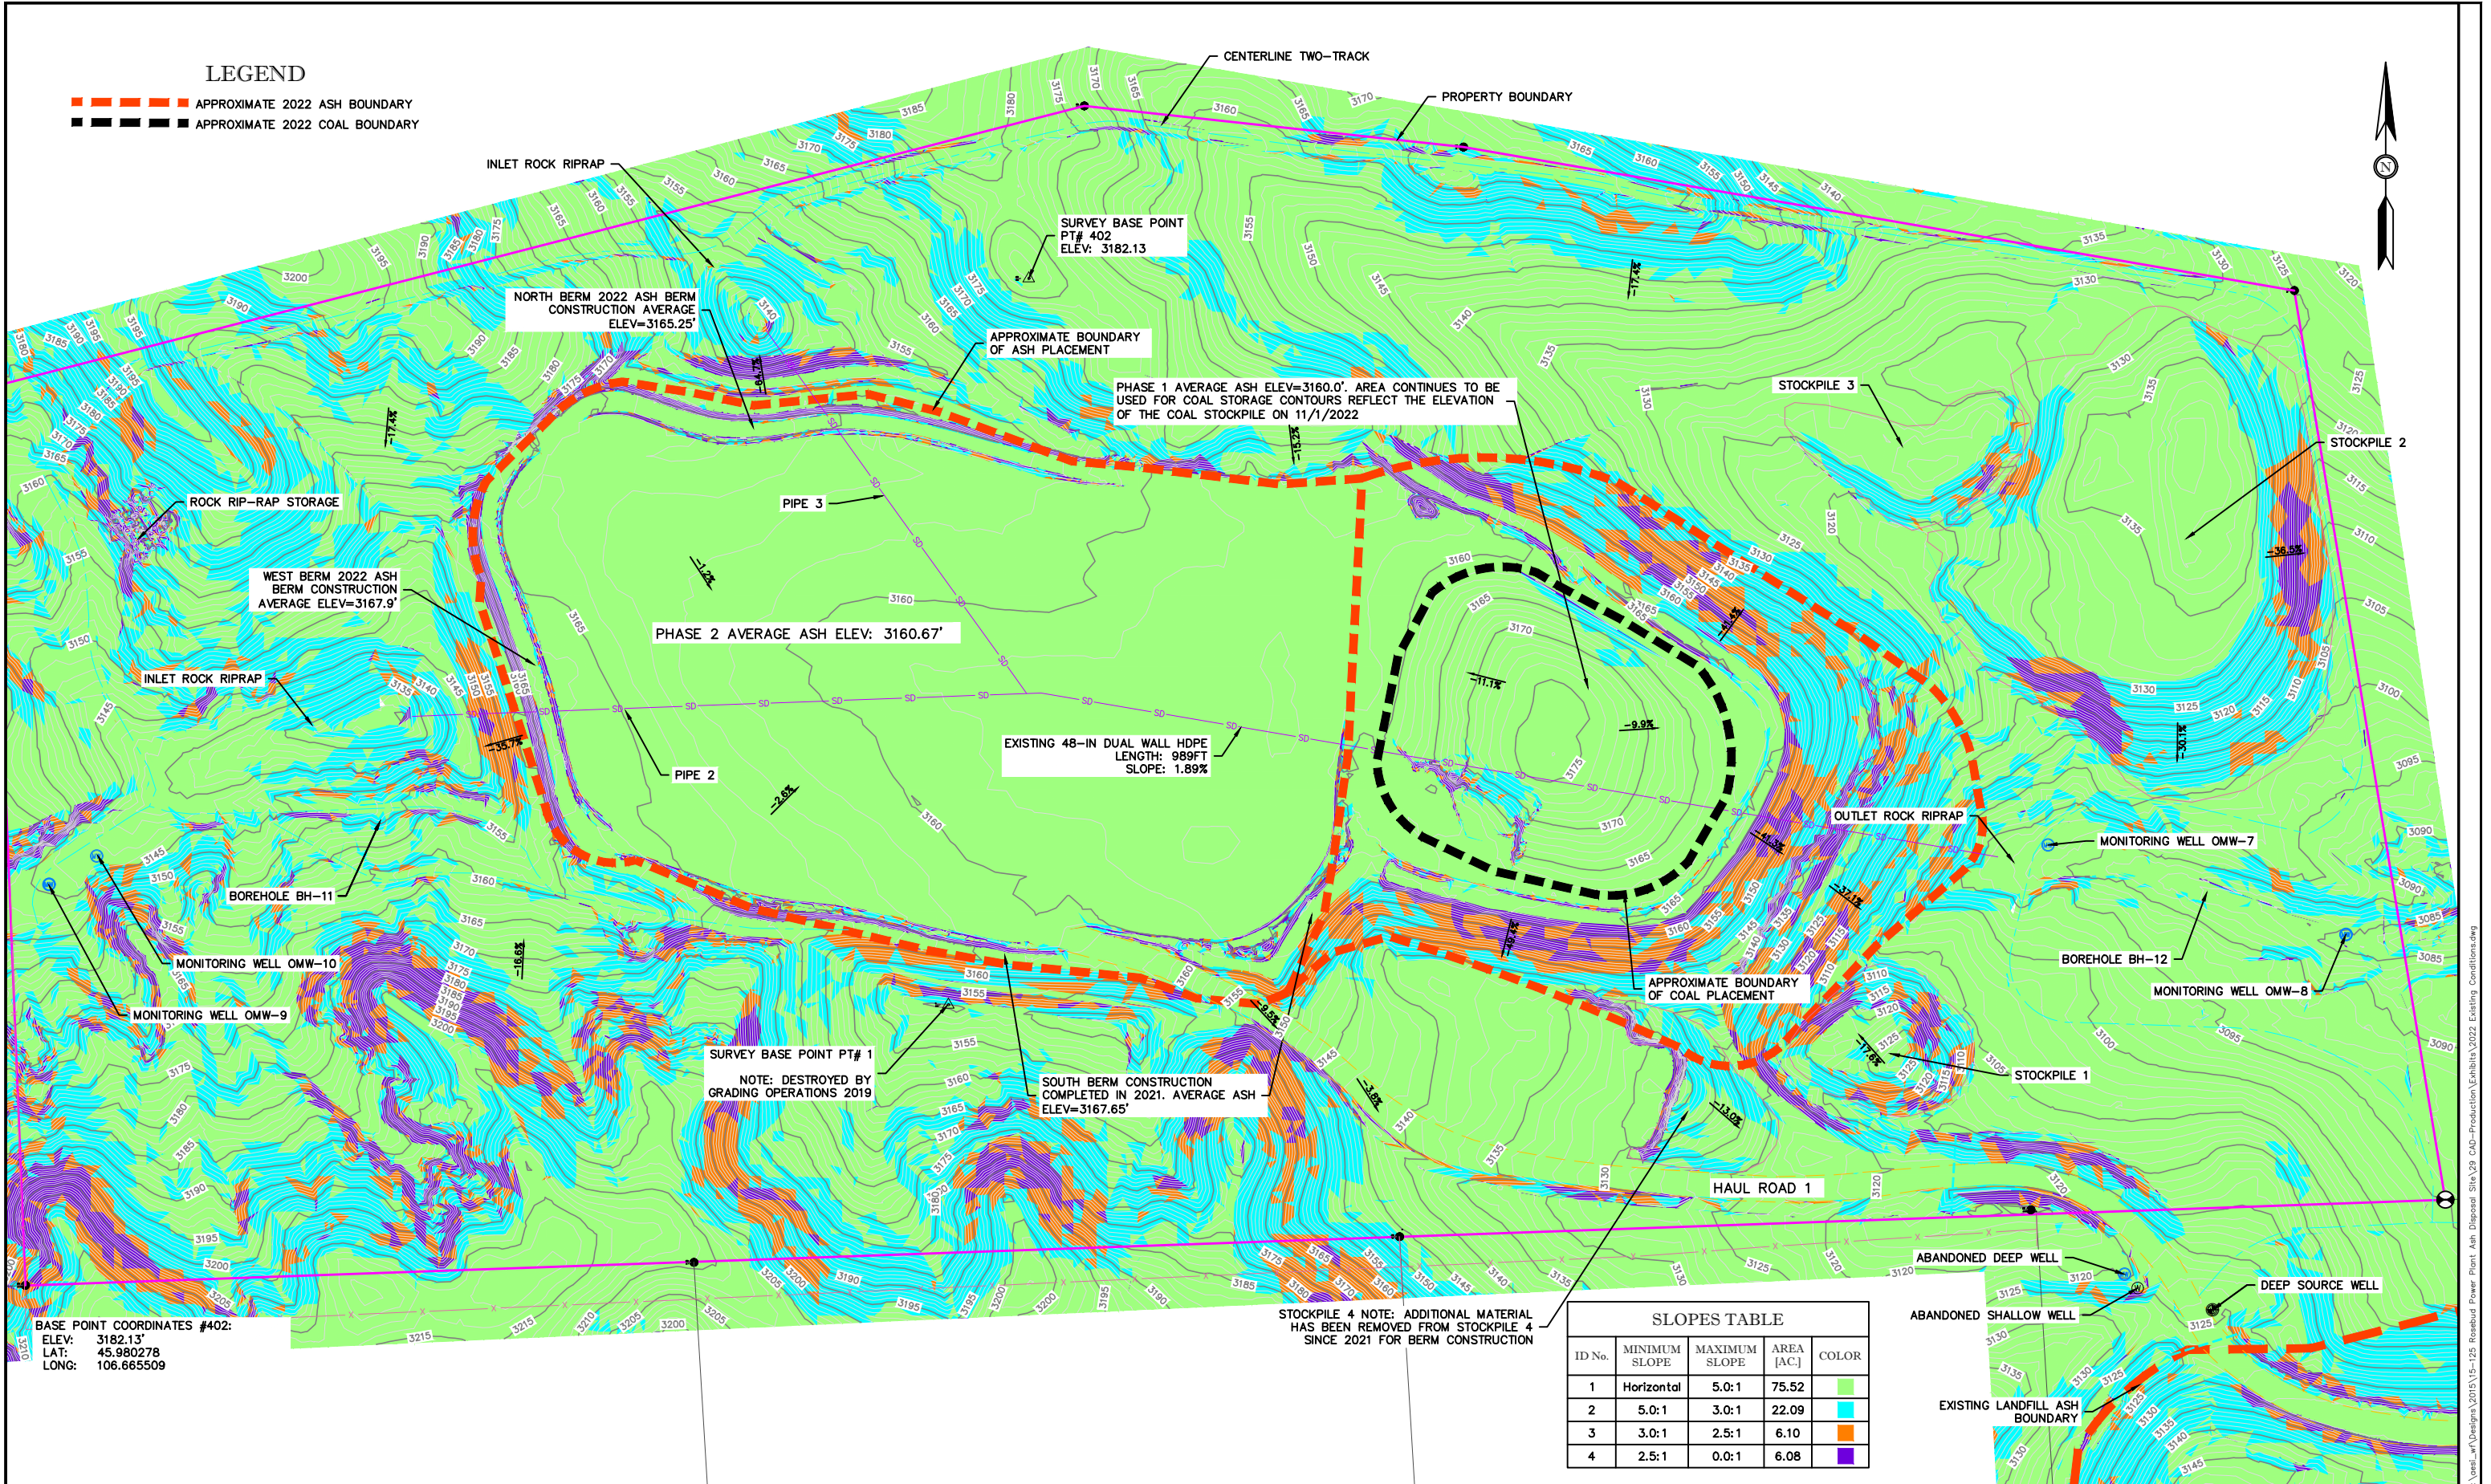
PROJECT #: 15-125	SHEET
DATE: 1/9/2023	3
ACTIVE LANDFILL SLOPES

1. Grade outward facing slopes on most recent berm construction (2023 and future) to insure a 3:1 side slope or flatter geometry. Any existing or future finished slopes steeper than 3H:1V will require flattening from the bottom (i.e., additional fill placement) during final closure. Avoiding exterior slopes/berms steeper than 3H:1V is efficient with respect to total earthwork and re-vegetation. Existing areas steeper than 3H:1V are shown in red and purple in Sheet 3.

4. Continue periodic maintenance grading to flatten all slopes steeper than 3H:1V (See Slope Figure).
5. Continue periodic maintenance grading to fix erosion that may be occurring on finished areas to prevent ash from being exposed.
