Rosebud Power Plant 2023 Annual Engineer's Inspection Report

Prepared for Rosebud Operating Services, Inc.
by Allied Engineering Services, Inc.
2023 Report
Posted: January 15, 2024
Project: 15-125

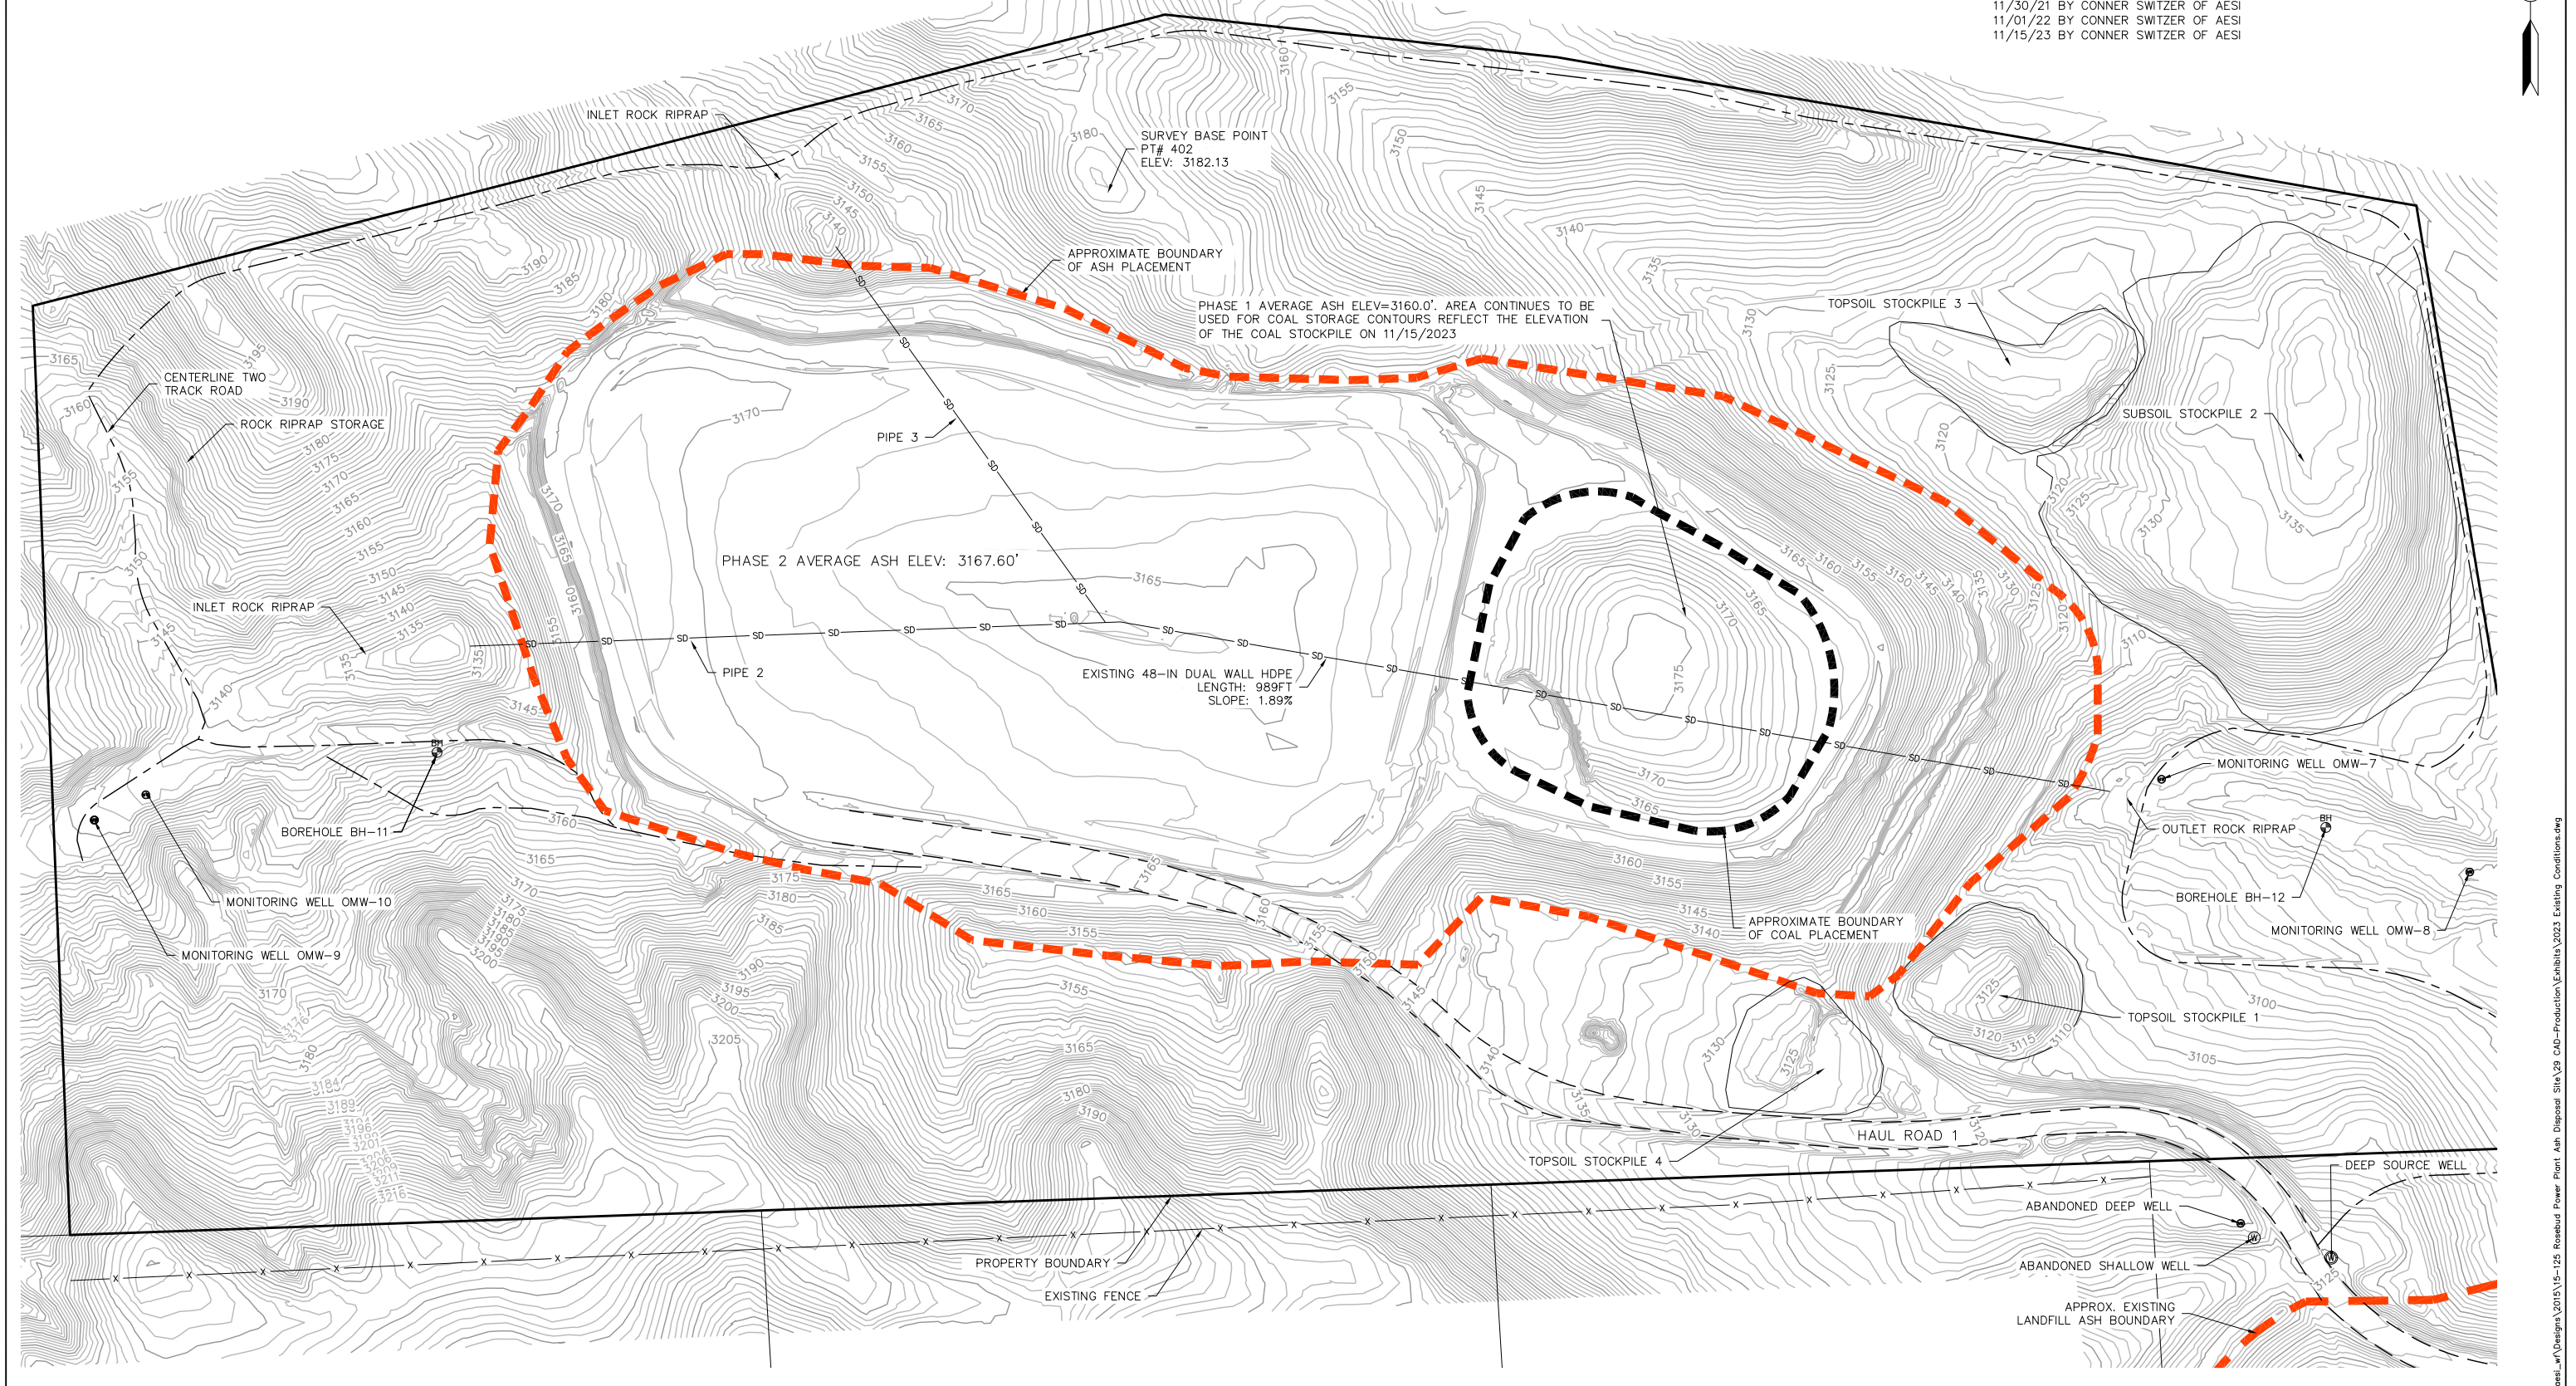
**ROSEBUD SURVEY FIGURE
 2023 ACTIVE LANDFILL (AS-BUILT)
 ROSEBUD COUNTY, MT**

The attached as-built survey sheets depict the topography of the ash surface as of November 15, 2023. The elevation of the ash placed in Phase 2 has risen an average of 6.4-ft since the last as-built survey on November 15, 2023. The general shape of Phase 2 is a depression which captures precipitation within the ash footprint. The average ash elevation of Phase 1 remains the same as the previous years (2018-2022) at 3160-FT. Phase 1 has been used as a coal storage area since 2018 and currently has about 15.5-FT of coal. Phase 2 has an average ash elevation of 3167.6-FT. A total of 106,797-CY of ash was placed in Phase 2 between as-built surveys (11/1/2022 – 11/15/2023). During this same timeframe, approximately 63.6 CY of ash was sold and not placed in the landfill area.

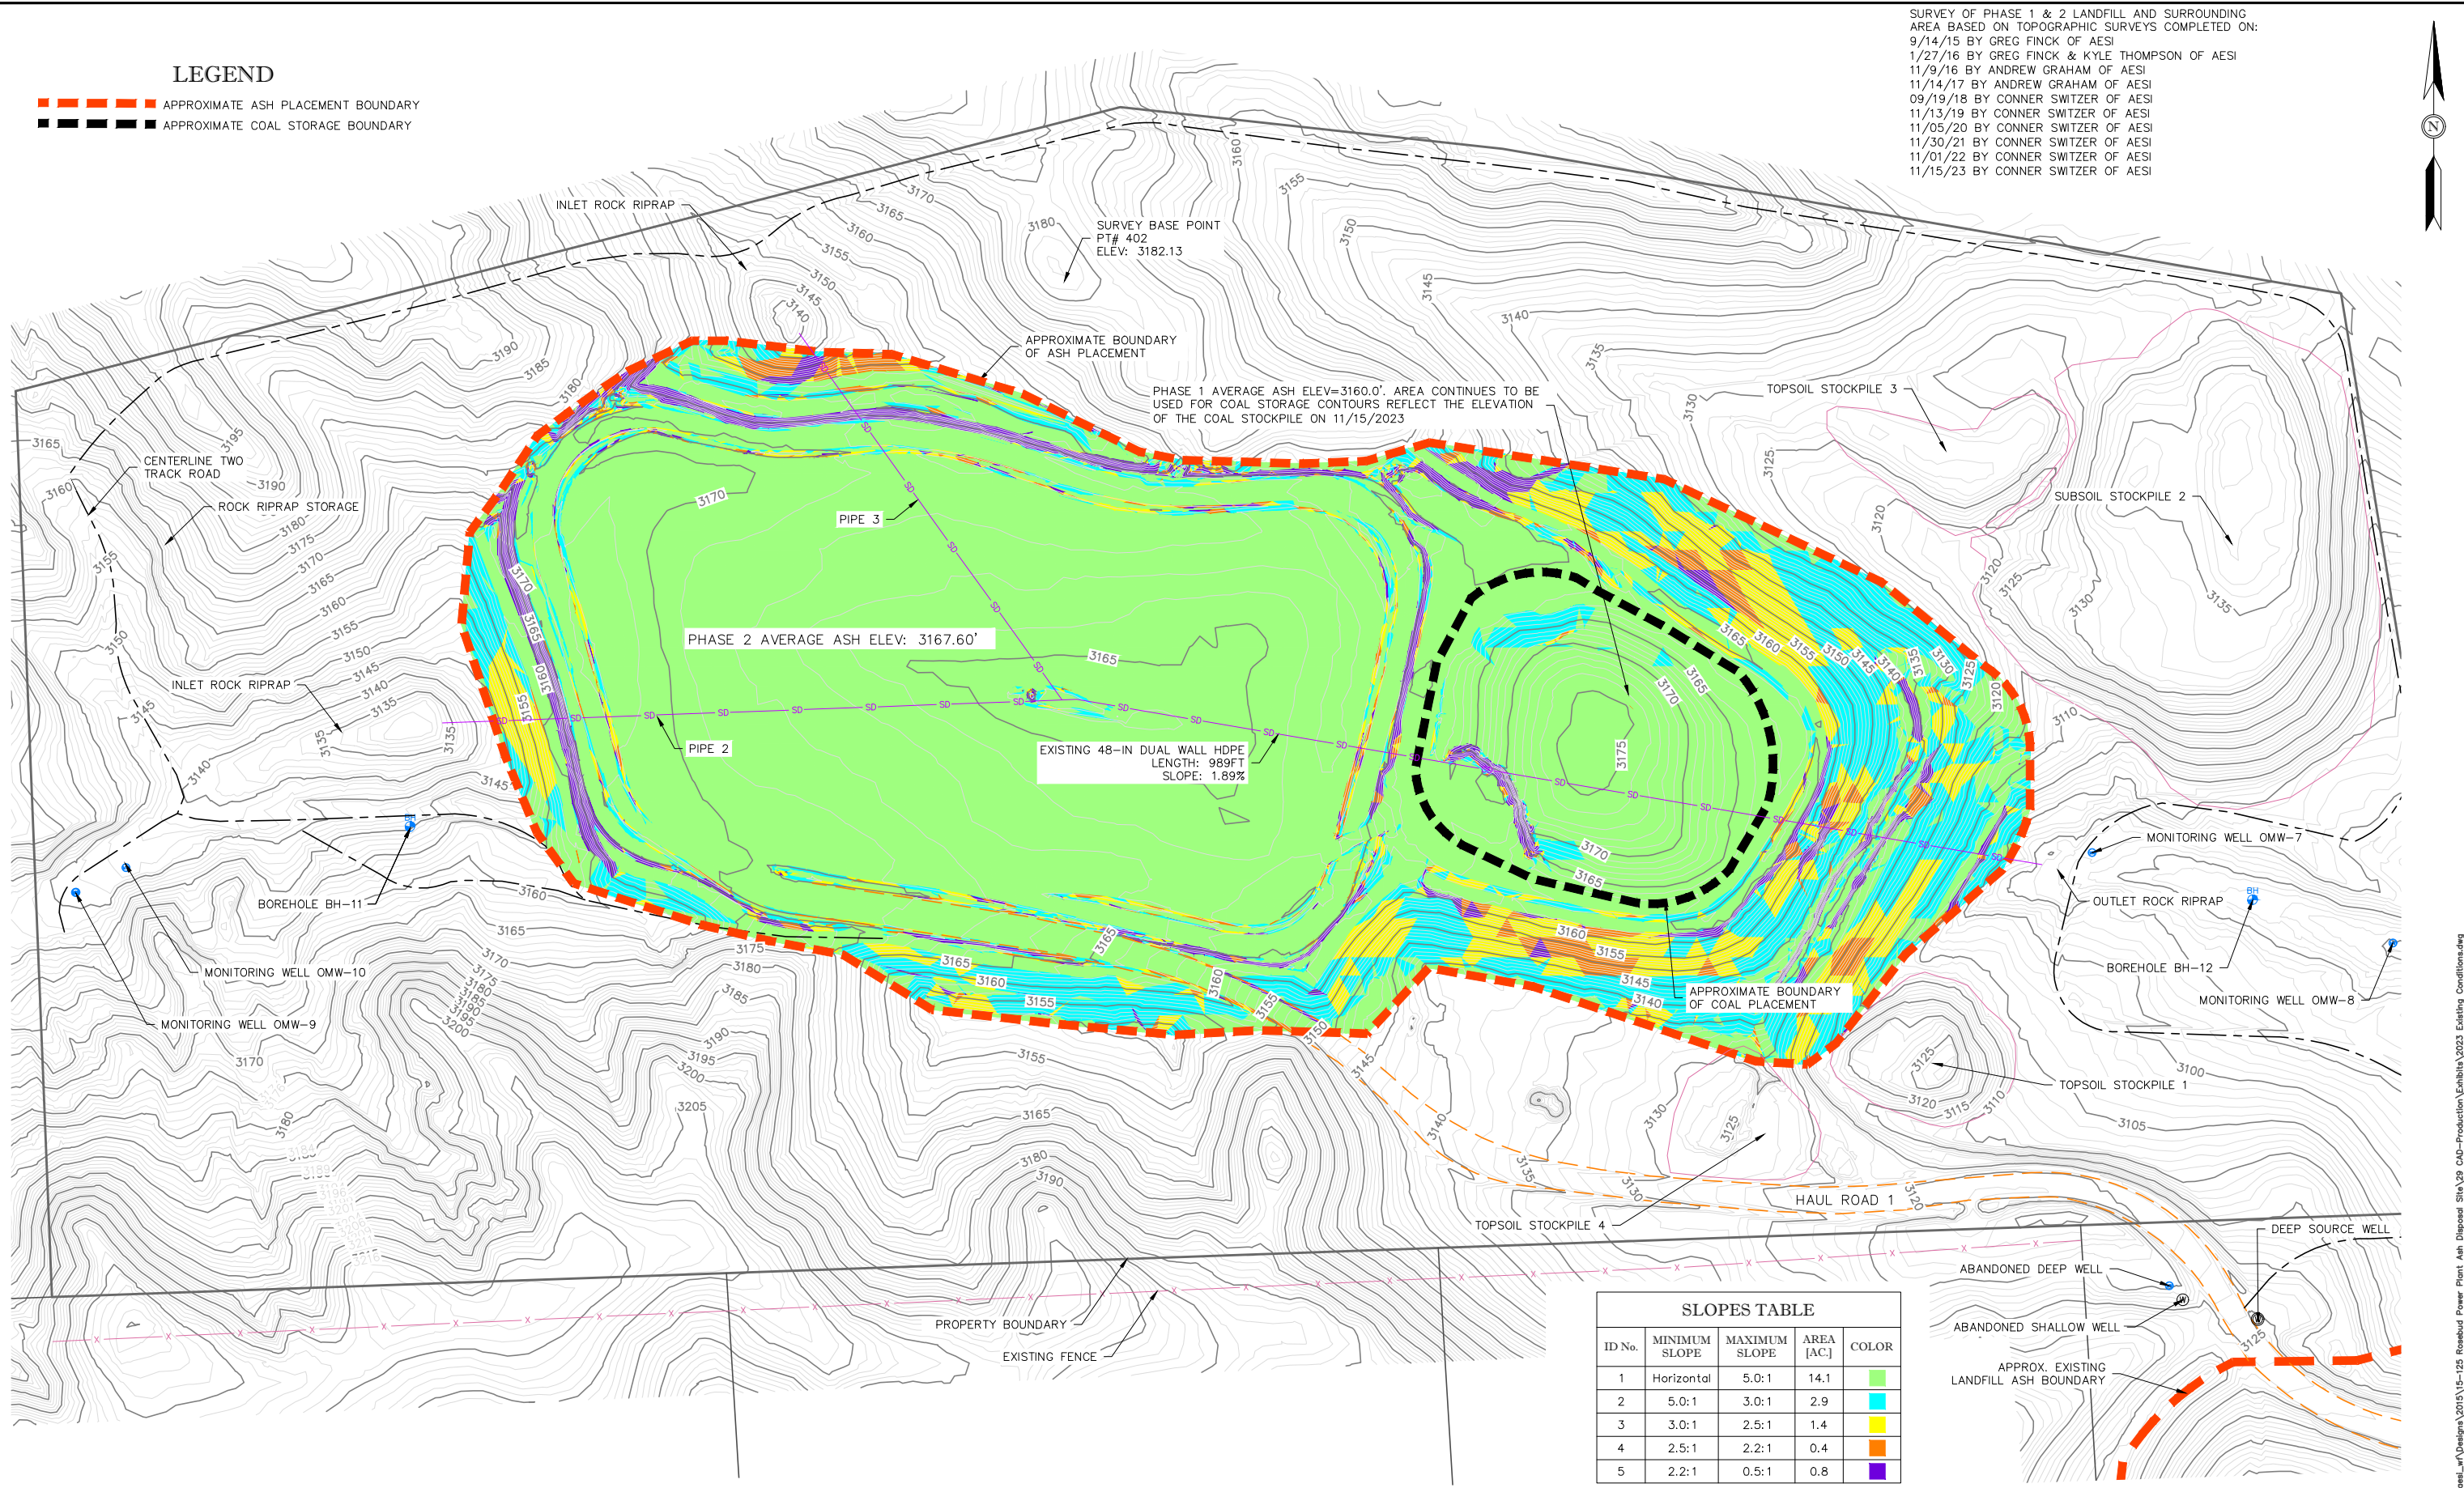
ROSEBUD SURVEY FIGURE
2023 ACTIVE LANDFILL (SLOPES)
ROSEBUD COUNTY, MT

1. Grade outward facing slopes for berm construction (2024 and future) to insure a 3H:1V side slope or flatter geometry. Any existing (2023 or earlier) or future finished slopes steeper than 3H:1V will require flattening from the bottom (i.e., additional fill placement) during final closure. See the attached Slope Figure for existing slopes. Note, areas that are orange and purple represent slopes steeper than 3H:1V.

5. Perform grading to flatten all slopes steeper than 3H:1V (See Slope Figure).
6. Perform grading to repair erosion that may be occurring on finished areas to prevent ash from being exposed.
