# Rosebud Power Plant 2024 Annual Engineer's Inspection Report

Prepared for Rosebud Operating Services, Inc. by Allied Engineering Services, Inc. 2024 Report Posted: January 15, 2025

Project #: 15-125

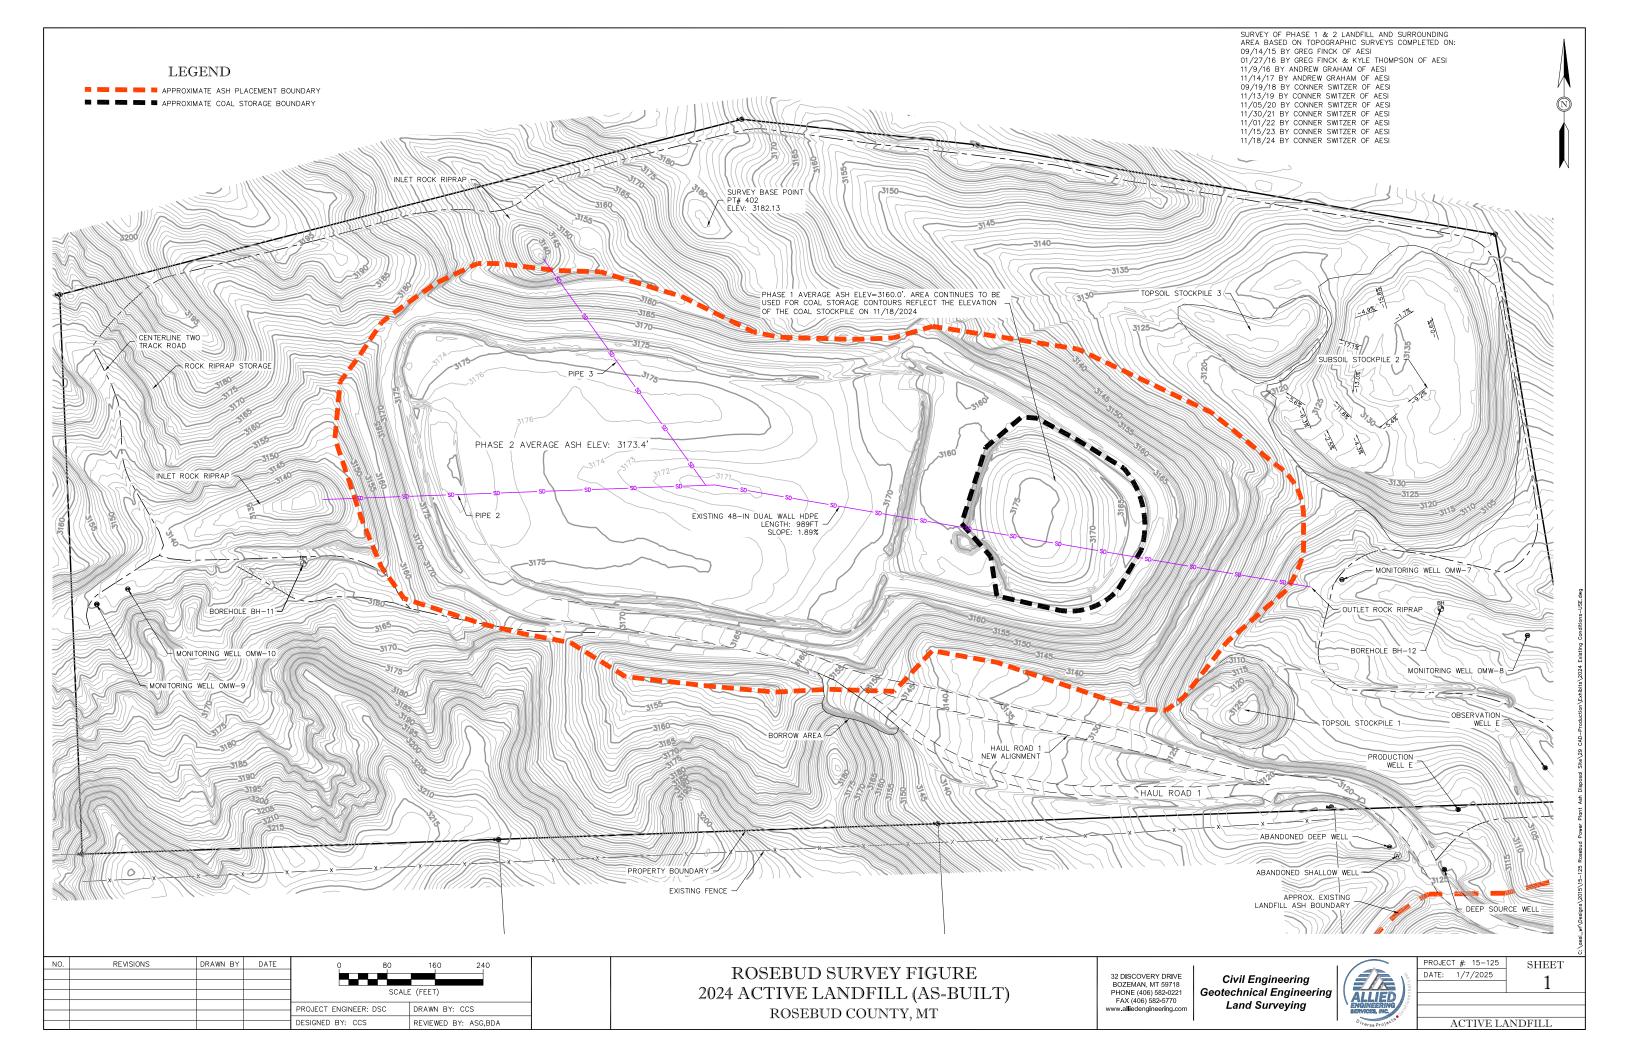
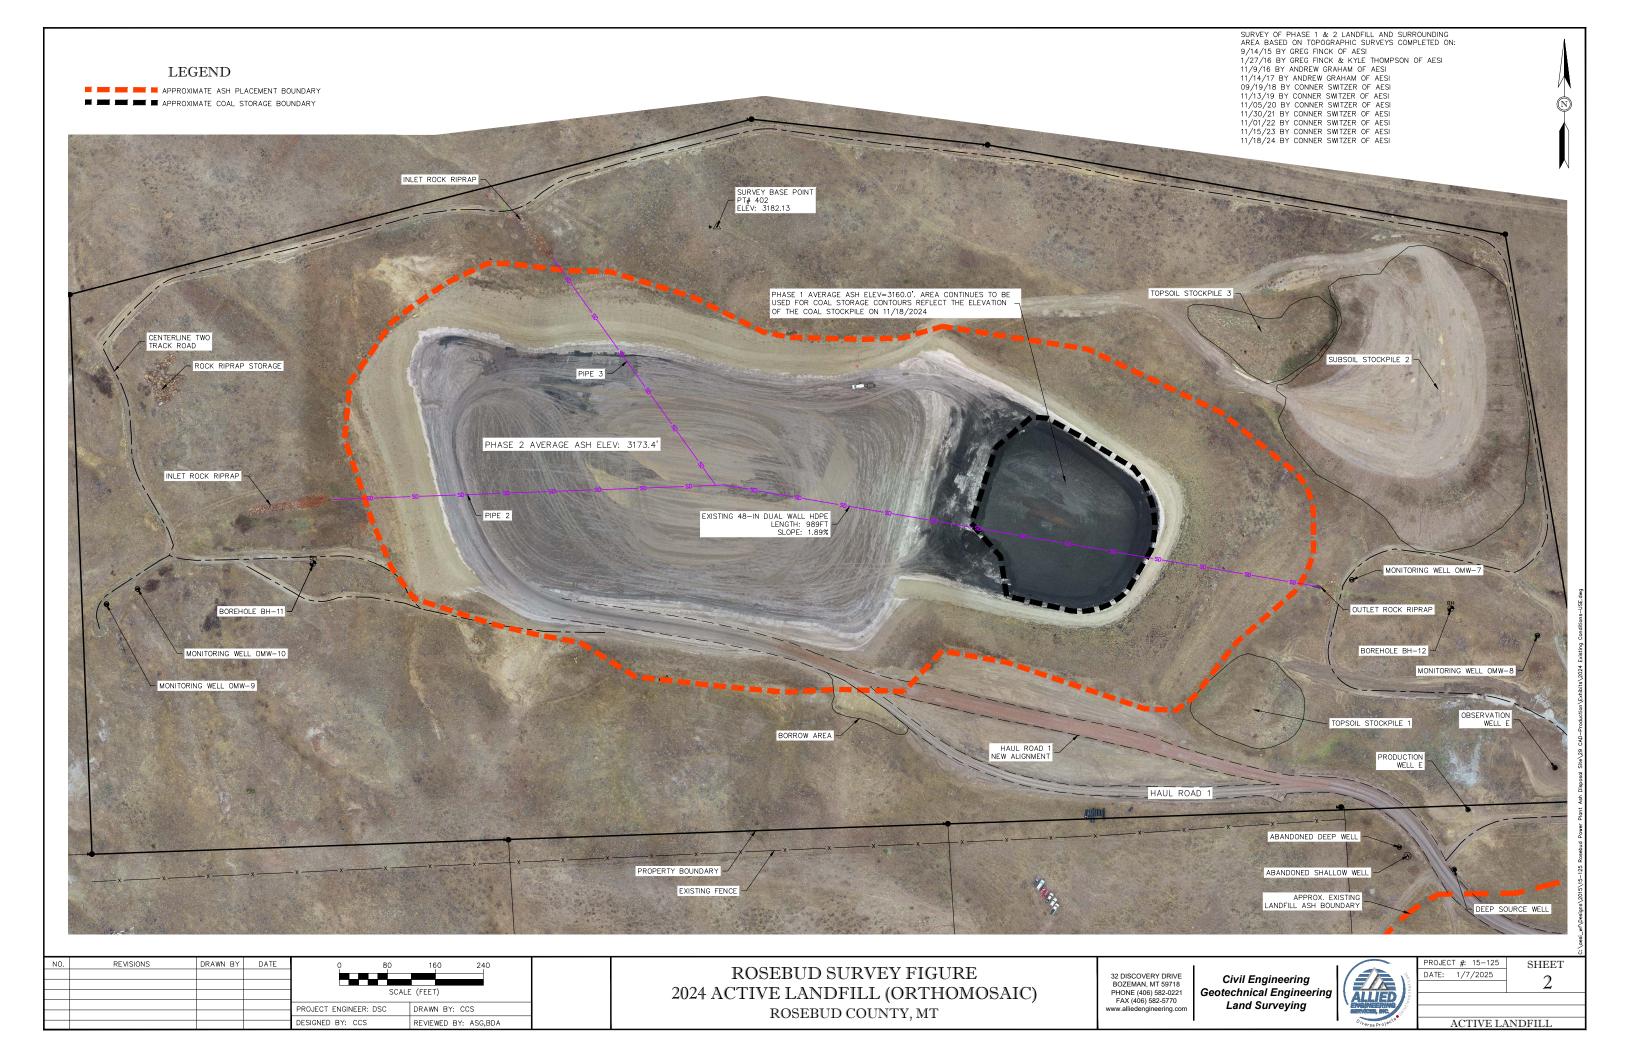
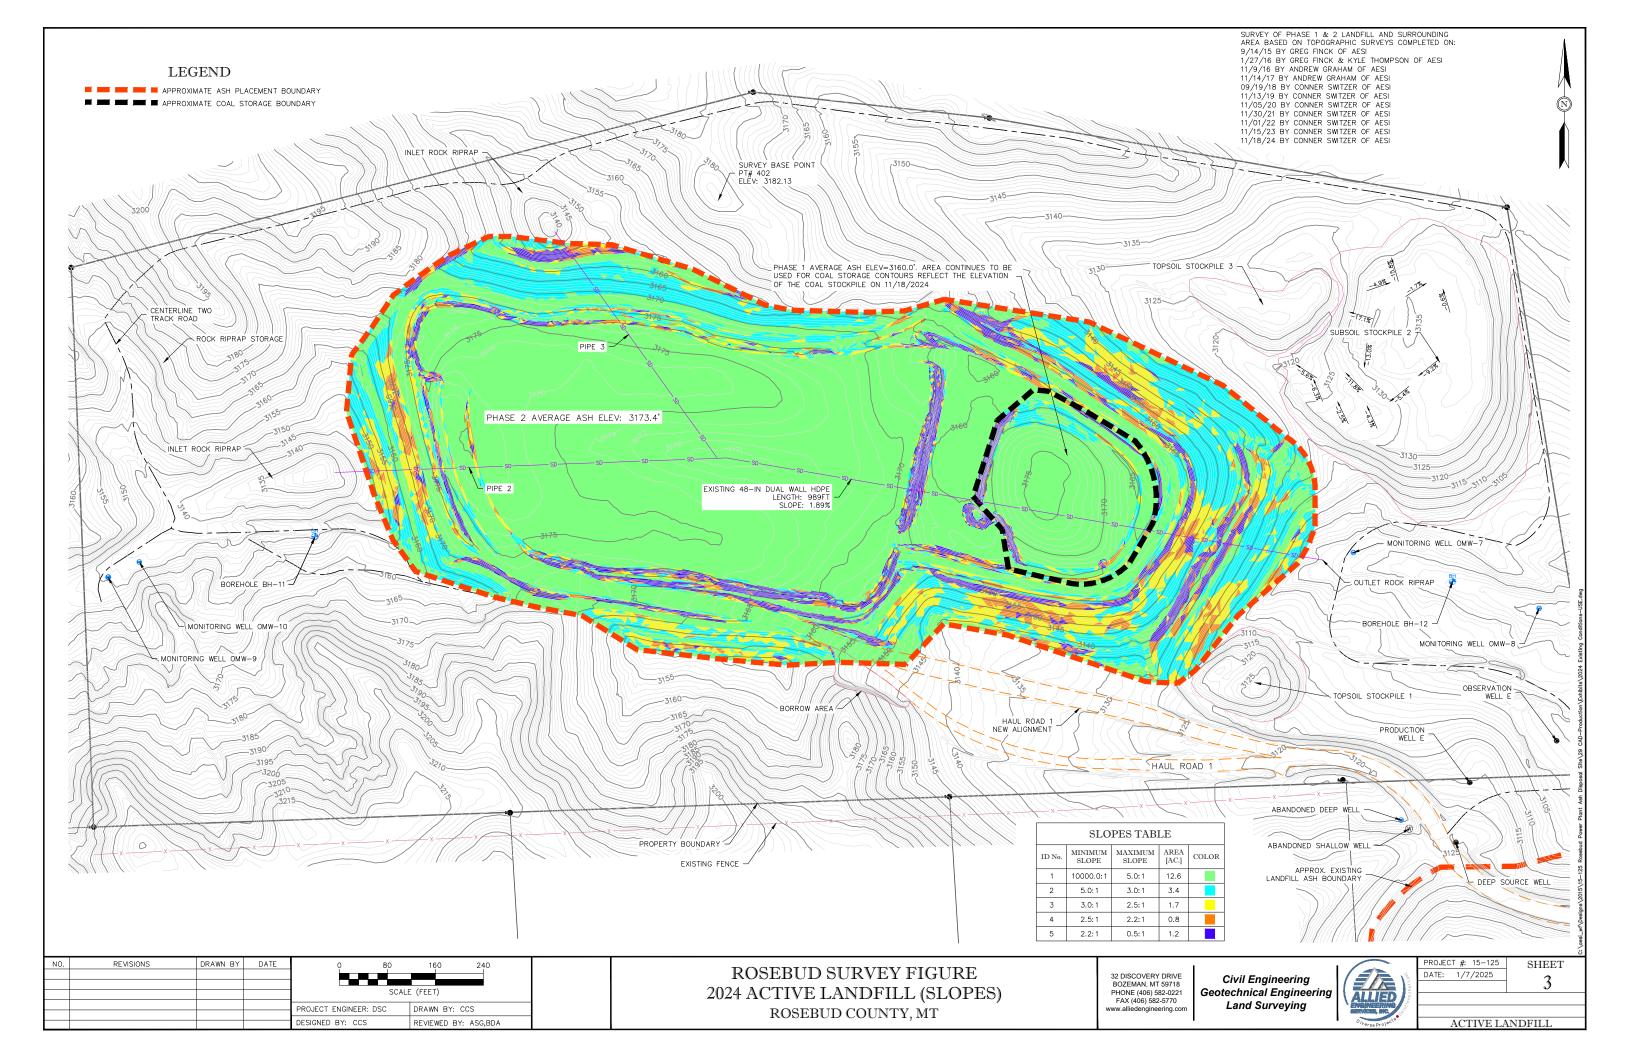
## Appendix A: Existing Conditions Survey, Orthomosaic, & Slopes Figures

The attached as-built survey sheets depict the topography of the ash surface as of November 18, 2024. The elevation of the ash placed in Phase 2 has risen an average of 5.8-ft since the last as-built survey on November 15, 2023. The general shape of Phase 2 is a depression which captures precipitation within the ash footprint. The average ash elevation of Phase 1 remains the same as the previous years (2018-2022) at 3160-FT. Phase 1 has been used as a coal storage area since 2018 and currently has about 15.5 feet of coal. Phase 2 has an average ash elevation of 3173.4-FT. A total of 86,847 CY of ash was placed in Phase 2 between as-built surveys (11/15/2023 – 11/18/2024). During this same timeframe, approximately 814 CY of ash was sold and not placed in the landfill area.

- Continue grading outward facing slopes for berm construction (2025 and future) to ensure a 3H:1V side slope or flatter geometry. Any existing (2024 or earlier) or future finished slopes steeper than 3H:1V will require flattening from the bottom (i.e., additional fill placement) during final closure. See the attached Slope Figure for existing slopes. Note, areas that are orange and purple represent slopes steeper than 3H:1V.
