**Placentia-Yorba Linda
Unified School District**

ADDENDUM NUMBER 1 (75 pages)

BID NUMBER 226-16
Golden and Fairmont TK Restroom Additions
BID DUE DATE: June 09, 2026, 11:00:00 A.M.

Asbestos Inspection Report

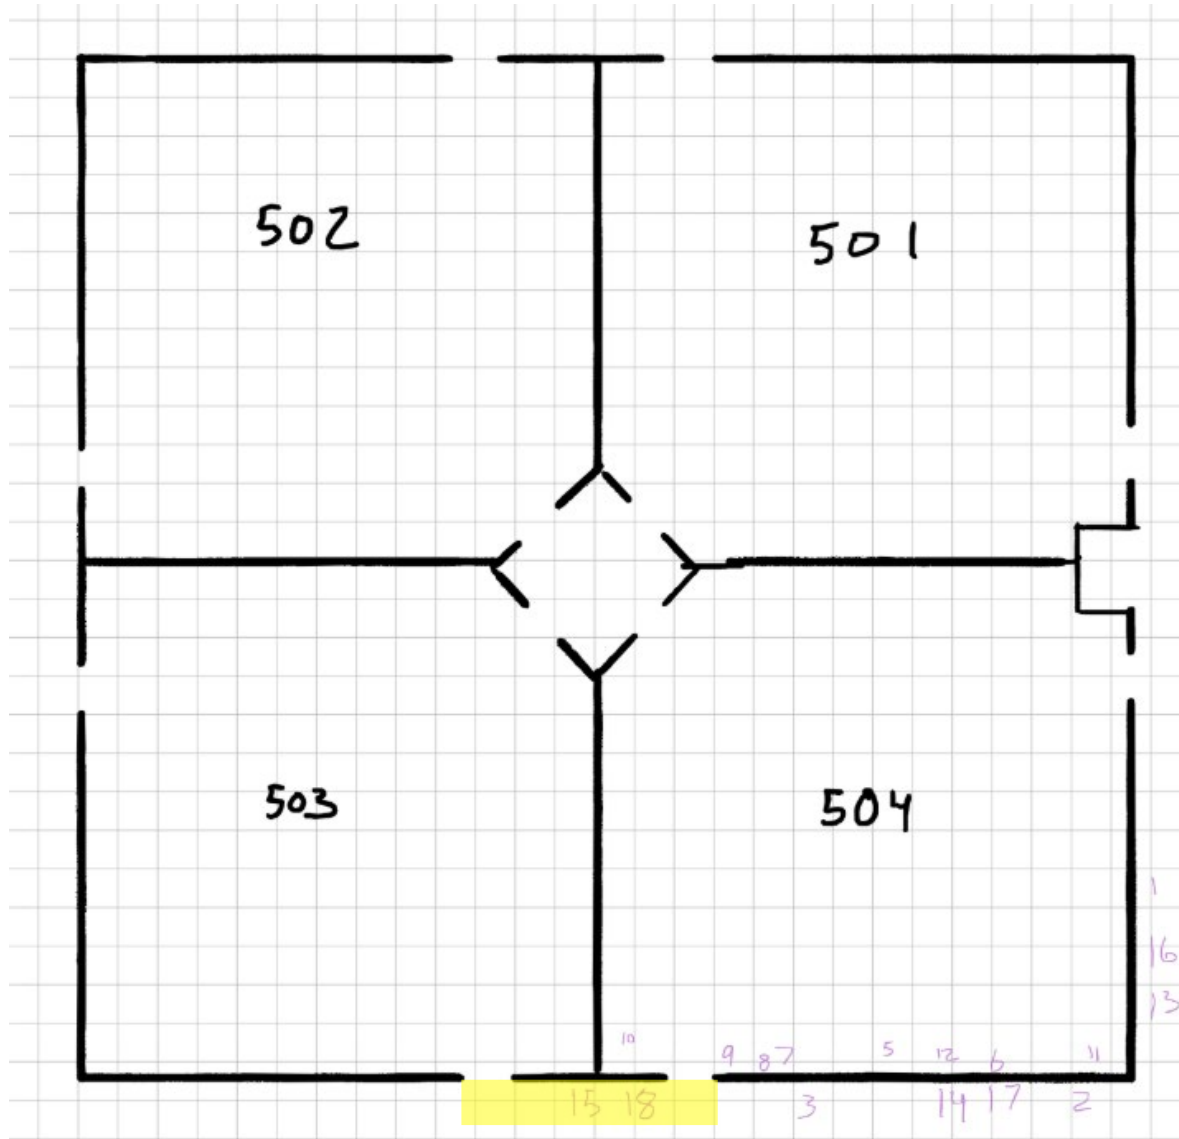
Site Diagram

Material	Location	Quantity
Transite Panel	Below Windows and Above Doors on South side of Building	40 sf

David Johnson (CAC 22-6940) assumes the transite window inserts to be asbestos containing greater than one percent subject to SCAQMD’s Rule 1403.
