We Inspect NJ

Inspector: Brian Duggan: NJ State License #21GI00228700

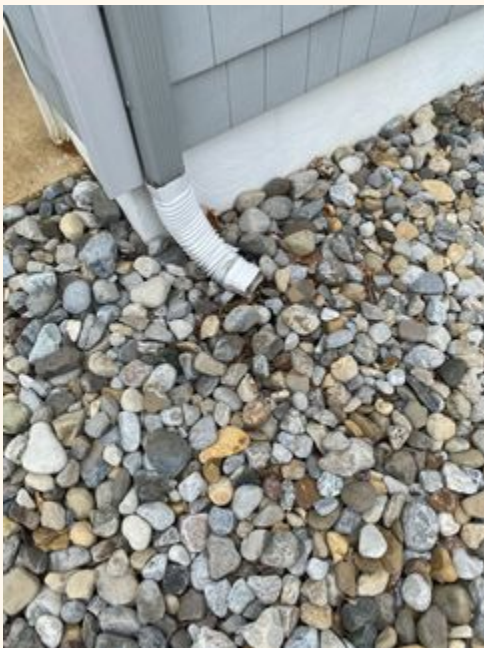
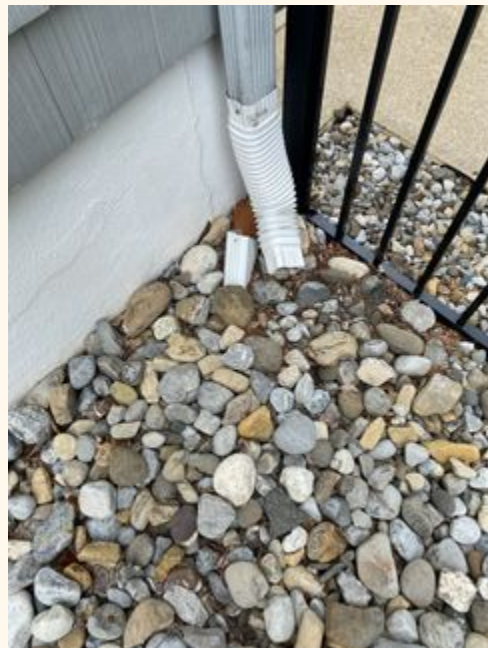
🔧 **(G1-2) Repair:** Downspouts are discharging adjacent to the foundation. This can cause foundation settlement or concrete slab moisture problems. Make sure all downspouts discharge into a proper tight-line system that diverts water at least 5 feet away from the foundation.

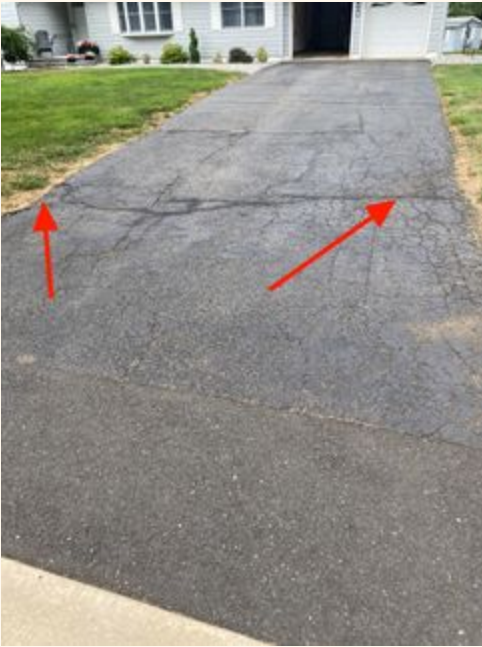
🔧 (G1-3) Repair: The asphalt driveway flatwork needs to be re-surfaced - see cracking and surface deterioration. Have the driveway and parking surface further investigated and repaired as recommended by a qualified contractor.

*Cracks were noted in driveway flatwork.
Repair as needed.*

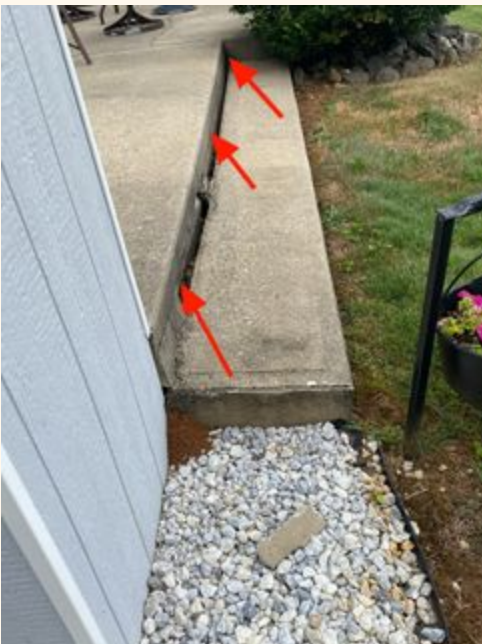
🔧 (G1-4) Repair: The soils have subsided below the concrete patio step. Repair as needed. This typically involves removal of concrete in these locations and addition of sand or other bedding material to level the surface and eliminate the step from continuing to fall away from the patio.

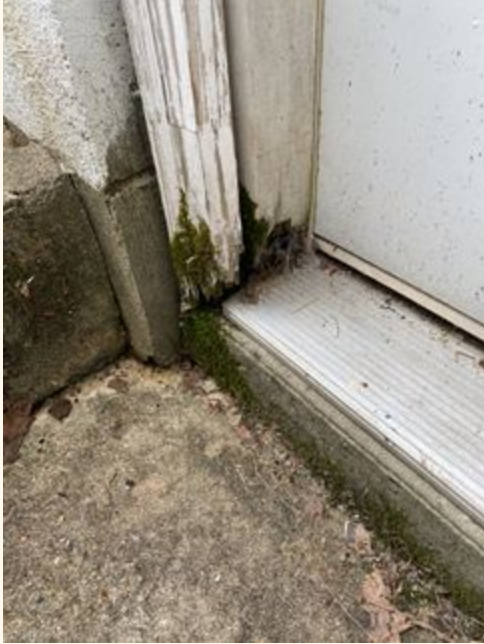
🔧 (G1-5) Repair: The door jamb and trim material to the basement door well is rotted and requires repair. Repair all damaged wood and try and ensure reliable drainage in this well to reduce risks from wood decay and water entry.

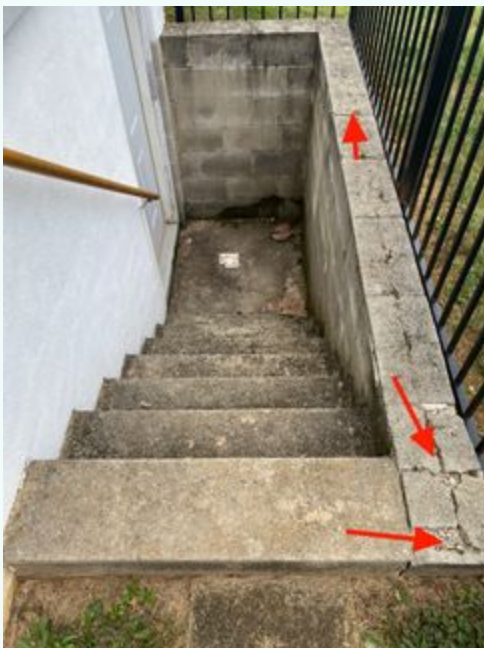
👁️ (G1-6) Monitor: The well structure it's self is starting to deteriorate. Most likely due to freeze and thaw cycle causing the cinderblock's capping to crack. Recommend monitoring at the moment but plan for budging repairs by a qualified contractor.

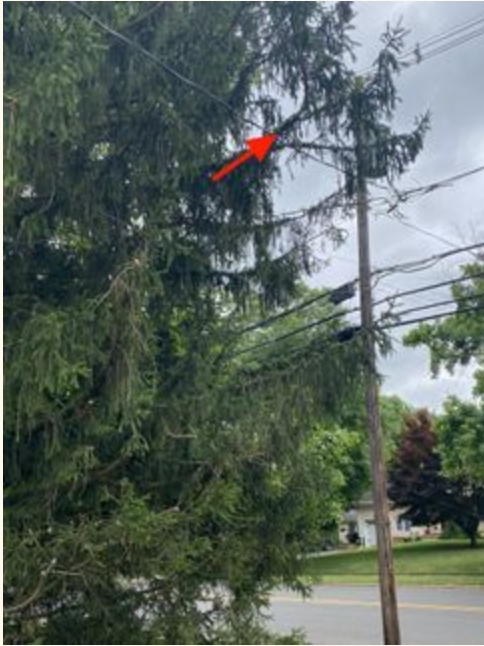
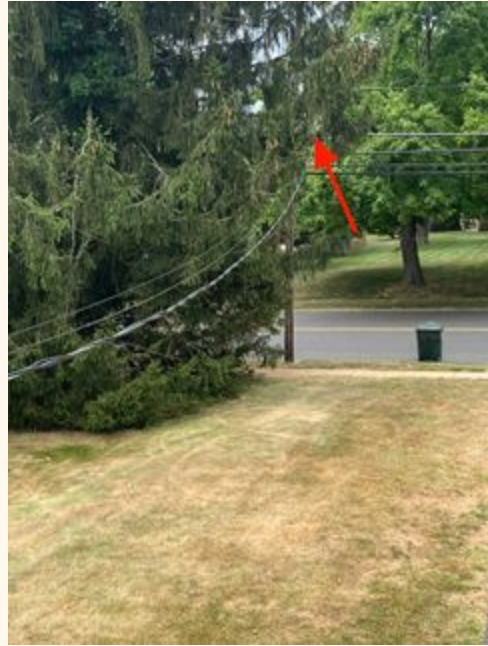
🔧 (G1-7) Repair: Trees and shrubbery should be pruned back away from the electric service drop to prevent damage to the electric service conductors. Contact the utility or a professional arborist to implement this repair as working around live electric wires is hazardous.

The red arrow is pointing at the tree branches that are hanging on top of the electrical drop. These branches could break causing tension on the electrical wire that can lead to larger electrical/safety issues.

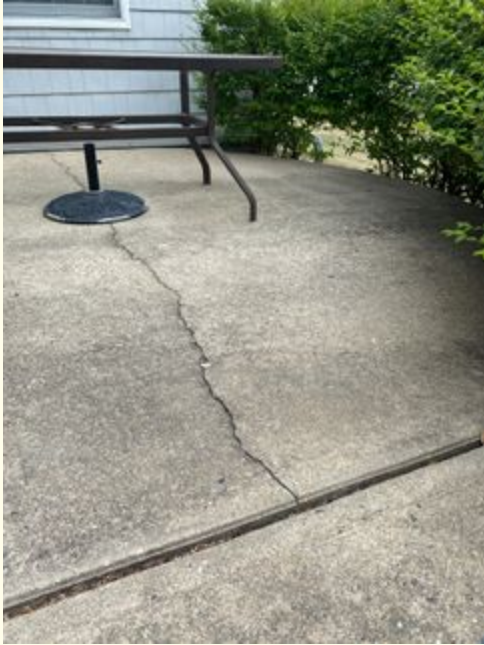
The concrete pad that is the back patio has settled and requires repair. Sometimes these can be lifted back into place by slab jacking. If the concrete is too old often this will not work and proper repair can necessitate removal. Hire a slab jacking company to further investigate and repair.

Arrows are pointing at the large crack through the concrete slab.

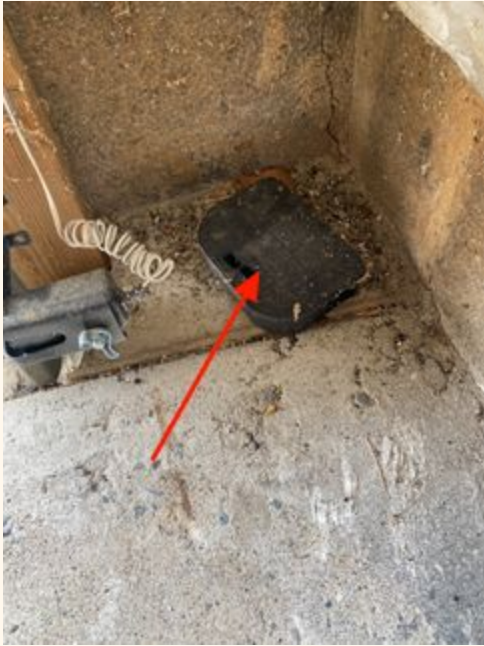
🔧 (G-1) Repair: Evidence of rodent entry was noted in the garage. All openings into the garage should be sealed to prevent rodent entry. All feces and contamination should be cleaned and a trapping program implemented to monitor sealing progress. See other sections of the report for more information on rodents.

Rodent trap located next to the garage door opening. Looks to have been placed a long time ago and no evidence of rodent entry was present at the time of the inspection.

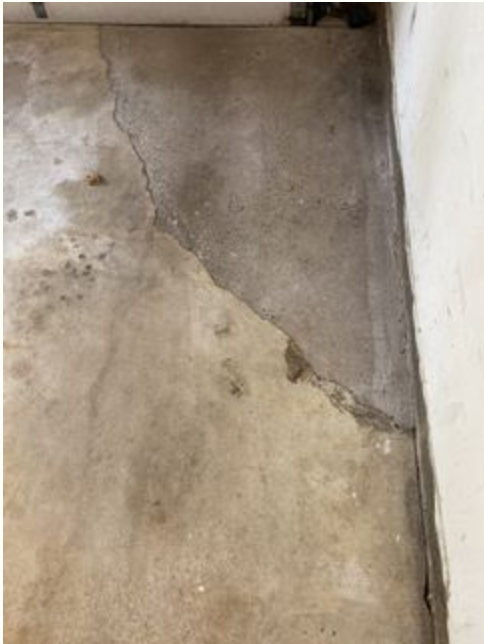
✦ **(G-4) Note:** Typical cracks were noted in the concrete garage slab. No control joints were used in the pour here so the concrete will crack. You can fill the cracks with a masonry rated caulking, but no repair is needed at this time; this is a cosmetic defect.

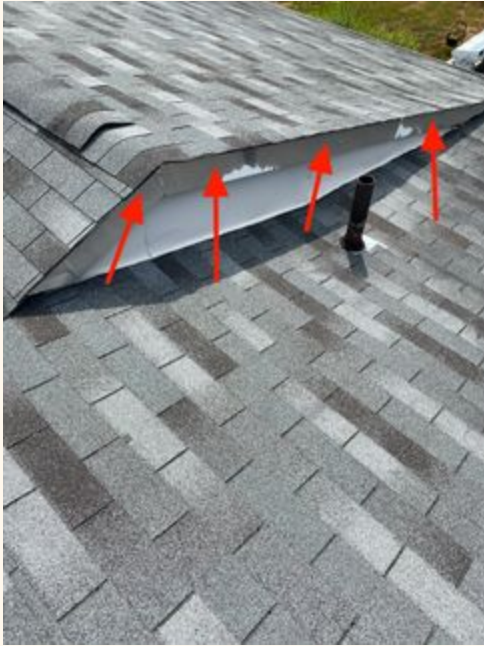
🔧 (RCG-3) Repair: Metal flashing has deteriorated and lifted in areas near the roof surface. Recommend further evaluation and repair by a qualified roofer.

The flashing has lost its exterior paint and is susceptible to an increased rate of deterioration.

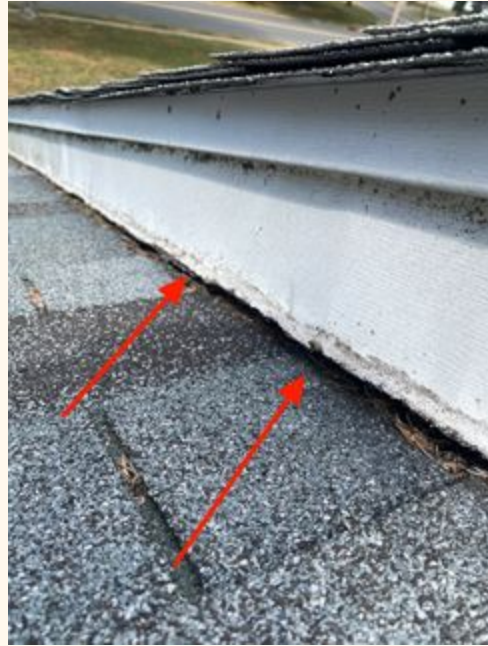
Minor lifting of this flashing where the garage roof and house roof meet.

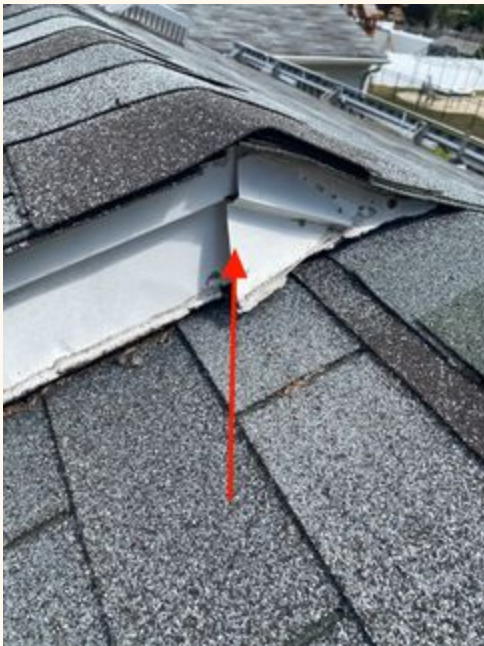
Flashing pulling away at the ridge of the roof.

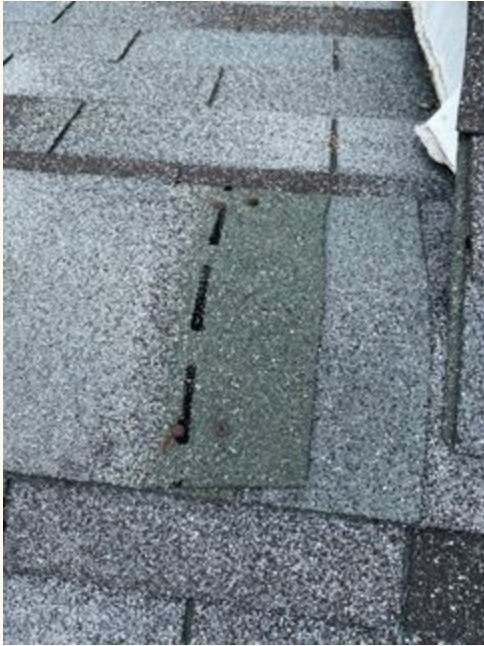
🔧 (RCG-4) Repair: End of roof ridge above the garage has a last set of shingles nailed without proper tar/sealant. This can allow for moisture to penetrate into this area. Recommend a qualified contractor to repair.

Arrows indicating the nails that are unsealed which can allow for water intrusion.

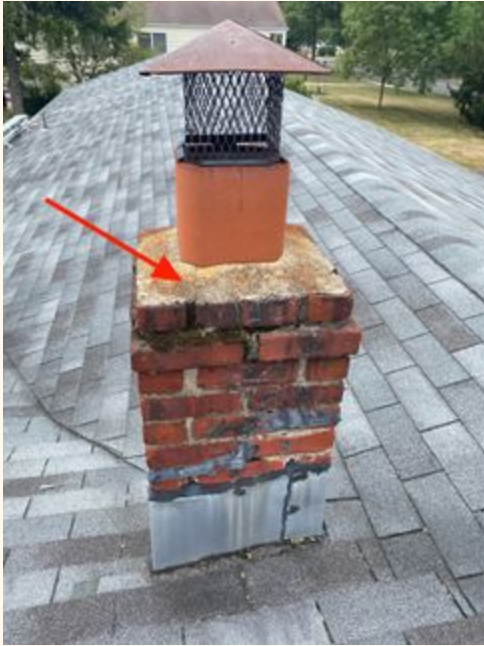
Arrow indicating the cement wash chimney crown. It is recommended for the chimney crown to overhang the chimney stack by two inches to prevent deteriorating of the chimney stack.

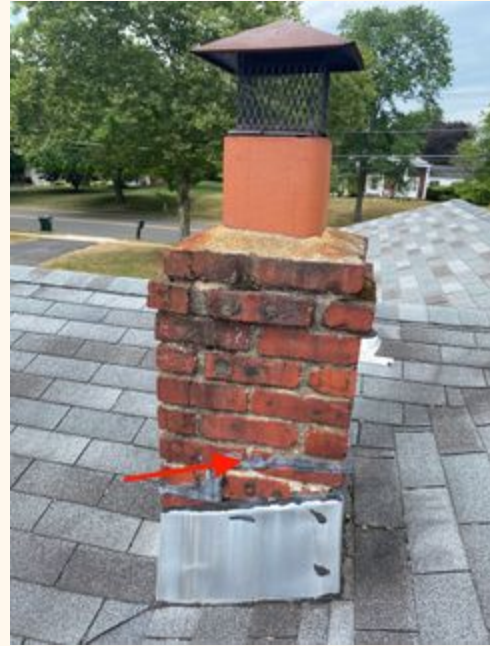
Around the chimney mortar, sealant was used. This is not a proper way to seal the chimney and it is recommended for a qualified mason to further evaluate and make repairs.

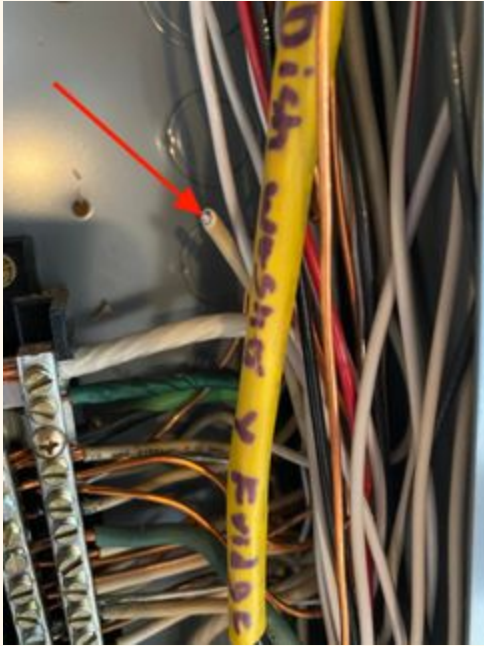
⚠️ (ES1-3) Repair: Abandon wire was found in the electrical box. This is an electrical safety concern and it is recommended to be removed by a licensed electrician.

Arrow pointing at the abandon wire

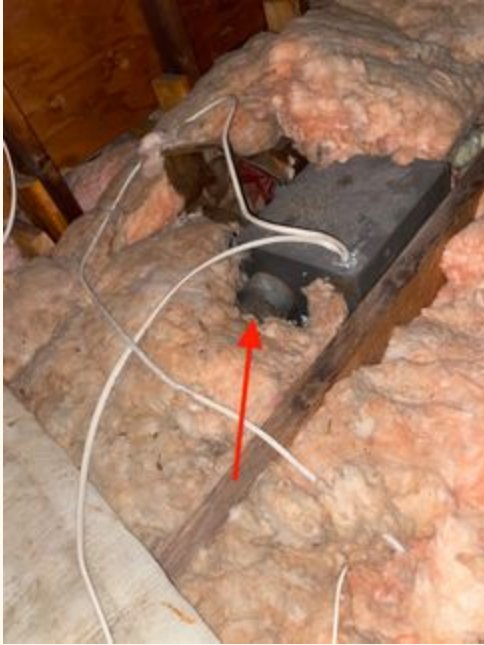
exhaust fans venting into the attic can cause lead to seasonal condensation and moisture controls problems and could damage the attic building materials. Repair to ensure proper discharge of air to the exterior and be sure exhaust ductwork is insulated to R-8 or better to reduce risks of seasonal condensation.

Bathroom fan is not venting out to the exterior.

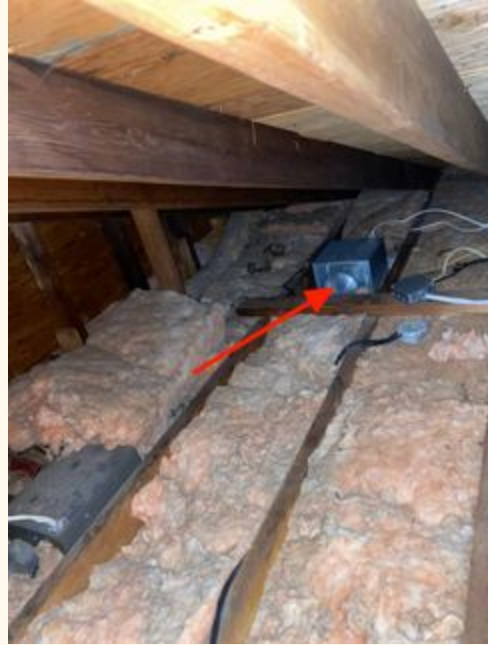
Bathroom fan is not venting out to the exterior.

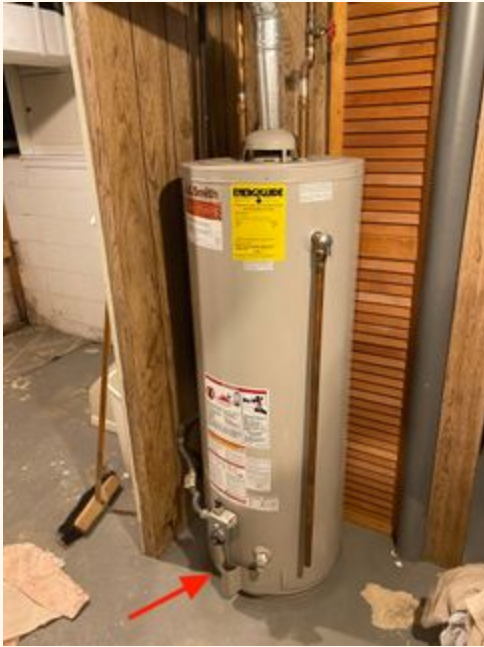
outside. A pan without a drain is often of limited benefit / protection. For improved protection from accidental water heater leaks, and where a drain is difficult to install, consider a pan with a moisture alarm and a flood-safe device such as this: [Watts Water Heater Leak Prevention](#).

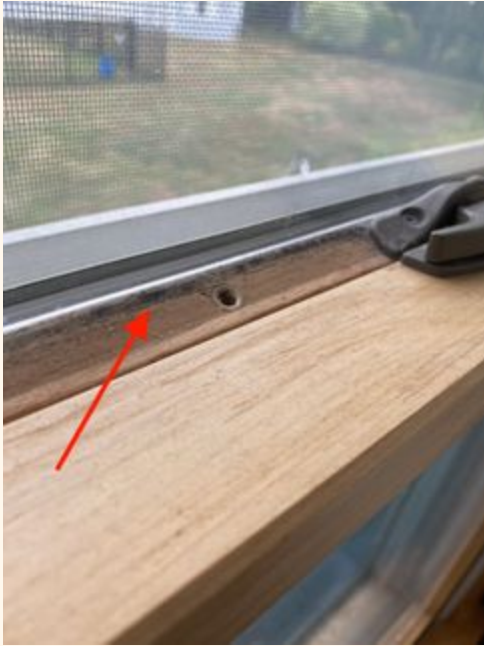
**(I-2) Repair:** Mold-like substances were noted around some of the windows. This is likely the result of condensation. Some types of windows are prone to condensation, especially single pane windows and older windows with metal frames. Mold testing is beyond the scope of this inspection. If you are concerned about indoor air quality, I recommend consulting with a specialist. To help eliminate molds on windows: keep blinds open to allow good air flow over windows, keep the home heated evenly, use bath and kitchen fans to get moist air to the exterior. As a general rule in cold seasons, try and keep indoor relative humidity below 50%. Use bath fans as needed to control indoor relative humidity. I recommend cleaning and monitoring.

Mold-like growth found on south facing windows of new master bedroom

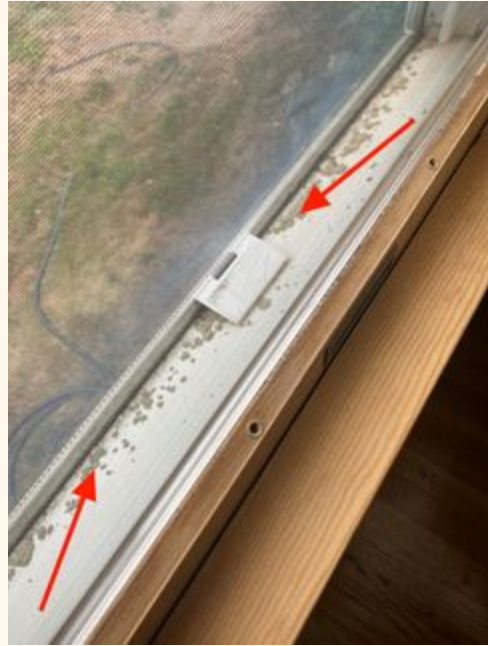
Mold-like growth found on south facing windows of new master bedroom

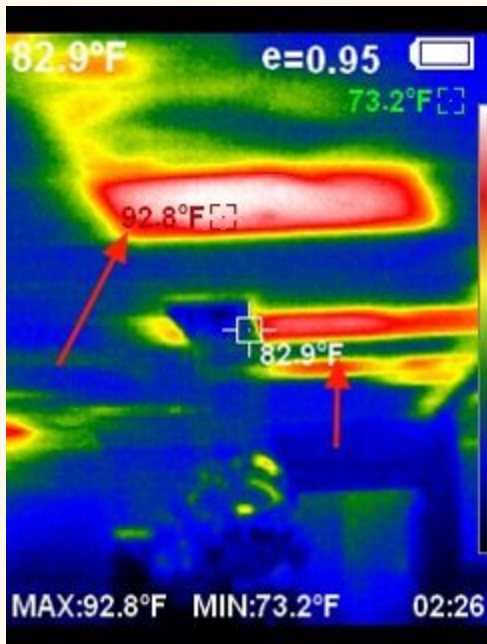
above the newly renovated kitchen. These areas of missing insulation will result in energy loss to the house. Please view pictures for visual example. Recommend a qualified contractor to further evaluate and insulate areas in need.

The arrows in the picture are showing the large areas of missing insulation. Most of the ceiling areas were about 76 degrees; the missing insulation areas were about 92 degrees.

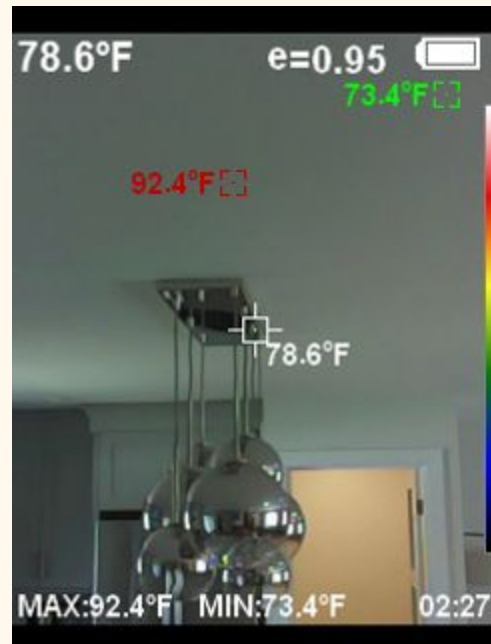
Same picture but not using the thermal image; for reference to the first picture.

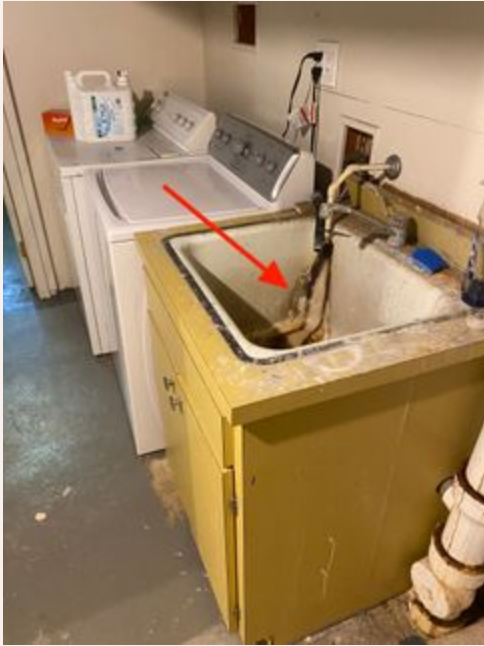
🔧 **(LF-5) Recommended Maintenance:** A slow drain was noted at the laundry sink indicating that the drain may be obstructed. Repair as needed so the drain keeps up with the fixture supply. This typically involves cleaning out the trap.

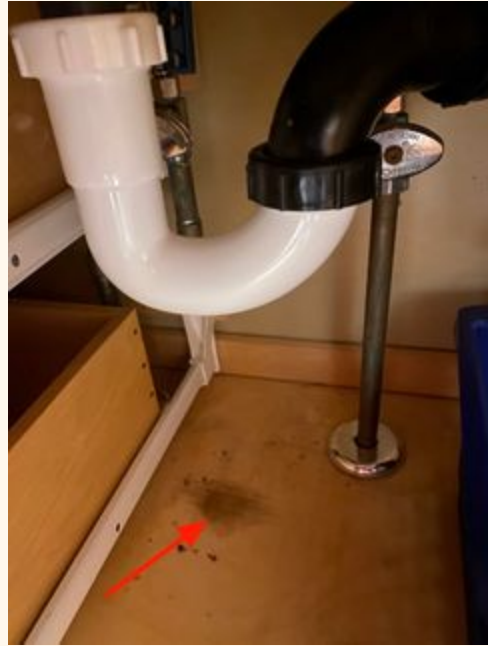
🔧 (FB5-1) Repair: The waste plumbing below the new master bathroom sink is leaking and requires immediate repair. Hire a licensed plumber to further evaluate and repair.

Leak causing water damage to the interior base of the vanity.

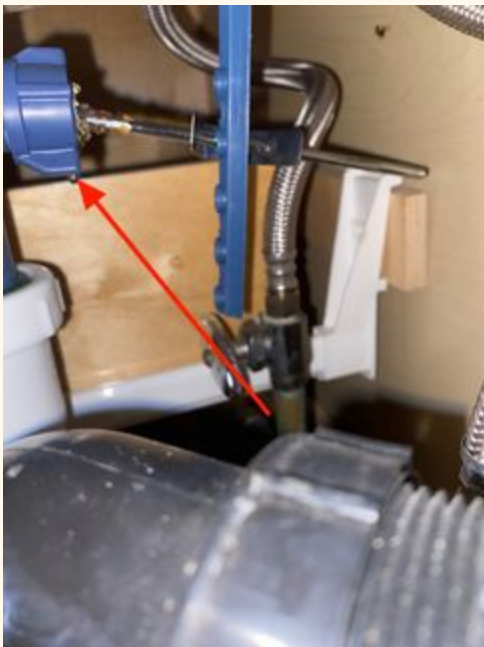
Location of the leak is coming the the sink stopper mechanism.

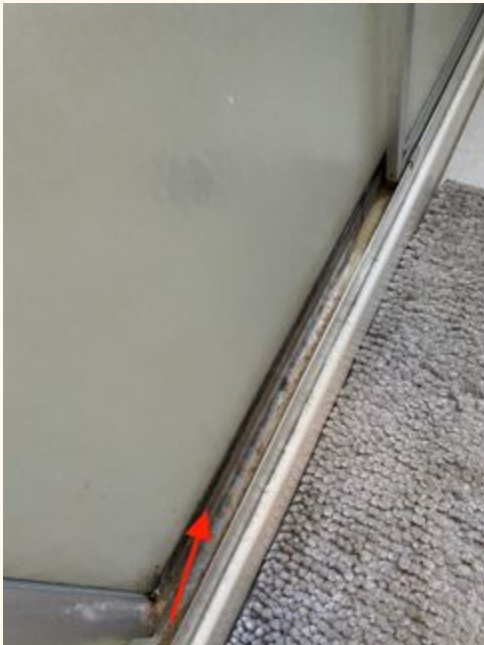
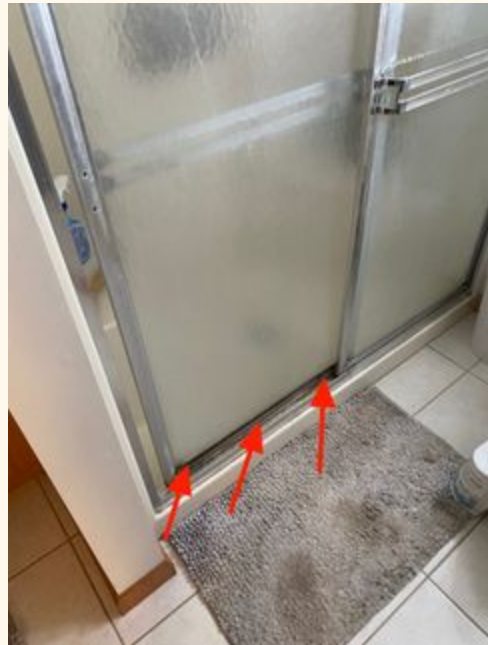
🔧 (FB5-2) Repair: Mold-like substances were noted in the family bathroom walls around the shower. Clean and seal all mold-like substances with cleaners and stain-killing paints as needed. Please note that mold and mold testing is beyond the scope of this inspection. Localized mold growth is common in bathrooms where building materials stay damp. Shellac-based stain-killing paints can be effective sealers. Finish paints should be glossy to low-sheen paint to better shed water and allow for cleaning. Using bath fans to exhaust moist air is important to prevent mold growth and fans can be placed on timers so they run. Mold specialists can be hired as desired to further investigate these stains and remediate. Mold remediation companies are often expensive and it can be more cost-effective to exhaust simple painting, sealing, cleaning and ventilation repairs prior to retaining specialists for such a localized water problem.

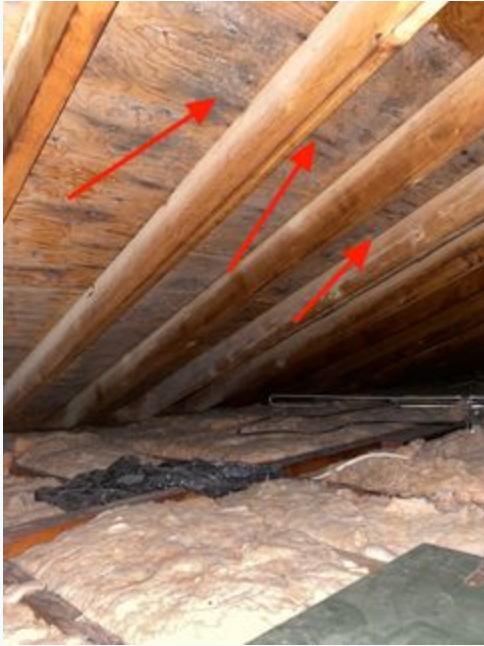
🔍 **(A-1) Due Diligence:** [Mold-like substances](#) were noted on several sheets of OSB in the attic. It appeared that adjacent sheets of OSB were clear. This could indicate that this is not a chronic attic condensation problem, but rather is the result of some sheets of OSB getting wet during the construction process. If you are concerned about molds, a mold remediation specialist should be hired to further evaluate this condition and treat or seal the substances as recommended. Please note that mold and mold testing is beyond the scope of this inspection. Given visible conditions at the time of inspection, and the fact that this is a new build, it seems likely this is just from the construction process. While this may not present any issues to the occupant, it could pose a re-sale issue. I recommend consulting with the builder about options for documenting and / or sealing as recommended.

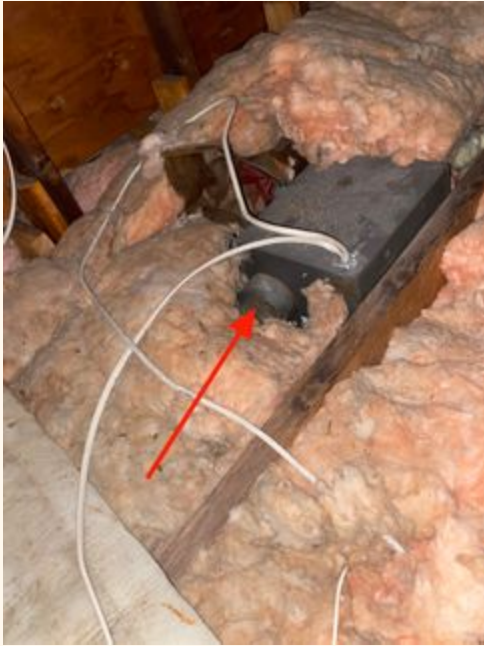
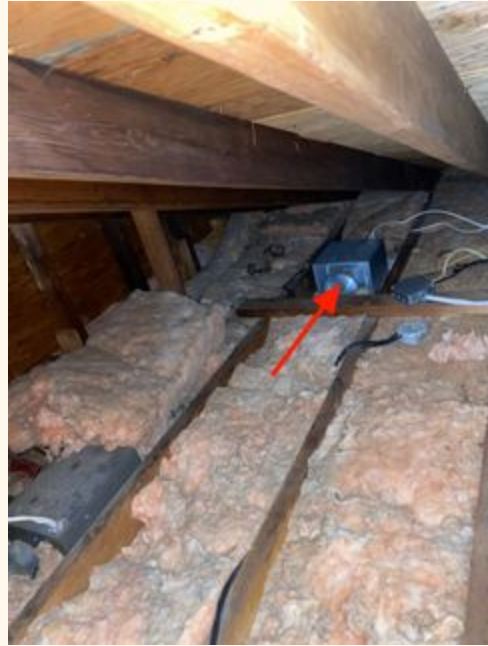
🔧 (A-2) Repair: The exhaust ductwork for the bathroom fans are disconnected in the attic and requires repair to ensure fan exhaust is properly venting to the exterior. Having exhaust fans venting into the attic can cause lead to seasonal condensation and moisture controls problems and could damage the attic building materials. Repair to ensure proper discharge of air to the exterior and be sure exhaust ductwork is insulated to R-8 or better to reduce risks of seasonal condensation.

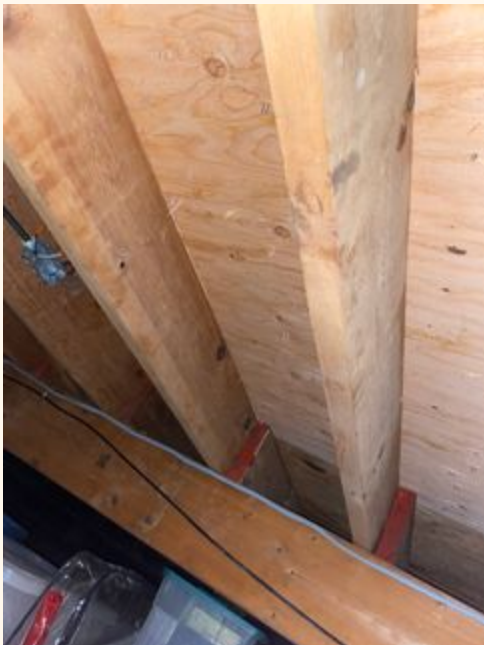
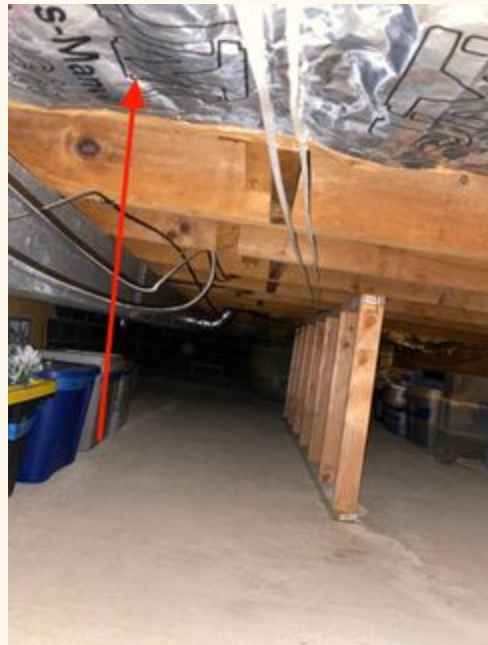
🔧 (CS1-1) Repair: No sub-floor insulation was noted in the crawl space. Sub-floors should be insulated to R-30 or better to conserve energy. Given the vulnerability to rodent intrusion in the space I do not recommend insulating with fiberglass as this is conducive to rodent nesting. Either leave uninsulated or insulate with spray or rigid foam.

Insulation is only located where supply ductwork is run.
