**CAPITAL RESERVE ANALYSIS**  
FOR  
**GRAND HAVEN AT ALCOVY MOUNTAIN**  
**MONROE, GEORGIA**

JANUARY 2023

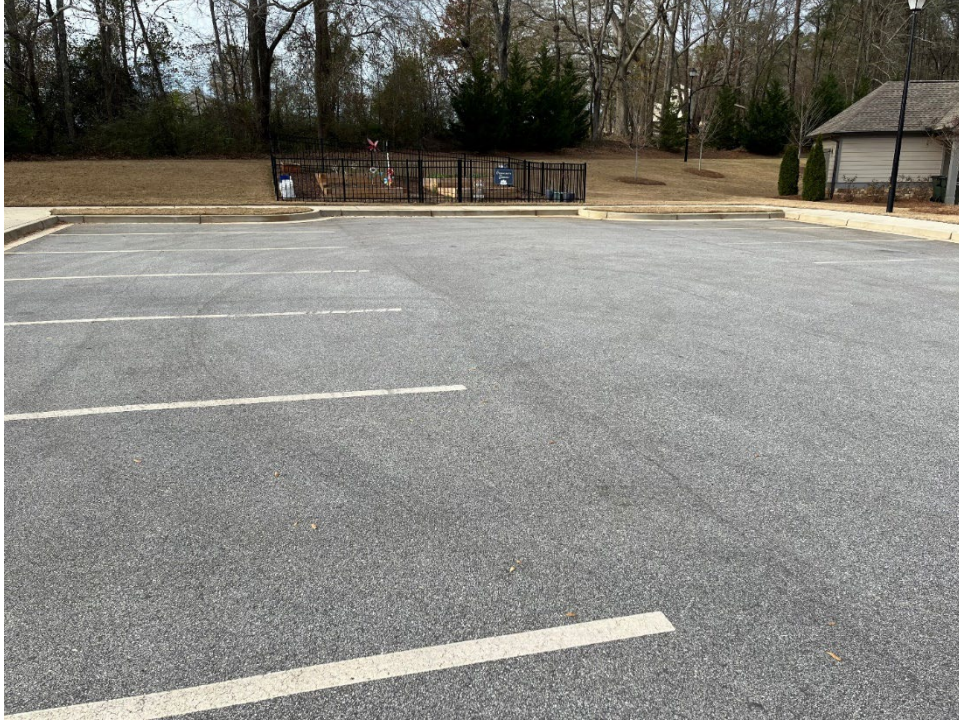
1. These items were found to be in good condition and well maintained. The useful life reflects the age and overall condition of the respective item.
2. **Private Roads/Parking Areas** – The asphalt roads and parking areas appear to consist of a graded aggregate base, asphalt base course, and asphalt surface course. The perimeters of the parking and private roads are surrounded by concrete curbs and gutters. From our review, the asphalt pavement appeared to be in generally good condition for its age and experiencing normal wear and tear. It should be noted that we did observe linear cracks and worn sections of asphalt at the front area of the community (reference photographs 1-2).

1. View of amenity area parking lot.

*In order to prolong the useful life of the asphalt pavement, we recommend that the cracks be filled, and the pavement be sealcoated and striped every six to eight years. The useful life of asphalt pavement is approximately 20 years, after which, a new layer of asphalt should be installed. Prior to overlay, any settled areas should be removed, the base then re-compacted, and a new layer of asphalt course installed. It is recommended that a budget be allocated for the resurfacing of the asphalt with a 1-1/2" mill and overlay every 20 years. We recommend that the asphalt surface be inspected approximately every ten years to determine if the condition of asphalt is adequate and if the useful life can be prolonged.*

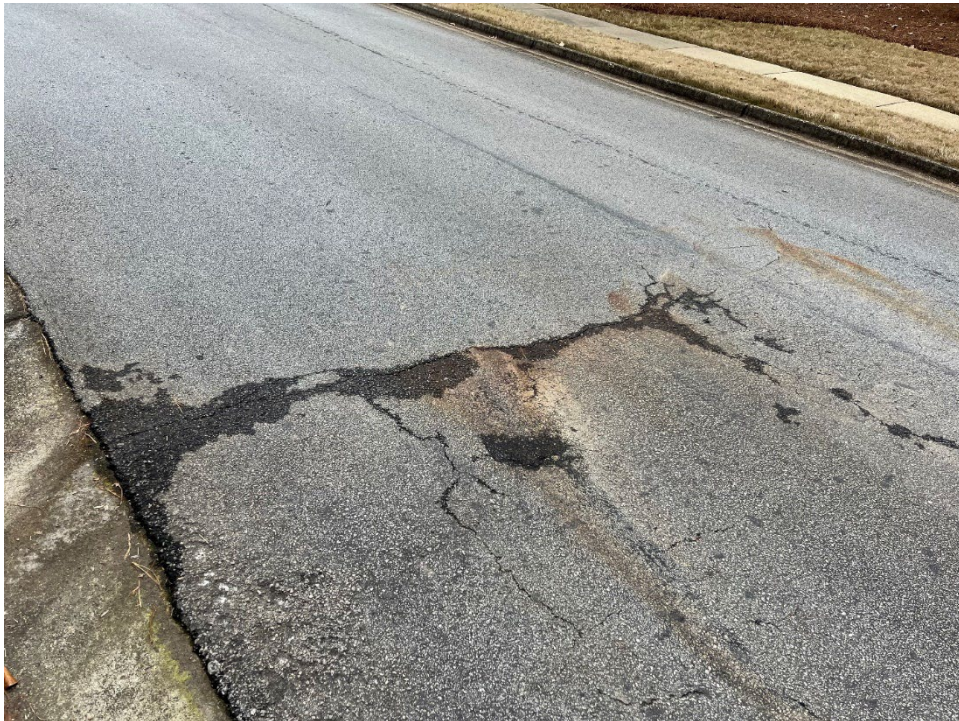
2. View of linear cracks in private roads near guard house.

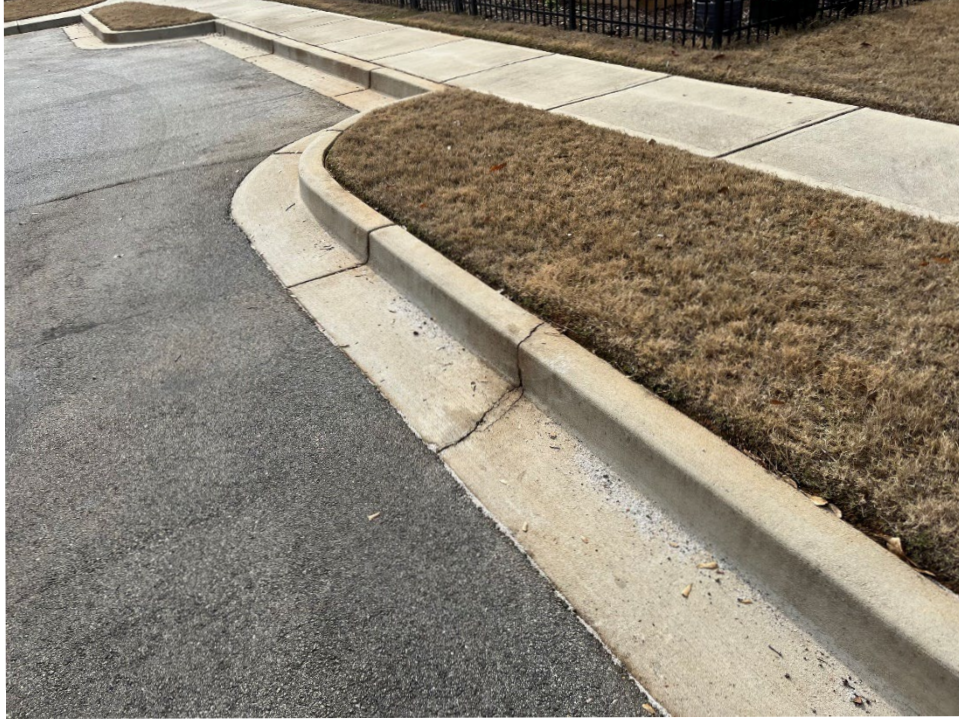
3. **Concrete Curb/Sidewalks** – The concrete curbs at the property appeared to be in generally good condition; however, we observed linear cracks in the curbs at several sections (reference photograph 3). The concrete sidewalks at the property are located primarily in the surrounding areas of the clubhouse and amenity areas. From our review, the sidewalks appeared to be in generally good condition; however, we observed linear cracks in several sections (reference photograph 4).

3. View of linear crack at section of curb in amenity area lot.

*Any sections of sidewalk or curb that are settling should be monitored, and if they continue to settle, these sections should be replaced. The budget is provided for the replacement of damaged, deteriorated, or settled sections of sidewalks and curbs at the property. The budget is provided every six years and the funding can be used when necessary, during the estimated useful life. The budget is not for complete replacement of the concrete sidewalks or curbs, only replacement of the sections that become trip hazards or safety concerns. Any vertical displacement at cracks that could potentially represent a trip hazard and liability should be replaced. If a tree is uprooting a section of concrete, the tree should be removed and de-rooted before the replacement of the concrete.*

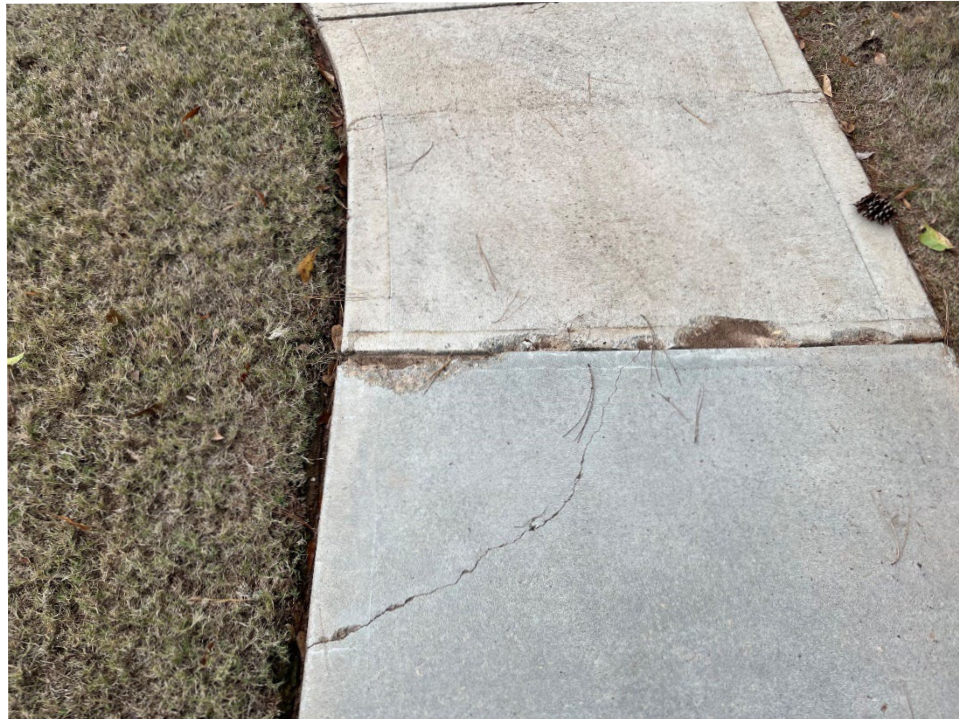
4. View of linear crack at sidewalk near pool and clubhouse.

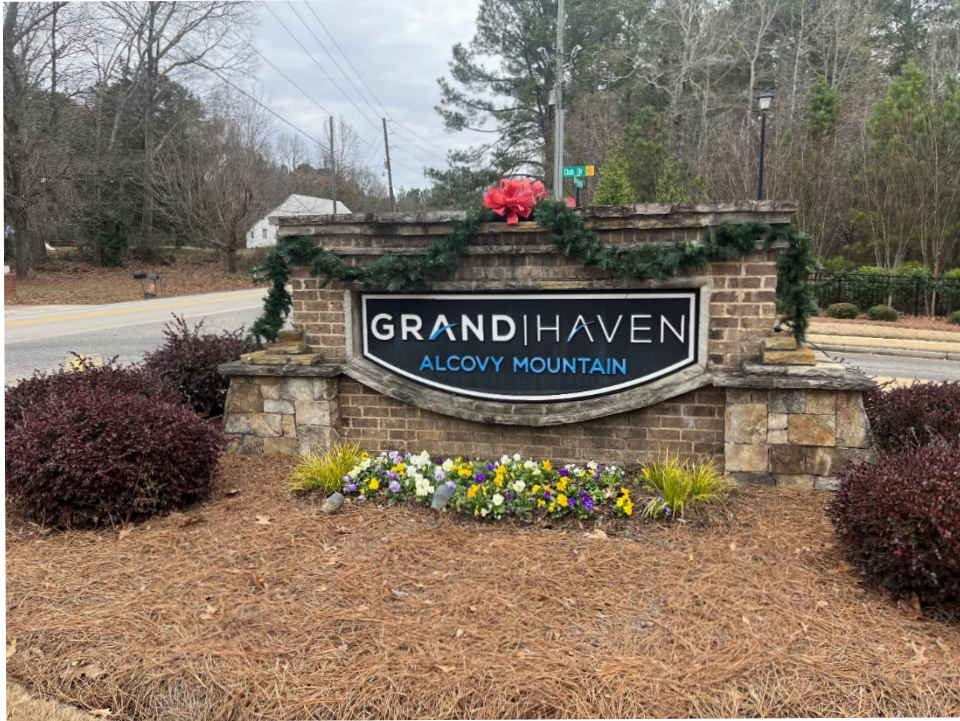
4. **Entry Monuments and Signage** – The entry monument and signage generally consist of a brick and a stone veneer monument at the entrance to the property with painted raised, metal lettering. From our review, the entry monument and signage appeared to be in generally good condition and well maintained (reference photograph 5).

5. View of entry monument signage.

*Any mildew growth on the monuments and grout joints may be power washed as part of regular maintenance for a better appearance. Additionally, a budget has been allotted for the cleaning, repair, tuck pointing and painting of the entry monuments and signage every ten years.*

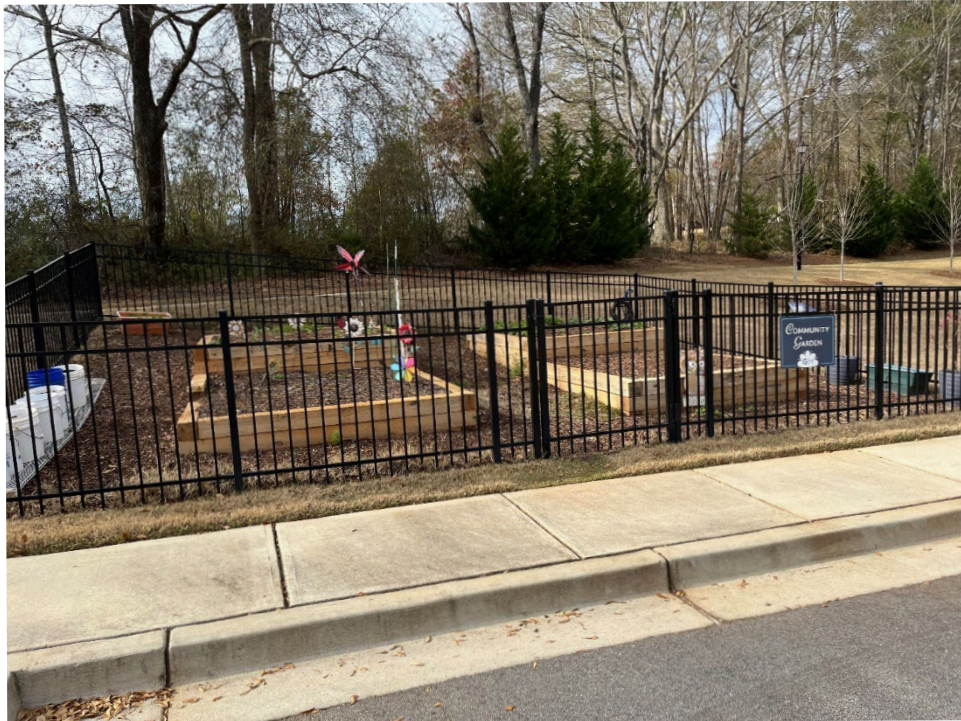
5. **Common Area Fencing** – The fencing at the property primarily consists of aluminum fencing at the dog park, community garden and retention pond areas. It is our understanding that the fencing was installed in 2018. From our review, the common area fencing appeared to be in generally good condition and well maintained (reference photographs 6-7).

6. View of aluminum fencing at community garden.

*It is recommended that a budget be allocated of the repair, maintenance, and partial replacement of the common area fencing every ten years.*

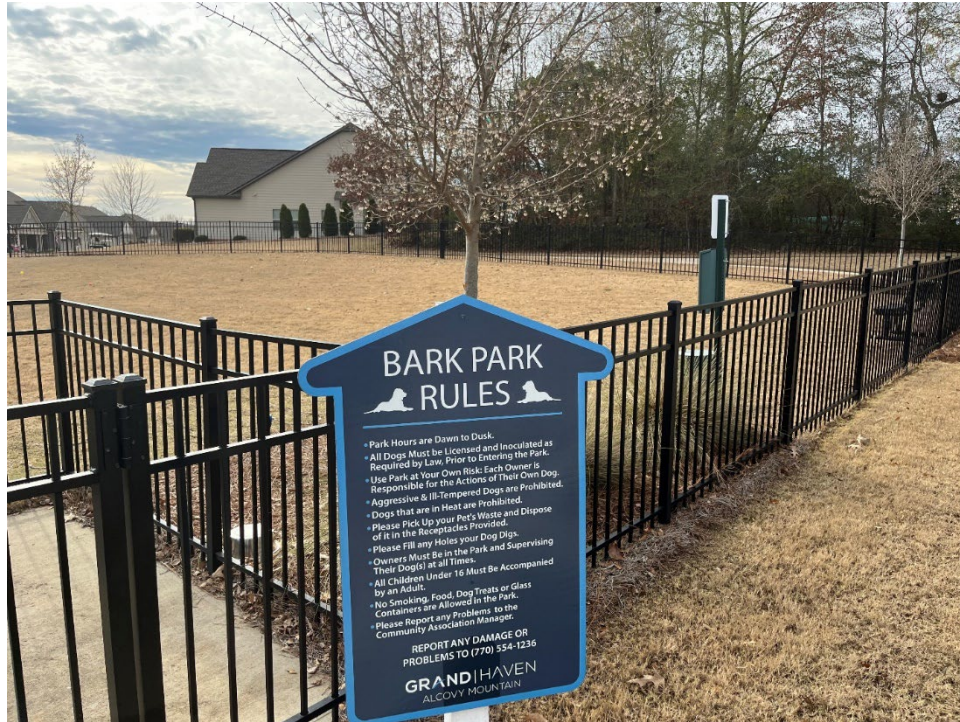
7. View of aluminum fencing at dog park.

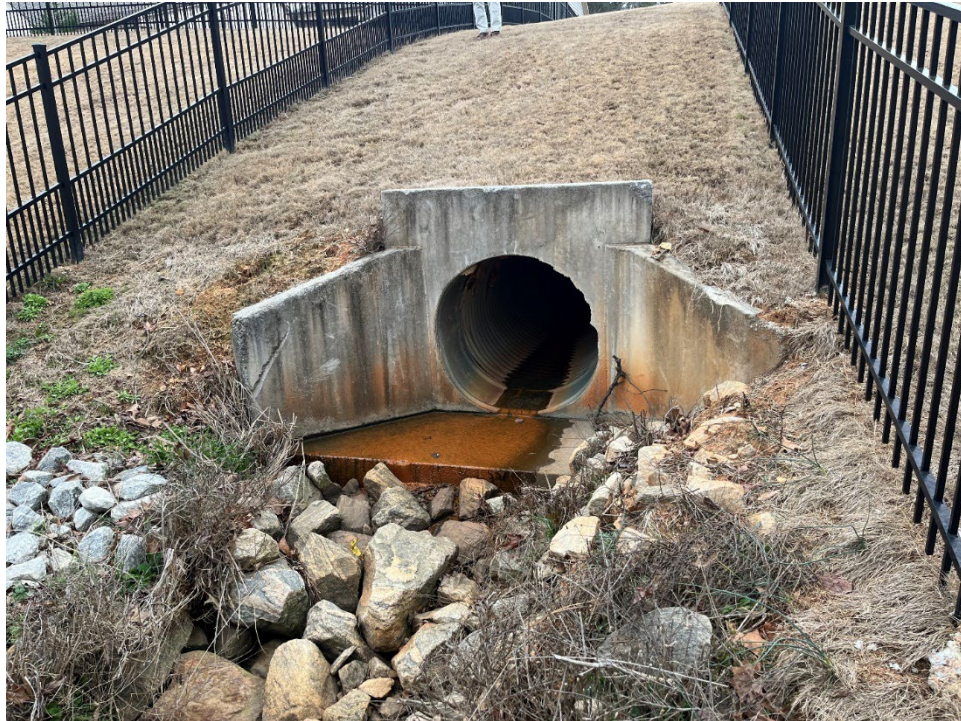
8. View of typical community drainage system.

*It is recommended that swales and river rock be installed to improve the surface flow of water, as needed. It should be noted that it is possible to install French drains in landscaped areas to further improve the drainage. Other forms of poor drainage may be remediated by redirecting the water flow by creating proper slopes or extending existing drainage lines. A budget has been allotted for the maintenance and repair of the storm water drainage every eight years. The budget for the drainage may decrease over time as a result of proper maintenance.*

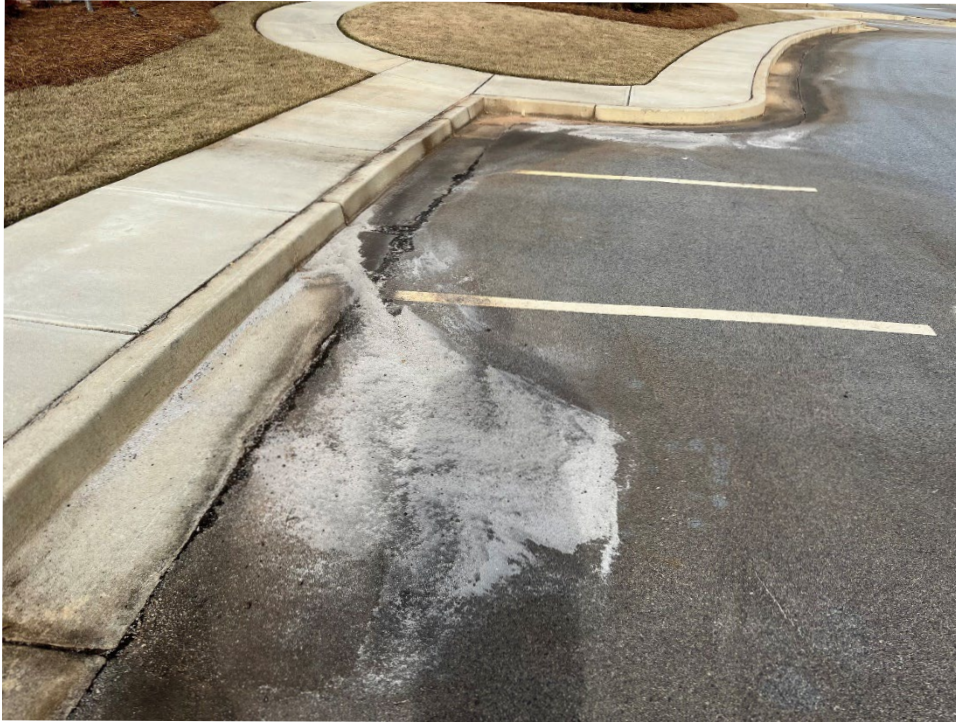
9. View of area with accumulated sediment near tennis court and pavilion

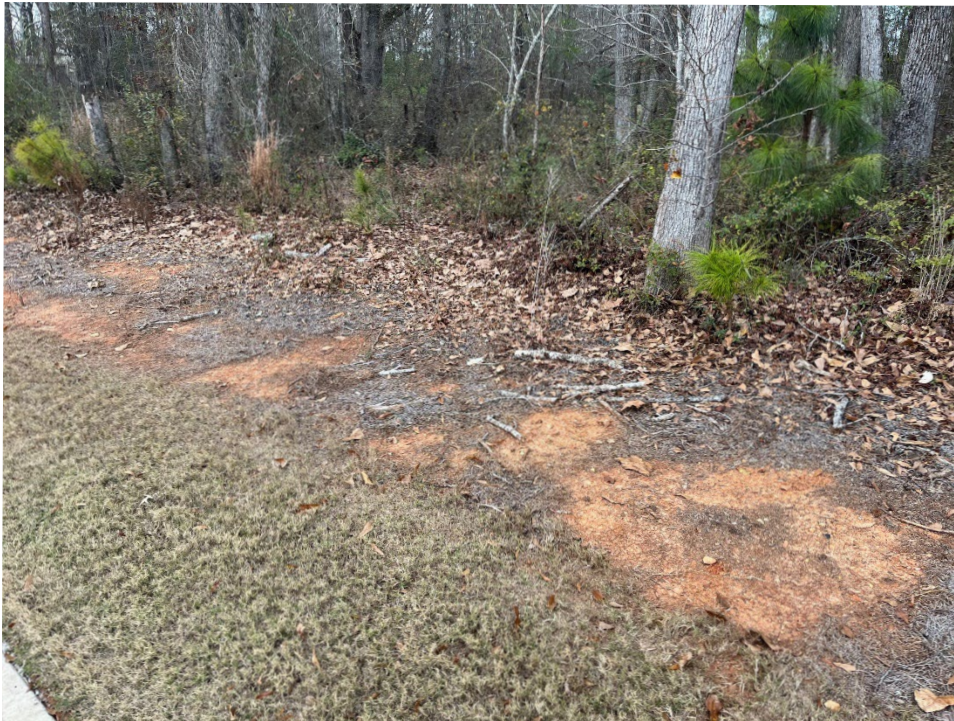
10. View of area with erosion and exposed soil near community garden.

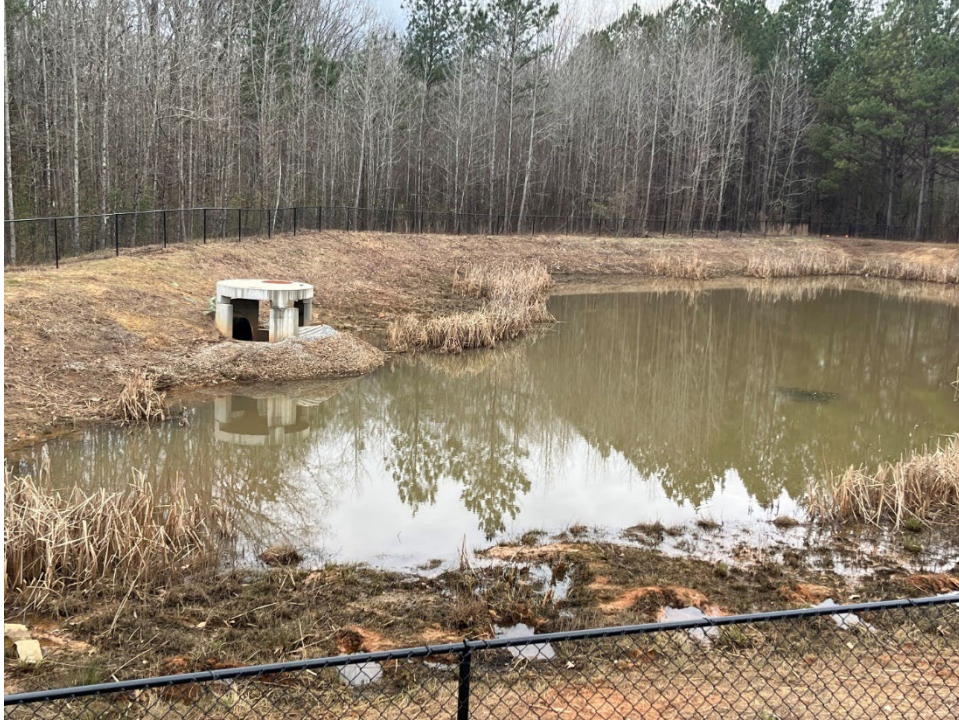
11. View of retention pond.

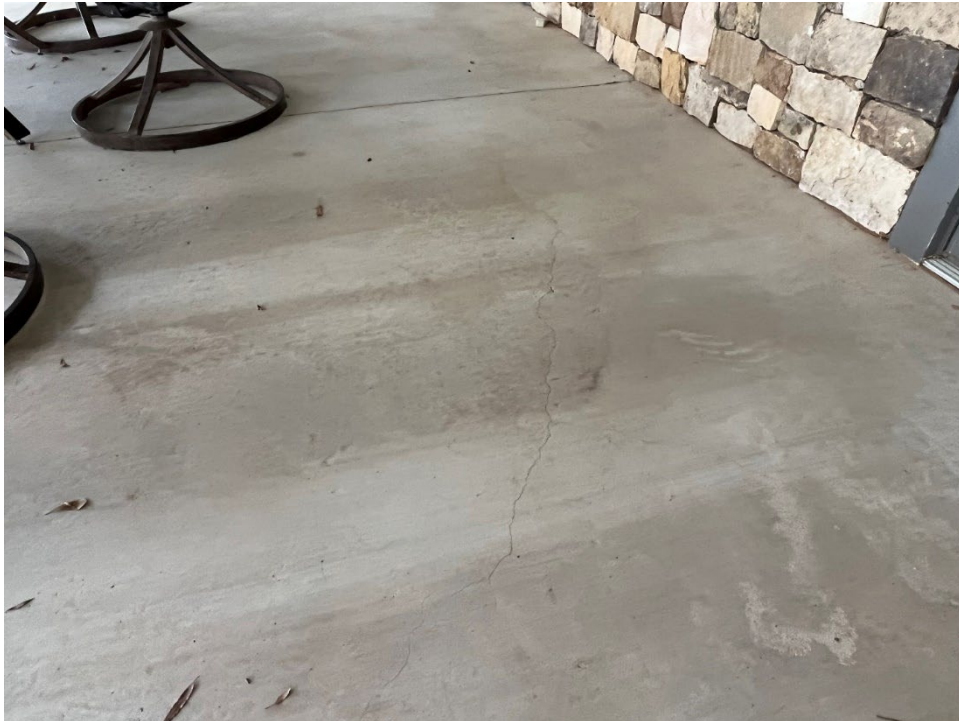
12. View of linear crack at pool deck area

<i>Swimming Pool Surface- Re-plaster/Replace Tiles</i> .....	<i>Every 8-10 years</i>
<i>Swimming Pool Deck – Repair/Seal Cracks</i> .....	<i>Every 6-7 years</i>
<i>Swimming Pool Furniture – Partial Replacement</i> .....	<i>Every 10-12 years</i>
<i>Swimming Pool Fence/Gate – Repair/Maintain/Paint</i> .....	<i>Every 7-8 years</i>
<i>Swimming Pool Cover – Replace</i> .....	<i>Every 9-10 years</i>
<i>Swimming Pool Equipment – Replace Pumps/Motors</i> .....	<i>Every 7-9 years</i>
<i>Swimming Pool Filtration System – Replace Filters</i> .....	<i>Every 7-9 years</i>

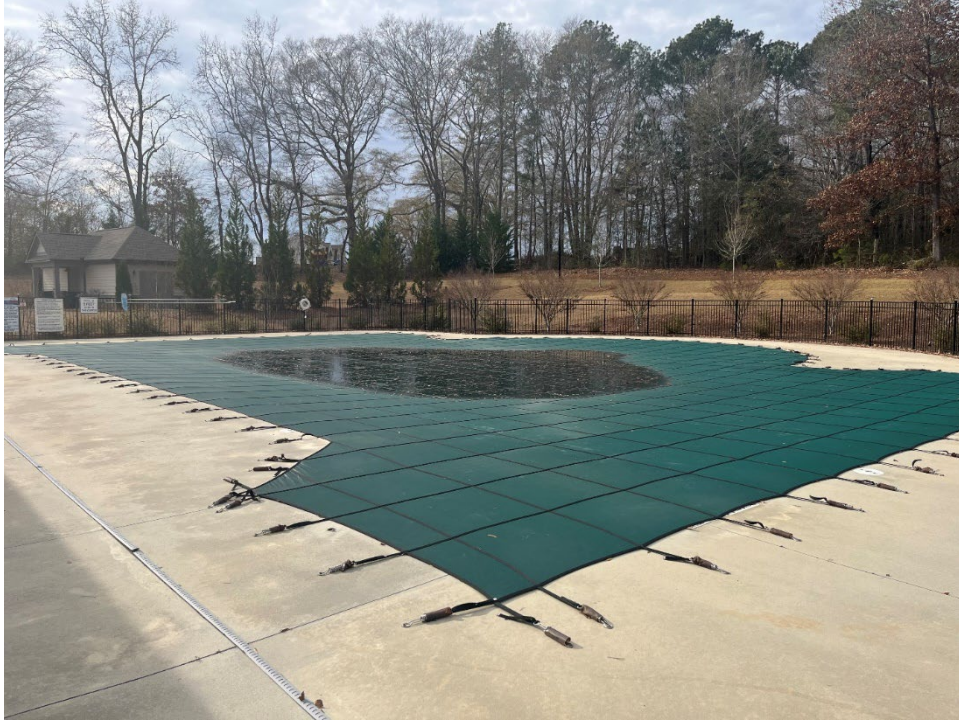
9. **Swimming Pool** – From our review, the equipment, and deck appeared to be in generally good condition and experiencing normal signs of wear and tear. It should be noted that at the time of our review, the pool cover was in place and therefore, we were not able to observe the surface of the pool or the water level tile. There were a few cracks observed at the concrete under the shaded area on the pool deck (reference photograph 12). Aside from the deficiencies mentioned the swimming pool was observed to be in generally good condition (reference photograph 13).

13. View of area of swimming pool with cover.

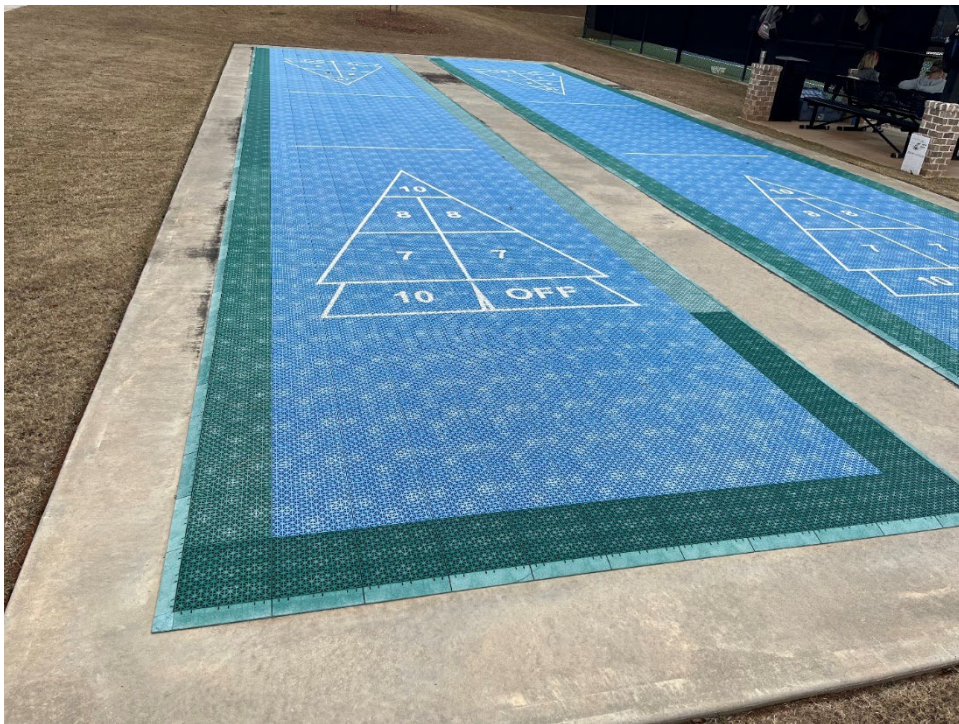
10. **Shuffle/Bocce Boards** – The shuffle and bocce boards are on the left and right sides of the pickleball courts. From our review, the shuffle/bocce boards appeared to be in generally good condition and well maintained (reference photographs 14-15).

14. View of shuffleboards.

*A budget for the replacement and repair/maintenance of both the shuffle boards and bocce boards has been included in the reserve.*

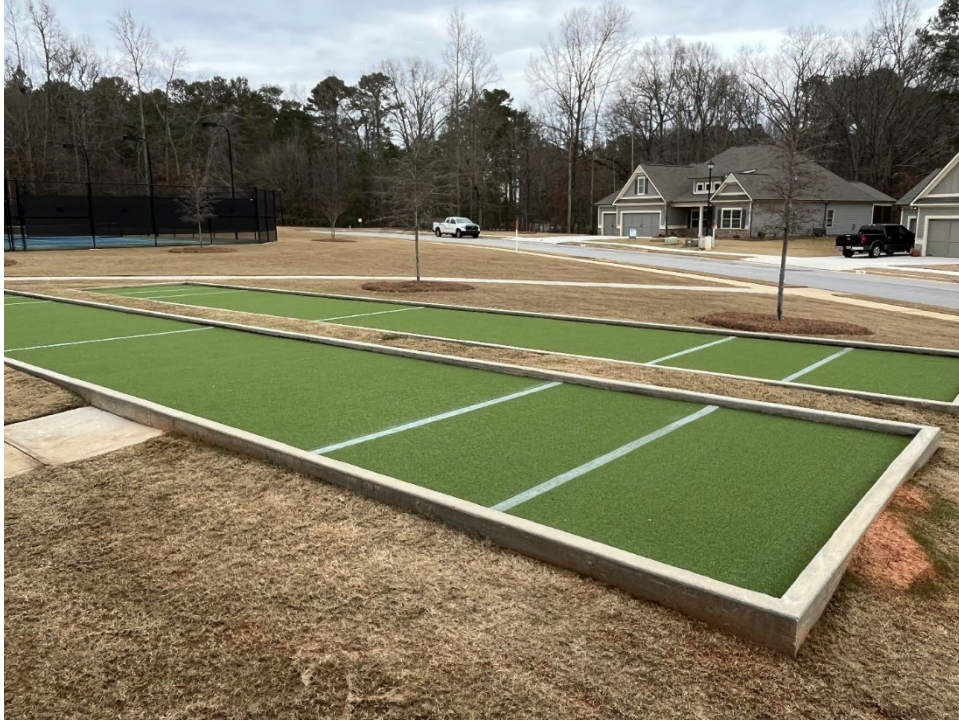
15. View of bocce boards.

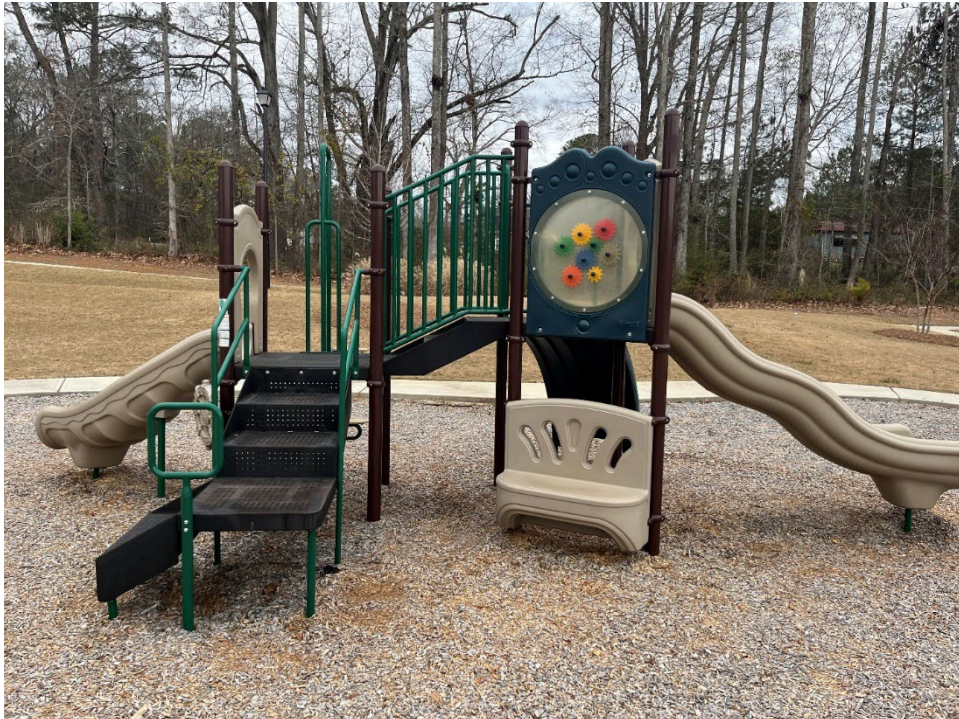
appears to be in good to fair condition; however, there was corrosion observed at the stairway leading to the platform on the tot lot (reference photograph 16-18).

16. View of tot lot.

*A budget has been allocated for the replacement of the tot–lot every 20 years. We have also included a budget for the repair, painting and maintenance of the tot-lot equipment every seven to eight years, beginning after the equipment is projected to be replaced.*

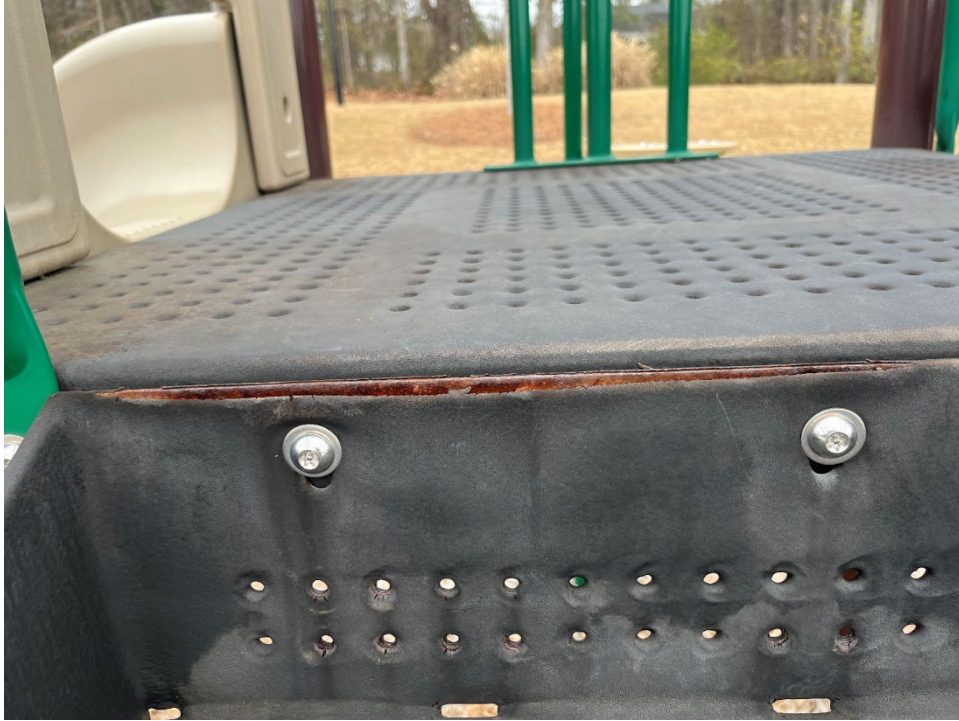
17. View of corroded stairs at tot lot.

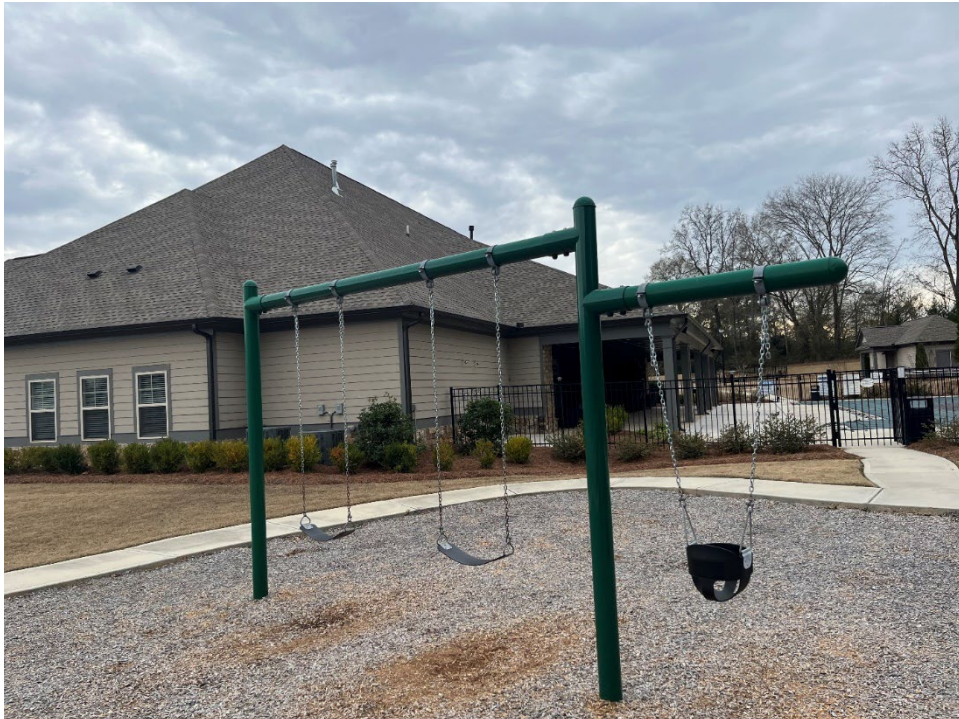
18. View of tot lot swings.

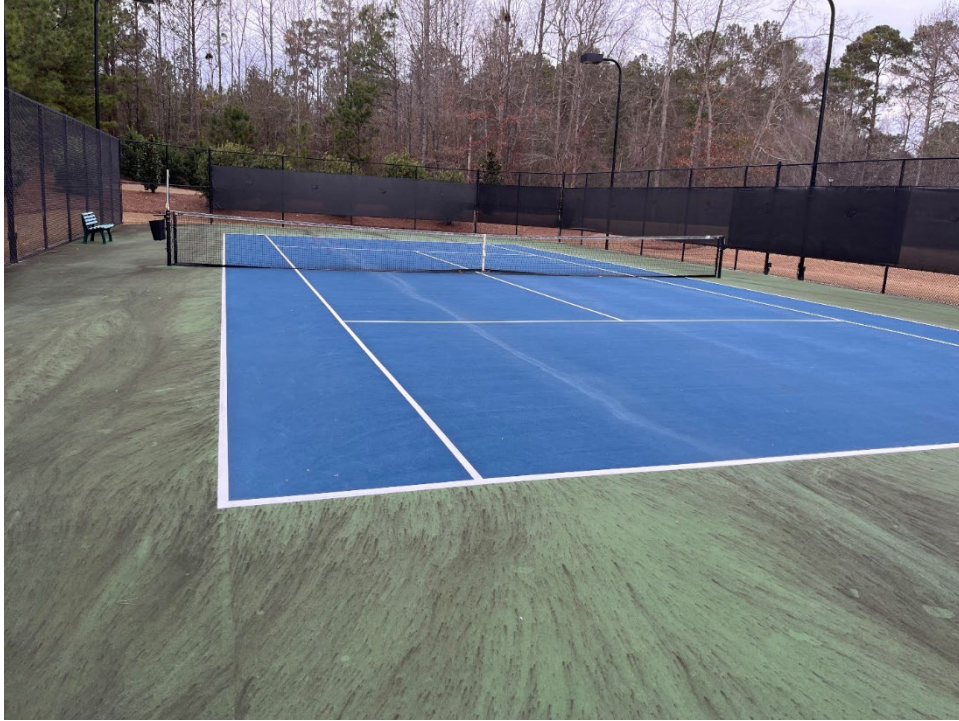
- 12. **Tennis/Pickle Ball Courts** – There is one tennis court and a total of two pickleball courts within the community. The courts are surrounded by metal chain link fences with swinging entry gates. From our review the tennis and pickle ball courts were in good condition with no deficiencies observed (reference photographs 19-20).

19. View of tennis court.

*Tennis Courts – Resurface (Crack Repair).....Every 6-7 years*  
*Tennis Courts – Replace Surface/Fence.....Every 20-25 years*  
*Tennis Cts. Fencing – Repair/Paint.....Every 5-6 years*  
*Tennis Cts. Light Poles – Repair/Paint.....Every 7-8 years*  
*Tennis Cts. Windscreens – Replace.....Every 4-5 years*  
*Pickle Ball Courts – Resurface (Crack Repair).....Every 6-7 years*  
*Pickle Ball Cts. – Replace Surface/Fence.....Every 20-25 years*  
*Pickle Ball Cts Fencing – Repair/Paint.....Every 5-6 years*  
*Pickle Ball Cts. Light Poles – Repair/Paint.....Every 7-8 years*  
*Pickle Ball Cts. Windscreens – Replace.....Every 4-5 years*  
*Pickle Ball Pavilion - Wood Repairs/Staining.....Every 10-15 years*  
*Pickle Ball Pavilion Roof – Replace.....Every 20-25 years*

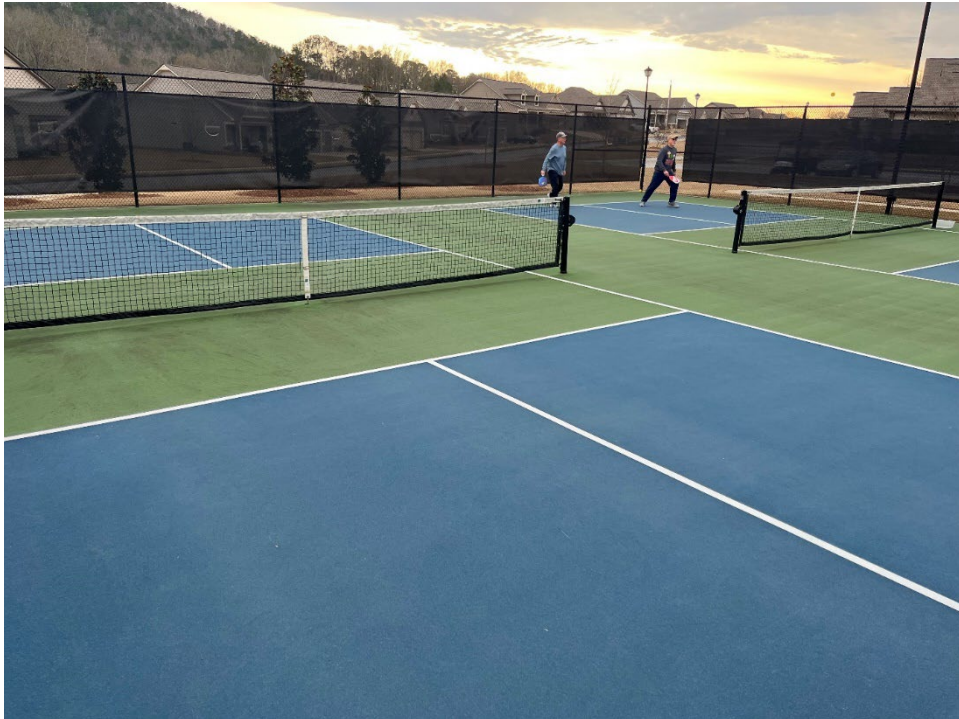
20. View of pickleball courts.

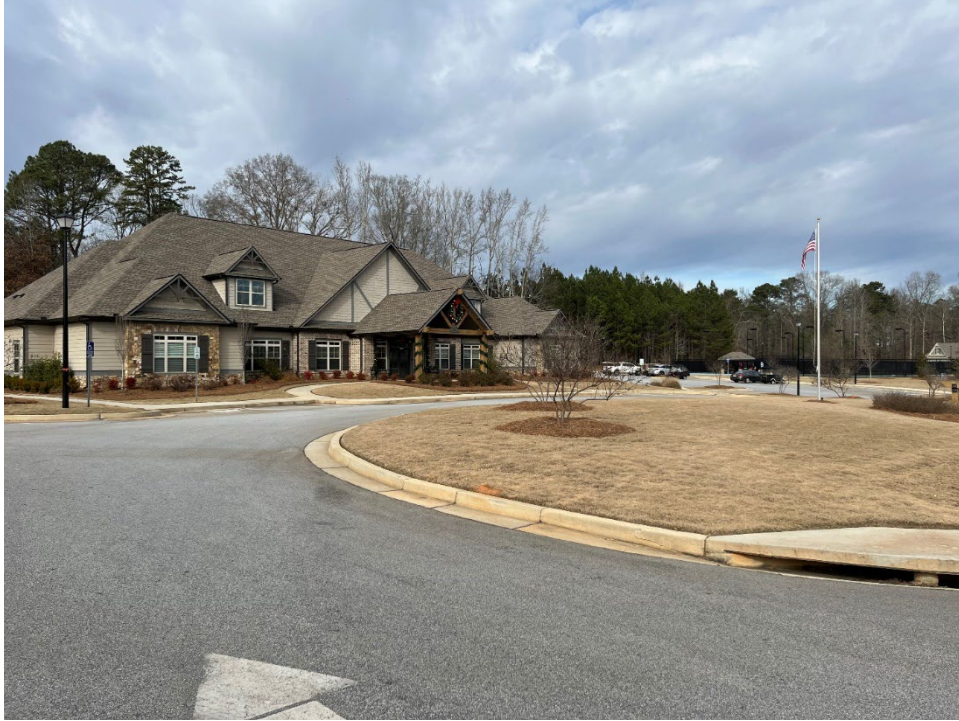
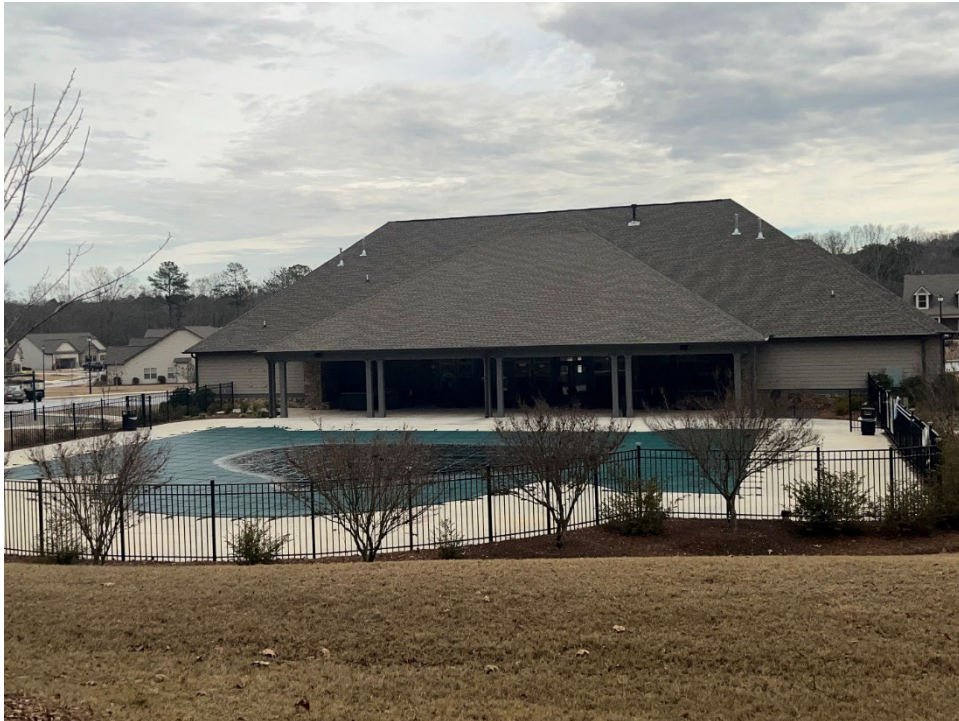
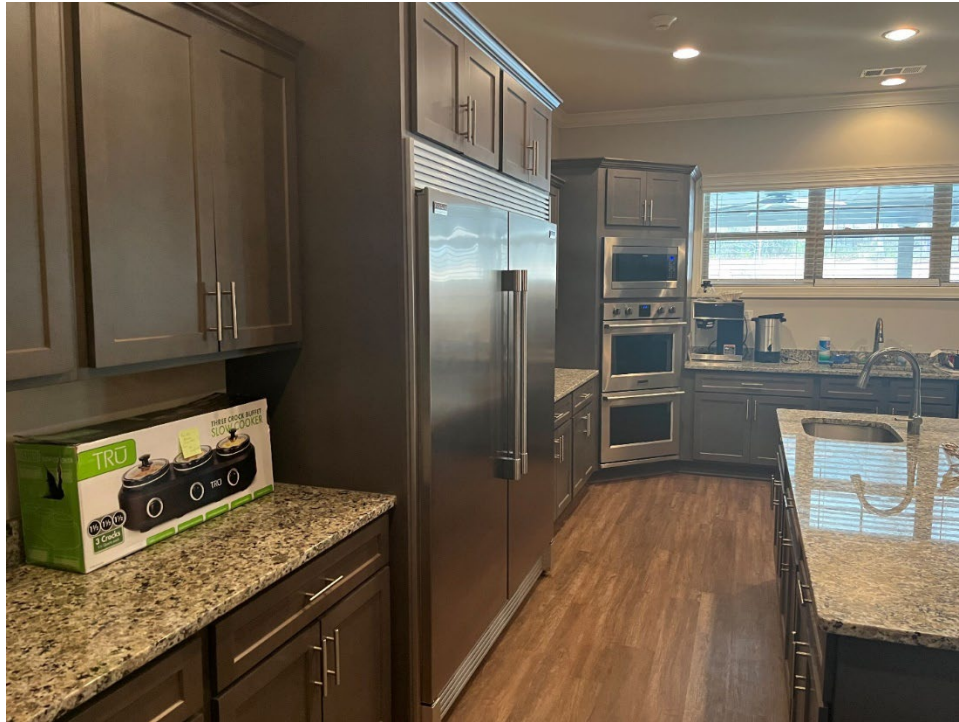
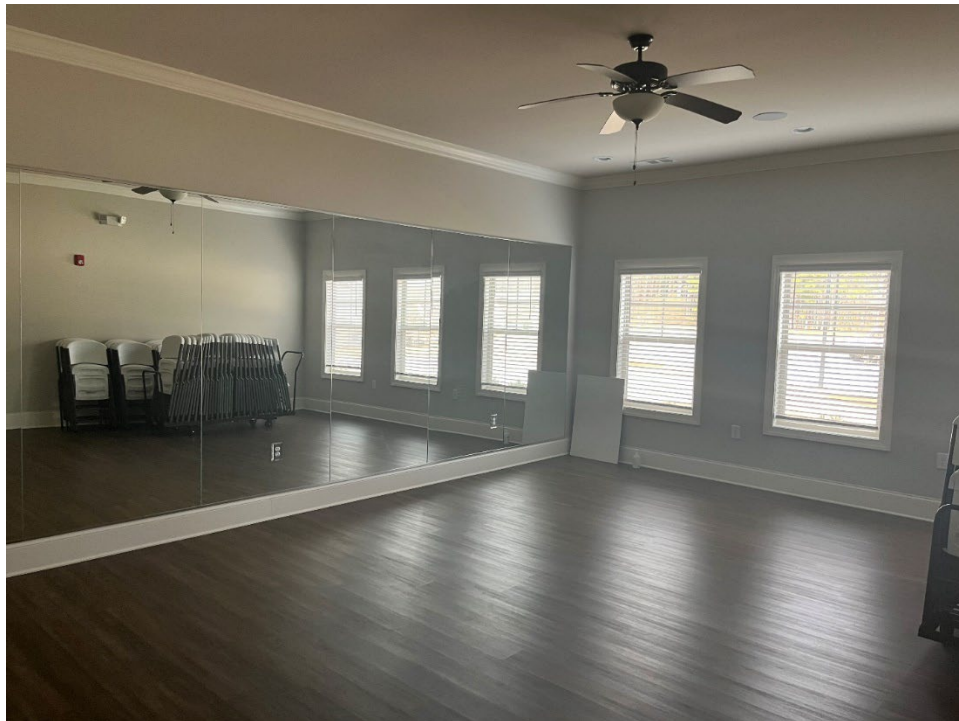
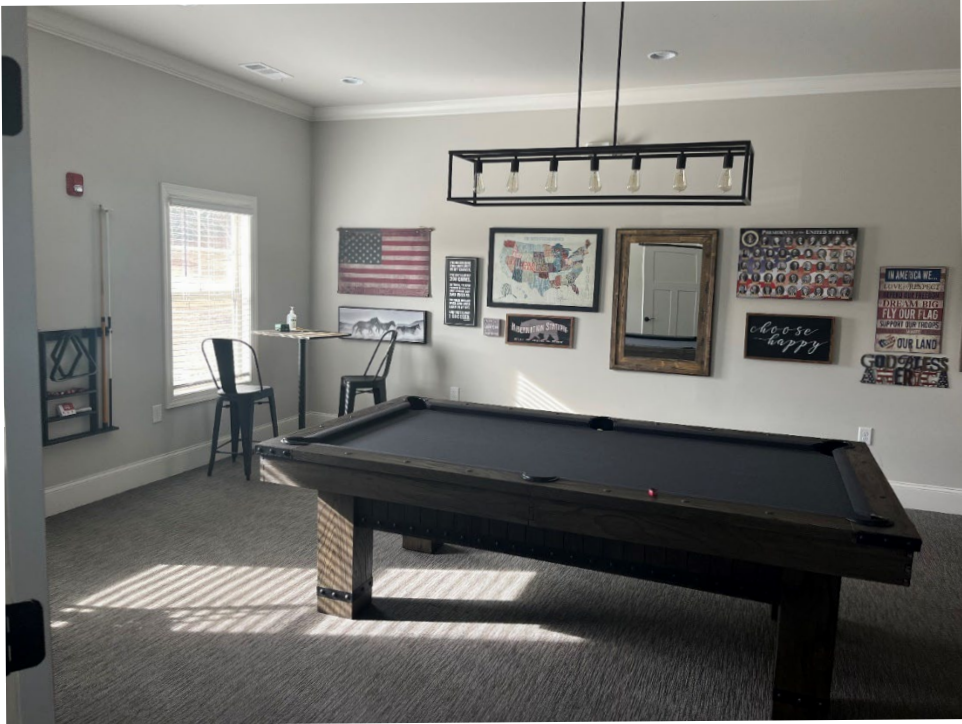
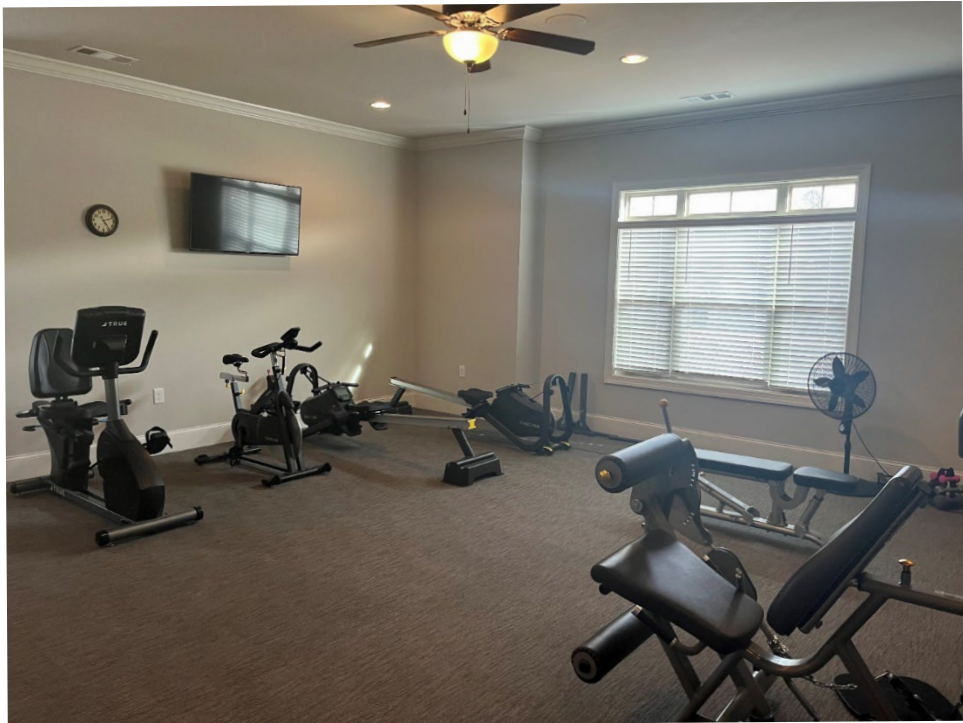
Overall, the condition of the clubhouse appeared to be in generally good condition and if maintained properly, should not require any major remediation at this time (reference photographs 21-26).

21. View of clubhouse.

22. Rear view of clubhouse.

23. View of clubhouse kitchen.

24. View of clubhouse aerobics room.

25. View of clubhouse pool room.

26. View of clubhouse gym.

<i>Clubhouse Roof – Replace Shingles .....</i>	<i>Every 20-25 years</i>
<i>Clubhouse Gutters/Downspouts - Replace .....</i>	<i>Every 20-25 years</i>
<i>Clubhouse Exterior - Repair/Paint Siding.....</i>	<i>Every 3-6 years</i>
<i>Clubhouse Exterior Brick - Repair/Maintain .....</i>	<i>Every 8-12 years</i>
<i>Clubhouse Exterior Stone - Repair/Maintain .....</i>	<i>Every 7-10 years</i>
<i>Clubhouse Interior - Repair/Paint/Wall Coverings.....</i>	<i>Every 6-8 years</i>
<i>Clubhouse Flooring - Replace .....</i>	<i>Every 12-15 years</i>
<i>Clubhouse Furniture/Fitness Equipment - Replace.....</i>	<i>Every 12-15 years</i>
<i>Clubhouse Bathrooms - Paint.....</i>	<i>Every 3-6 years</i>
<i>Clubhouse Bathrooms - Flooring Repair .....</i>	<i>Every 8-12 years</i>
<i>Clubhouse Pool Area Bathrooms - Flooring Repair .....</i>	<i>Every 3-6 years</i>
<i>Clubhouse Pool Area Bathrooms - Flooring Repair .....</i>	<i>Every 8-12 years</i>

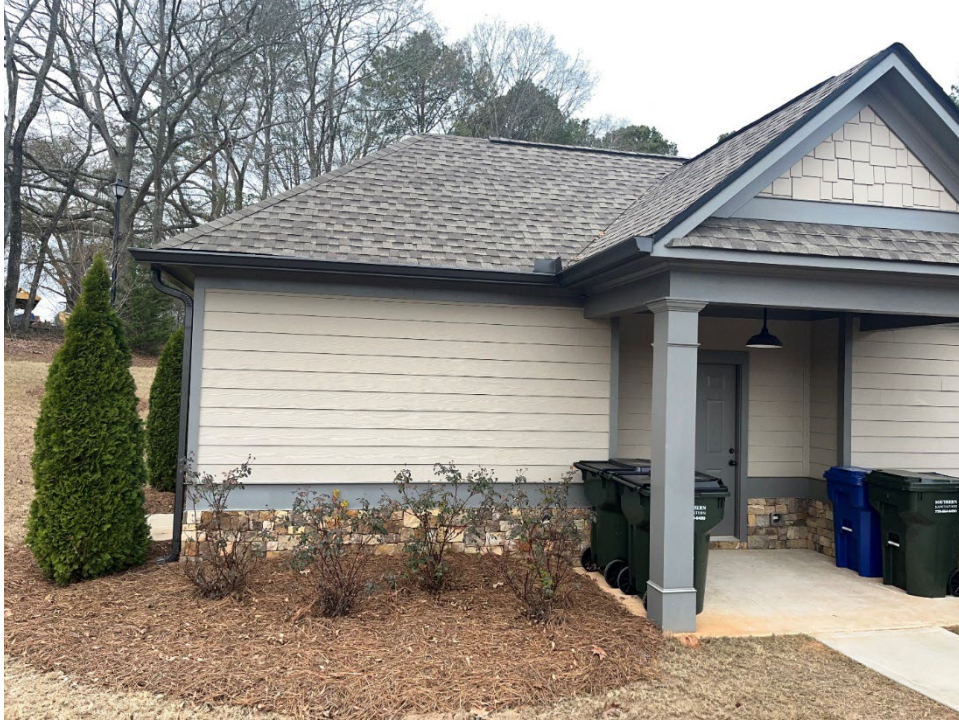
27. View of pool house.

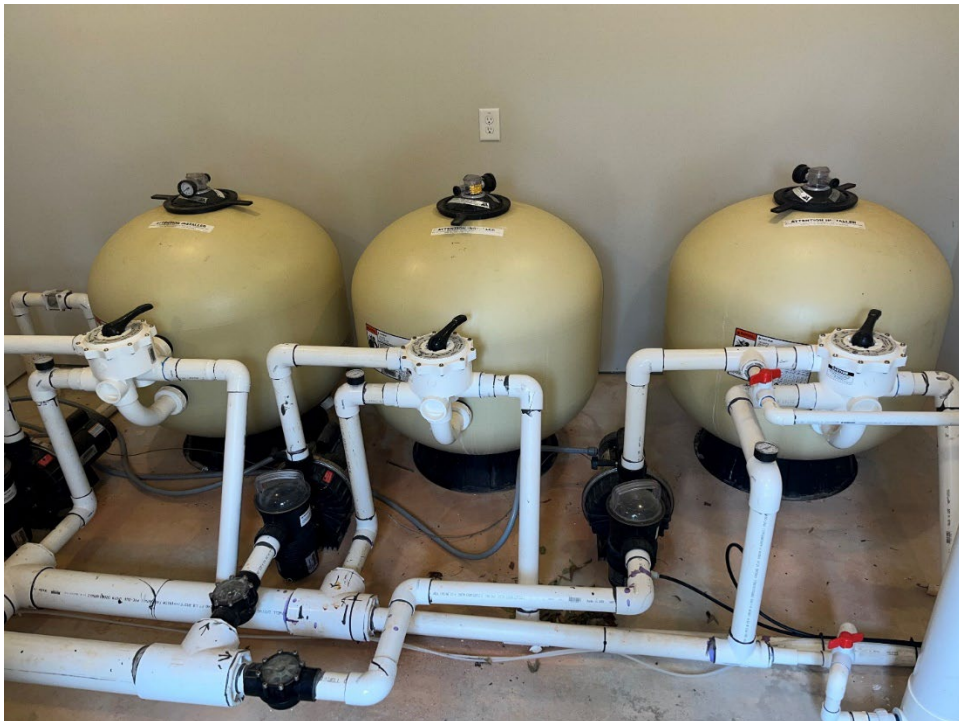
28. View of pool house interior.

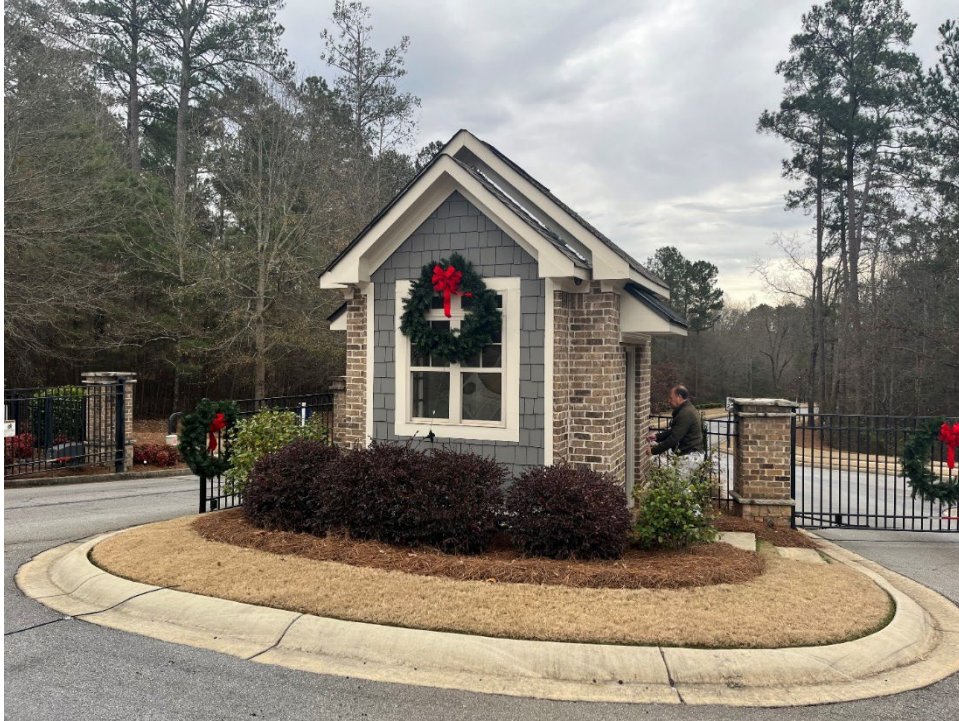
Based on our review, the gate, security system and guardhouse appear to be in generally good condition (reference photograph 29).

29. View of guardhouse and entry gates.

*It is recommended that a budget be allocated for the upgrading of the security*
