Upper South Branch Kishwaukee Watershed Inventory

August 7, 2019 Stakeholder Meeting
Steve Zimmerman, M.S. (AES Senior Ecologist)

Watershed Inventory Discussion Topics

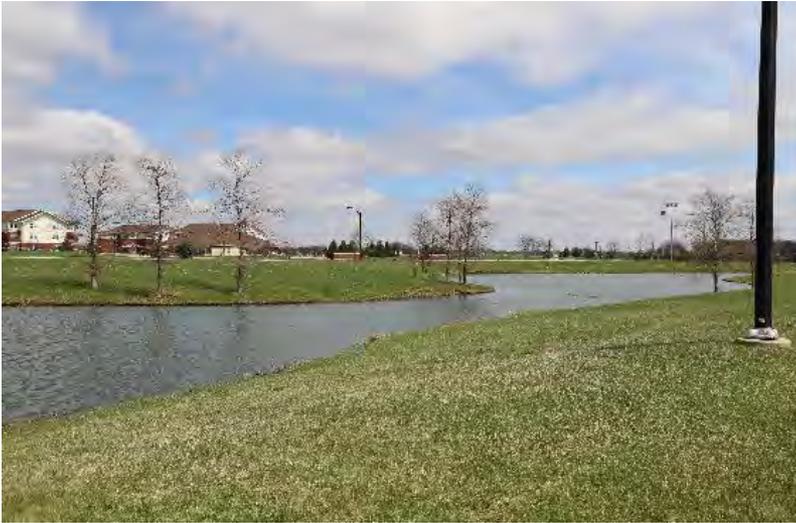
Typical Wet Bottom-Turf Slopes

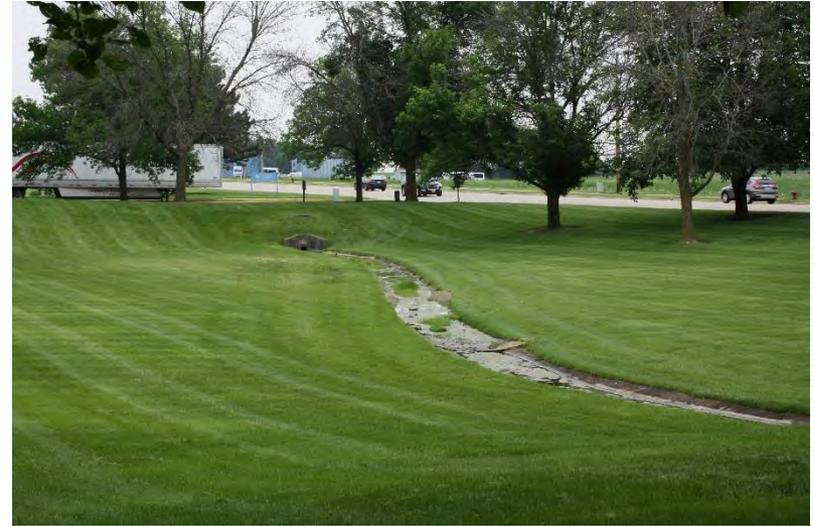
Typical Dry Bottom Turf w/Channel

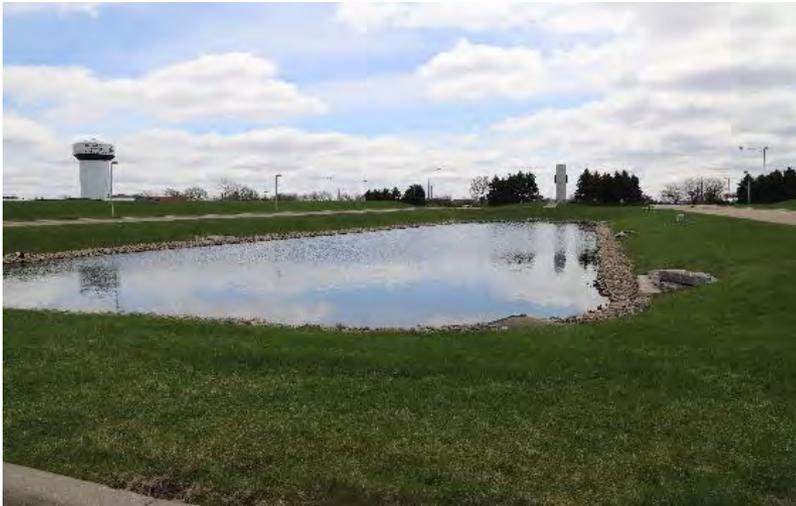
Typical Wet Bottom- Riprap Slope

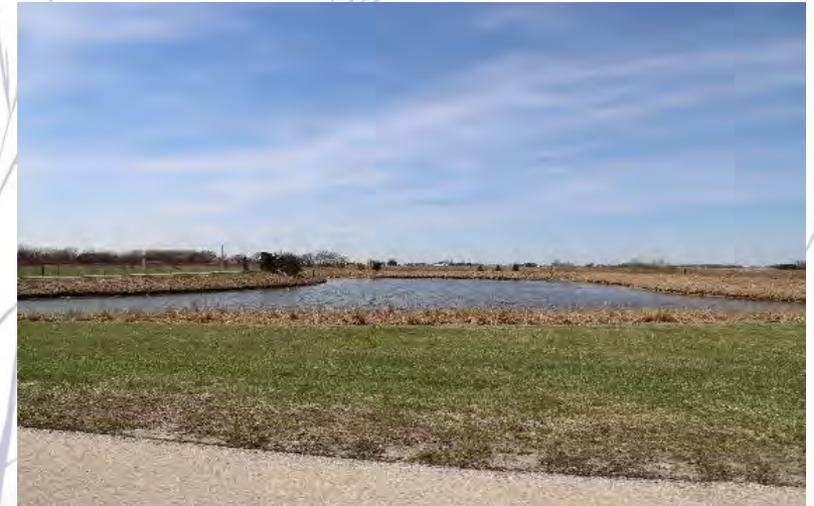
Typical Naturalized Wet Bottom

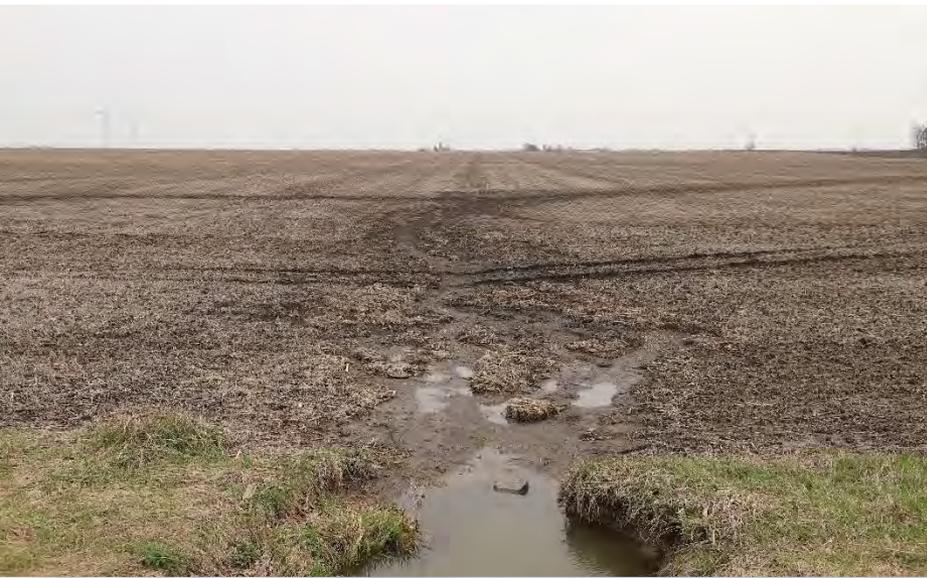
Eroded Swales

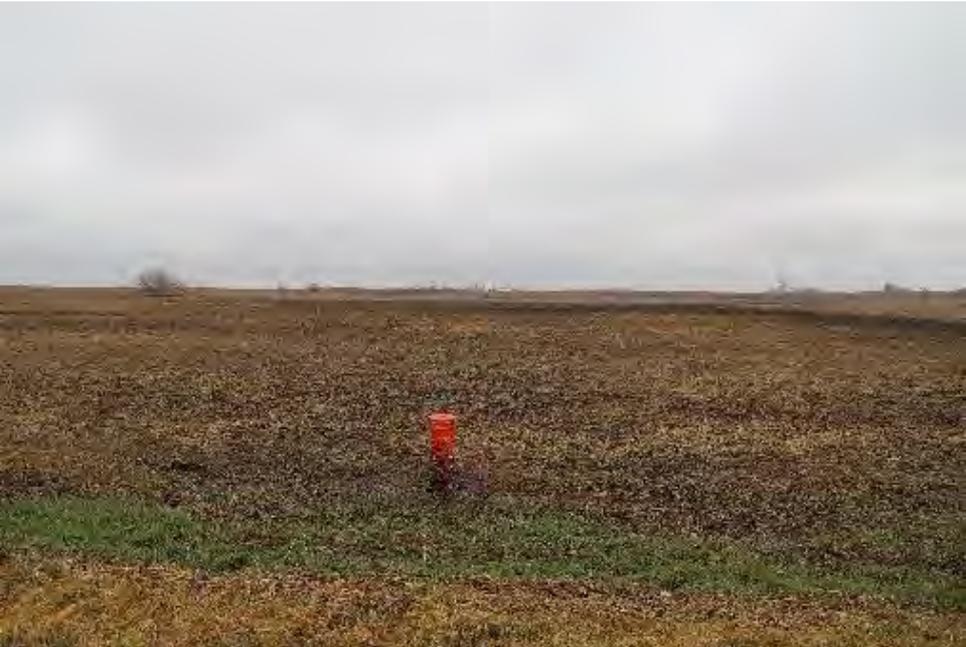
Riser Structure in Wetland

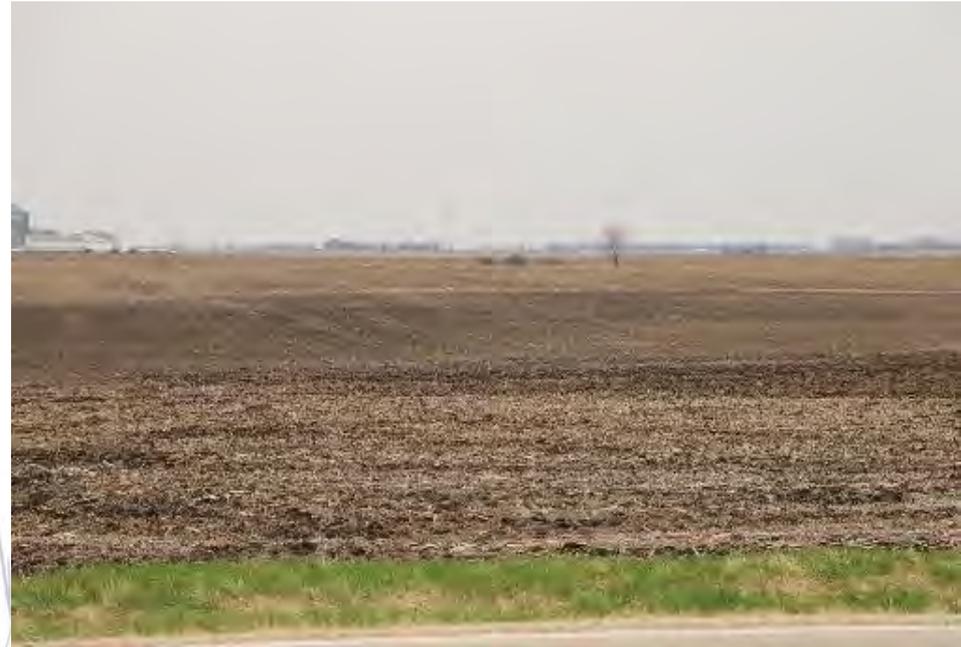
Typical Farmed Wetland
