Project: Flood Documentation

MEMORANDUM

RE: Flood Documentation June 8, 1987- Lena Gulch/Trib. "G"

At the request of Bill DeGroot, Urban Drainage and Flood Control District (UDFCD), we investigated the flooding which occurred in Lena Gulch between West 6th Avenue and West 32nd Avenue and Tributary G of Lena Gulch in the Cities of Lakewood and Wheat Ridge.

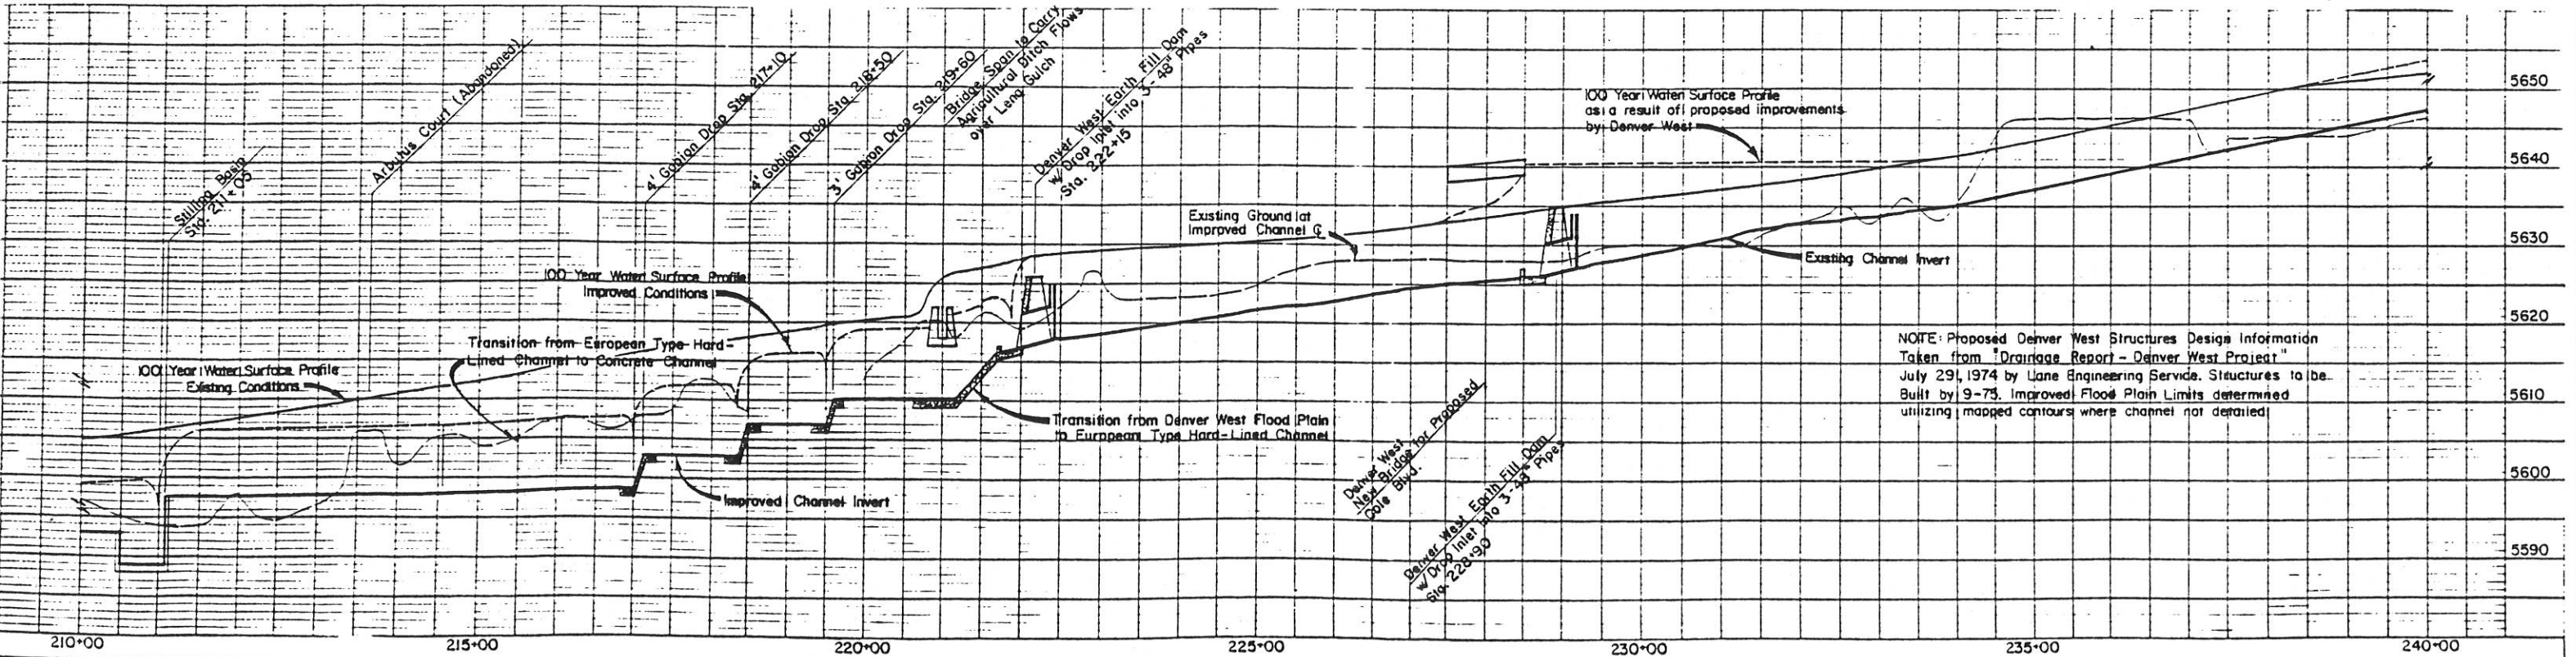
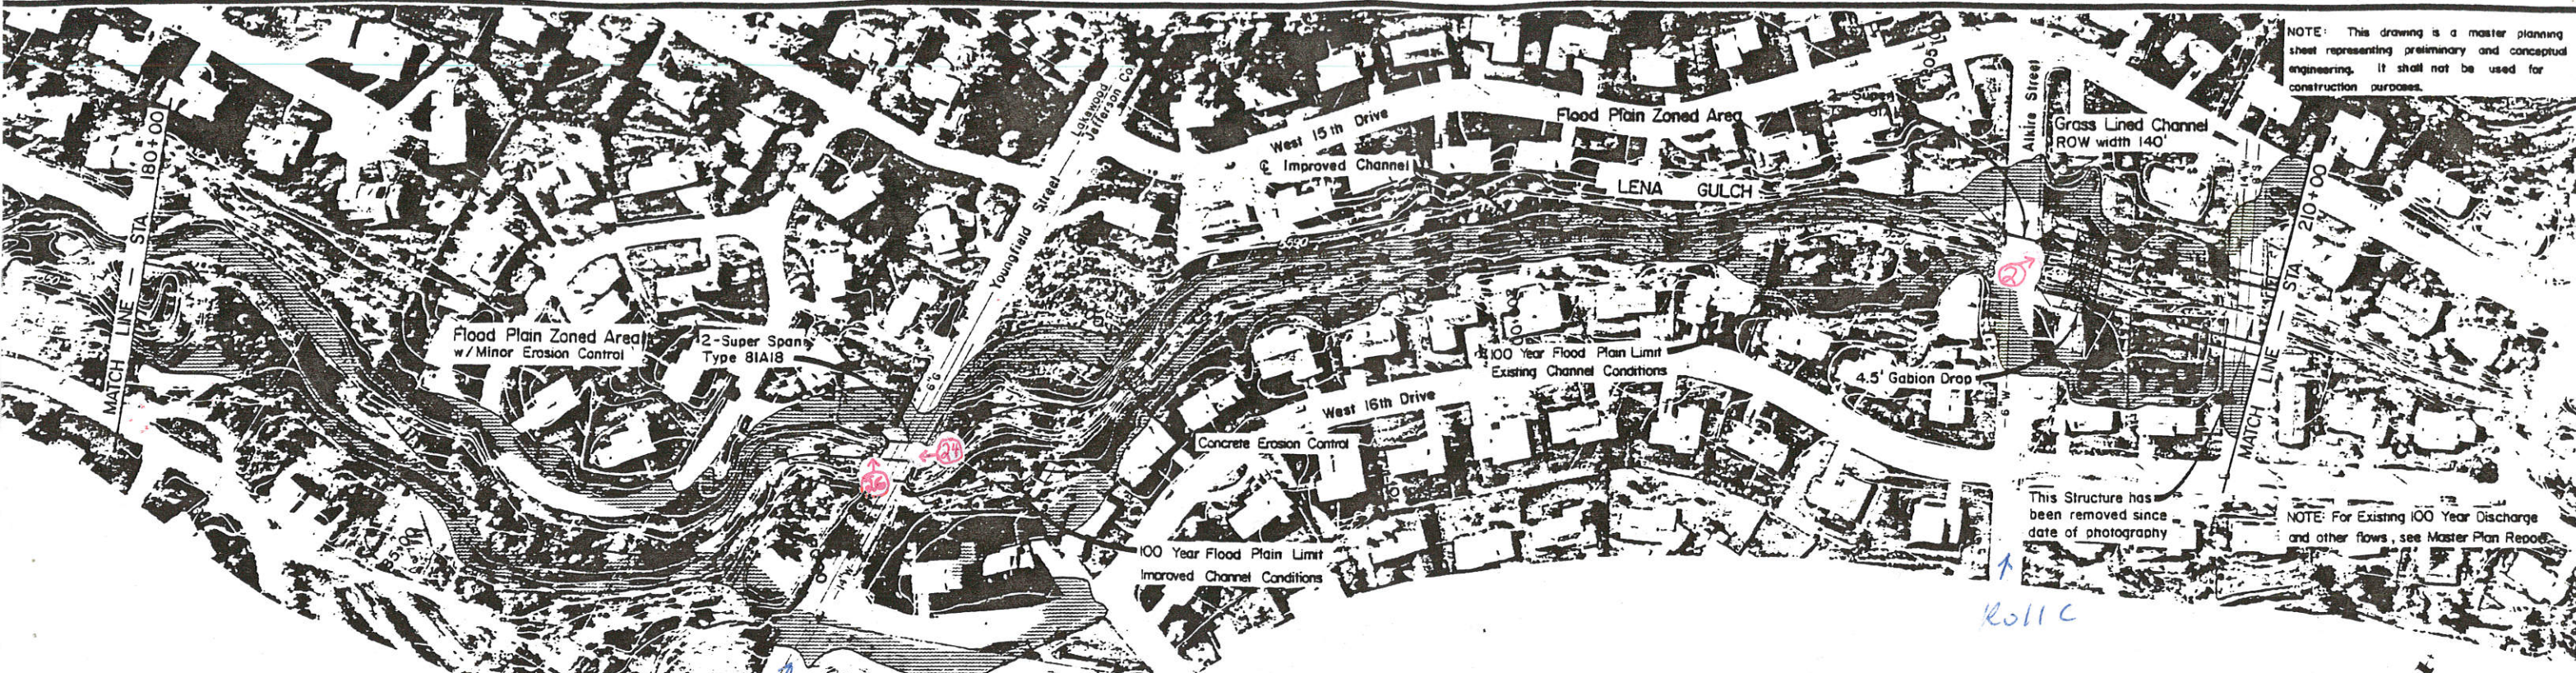
- #18 & #19 Lena Gulch just upstream of first (upper) pond in Denver West. Channel was heavily eroded (from south bank).
- #20 Dam for first (upper) pond in Denver West. Mud on grass indicates high water line (from south bank).
- #21 Second Lake in Denver West (from south bank).
- #22 Dam for 2nd pond. Water ran over dam at least 1 1/2 feet deep.
- #23 Dave shows big water mark in grass above second pond near dam (looking south from dam culvert inlet).

#17 through #23 Photos not located - channel highly altered. Rull B

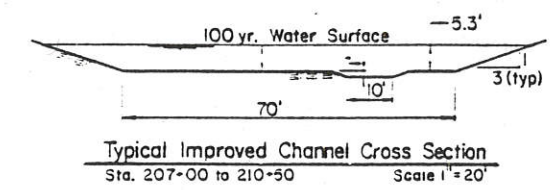
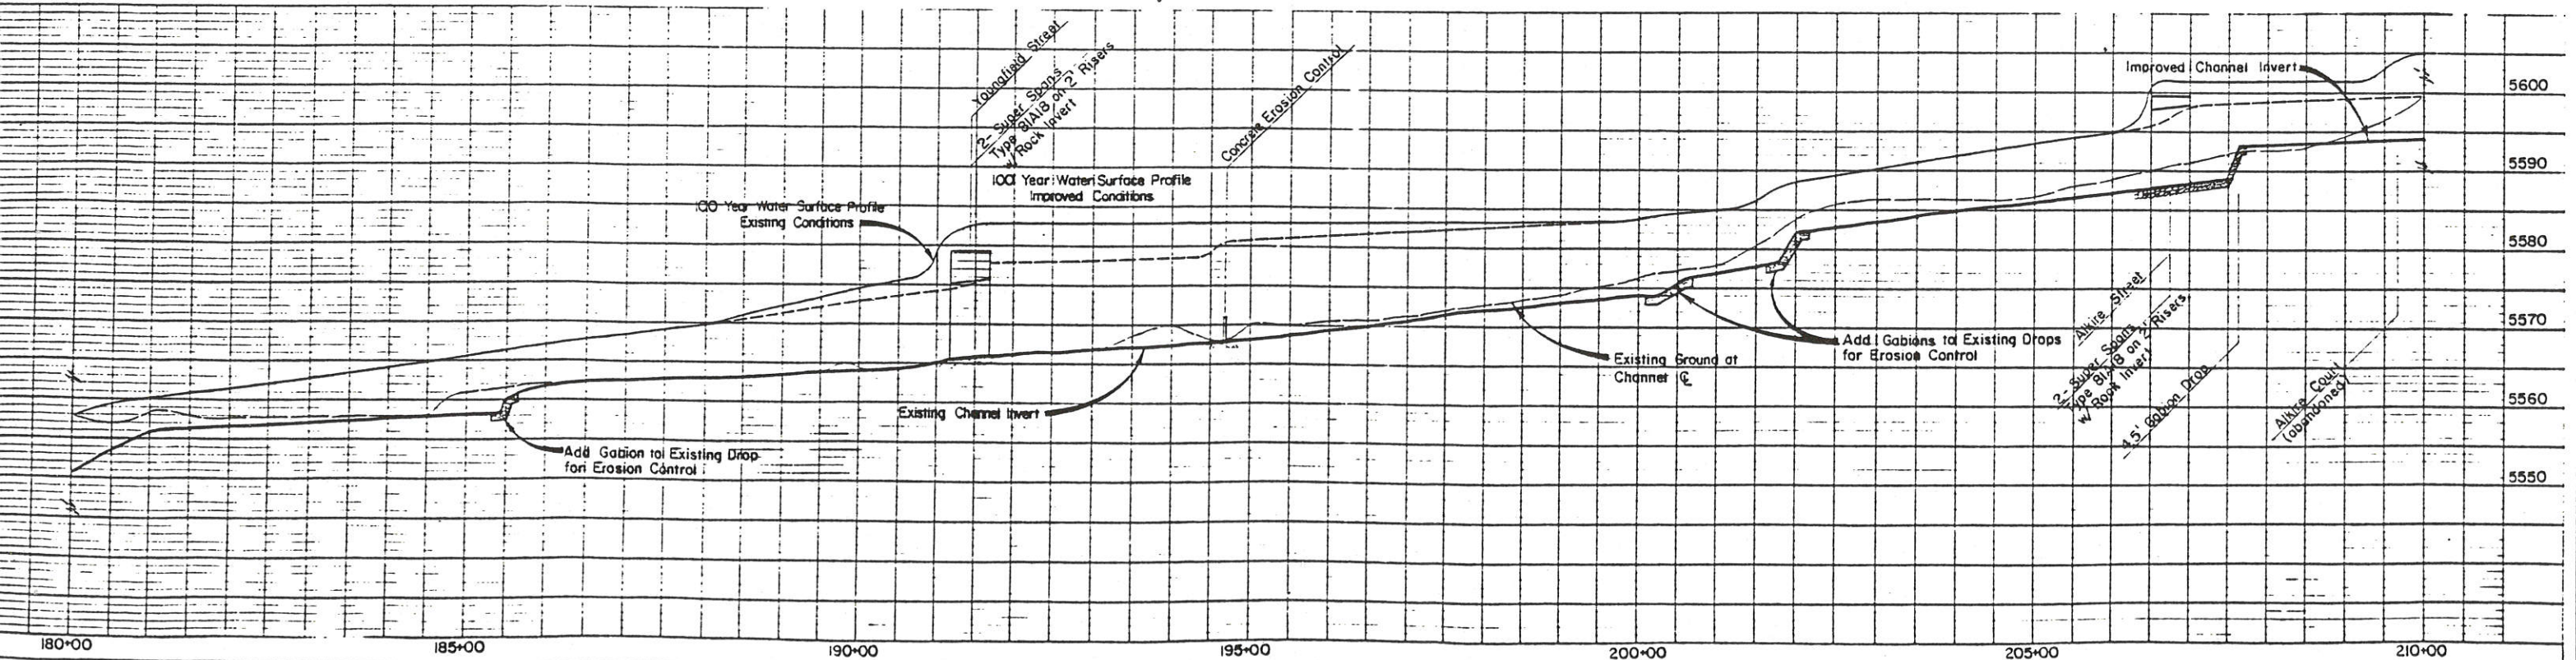
SHEET NO.
 12 OF 21

Lena Gulch came within a few feet of washing over Youngfield Street (see photo #24). Water backed up (approximately 10 feet) behind the road and culvert but because the gulch has high banks here. No property damage occurred.

- #24 Lena Gulch box culvert under Youngfield Street. Dave points to approximate high water line. Water backed up behind Youngfield culvert but channel has very high banks here so no property damage occurred.
- #25 No photo
- #26 Lena Gulch just below Youngfield, matted grass shows water line.

High water @ Youngfield
