Gingrich Home Inspections

Confidential Inspection Report

LOCATED AT:
1011 Ironwood Court
Leavenworth, KS 66048

INSPECTED ON:
Tuesday, August 3, 2021

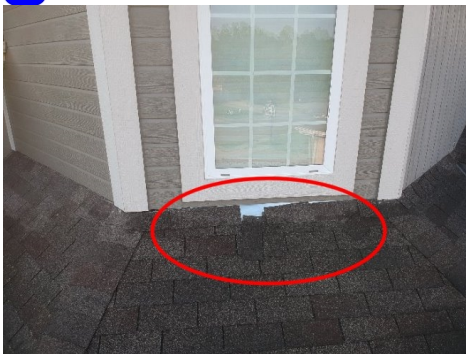
IMP 8: Upgrade: Loose and missing shingles were observed. All loose or missing shingles should be replaced.

IMP Upgrade: Loose and missing shingles were observed. All loose or missing shingles should be replaced.

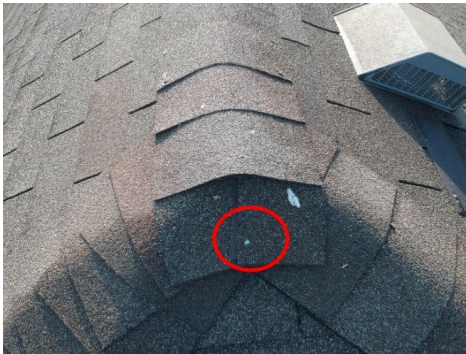
Upgrade: Nail heads are exposed. Recommend sealing fasteners.

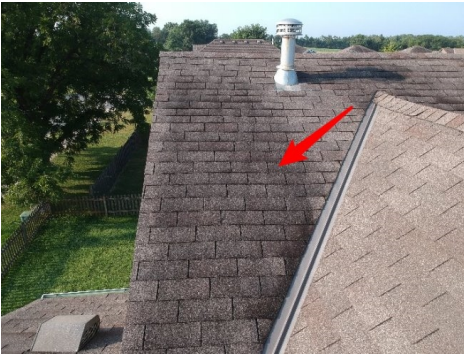
Monitor: The roofing is considered to be in fair condition. This roofing is wearing at uneven rates. The sides of the roof that are most exposed to the sun's light are wearing more quickly than the more shaded areas. Repair or replacement of deteriorated roofing may be needed in some areas, prior to the entire roof covering requiring replacement.

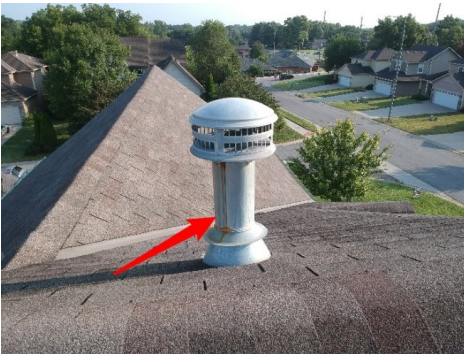
Upgrade: The metal flue for servicing the water heater and or furnace is rusted. This should be painted to prevent further deterioration.

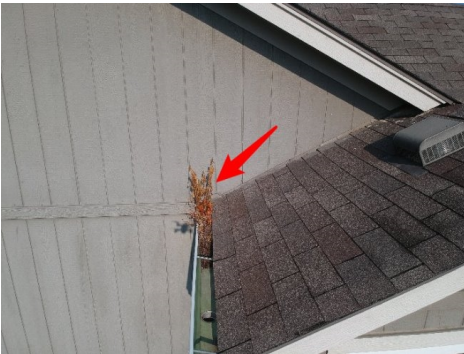
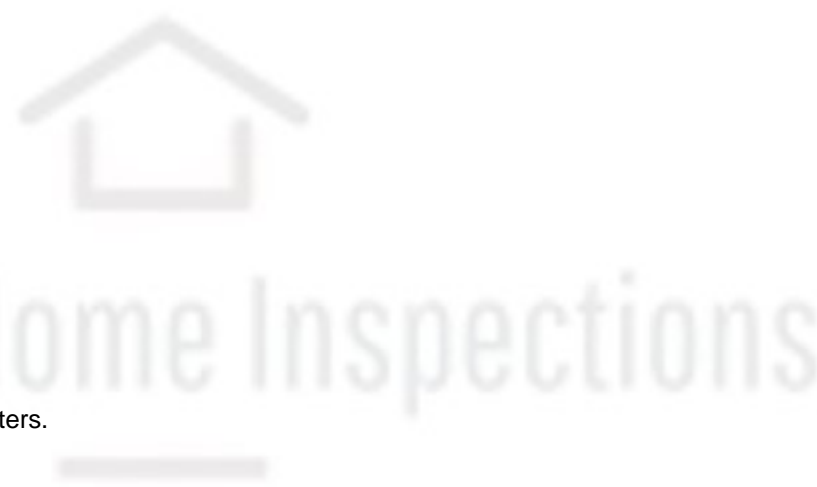
Upgrade: Debris should be removed from gutters.

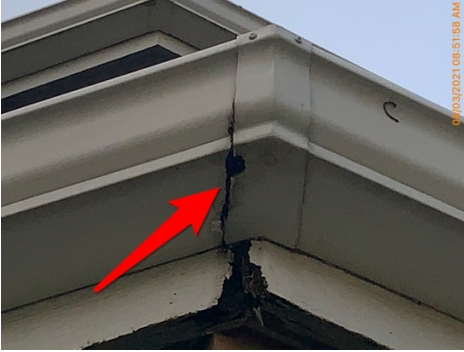
Upgrade: The gutters are leaking at some of the joints. Recommend the joints be repaired, patched and sealed.

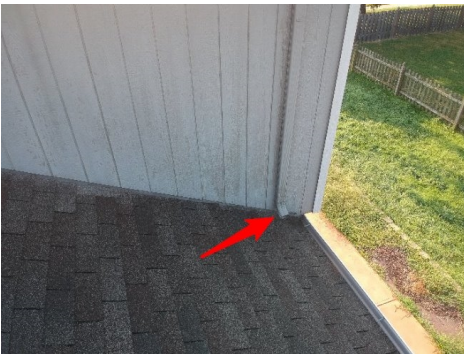
Upgrade: Downspouts that discharge onto the roof directly may affect the longevity of the shingles. Downspouts should be routed to the gutters directly.

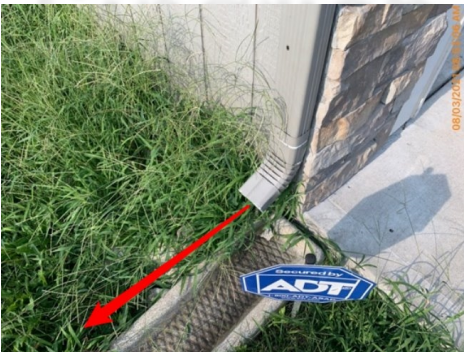
Upgrade: Recommend diverting all downspouts 5 feet or further from the house.

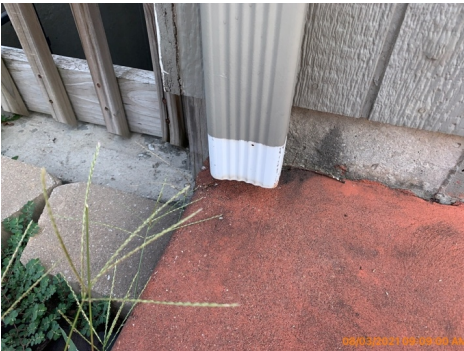
Upgrade: The downspout rear right corner has been damaged. Replacement is recommended.

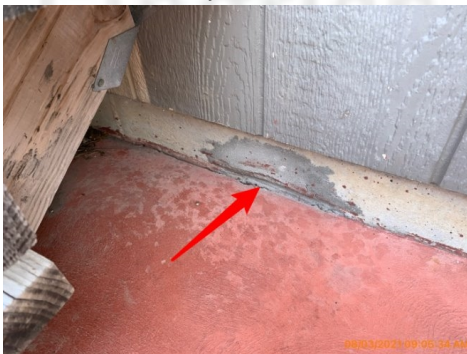
Monitor: Prior repairs were noted to the foundation. It may be wise to consult the seller as to when and what repairs became necessary.

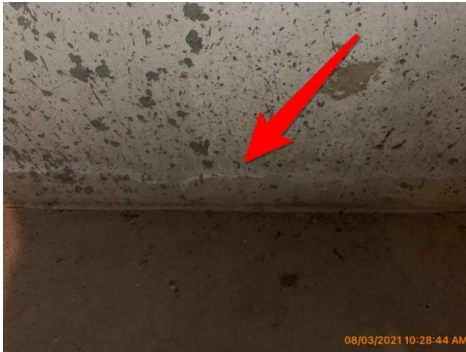
Efflorescence (white chalky discoloration) often indicates an occasional surplus of moisture on the outside of the slab. Steps should be taken to improve the exterior drainage, but no other action is indicated at this time.

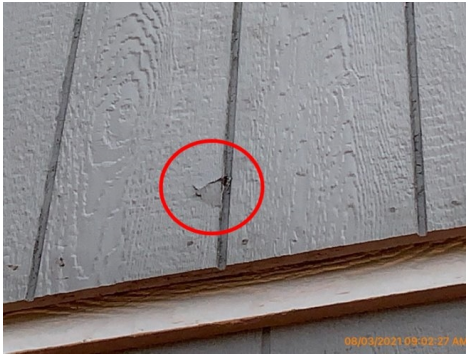
Upgrade: Damaged siding should be repaired or replaced as needed.

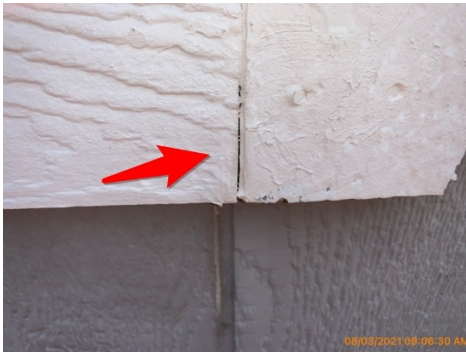
Upgrade: There are openings at seams and joints of the trim in various locations on the exterior. Recommend re-caulking and sealing to prevent moisture entry and damage.

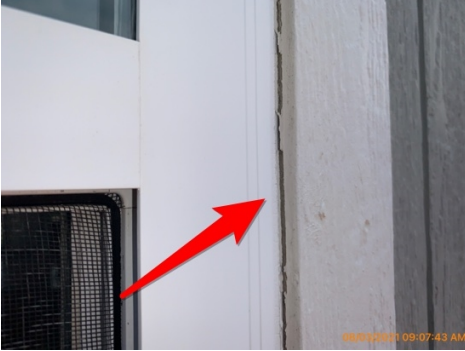
Upgrade: The window frames require painting and caulking.

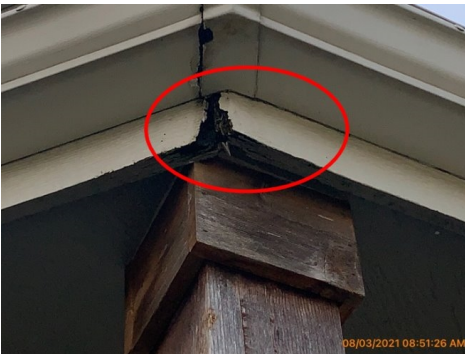
Upgrade: Sections of the fascia at the front wall show signs of rot.

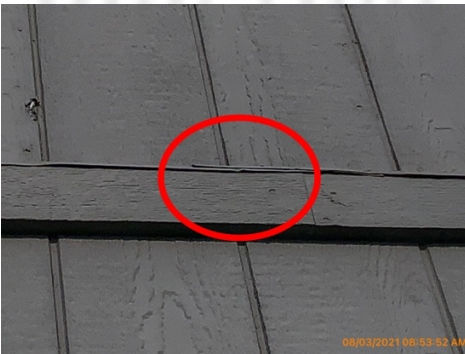
Upgrade: Flashing should be caulked at left side of the house.

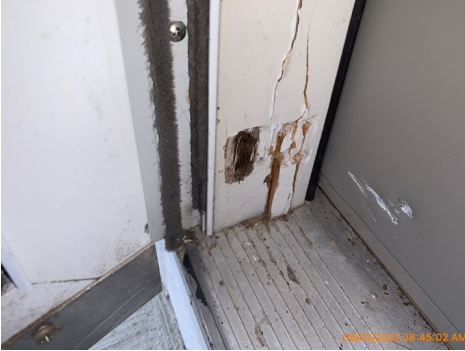
Upgrade: The door jamb to the front door is damaged. Recommend it be repaired or replaced as necessary.

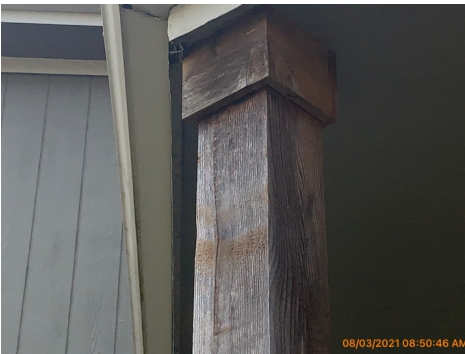
Monitor: The porch columns are weathered and should be stained or painted.

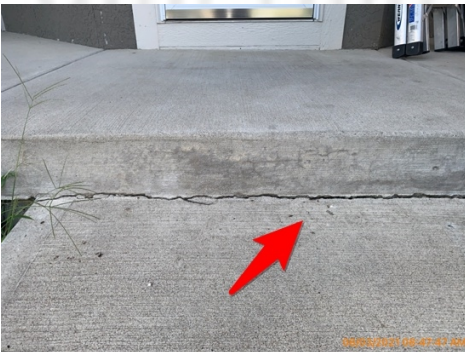
Upgrade: The walkway at the front door has settled in relation to the front porch.

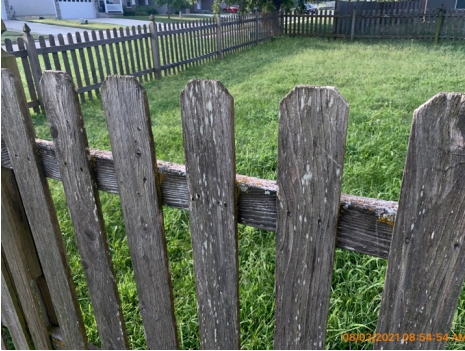
Upgrade: The fencing is generally serviceable but shows signs of routine wear and is in need of minor maintenance.

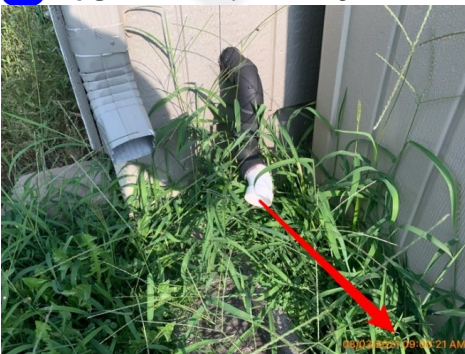
IMP 9: Upgrade: Sump discharge should be extended ten feet or further from the house.

IMP Upgrade: Sump discharge should be extended ten feet or further from the house.

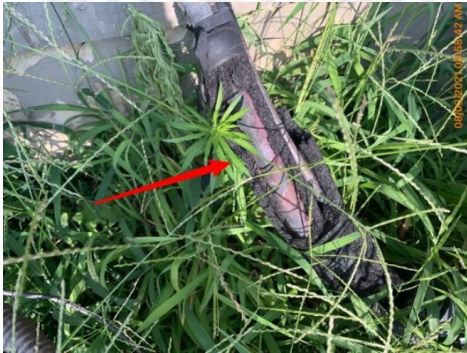
Upgrade: Damaged insulation on refrigerant lines should be repaired.

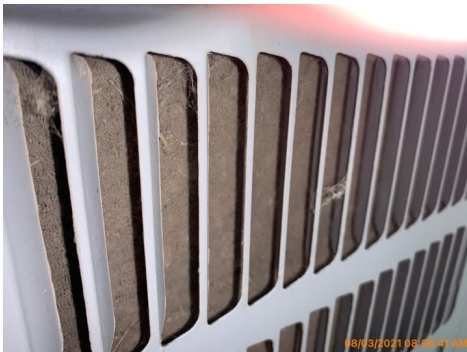
Upgrade: Fins on the unit require cleaning.

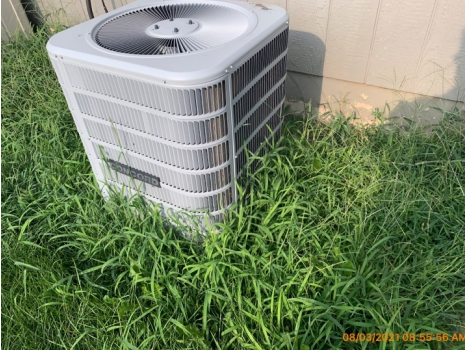
Upgrade: Recommend vegetation be cut back to provide three feet of clearance from the unit.

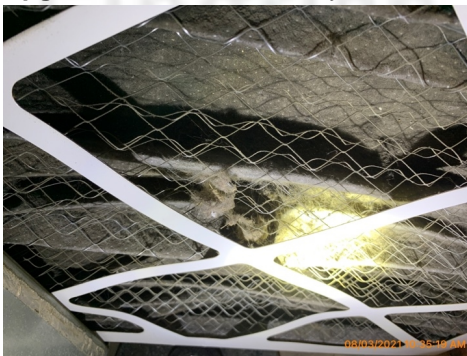
Upgrade: The air filter is dirty and should be replaced.

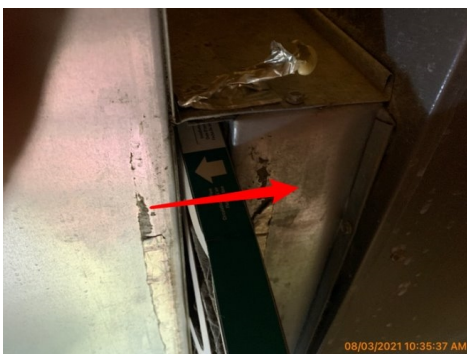
Upgrade: The air filter for the supply air has been inserted backwards. The air flow arrow should point towards the furnace unit.

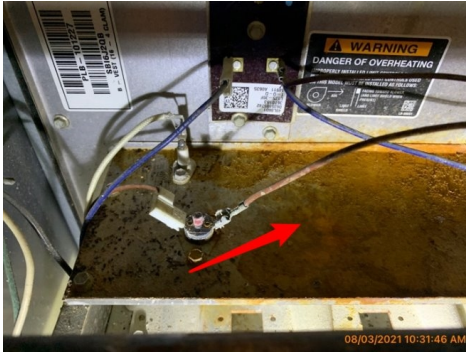
Monitor: Some evidence of prior condensate leakage was noted on the unit. This condition requires close monitoring.

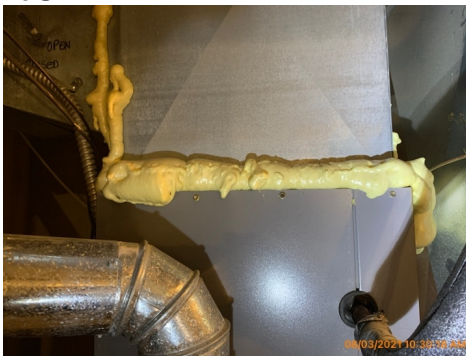
Upgrade: Recommend a HVAC technician be consulted. Foam being used is inadequate in sealing ductwork.

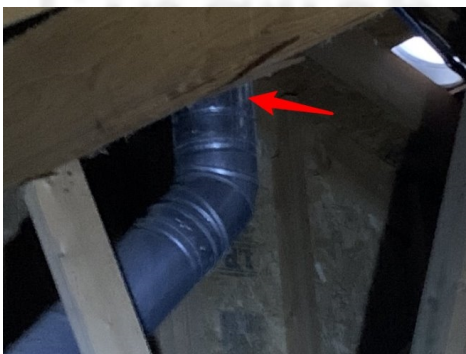
Upgrade: The skirt over the flashing for the exhaust flue should be caulked to prevent further water streaking down the outer skin of the flue in the attic.

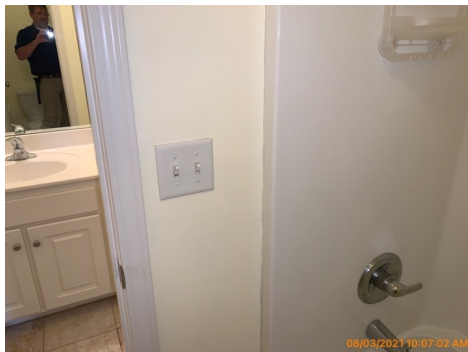
WRN: 2: Warning: It was observed during the course of the inspection a light switch in close proximity to the shower in the Jack and Jill bathroom. If there is a short within the switch this could lead to shock hazard if in the shower. This should be improved for safety reasons.

WRN: Warning: It was observed during the course of the inspection a light switch in close proximity to the shower in the Jack and Jill bathroom. If there is a short within the switch this could lead to shock hazard if in the shower. This should be improved for safety reasons.

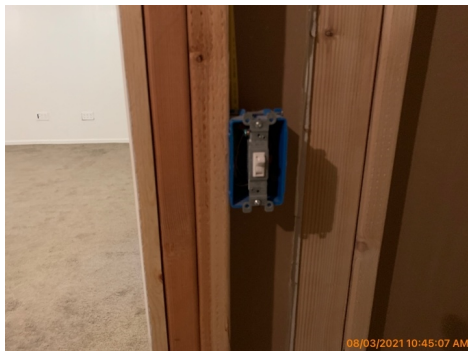
Upgrade: Switch plates are missing in the basement storage room. Recommend cover plates to reduce the risk of electrical shorts and hazardous shocks.

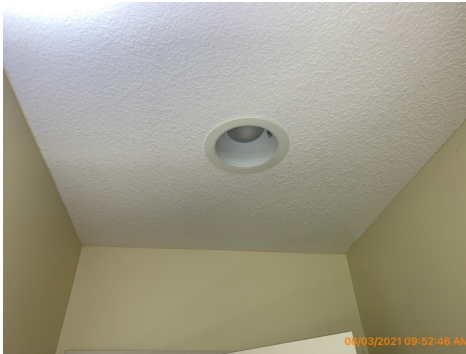
Upgrade: Light in the master bedroom was not working at the time of the inspection. The bulbs may have burned out. Where bulbs are not the problem, the condition of the fixtures and/or wiring should be verified.

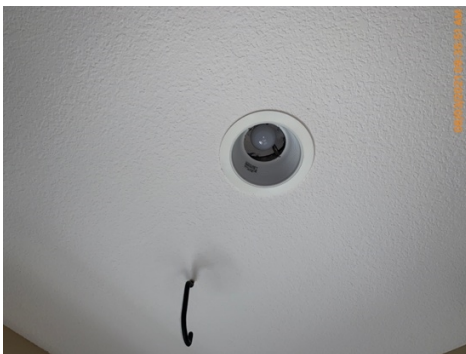
Upgrade: The current bulbs in the can lighting system may not be suitable for the fixture. Bulbs appropriate for fixtures should be used.

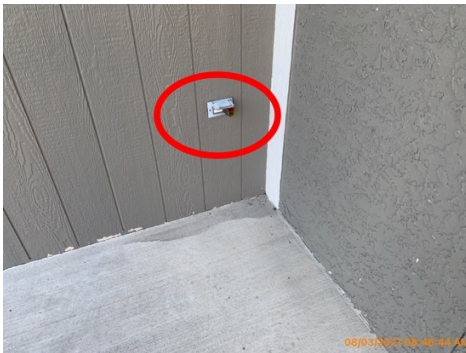
Upgrade: A ground fault circuit interrupter (GFCI) outlet did not respond correctly to testing during the inspection in the areas GFCI's are located. These receptacles should be replaced.

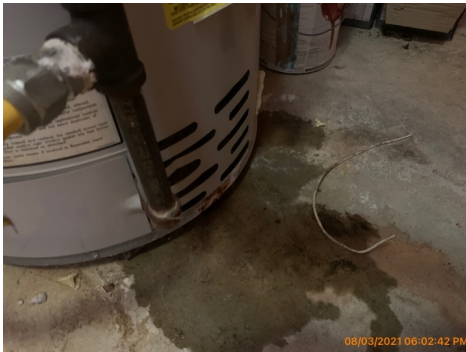
IMP 11: Upgrade: The Temperature and Pressure Relief (TPR) Valve serving the water heater is leaking slightly. Minor repairs or cleaning can usually rectify this condition.

IMP Upgrade: The Temperature and Pressure Relief (TPR) Valve serving the water heater is leaking slightly. Minor repairs or cleaning can usually rectify this condition.

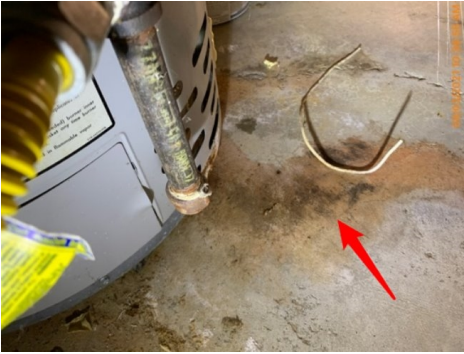
Monitor: The water heater shows evidence of prior leakage. This should be carefully monitored.

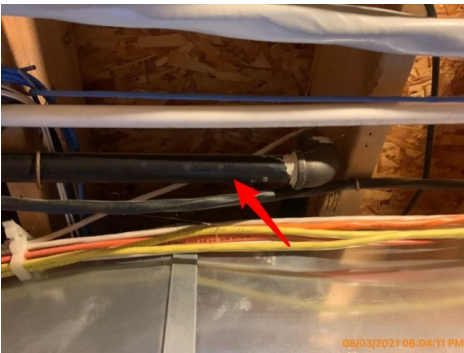
WRN: 3: Warning: No visible electrical bonding was observed on the gas piping system. The pipe manufacturers recommend this type of pipe be electrically bonded to the ground source for the electric service to prevent pipe damage caused by arcing during certain circumstances, such as a direct or indirect lightning strike. It is possible the gas pipe system is bonded at a location concealed by finish surfaces. Verifying the presence of a suitable ground and bonding connection is outside the scope of this inspection.

WRN: Warning: No visible electrical bonding was observed on the gas piping system. The pipe manufacturers recommend this type of pipe be electrically bonded to the ground source for the electric service to prevent pipe damage caused by arcing during certain circumstances, such as a direct or indirect lightning strike. It is possible the gas pipe system is bonded at a location concealed by finish surfaces. Verifying the presence of a suitable ground and bonding connection is outside the scope of this inspection.

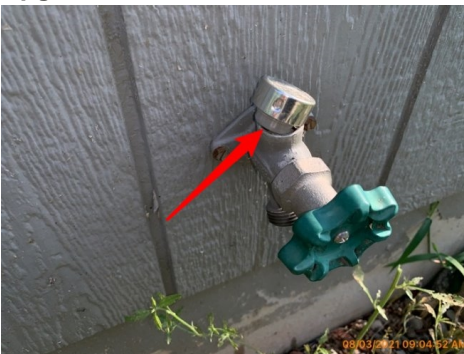
Upgrade: The hose bib at rear wall is damaged.

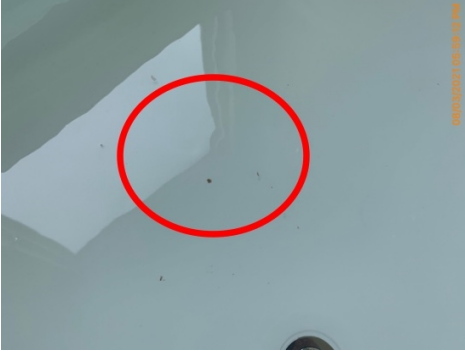
Upgrade: Due to ejection of mold or other organic growth from the jets during operation, it is recommended the whirlpool bath be professionally cleaned and sanitized.

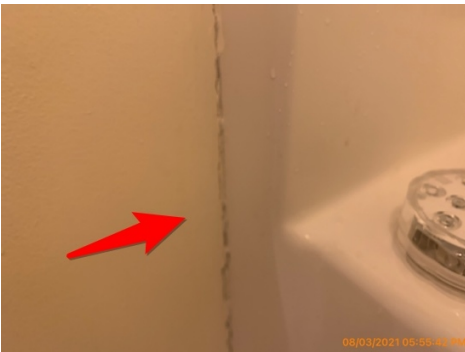
Upgrade: Cracked, deteriorated caulking missing around bathtub. Caulking should be replaced.

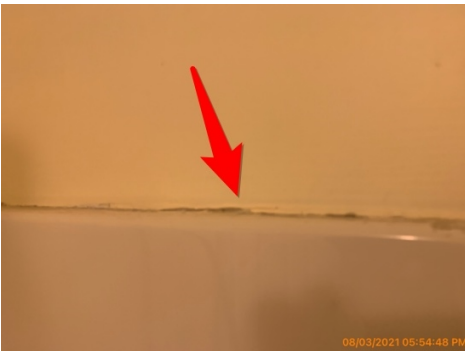
Upgrade: Missing caulk along the top edge of the shower tile enclosure should be replaced.

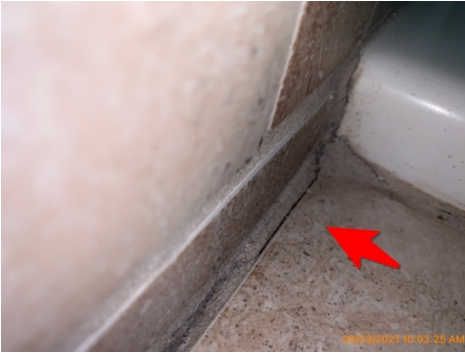
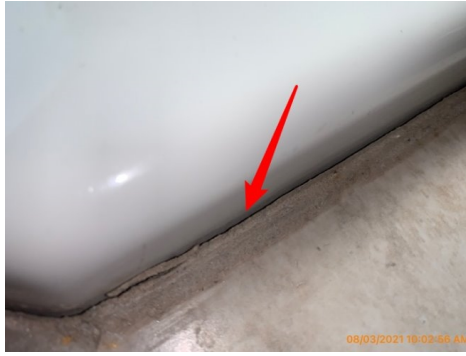
Upgrade: Cracked, deteriorated and/or missing shower stall grout and caulk should be replaced.

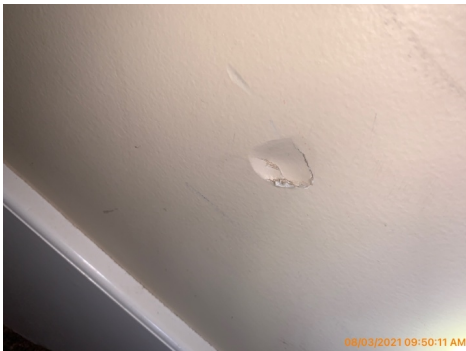
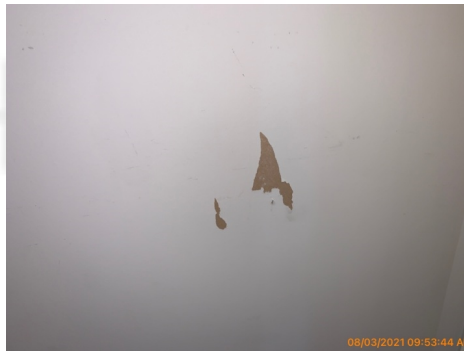
Upgrade: Damage to the interior finish was observed.

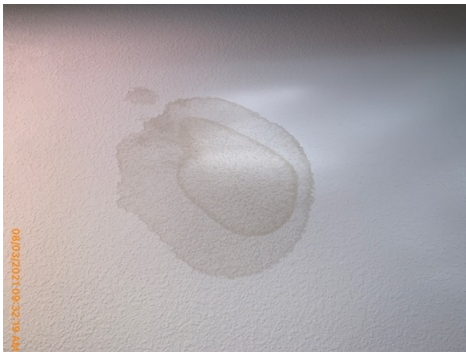
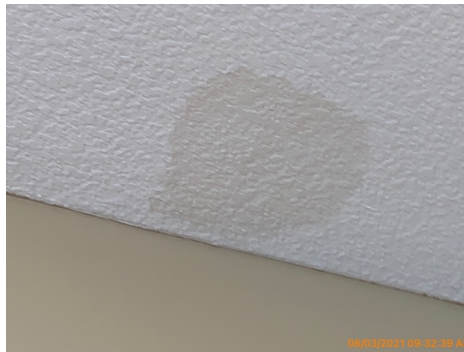
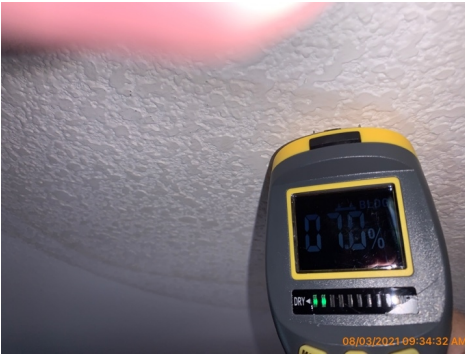
Monitor: Water staining was noted in the kitchen. The stain tested dry with a moisture meter at the time of inspection.

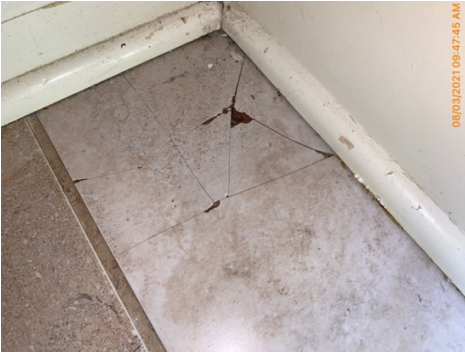
Upgrade: The tile floor is cracked in the powder room.

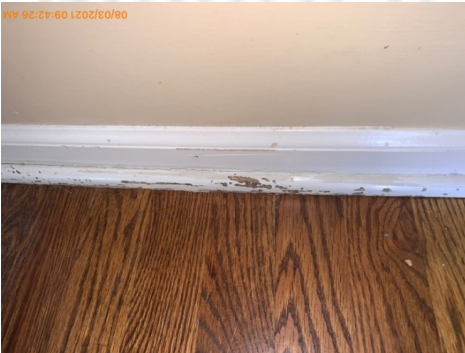
Upgrade: The trim is damaged.

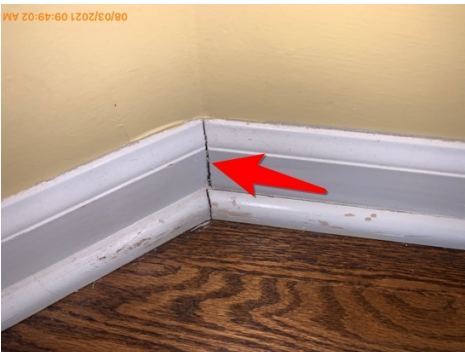
Upgrade: Trim should be caulked in various locations.

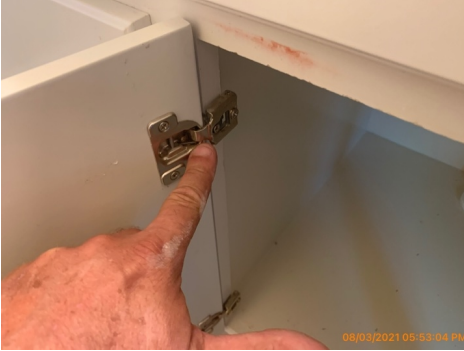
Upgrade: Loose hinges for the bathroom cabinets should be improved.

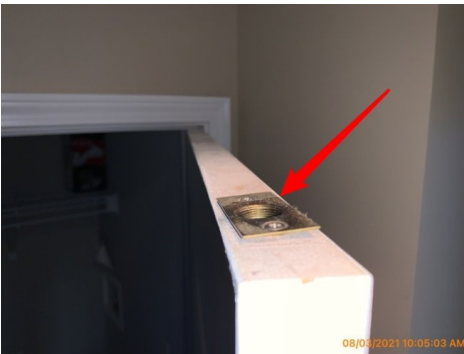
Upgrade: The bullet catch hardware is damaged or missing on the doors at the following locations: .

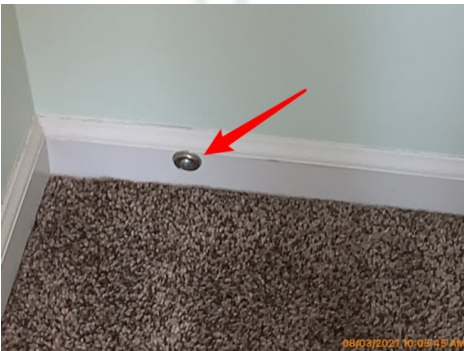
Upgrade: The installation of door stoppers will help in reducing damage to interior finishes.

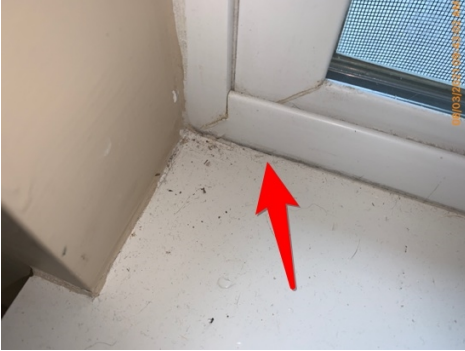
Upgrade: The inside frames of the windows require caulking in various locations.

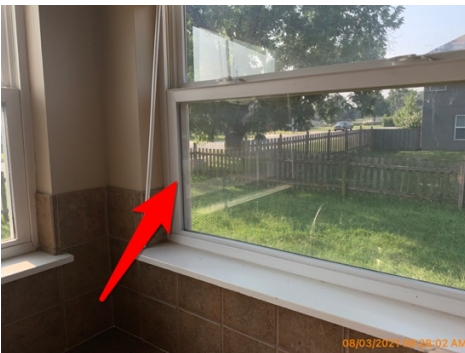
Upgrade: The operation of the window in the kitchen is rough. Recommend it be cleaned, lubricated, and adjusted for smoother operation.

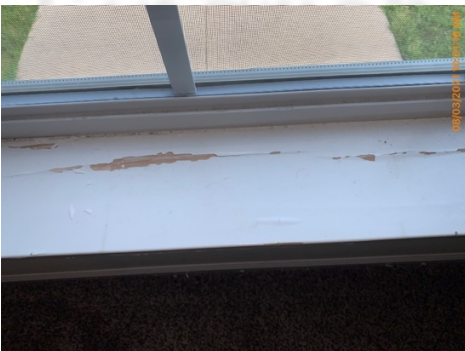
Upgrade: Water stains were observed on some of the window sills. Sealing or painting windows to protect against the elements is recommended.

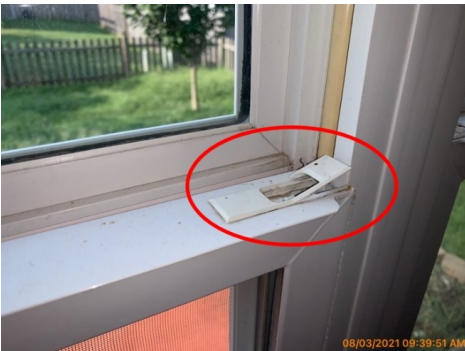
Upgrade: Window tilt latch hardware is damaged.

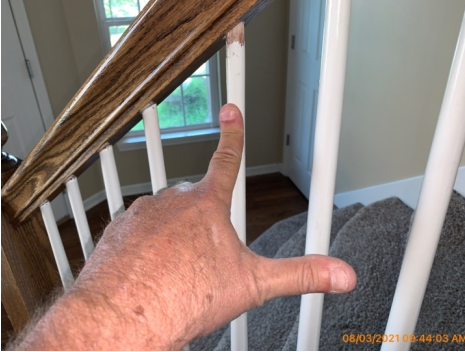
WRN: 4: Warning: The baluster servicing the stairs to the second floor is loose and should be repaired for safety reasons.

WRN: Warning: The baluster servicing the stairs to the second floor is loose and should be repaired for safety reasons.

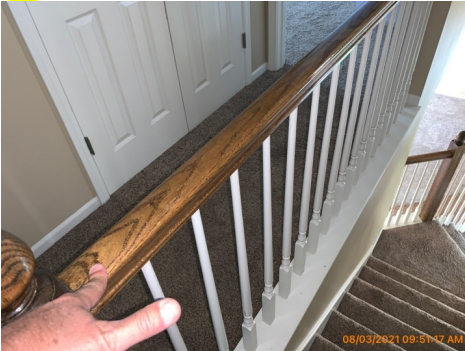
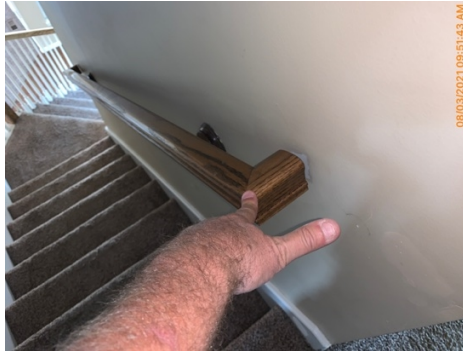
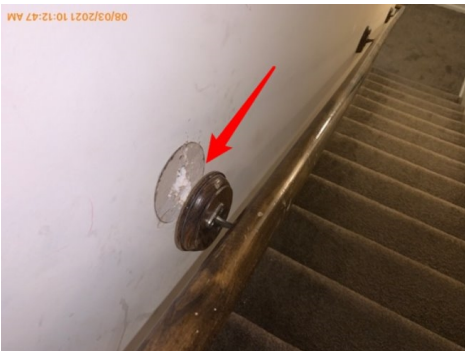
WRN: 5: Warning: The loose handrail should be better secured.

WRN: Warning: The loose handrail should be better secured.

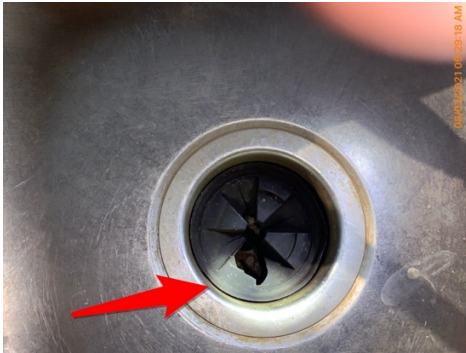
Upgrade: The splash guard for the waste disposer is damaged.

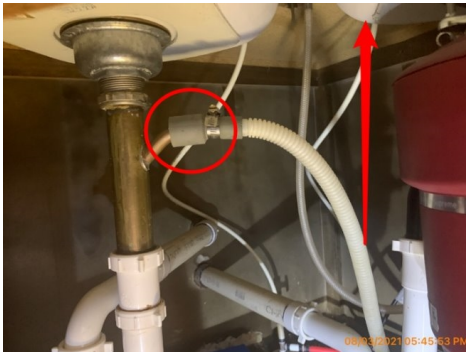
Upgrade: For proper operation, the dishwasher waste line should loop above or higher than the connection point under the sink.

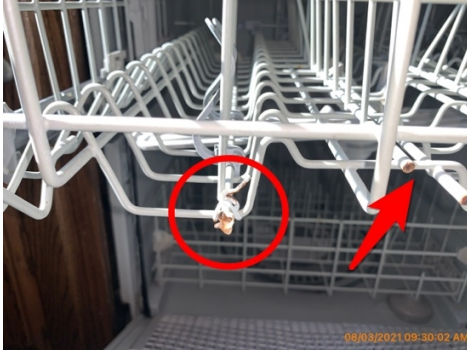
Upgrade: The dishwasher racks/rollers are in less than ideal condition.

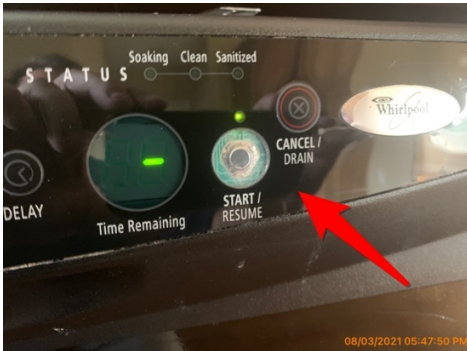
Upgrade: Dishwasher start button is damaged.

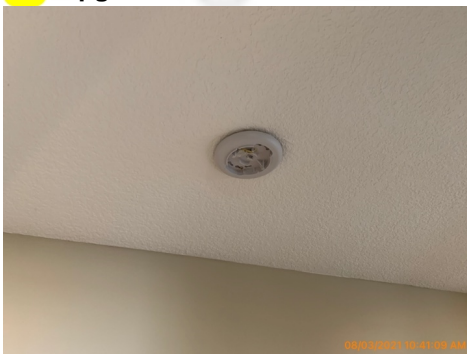
WRN: 7: Upgrade: Smoke Detector is missing in the upper hallway. Recommend installing missing smoke detector.

WRN: Upgrade: Smoke Detector is missing in the upper hallway. Recommend installing missing smoke detector.
