# PROPERTY INSPECTION REPORT

**Concerning:** 1977 build - 2619 sf, Houston, TX 77071  
(Address or Other Identification of Inspected Property)

**By:** David Gibbs, Lic #7406 TREC Professional Inspector 02/09/2021  
(Name and License Number of Inspector) (Date)

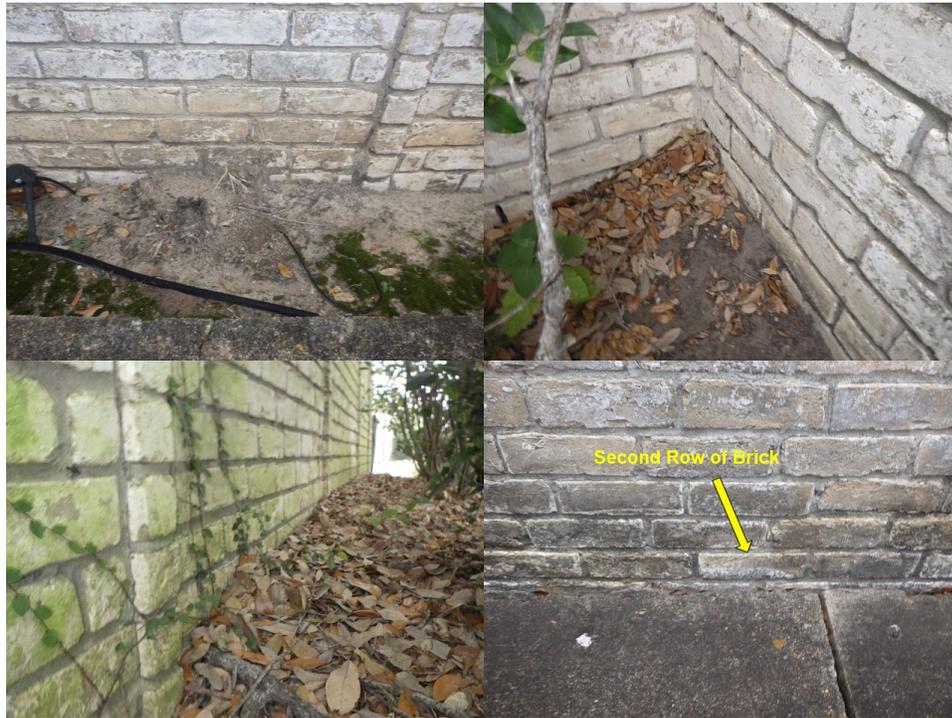
The concrete walkway and soil level was too high in some areas (above top of foundation). Common industry practice requires a clearance of at least 4 inches between grade level and bottom of masonry veneer. High soil level promotes water penetration / wood rot and is considered a conducive condition to termite activity. We recommend repair as necessary.

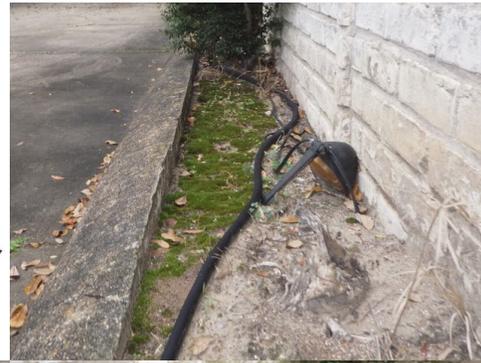
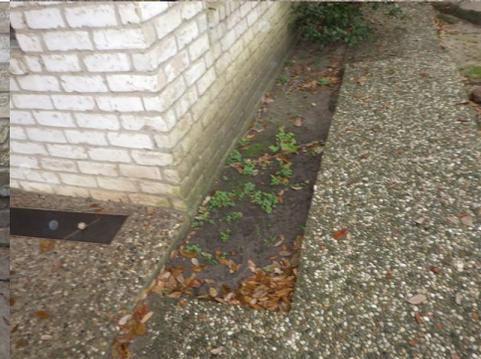
Soil grading had depressions or inadequate / negative slope in some areas and did not appear to properly direct runoff water away from foundation as required according to today's standards (6" drop in 10' Ref: IRC 401.3). This may promote water penetration, adversely affect the foundation and cause differential settlement. We recommend repair as necessary.

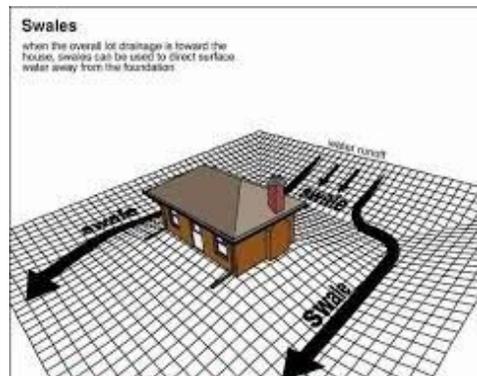
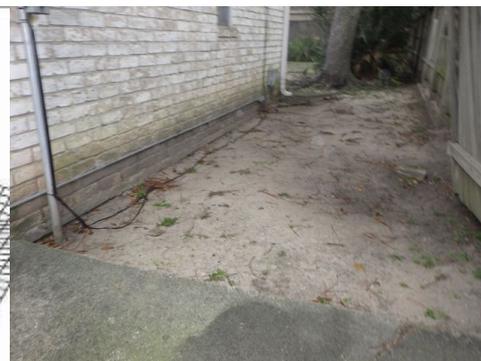
The drainage swale was not continuously sloped to street as required according to today's standards, may cause water ponding at sides and rear of house. We recommend repair as necessary to promote proper drainage away from foundation and extend service life of fence.

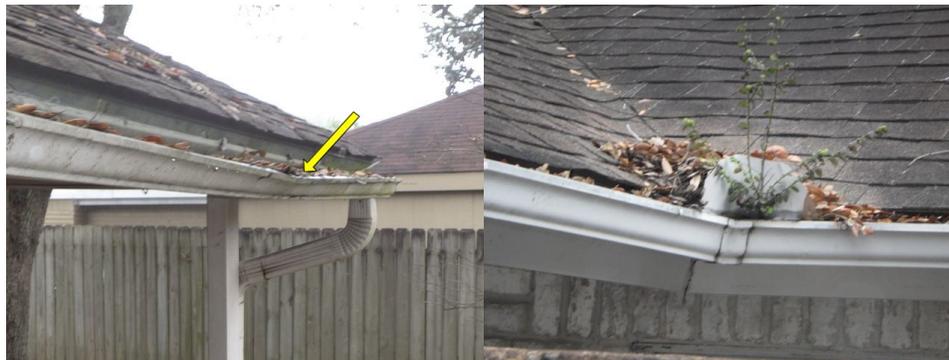
The gutters were damaged in one or more areas, had accumulated debris preventing proper drainage. We recommend all debris be cleared.

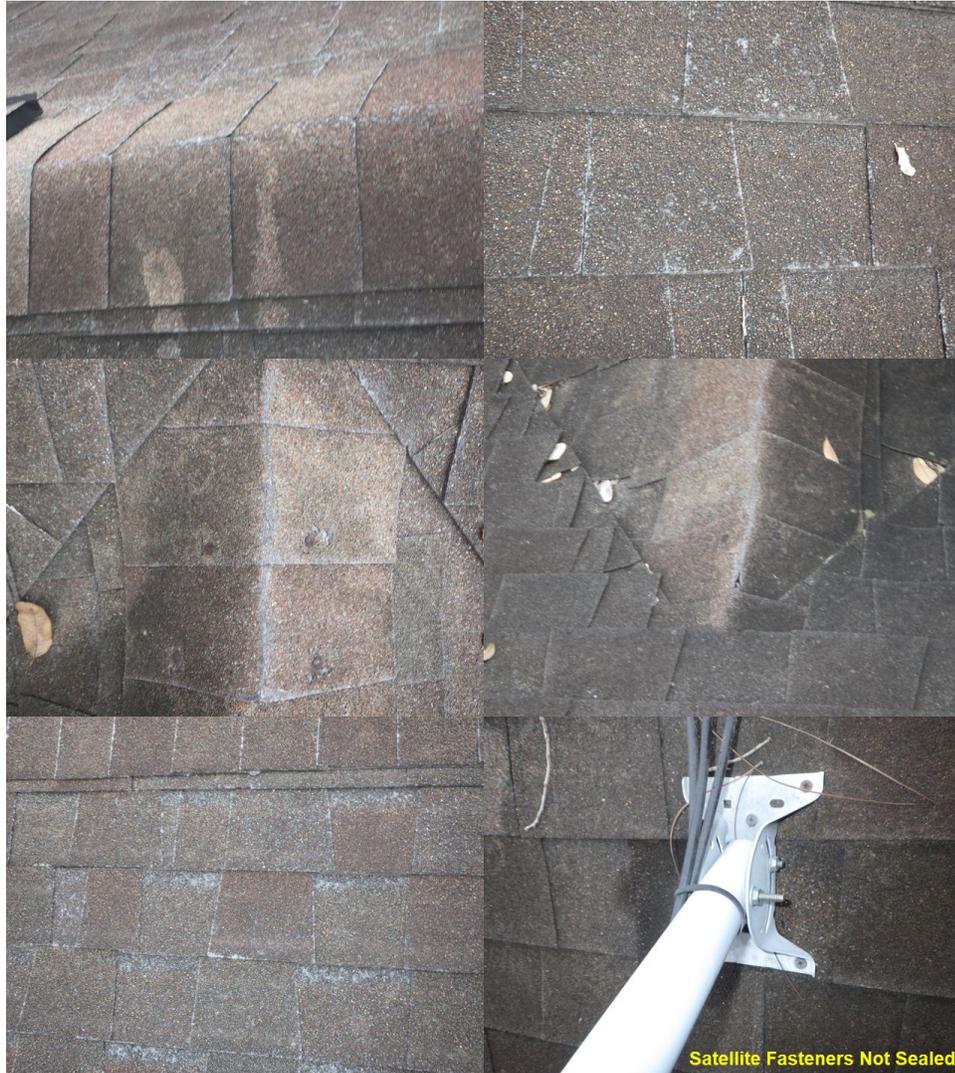
Roof appeared to be late in service life. Observed exposed fasteners, cracked ridges and excessive granular loss of shingles. We recommend preventive maintenance, repair or seal any cracks and exposed fasteners to prevent water penetration.

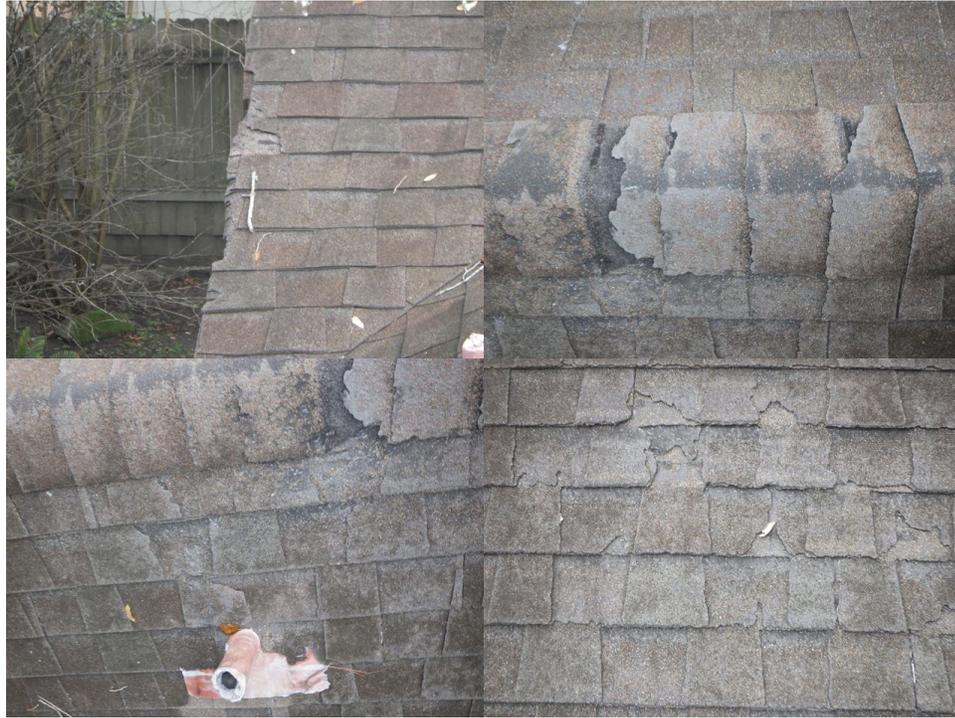
Damaged (broken, torn etc.) shingles were observed caused by contact with trees. We recommend further inspection by a specialist contractor and repair or replace as necessary to prevent water penetration.

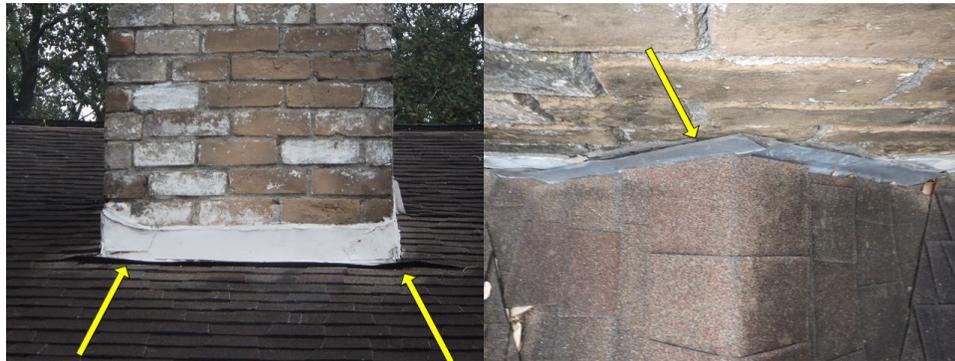
Observed lower edge and upper edges of chimney flashings were loose or not sealed down. Wind driven rains can cause water penetration. We recommend repair or replace as necessary.

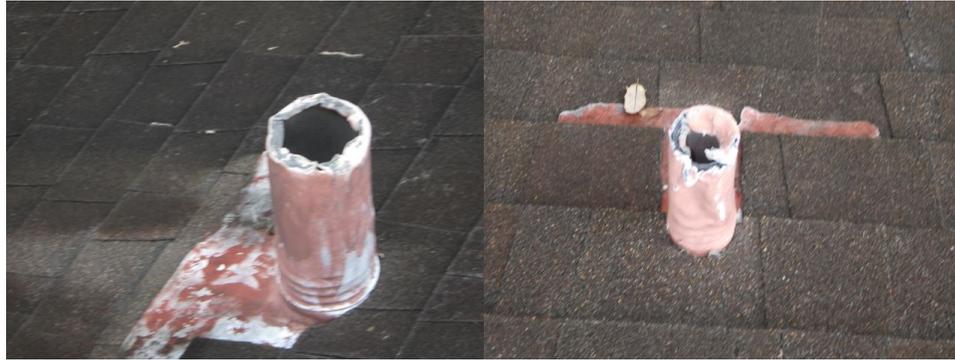
Observed lead flashing covering drain waste vent pipes were damaged by rodents in one or more areas. This will allow some rain water entry into attic. We recommend repair or replace as necessary.

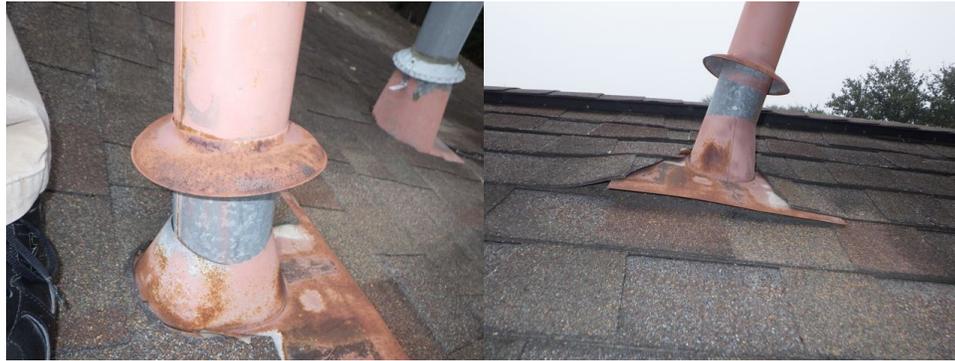
The storm collar was not properly positioned or sealed on water heater vent above roof line. The lower edge of flashing was improperly lifted. This will promote water penetration. We recommend repair and seal as necessary.

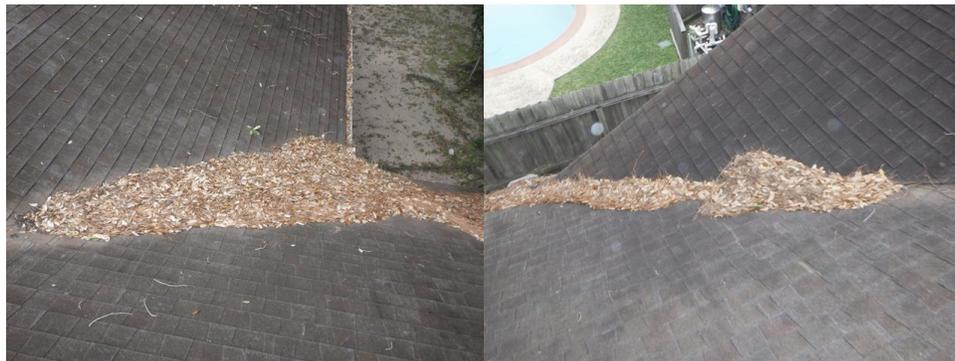
Observed tree debris on roof. We recommend remove piles of debris as they can be a conducive condition for wood destroying insects and promote leakage.

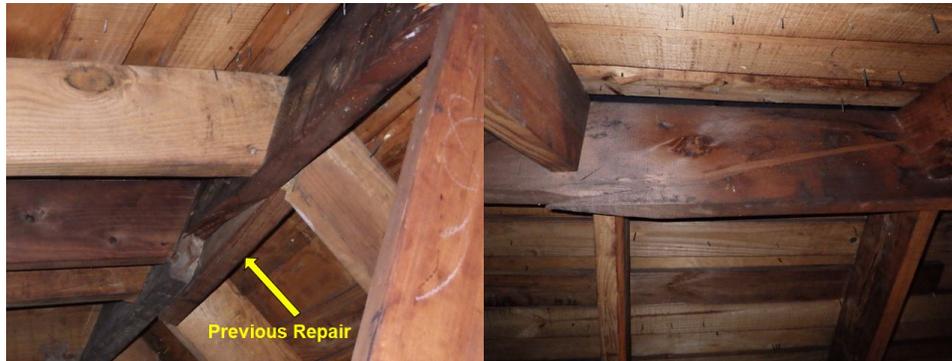
The ridge board was cracked in two or more areas near right side, one had previous improper repair. We recommend further inspection by a specialist contractor and repair as necessary.

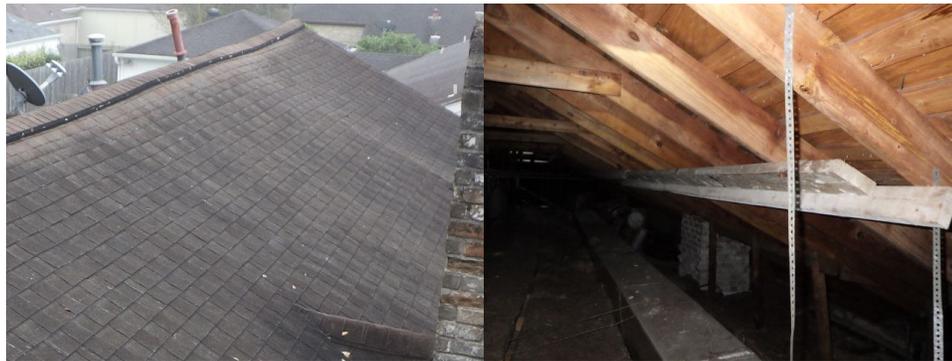
Some sag or unevenness in roof decking observed at front / right side of house. Probable cause from improper/inadequate framing in attic. (This is common where wood shingle roof with skip sheathing has been covered with solid decking and composition shingles.) We recommend installation of stronger purlins with bracing down to load bearing walls to arrest further movement/sagging of roof.

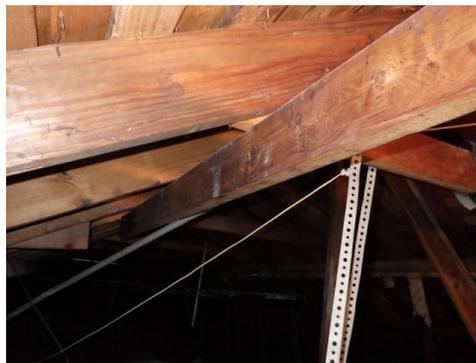
A purlin / strut (roof support) was loose at front near attic access. We recommend repair as necessary.

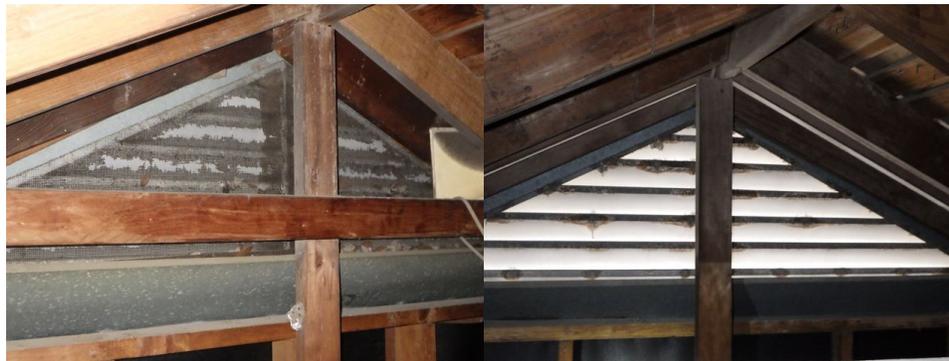
Observed gable screening damaged or missing in two areas. We recommend repair or replace to keep pests out of attic.

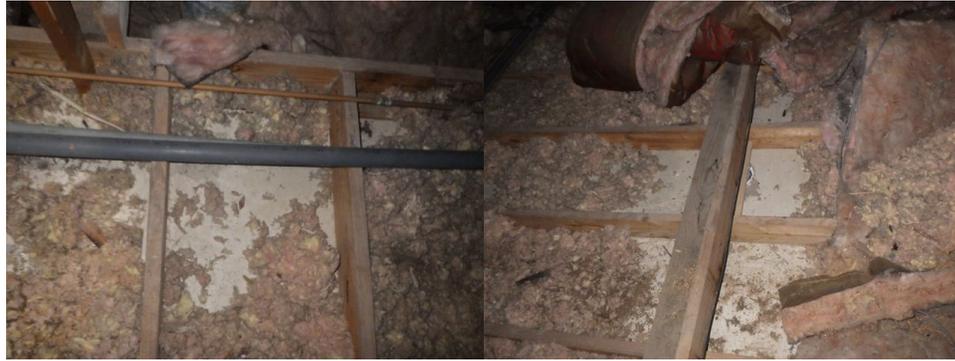
Attic insulation was minimal by today's standards. The insulation has been compressed and/or been disturbed in some areas and no longer provides the same R-value as when it was installed. We recommend reposition or add more insulation to increase energy efficiency.

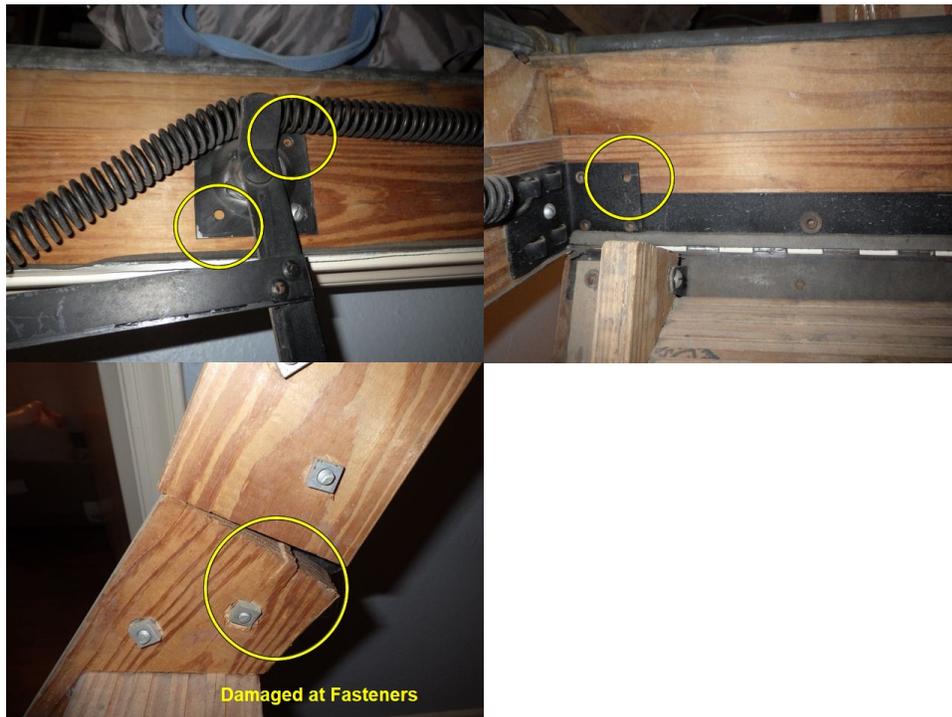
**Observed attic access stairway hinges were not properly secured to attic framing. The attic access stairway had damage or gaps at joints that creates additional stress that can reduce weight bearing capacity. This may pose a hazard as stair frame may separate from ceiling framing or joint may fail. We recommend repair or replace as necessary.**

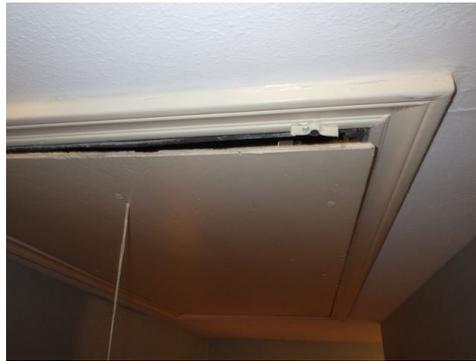
The folding attic stairs did not close properly. We recommend repair to seal gaps and prevent loss of conditioned air to attic and/or sucking attic air into house. As an upgrade, we recommend weather stripping and insulating stairway if not done already.

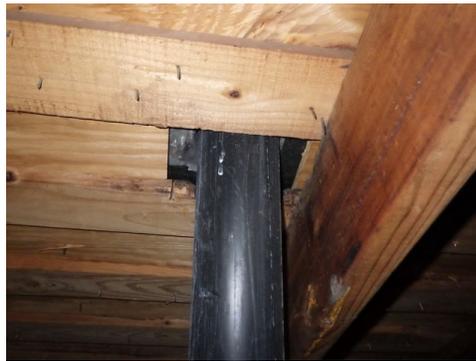
Water stains were observed in attic at left bathroom plumbing vent and water heater vent area. See comment in Roof Covering - Flashings section.

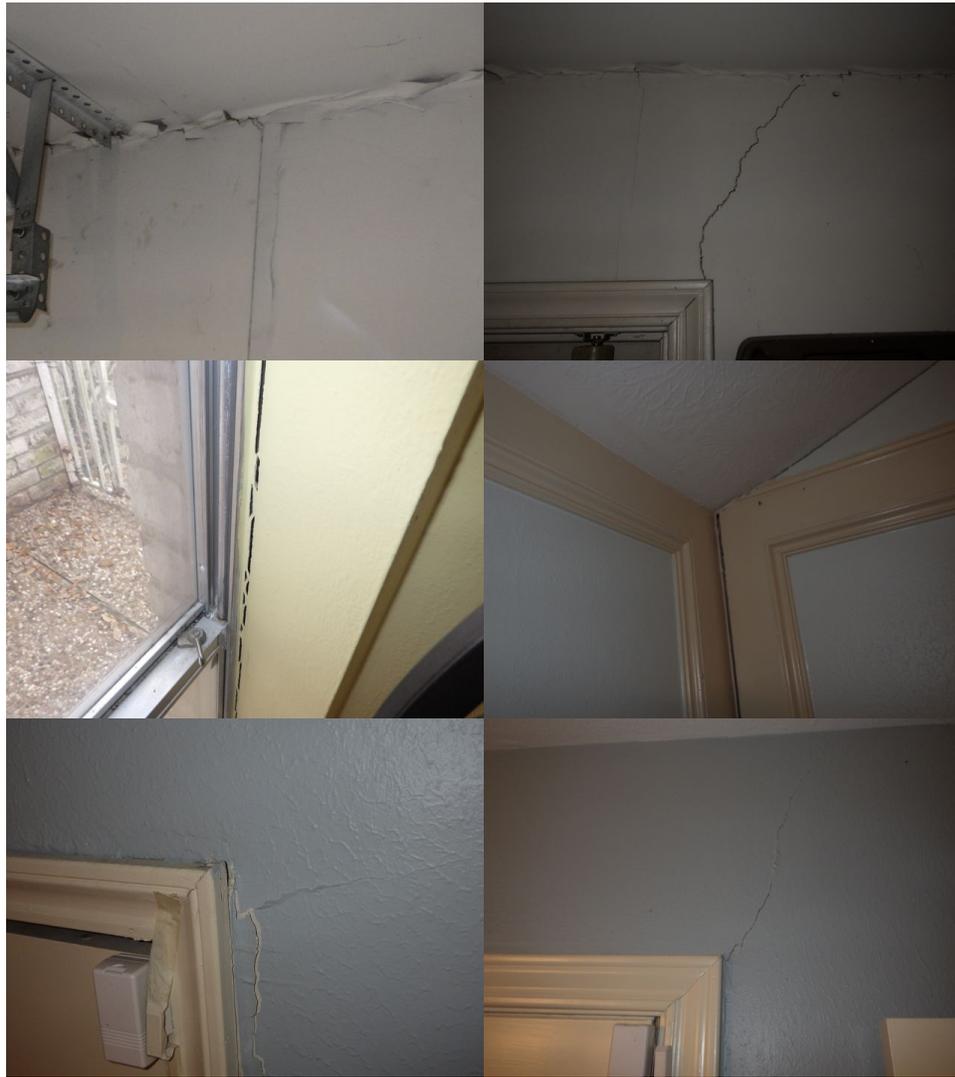
Corner cracks, wrinkled sheetrock tape and separation of windows from walls were observed in areas of garage and interior. (Photos are examples only and do not represent all instances of condition.) This is typically an indication of movement in the structure. Flexible patching materials are recommended to prevent recurrence. We recommend monitor for changes and take action as necessary.

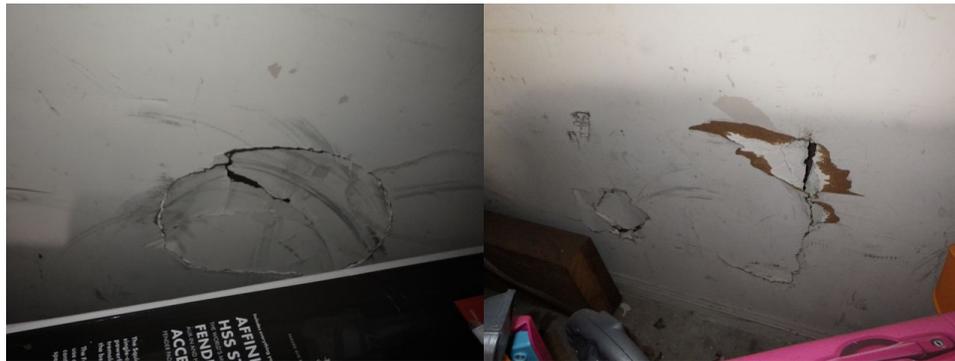
Damage to garage wall in 3 or more areas appears to have been from contact with car. We recommend repair or replace as necessary.

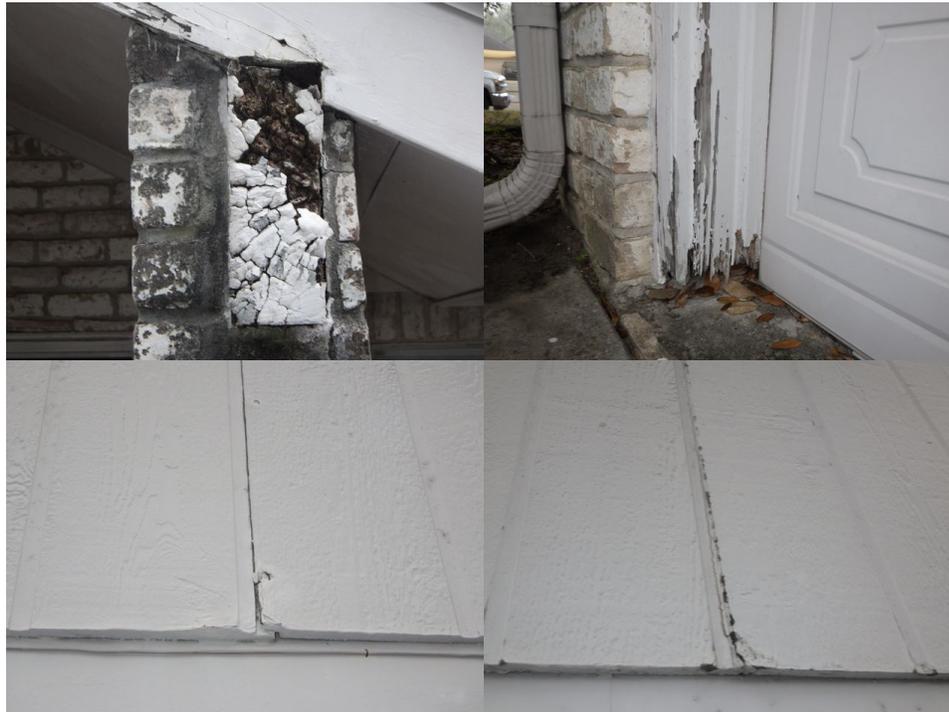
Wood trim and manufactured wood siding were deteriorated in some areas. (Photos are examples only and do not represent all instances of condition.) We recommend repair or replace as necessary.

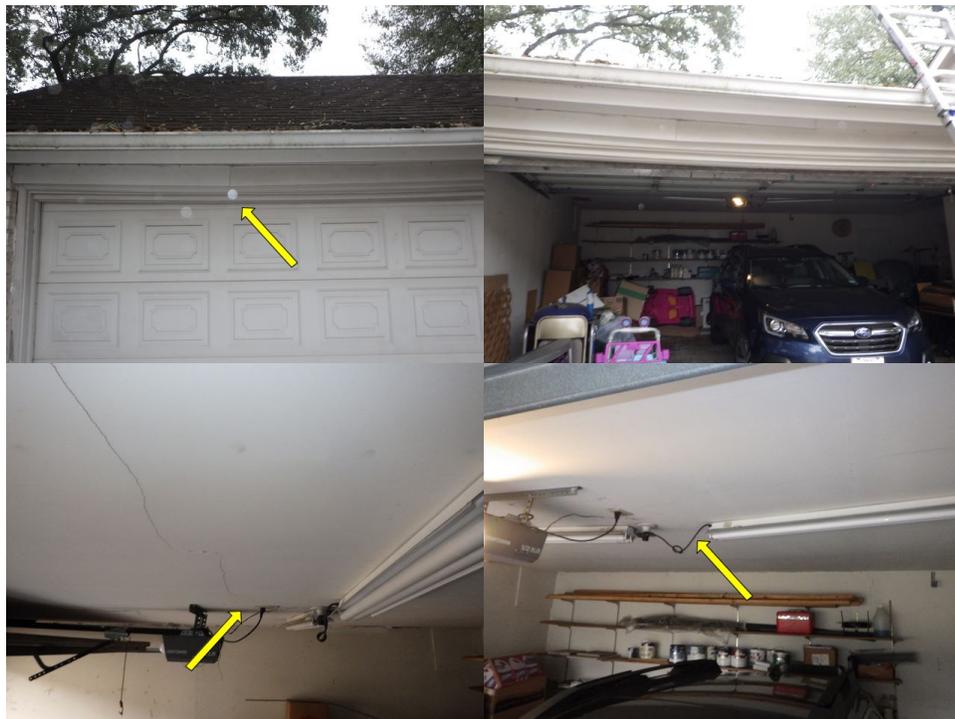
Observed what appeared to be sagging of header (support beam) over garage door and sag in garage ceiling. This can be caused by movement in the structure and/or deteriorated or improper framing. We recommend further inspection by a specialist contractor and repair or replace as necessary.

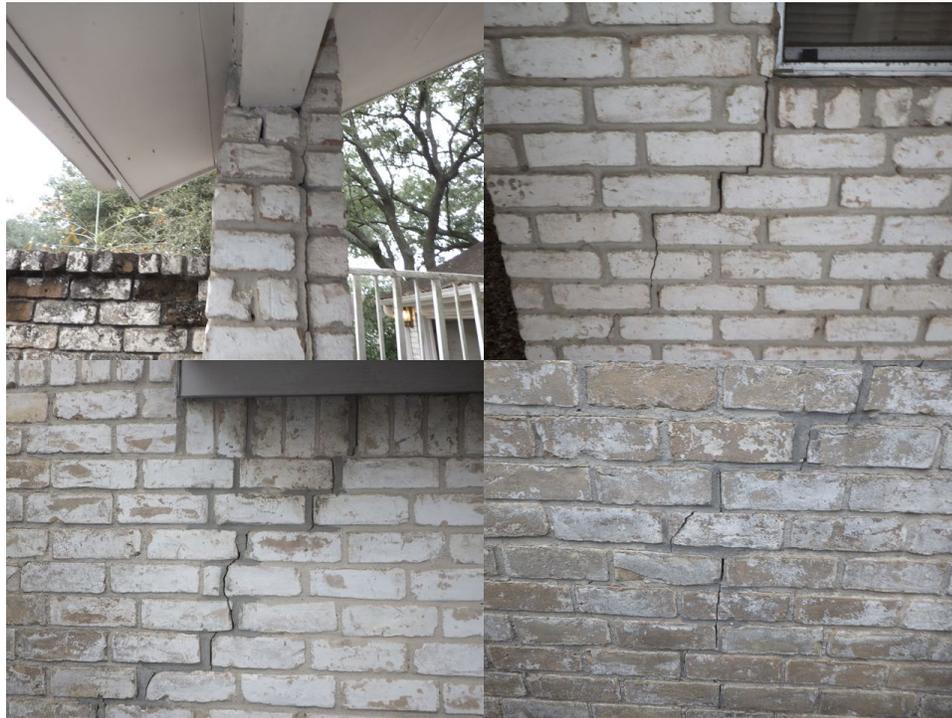
Observed brick / mortar cracks or previous repairs in masonry veneer at one or more areas. Typically these types of cracks are a result of movement in the structure. Repair of the cracks for a better appearance would be considered optional. We recommend sealing cracks to prevent water penetration and monitor for changes that may indicate movement.

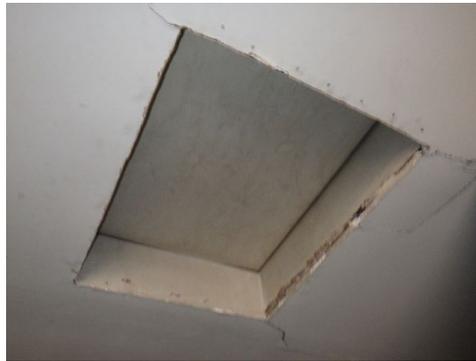
**Attic access located in garage ceiling was not fire resistant as required according to today's standards to protect an opening between garage and dwelling (Ref IRC 302.5.1). A solid core wood door / honeycomb steel door 1 3/8" thick minimum or labeled 20 minute fire rated (metal or treated with fire retardant) cover is required. We recommend install UL listed fire resistant stairs or cover as required according to today's standards.**

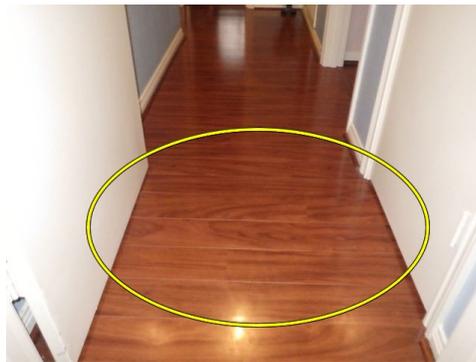
The laminate or wood flooring was loose on uneven floor in front hallway. This can be caused by foundation movement / crack. We recommend repair or replace as necessary.

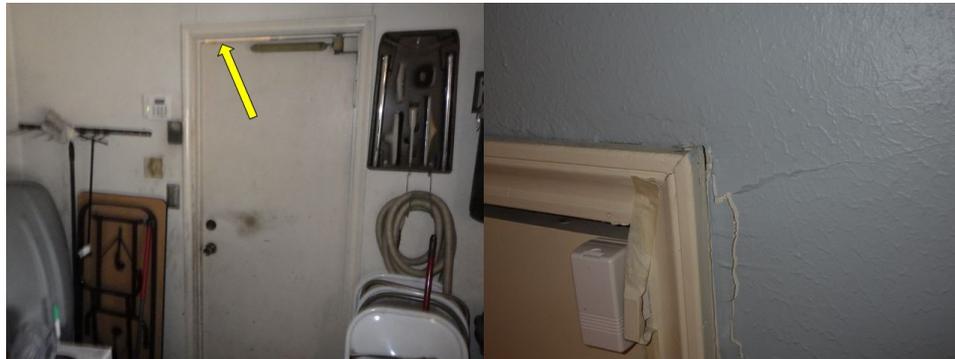
The door from house to garage was not square, had a gap at top, meaning it was not a fire resistant assembly as required to protect an opening between garage and dwelling (Ref: IRC R302.5.1). A solid core wood or honeycomb steel door 1 3/8" thick minimum or UL listed 20 minute fire rated door with self closer is required. We recommend install fire resistant door with self closer as required according to today's standards.

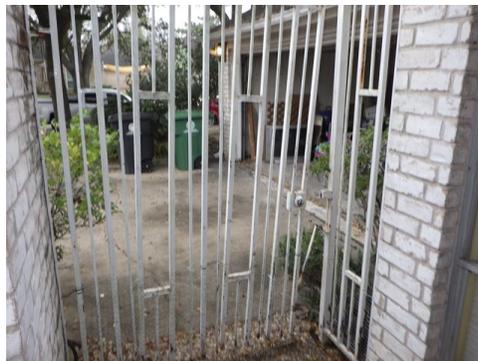
The front porch security gate was deteriorated and sagging. This is a potential hazard if it falls. We recommend remove or replace.

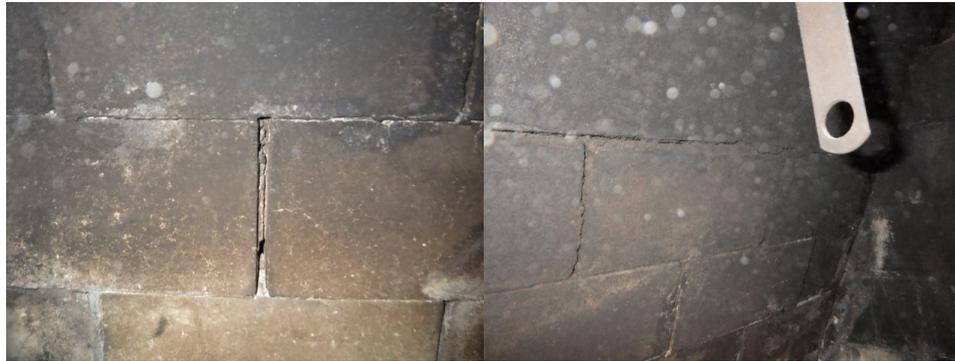
Observed hearth fire bricks are not secured in place / fire brick mortar weak/loose between bricks. Recommend chimney professional verify integrity of interior of chimney before burning any wood in fireplace.

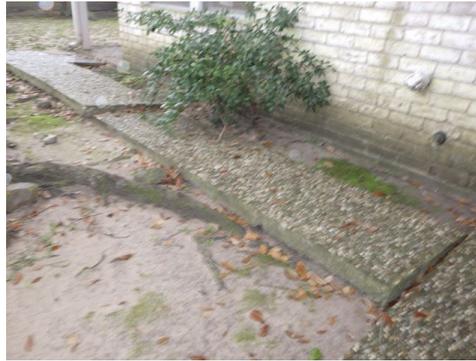
There are one or more trip hazards throughout the walkways / patio / driveway. A trip hazard is defined as an irregularity in a walking surface exceeding one inch in height. We recommend they be patched or repaired to provide an even walking surface.

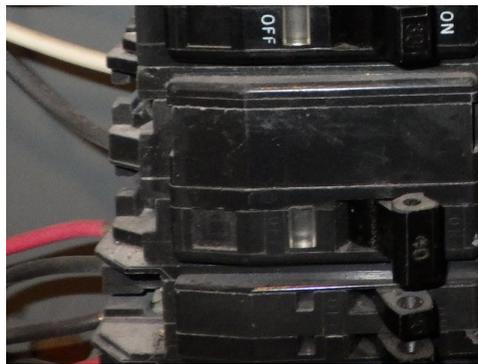
We found overfusing in the main electrical service panel, meaning the conductor was inadequate size to safely carry current allowed by the circuit breaker. This is a potential fire hazard. We recommend the circuit be equipped with a properly rated conductors and/or circuit breaker.

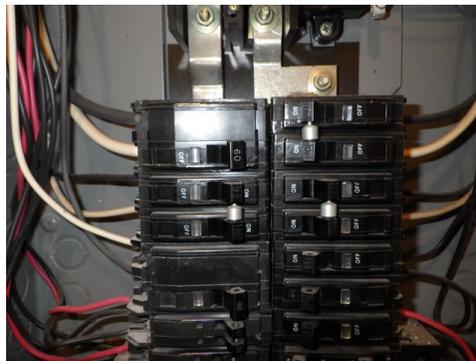
One or more screws were observed to be missing from electrical panel dead front(s). We recommend replace with the correct blunt ended screws. (Sharp / pointed ends can penetrate live electrical wiring behind dead front and cause shock.)

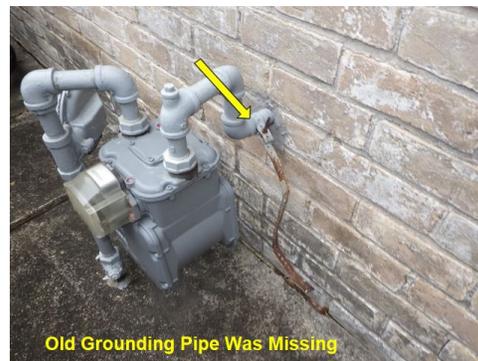
The hot & cold metallic water piping did not appear to be properly bonded to gas piping and the house grounded service at main panel as required according to today's standards. This may not have been required at time of construction, but to minimize shock hazard in case of ground fault, we recommend install bonding connections. (Ref: IRC E3509.7)

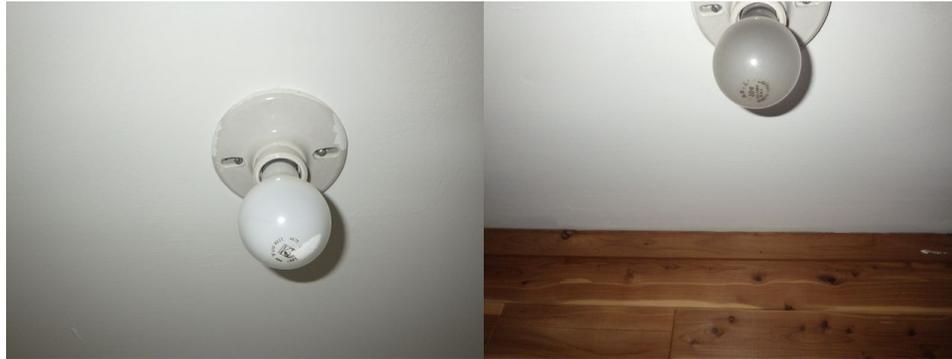
**Observed open incandescent type light fixtures in closet which is considered a potential fire hazard by today's standards. We recommend replace bulb (LED or CFL) or fixture with approved type.**

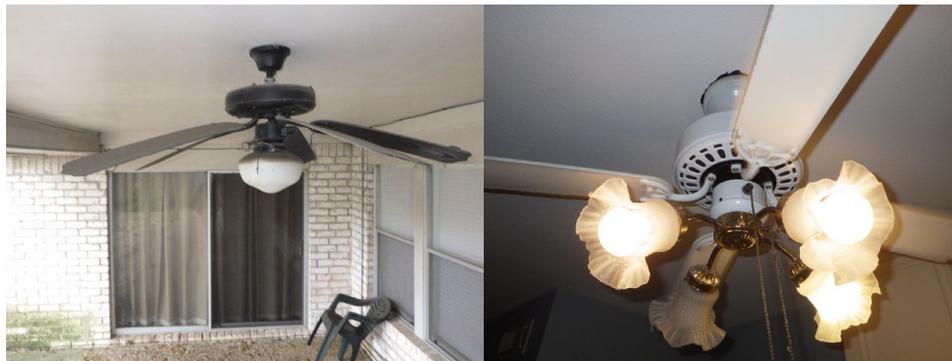
One or more ceiling fans were noisy or out of balance (wobbly). We recommend repair or replace.

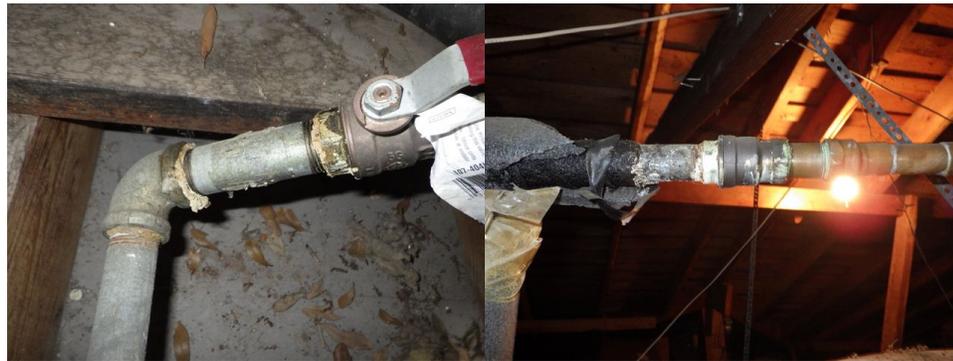
Some of the water heater water connections were corroded and leakage may become apparent over time. These connections should be monitored for leakage and repaired or replaced as necessary.

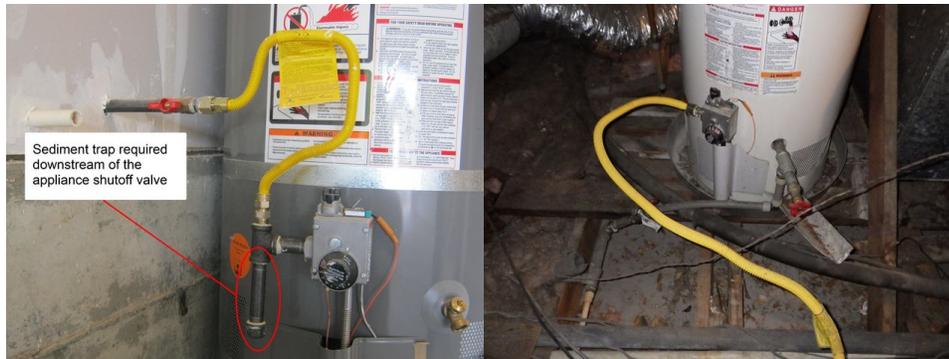
The water heater gas piping did not include a drip leg (sediment trap) extension to collect contaminants (sediment, debris etc) as required according to today's standards. For enhanced safety and proper operation, we recommend alteration as required according to todays standards (Ref: IRC G2419.4) and manufacturer's recommendations.
