Solid Home Inspections

PROPERTY INSPECTION REPORT

Concerning: 2006 build - 3,611 sf, Houston, TX
(Address or Other Identification of Inspected Property)

By: David Gibbs, Lic #7406 TREC Professional Inspector 01/25/2021
(Name and License Number of Inspector) (Date)

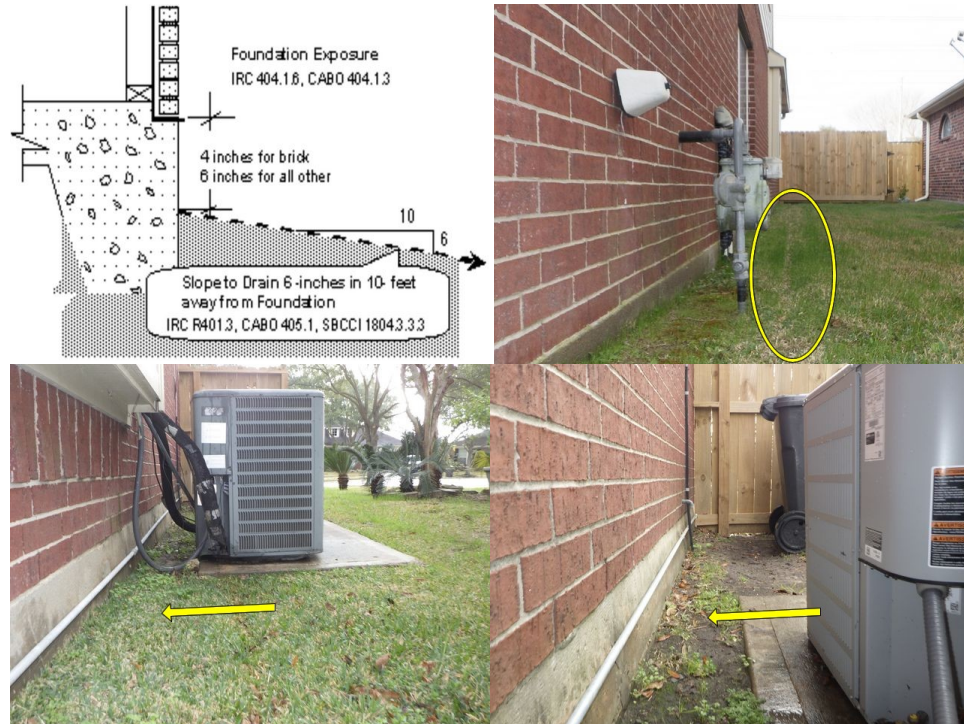
Soil grading had depressions or inadequate / negative slope in some areas and did not appear to properly direct runoff water away from foundation as required according to today's standards (6" drop in 10' Ref: IRC 401.3). This may promote water penetration, adversely affect the foundation and cause differential settlement. We recommend repair as necessary.

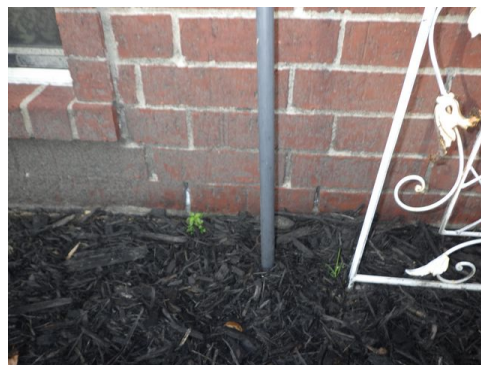
The soil level was too high in front flower bed. Common industry practice requires a clearance of at least 4 inches between grade level and siding or masonry veneer. High soil level promotes water penetration / wood rot and is considered a conducive condition to termite activity. We recommend repair as necessary.

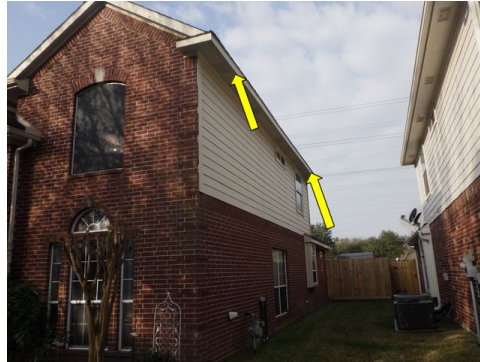
We recommend addition of rain gutters where not present to help improve drainage and foundation performance. Gutters with downspouts and splashblocks at bottom will minimize erosion and foundation movement associated with expansive soils.

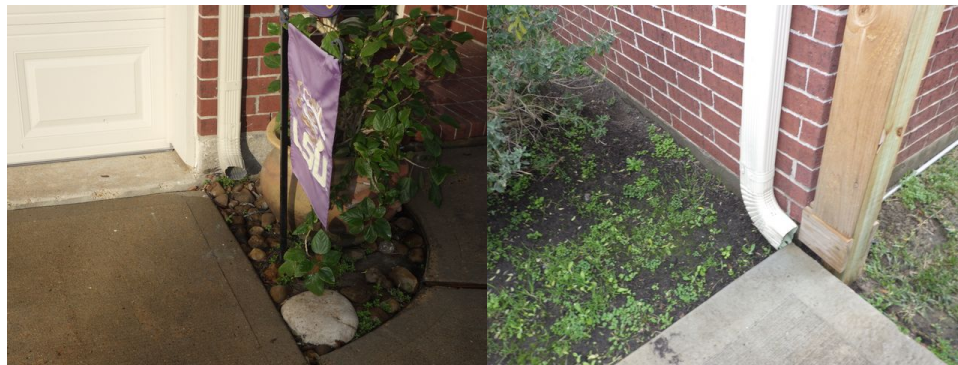
Runoff water from the roof gutters discharged next to the building at front and rear, trapping water in depression next to foundation. For improved foundation performance we recommend direct runoff water sufficiently away from the building prevent erosion and saturation of the soil at foundation.

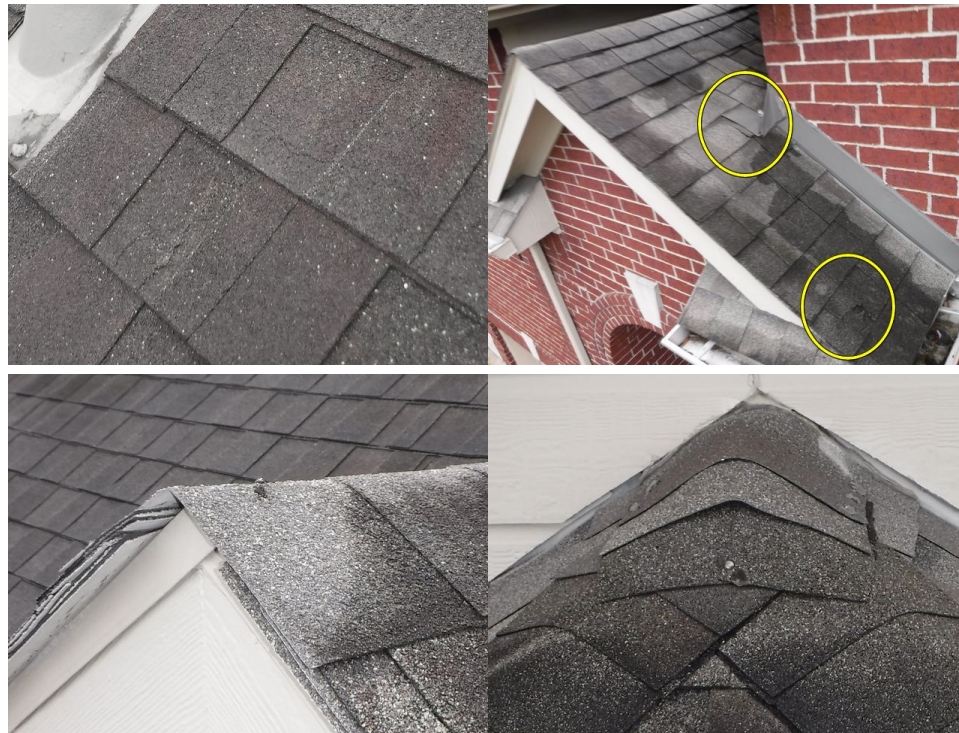
Observed exposed fasteners, minor cracking and surface granular loss of shingles in some areas. This is typical wear. We recommend preventive maintenance, seal exposed fasteners, repair or seal any cracks to prevent water penetration.

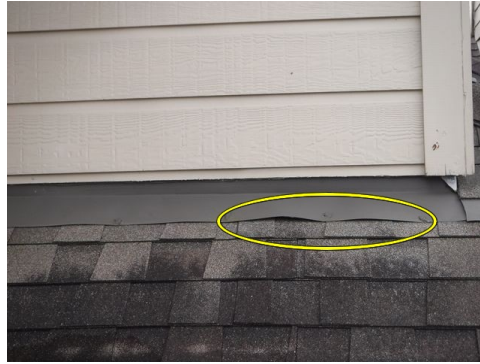
Lower edge of flashing was lifted or not sealed down at right rear where roof meets base of wall. Wind driven rains can cause water penetration. We recommend repair / seal as necessary.

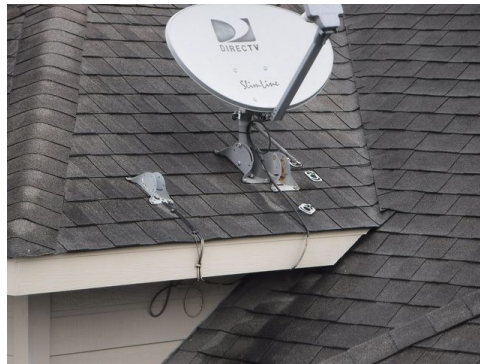
Unused satellite dish components were observed on roof. We recommend remove fasteners and seal holes to prevent water penetration.

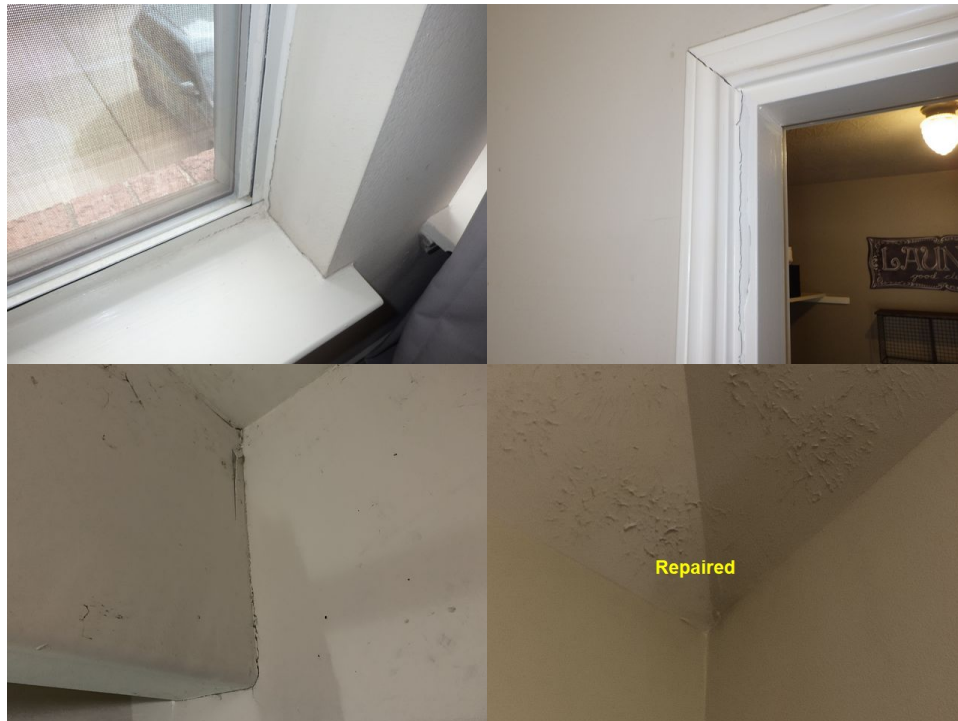
Separation of window frame from interior drywall and corner gaps in door trim were observed in some areas. Corner cracks and previous repairs in walls were observed. This may be an indication of movement in the structure. (Photos are examples only and do not represent all instances of condition.) Flexible patching materials are recommended to prevent recurrence. We recommend monitor for changes and take action as necessary.

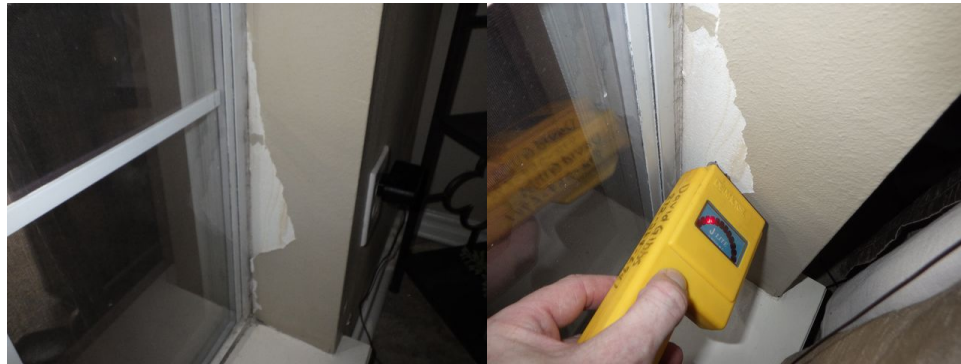
Observed water stains or damage at a living room window area. Moisture detection equipment indicated that the area was not wet at time of inspection. We recommend inquire with seller about cause of moisture and previous repair, monitor for water penetration and repair as necessary.

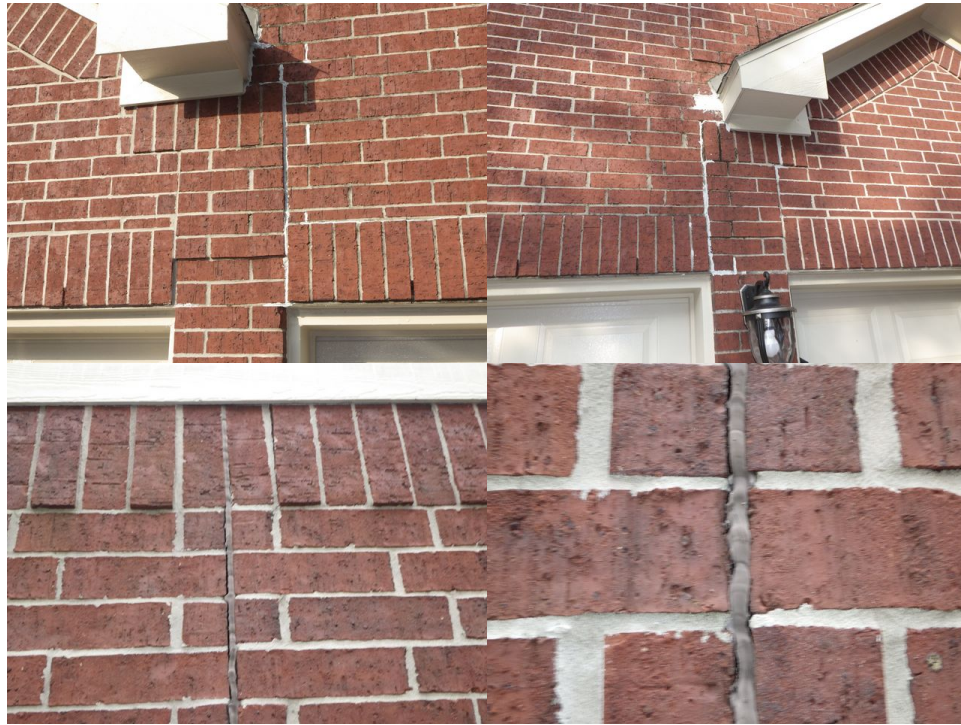
Observed non-professional repairs of mortar cracks at front of garage. The masonry expansion joint at right side appeared to be spreading (wider at top than bottom). Typically these are a result of movement in the structure. Repair of the cracks for a better appearance would be considered optional. We recommend sealing cracks to prevent water penetration and monitor for changes that may indicate movement.

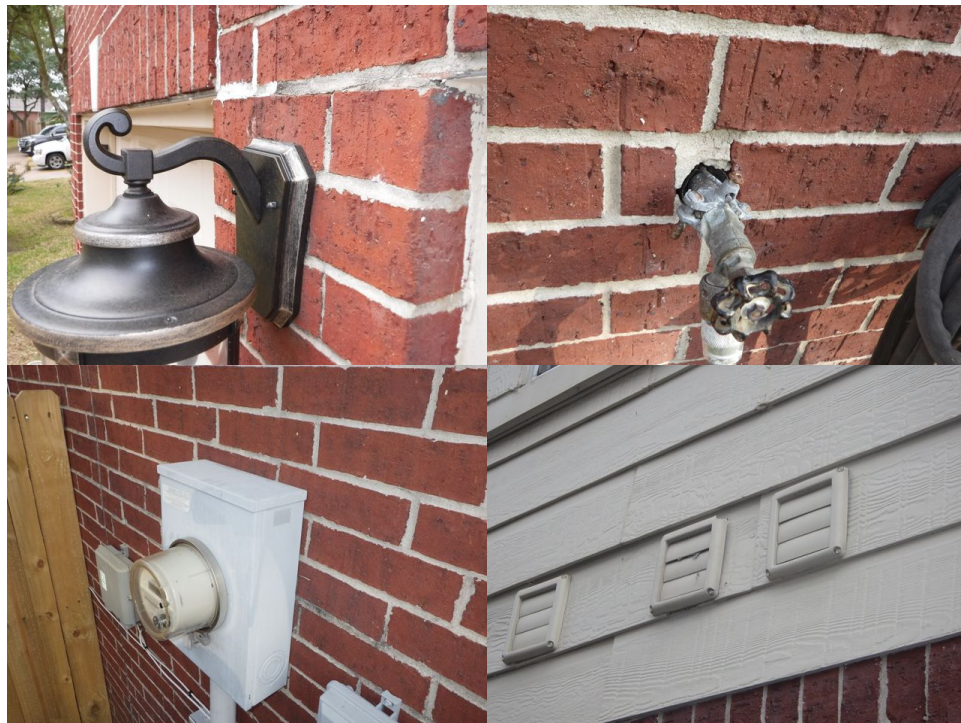
Observed caulking missing or deficient around wall penetrations. We recommend all wall gaps for vents / plumbing / electrical etc, be caulked to prevent water penetration.

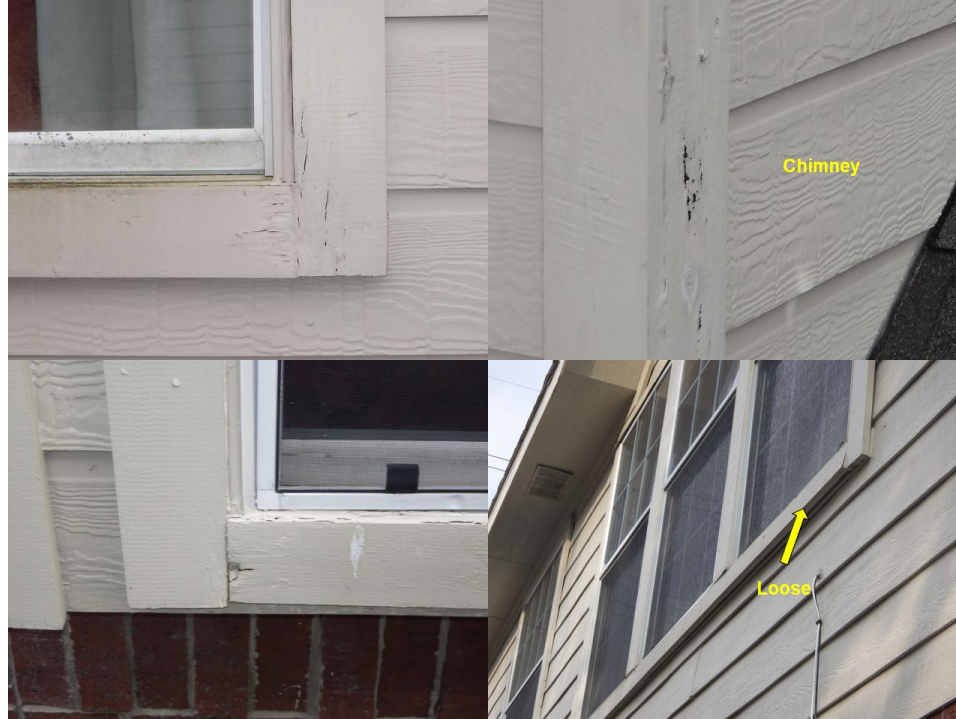
Sections of the wood trim were loose or deteriorated on chimney and some windows. We recommend repair or replace as necessary.

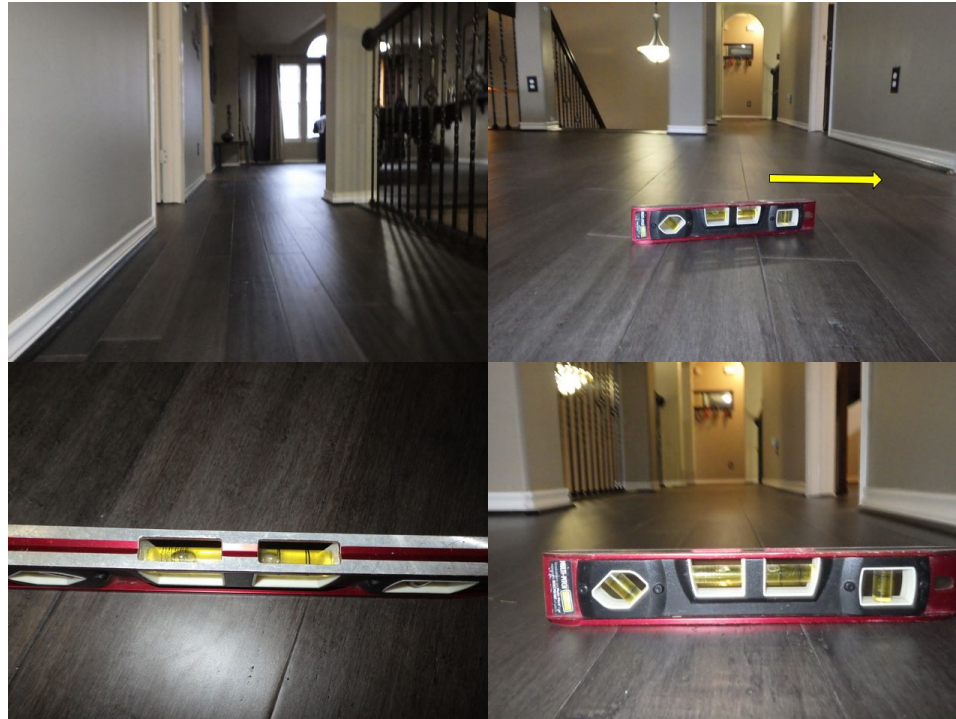
The interior floors were sloped or uneven in upstairs hall / gameroom. The floor may have been built this way or may have settled since construction. If this is a concern, we recommend further inspection by a qualified contractor for repair recommendation.

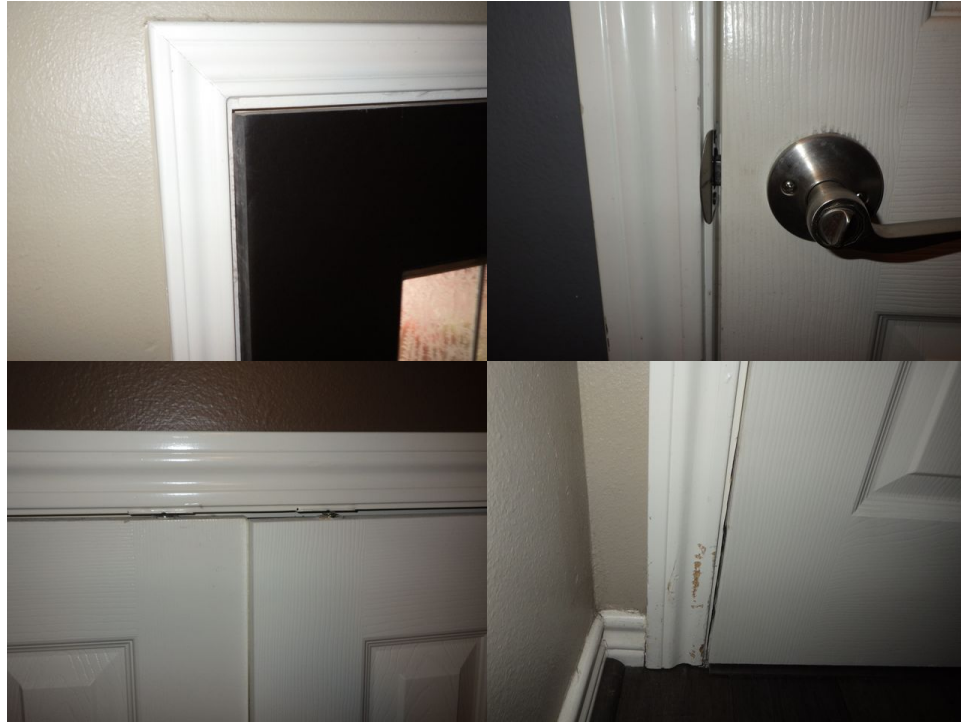
Multiple interior doors and front exterior door appeared to have been replaced. Doors were not square in jamb and 4 would not latch or rubbed frame. We recommend repair / adjustment to restore these doors to a serviceable condition. This may be an indication of foundation movement and/or improper installation.

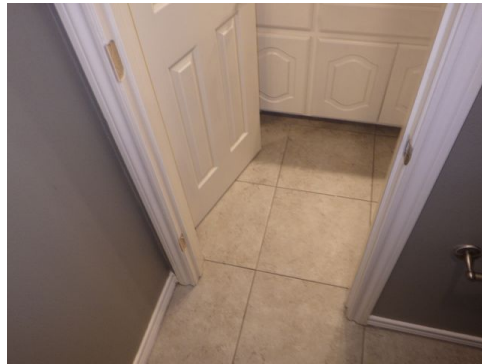
The upstairs front bathroom door was missing. We recommend repair or replace as necessary.

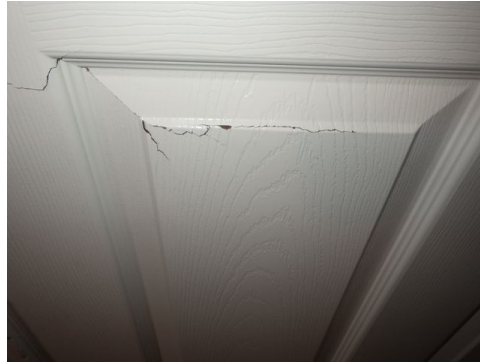
The right rear bedroom interior door was damaged, but functional. For cosmetic reasons, we recommend replace.

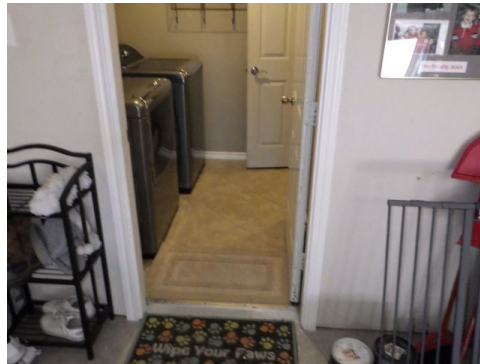
The garage passage door appeared to be fire-resistive construction, but lacked the presently required self-closing mechanisms. This may have not been required when house was constructed, however, a greater margin of safety would be achieved by installing a self closer. (Ref IRC 302.5.1)

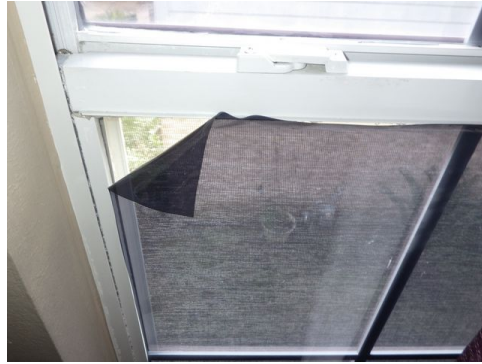
One or more window screens were missing or damaged. We recommend repair or replace as necessary.

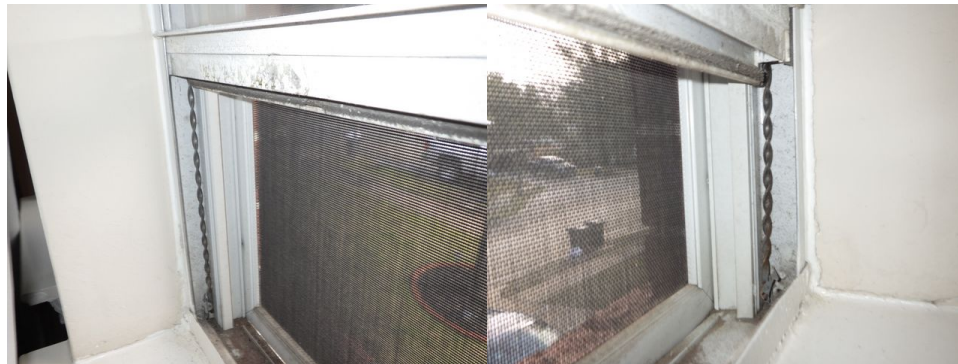
The springs clips (lift mechanisms) have come loose on windows in one or more areas. This means they will not stay up when opened. We recommend repair as necessary.

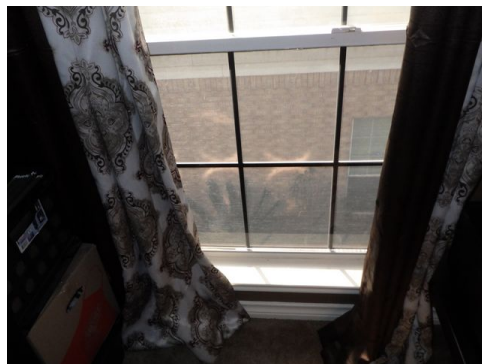
Observed upstairs windows with sills below 24" in one or more areas. This may be a falling hazard for small children. We recommend installation of child safety barriers in these areas as required according to today's standards (Ref: IRC 312.2.1).

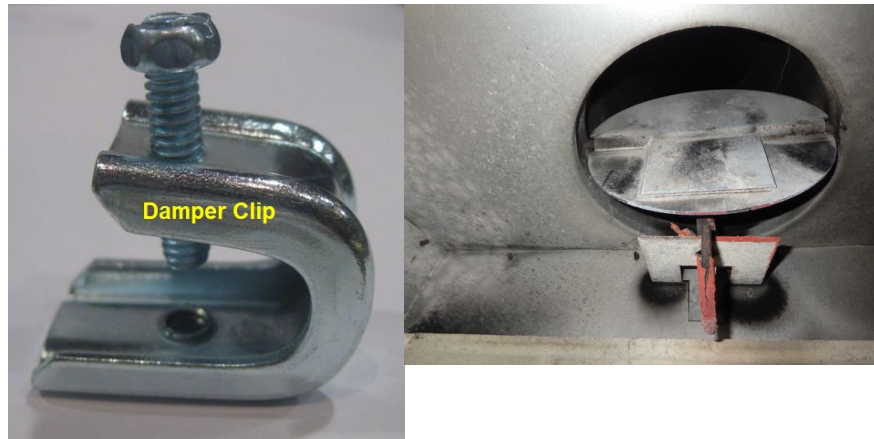
The fireplace was missing a device to keep damper from completely closing as required according to today's standards when a gas appliance (gas log or log lighter) is present. A clamp on the edge of the damper is commonly used. This will help prevent an inadvertent buildup of combustible gas and/or combustion product (including carbon monoxide) in the event the damper is not opened when in use. (Ref: IRC G2453.1)

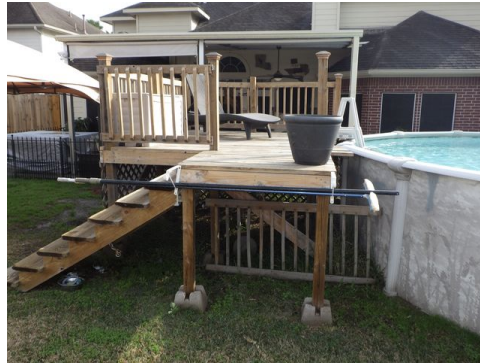
Note: The detached deck and stairs were not inspected, but in passing was noted to be amateurish and not built as required according to today's standards (missing guard rail, improper support, posts not secured, etc). We recommend inspection and repair by a specialist contractor to ensure structure is safe.

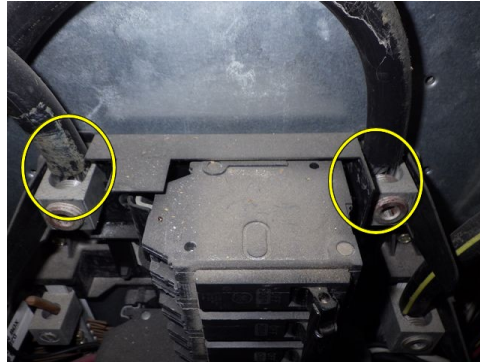
There was no anti-oxidant compound (grease) visible on the aluminum feeder wire connections as required by TREC. Antioxidant is applied to aluminum connections to prevent oxidation which leads to electrical resistance and heat. (This may not be required by manufacturers of modern aluminum cables and equipment.) For maximum protection, we recommend apply antioxidant to connections.

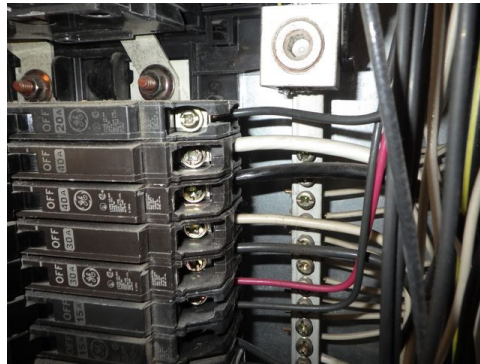
Observed improper wire colors in electric service panel. This can be hazardous for service personnel. Positive / hot conductors (to breakers) should only be black or red, Neutral are white, grounding are green or bare. We recommend use caution when working in panel and mark wires inside panel when possible.

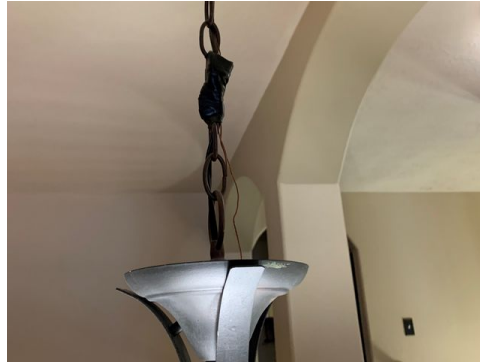
A running splice (improper connection) was observed at power supply for chandelier over stairs. We recommend repair or replace as necessary.

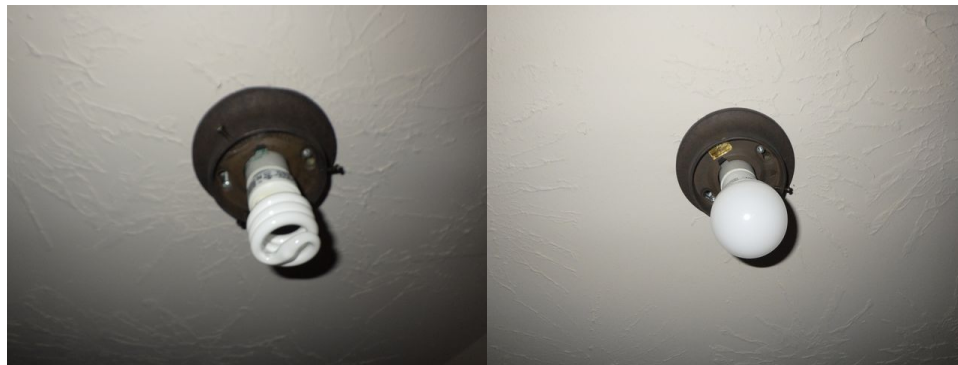
Observed three closet lights with diffuser / globe missing. We recommend replace.

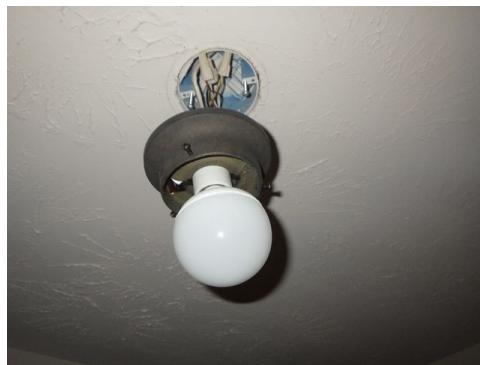
Observed loose light fixture in left front bedroom closet. We recommend repair as necessary.

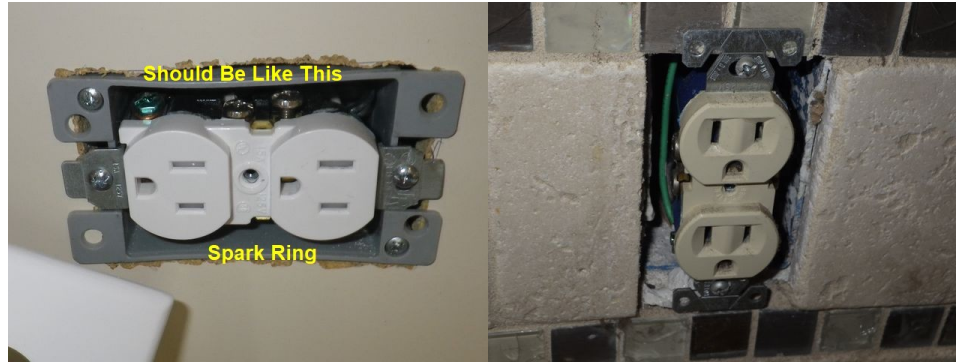
Observed one or more areas in kitchen where space between face plate and edge of electrical junction box exceeds ¼ inch allowable for non-combustible surfaces according to today's standards (Ref IRC 3907.3). We recommend install spacer - spark ring to reduce possible fire hazard.

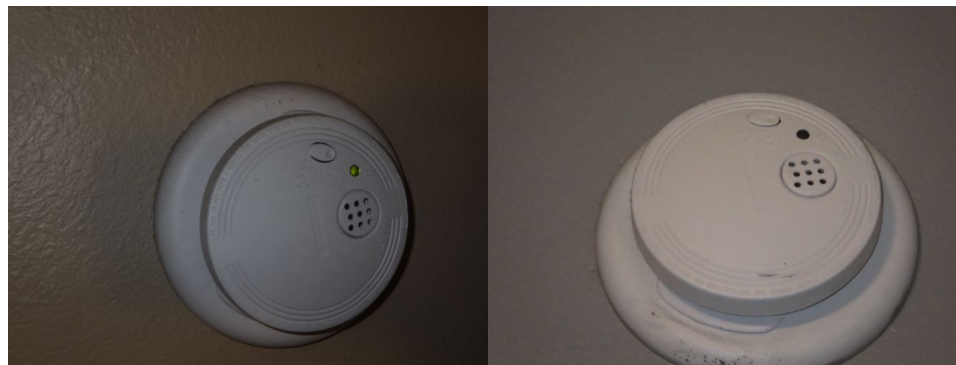
One or more smoke alarms appeared older and may not be reliable. The expected service life of a smoke alarm is approximately 10 years and sensors may lose effectiveness at 7-8 years according to CPSC. We recommend they be replaced to enhance fire safety.

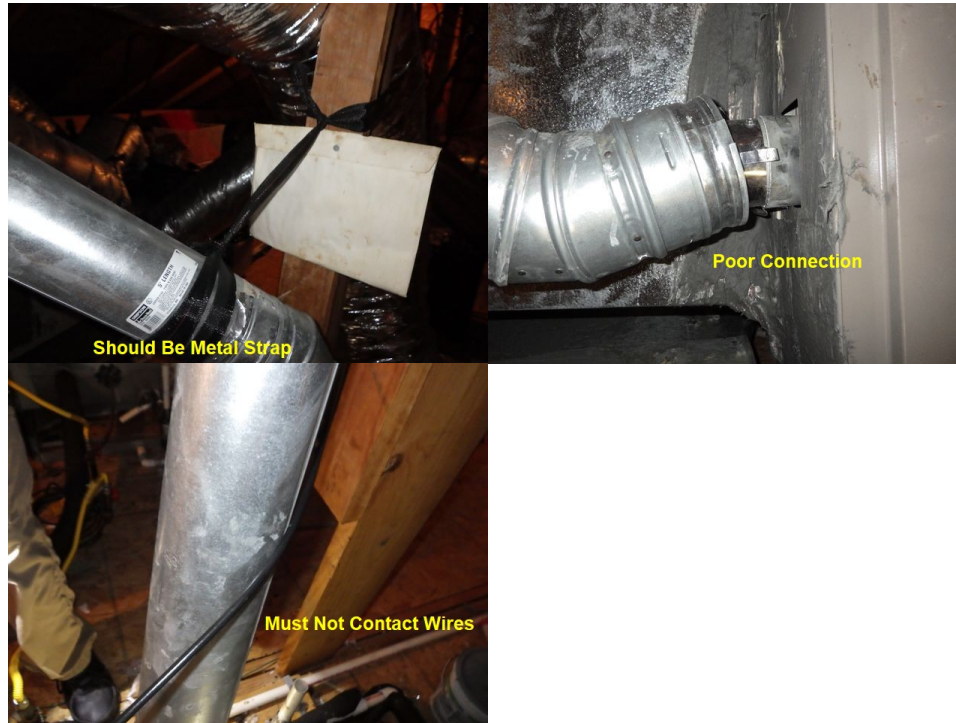
The upstairs furnace vent was sagging down, not properly connected to furnace. The vent was improperly supported with plastic strap and contacting wiring. This is a possible fire and carbon monoxide hazard (if disconnected). We recommend further inspection by a licensed HVAC technician and repair as needed.

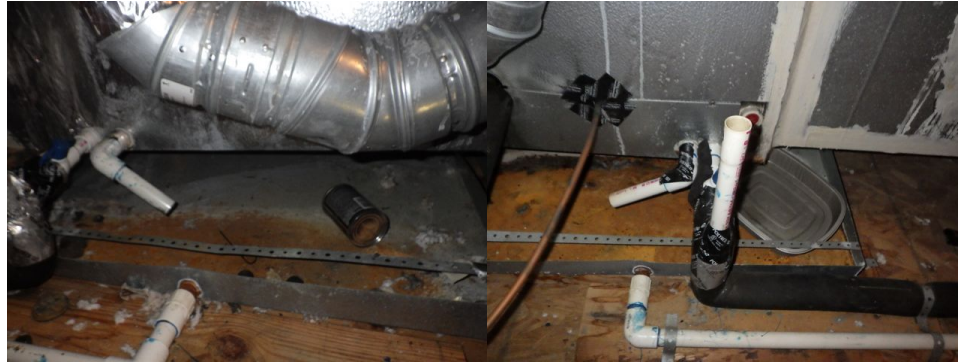
Observed corrosion or water stains below the air conditioner evaporator coil in the furnace / emergency drain pan / floor. This is an indication of past or current leakage of condensation from evaporator coil or drain line. We recommend further inspection by a licensed HVAC technician and repair if/as necessary.

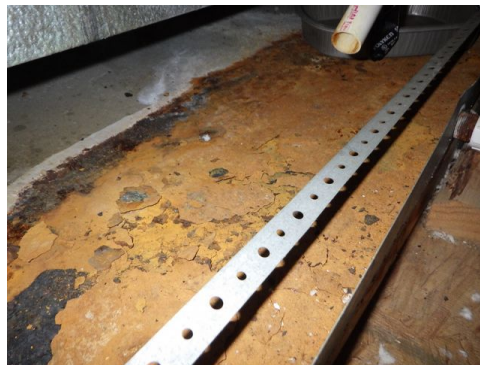
The downstairs unit secondary drain pan is heavily corroded from condensation dripping from the evaporator coil. We recommend further inspection by a licensed contractor for repair of leak and replacement of pan.

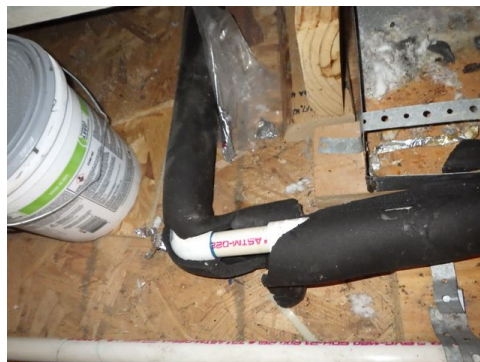
Observed evaporator coil primary drain line was not properly insulated. We recommend insulating the primary condensate drain along entire length in attic to prevent condensation dripping from outside of pipe onto attic floor / ceiling below.

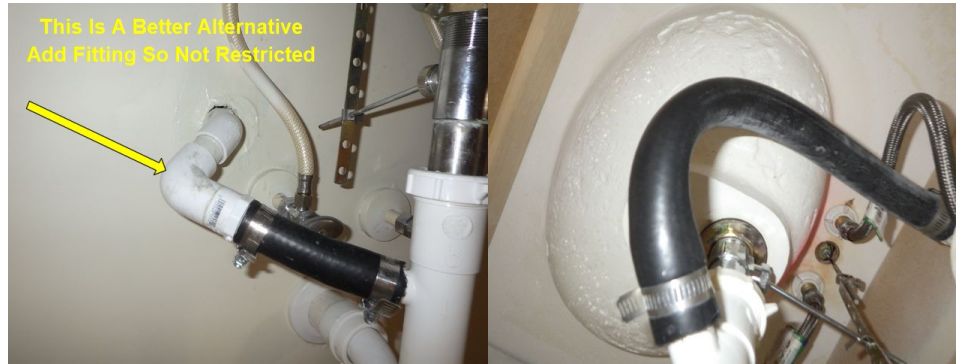
The primary condensation drain hoses from both air conditioners were was restricted / kinked where connecting to the upstairs bathroom sink drains. We recommend adjusting hose to relieve strain and reduce potential for drain to become obstructed.

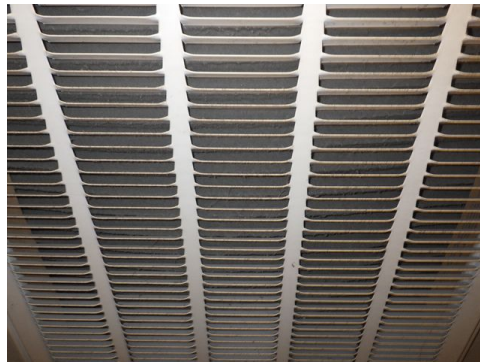
The disposable HVAC system filter was dirty. This can decrease the efficiency of the HVAC system and possibly cause damage and/or reduced system service life. We recommend the filter be replaced.

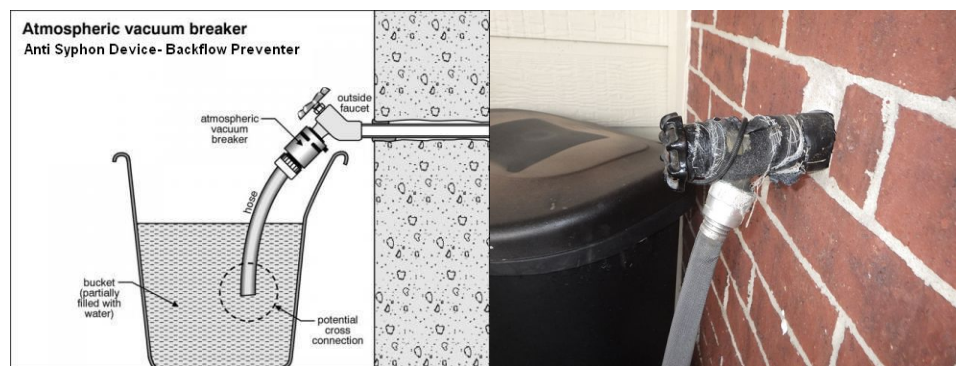
The rear exterior hose bib was missing backflow preventer device required according to today's standards (IRC P2902.3). This is a possible hazard. We recommend install approved backflow prevention devices at all exterior hose bibs.

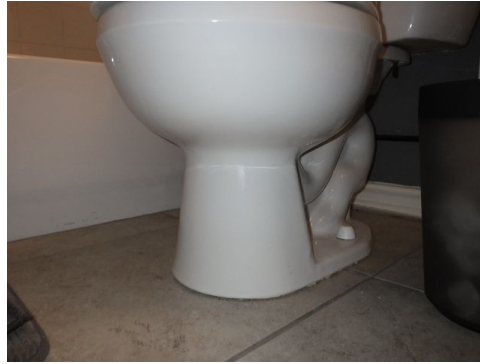
The upstairs right bathroom toilet(s) was loose at the floor. While no leakage was evident, this is conducive to leakage and damage over time. The toilet should be removed and reset upon a new wax seal.

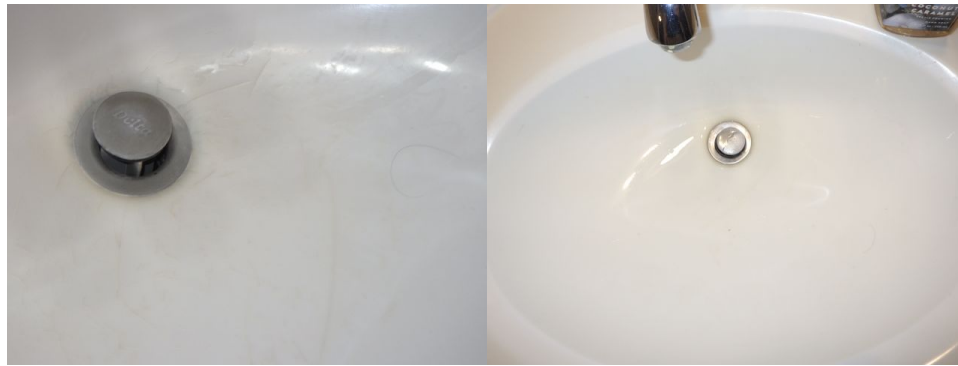
The cultured marble bathroom sink in one or more areas has surface deterioration / cracking. No leaking was visible. This is primarily a cosmetic concern that can be refinished for a better appearance.

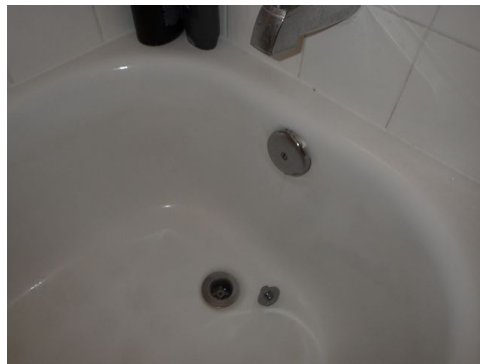
One or more bathtub drain stops was missing or inoperative. We recommend repair or replace as necessary.

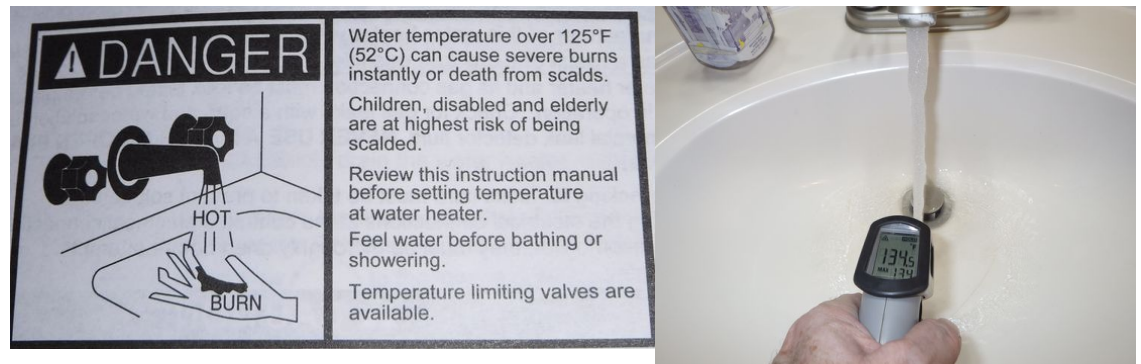
The water heater temperature was set too high. Excessive temperature is a scalding hazard for children, and uses additional energy. The CPSC recommends the temperature setting be maximum 120 degrees for safer operation.

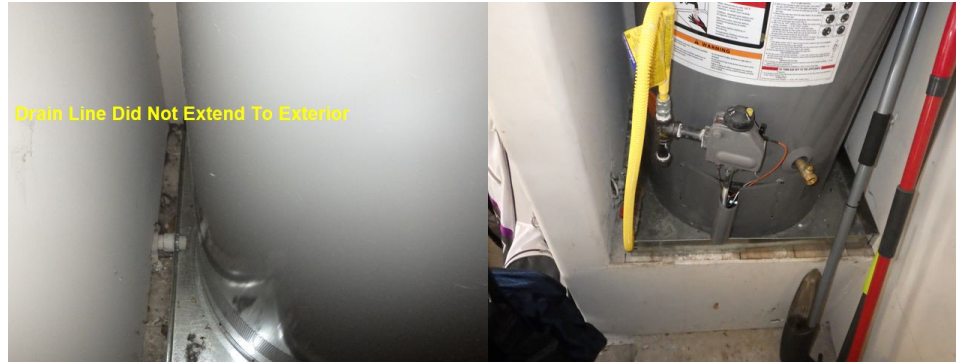
There was a pan under the water heater to catch dripping water but no drain to exterior

was visible. This may cause water to leak into wall if tank leaks. We recommend further inspection by a licensed plumber and repair or replace as necessary. to exterior.

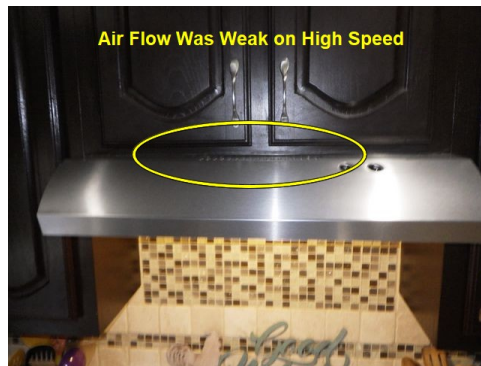
The exhaust fan motor appeared weak. This typically indicates advanced wear and that the unit is near the end of its useful life. We recommend further inspection by a specialist contractor and repair or replace as necessary.

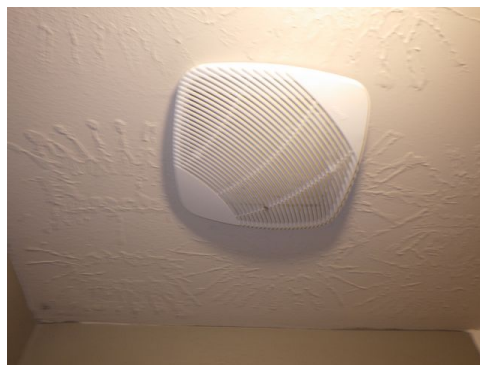
The upstairs front bathroom exhaust fan was not functioning. We recommend repair or replace as necessary.

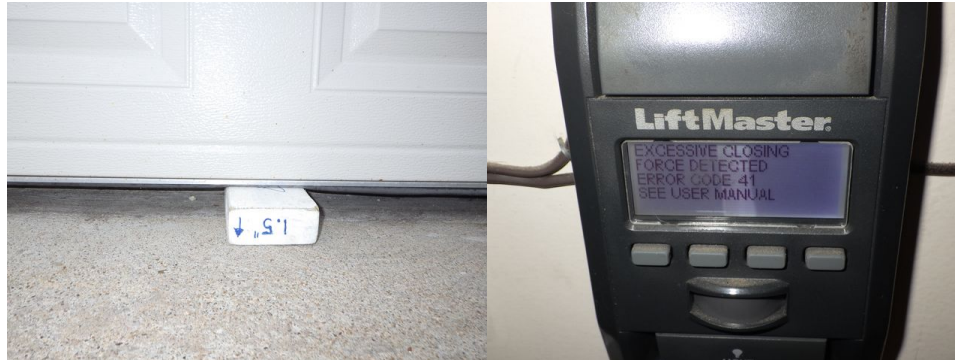
The left automatic garage door opener did not reverse properly when tested according to most manufacturer's recommendations with a 2x4 board laid flat on the floor. The center opener had error message on control display. We recommend adjustment, repair or replacement to restore proper function and safety.

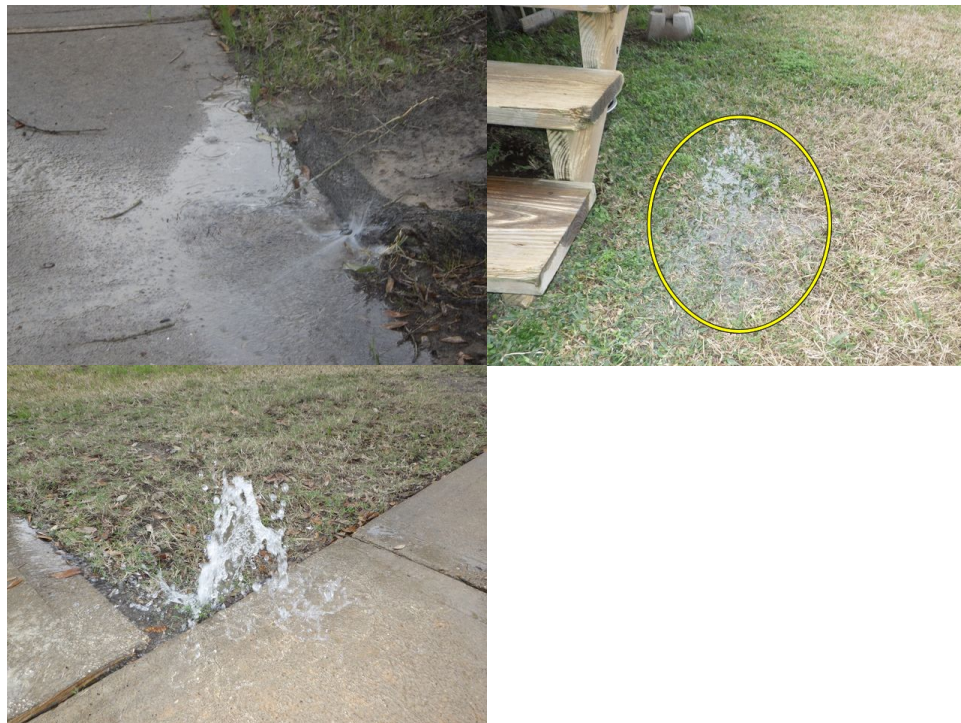
Observed multiple damages spray heads and/or buried water lines. We recommend repair or replace as necessary.
