**2014 2.5k
Cypress, TX**

PROPERTY INSPECTION REPORT

Prepared For: Sample Report
(Name of Client)

By: David Gibbs, Lic #7406 TREC Professional Inspector 01/20/2021
(Name and License Number of Inspector) (Date)

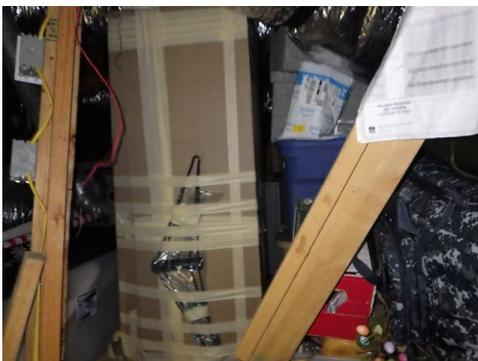
Investigate Further: Portions of this building have been remodeled, altered and/or added. We recommend consultation with the owner to determine if all necessary county permits and HOA approval as needed were obtained.

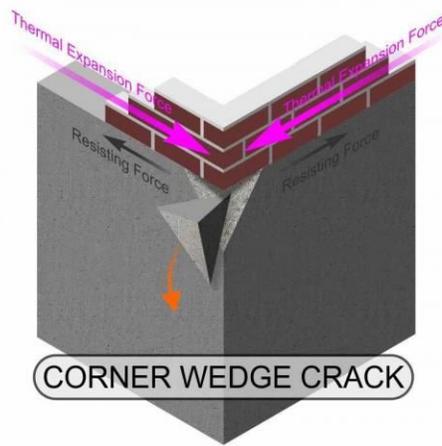
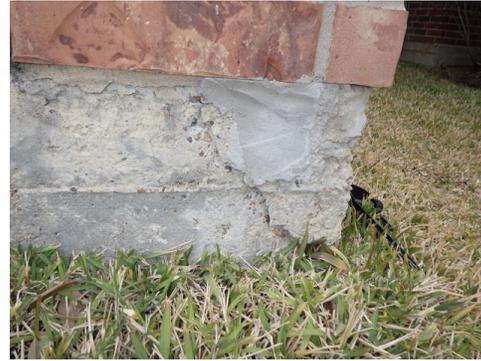
Spalling (i.e., corner cracks) was observed at one or more corners. This is common to slab foundations, usually caused by expansion of brick veneer and does not affect the structural integrity of the foundation as long as it is supporting brick veneer above. This can be a location for wood destroying insect to enter house unseen if crack extends below grade. For cosmetic reasons and to keep out pests, we recommend cracks be sealed with cement patch or epoxy type material.

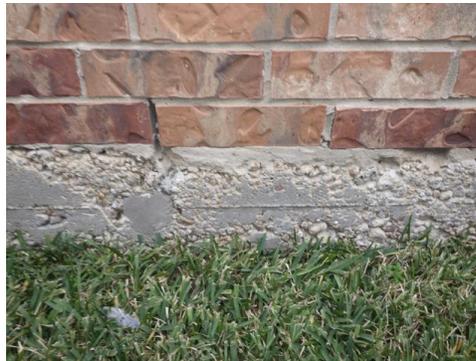
Observed uneven surface at foundation edge / aggregate visible. This is primarily a cosmetic condition, no repair recommended.

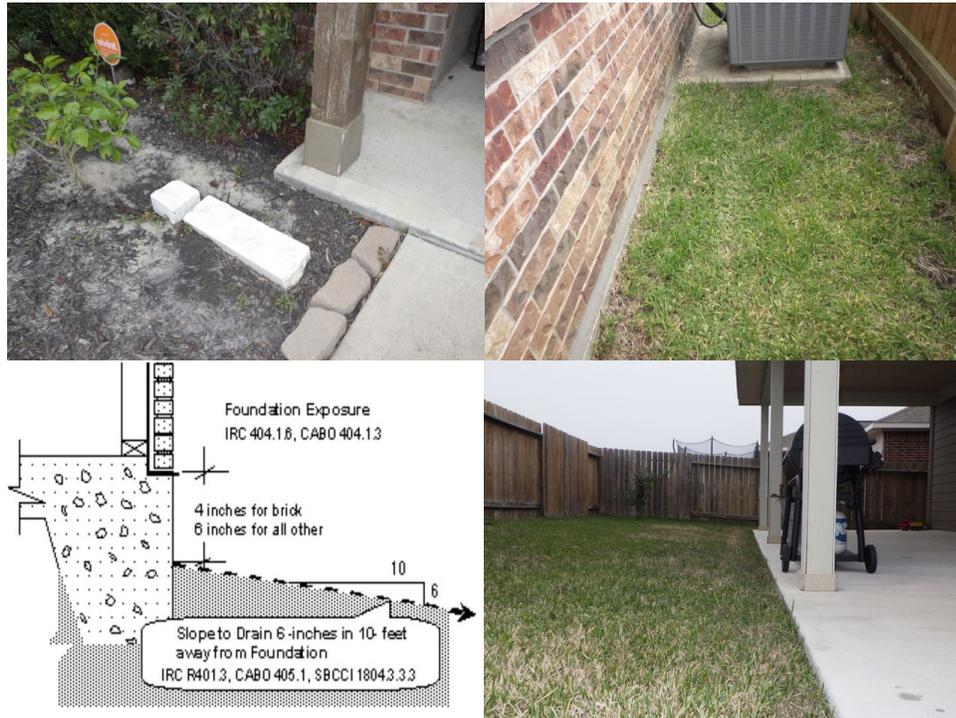
Soil grading had depressions or inadequate or negative slope in some areas and did not appear to properly direct runoff water away from foundation as required according to today's standards (6" drop in 10' Ref: IRC 401.3). This may promote water penetration, adversely affect the foundation and cause differential settlement. We recommend repair as necessary.

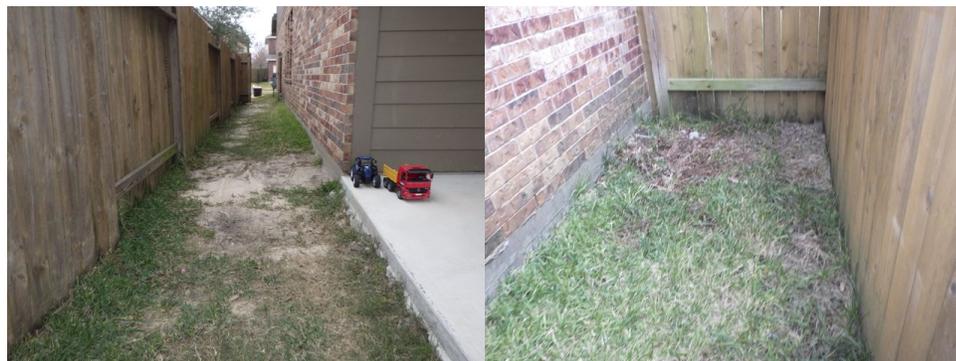
The drainage swale was not continuously sloped to street as required according to today's standards, may cause water ponding at side(s) of house. We recommend repair as necessary to promote proper drainage away from foundation and extend service life of fence.

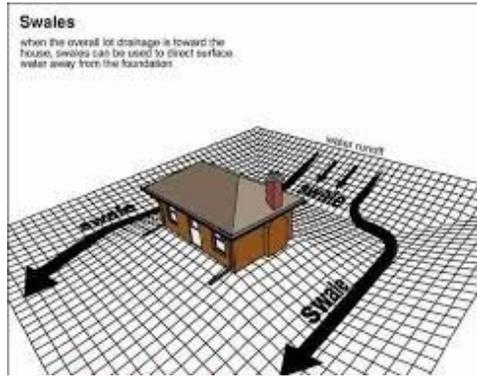
We recommend addition of rain gutters where not present to help improve drainage and foundation performance. Gutters with downspouts and splashblocks at bottom will minimize erosion and foundation movement associated with expansive soils.

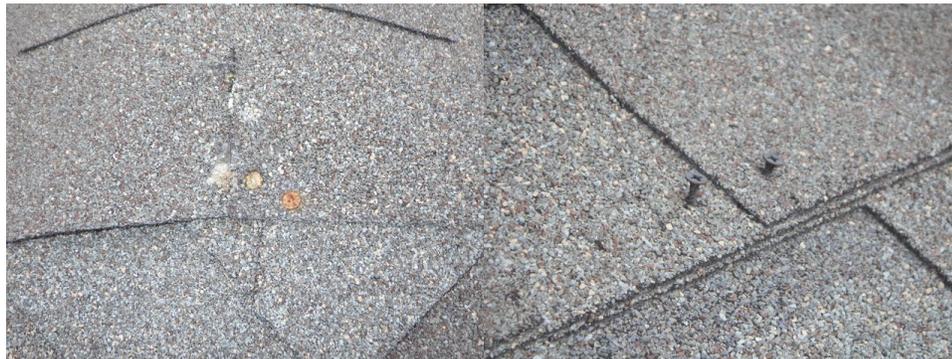
Improperly exposed fasteners were observed on roof in one or more areas. (Photos are examples only and do not represent all instances of condition.) All exposed fasteners must be sealed to prevent water entry.

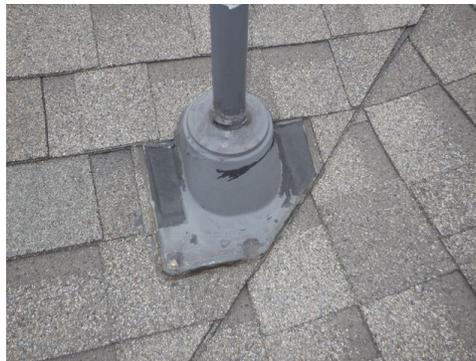
The kitchen plumbing drain waste vent flashing was improperly altered for patio cover addition. There was evidence of leakage at this location (water damage kitchen ceiling). We recommend further inspection by a specialist contractor and repair or replace as necessary.

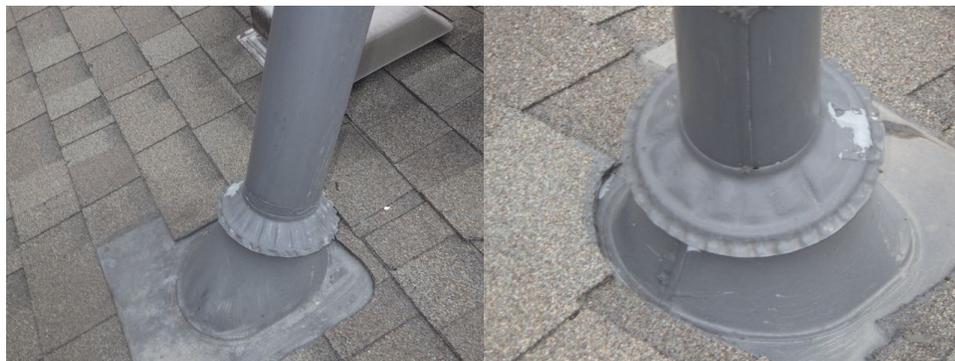
Caulking was observed to be missing or deficient on the storm collar above roof line for water heater and furnace vent. The storm collar protects the joint between a gas appliance vent pipe and roof flashing. We recommend caulking to prevent water penetration into attic.

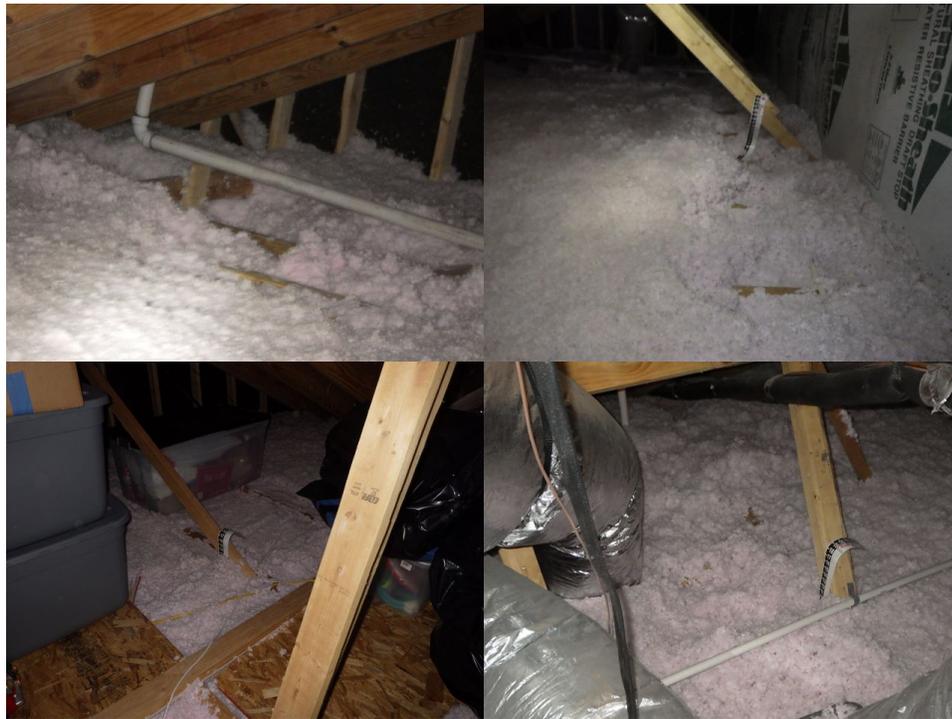
The insulation has been compressed and/or been disturbed in some areas and no longer provides the same R-value as when it was installed. We recommend reposition or add more insulation to increase energy efficiency.

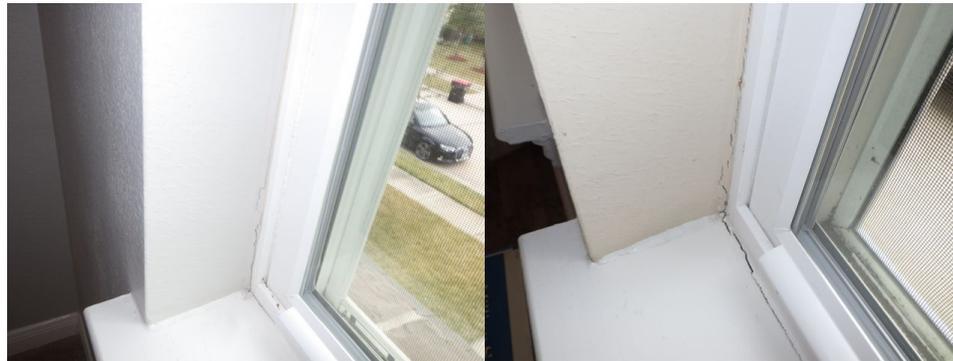
Gaps between window frame and interior drywall were observed one or more areas. This may be an indication of movement in the structure. Flexible patching materials are recommended to prevent recurrence. We recommend monitor for changes and take action as necessary.

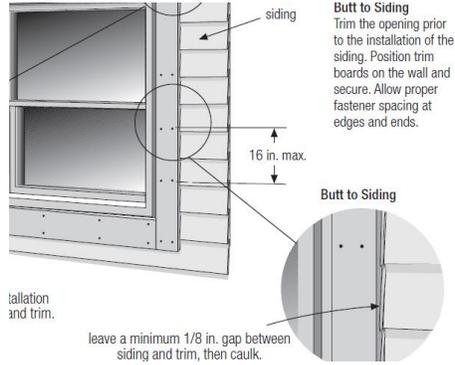
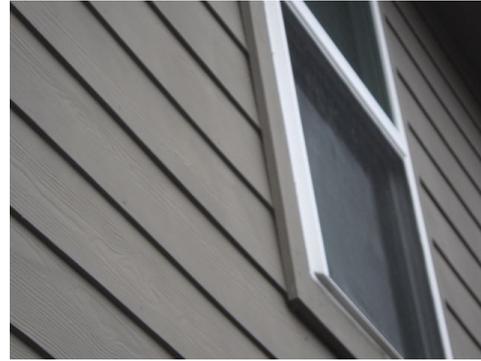
The cement board window trim appears to have been installed wrong, applied on top of siding leaving gaps. This may promote water penetration, pest entry and affect warranty. Typical installation instructions require siding to be cut to fit with ends flush and caulked against trim (diagram below is from James Hardie). We recommend caulk trim to mimic proper installation and minimize chance of water penetration.

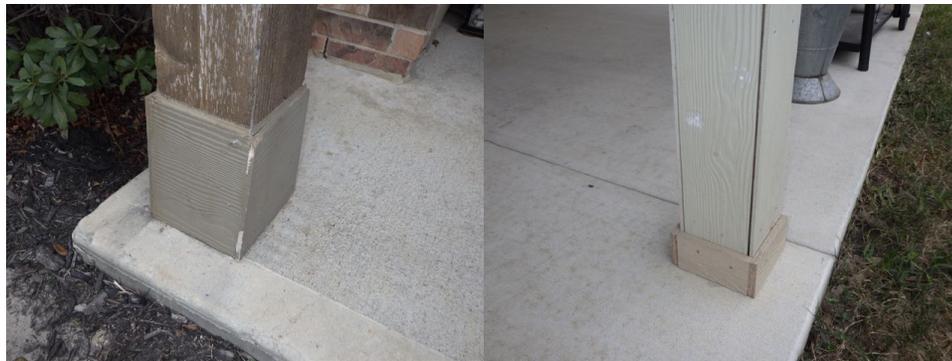
Observed cement board siding or trim improperly installed too close to cement walking surface in one or more areas. Typical installation requires 1" - 2" clearance from bottom of siding to cement according to manufacturer's recommendations to prevent moisture wicking. We recommend monitor for deterioration and repair as necessary.
<http://www.jameshardie.com/pdf/HardieZone-HZ10-Care-and-Maintenance-Guide.pdf>

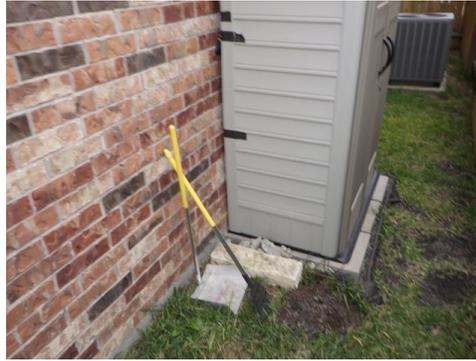
Observed storage building against foundation and wall at left. This is considered a conducive condition for wood destroying insects and can allow insects to enter the structure undetected. We recommend remove stored materials.

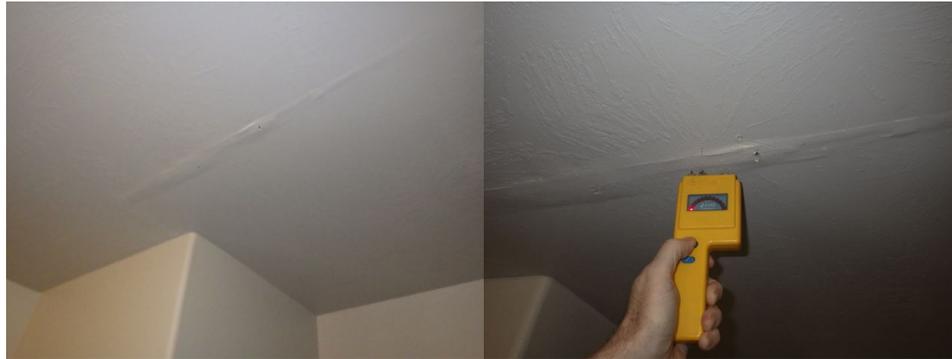
Water stains or damage was observed on ceiling in kitchen. Moisture detection equipment indicated that stains were not wet at time of inspection. We recommend further inspection by a specialist contractor and repair as necessary (stop leak and replace damaged materials).

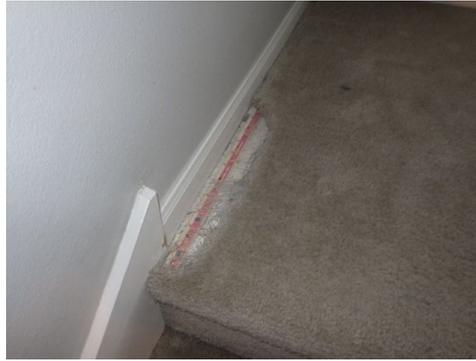
Observed carpet damaged, tack strip exposed at top of stairs. This is a tripping hazard. We recommend repair as necessary.

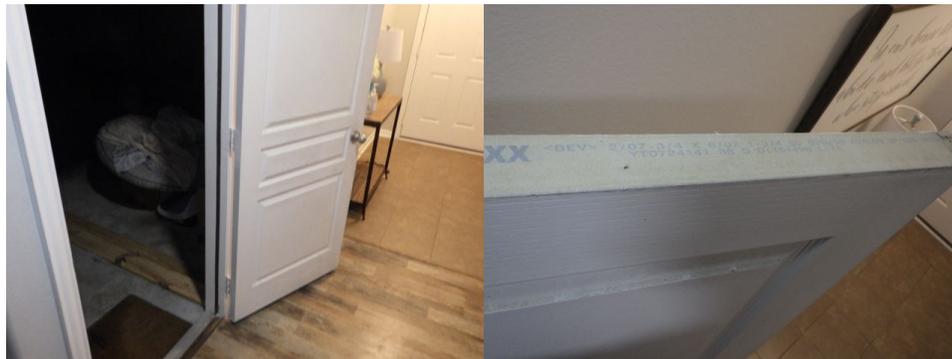
The door from house to garage did not appear fire resistant as required to protect an opening between garage and dwelling (Ref: IRC R302.5.1). The door was too thin due to decorative cuts. A solid core wood or honeycomb steel door 1 3/8" thick minimum or UL listed 20 minute fire rated door with self closer is required. We recommend install fire resistant door with self closer as required according to today's standards.

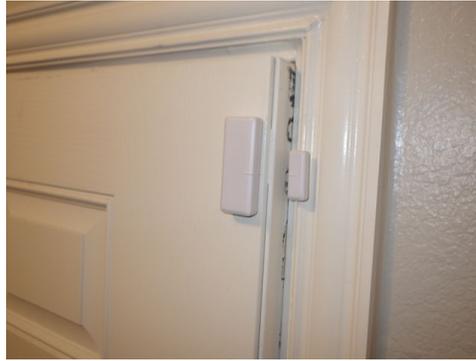
The front door was not square in jamb, improperly rubs frame. We recommend repair / adjustment to restore door(s) to a serviceable condition. This may be an indication of foundation movement or improper installation.

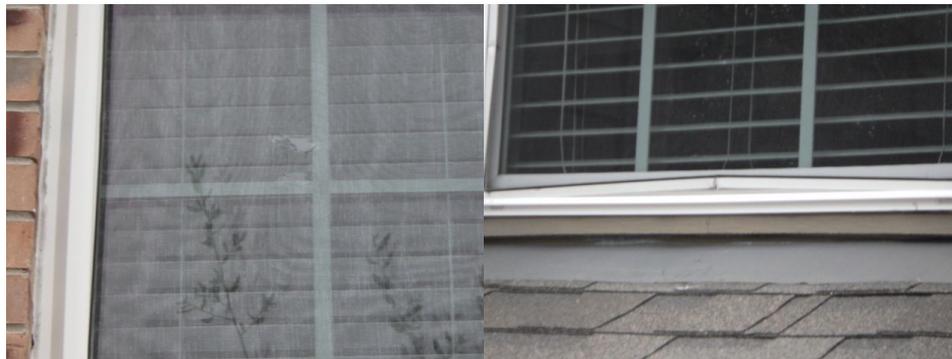
Two window screens were damaged. We recommend repair or replace as necessary.

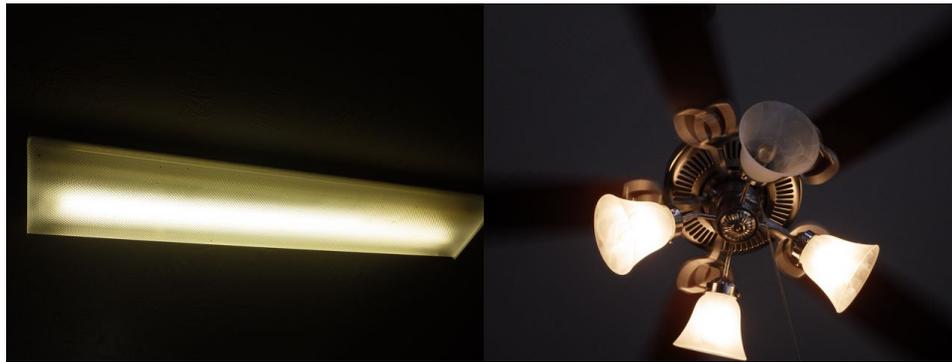
Light(s) were found to be not functioning in one or more areas. This is likely a burned out / missing bulb, but could be a broken fixture. We recommend repair or replace as necessary.

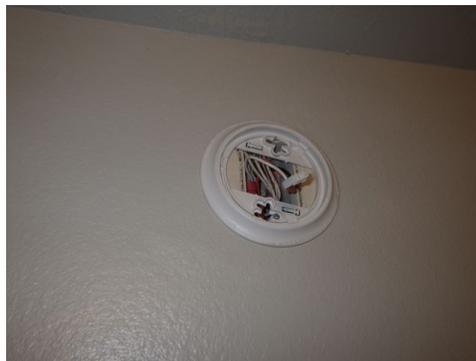
Smoke alarm was missing in upstairs middle bedroom . We recommend alarms be installed in each bedroom and in area nearby outside all bedrooms and at least one per level according to state law.

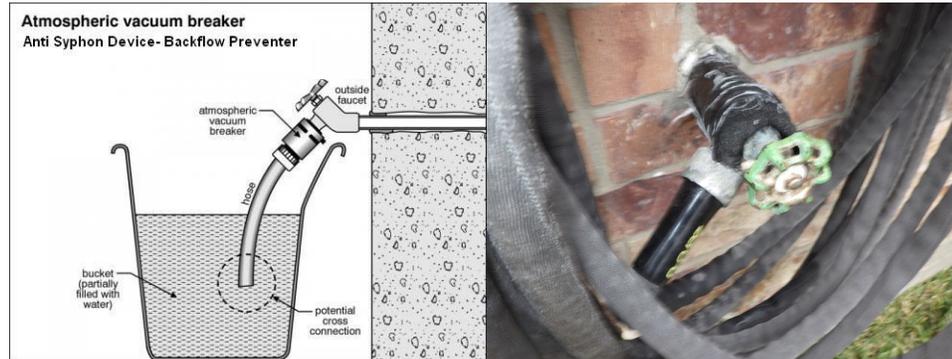
The right side hose bib was missing backflow preventer devices as required according to today's standards (IRC P2902.3). This is a possible hazard. We recommend install approved backflow prevention devices at all exterior hose bibs.

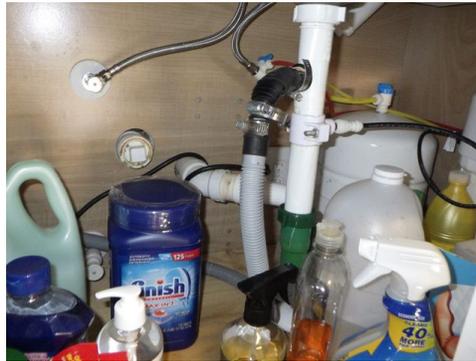
The dishwasher drain line lacked a visible backflow preventer (air-gap or high loop) as required by present standards and necessary to prevent mixture of supply and waste water from disposal. We recommend a high loop or an approved backflow preventer be installed.

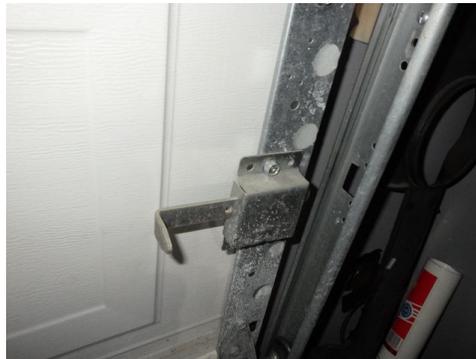
Observed operational lock on door equipped with automatic opener. Locks should be disabled on garage doors equipped with openers to prevent damage to door / track.

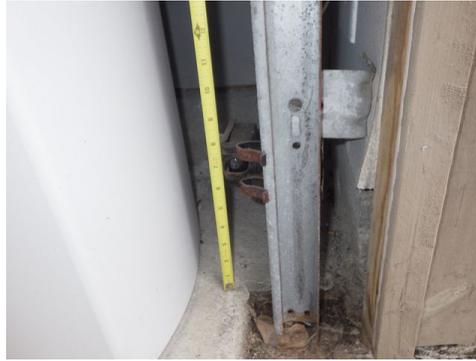
The garage door's infrared reversing beams were installed too high (more than 6") above the floor which decreases the devices effectiveness in preventing entrapment or injury. We recommend the beams be lowered to between four and six inches above the floor.

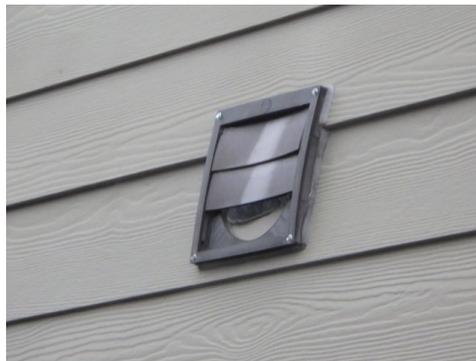
The dryer vent back draft damper was damaged. We recommend it be replaced to prevent water penetration.
