2021 build - 2630 sf
Hockley, TX

PROPERTY INSPECTION REPORT

By: David Gibbs, Lic #7406 TREC Professional Inspector 02/12/2021
(Name and License Number of Inspector) (Date)

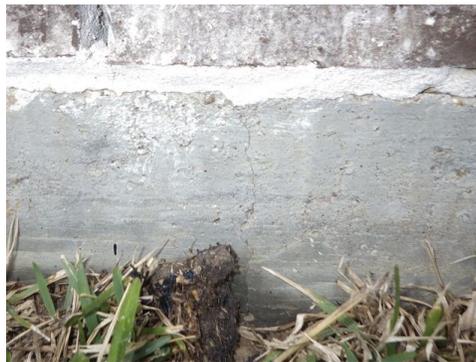
A hairline foundation crack was visible at edge of slab foundation at left rear. This cracking is likely result of shrinkage of materials or drain pipe too close to edge. Cracks 1/8" or less generally do not affect foundation strength. We recommend monitoring for changes and take corrective action as necessary.

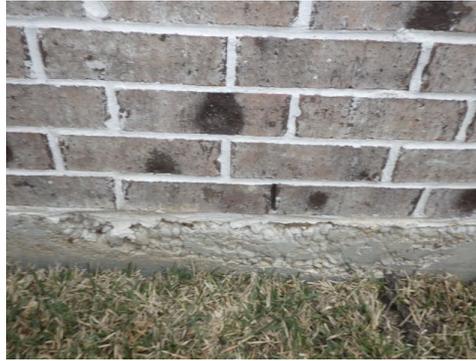
Observed uneven surface at foundation edge / aggregate visible. This is primarily a cosmetic condition, no repair recommended.

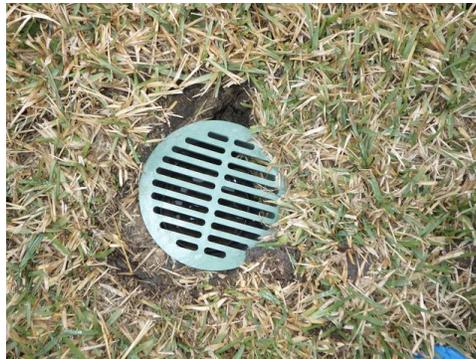
Soil grading had a depression or inadequate slope at rear, did not appear to properly direct runoff water away from foundation as required according to today's standards (6" drop in 10' Ref: IRC 401.3). This may adversely affect the foundation and cause differential settlement. We recommend repair as necessary.

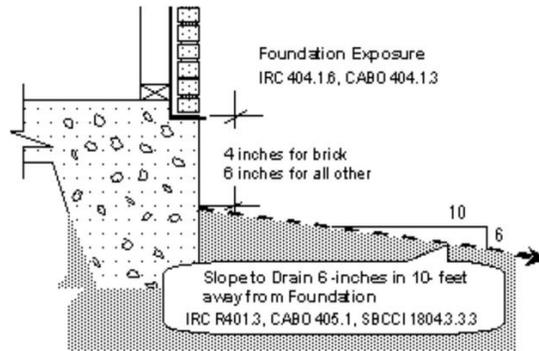
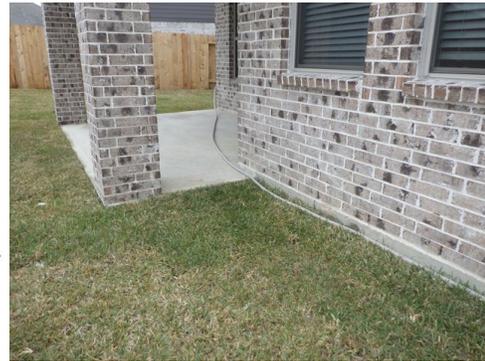
We recommend addition of rain gutters where not present to help improve drainage and foundation performance. Gutters with downspouts and splashblocks at bottom will minimize erosion and foundation movement associated with expansive soils.

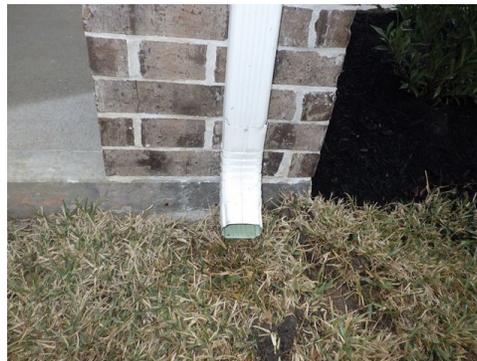
Runoff water from the roof gutters discharged next to the building. For improved foundation performance we recommend install splash blocks to direct runoff water sufficiently away from the building prevent erosion and saturation of the soil at foundation.

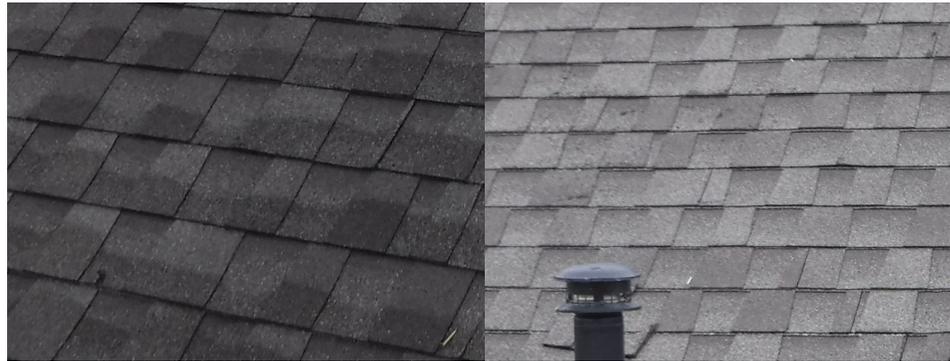
Observed shingles with minor surface damage / granular loss in one or more areas. These appear to be caused by foot traffic. Shingles with UV protective mineral coating damaged may wear out prematurely. We recommend use care when walking on roof, monitor for leakage and repair as necessary.

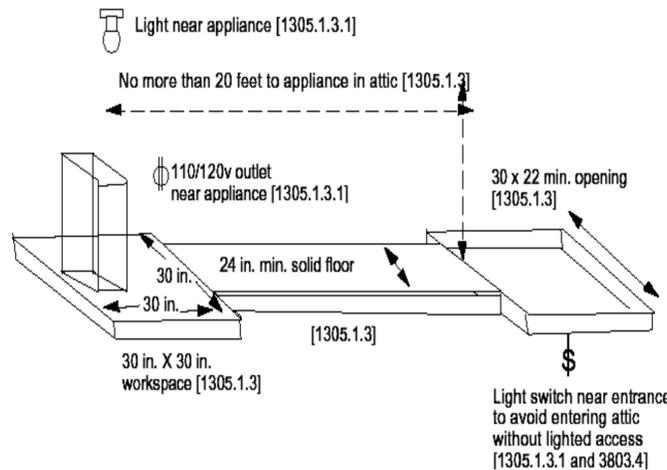
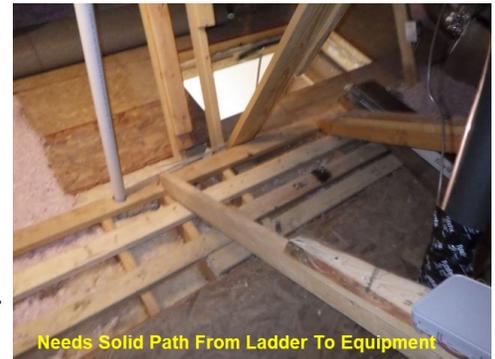
Observed inadequate attic walkway to mechanical equipment in attic for safety of service personnel. Today's standards require 30" head clearance and a minimum 24" wide solid path to equipment for servicing (Ref: IRC M1305.1.3). We recommend repair as necessary.

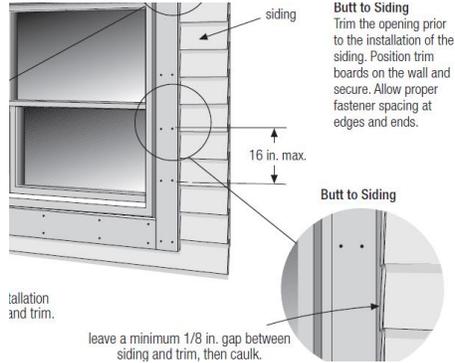
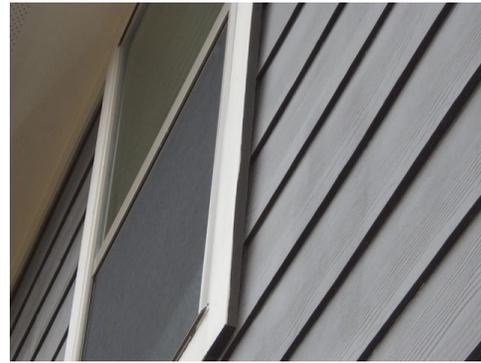
The cement board window trim appears to have been installed wrong, applied on top of siding leaving gaps. This may promote water penetration, pest entry and affect warranty. Typical installation instructions require siding to be cut to fit with ends flush and caulked against trim (diagram below is from James Hardie). We recommend caulk trim to mimic proper installation and minimize chance of water penetration.

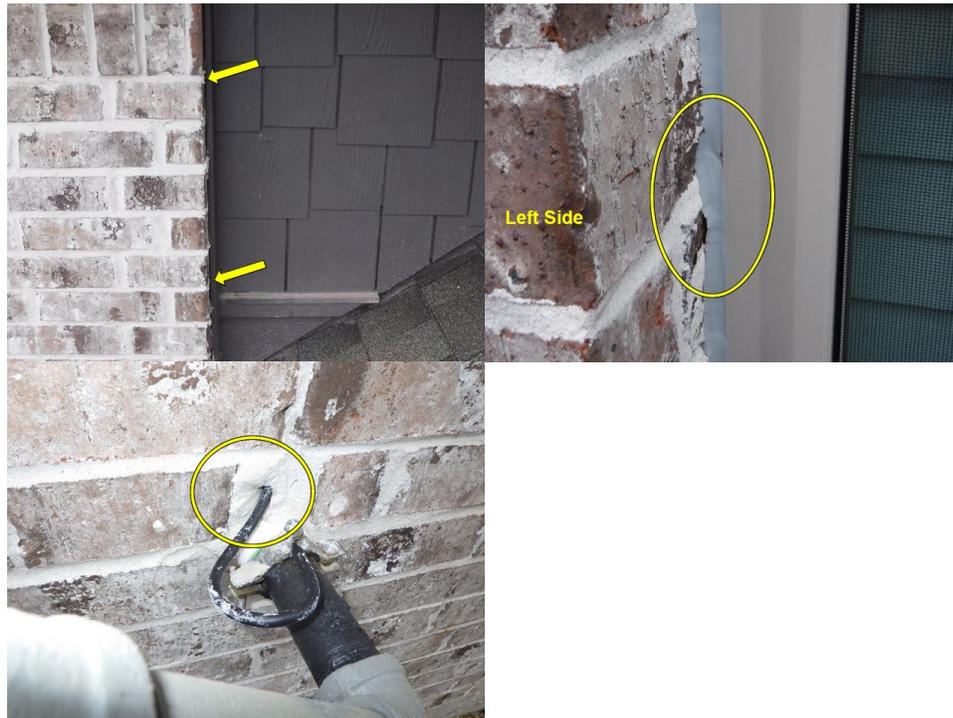
Observed caulking missing or deficient around wall penetrations in one or more areas. We recommend all wall gaps for trim over front entry / windows / plumbing / electrical etc, be caulked to prevent water penetration.

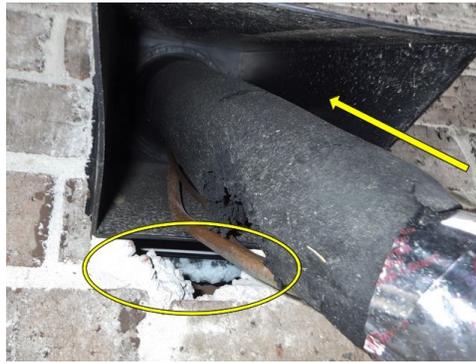
Observed gap in wall below flashing where air conditioner refrigerant / electric supply lines pass through exterior wall. We recommend install mortar and foam sealant to prevent water penetration and rodent entry.

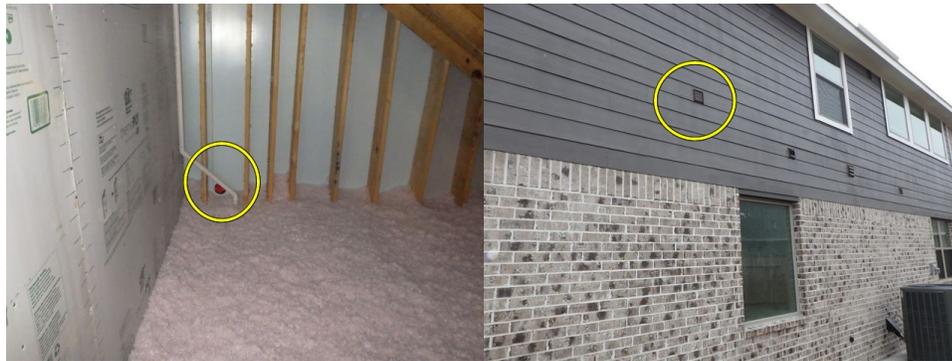
An unused / abandoned exhaust fan backdraft damper was visible over master bedroom. We recommend cover and seal to prevent water penetration.

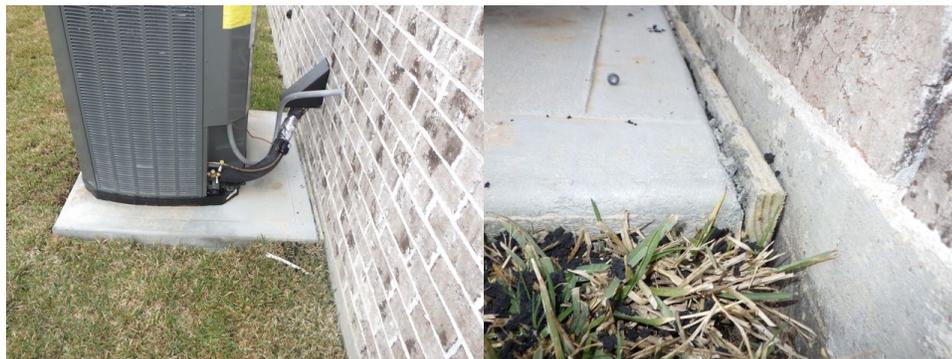
Wood form board(s) were observed against the foundation. These are left over from construction of foundation or adjacent flatwork and are considered a conducive condition for termites. We recommend remove any wood in contact with soil next to the house.

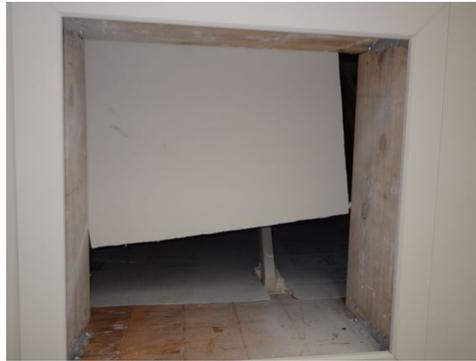
Attic access located in garage ceiling was not fire resistant as as required according to today's standards to protect an opening between garage and dwelling (Ref IRC 302.5.1). A solid core wood door / honeycomb steel door 1 3/8" thick minimum or labeled 20 minute fire rated (metal or treated with fire retardant) cover is required. We recommend install UL listed fire resistant stairs or cover as required according to today's standards.

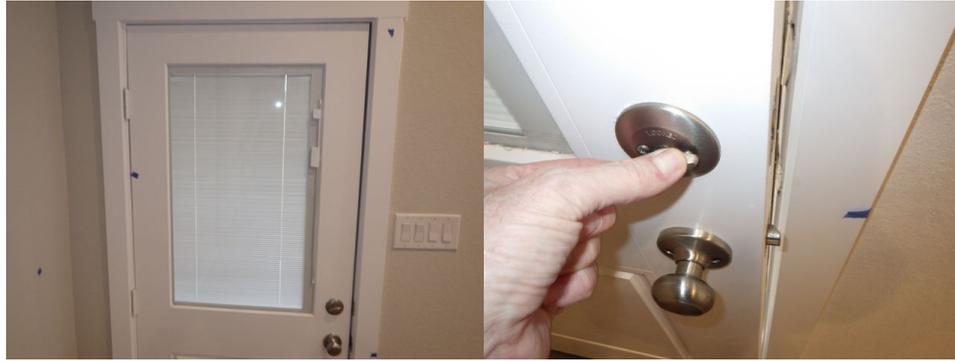
The back door was not square in jamb. The deadbolt appeared under tension and binding (even when door was open). We recommend repair / adjustment to restore door(s) to a serviceable condition. This may be an indication of foundation movement or improper installation.

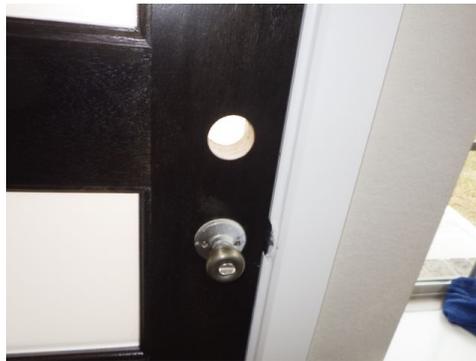
(work in progress) Temporary hardware was present in front door with no deadbolt. We recommend complete installation.

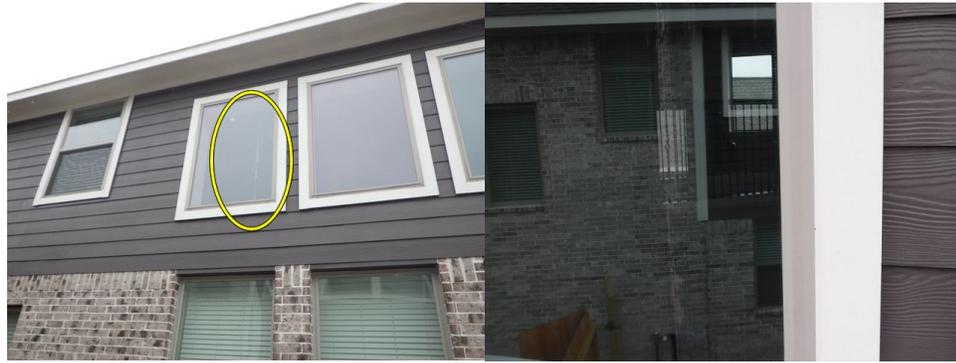
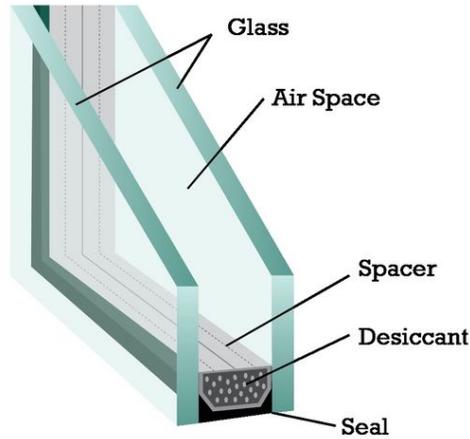
There was discoloration or condensation between the panes of insulated glass in a living room window. This suggests a failed seal or defect between the panes. This is primarily cosmetic with likely minor effect on insulating quality. The common repair for this would be to replace the glass.

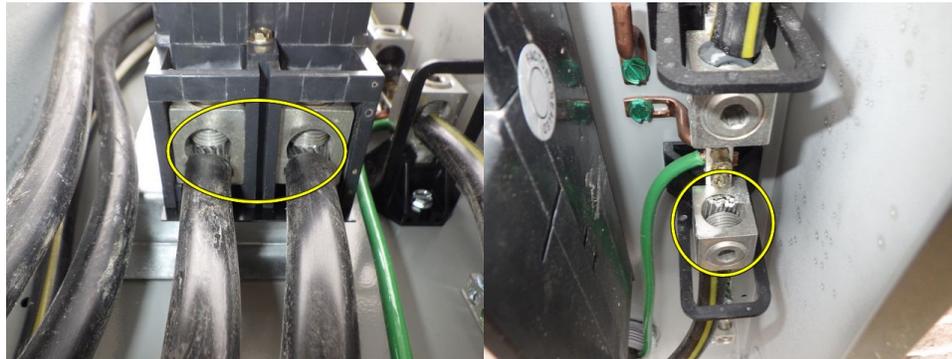
There was no anti-oxidant compound (grease) visible on the aluminum feeder wire connections as required by TREC. Antioxidant is applied to aluminum connections to prevent oxidation which leads to electrical resistance and heat. (This may not be required by manufacturers of modern aluminum cables and equipment.) For maximum protection, we recommend apply antioxidant to connections.

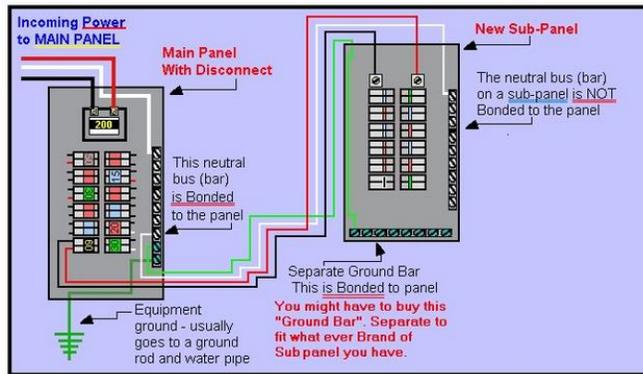
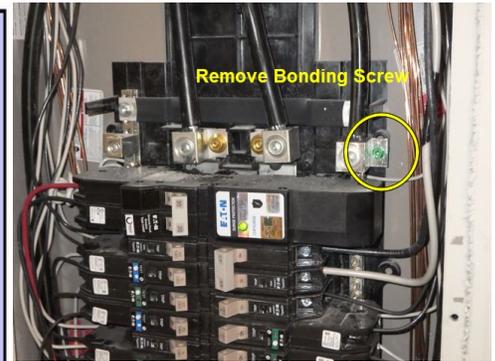
The system neutral and grounding conductors appeared to be improperly bonded together in garage subpanel. This can create two paths to ground and a create a shock and/or fire hazard in case of ground fault. We recommend further inspection by a licensed electrician and repair or replace as necessary (Ref: IRC E3607.2). We recommend further inspection by a licensed electrician and repair as necessary.

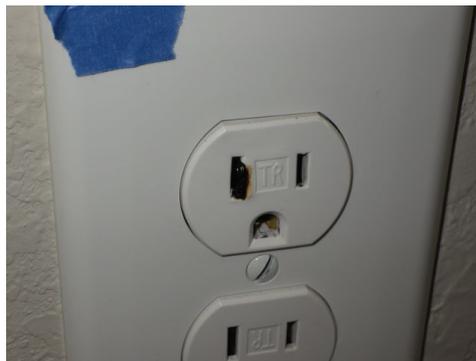
Observed damaged or burned outlet in entry hall / living room. We recommend replacement to prevent shock or fire hazard.

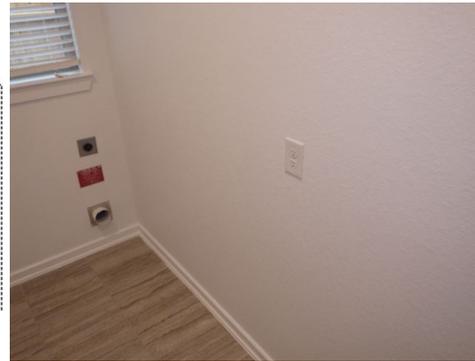
GFCI protection was not observed at 120 volt receptacles in laundry room, considered a wet/hazardous location according to today's standards. This may not have been required at the time of construction, but to minimize shock hazard, we recommend install GFCI protection.

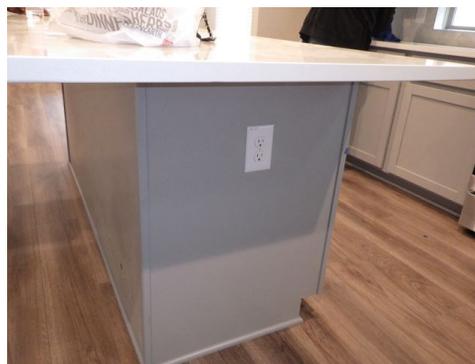
Observed improper location of kitchen island outlets more than 12" below countertop. This is required according to today's standards (code) to prevent use of extension cords in wet locations, a possible shock hazard. (Ref: IRC E3901.4.5 Exception). We recommend repair or replace as necessary.

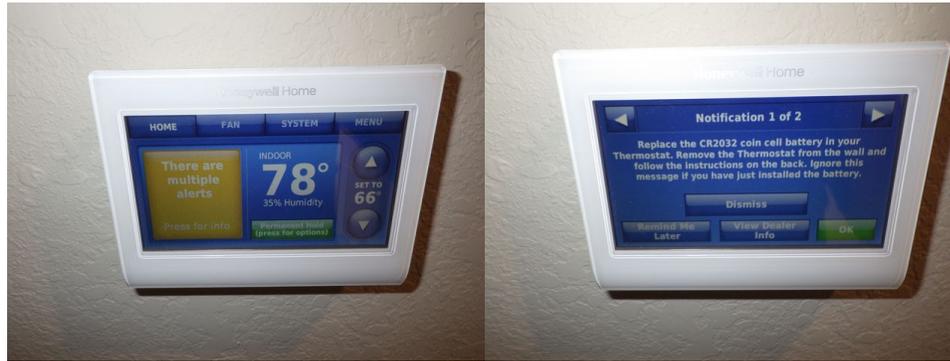
Observed upstairs thermostat did not appear to operate properly (12 degrees higher than setting & low battery). We recommend repair or replace as necessary.

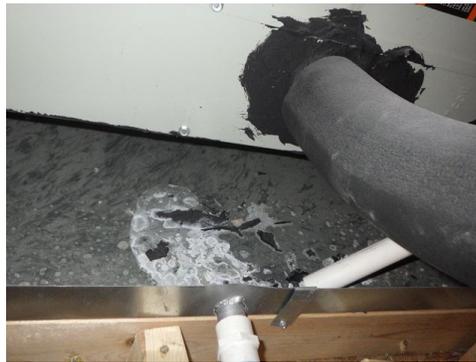
Observed corrosion or water stains below the air conditioner evaporator coil in the emergency drain pan. This is an indication of past or current leakage of condensation from evaporator coil or drain line. We recommend further inspection by a licensed HVAC technician and repair if/as necessary.

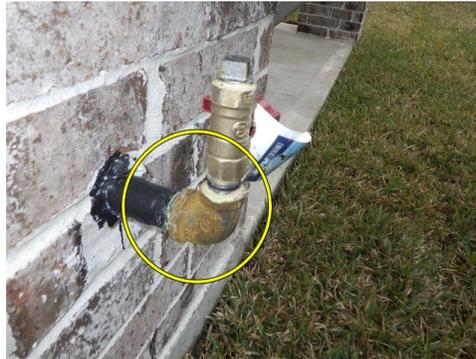
Gas piping was corroded at exterior BBQ connection. We recommend the affected piping be cleaned and painted to prevent deterioration.

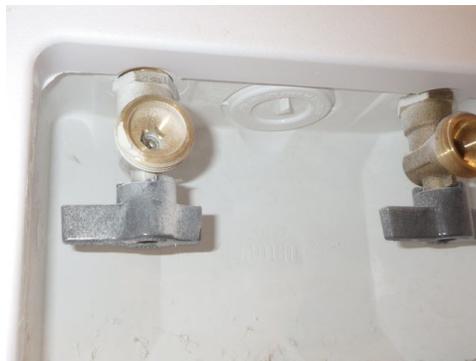
Observed laundry washing machine water supply hose bibs are heavily corroded and show evidence of past leakage. We recommend further inspection by a licensed plumber and repair or replace as necessary.

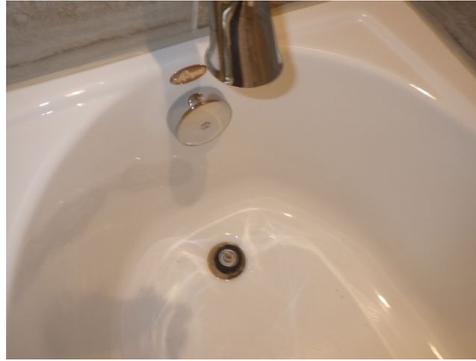
The downstairs hall bathroom tub drain stop was missing or inoperative. We recommend repair or replace as necessary.

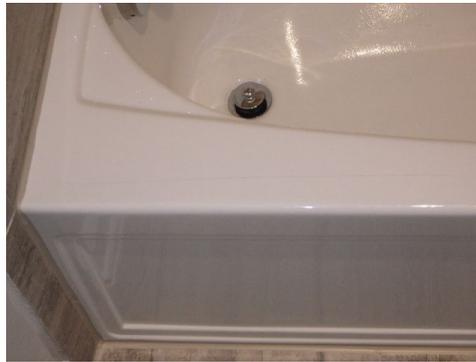
The upstairs bath tub had a large scratch / cosmetic damage.

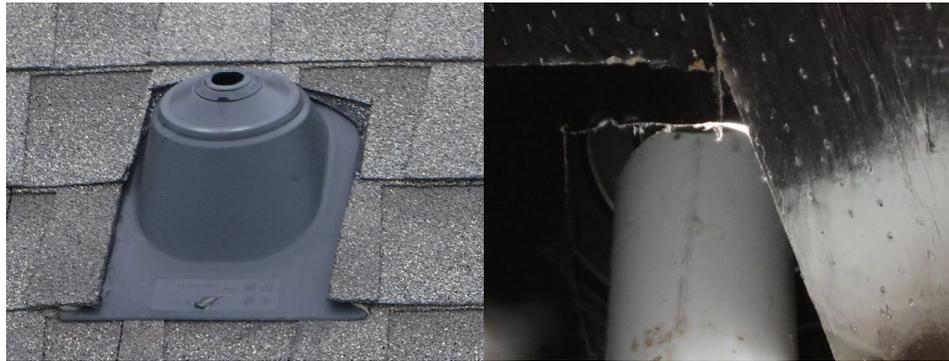
The plumbing vent pipe near water heaters (upstairs bathroom?) did not extend above the roof flashing. This will allow water penetration into attic. We recommend the vent be extended 6" or more past rubber boot as required according to today's standards to prevent water penetration.

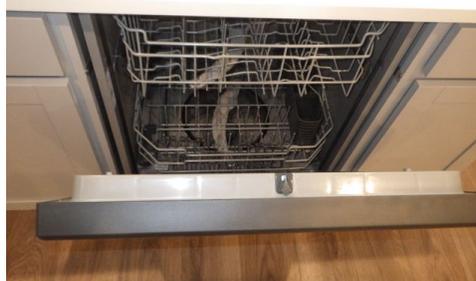
The dishwasher was not properly secured to cabinet, movement was observed when door opened. We recommend the dishwasher be secured as required according to manufacturer's recommendations.

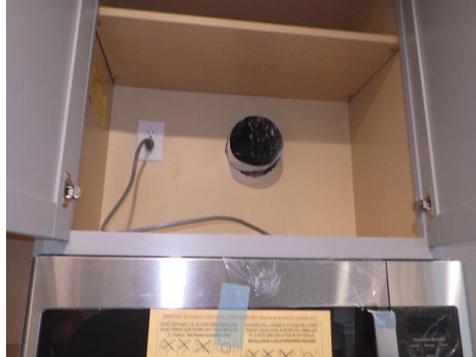
(work in progress) The kitchen exhaust fan does not vent to the exterior. Instead it terminates in the cabinet. This is a potential fire hazard as well as a condition that can damage the interior of the cabinet from moisture and grease. We recommend the exhaust fan be routed to the exterior in accordance with present standards.
